ARCHAEOLOGICAL WATCHING BRIEF

WEST STREATLEY HOUSE, HIGH STREET,

STREATLEY-ON-THAMES, BERKSHIRE

NOVEMBER 2020

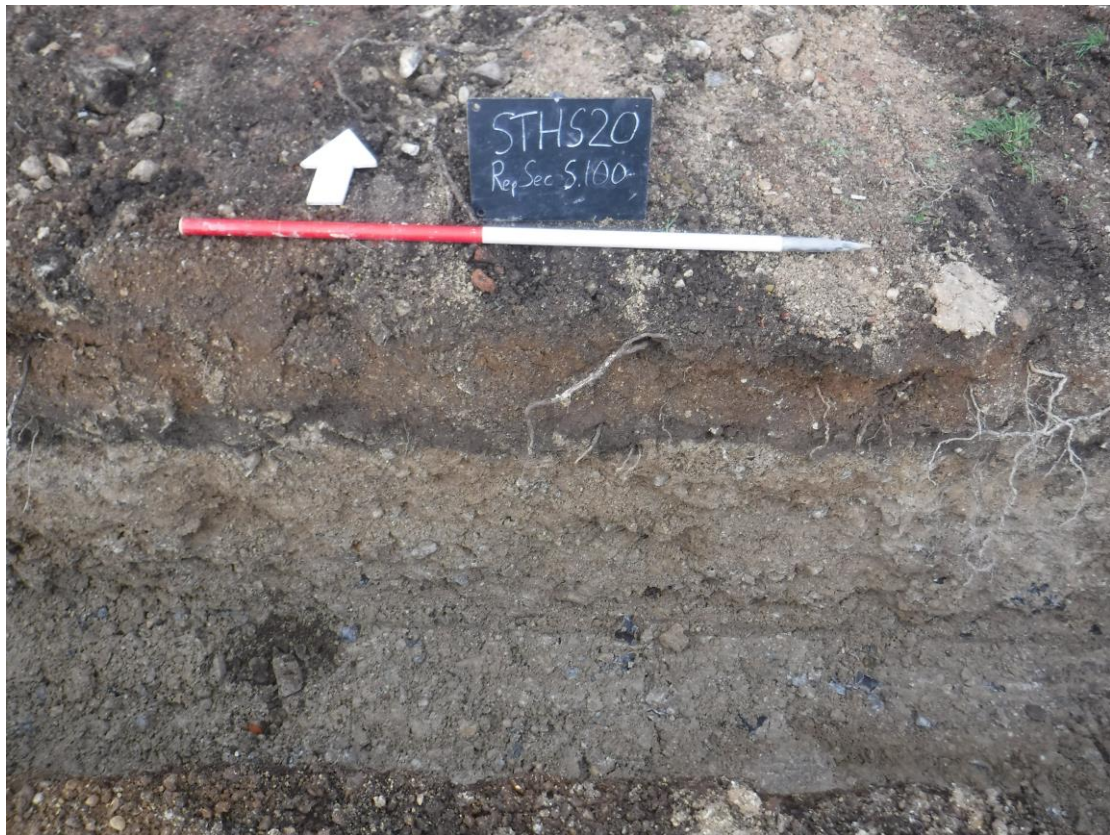
Plate 1: Section 100. Looking North.

The earliest recorded deposit comprised a compact, mid yellowy-grey sandy gravel (102) (Figure 2; Plan 100, Sections 100 and 101; Plates 1 and 2). It contained frequent inclusions of small to large pieces of flint and chalk. Deposit (102) measured greater than 12m in length and in width, as well as greater than 0.74m in thickness at a maximum depth of 1.02m. This deposit was identified as the natural chalk geology and was observed throughout the full extent of the excavated foundation footings.

Stratified above deposit (104) was a friable, dark grey silty-clay (101) (Figure 2; Plan 1 and Sections 100 and 101; Plates 1 and 2). This deposit contained infrequent inclusions of flecks to small pieces of chalk and stones as well as infrequent rooting. It measured greater than 12m in length and in width as well as measuring between 0.4 and 0.28m in thickness. This deposit was observed at a depth of between 0.20m and

Overlying deposit (101) was a loose, mid brown silty-sand (100) (Figure 2; Plan 100 and Section 100; Plate 1). It contained inclusions of flecks to medium-sized pieces of stone rubble, brick rubble and chalk. Deposit (100) measured greater than 12m in length and in width, as well as measuring 0.28m in thickness. This deposit was observed as underling the existing patio surface, as well as being truncated by the construction of the existing house foundations. Deposit (100) has therefore been identified as a made-ground levelling deposit for the construction of the house.

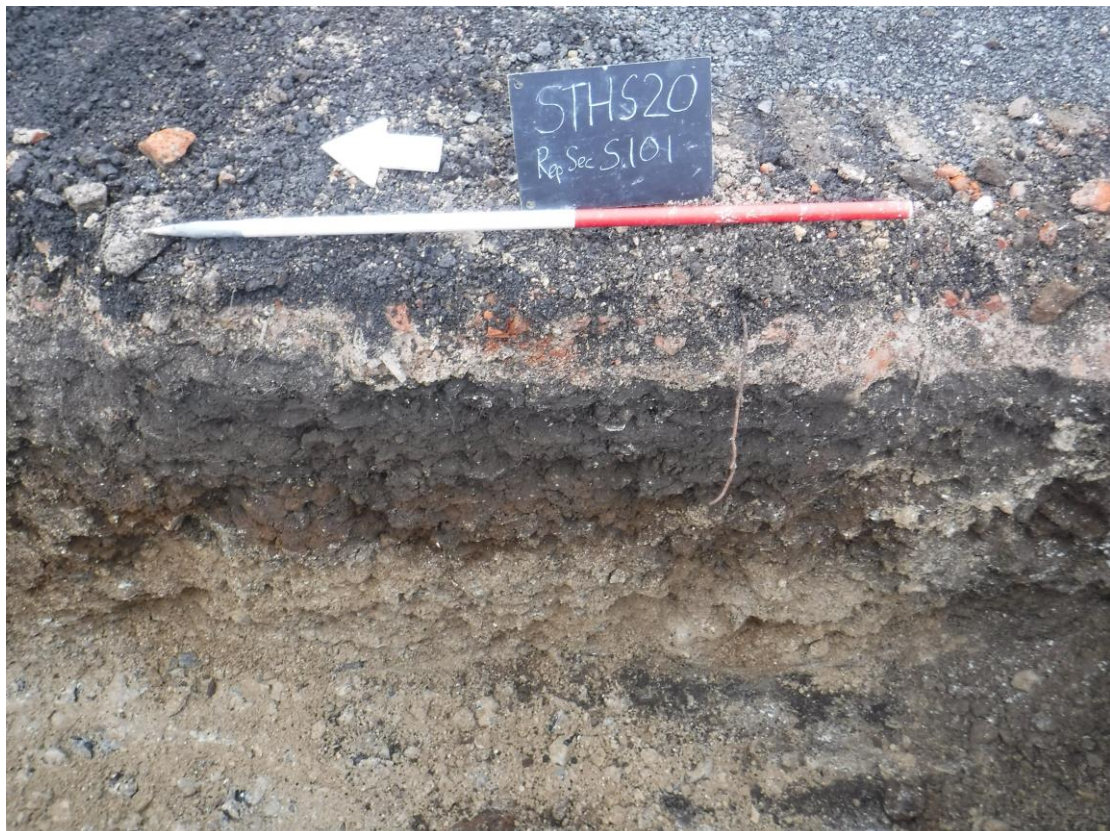
Plate 2: Section 101. Looking East.

Overlying the natural deposit (102) was a friable, mid brown sandy-silt (104) (Figure 2; Plan 100 and Section 101; Plate 2). It contained inclusions of infrequent flecks to small pieces of chalk. It measured greater than 0.70m in width and greater than 4m in length, with a thickness of 0.45m at a depth of 0.55m. This deposit was only observed in the south-western extent of the site, and was not identified towards the existing house. Deposit (104) has been identified as a subsoil associated with the pre-existing garden plots within this area.

The latest deposit observed, and subsequently overlying the made-ground deposit (100) was a loose, light grey-white mixed material of chalky sand and tarmac (103) (Figure 2; Plan 100 and Section 101; Plate 2). It contained further inclusions of small pieces of brick and stone rubble. Deposit (103) measured greater than 2.50m in width and greater than 3m in length and had a maximum thickness of 0.30m. This deposit was identified as a modern surface, it was identified as overlying the made ground deposit (100) in the south and south-eastern area of the site.

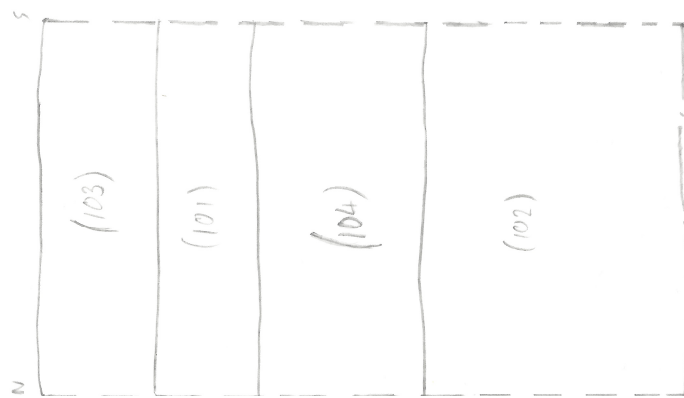
STHS20 5.101

Discussion Modern surface for the installation of a faience surface, observed in the SW part of the site. This deposit was observed in S.101, above deposit (101).

Discussion Made good layer similar to deposit (100) observed in the northern parts of the site. Observed underlying (101) in S.101 and underlying natural (102). Not observed within S.100. Identified as a levelling layer. Possible subsol of pre-existing gravel bauls, as it was not identified near the house.
