AN ARCHAEOLOGICAL EVALUATION

CASTLE HOUSE, 5 NORTH STREET,

CASTLETHORPE, MILTON KEYNES

FEBRUARY 2021

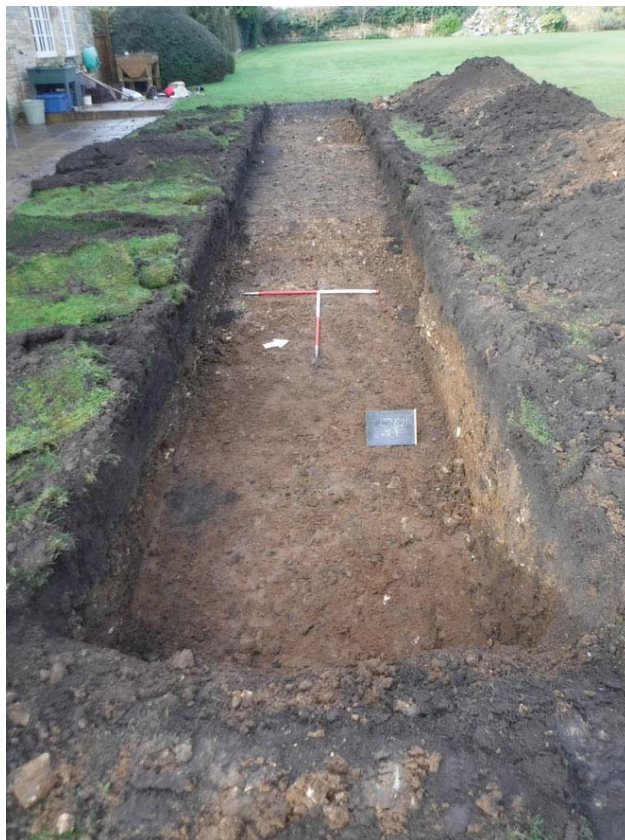
Plate 1. Trench 1.

The lowest deposit was mid reddish/orange brown clay with moderate to frequent angular stone inclusions (Fig. 2, Section 1.01, 1.02, Plan 1.01; Plate 1). The deposit was identified as a natural geological deposit (1/06). The deposit was only identified in the easterly half of the evaluation trench and in a small test pit in the westerly part of the trench. This was due to presence of potentially important overlying archaeological deposits in the west of the excavation which prevented machine excavation down to the natural in the west of the trench.

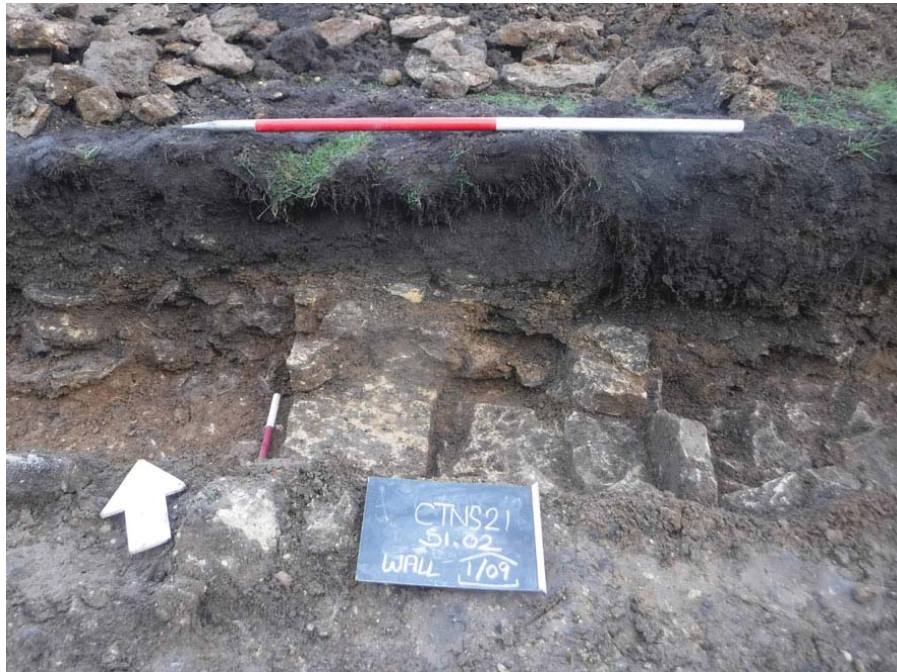
Plate 2. Wall 1/09. NNE view.

Overlying the natural was a 0.35m thick deposit of very firm, mid-reddish brown clay with occasional grey patches and with frequent to dominant angular limestone fragments and moderate inclusions of charcoal (1/05) (Fig. 2, Section 1.01). The lower horizon of the deposit displayed a diffuse transition with the underlying geology, suggesting that the deposit contained a high proportion of re-deposited geological material that was only slightly modified. The deposit may have been the same as one identified towards the westerly end of the trench, which was 0.2m thick, of a similar colour and consistency and contained moderate to frequent angular and platy limestone inclusions and moderate charcoal flecks (1/12) (Fig. 2, Section, 1.02; Plate 2).

Wall **1/09** was orientated SSE to NNW; it was greater than 1.6m in length and measured 0.9m wide (Fig. 2, Section 1.02, Plan 1.01; Plate 2). The surviving height of the wall foundation was between 0.26m and 0.37m. The wall was constructed of large squared stones on the outer faces, at the base of the foundations, with more roughly cut angular pieces for the higher surviving courses. The higher courses were set with the flat face flush with the face of the wall. The core of the wall featured more roughly squared angular pieces. The easterly face of the wall featured a large flat slab set on its narrow edge with the large face of the slab set against the wall face.

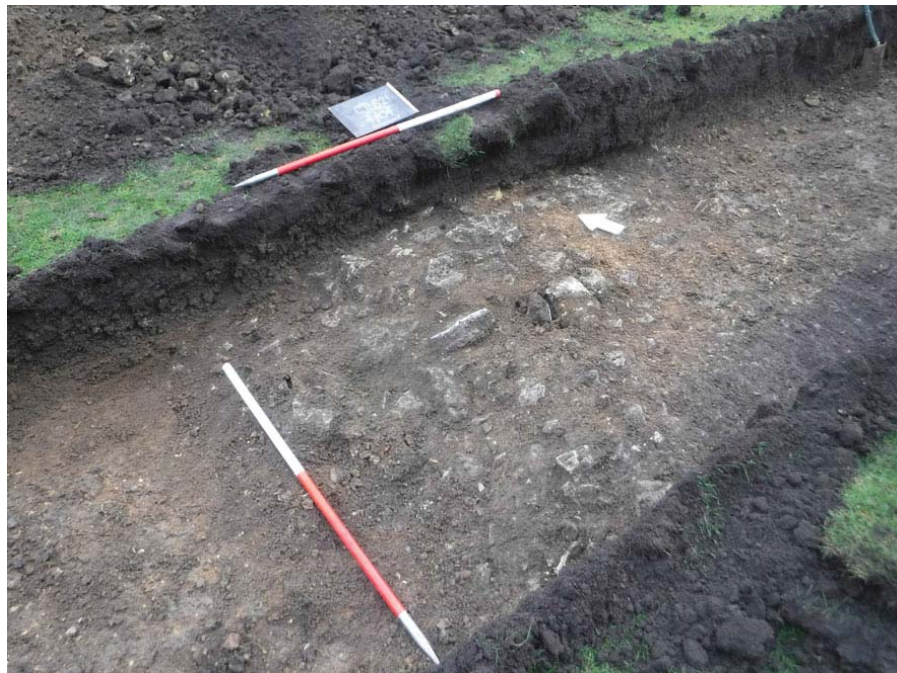
Plate 3. Demolition rubble 1/04 overlying Wall 1/09. North-East view

Overlying the wall and immediately to the edges of the wall was a deposit of limestone rubble (1/04) (Fig. 2, Section 1.02, Plan 1.01; Plates 2 and 3). The rubble was well cemented in a deposit of mid to light grey sandy clay loam, which was around 0.35m thick. The deposit contained ceramic roof tile that was broadly dated from the medieval to the post-medieval period.
