JOHN MOORE HERITAGE SERVICES

**ARCHAEOLOGICAL RECORDING ACTION**

**CRUSHER YARD SITE, PIPEYARD LANE,  
NEWBOLD COLEORTON, LEICESTERSHIRE**

**MARCH 2021**

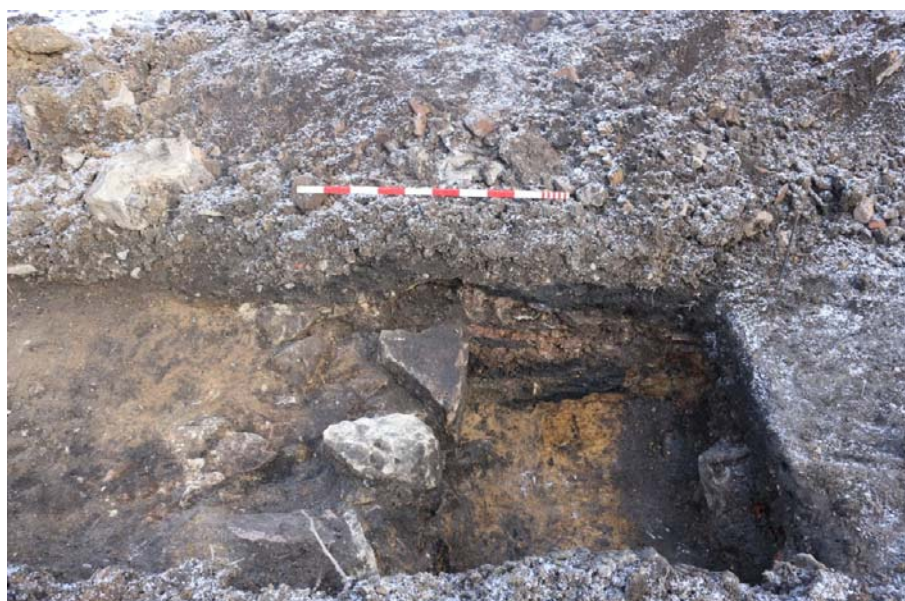
A single archaeological feature was encountered within the trench. This was a linear cut, 112, situated at the southernmost end of the trench (Figure 2; Plate 1). The cut appeared to be aligned NE-SW and measured 1.25m in length, continuing beyond the limit of excavation (l.o.e.) to the NE and SW, at least 2.4m in width, also continuing beyond the l.o.e to the SE and 0.6m in depth. The SE side of the feature had been truncated by a modern service trench 104. The cut, which had steep sides and a flat base, was associated with a wall or revetment **113**, built into its NW side. This structure was built of large sandstone blocks measuring approximately 400mm x 300mm x 300m; no coursing was evident as the structure only survived to the height of one block. The wall was bedded in a packing deposit of compact mid grey silty clay (115) which contained occasional angular stones.

Plate 1: Section 3; Wall **113**. Looking NE

Within Trenches 1 and 3 the south east face of a sandstone block wall was recorded, aligned in a north east – south west direction; within Trench 1 this was seen to sit within a shallow cut that had a flat base and extended beyond the edge of the excavation to the south. Though it cannot be said for certain, the orientation and location of the wall is highly indicative of this being the south eastern face of a revetting wall associated with the plateway. The plateway would therefore have sat within the cut seen to the south of the wall in Trench 1. Evidence of the track itself was recorded in Trench 2, where four large sandstone blocks were found, three of which had centrally located holes. It is probable that these represent sleepers associated with the plateway; the holes would have been plugged with wood, into which a metal nail was inserted, securing the track to the sleeper

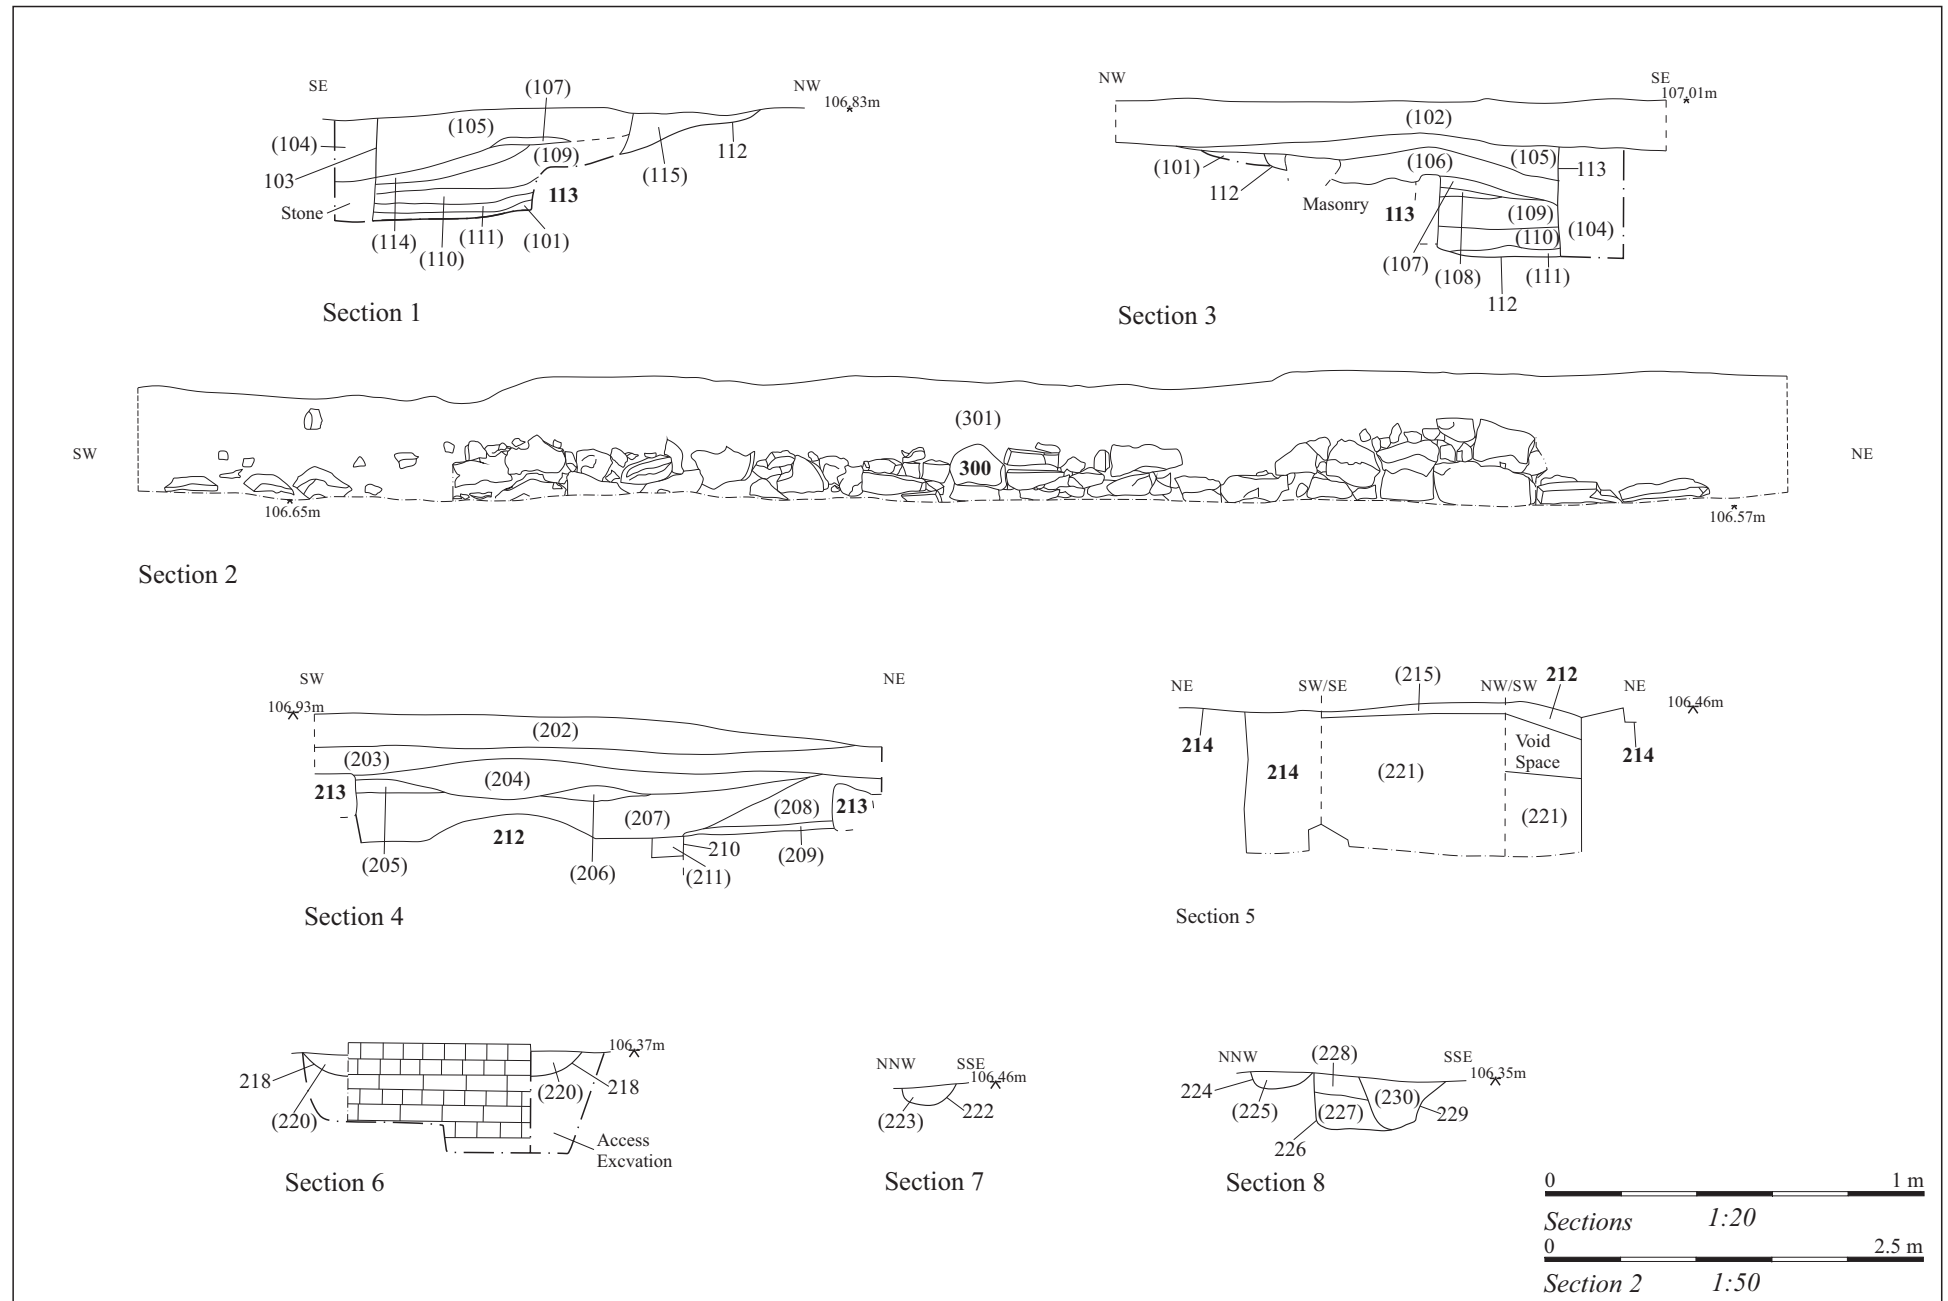
Figure 3: Sections

The cut was filled with a series of layers that were likely to have been deposited in order to backfill the feature (Figure 3; sections 1 and 3). The lowest of these was (111), a thin lens of coal dust; this was overlain by (110) a soft mid greyish brown silty clay with occasional charcoal flecks, 0.18m in thickness. Deposit (109), overlying (110), was a friable dark brownish grey sandy silt containing coal dust, 0.2m in thickness. This in turn was overlain by a small deposit of coal dust (108) and a brownish red firm sandy silt (107), both approximately 80mm in thickness. These deposits were overlaid by a thicker deposit of firm mid grey sandy silt (106) measuring 0.2m in thickness. The final layer of the sequence was a soft dark blackish brown silt (105), up to 0.4m thick, which had the appearance of a former topsoil. Finds recovered from this deposit indicated a 20<sup>th</sup> century date.

This structure was truncated by construction cut 210 for a vaulted brick culvert or cess pit **212** and **214** associated with Pipe Yard House (Figure 3; Section 4).

Where the vaulted culvert **212** had been constructed a series of made ground layers were present, raising the ground level above the structure (Figure 3 section 4, plate 3).

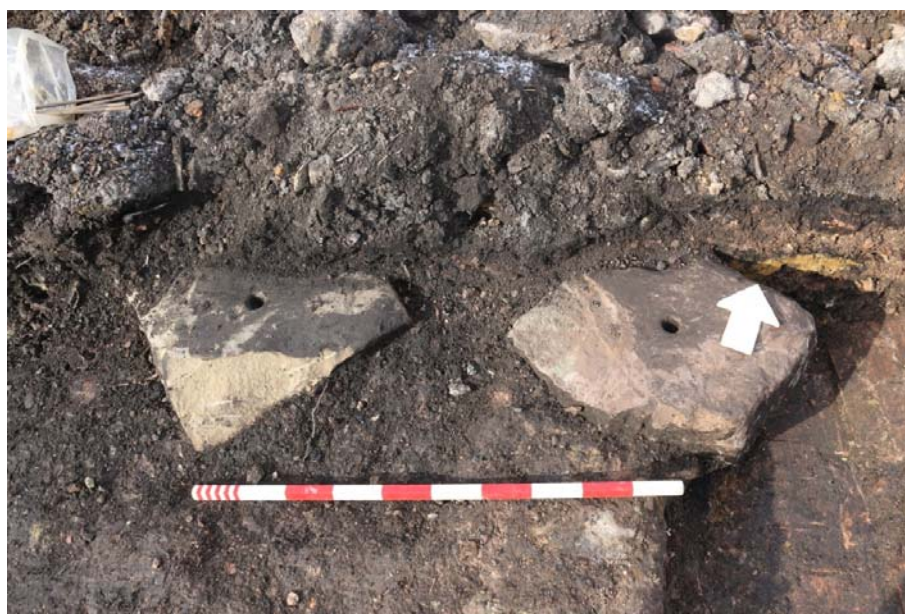
A row of four sandstone blocks **213**, extending for a length of 5m, were encountered against the western l.o.e (Figure 2). Each block was between 0.5 to 0.8m in length, 0.4m in width and 0.2 to 0.5m in depth; no construction cut was observed, instead it appeared that each block sat within subsoil (200) directly on top of the natural geology. Three of the blocks contained a central hole with a diameter of approximately 40mm; the fourth had been damaged. The blocks appeared to form a line, aligned NNE-SSW, extending beyond the l.o.e. in both directions.

Plate 2: Structure **213**; showing sandstone blocks and central holes. Looking NNW

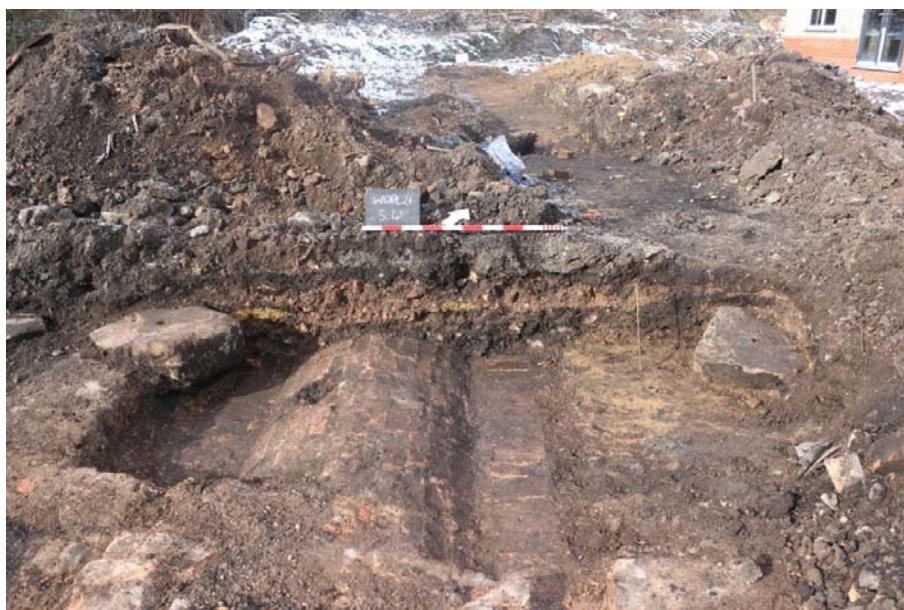
Plate 3: Structure **213**, showing truncation by vaulted cess pit **212**. Looking NNE

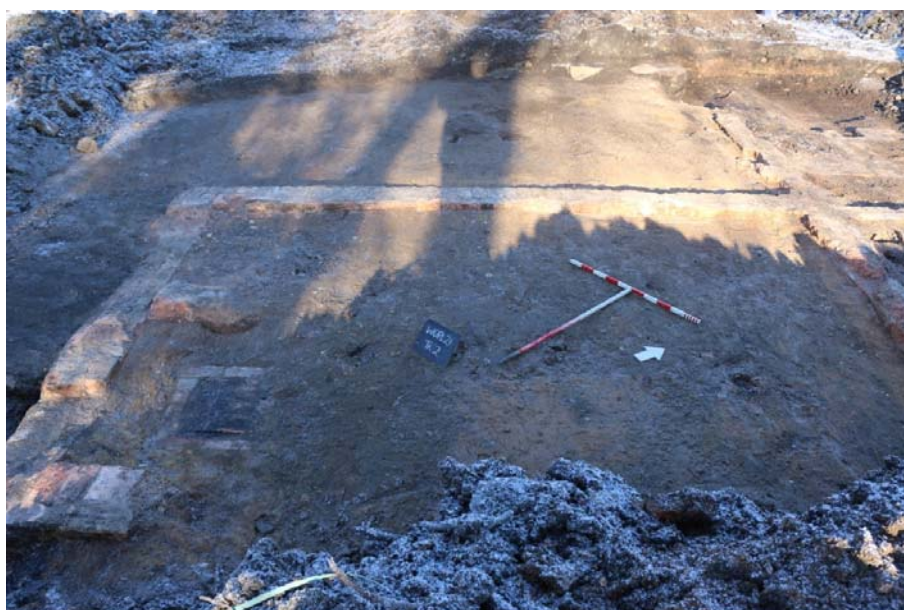
The foundation of the former Pipe Yard House was encountered within the trench. The foundation, recorded as **219**, **232**, **235** and **237** comprised two rectangular foundations with internal features including a brick hearth **217** and previously mentioned vaulted culvert or cess pit, **212**, **214** (Figure 2). The foundations were built of bricks measuring 220mm x 110mm x 70mm set in an English bond and bonded with a light whitish grey cement mortar. The walls were built within a construction cut 118 that was cut into the natural deposit to a depth of 0.5m (5 courses). The upper 0.2m of the construction cut was filled with a soft light brownish yellow silty clay, though the lower extent of the cut was not visible (Figure 3; section 6).

Plate 4: The southern end of Pipe Yard House, foundation **119**, looking NE.

The foundations of the former Pipe Yard House were recorded in Trench 2. A single phase of construction seemed evident, with bricks, mortar and construction methods appearing consistent throughout. The size and uniformity of the brick suggests a 19<sup>th</sup> century date. Of note was a brick hearth located against the southern wall of the building and a cess pit and vaulted culvert situated on the western side of the building. The construction of this feature had resulted in the removal of some of the stone sleepers associated with the plateway, thus indicating that the house was built after the route had fallen out of use.

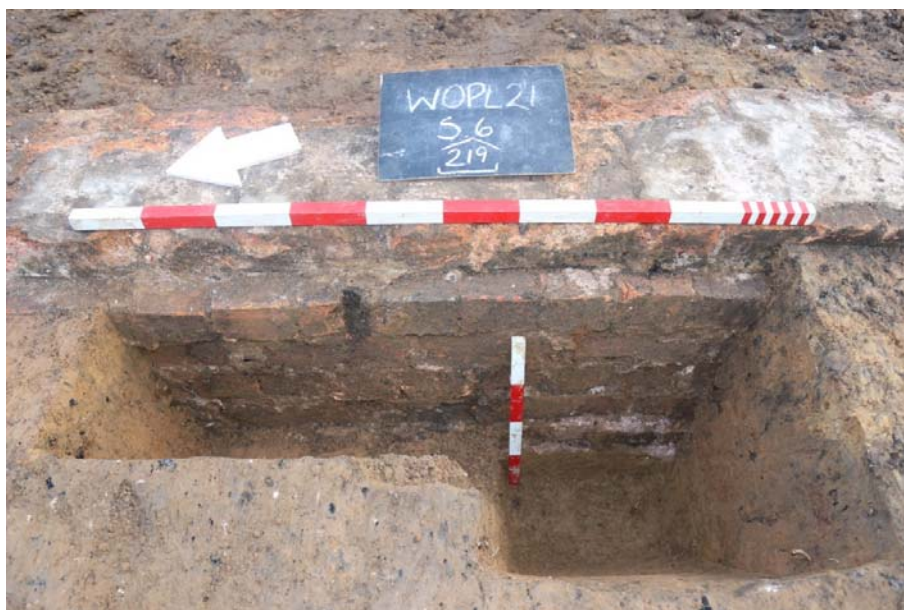
Plate 5: Foundation wall **219**; section 6. Looking ESE

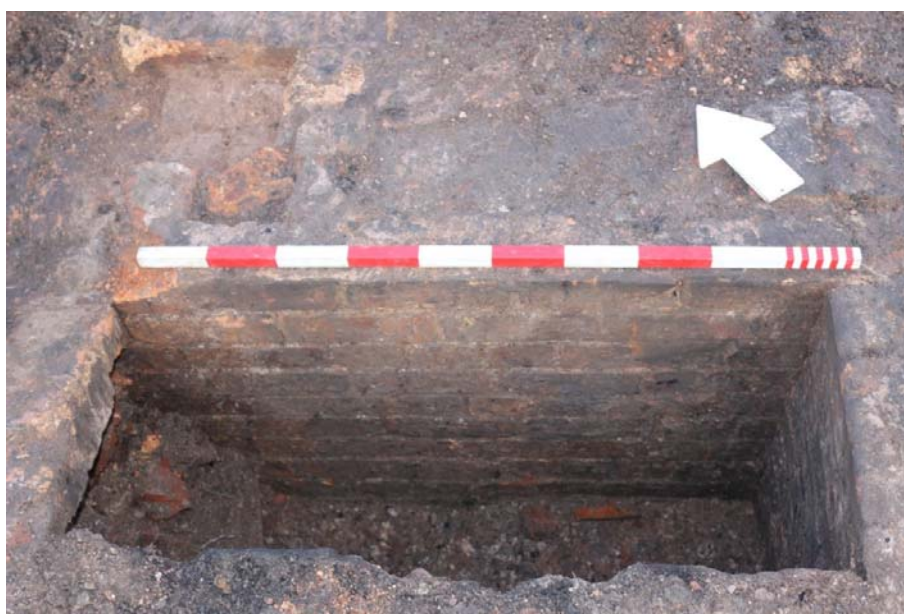
The brick built cess pit **214** was built into the western foundation wall and measured 1.4m in length by 1.2m in width; the cess pit was excavated to a depth of 0.8m, though extended deeper. The brick was set in an English bond and bonded with the same light whitish grey cement mortar. Vaulted culvert **212** extended west from the cess pit for a length of 1.2m, extending beyond the l.o.e. to the west. The cess pit and culvert had been backfilled with demolition rubble, presumably associated with the demolition of the building (Figure 3; section 5). The lowest deposit (221) was a loose light brownish grey sandy silt with frequent fragments of brick and tile, at least 0.7m in thickness, extending below the l.o.e. The upper fill (215) was a loose light greyish brown sandy silt 80mm in thickness.

Plate 6: Cess pit **214**; section 5. Looking NE

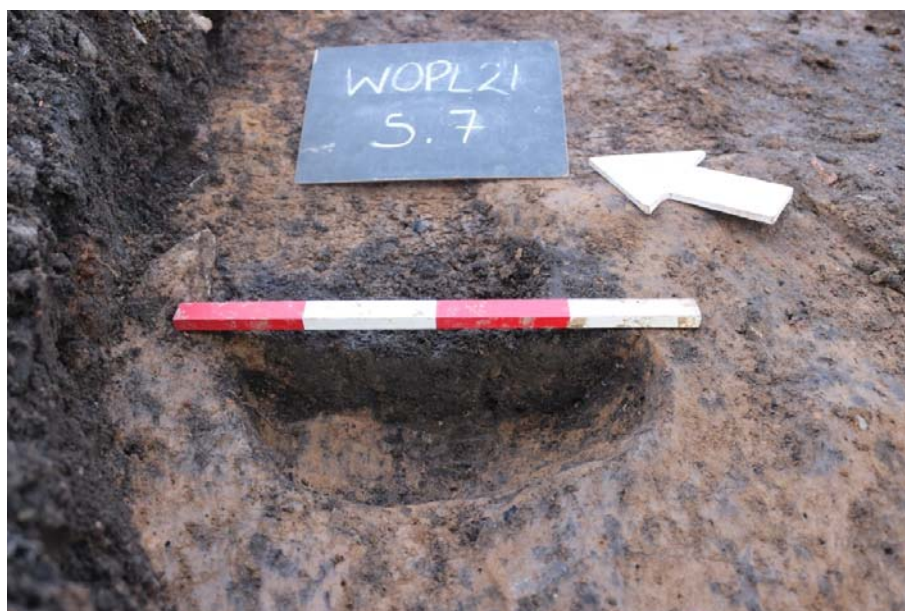
In addition to the structures associated with Pipe Yard House four postholes or pits were recorded. These were located in a small cluster to the west of the former building (Figure 2). Posthole 222 measured 0.29m in diameter and 0.2m in depth, with steep sides and a concave base. The single fill (223) was a friable dark brown silt very similar to subsoil (200). Located c. 1.5m east was ovoid posthole 224, measuring 0.55 in length, 0.35m in width and 0.1m in depth; the single fill (225) was a friable dark brown silt, also similar to subsoil (200). Located immediately east was pit 226. This was sub-circular, measuring 0.67m in length by 0.3m in width with steep sides and a flat base. Both fills (227) and (228) appeared to be a mixture of redeposited natural clay and subsoil. Basal fill (227) was a firm mid greyish yellow silty clay, 0.2m in thickness whilst upper fill (228) was a stiff light brownish yellow silty clay. The pit was truncated on its eastern side by pit 229. This was ovoid in plan, measuring 0.85m in length, 0.4m in width and 0.25m in depth, with steep to irregular sides and a concave base. Fill (230) was a firm mid yellowish brown and greyish brown silty clay, also a mixture of redeposited natural material and soil.

Plate 7: Posthole 222; section 7. Looking ENE

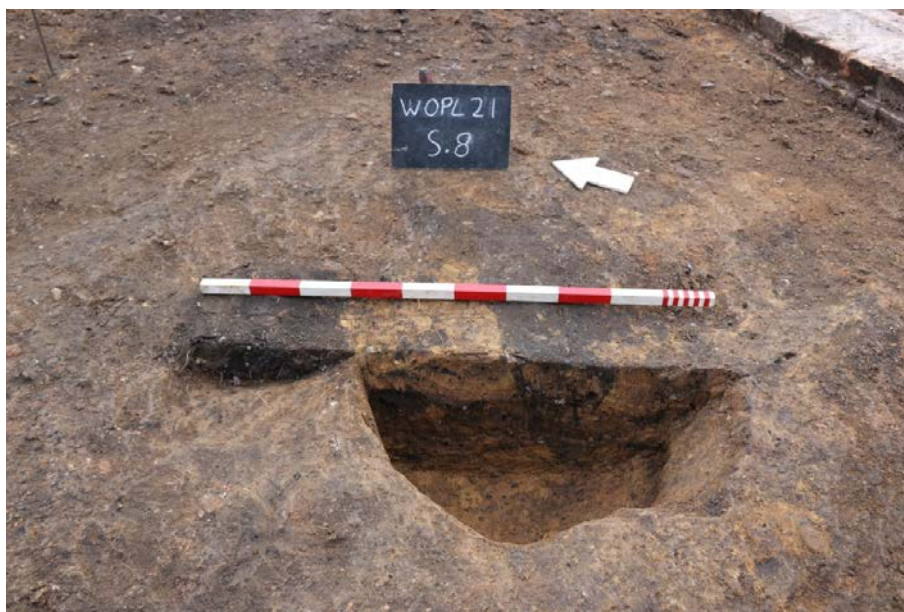
Plate 8: Posthole 224 and pits 226 and 229; section 8. Looking ENE

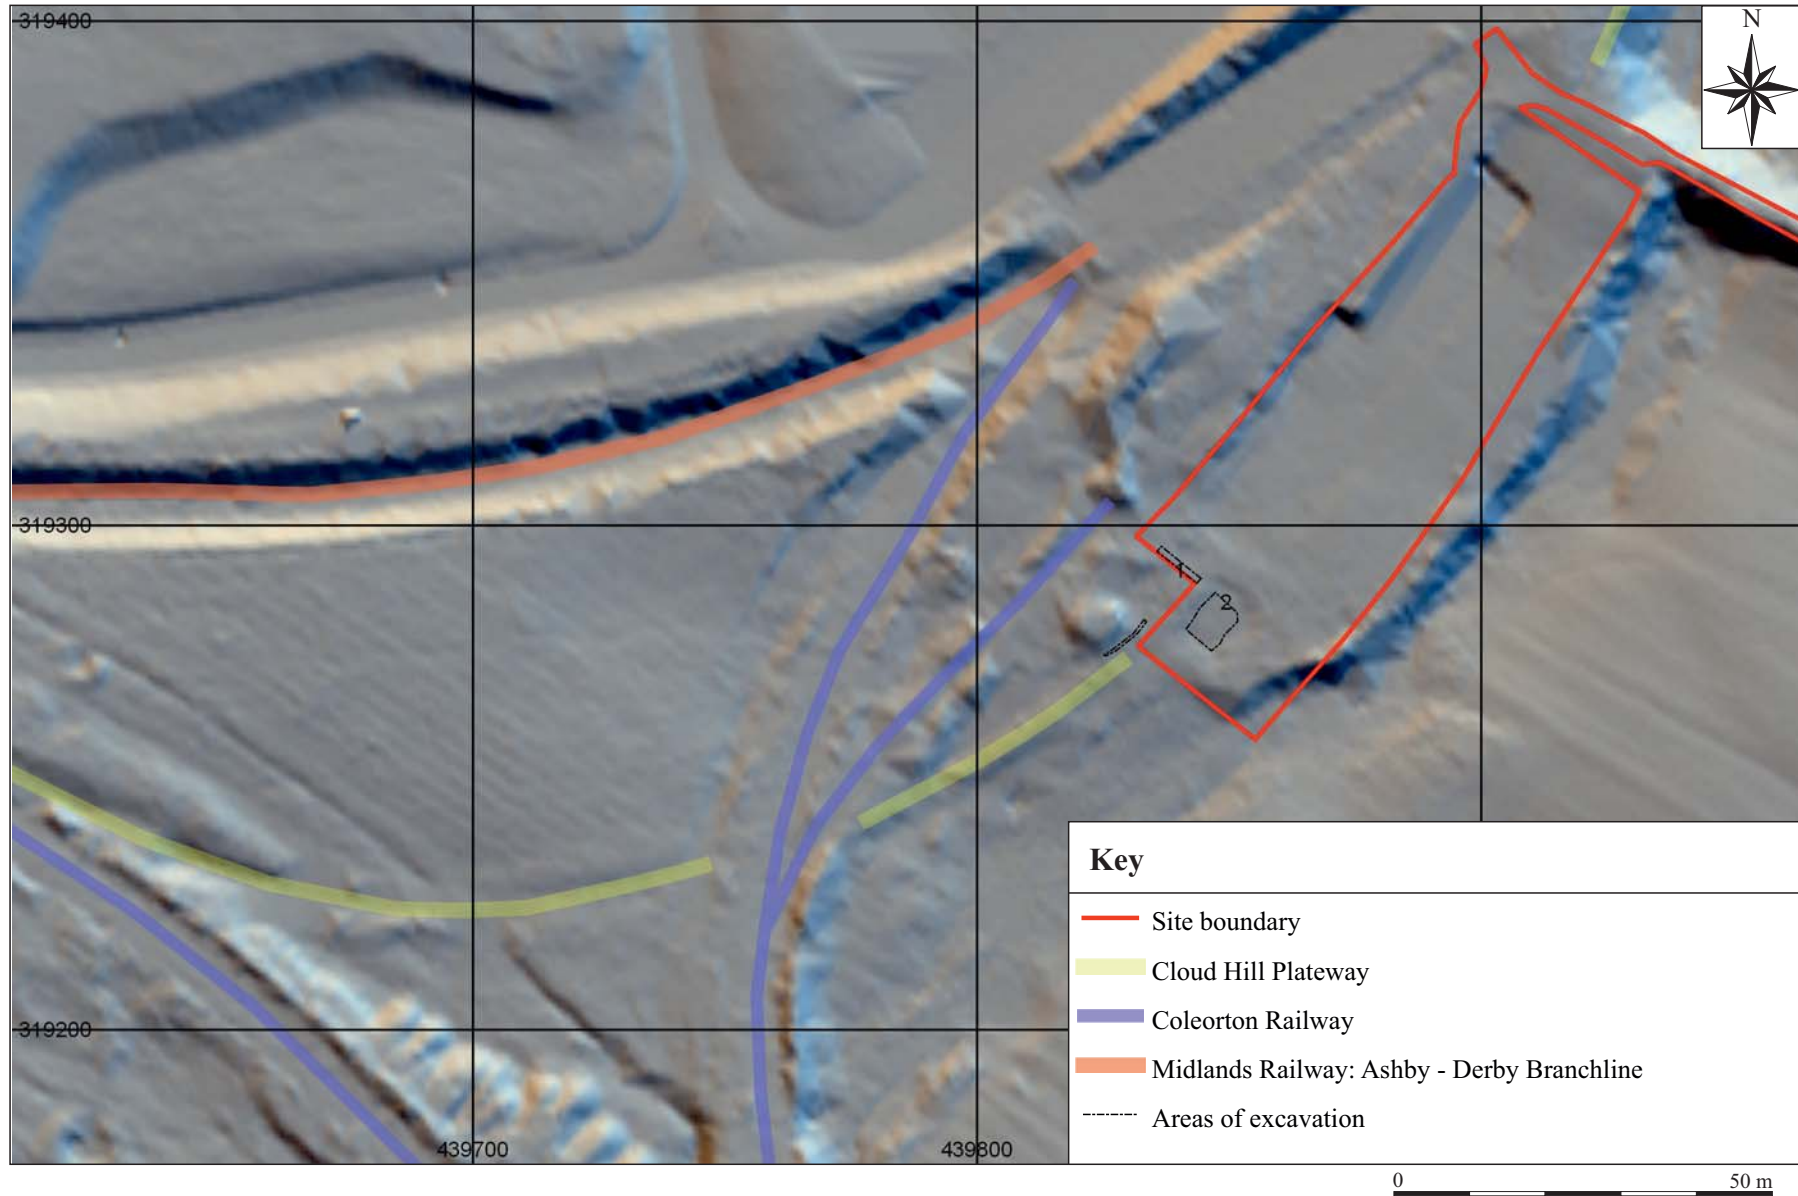
Figure 4: Environment Agency LIDAR: 1m resolution digital terrain model with hillshade from multiple directions.

LIDAR data, analysed using a multiple hillshade visualisation, shows earthworks associated with the tramway extending from the site to the south, aligning with the remains recorded during the excavation (Figure 4). These earthworks are truncated by the later Coleorton Railway, which comes from the south, turning east to run parallel to the site boundary.
