JOHN MOORE HERITAGE SERVICES

ARCHAEOLOGICAL WATCHING BRIEF

31 MARTINS LANE, DORCHESTER-ON-THAMES,

MAY 2021

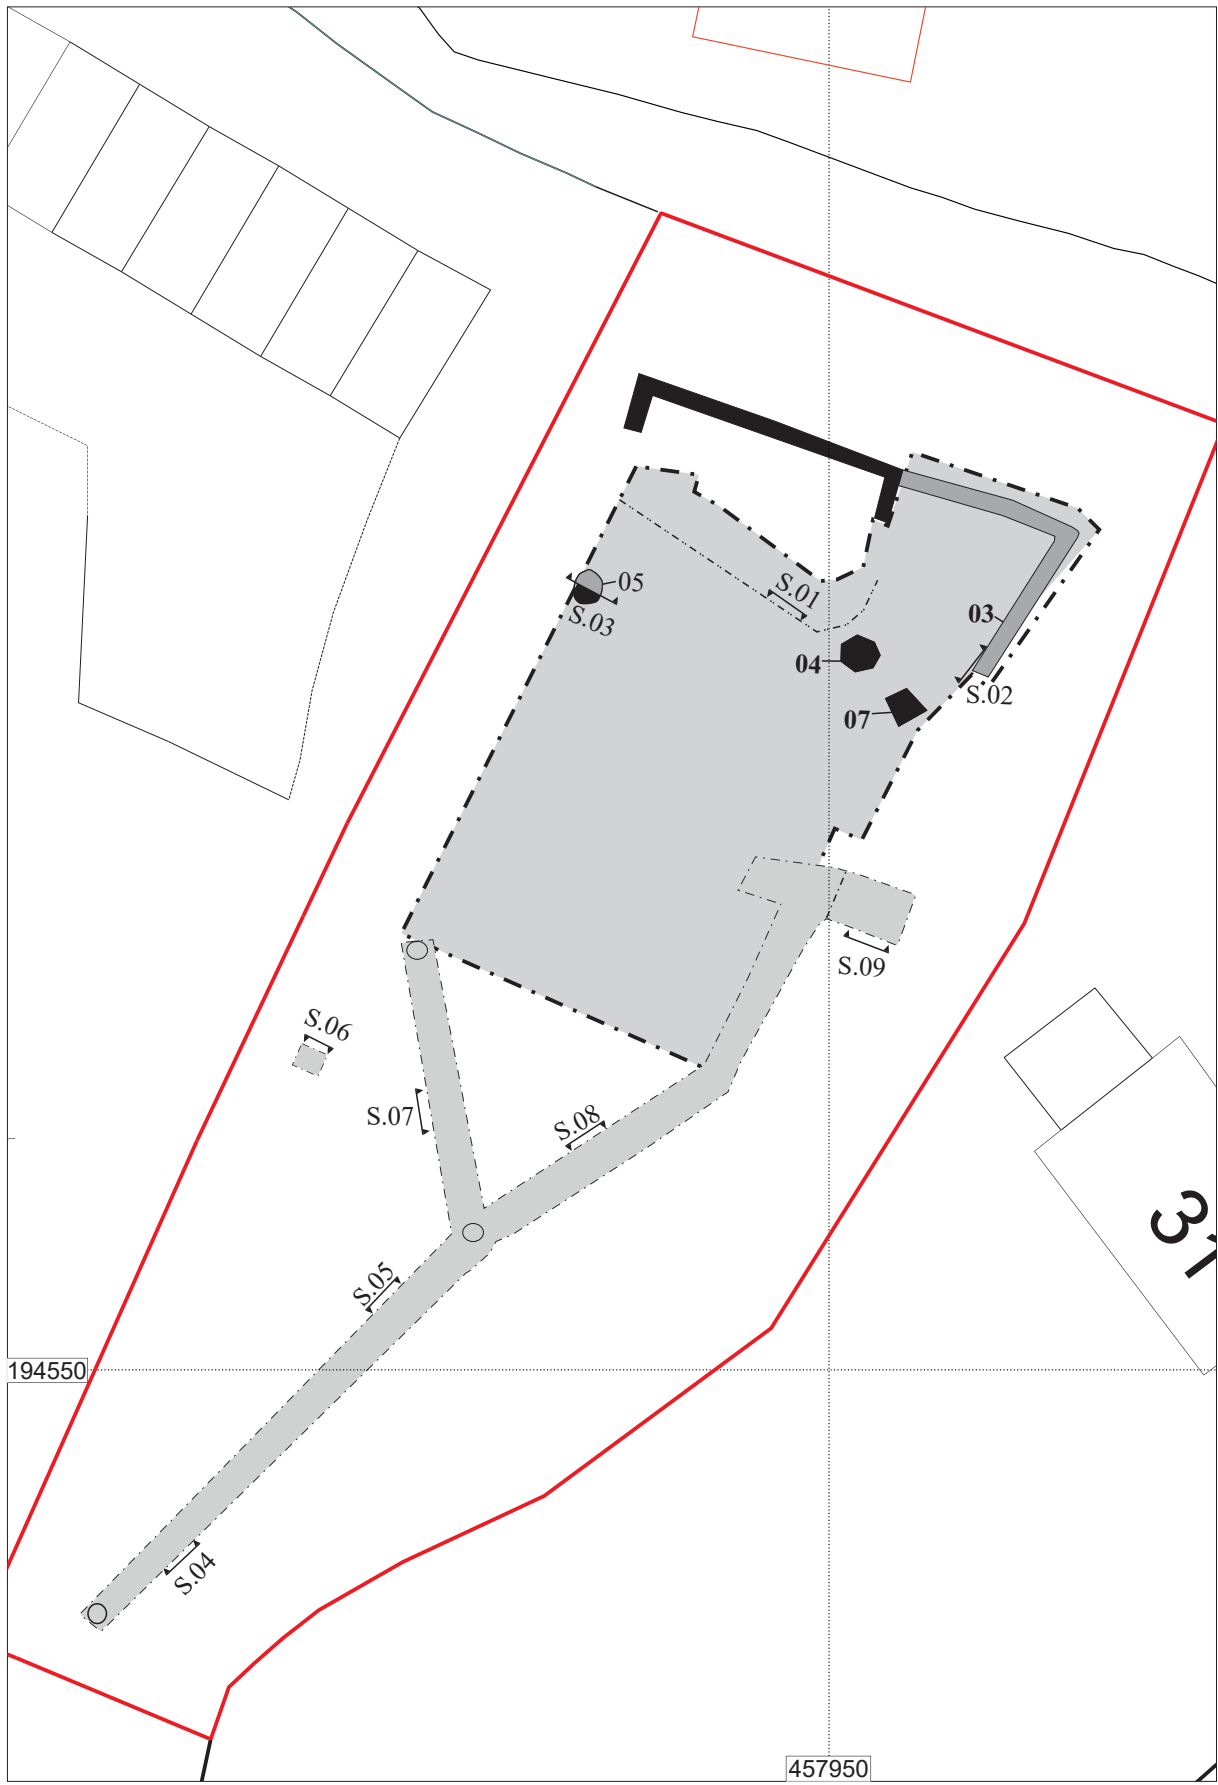
Figure 2: Site Plan with section locations

A stone wall, **03**, was partially removed in advance of the garage (see Fig 2 for plan and Fig 3, section 2).

A very shallow, modern pit 05, with a single fill (06) was revealed. The fill was a mid-brown clayey silt with no inclusions, 0.89m diameter and 0.07m deep (see Fig 2 for plan and Fig 3, section 3).

Two modern masonry features were also uncovered, both associated with the mid-century residential development at 31 Martin's Lane. A decorative well, **04**, and manhole for the associated water service, **07**, were both uncovered to the southeast in the footprint of the house and garage (see Fig 2).

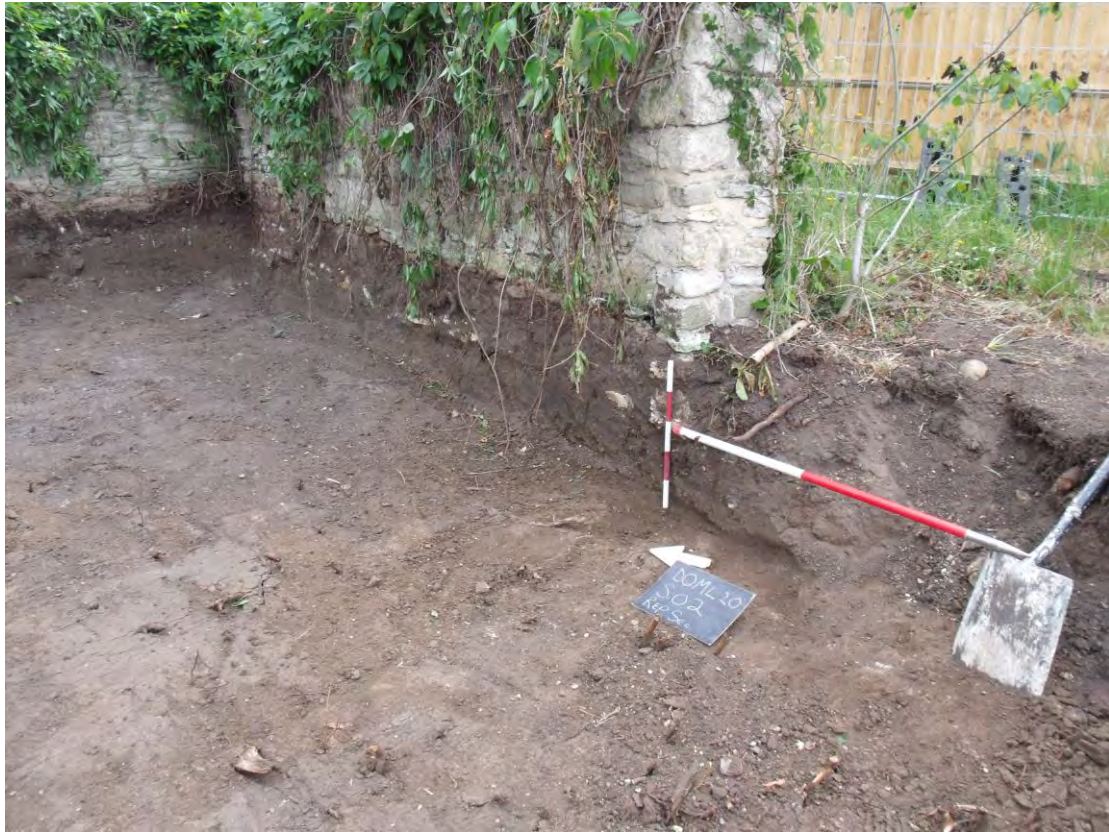
Plate 1: Garage footprint; Section 02, wall **03**, prior to removal. View facing ENE.

Discussion *Stone wall, partially removed to North & East of garage. Extant portion makes up Kitchen Garden wall, 9.5m surviving. Foundation extended about 30cm below ground level*

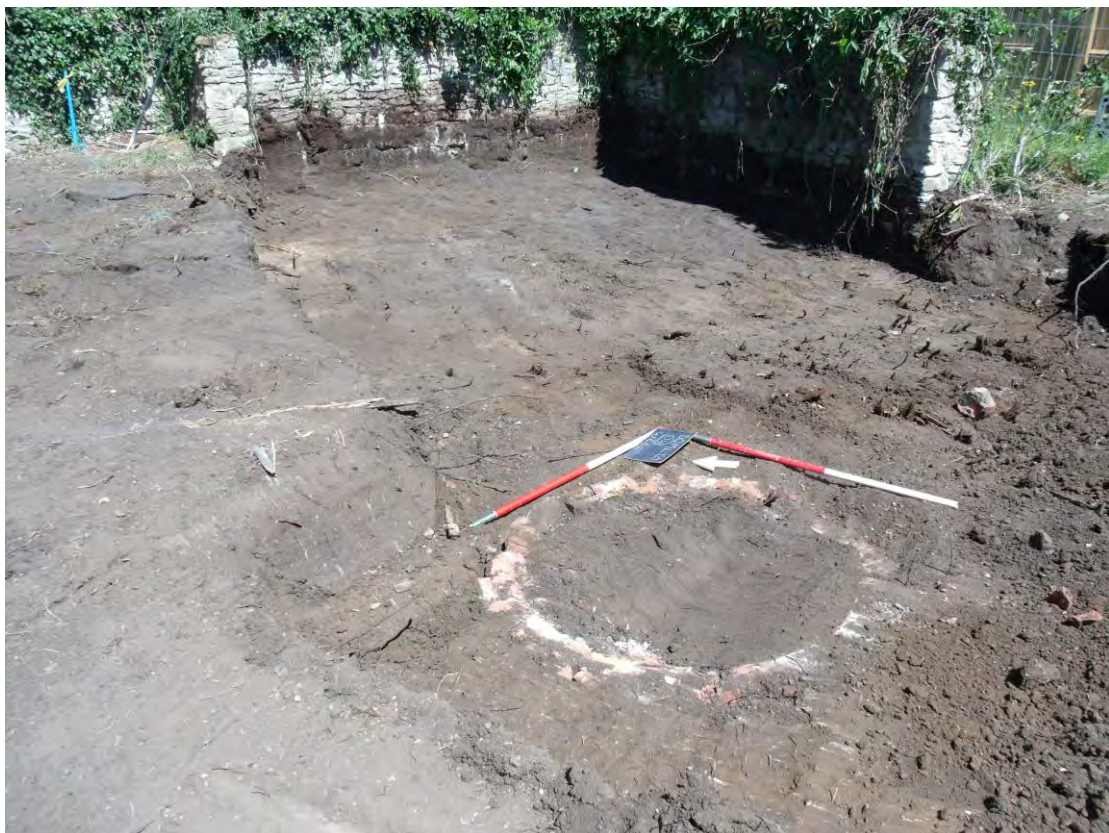
Plate 2: Garage footprint; Modern decorative well, **04** (wall **03** visible in background). View facing east.

Interpretation: Internal External *Decorative well, mid-20th C.*
*associated w/ rectangular man-hole *07* 1m East*
very shallow preservation of well (3 courses deep max)
w/ max ash & refuse within central fill. GPS & drawn
masonry ~~not~~ ~~not~~ ~~not~~ only.

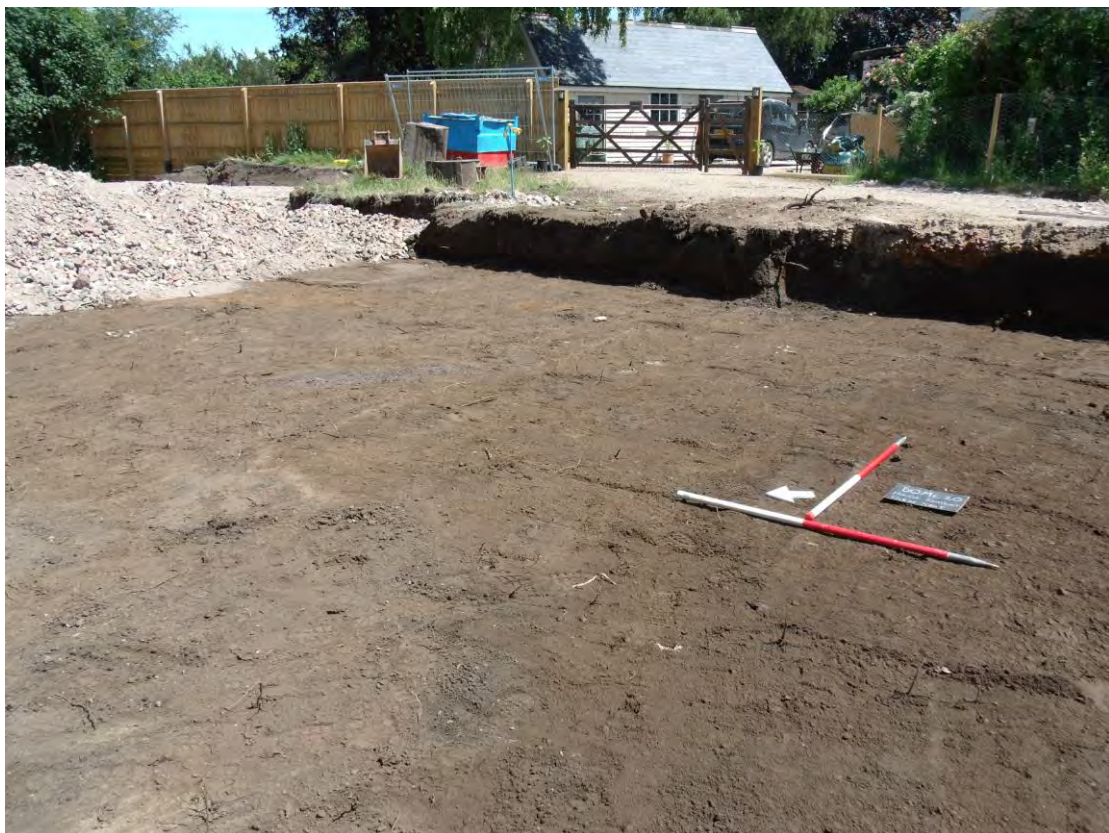
Plate 3: General area of footprint of house; background showing wall 03 removed and garage area covered with hardcore. View facing east.
