JOHN MOORE HERITAGE SERVICES

AN ARCHAEOLOGICAL EVALUATION
AT
TURNFORD TRIANGLE, BROXBOURNE,
HERTFORDSHIRE
TL 3630 0460

On behalf of
Charles Church North London

MARCH 2008

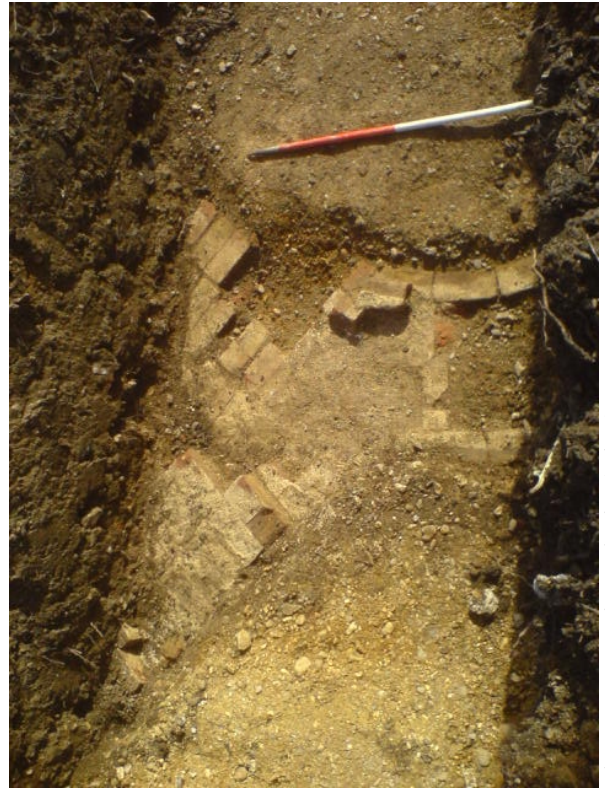
Plate 4. Trench 4, drain (4/19)

To the north of these features was a Y shaped cut (4/18) containing a brick built structure (4/19) with a cut suggesting a drainage function (Plate 4). It seems possible that this was an external back wall to the property with a drain cut into the base.

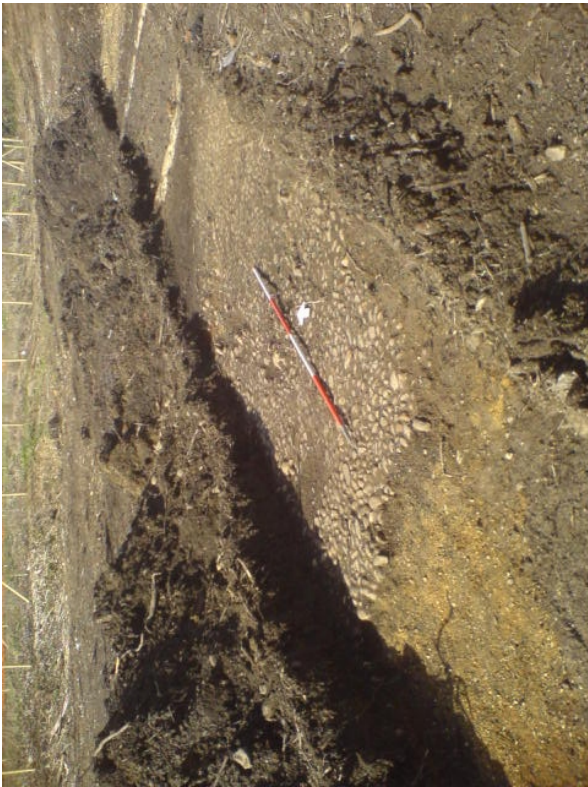
Plate 1. Trench 3

Towards the SE of the building a cut [3/05] was seen containing a loose mid orange gravel bedding layer (3/06) for a compact cobbled surface (3/07) approximately 0.07m thick. This is thought to have been a yard surface or track-way serving the building (Plate 1).

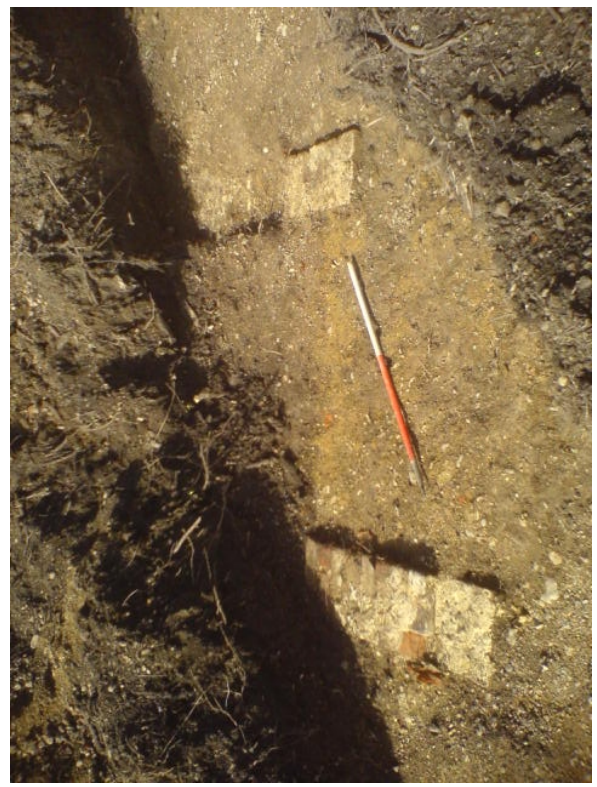
Plate 3. Trench 4; walls (4/15) and (4/17)

To the north of these features are two further wall bases (4/15) and (4/17) within the trench, parallel to one another and on the same alignment as the earlier features mentioned above (Plate 3). It would seem reasonable to suggest that these represent the remains of internal walling. There is a gravel layer between the walls similar to (4/09) and probably representing packing for a floor layer.
