**ARCHAEOLOGICAL OBSERVATION,  
INVESTIGATION, RECORDING, ANALYSIS AND  
PUBLICATION OF WORKS**

**DANVERS HOUSE, HIGH STREET, CULWORTH,**

**NOVEMBER 2021**

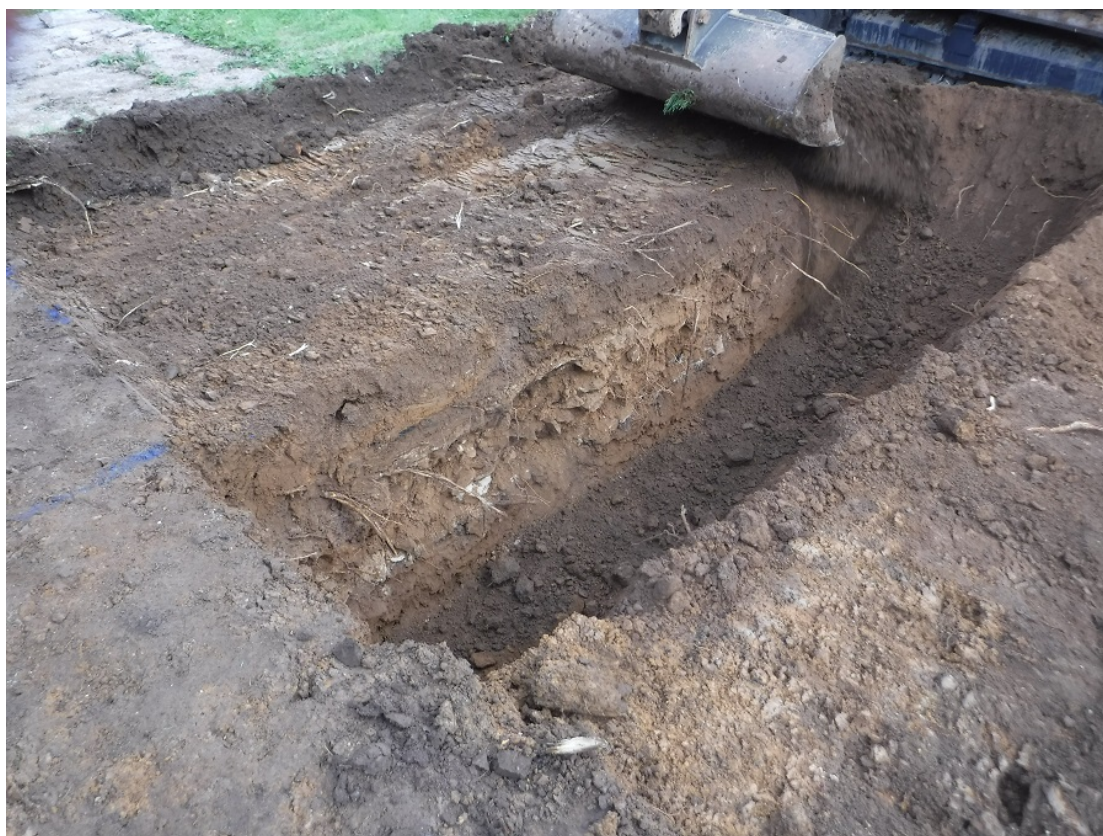
Natural geology (04) was overlain in the northern end by 0.60m thick deposit of stone rubble (03) (Figure 2, Section 1, Plate 1). Deposit (03) is part of the latest phase of garden landscaping seen throughout the extent of the garden; it contained fragments of 19<sup>th</sup>-20<sup>th</sup> century glass and ceramic building material.

*Plate 1. Northern end of the excavated area, showing stone rubble deposit (03)*

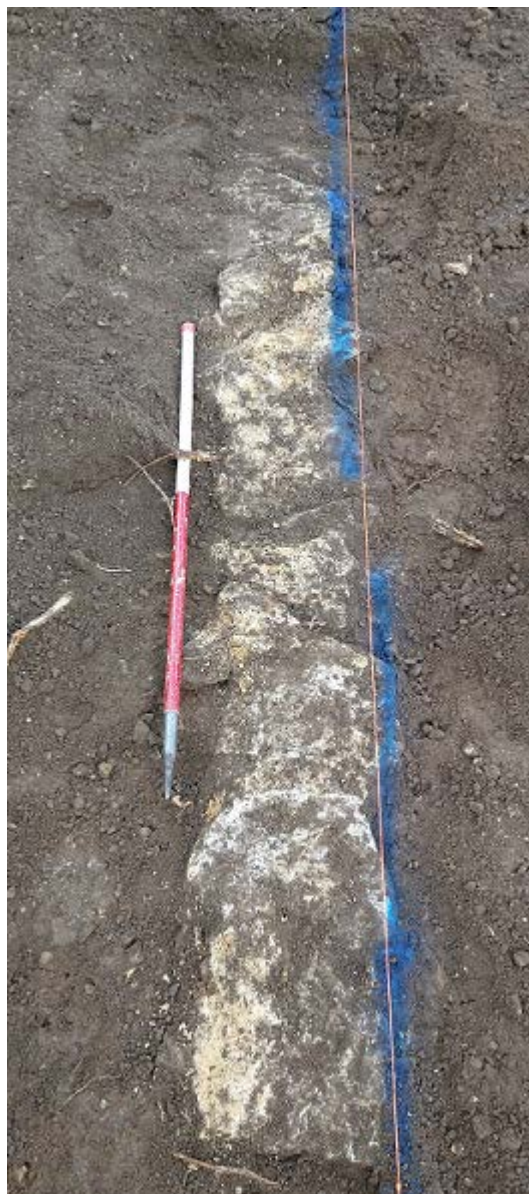
Limestone wall **05** (Figure 2, Plate 2), part of a garden feature, was uncovered in the south-western part of the excavated area. The wall, aligned North-South, measured 2.34m in length by 0.33m in width, and was uncovered to a maximum height of 0.15m. The exposed masonry consisted of a single course of roughly squared limestone, bonded with sand and mortar. The feature was not further investigated as it lay below the impact level of 0.25-0.30m BGL.

*Plate 2. Limestone wall 05, looking north*
