# ARCHAEOLOGICAL WATCHING BRIEF

# WANSBECK, 16B CASTLE STREET, WALLINGFORD, OXFORDSHIRE, OX10 8DL

JMHS Project No: 4176

Site Code: WACS21

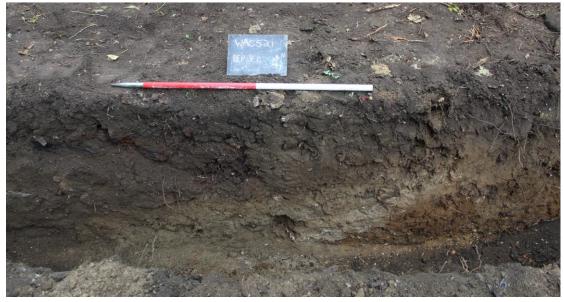
A north-south cut 07 was seen in the western two thirds of the footprint. The side was at 45° and the base was not seen. The lowest fill layer encountered was (04), which was a sterile friable to loose light greyish yellow sand, with no inclusions, >0.45m thick. Overlying this was (03), which was a >0.16m thick friable to compact mid yellowish brown silty sand with frequent sub-rounded chalk pebbles, 10-40mm. Deposit (03) also contained frequent flecks of charcoal, and was heavily disturbed by rooting action. Above deposit (03) was a 0.49m thick friable mid yellowish brown silty sand, (02), which contained occasional sub-rounded chalk pebbles, 10-30mm in size. Similar to deposit (03), this deposit also contained frequent flecks of charcoal, and disturbance from rooting action. Several fragments of pottery, and ceramic building material were recovered from this fill.

Plate 1: Representative Section (S.2) of Footings, showing fill layers (02), (03), and (04) within cut **07**.

The watching brief identified a large cut covering the western area of the footprint of the car port. The fill contained late post-medieval pottery and building materials. A single sherd of residual medieval pottery was recovered from the latest fill of the cut. The purpose for the cut is unknown. It may have been the remains of quarrying action for sand and gravel.

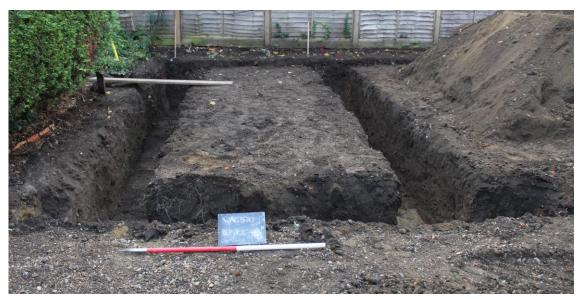
The footings trenches for the new carport were observed, which enclosed an area approximately 9.40m in length by 5.40m in width. The footings were excavated to a depth of approximately 1m and measured 0.60m in width.

Plate 2: Completed Footings Trenches (southern extent).

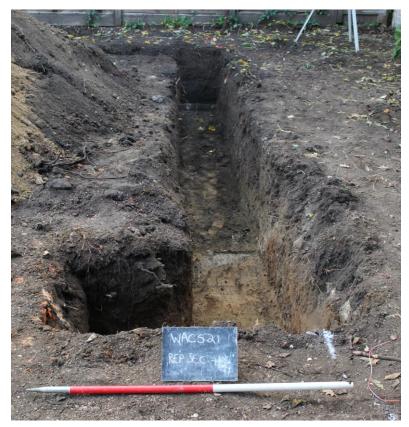
Plate 3: Completed Footings Trenches (northern extent).

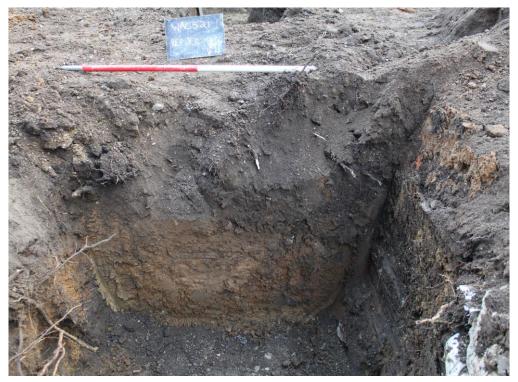
The footing pad pit excavation for the new carport was observed, which enclosed an area approximately 1.30m in length by 1m in width. The pit was excavated to a depth of approximately 1m.

The lowest deposit encountered was a natural sand layer, (10), which was probably the same as deposit (06) within the Footings Trench. Natural deposit (10) was a friable to loose mid yellowish brown sand, >0.08m thick, with occasional subrounded pebble inclusions, 10-20mm in size.

Overlying the natural sand was another natural deposit, (09), which was probably the same as deposit (05). Natural deposit (09) was a 0.59m thick compact mid reddish orange gravel in a sand matrix, which contained abundant sub-angular gravel, 10-40mm in size.

Above this was topsoil (08), which was the same as topsoil deposit (01); this deposit was a 0.31m thick friable to loose mid blackish brown silt with frequent bioturbation disturbance, and occasional small shingle inclusions, resulting from the previous gravel driveway. Within deposit (08) the remains of concrete footings for the previous garage were removed.

Plate 4: Representative Section (S.3) of Footing Pad.
