JOHN MOORE HERITAGE SERVICES

ARCHAEOLOGICAL WATCHING BRIEF

2 DEANERY COTTAGE, HIGH STREET, SONNING,

WOKINGHAM RG4 6UP

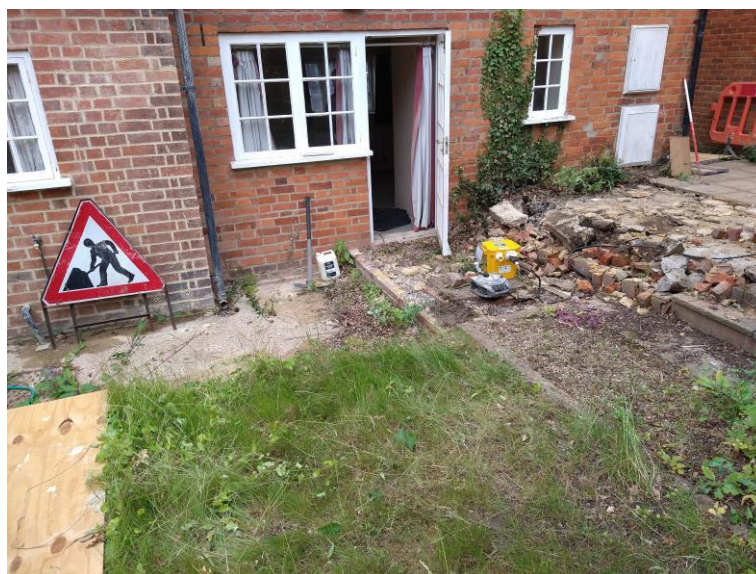
The area of development was a terraced residential garden (Plates 1 and 2). The underlying geology of Seaford Chalk Formation and Newhaven Chalk Formation (undifferentiated) was not reached in the entirety of the development area. Post-medieval yellow mottled very dark brown homogenous clay loam (03) was encountered instead. No finds could be safely allocated to the context (03) due to heavy disturbance but it can be postulated that deposit is of Post-Medieval date.

Plate 1: Area of development, pre-ex, looking north-west.

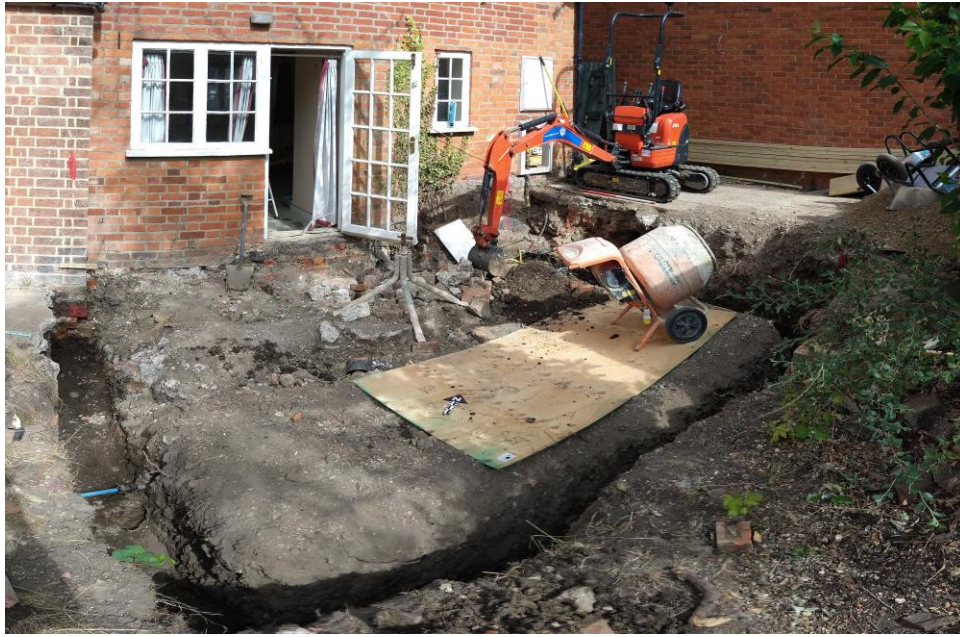
Plate 2: Area of development, post-ex panorama, looking north north-

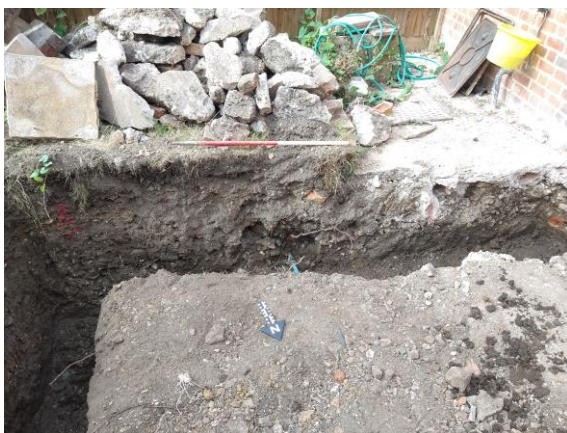
In the west south-western end of the development area (Plate 3) the stratigraphy comprised 0.26-0.46m thick deposit of homogenous yellow mottled very dark brown clay loam (03) which was overlain in the north-western end by 0.18m thick paving slabs (01); in the south-eastern end deposit (03) was overlain by 0.66m thick deposit of modern mixed soils (02) which in turn was overlain by 0.11m of turf (04). The impact depth in this area measured 0.66-1.03m BGL (below ground level). At the eastern most extent of the site, the footings (Plate 4) measured 1.03m BGL in the southern end and 1.40m BGL north north-eastern end. Stratigraphy comprised a 0.37m-0.39m thick deposit of homogenous yellow mottled very dark brown clay loam (03) which was overlain by 0.74m-0.91m of modern mixed soils (02). Modern deposit (02) was overlain by 0.10m thick paving slab (01) in the north north-eastern end.

Plate 3: Sections 1 and 2, post-ex, looking south south-west.

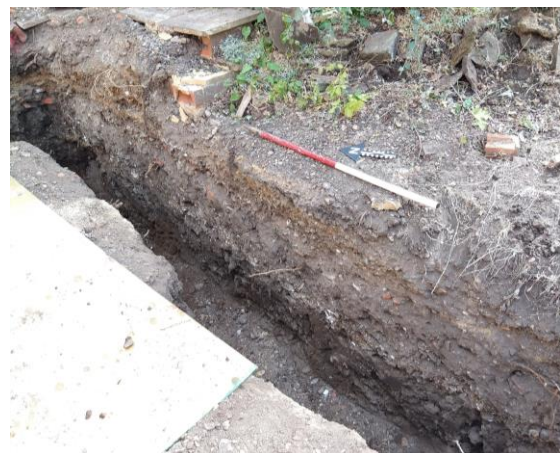
Plate 4: Sections 3 and 4, post-ex, looking east.

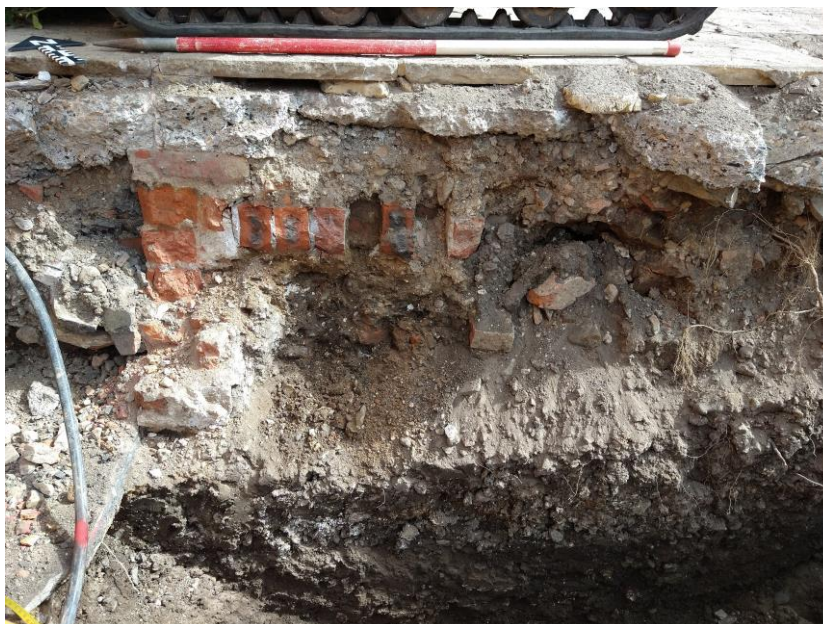
Plate 5: Section 5, showing collapsed wall 06, looking north-east.

The northern most part of the footings (Plate 5) measured 1.50m BGL. Stratigraphy comprised 0.23m of homogenous yellow mottled very dark brown clay loam (03) which was overlain by 0.49m of modern mixed soils (02). Deposit (02) was overlain by 0.42m thick layer of rubble and mixed soil (07) that contained structural remains/collapsed wall **06** (Plate 5). Structural remains **06** measured 0.16m-0.46m wide and 0.43m deep. The remaining six course collapsed wall **06** was most likely part of the earlier garden layout, but have been demolished in order to build up the ground to establish a terraced garden. No further continuation of structural remains **06** was encountered. Structural remains **06** and deposit (07) were in turn overlain by 0.15m thick deposit of modern builders' sand which was overlain by two layers of 0.20m thick of paving slabs (01).

the earlier garden arrangement and have been demolished in order to form a terraced garden. The continuation of **06** could not be established.

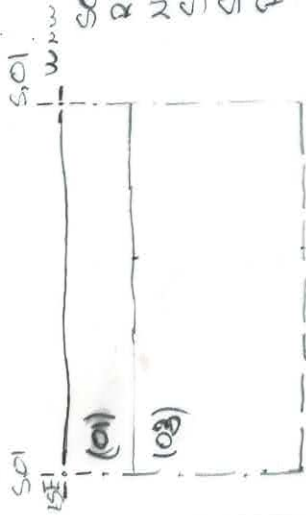
SOHS 22
REP. SEC. III
NW FACING
S. 03
Scale 1:20
PE 13/7/22

SOHS 22
REP. SEC. II
NNE FACING
S. 02
Scale 1:20
PE 13/7/22

SOHS 22
REP. SEC. I
NNE FACING
S. 01
Scale 1:20
PE 13/7/22

SOHS 22
REP. SEC. V
SE FACING
S. 05
Scale 1:20
PE 13/7/22

SOHS 22
REP. SEC. IV
NNE FACING
S. 04
Scale 1:20
PE 13/7/22
