JOHN MOORE HERITAGE SERVICES

ARCHAEOLOGICAL WATCHING BRIEF

THE WILDERNESS / 1 VALENS TERRACE,

BOX, WILTSHIRE

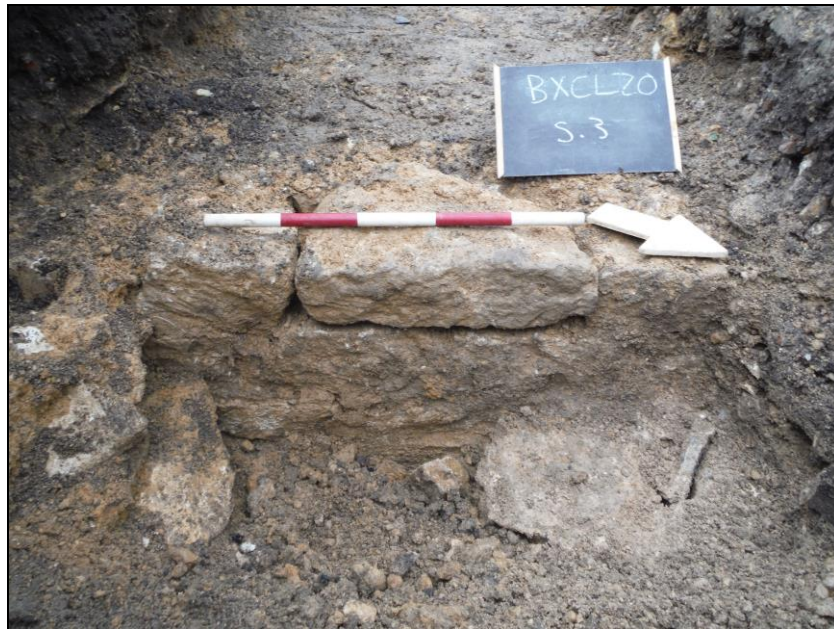
Plate 1: Roman masonry structure **4**

A Roman wall or other masonry structure – oriented north-northwest to south-southeast and recorded as structure **4** – was uncovered in the east-northeast half of the trench and consisted of large roughly squared limestone with squared random coursing. It was bonded by mid yellowish grey lime mortar. The structure was over 1m in length and over 0.36m in width; three courses were visible, though it extended below the limit of excavation (see Plate 1).

Whilst the late post-medieval boundary wall was constructed just above the Roman deposits, antiquarian protective sandy layer (3) probably shielded much of the Roman masonry from damage. The wall recorded as 4a by Hurst et al. (1987) survived at a higher altitude than any other Roman masonry in this area; layer (3) was very thin at this point, but the boundary wall does not appear to have caused considerable damage to the stone of wall 4a. The unmapped section of wall running perpendicularly (recorded during this watching brief as structure 14) also had a recognisable face and form, though showed signs of disturbance, especially at its east-northeast end. It is possible that this disturbance represents partial wall collapse or robbing following the villa's abandonment; however, the possibility that the construction of the boundary wall damaged structure 14 cannot be discounted.

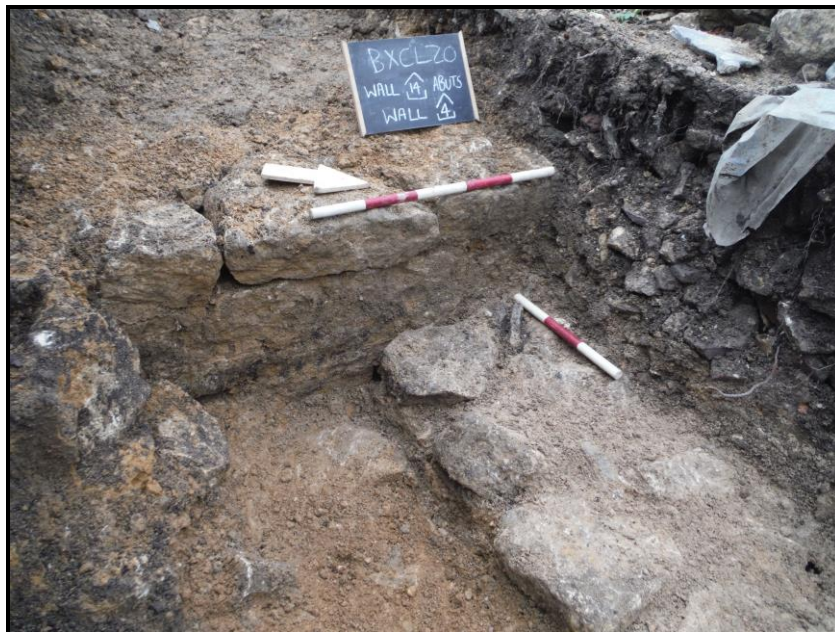
Plate 2: Structure **14** butting structure **4**

Masonry structure **14** abutted the east-northeast edge of structure **4** and ran perpendicularly, aligned west-southwest to east-northeast (see Plate 2). The top of structure **14** was discovered 0.28m below the top of wall **4**, and was also made with large limestones. The largest limestone visible measured 250mm in breadth by 200mm in length by 65mm in thickness, whereas the smallest stone measured 100x160x60mm. The limestone was roughly squared, random coursed, and bonded with

mid yellowish grey lime mortar. Two courses were visible in wall **14**, though it also extended below the limit of excavation. It was over 0.52m in width and 2.07m or greater in length; a possible east-northeast edge was observed, but it could instead have represented wall robbing, collapse, or other disturbance at this point.

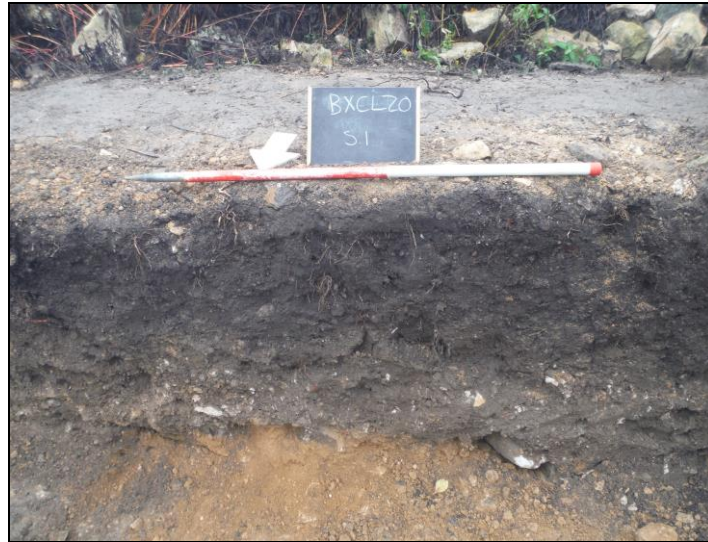
Plate 3: Representative section showing the deposits which form the landscape

Above and beside the top courses of structures **4** and **14** was a deposit which was encountered across the development area, consisting of compact mid brownish orange sand (3), with frequent inclusions of sub-angular gravel (10-50mm in size) (see Plate 3). Finds of Roman wall plaster, a mosaic *tessera*, tile fragments, post-medieval pottery and an iron fastener were recovered from the deposit.

Overlying deposit (3) across the trench was a friable to compact mid brownish grey silty clay made ground or built-up garden soil layer (2), which was approximately 0.44m thick (see Plates 3 and 5). Deposit (2) contained frequent sub-angular stone inclusions, ceramic building material, and occasional grass roots. A representative sample of the finds were retained, including a small glass bottle, several late post-medieval pottery sherds and a residual medieval pottery sherd. Several large modern metal items were also observed, but not collected.

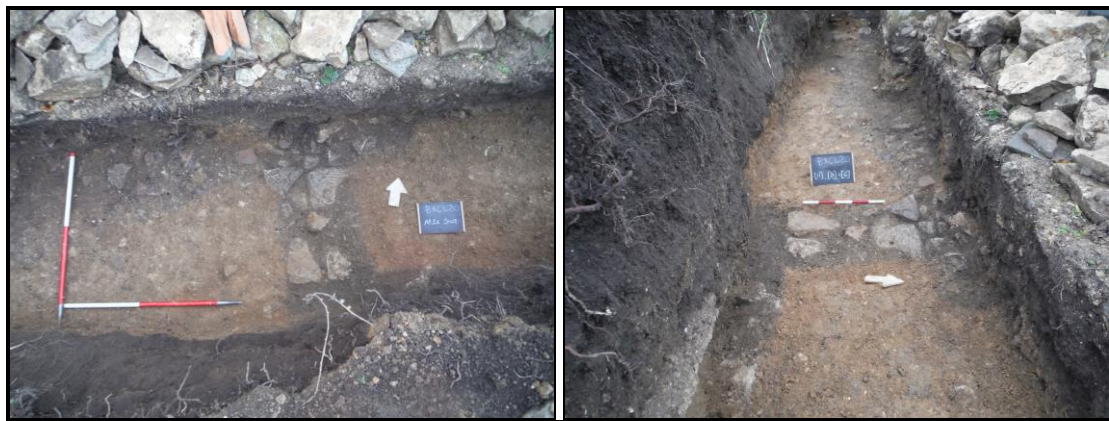
Plate 4: Ditch 6, construction cut 8, and feature 11

Cut into deposit (3) was linear ditch 6, which was located at the west-southwest end of the trench, oriented northeast-southwest (see Plate 4). The ditch was over 5.73m in length, and probably approximately 0.75m in width. The edge of the ditch curved at the furthest northeastern point that could be seen in the trench, indicating a potential turn or termination of ditch 6 just beyond the limit of excavation. The feature did not require excavation as it was not impacted by the proposed works. The top fill of ditch 6 was recorded in plan and consisted of friable mid greyish brown sandy clay (7), with frequent small sub-angular stones (2-15mm) and occasional larger sub-angular stones (50-200mm). The fill contained Roman pottery, wall plaster, *tesserae*, brick, and tile, as well as a fragment of animal bone.

Deposit (3) and ditch fill (7) were both cut by construction cut 8, which housed masonry structure **9** and backfill deposit (10) (see Plate 4). Construction cut 8 was rectangular in shape, with 90° corners, dimensions of 0.75m by 0.60m, and a north-northwest to south-southeast orientation. This feature also did not require excavation so its depth is unknown, though a small test sondage proved that it was greater than 0.15m. Structure **9** within the construction cut was made with large limestones; the largest limestone visible measured 280mm in breadth by 360mm in length by 95mm in thickness, whereas the smallest stone measured 120x200x85mm. The limestone was roughly squared, with coursing that was probably either random coursed or random uncoursed – only one course of stone could be seen so this could not be confirmed. Once again, the structure extended below the limit of excavation. Unlike other limestone structures observed in the trench, structure **9** appeared only to be bonded by earth, a sandy clay loam matrix: deposit (10). Deposit (10) was a loose mid greyish brown sandy clay loam containing frequent sub-rounded stones (1-18mm), a piece of animal bone and a fragment of Roman roof tile.

Immediately adjacent to the south-southeast edge of construction cut 8 was rectangular or square feature 11 (see Plate 4). It also had 90° corners, with a length of

1.40m, a width of over 0.25m, and an unknown depth. The feature extended beyond the south-southeast limit of excavation, as well as below the base of the trench. The uppermost fill of feature 11 consisted of friable dark brown sandy clay (12), which abutted structure 9. Fill (12) contained rare inclusions of sub-angular stone (30-110mm), as well as Roman and undated ceramic building material.

Chronologically, the next evidence for activity in the area was ditch 6 which was cut into layer (3). The ditch does not share an alignment with the Roman walls, the extant garden boundary wall, or any other feature observed during this stage of works, and may be unrelated to them all. This activity appears to have significantly impacted the Roman remains below, as a relatively large quantity of Roman artefacts was observed at the top of ditch fill (7). These artefacts – including pottery, *tesserae*, wall plaster, and ceramic building material – were not found *in situ*, and must have been disturbed during the digging of ditch 6. It is likely that the ditch was not intended for artefact collection for commercial gain, as the finds have not been removed from the property. Instead, ditch 6 may be related to residential 19th-century garden use; if the ditch did terminate just northeast of the limit of excavation, then this would correspond to the approximate boundary between the newly-divided land plots A and E (Corney 2012: 18-19). Furthermore, evidence for archaeologically insensitive residential garden use is documented in the mid-19th century, as at least one owner of The Wilderness

Two pieces of possible Roman ceramic building material were recovered from adjacent rectangular or square feature 11, though they were residual finds not relating to the date of the feature’s construction. Feature 11 was cut into layer (3) and must relate to the late post-medieval or modern period. It was not possible to ascertain its function because only the edge of the feature was revealed in this phase of works. Similarly, only the edge of the frogged brick structure on the east-northeastern side of the trench was observed. The frogged brick indicates a post-medieval to modern date of construction, but the function of the structure is unclear. An early-20th-century map of the area shows an unlabelled building or lean-to, measuring approximately 4.6m by 3.0m, abutting the south face of the garden boundary wall in this area (Brakspear 1904: 7); the frogged brick structure may relate to the same phase of construction, though this conclusion can only be considered tentative.

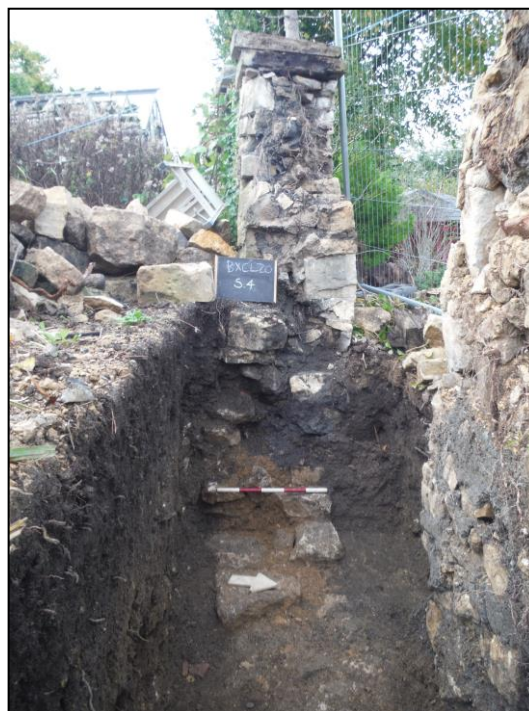
The extant garden boundary wall separating The Wilderness from 1 Valens Terrace was recorded as wall **5**, constructed with roughly squared random coursed limestone, bonded with cement and lime mortar. Before its collapse, wall **5** would have directly overlaid structure **9**. Similarly, deposit (13) lay at the base of wall **5** at the west-southwest end of the trench, and deposit (15) lay at the base of wall **5** at the east-northeast end of the trench. Both deposits were friable mid greyish brown sandy clays with frequent sub-angular limestone inclusions, ranging in size from 80mm to 350mm. At the far west-southwest end of the trench, loose mid orange sand very similar to deposit (3) was mixed with deposit (13) (see Plate 5).

Plate 5: Section 4, showing the extant garden boundary wall; deposit (13); ditch 6; and imported garden soils (2) and (1)

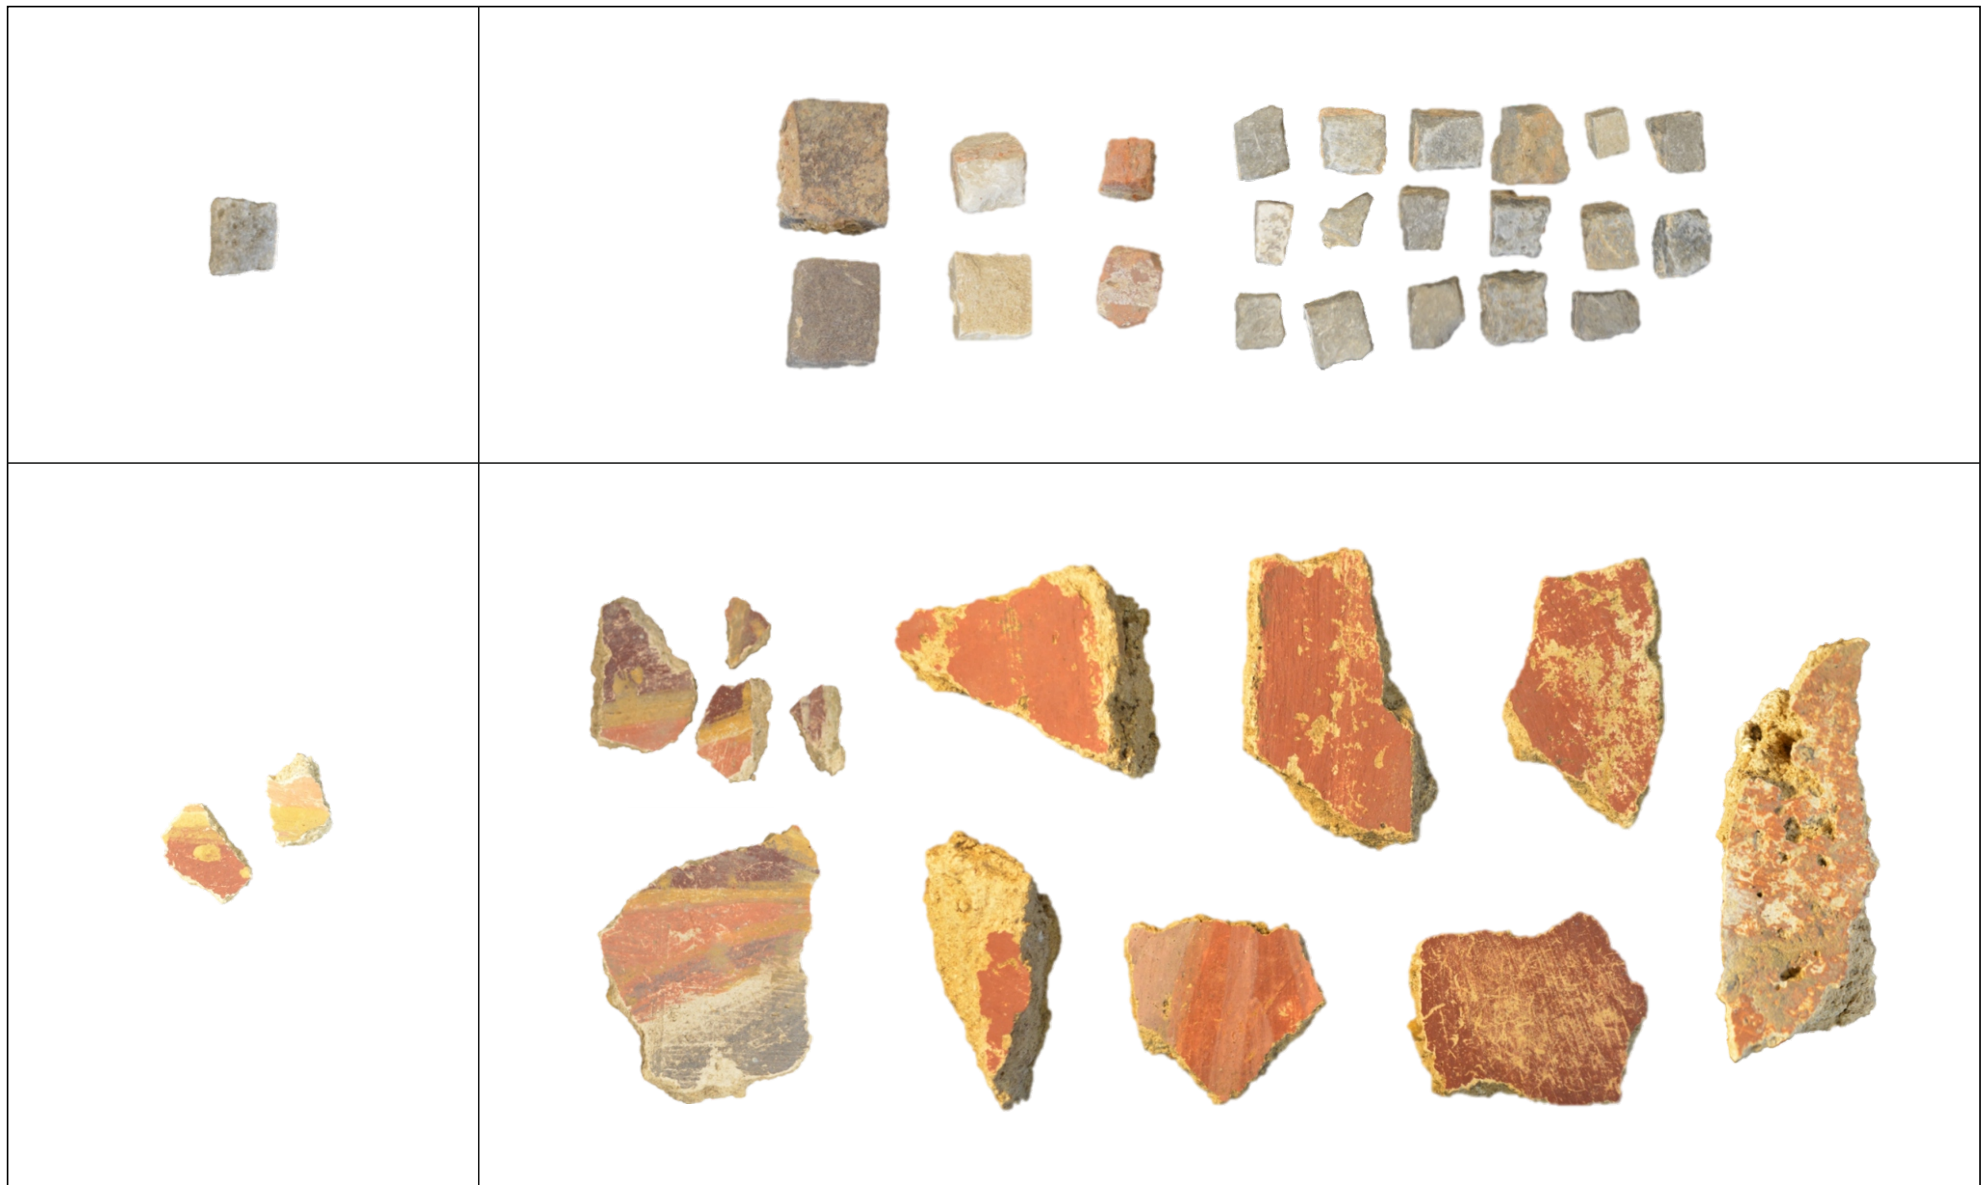
Wall plaster fragments were recovered from two deposits: sandy layer (3), and fill (7), contained in ditch 6. The material included monochromatic examples as well as items decorated with an assortment of colours (see Plate 6). The identifiable patterns consisted of multi-coloured elements, possibly forming panels or decorative bands. The material is generally fairly preserved, although fragmentary and displaying degradation of the painted surfaces.

A total of 24 *tesserae* was collected; with the exception of a single item found in sandy layer (3), all of the examples were recovered from deposit (7), the fill of ditch 6 (see Plate 6). The *tesserae* weighed 185g combined and originated from a Roman mosaic floor; however, none of the items was found *in situ*, therefore no design pattern was preserved. The *tesserae* varied in size, from a minimum of 10x9mm to a maximum of 33x22mm; however, most of the items measured ca. 15x15mm. Traces of white mortar were present on some of the objects.

The vast majority (19 *tesserae*) were made of blue/grey lias; two examples were of white limestone. A single item, the largest (32x22mm) of the group, was made of a reddish stone. Two *tesserae* made of ceramic building material of an orange-pink colour were also present.

Plate 6: Tessera from deposit (3) *top left*; tesserae from deposit (7) *top right*;
 wall plaster fragments from deposit (3) *bottom left*; selection of wall plaster fragments from deposit (7) *bottom right*

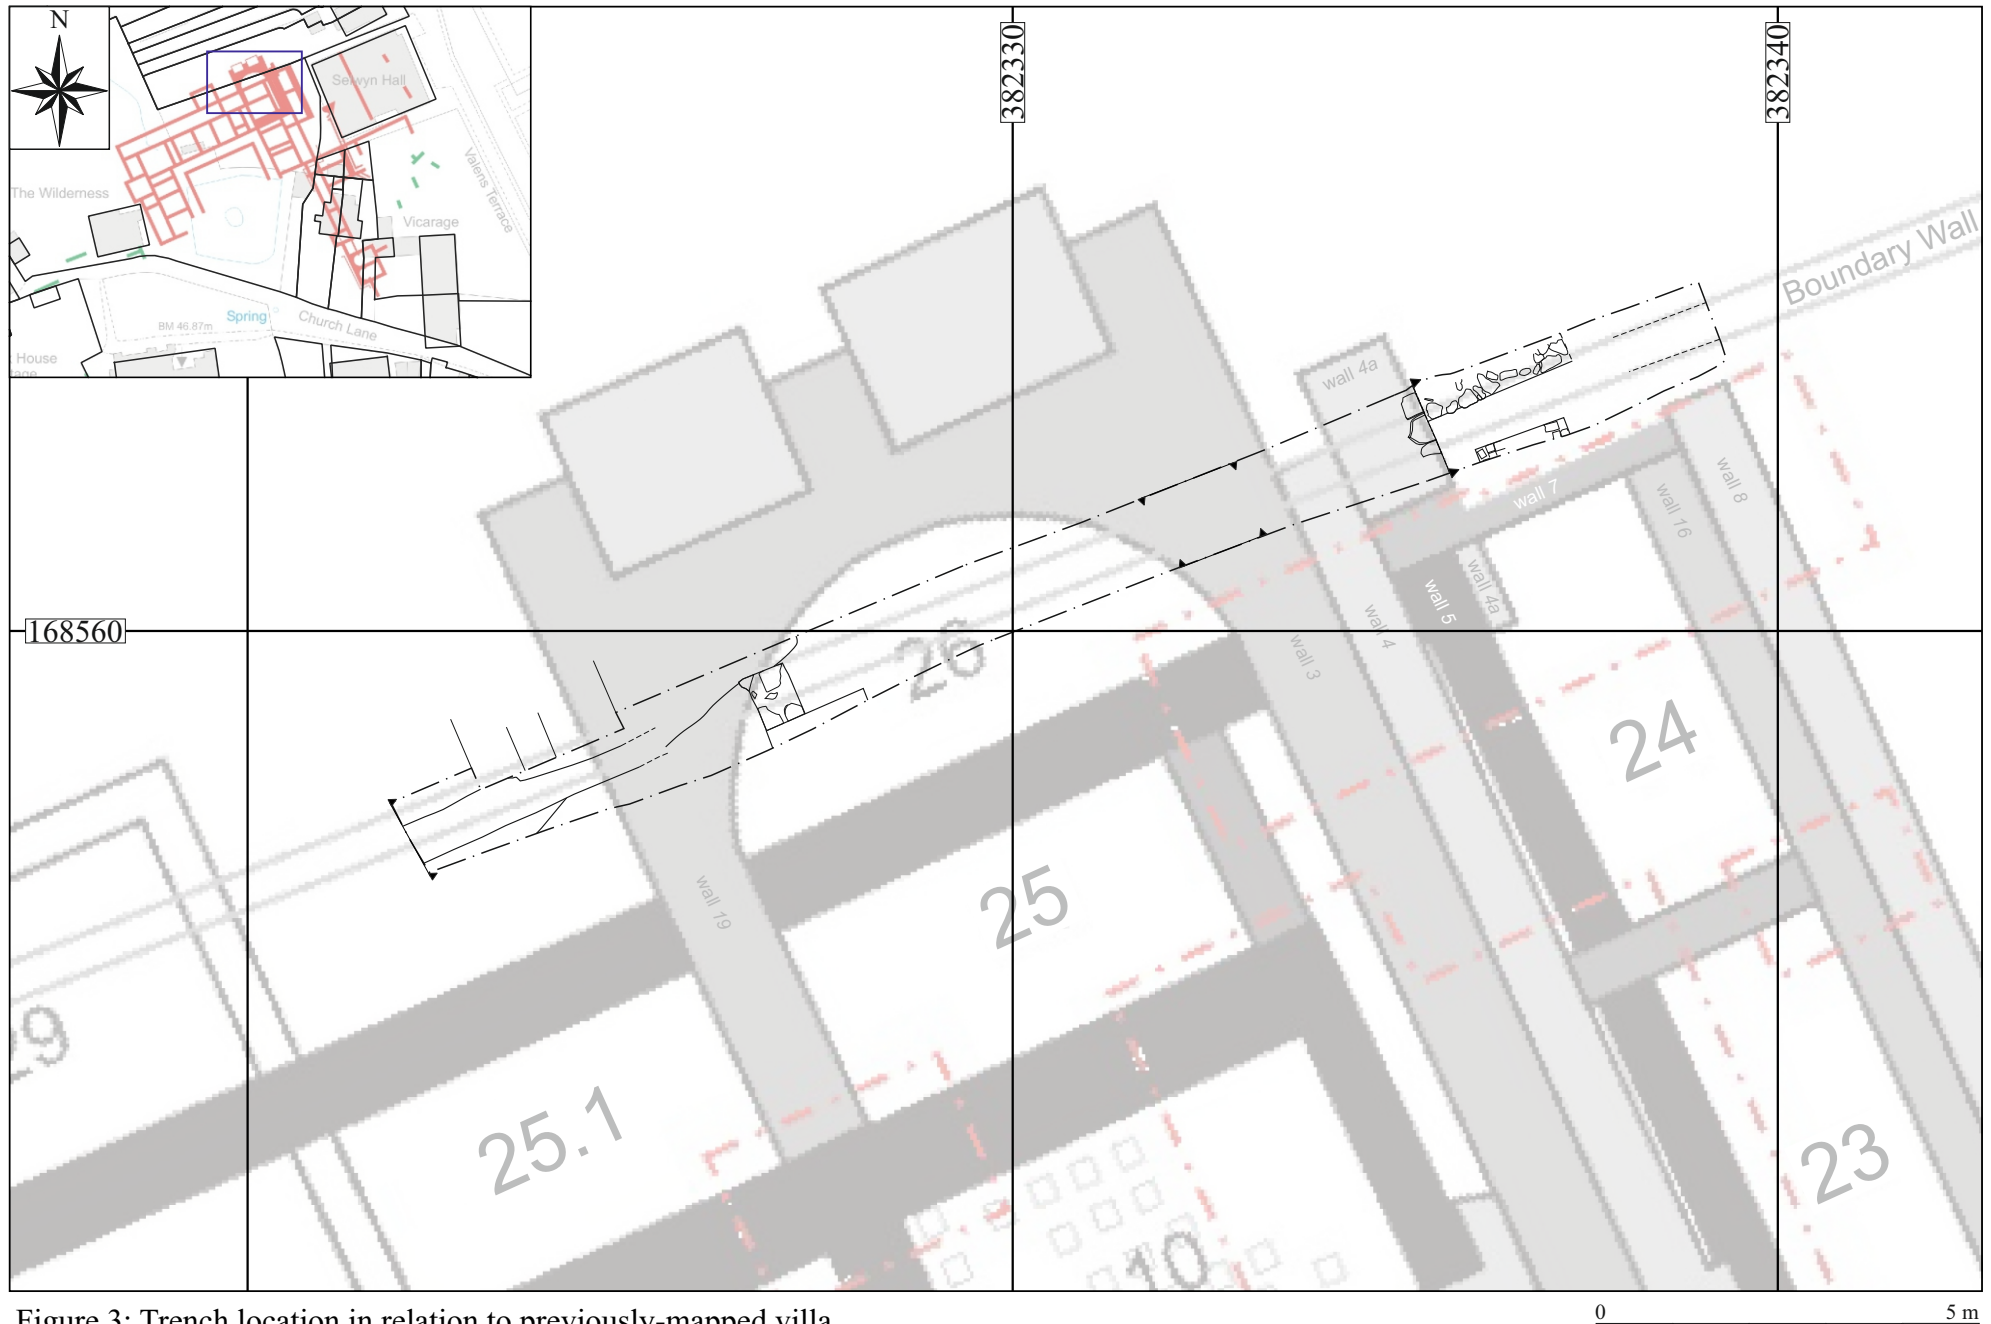
Figure 3: Trench location in relation to previously-mapped villa

To the west of wall 4a, no further Roman masonry was encountered at the depth of the limit of excavation. It is highly likely therefore that layer (3) continues to protect the walls recorded by Hurst et al. 1987 as 4, 3, and 19, with limited or no impact from the construction of the boundary wall. The exception may be construction cut 8, which was excavated to an unknown depth to house an additional foundation for the boundary wall. Due to its location, construction cut 8 may have physically impacted upon the Roman deposits located internally to apsidal Room 26, as well as the room's western wall (wall 19 (Hurst et al. 1987)). The extent of the impact on the Roman remains is dependent on the depth of cut 8, which could not be investigated during this stage of works.

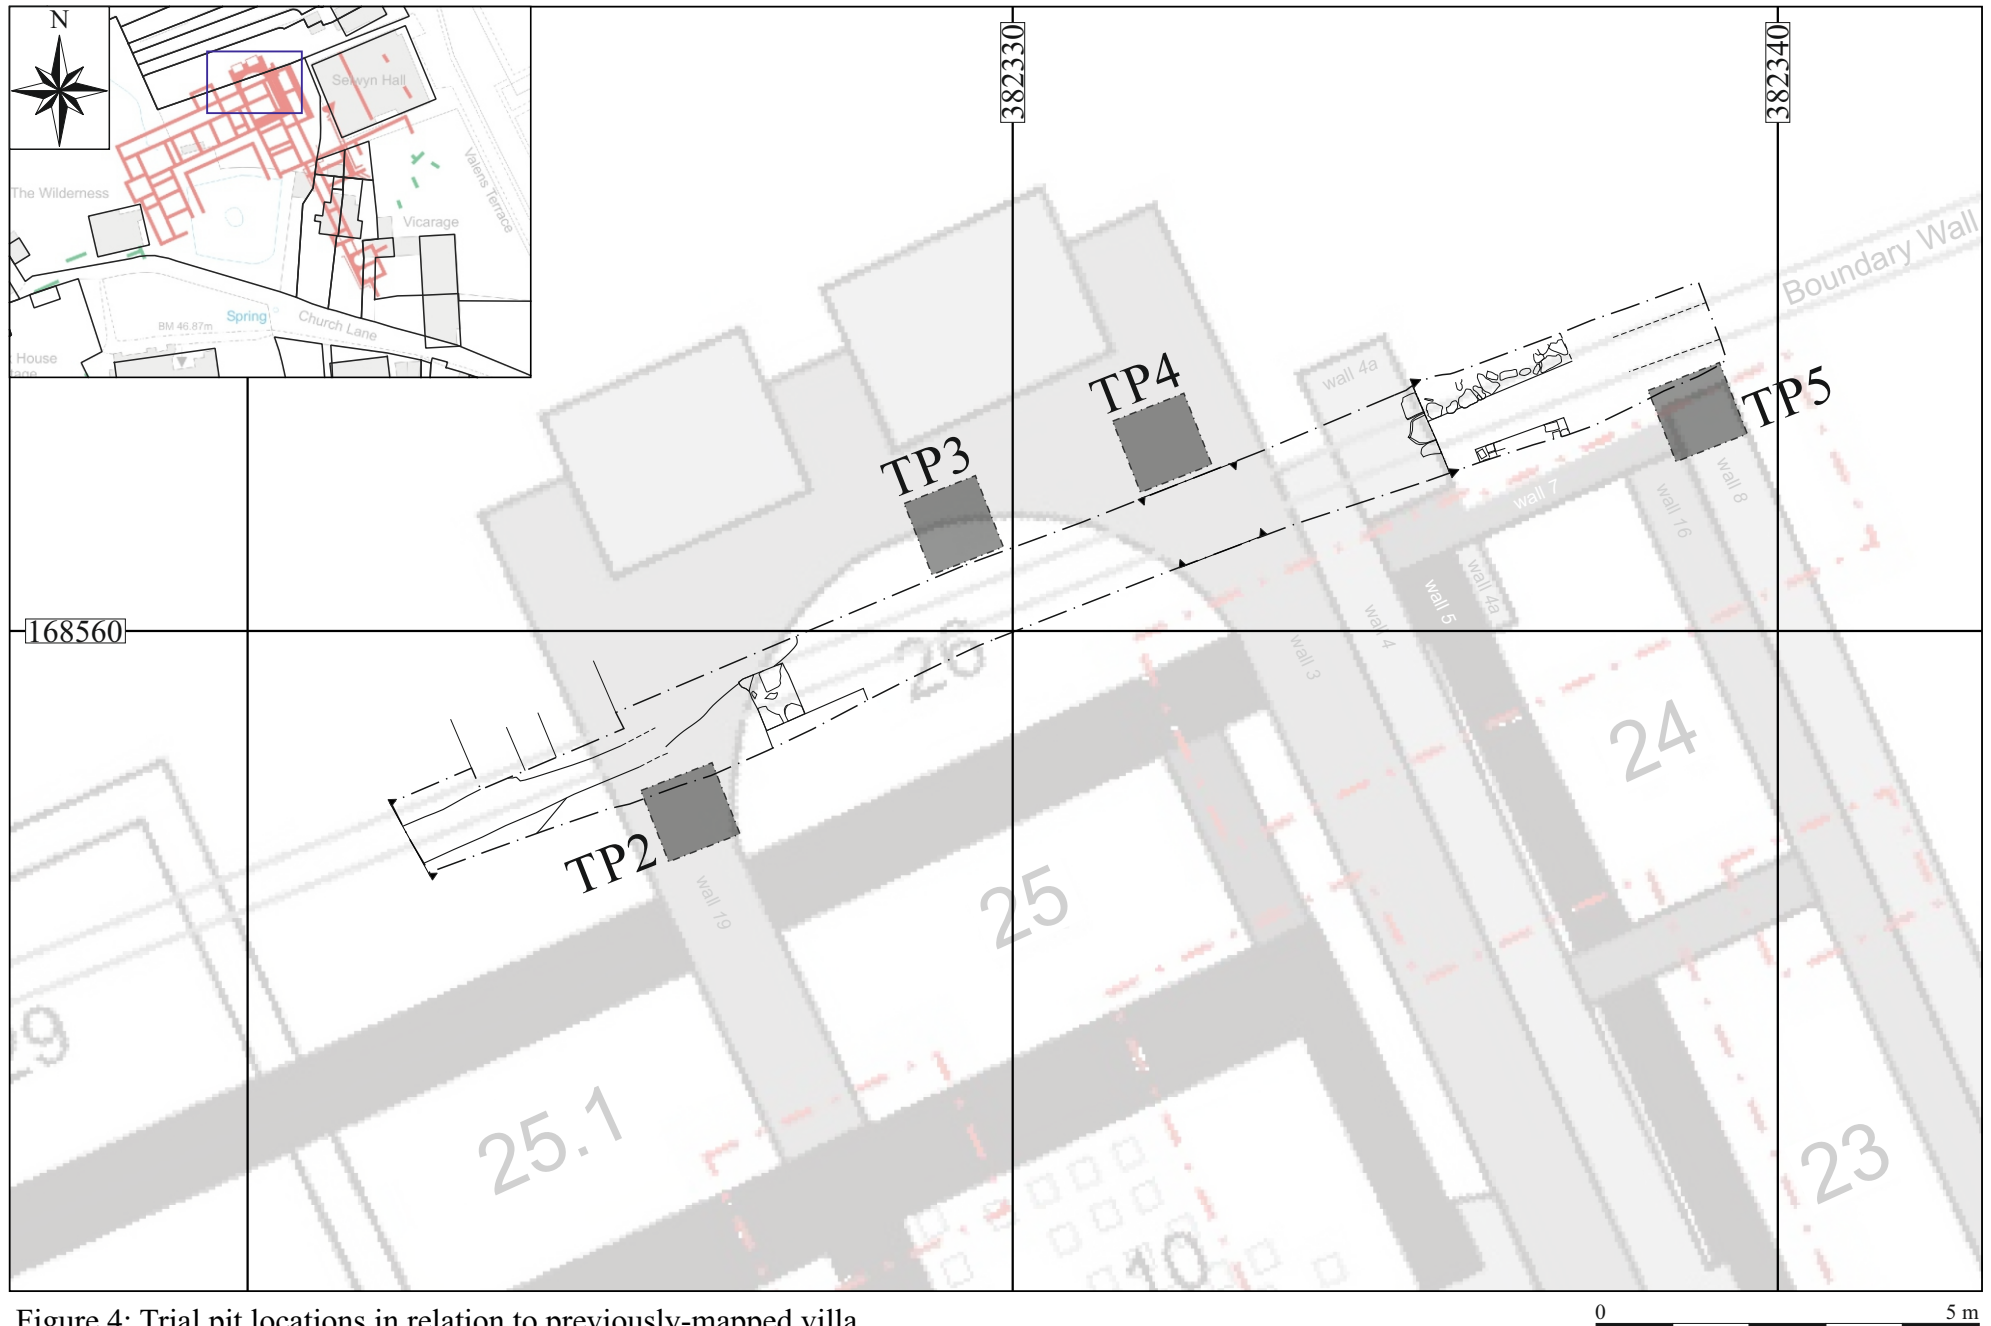
Figure 4: Trial pit locations in relation to previously-mapped villa

Trial Pits 2, 3, and 4 were positioned over the wall of apsidal Room 26 (numbered as 3 and 19 by Hurst et al. (1987)) (see Figure 4). The greatest depth reached in this part of the watching brief trench was 41.96m AOD, where the Roman wall was not encountered. This elucidates the reason why shallower Trial Pit 2 (maximum depth: 42.17m AOD) did encounter the Roman wall. Deeper Trial Pits 3 and 4 (depths of 41.78m AOD and 41.61m AOD respectively) both encountered limestone rubble which may relate to the Roman wall of Room 26. Furthermore, it is possible that the curve of the wall of Room 26 is seen running through the centre of Trial Pit 3.
