ARCHAEOLOGICAL WATCHING BRIEF

WOODSTOCK HOUSE,

RECTORY LANE, WOODSTOCK,

DECEMBER 2023

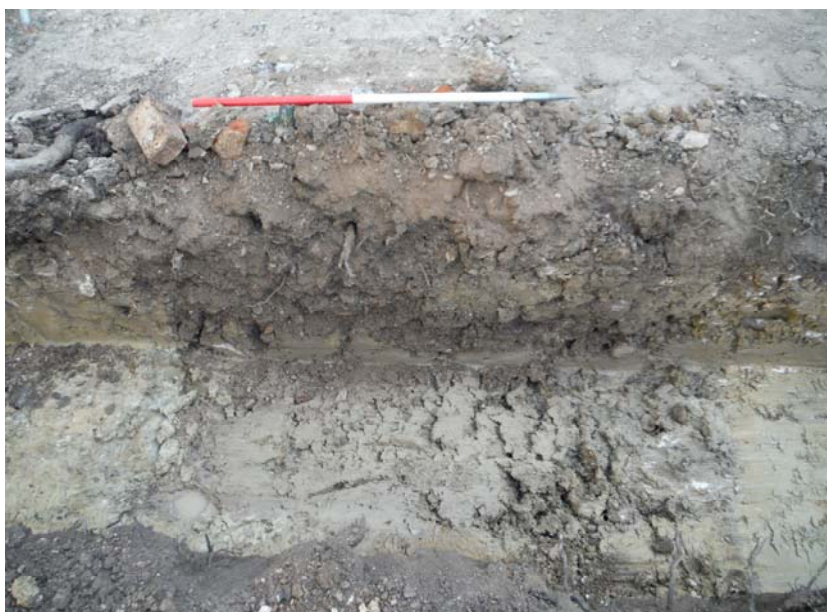
Plate 1: Soakaway 14 in plan. Looking north-east.

Observed in footings trenches excavated for the eastern garden wall, cut into the natural geology (02) was a previously excavated soakaway 14 (Figure 2, Plan 1, Plate) associated with an earlier phase of construction for the house. The soakaway appeared rectangular in plan with 90-degree, sharp corners, straight sides and a sharp break of slope at the top. It measured 1.7m in length, 0.6m in width and greater than 0.3m in depth. The soakaway contained a single fill comprised of compact, mid yellowish grey clay (15) with rare inclusions of sub-rounded stones. The deposit measured greater than 0.3m in thickness and no finds were identified during excavation. The soakaway was not fully excavated as its depth exceeded the limit of excavation.

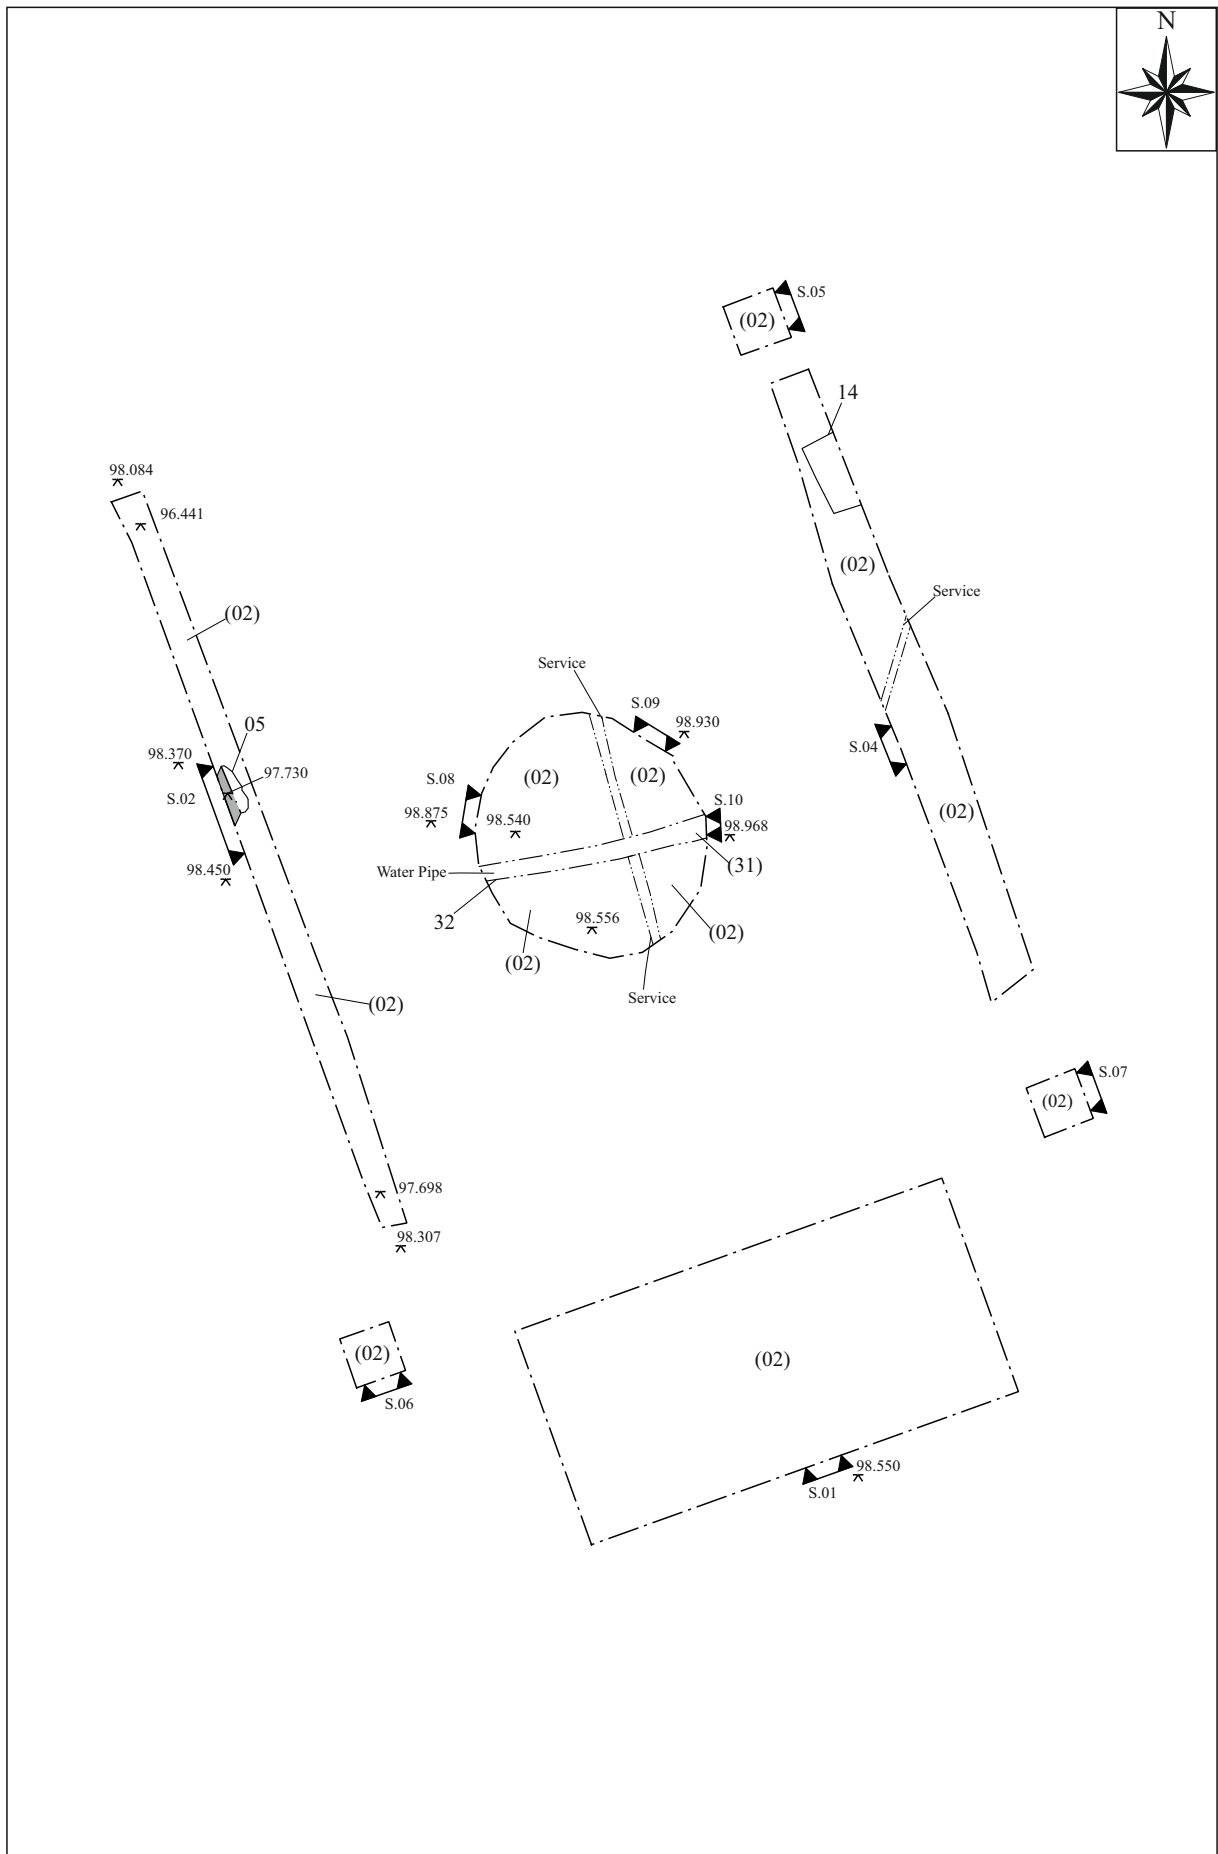
Figure 2: Plan of excavated areas

The earliest context encountered was a deposit comprised of soft, mid brownish-yellow, sandy-clay (02) (Figure 2, Plan 1; Figure 3, Sections 1 to 9) with occasional inclusions of limestone. The deposit measured a thickness greater than 0.6m. No archaeology was observed within the deposit and no finds were recovered. This deposit was identified as the archaeological horizon and the top of the natural marble limestone geology.

Excavation of the pond area in the parterre gardens revealed a modern service trench 32 (Figure 2, Plan 1, Plate 2) cut into the natural geology (02). The service trench measured greater than 6.1m in length, 0.5m in width with an unknown depth. The service contained a single fill comprised of loose, mid orangey/reddish-brown, silty-sand (31) (Figure 3, Section 10, Plate 2) and measured a thickness greater than 0.08m. The trench was not excavated or investigated further for safety reasons. No finds were recovered from the fill.

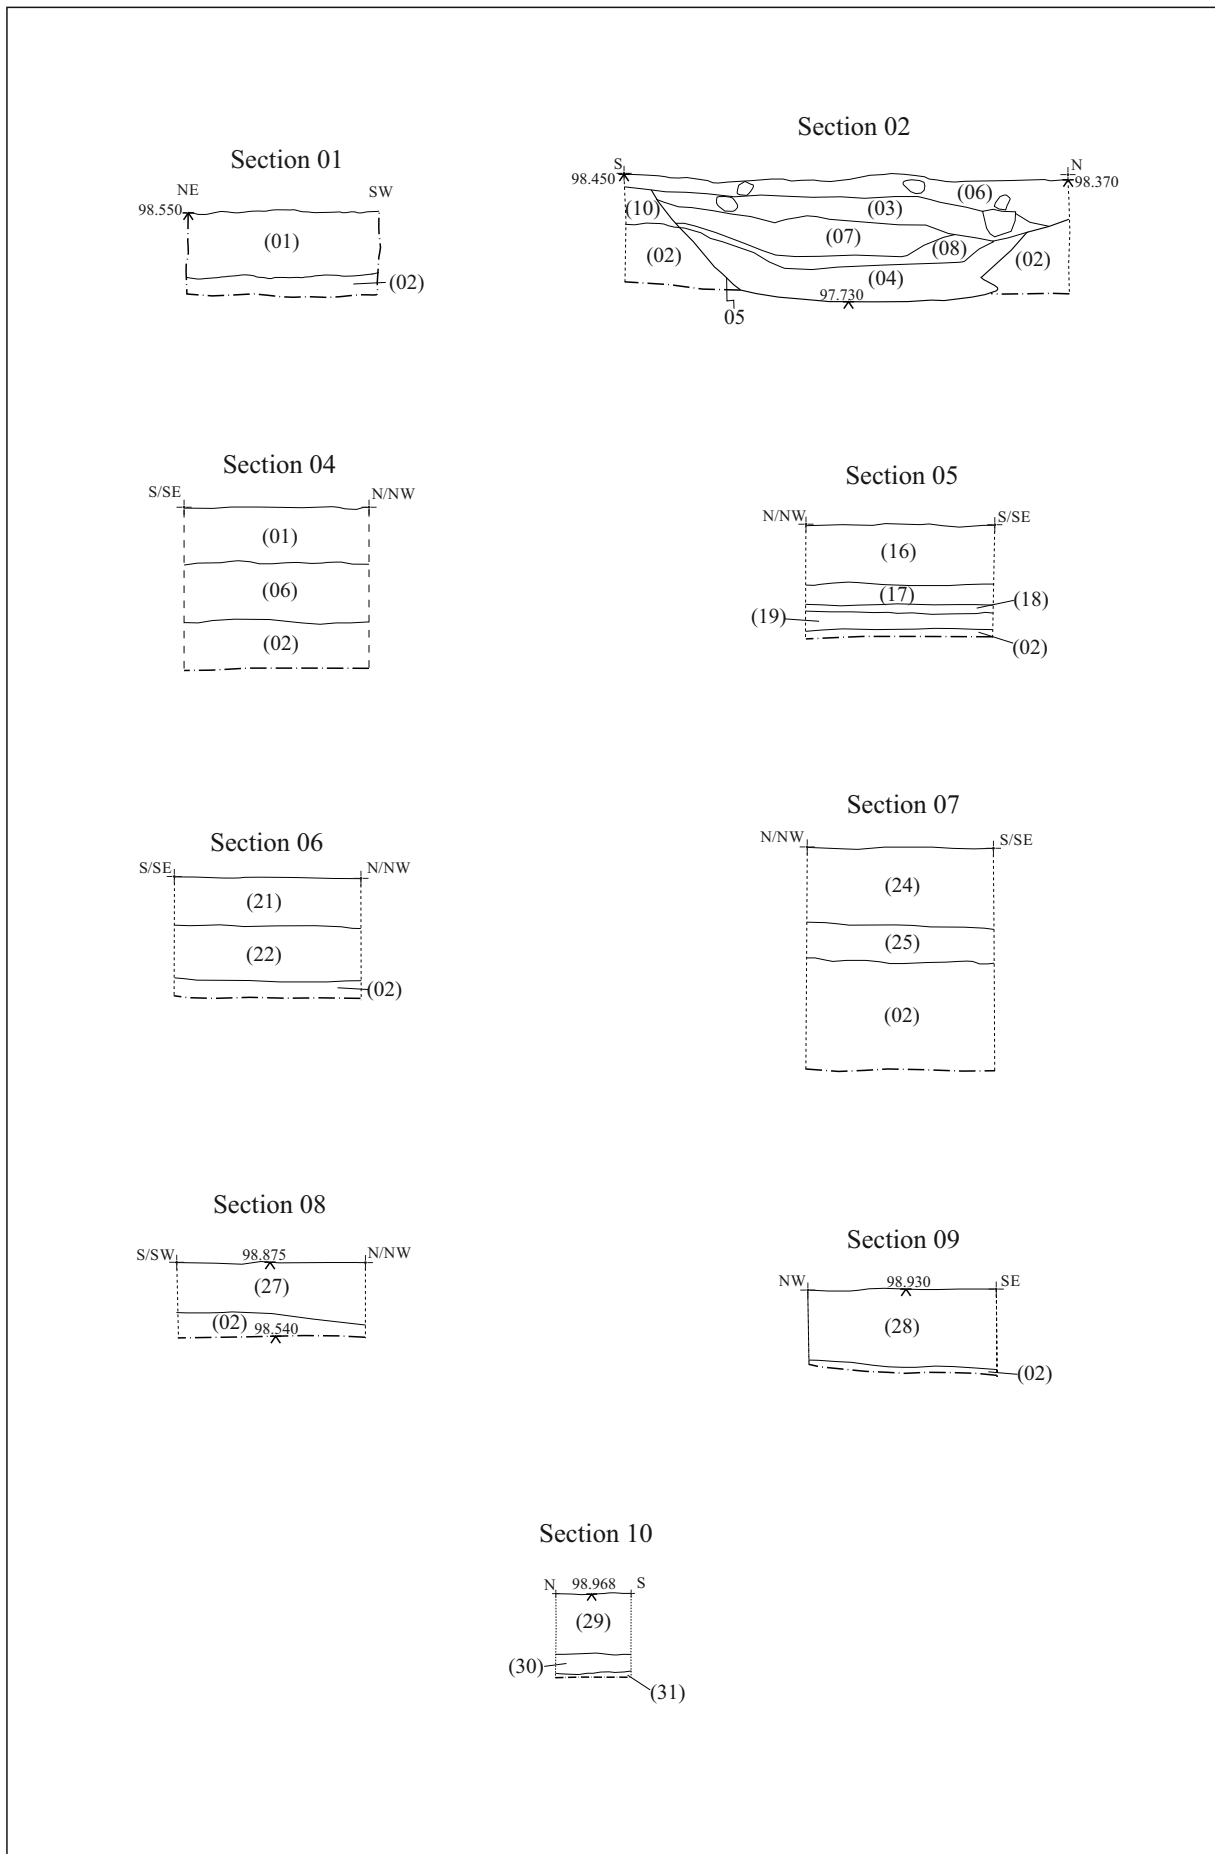
Figure 3: Sections 01-02 and 04-10

Overlying the natural observed in the south-west foundations trench was a buried soil deposit comprised of firm, mid reddish-brown, sandy-loam (10) (Figure 3, Sections 2 and 3) with frequent inclusions of small, angular limestone. The deposit was disturbed in the upper part of the profile, by modern activity. It measured between 0.2m and 0.3m in thickness and was sterile of finds.

Overlying this was a thin made ground deposit of soft, black, sandy-clay (18) (Figure 2, Plan 1; Figure 3, Section 5), measuring a thickness of 0.06m. This deposit was observed in a square footings trench excavated to the south-east corner of Woodstock House. The deposit was identified as a made ground deposit, likely associated with previous ground levelling works.

Above this was a deposit comprised of soft, mid brownish-yellow, sandy-clay (17) (Figure 2, Plan 1; Figure 3, Section 5) with rare inclusions of sub-angular stones. It measured 0.1m in thickness and was sterile of finds. The deposit was also observed across excavations to the west of the landscaping area, to the south-east corner of the house. The deposit was identified to be re-deposited natural resulting from ongoing excavations and ground levelling within the vicinity. No finds were recovered from the deposit.

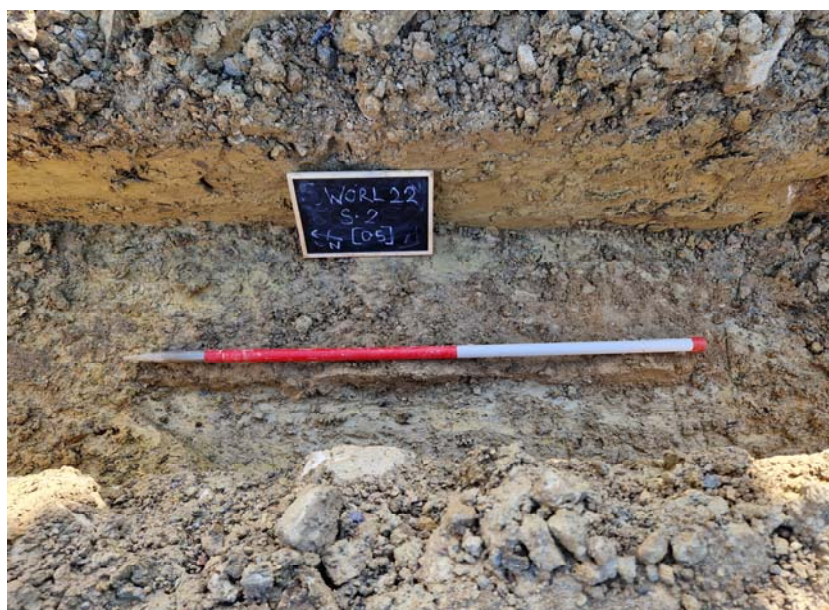
Plate 3: Section 02, Pit 05. Looking south-west.

Overlying this was a second fill, comprised of firm to friable, black, silty-loam (08). The fill had a high humic content and appeared as if possibly burnt. The fill measured between 0.03m and 0.14m in thickness. Signs of burning within the deposit suggested the material may have been the result of removal and backfilling of a small tree or shrub. A single fragment of Ceramic Building Material was recovered from the fill, thought to originate from a roof tile. Due to the limited potential to date plain roof tiles, the fragment remains broadly dated to the post-medieval period.

A third fill was observed above this, comprised of hard, mid to light orangish-brown clay (07) with moderate to frequent inclusions of small, angular limestone. The fill measured between 0.1m and 0.22m in thickness and was sterile of finds. This fill was similarly partially truncated in plan and may have been the result of backfilling following the removal of a tree/shrub.

Overlying this was the pit's upper fill, comprised of compact, black silt (03) with frequent inclusions of charcoal and wood/plant remains and rare inclusions of stone. The fill measured between 0.08m and 0.15m in thickness and again was partially truncated in plan, by modern disturbance. No finds were recovered from the deposit.

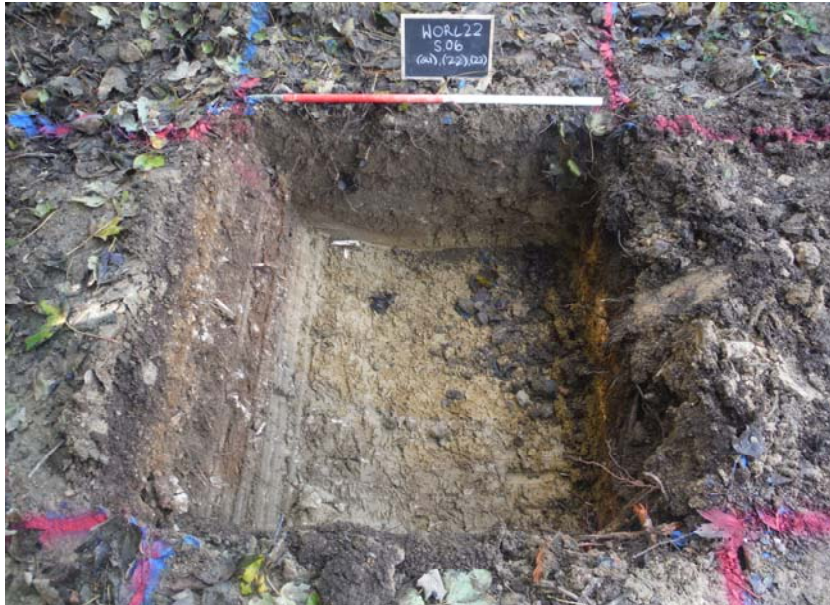
Plate 4: Section 06. Representative section of square footing trench. Looking south-west.

A deposit comprised of firm, dark reddish-brown, sandy-clay (22) (Figure 2, Plan 1; Figure 3 Section 6, Plate 4) with rare inclusions of sub-angular stones was identified in a square trench footing located on the north-west corner of the newly constructed garden temple. This deposit was heavily rooted by trees and was identified as a subsoil deposit. It measured a thickness of 0.28m and was sterile of finds.

A garden soil deposit (Figure 2, Plan 1; Figure 3, Section 4, 6 and 7, Plate 4) was observed on the south/south-east side of the site during excavations for the

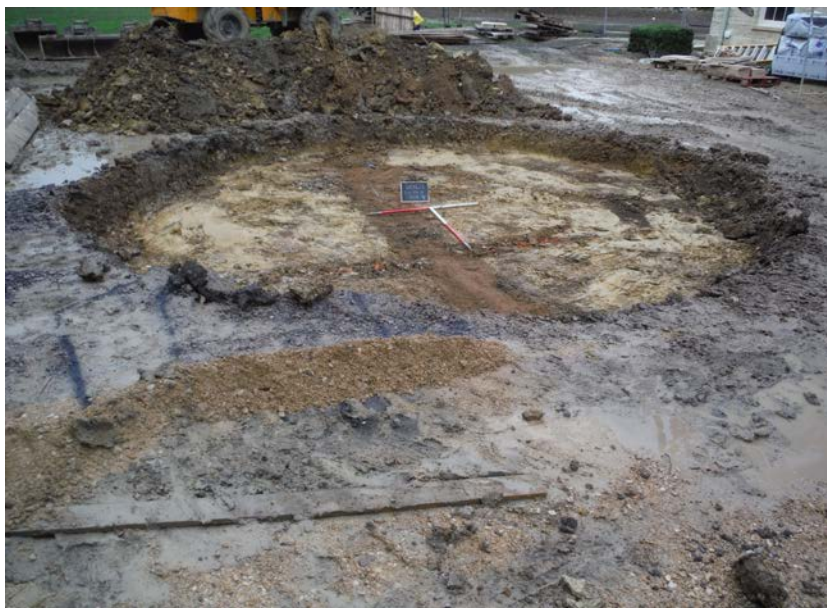
Plate 2: Post-excavation of 'Pond Area', showing service trench 32. Looking west.

Excavation of the pond area in the parterre gardens revealed a modern service trench 32 (Figure 2, Plan 1, Plate 2) cut into the natural geology (02). The service trench measured greater than 6.1m in length, 0.5m in width with an unknown depth. The service contained a single fill comprised of loose, mid orangey/reddish-brown, silty-sand (31) (Figure 3, Section 10, Plate 2) and measured a thickness greater than 0.08m. The trench was not excavated or investigated further for safety reasons. No finds were recovered from the fill.

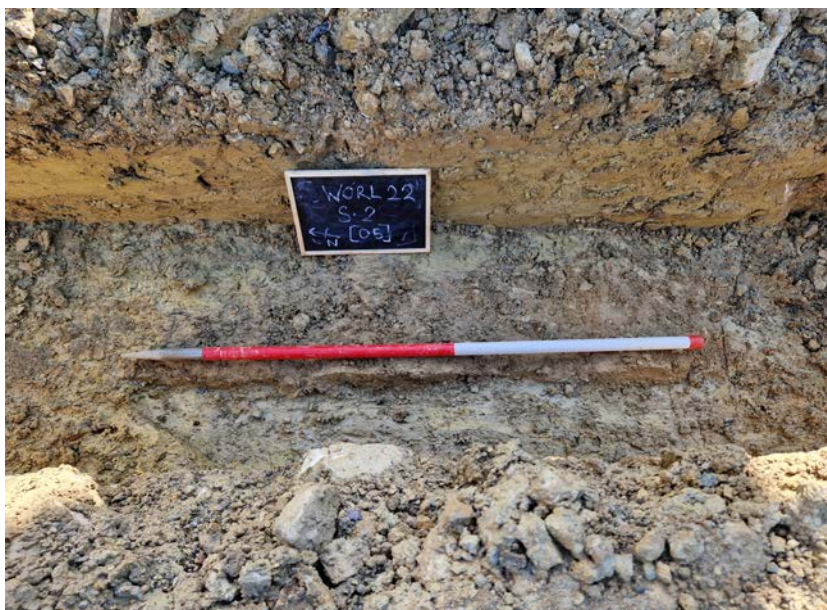
Plate 3: Section 02, Pit 05. Looking south-west.

Overlying this was a second fill, comprised of firm to friable, black, silty-loam (08). The fill had a high humic content and appeared as if possibly burnt. The fill measured between 0.03m and 0.14m in thickness. Signs of burning within the deposit suggested the material may have been the result of removal and backfilling of a small tree or shrub. A single fragment of Ceramic Building Material was recovered from the fill, thought to originate from a roof tile. Due to the limited potential to date plain roof tiles, the fragment remains broadly dated to the post-medieval period.

A third fill was observed above this, comprised of hard, mid to light orangish-brown clay (07) with moderate to frequent inclusions of small, angular limestone. The fill measured between 0.1m and 0.22m in thickness and was sterile of finds. This fill was similarly partially truncated in plan and may have been the result of backfilling following the removal of a tree/shrub.

Overlying this was the pit's upper fill, comprised of compact, black silt (03) with frequent inclusions of charcoal and wood/plant remains and rare inclusions of stone. The fill measured between 0.08m and 0.15m in thickness and again was partially truncated in plan, by modern disturbance. No finds were recovered from the deposit.

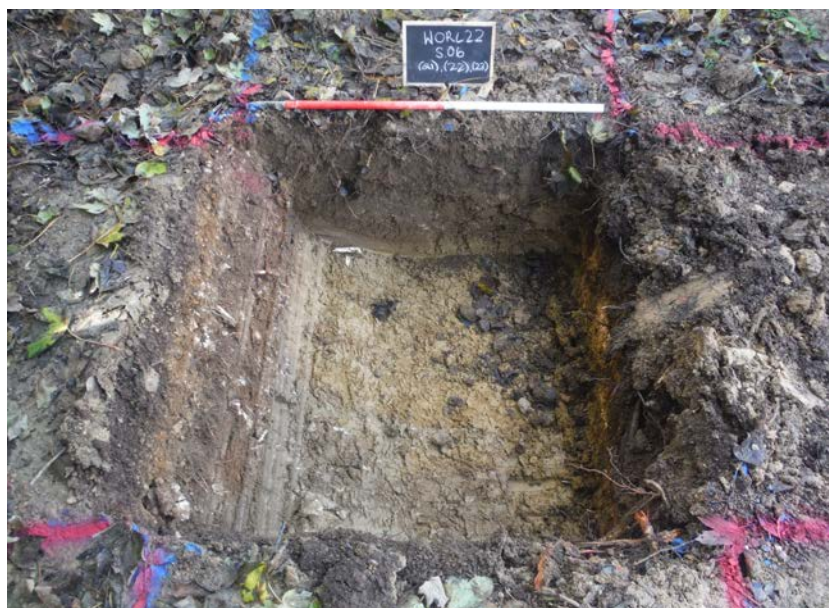
Plate 4: Section 06. Representative section of square footing trench. Looking south-west.

A deposit comprised of firm, dark reddish-brown, sandy-clay (22) (Figure 2, Plan 1; Figure 3 Section 6, Plate 4) with rare inclusions of sub-angular stones was identified in a square trench footing located on the north-west corner of the newly constructed garden temple. This deposit was heavily rooted by trees and was identified as a subsoil deposit. It measured a thickness of 0.28m and was sterile of finds.

A garden soil deposit (Figure 2, Plan 1; Figure 3, Section 4, 6 and 7, Plate 4) was observed on the south/south-east side of the site during excavations for the
