**AN ARCHAEOLOGICAL EXCAVATION**

**DE LA BECHE, ALDWORTH,**

**WEST BERKSHIRE**

**FEBRUARY 2009**

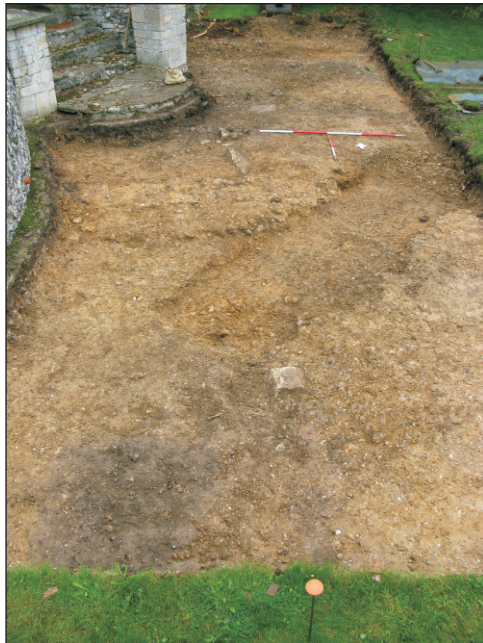
Figure 5. Excavation area looking north after stripping; Evaluation Trench 1 visible cutting demolition rubble (147), wall [103] and cobbling (134).

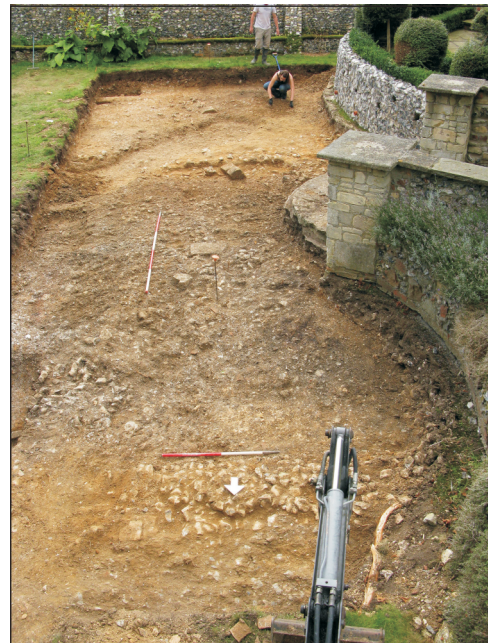
Figure 6. Excavation area looking south; wall [124] is located under North arrow, cobbling (134) and wall [103] are to the south, while floor (116)/(117)/(110) is being cleaned

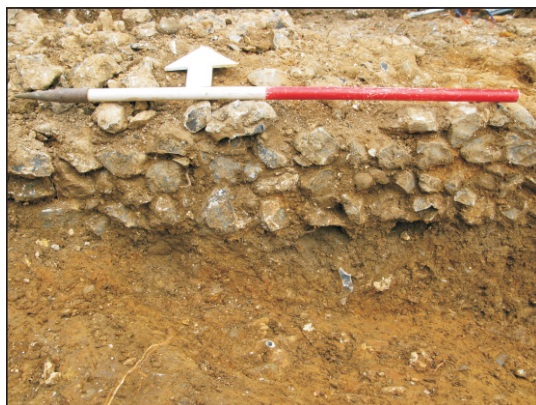
Figure 7. Wall [124] and treebole [150]

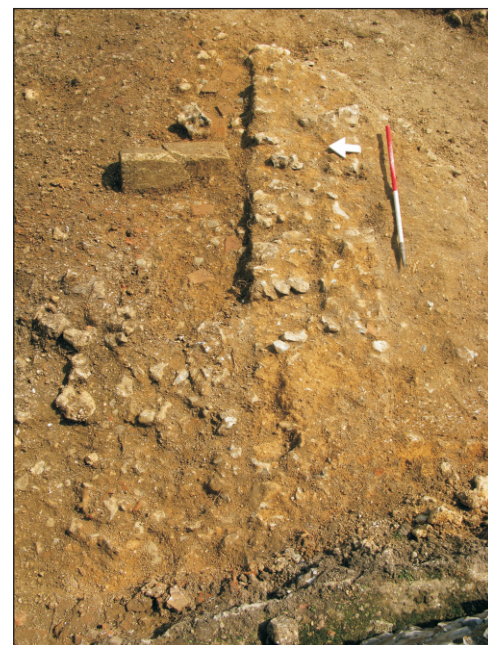
Figure 8. Wall [128] looking east; rubble and limestone architectural fragment to north and rubble to south

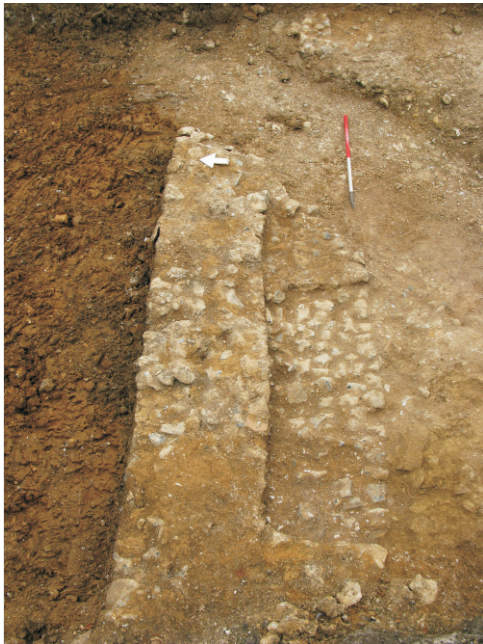
Figure 9. Wall 103 with stone feature 135 and floor (117) to south.

The stone structure [135] (Fig. 9) was located hard against the south face of the northern wall [103]. It comprised a single course of packed roughly or unworked flint nodules with some sandy mortar through it and also partly sealing it (132) (Fig. 4, S.8). It was 0.55m – 0.6m wide. This group of deposits was observed during the evaluation (01/05), where it was interpreted as the fill of a construction trench. The excavation did not indicate its exact function; it may have formed a drain, or equally the compacted flints may have been to provide a base or support, which would not be susceptible to subsidence along the north wall of the room. Elsewhere within the room repairs to and patching up of the floor (116)/(117)/(110)/(01/04) were observed.

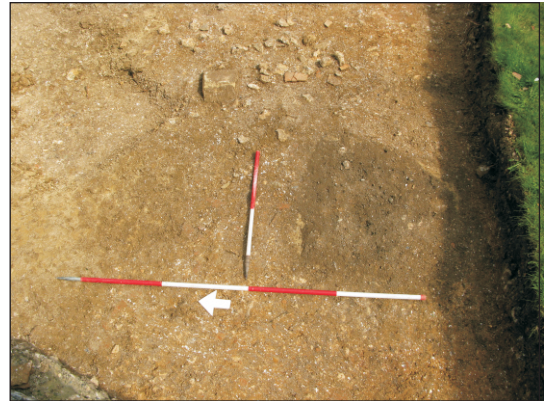
Figure 10. Post-medieval pit 107

By the 16<sup>th</sup> century the building at De La Beche had been abandoned, and probably razed, to be used only for the occasional disposal of rubbish, as evidenced by the pit [107] (Fig. 10; Fig. 4, S.10) containing pottery dating from after the mid 16<sup>th</sup> century (106).

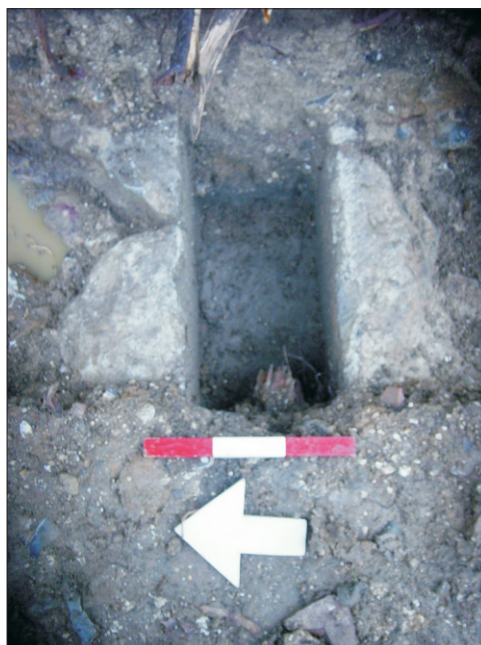
Figure 11. Drain 160

To the north of the wall [164], and cutting the northern extent of deposits (167), (156) and (155) was a cut [161] for a stone-lined drain [160], which was cut into the natural (102) (Fig. 11; Fig. 4, S.5). The cut was not fully examined given the physical and time constraints. The top of the cut was *c.* 0.55m across and more than 0.5m deep: the thickness of the basal slabs of the drain [160] is unknown. The slabs were roughly worked limestone with an internal facing and bonded with yellow mortar. The construction cut [161] of the drain was backfilled with sandy grit (162), and the drain itself was filled with grey sticky clays (165) and (166), indicating that it had silted up.

The drain appeared to be parallel with the north wall [124] of the building, and clearly post-dated the wall [164]. The drain did not appear to have been capped, although the limited view afforded by the intervention means that it cannot be precluded, and is probably more than likely. Deposit (173) and part of the top of cut [161] may be robbing of the drain cover. The drain is also more than likely associated with the building, although its exact relationship was not established.

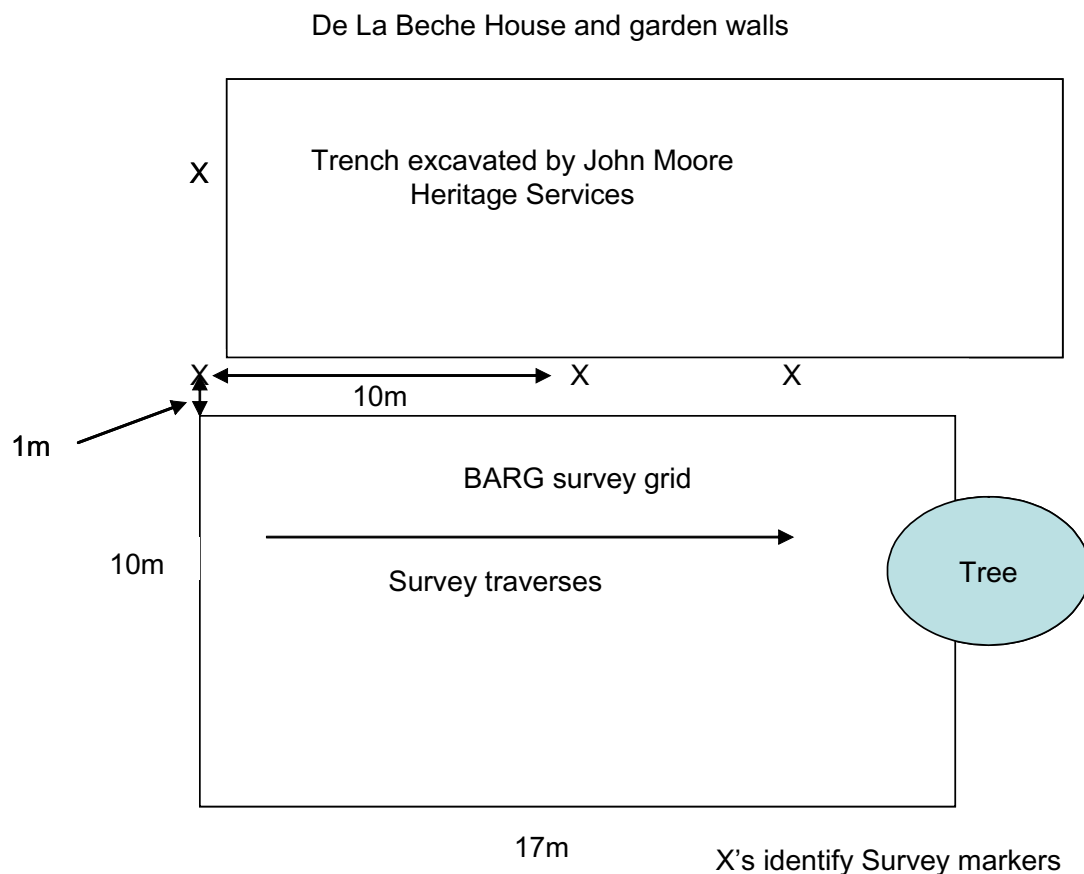
**Figure 1: layout of the BARG survey grid** Not to scale

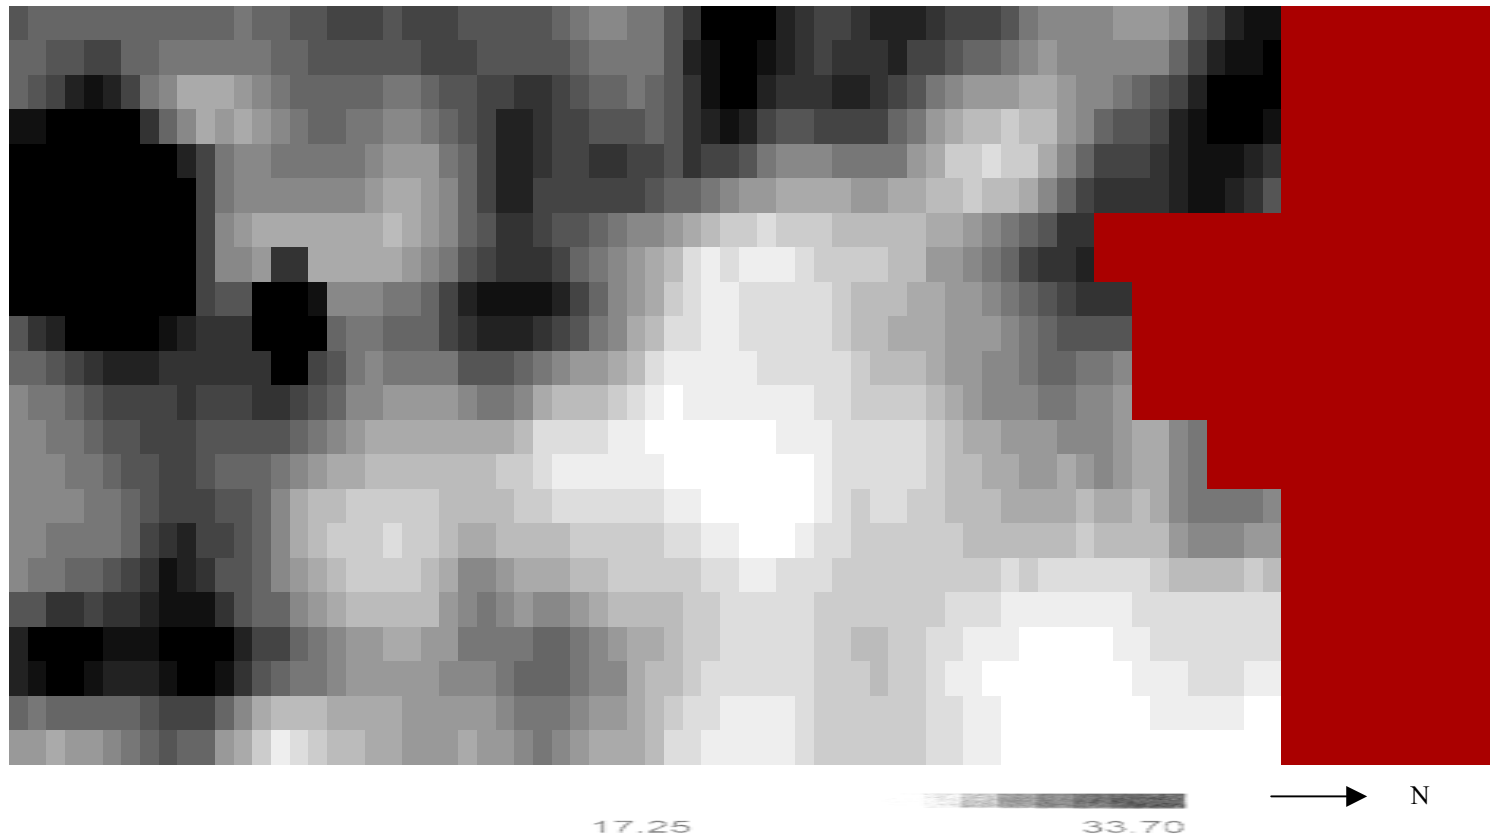
**Figure 2: Resistivity results from the De La Beche garden**

This plot represents an area 10m wide (east/west) and 20m long (north/south)

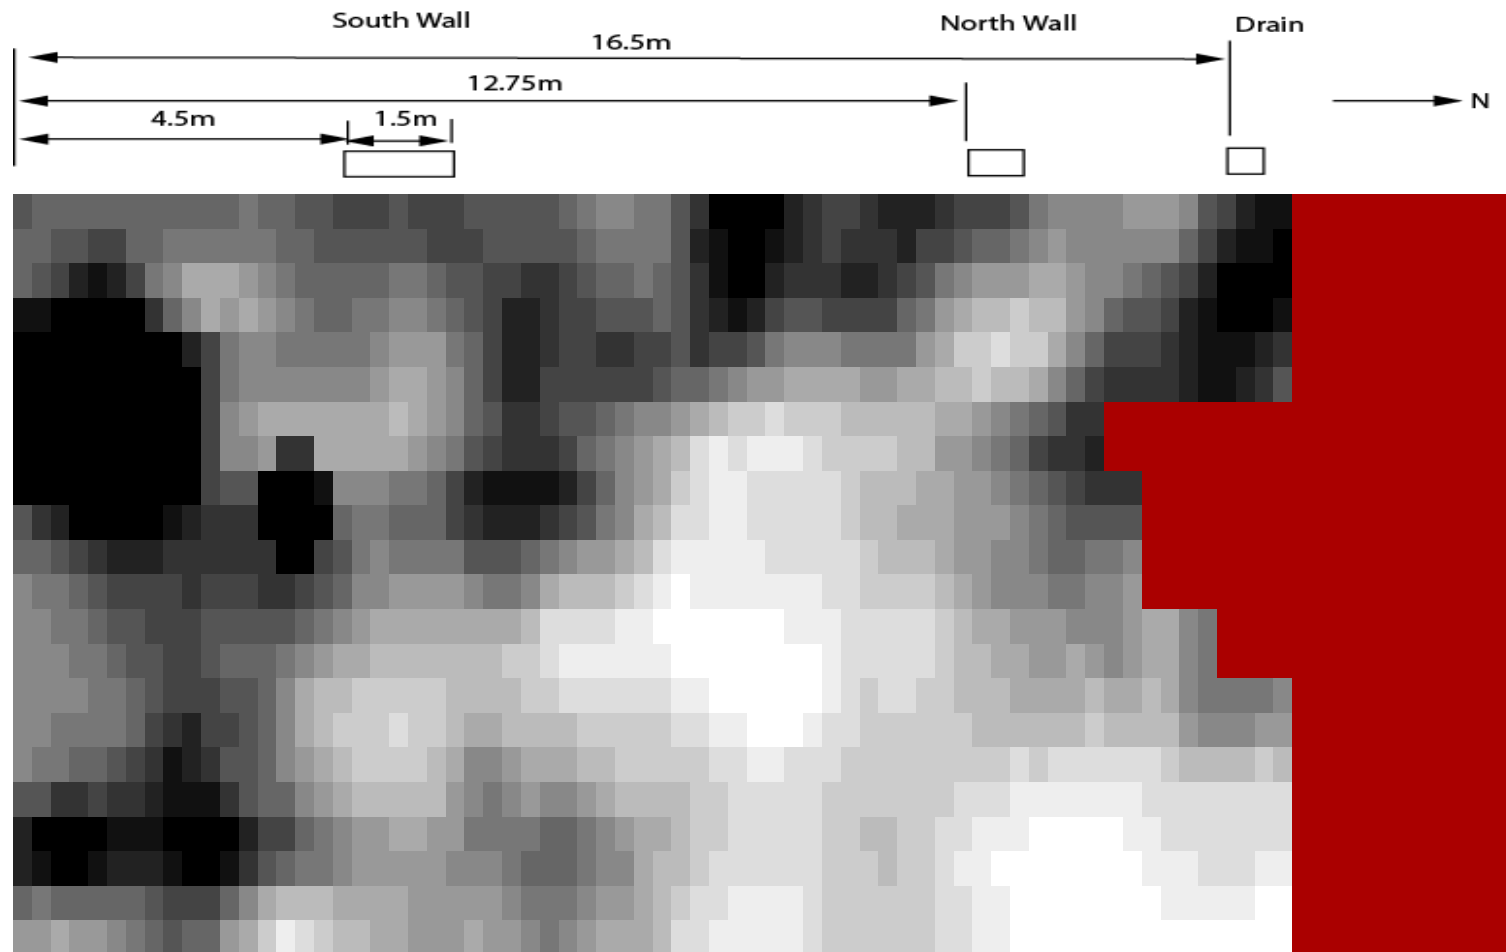
**Figure 3: Resistivity plot showing the correlation with the features found in the excavation trench**

Figure 3 shows plots the features found in the excavation trench against the resistivity results. These features were: the south wall located between 4.6m and 6.0m, the north wall located between 12.75m and 13.5m and the external drain located between 16.5 and 17.1m from the 0m point established by the excavators.

The evidence suggests that south wall terminates some 3m east beyond the excavation trench in an area with other features which extend eastwards for another 9m. Taken together these could represent the remains of a building with two rooms to east of the south wall. The western (upper, see figure 3) of these feature has internal dimensions of approximately 5m north /south and 3m east/west, with a large area of high resistance on the southern side, which is approximately 2.5m north/south and 3m east/west and may represent the foundations of a chimney. The lower (eastern) feature with internal dimensions of approximately 4-5m north /south and 4m east/west may represent the remains of another room.

There also is a large high resistance feature to the south east of the end of the north wall.

Figure 3 shows that the external drain continues for another 5.5m south east of the excavation trench and seems to terminate in a high resistance feature which currently has a large tree growing on it. The high resistance may be caused by tree roots. It could also be caused by loosely packed rubble used to create a soakaway.
