JOHN MOORE HERITAGE SERVICES

**ARCHAEOLOGICAL EVALUATION AT
SHREWSBURY PLACE, BAMPTON
OXFORDSHIRE**

SP 3128 0311

SEPTEMBER 2008

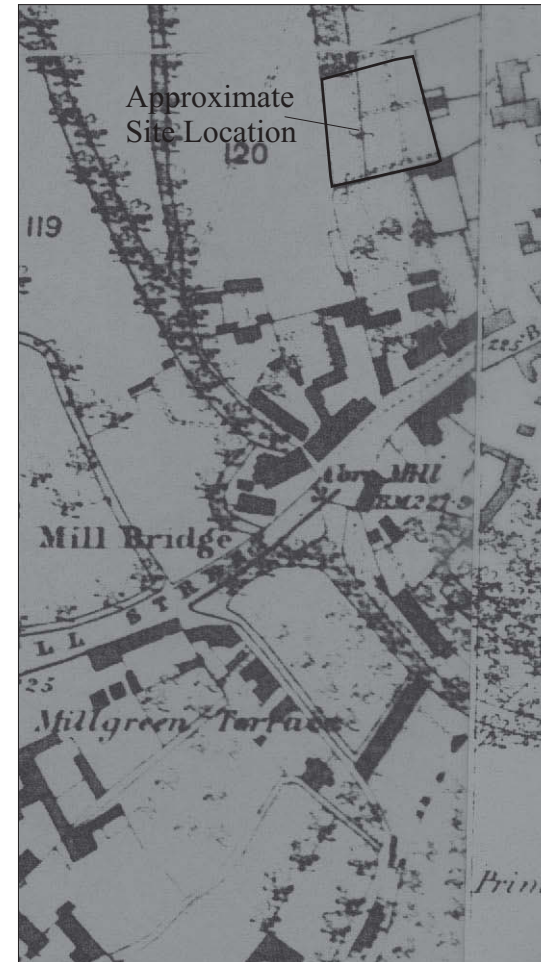
Figure 3. Historic Maps

1876 1st Ed OS

1899 2nd Edition OS

The building observed is an outbuilding of the school, visible on the 1st and 2nd editions of the Ordnance Survey (OS) maps for Bampton at 1:2500 (Figure 3). The building is not visible on the 1870 Shrewsbury Estate map of Bampton. The 1821 tithe map shows the land before the school was built; no structures are shown at all. The 1870 estate map shows the school and the field to the rear of the school, which continued to form the western extent of the school on the 1876 OS map. Interestingly, the school yard overlies an ornamental garden shown on the 1876 OS map; no evidence for this garden was observed in either Trenches 1 or 2. The plot boundary visible on the 1870 Bampton estate map was not observed as an archaeological feature. The walls observed are most likely to be the north-east return of the northern of the two outbuildings observed on the 1876 and 1899 OS maps. As a wall is visible extending to the east toward the school, we can assume that this probably divides the

boys from the girls, each having their own yard in which to play. The out-buildings observed during the evaluation were most likely part of a toilet-block.
