**AN ARCHAEOLOGICAL WATCHING BRIEF**

**THAMES WATER PIPELINE AND NEW STW,**

**BECKLEY, OXFORDSHIRE**

**MARCH 2009**

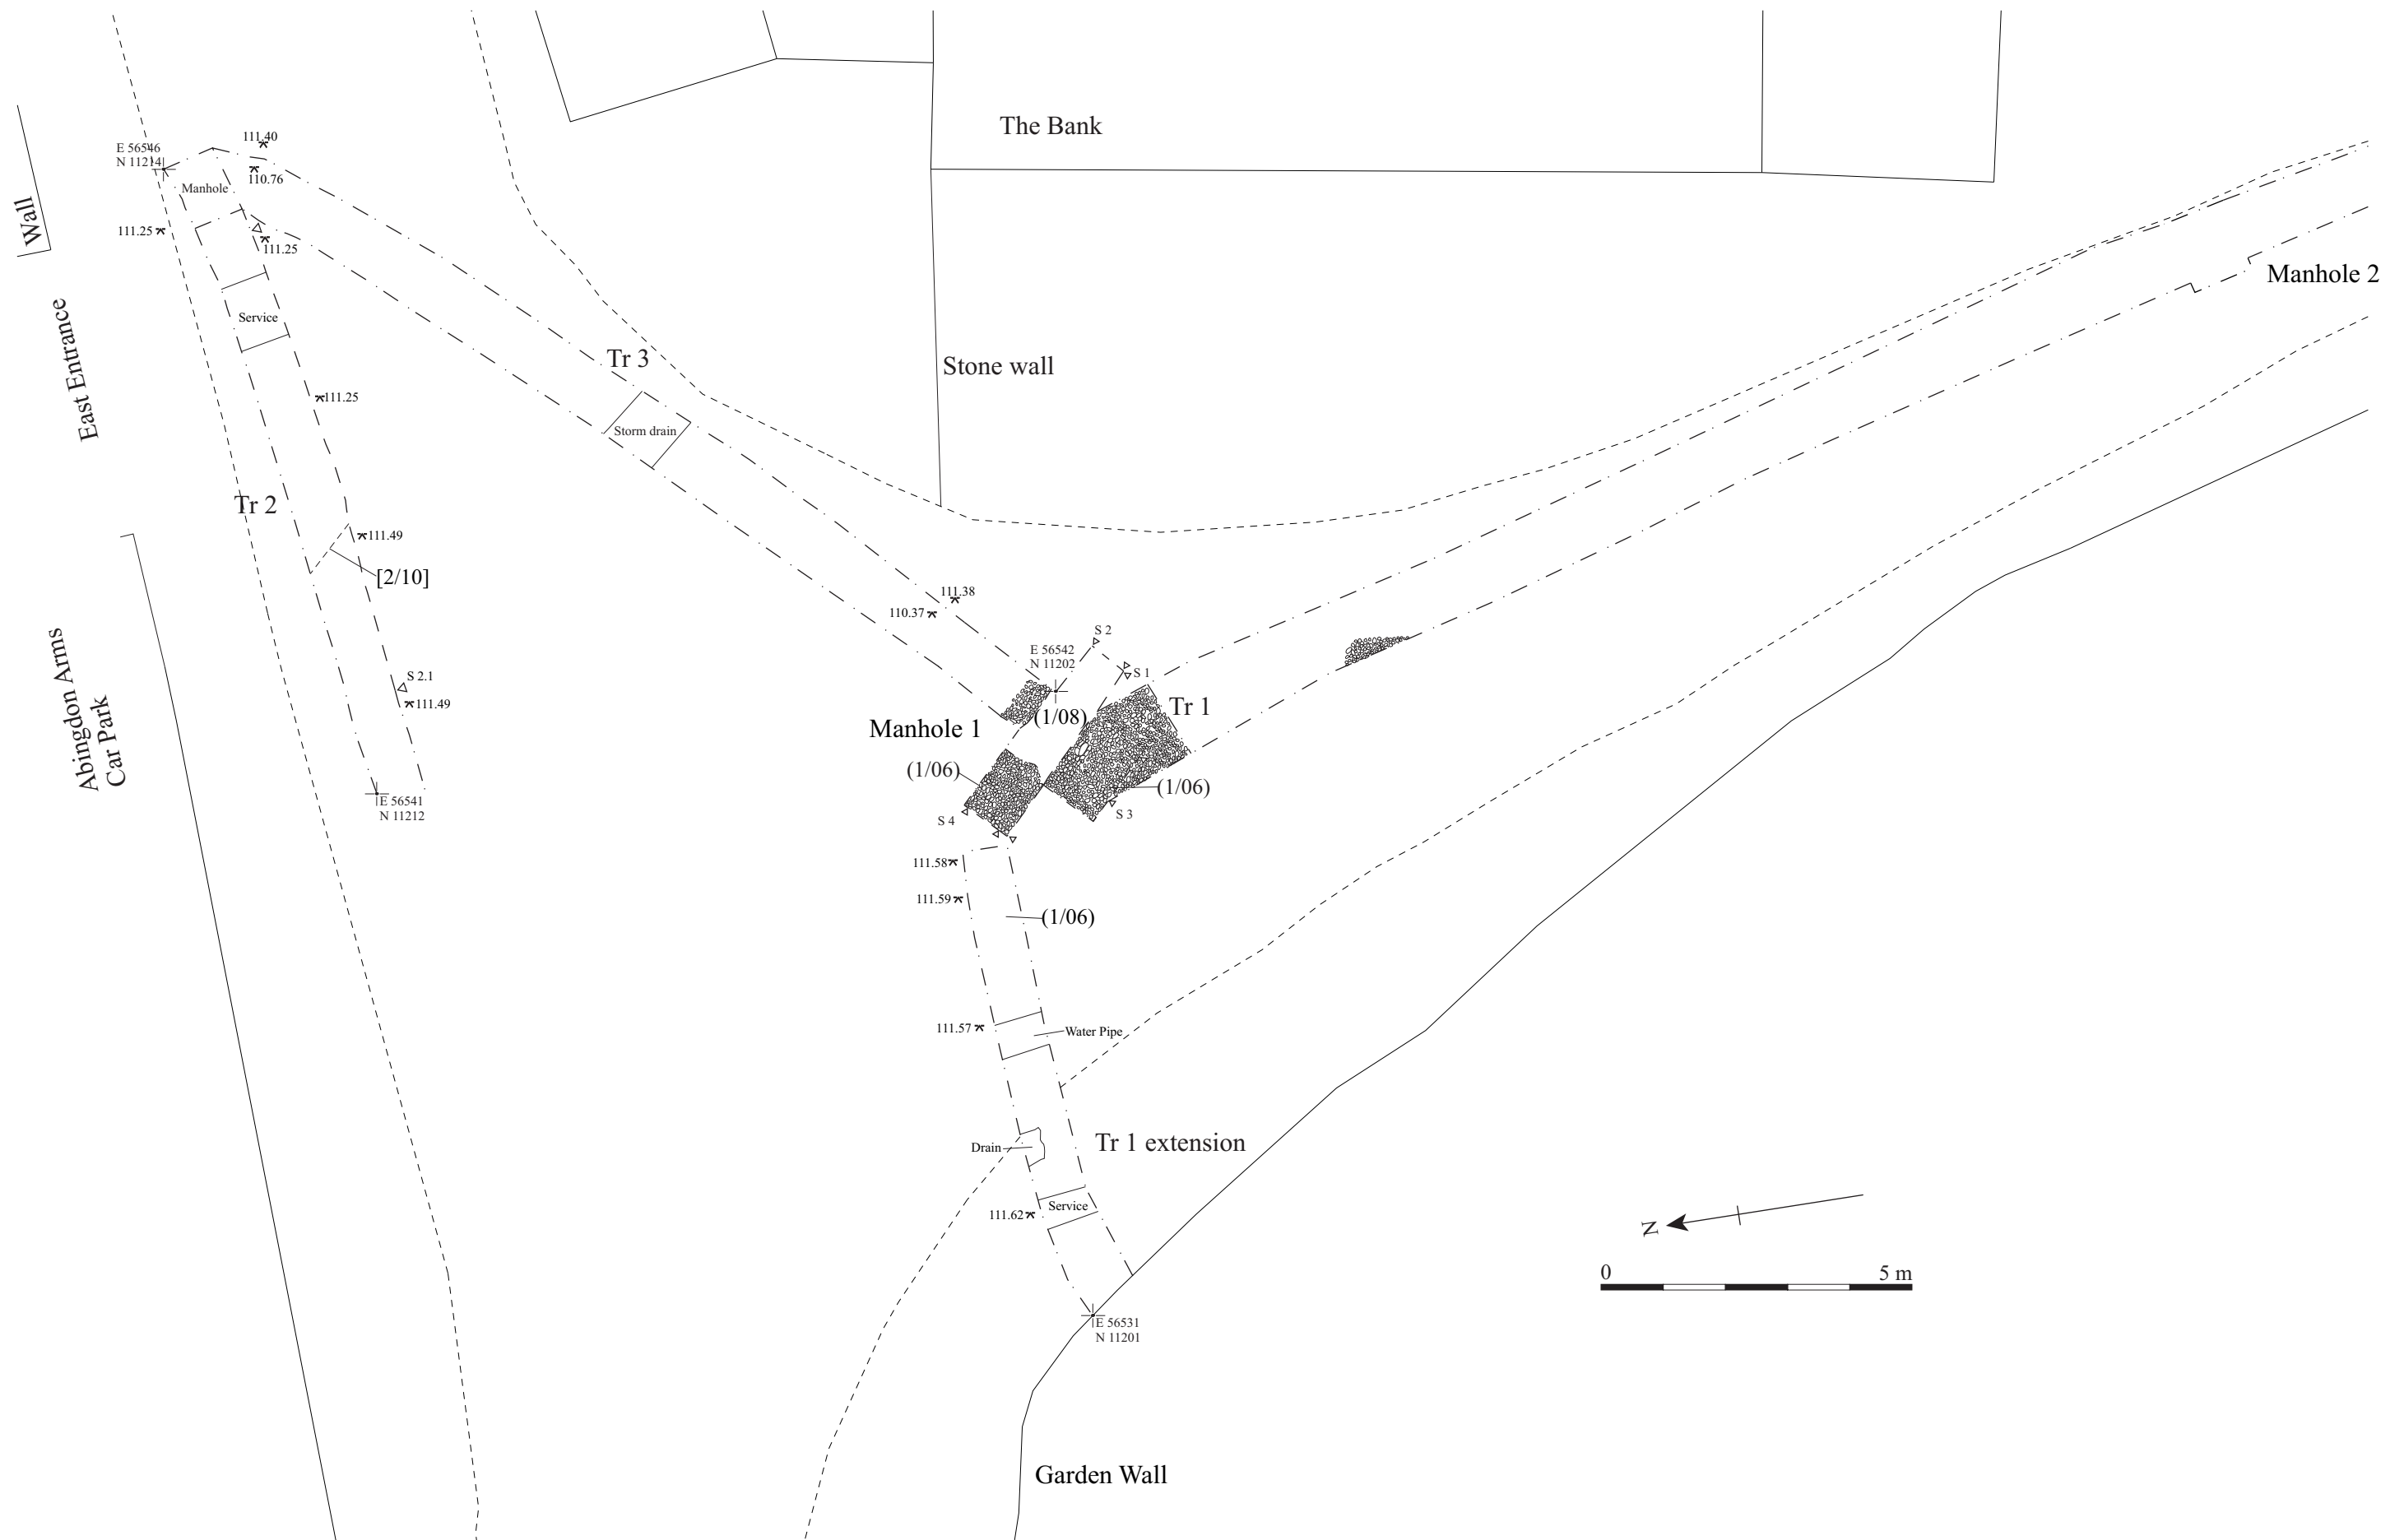
Figure 5. Plan of Trenches 1, 2 and 3

Trench 1 originally was 3.70m long and 0.65m wide at 111.20m OD and was dug to investigate the position of a service. The lowest deposit encountered was (1/08), which was firm greyish blue silty clay, c. 0.16m thick with occasional inclusions of pebbles (Fig 6). This may have been West Walton Formation. Overlying this deposit was Beckley Sand Member (1/07), a hard mid brownish yellow sandy clay, 0.24m thick. It lay directly beneath (1/06), which was the Roman road surface.

An extension of Trench 1 was excavated to the west. The Roman road was observed in this trench and was described as the same as (1/06). A service trench truncated the western edge of the Roman road at c. 1m from the western end of the trench. The road was level with the top at 111.12m OD at this point. Further sections were seen in Trench 3 and further south along Roman Way (see below).

A similar sequence of deposits was observed in the northern section of Trench 3 with the equivalent trench 2 context numbers being given. Trench 3 was 14.20m long and 1.10m wide and at a level of 111.38m OD at the SW corner, which rose to 111.40 at the NE corner. A modern storm drain was present at c 7m along the trench from trench 1. The Roman road was present to the south west of this division and due to the high level of truncation by services, was not visible in the northeastern section of the trench. All other deposits were visible for the length of the trench where not disturbed by services. The lowest layer (3/09) (2/09) was friable bluish grey sand that was c 0.50m deep. Towards the northern end of the trench deep disturbance had occurred with pieces of wood and animal bone within the material. Overlying it, deposit (3/08) (2/08) was firm in consistency and dark bluish grey sand in colour and composition and was c 0.20m deep. Overlying (3/08) was deposit (3/07) (2/07), mid bluish grey friable sand and c 0.40m in depth. Directly overlying was (3/06) (2/06), described as mid reddish brown firm sand that was c 0.34m deep. Finds from this layer where it was above the Roman road were labelled (3/11) and comprised post-medieval pottery,, animal bone, clay tobacco pipe stem and an piece of iron fitting. It was covered by (3/05) (2/05), a mid orangey yellow friable sand. It was approximately 0.24m deep. (3/05) was overlain by (3/04) (2/04), friable mid reddish orange sand, 0.12m in depth. It was covered by three modern layers (3/03) a 0.22m deep layer of crushed brick, (3/02), a 0.14m thick layer of mid reddish brown friable sand and a final layer of 0.06m thick black tarmac (3/01) (2/01). The Roman road surface (3/10) was observed beneath layer (3/04), southwest of the storm drain at a depth of 110.76m OD. It was similar in appearance to the road visible in trench 1. It comprised mainly of small pebble c. 0.09 by 0.06m in dimension and bonded by a firm mid brownish orange clay.

A patch of the Roman road was seen c. 5m south of manhole 1 with a large stone (1.4m x 0.30 – 0.64m x 0.34 – 0.38m) to the west of this. This may have been a kerb stone. A further part was seen in manhole 2 but not between the two (Fig. 5). Further south of manhole 2 no traces were found although this was expected due to the

Given the evidence of the parts of the Roman road found in High Street and Roman Way, and if it is on a presumed NNE/SSW alignment here, then the road was 9.5-11m wide. This is wide for such a road although roads could vary in width from 5-15m (Bagshawe 1979). Aligning the part found with Sandy Lane, the edge of the road would have passed immediately west of lateral Trench 4. Sandy Lane survives as a hollow way approximately 10m wide. Given that the road was surfaced in stone then it seems unusual for a hollow way to have formed. It is possible, but unlikely, that this was a well-used prehistoric path. As there is no evidence for any banks it does not appear that the Romans created a cutting for the road. It is therefore possible that the course of a small valley was utilised for the route. Slight subsidence under Nos. 1-5 Roman Way is thought to be from an underground stream. Evidence for possible kerbing to the road was found south of manhole 1 in Roman Way.

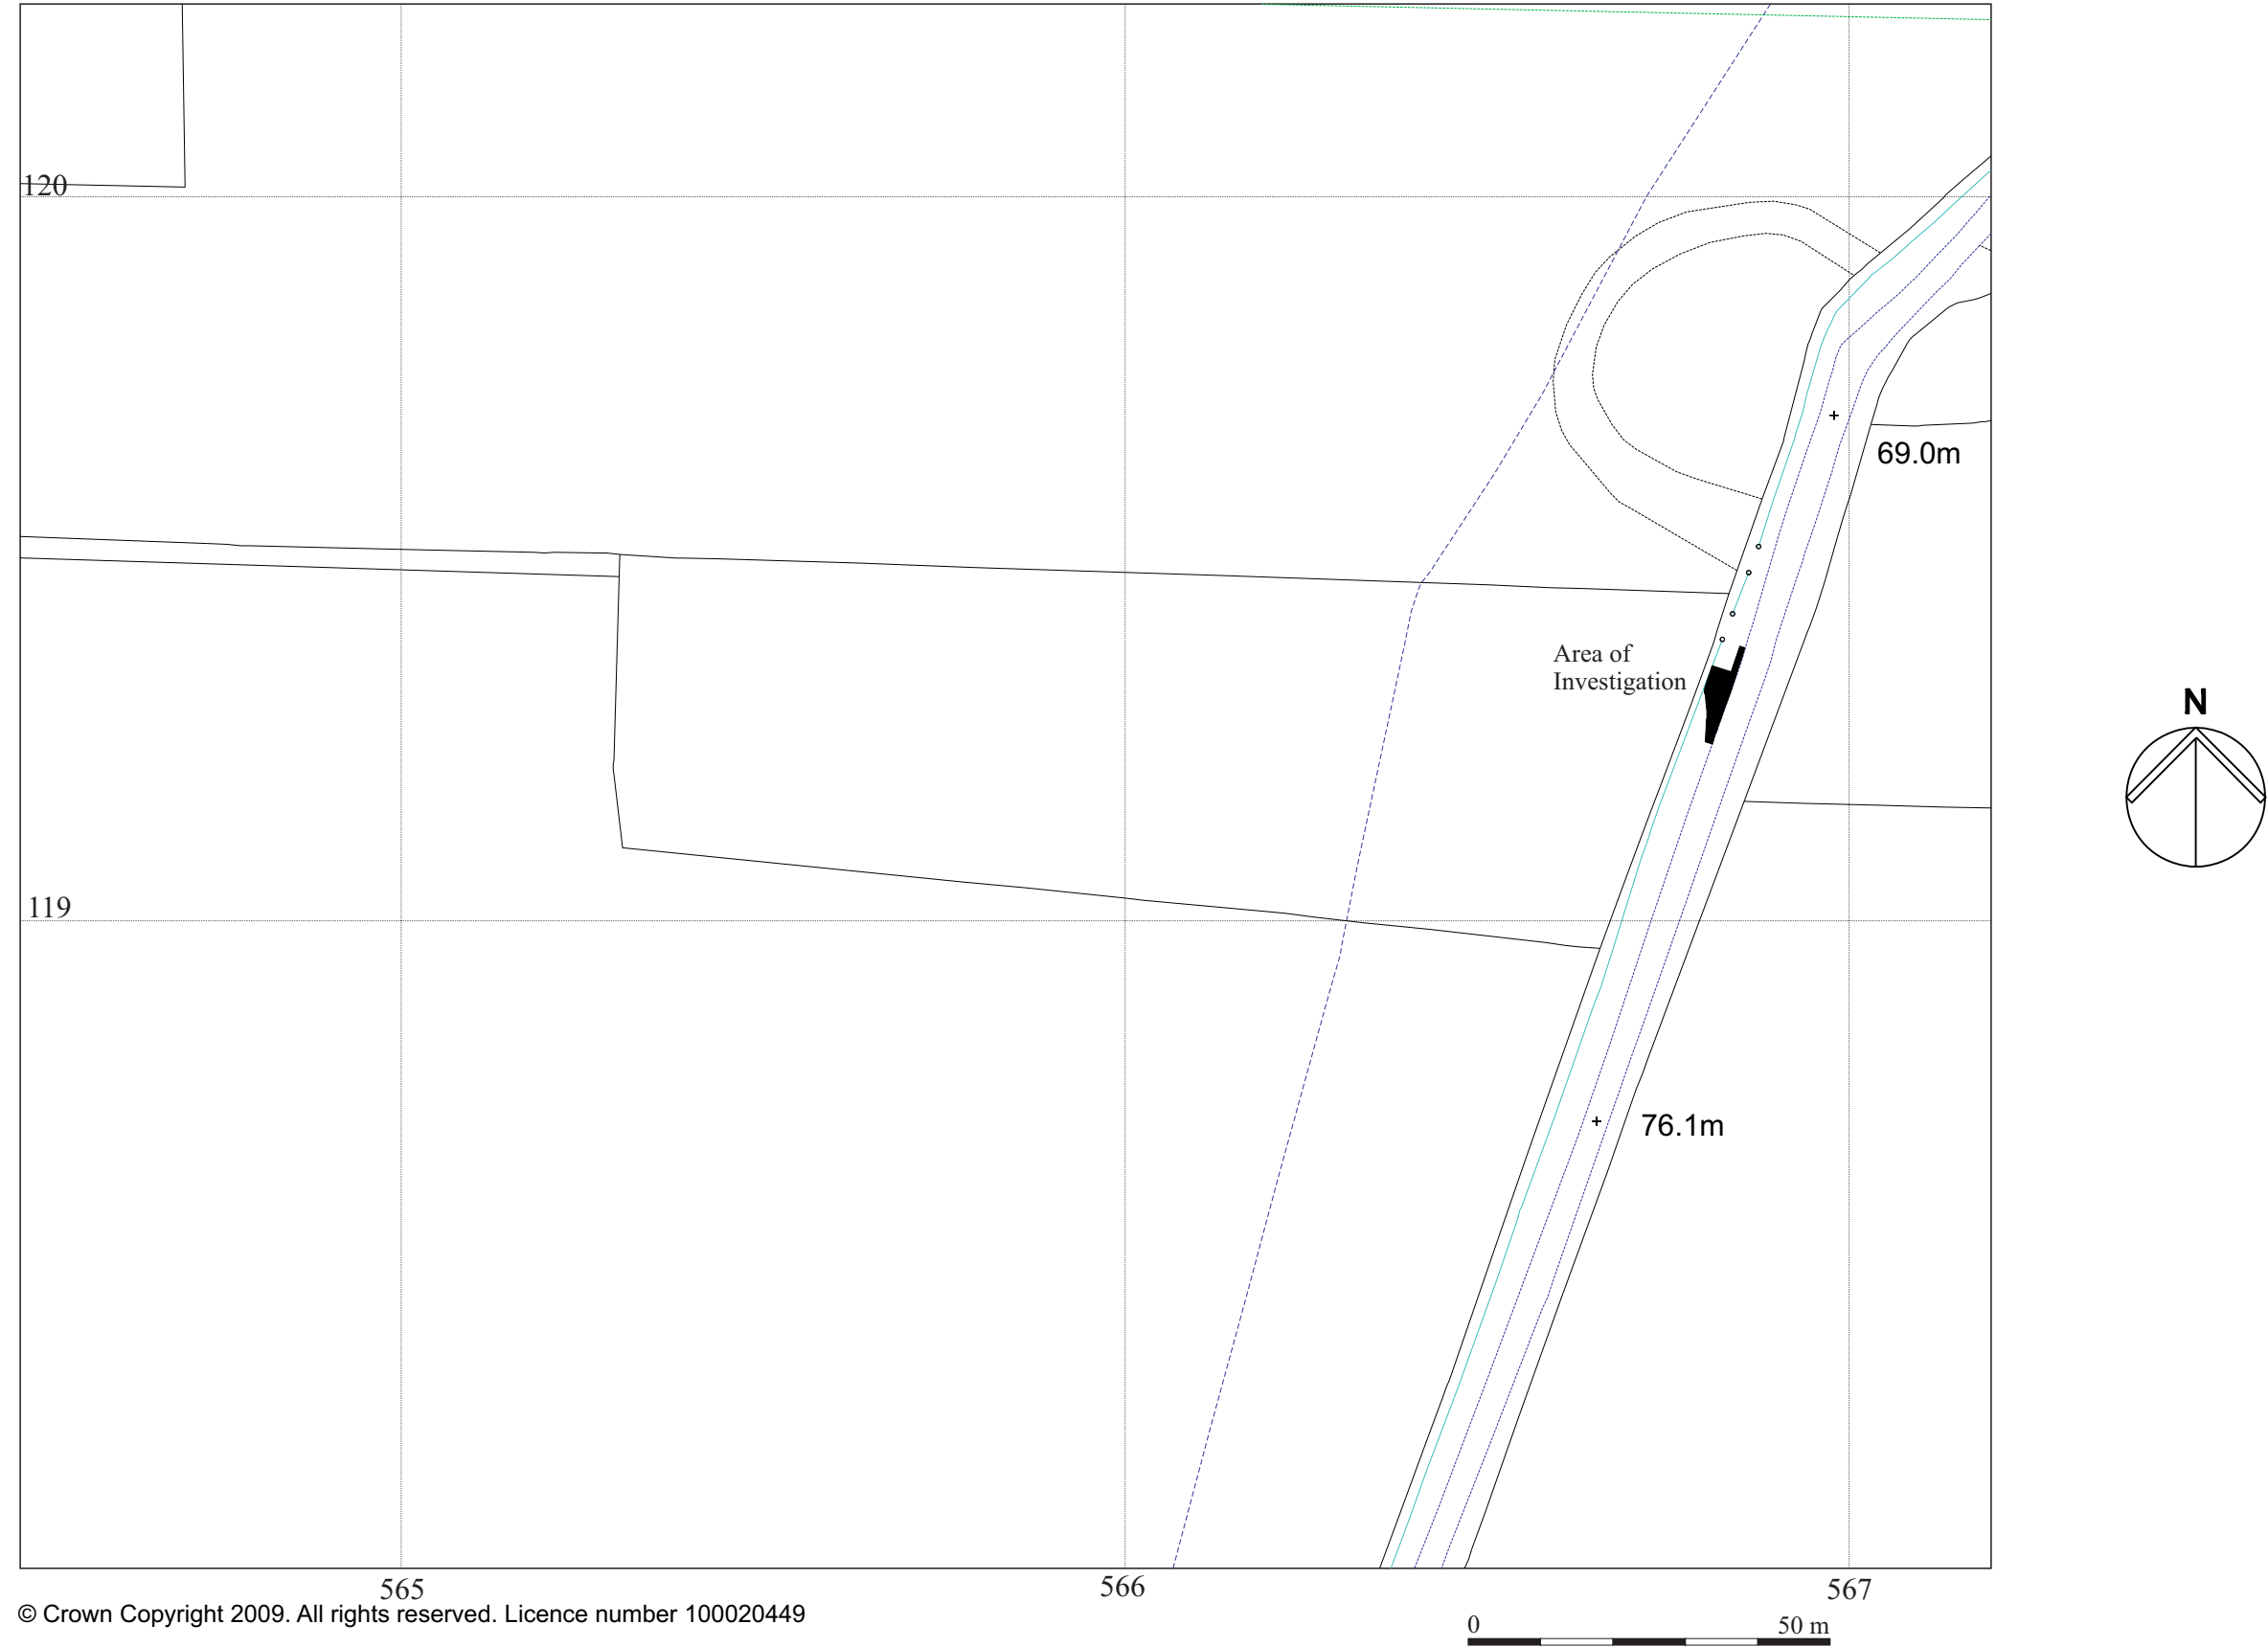
Figure 7. Location of Otmoor Lane investigation

A section of the Roman road was uncovered during the stripping of an area west of Otmoor Lane at the entrance to the sewerage treatment works. The area of the site was c. 15m in length and tapered in width from c. 2.5m at the southern end of site to c. 9m at the centre of the site (Figs. 7 & 8). Two sections were excavated through the Roman road. The road was recorded on the southern end at 69.35m OD with it gradually sloping down to 68.93m OD 6m to the north. The road does rise slightly to a level of 68.80m OD at 8m to the east, but then descends to 68.53m OD indicating a displacement of the stones due to continual tracking over of them. The northern end of the Roman road as seen was at 68.09m OD, 1.26m lower than the southern end of the road. This reflects the present gradient of Otmoor Lane.
