**AN ARCHAEOLOGICAL WATCHING BRIEF
AND RECORDING ACTION**

LAND AT MILCOMBE HALL, HORTON LANE,

MILCOMBE, OXFORDSHIRE

June 2009

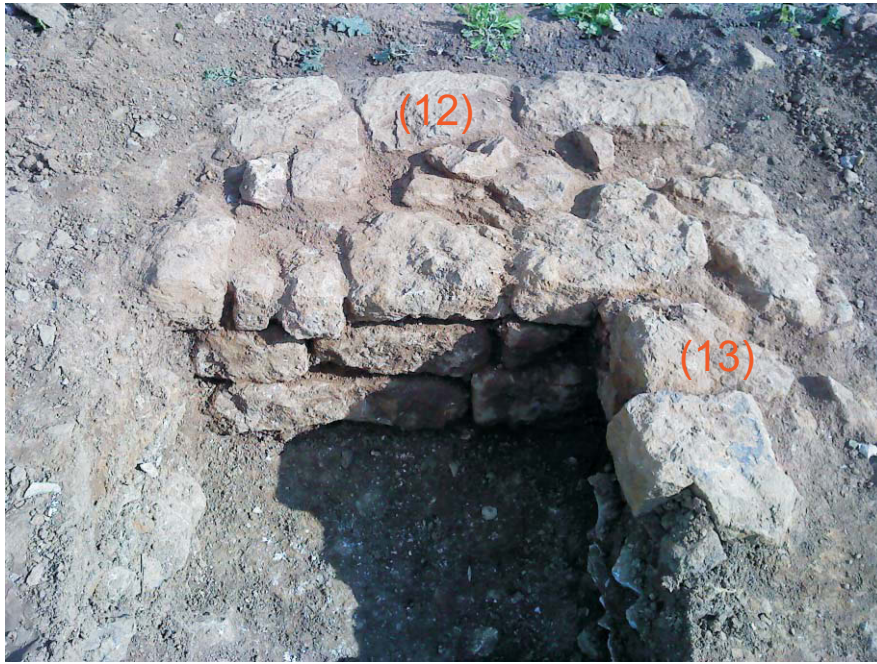
At its southern most extent it formed a right-angled corner with wall (12) that ran in a rough south-easterly direction for at least 2.5m before continuing under the section. This wall was also 0.8m wide and again survived 3 courses high to a height of 0.4m (plate 1).

Plate 1. Corner of Walls (12) and (13)
