JOHN MOORE HERITAGE SERVICES

ARCHAEOLOGICAL WATCHING BRIEF

AT FOSCOTT OLD CHURCH,

BUCKINGHAMSHIRE

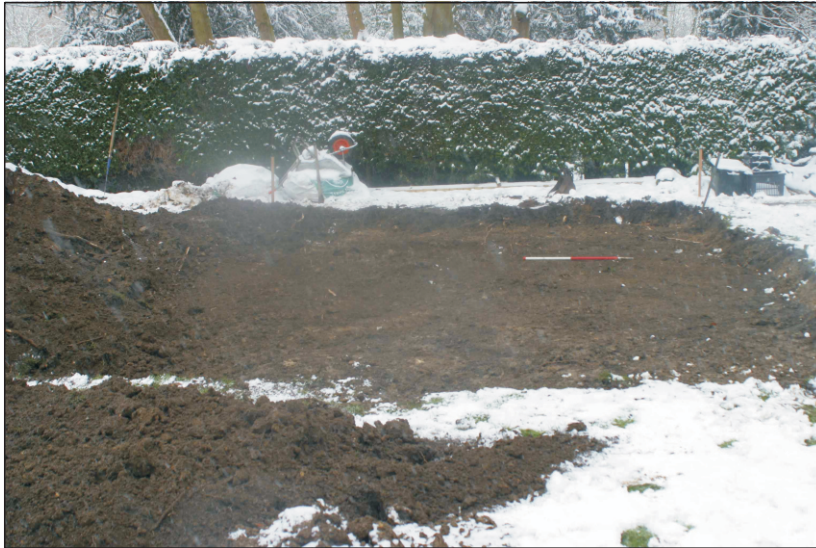
Figure 2. Barn area, looking west

The barn was excavated to a deposit of brown clay silt (3), which probably represents the interface of the original topsoil and the subsoil (Fig 2); this surface was at 102.1m OD. No finds were recovered from this deposit. This interface deposit, which represents a reduced, or stripped, level probably associated with earlier groundworks, was sealed by 200mm of dumped yellow clay (2) (Fig. 3) containing modern ceramic building material and a penny dating from 1980. The penny was not retained. The access area to the south of the barn was excavated to a depth of 200mm and so did not go through the clay dump (2) (Fig. 4), which can be seen to the bottom of the photograph. The area was sealed by topsoil (1), which measured 100mm thick.
