**AN ARCHAEOLOGICAL EVALUATION
FOR ENFIELD EVANGELICAL FREE CHURCH
ON LAND ADJACENT TO 81 CECIL ROAD,
ENFIELD,
LONDON BOROUGH ENFIELD
NGR TQ 3266 9634**

*On behalf of
C P L Architects*

JULY 2010

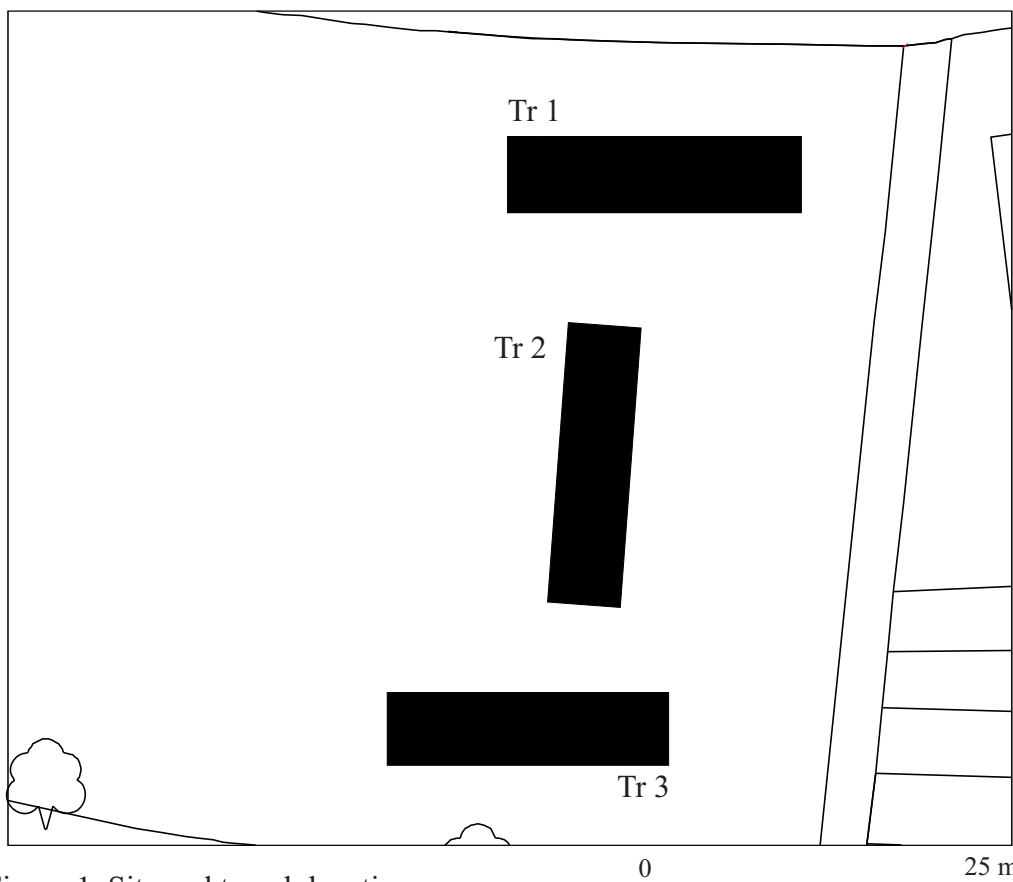
Figure 1. Site and trench location

In response to a Brief issued by GLAAS, JMHS carried out the work, which comprised the excavation of three trenches across the site (Fig. 1).

The site is located on land adjacent to 81 Cecil Road, Enfield NGR TQ 3266 9634. The site is currently used as a car park. The site lies at *c.* 29.5m AOD. The underlying geology is London Clay (BGS sheet 51N 02W), with gravel terrace deposits forming the drift.
