The structural history
of
OXFORD HOUSE
12 St Martin's Street
WALLINGFORD
OXFORDSHIRE

K A Rodwell
for
JOHN MOORE HERITAGE SERVICES
November 2009

THE STRUCTURAL DEVELOPMENT OF OXFORD HOUSE, 12 ST MARTIN'S STREET, WALLINGFORD

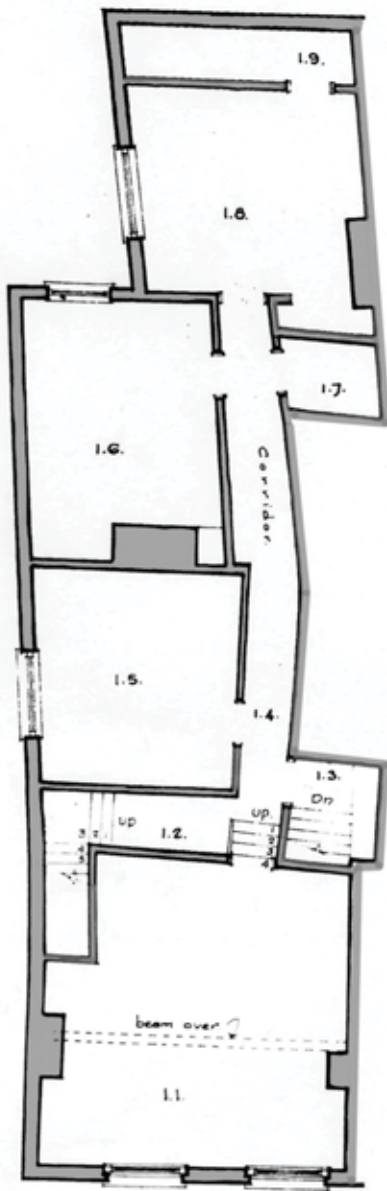
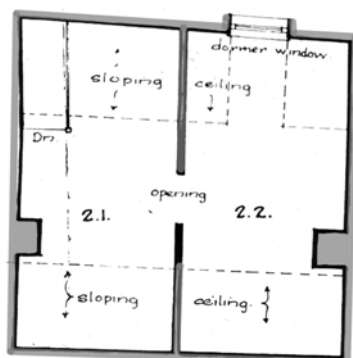
Fig 3 Plans

First floor before late 20th century alterations (left)

Current first floor plan

Top floor before late 20th century alterations (no current plan)

First floor – this has a corridor against the north wall and there were formerly four principal rooms. Like the ground floor it has been modernised and all doors are modern fire-doors. The front room (1.1) has a higher floor level than the rooms to the rear and spans the full width of the building with two windows overlooking the street; these have 19th century architrave mouldings. There is a chimney breast in the south wall and the flue of the ground floor fireplace against the north wall. The walls and ceiling are plainly plastered with a simple skirting and there is a cased transverse ceiling beam. The upper part of the attic staircase formerly projected into the south-

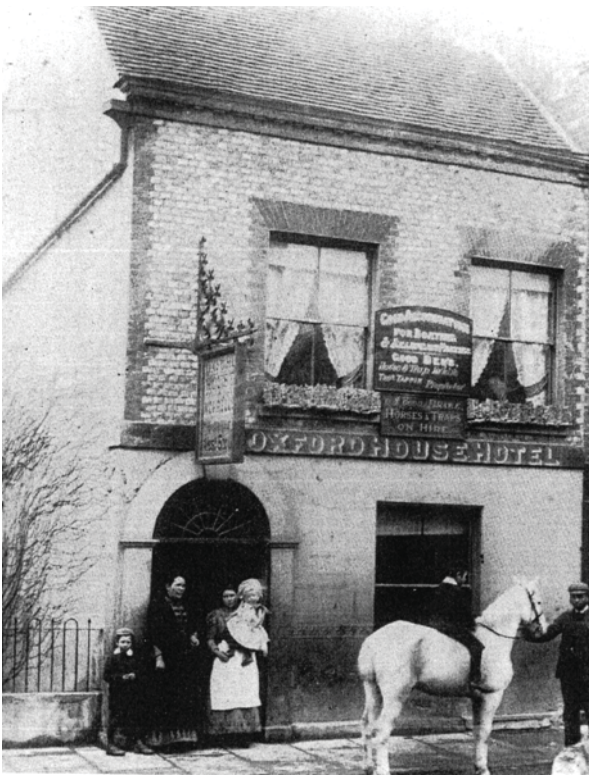
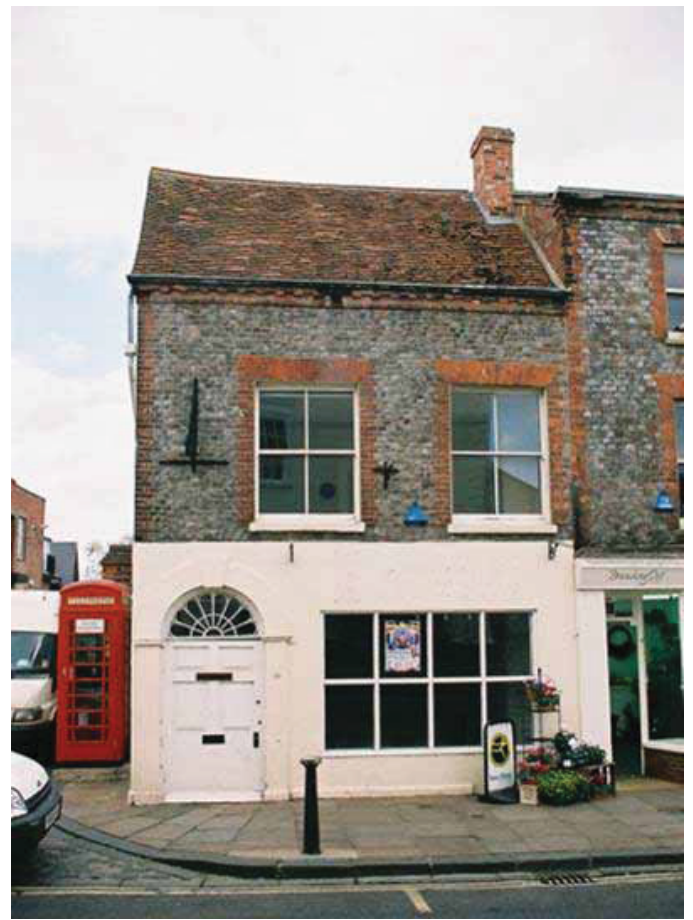
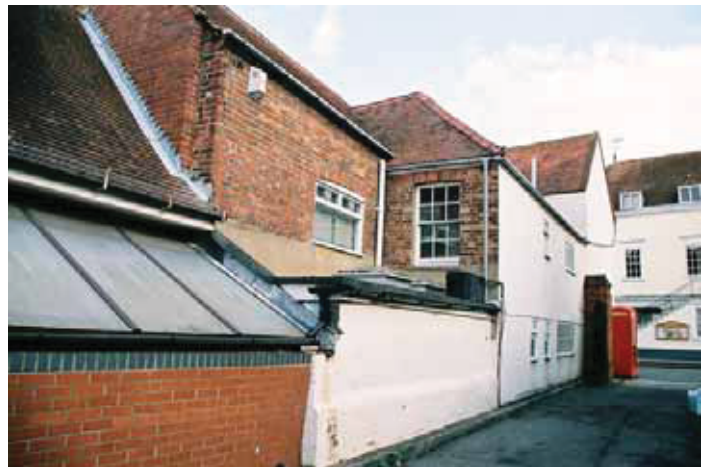
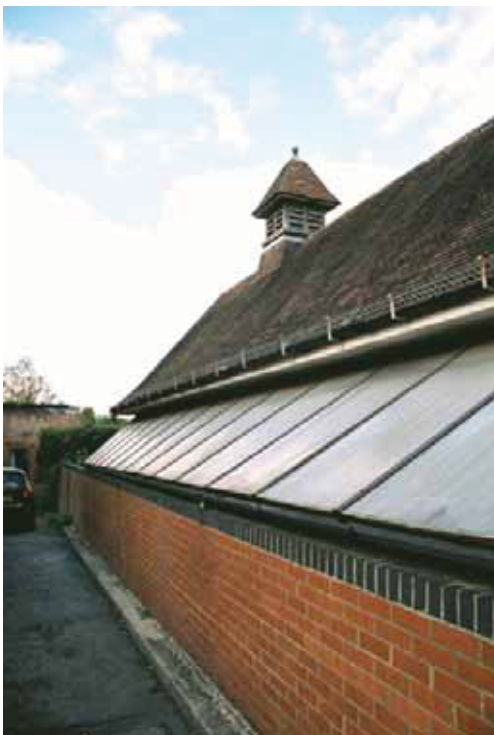
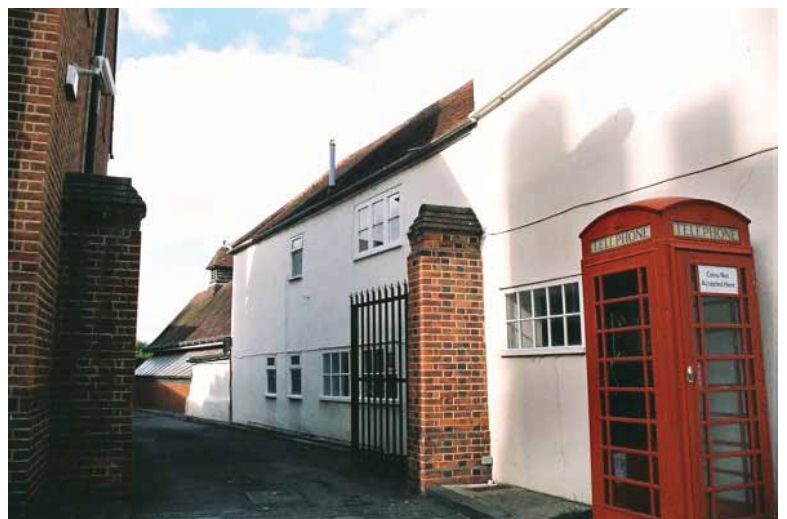
Fig 5 Exteriors
(clockwise from above)

Street façade c.1900 (Beasley 1994, 28)

Market Place elevation (east) today

South elevation from the west

South elevation from the east

The hall from the south-east; modern wall & roof in foreground

The street frontage is two bays wide and there is a straight joint with the property to the north. The ground floor is rendered and has a wide front door in a raised arched surround with pilasters and a keystone. The six-panelled door and decorative fanlight are of 18th century pattern. To the north there is a modern eight-light shop window

which replaces a sash window similar to those on the first floor (compare Fig 5). The first floor is built of grey brick headers with red brick dressings to the quoin, the windows and the dentil course at eaves level. There are two four-light horned sash windows and a large wrought iron bracket over the door which formerly held a hanging sign (Fig 5). The roof is tiled and there is a reconstructed chimney stack at the north end.

4 *later 19th century* – the hall at the back of the plot dates to this period when the property was a public house; it has separate external access. The sash windows on the front of the building were replaced and the large iron sign bracket, visible on the photograph of c.1900 (Fig 5) survives from this time.

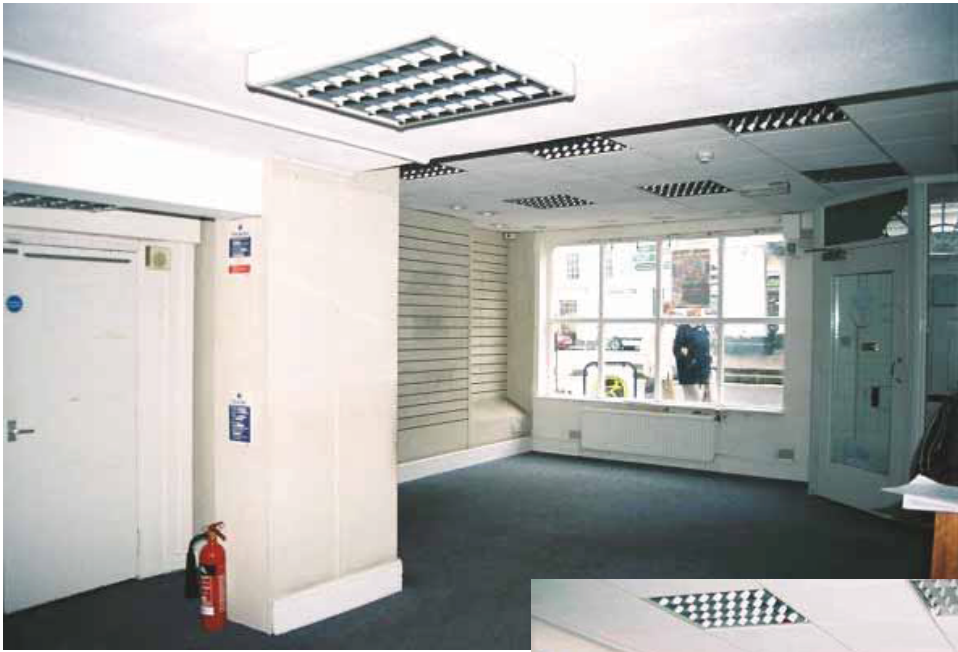
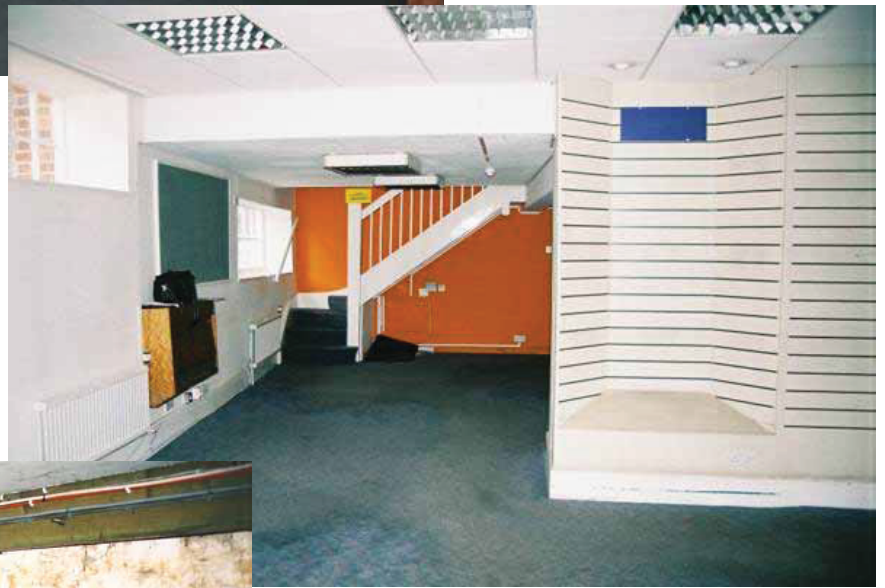
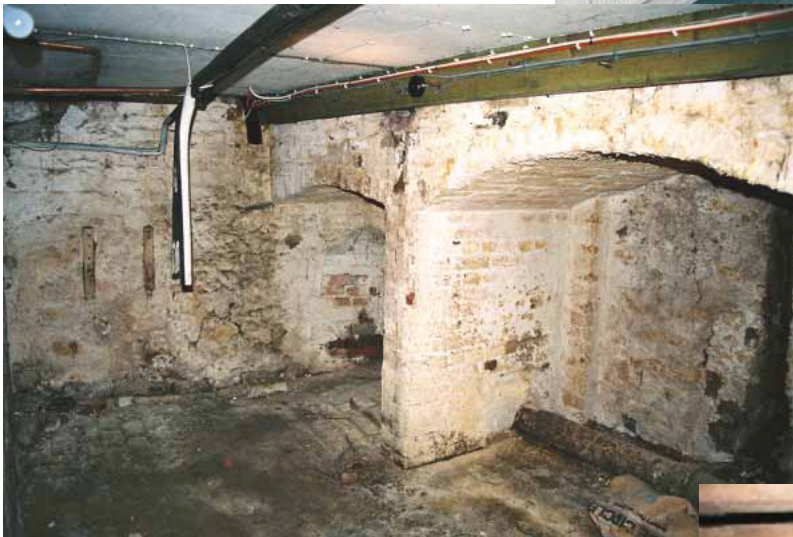
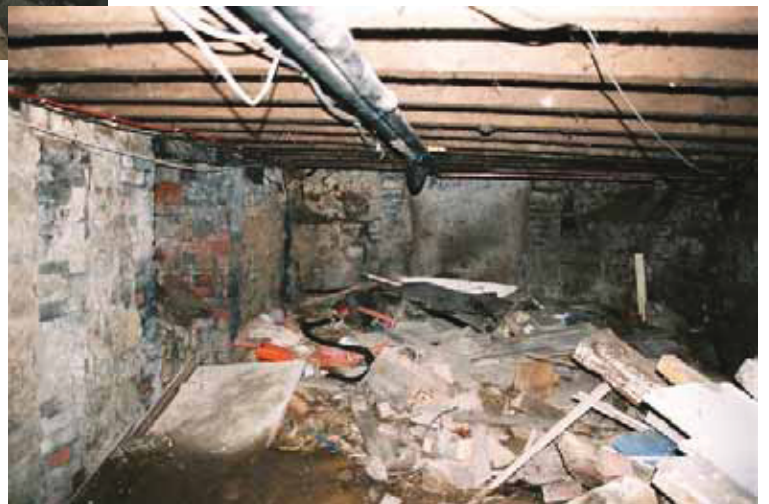
Fig 6 Interiors

Ground floor (G2 & 4) looking towards street, modern finishes

Ground floor (G2 & 4) looking west, modern finishes & stairs

Wine bins in front cellar, looking east

Cellar at rear looking west

Cellars – there are extensive cellars accessed from a winder stair set into the north wall between G2 and G4 (Figs 2, 6); these are of mixed brick and rubble stone construction. The front basement room has been subdivided by a modern blockwork wall. There is a blocked light-well in the front wall, which is of rubble construction, and it is spanned by a pair of transverse ceiling beams; the joists are hidden by modern boarding. The south and west walls are also largely rubble-built and a three bay brick arcade c.1m deep has been constructed against the south wall; this housed wine bins. The floor is brick, skimmed with concrete.

To the rear is a second cellar, also rubble-built with similar arched brick wine-bins against the south wall; these are subdivided by internal partitions. A large cast iron pipe has been punched through the brick partitions in both cellars. The exposed ceiling joists are machine-sawn pine of late 19th or 20th century date. A pair of brick piers divides off the east side of the room to form one end of a sloping passage to a third cellar at the back. This has rubble walls with piers of brick at intervals and there is a former light-well with steps in the middle of the south wall. The corners are curved for half their height and squared-out above. The ceiling joists are of late 19th or 20th century pine.

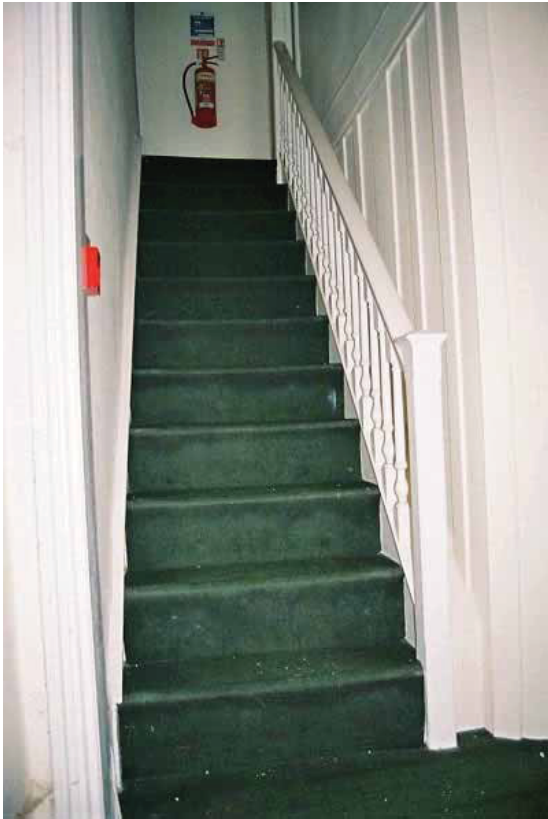
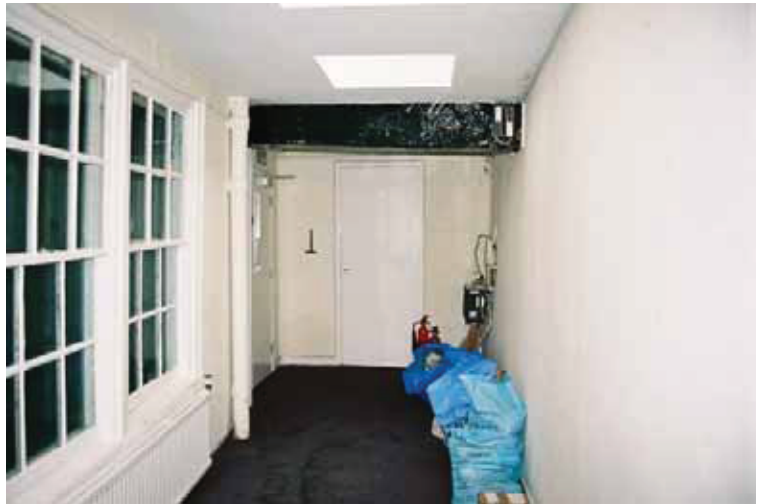
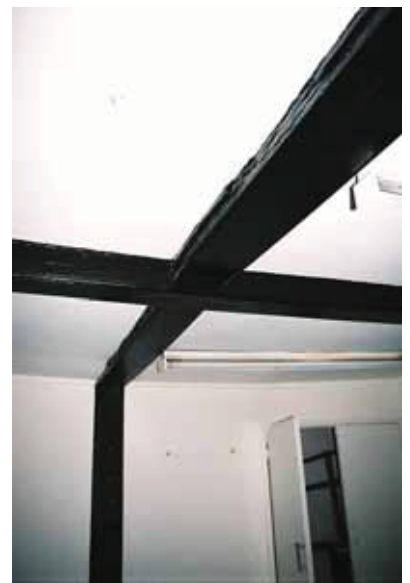
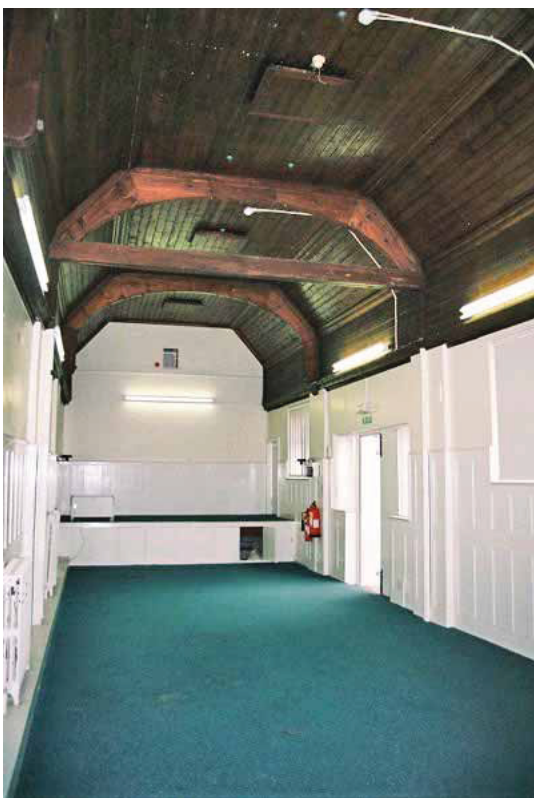
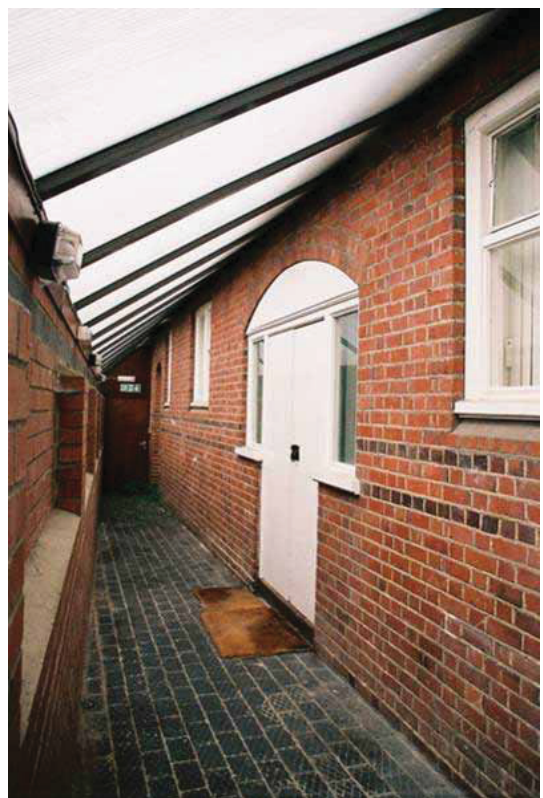
Fig 7 Ground floor
(clockwise from above)

Staircase west of G8

Passage (G7) looking east with windows to G8 on left

Ceiling beams in G8 looking west

Passage south of hall looking west

Interior of hall looking east

The passage to the south (G7) has a large cased transverse beam at the east end which carries the corner of room 1.6 but the remainder of the ceiling is modern with top lights. Immediately to the west of the paired sash windows to G8 there is an archway to a staircase. This is a straight flight with a closed string on the east side inset from a boarded partition; it has turned vase-shaped balusters, a rounded handrail and a square lower newel post with small chamfers and a low moulded cap. The upper newel is a plain square post. The face of the adjoining west wall is uneven and at first floor level incorporates a small window into the adjoining hall.

There is a formerly external door in the west wall of G7 leading to a continuation of the passage. This has a vitrified brick floor, a modern glazed lean-to roof and a modern south boundary wall. On the north side there is a late 19th century hall built of brick in Flemish bond with two bands of vitrified headers below window cill level. Doorways are arched; windows are of casement type with flat brick lintels. The principal door towards the centre is double and has side-lights. Internally the hall is

four bays long, articulated by pairs of shallow pilasters below the roof trusses. The walls have a high panelled dado, there are no openings on the north side but there is a large six-light window in the west wall and a stage at the east end. The pine open roof is of arch-braced type secured by iron bolts and the middle truss has a tie beam. The apex is hidden by a canted ceiling of tongue and groove boarding.

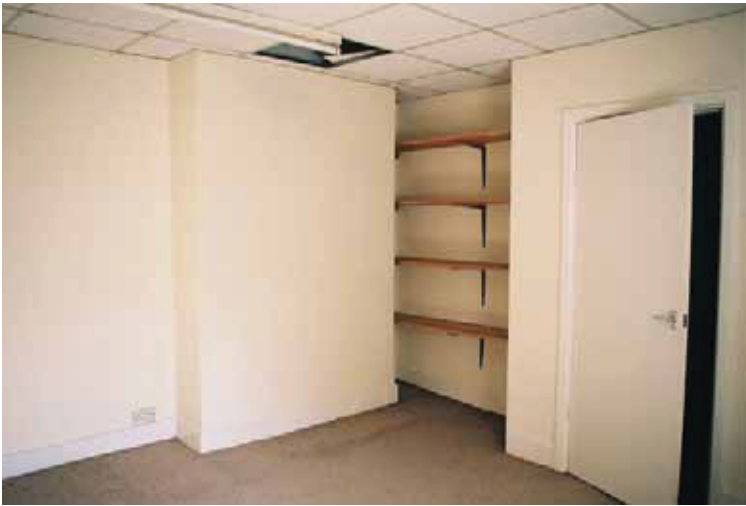
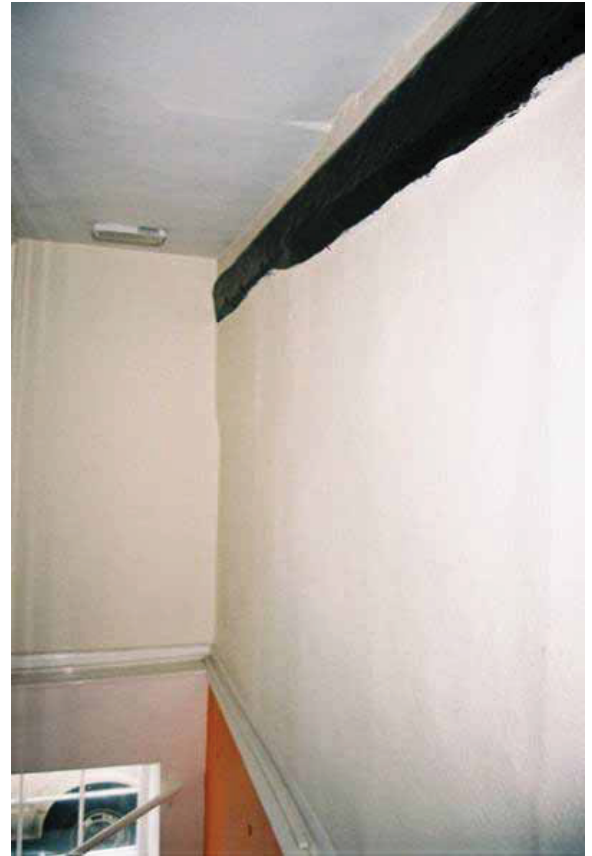
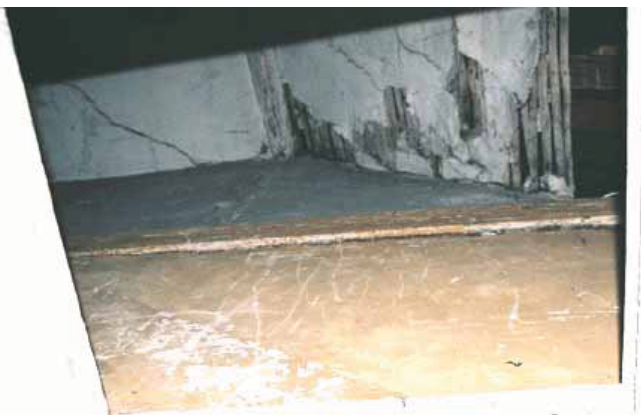
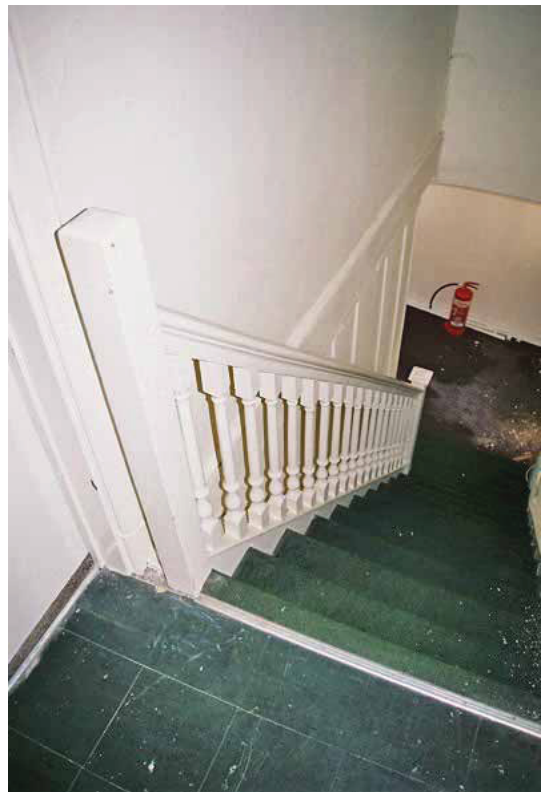
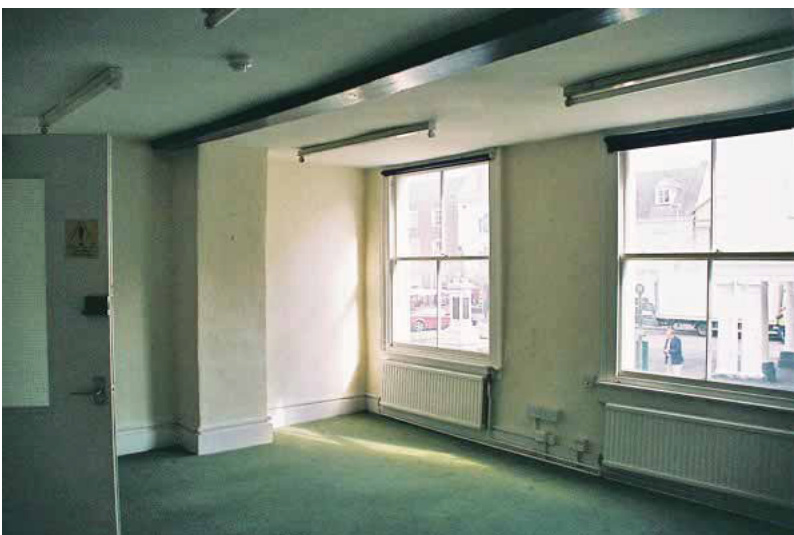
Fig 8 First floor

Room 1.8 looking north-east

Tie beam over modern staircase, west wall of 1.5

Rear staircase (1.9)

Front room (1.1) looking north-east

South wall of attic over 1.1 (viewed through hatch)

The head of the former staircase from the ground floor (1.3) has been turned into a cupboard and the replacement staircase has been cut out of the west end of room 1.5 enclosed by a modern glazed partition. Over the stairs just below ceiling level there is a large exposed tie beam but this room has no other visible historic features. To the east a former passage and attic staircase (1.2) have been made into a cupboard with a modern door. To the west room 1.6 has been subdivided; there is a chimney breast at the east end and an original window in the west wall. Room 1.8 at the end of the range has unaltered dimensions but a modern suspended ceiling; a panel has been removed to expose the original, which is plain plaster without a cornice. There is an off-centre chimney breast in the north wall and the centre of the floor has a pronounced sag.

Top floor – this is confined to the front of the house over room 1.1 where there are two attic rooms (not fully investigated) divided by a central partition. They are formed within the roof space with sloping ceilings which are fully plastered out on old laths. The collar and post from a roof truss are visible built into the south wall. Holes in the plaster indicate that the roof has been renewed and the rafters replaced, removing the dormer window which formerly lit the space. There was no access to the roofs of the rear ranges.
