The structural development
of
THE OLD RECTORY
BRIGHTWELL BALDWIN
OXFORDSHIRE

K A Rodwell
for
JOHN MOORE HERITAGE SERVICES

May 2008

THE STRUCTURAL DEVELOPMENT OF THE OLD RECTORY, BRIGHTWELL BALDWIN OXFORDSHIRE

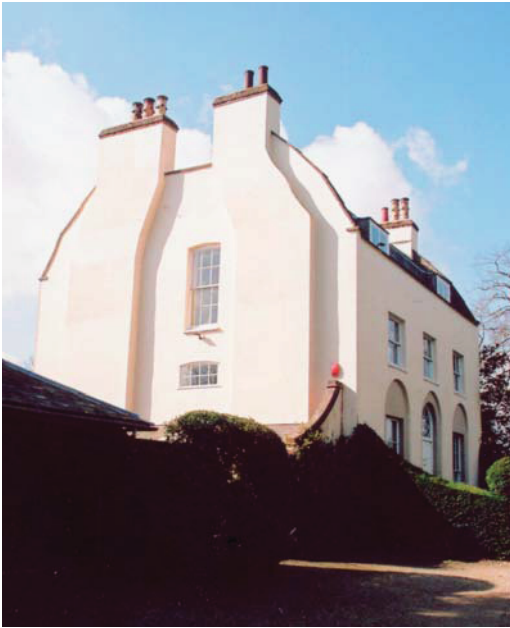
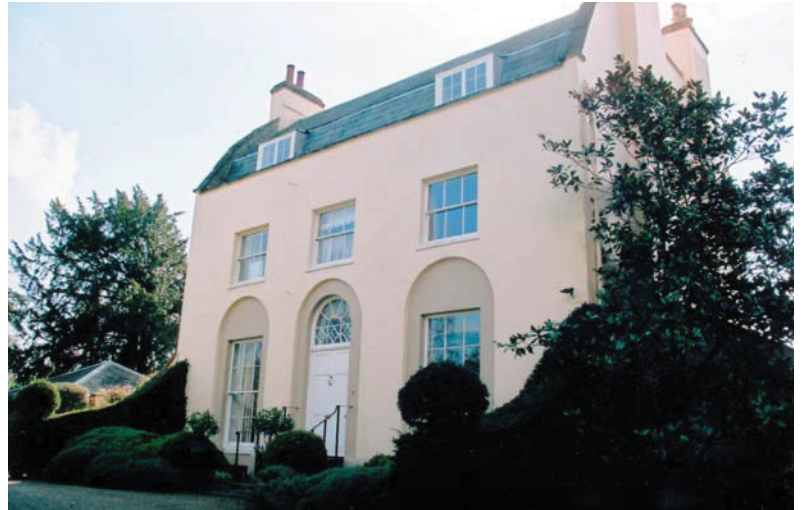
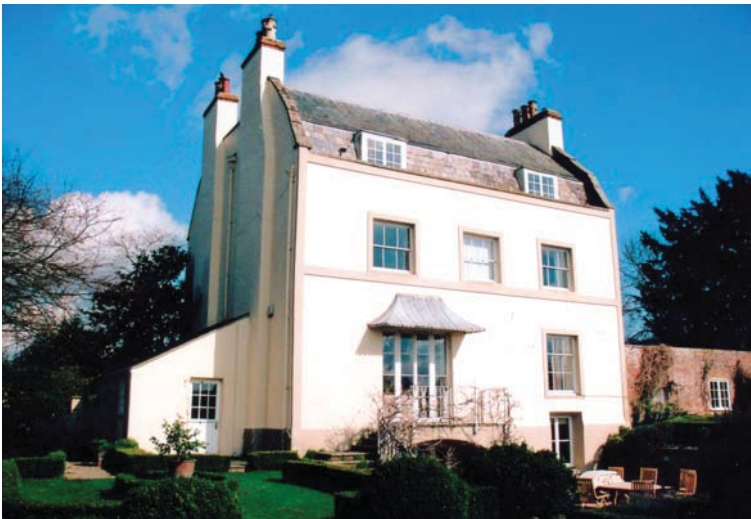
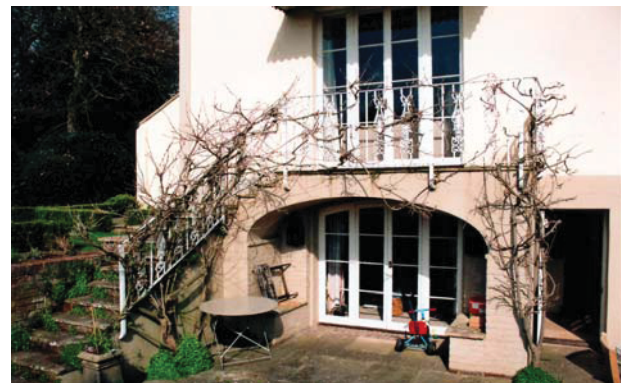
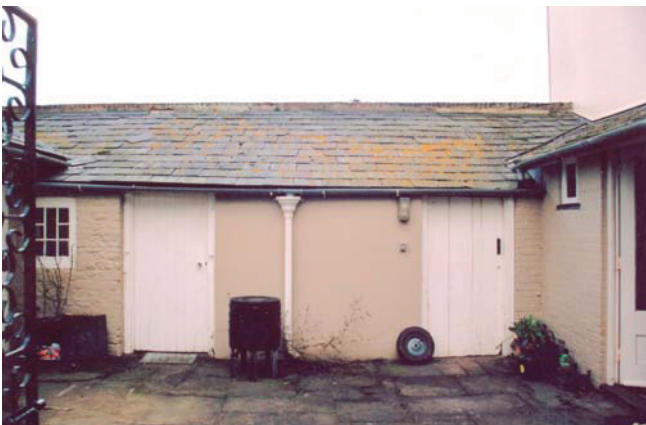
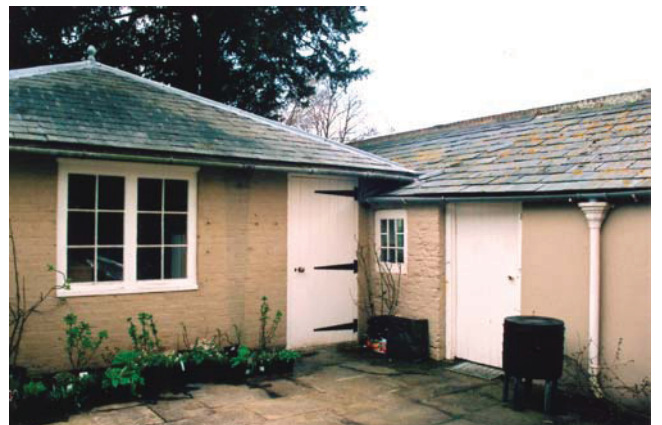
Fig 4 Exteriors

East elevation

North elevation

South elevation, balcony

Yard, south-east corner, garage on left

Yard, outbuildings on south side

South elevation

The gabled end walls have coped parapets and paired projecting stacks. There are no windows in the west wall which has a 20th century single-storey outbuilding butted against it; this has external access only. The rear south elevation has raised rendered quoins, string bands and window architraves. The upper floors mirror the front but the ground floor is asymmetric with a nine-light sash window at the east end and original French windows to the principal west reception room. These have a lead canopy (probably a 20th century replacement) and a balcony leading to garden stairs. This has a cast iron balustrade incorporating panels with anthemion decoration but the extent to which this was altered in the 20th century is unclear. The substructure is brick and forms a segmentally arched recess over French windows at basement level; this work

is 20th century. The garden in front of the basement has been landscaped to form a sunken courtyard accessed by the balcony stairs. There is a central door at this level and an inset east window.

The east gable wall was remodelled in 1979 when the ground floor lean-to extension and upper floor windows between the stacks were added. Before this (Fig 1) there was a projecting two-storey porch with a shallow hipped roof, a twelve-pane sash window at first floor level and a door with a top-light below. Adjoining this elevation is a service yard bounded to north and south by high brick walls with ramped ends built in English garden wall bond on a rubble base. There is a range of narrow single story outbuildings along the south side which has a lean-to slate roof. The walls are rubble and brick with a central rendered section that the 1978 photograph shows to be blockwork. There are two boarded doors and an original window with small panes. The square brick garage with a pyramidal roof at the east end of the yard is modern.

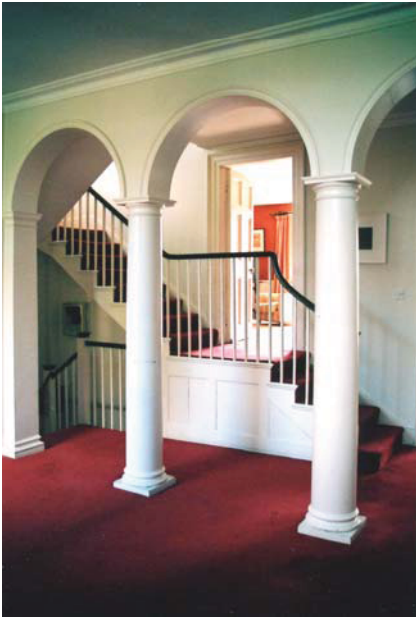
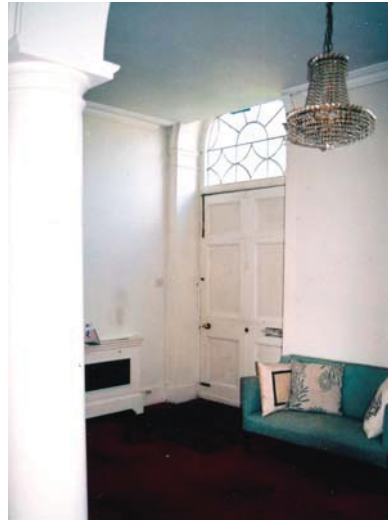
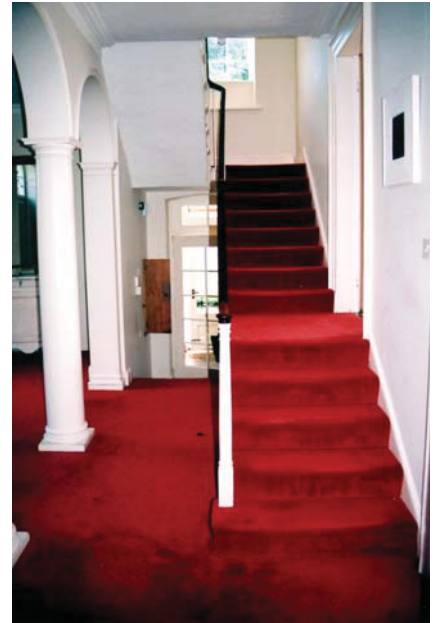
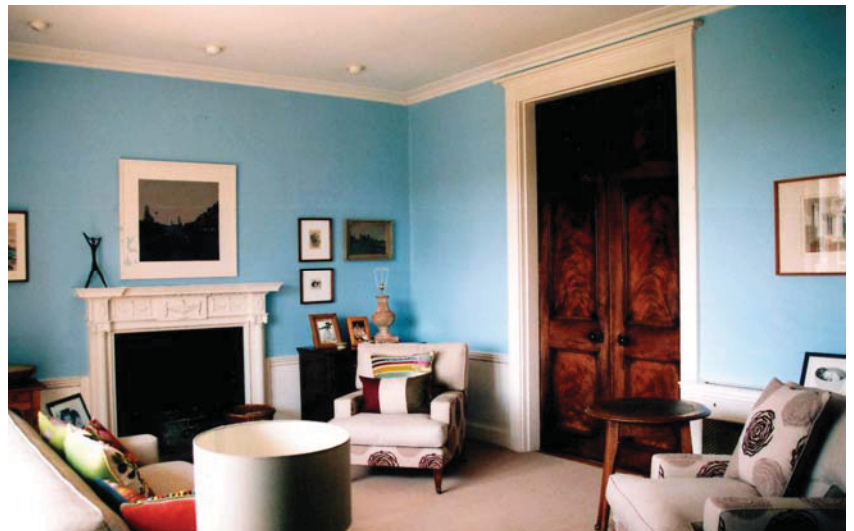
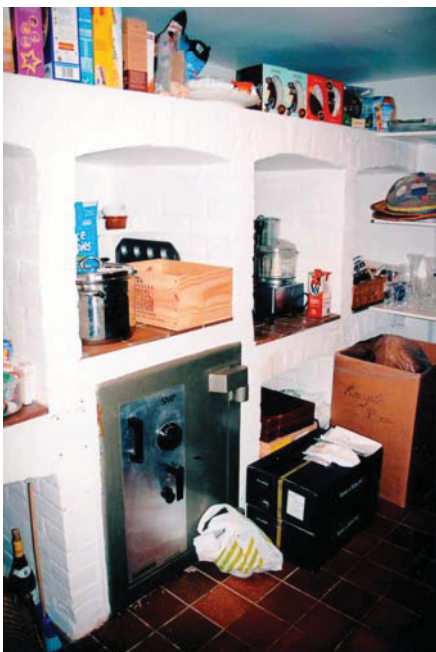
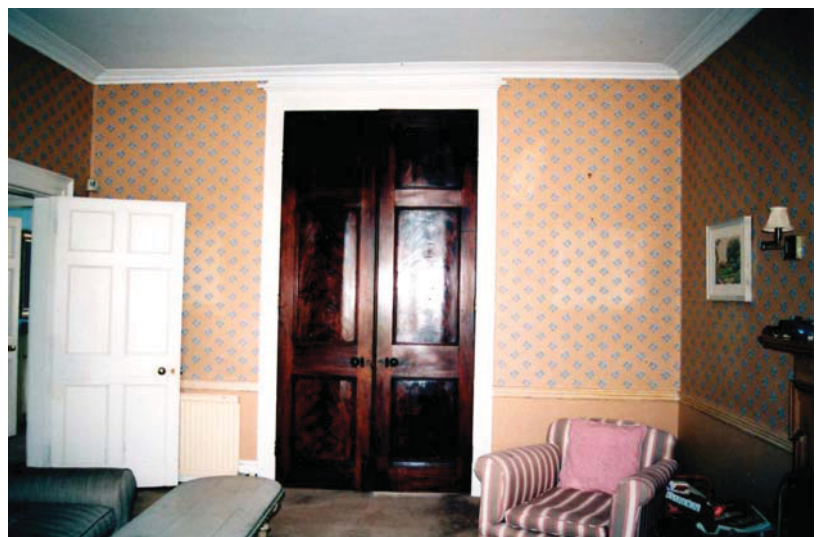
Fig 5 Interiors

Hall arcade and staircase

Hall looking towards front door

Staircase hall looking east

South-west reception room

North-west reception room

with connecting double doors

Bins in wine cellar

Ground floor – the front door opens into a large rectangular hall divided from an inner staircase hall by a triple arcade of Doric columns. These appear to be inserted; the skirting board runs behind the base of the western pilaster and the two mouldings are not in register; at the other end of the arcade the skirting has been cut. A fireplace has been removed from the east wall of the outer hall and both compartments have separate rib-moulded cornices.

The two principal reception rooms are at the west end of the house and open off the stair hall. They are similarly detailed with six-panelled doors in moulded architraves, full-height shuttered windows, original dado rails, wall plaster battened out on laths and reeded ceiling cornices. They are connected by a pair of room-height mahogany doors in a reeded architrave. The north-west room has an imported 18th century stripped pine fireplace. The south-west room has a reproduction Adam-style fireplace which is narrower than the original; vertical battens fill the gaps with the dado mouldings.

Basement – this housed the service rooms and is plainly finished with exposed ceiling beams in most rooms; some of these are reused timbers with redundant mortices. On the north side there is an original wine cellar with arched brick bins; the south-east room, which has a higher ceiling than elsewhere is the kitchen and there is a garden room to the west.

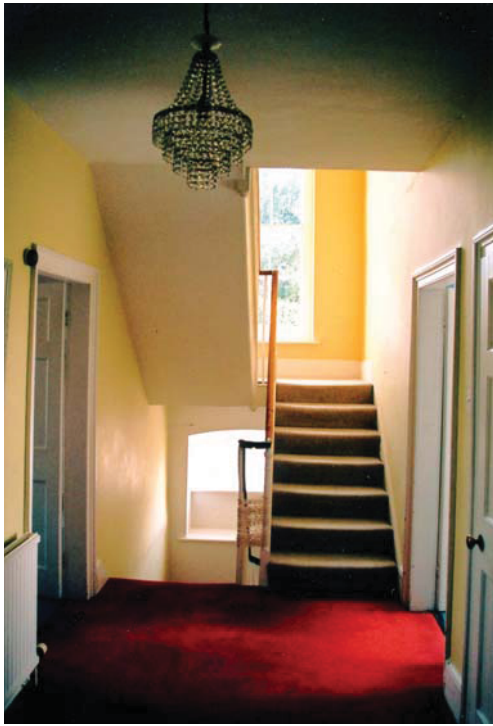
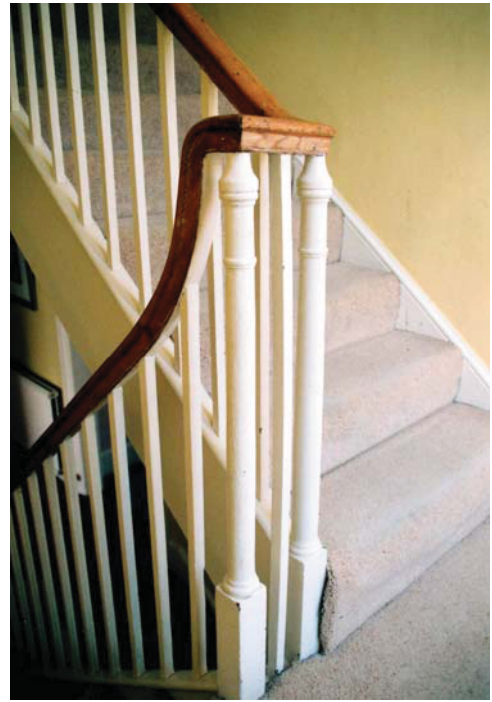
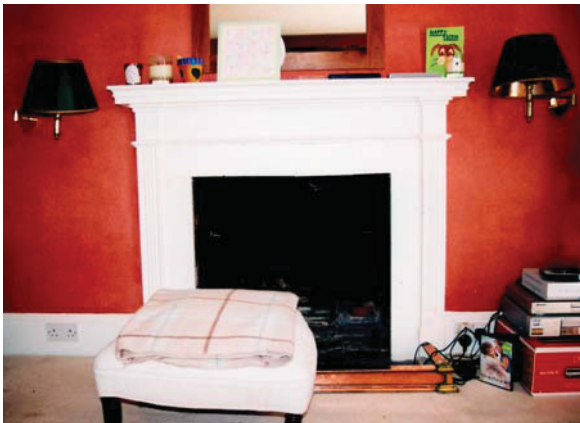
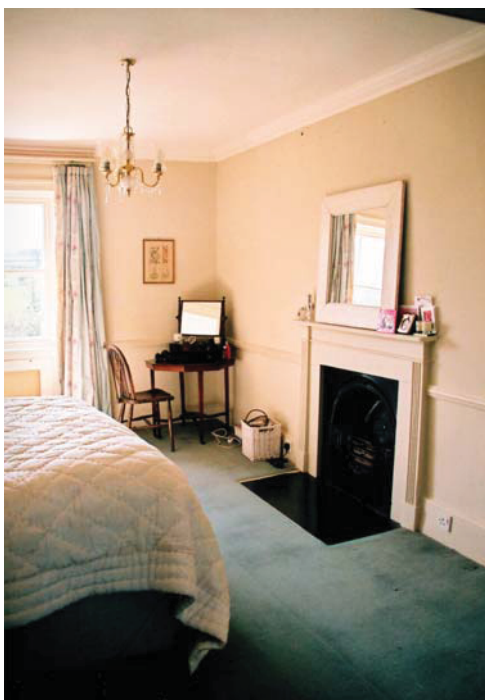
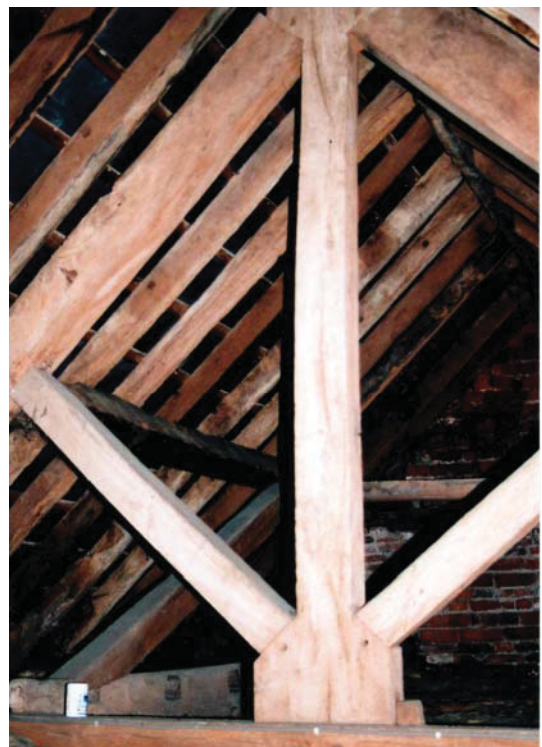
Fig 6 Interiors

First floor landing and stairs to attic

Detail of attic staircase; pine handrail

Kingpost roof truss

Main bedroom (SW) with original fireplace and modern cornice

Original fireplace in SE reception room

First floor – there are four bedrooms and two bathrooms opening off a central landing which has a full suite of original six-panelled doors. Most rooms have no historic features apart from the window architraves; the two bedrooms at the west end have been knocked together and given modern cornices but the south-west room has an original fireplace with reeded pilasters and an arched cast iron grate.

Second floor – the staircase rises to attic level but the upper flight has a closed string and a pine handrail (formerly stained). There are four bedrooms which have two-panelled doors hung on L-hinges and simple original fireplaces. The roof is in two sections with a central valley gutter and is of pegged construction with braced king post trusses.
