JOHN MOORE HERITAGE SERVICES

ARCHAEOLOGICAL WATCHING BRIEF AT

BASTION 11/MONK'S PASSAGE,

CITY WALL, NEW COLLEGE,

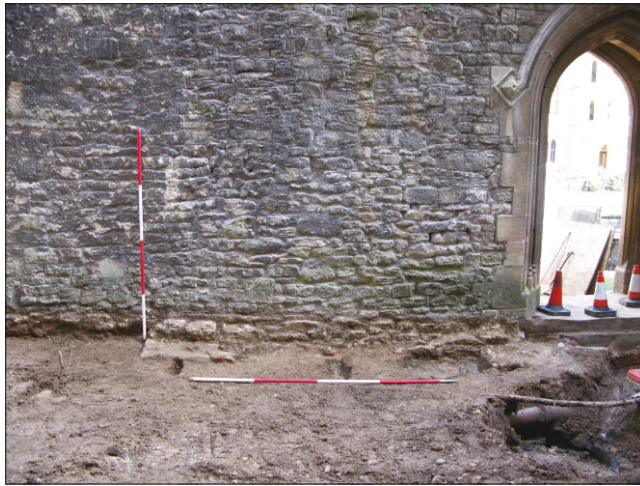
Blocked postern

The infill [64] appeared to be the internal remains of a small entrance or postern, which was subsequently blocked. Layer (69), a mixed deposit of red brown and pale yellow sandy clay silt and gravel (15%) sealed (68), as well the pier bases [62] and [63]. The layer (68) was only observed on the eastern side of the blocked area. It comprised a moderately compact dark grey brown sandy silt with 10% gravel overlying the cobbling (67). The context (74) was a piece of clay pipe which came from between [63] and [64], just below [58]. It may well be intrusive, as the gap was unmortared.

Although no dating was recovered for dating the postulated postern gate, it is clear that it is from an early phase in the history of the wall, predating the current visible section (Figure 3). Cleaning revealed the presence of two piers [62] and [63] below the deposit (69), which is undated although it is undoubtedly a post-13th century as it seals part of the wall. The postern gate may be original to the construction of the City Wall in the mid 13th century or was inserted when the outer wall was constructed later in that century. Within the opening defined by the piers was a cobbled surface (67); to the north of the cobbles was a threshold [65]. This was overlain by several courses of stone [64] interpreted as the blocking of the postern gate.

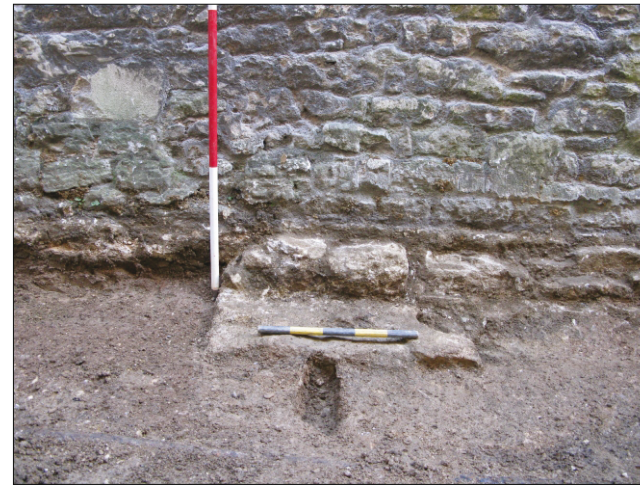
Detail of pierbase [62]

There were two pier bases revealed during the investigation, which materially were similar and extended as far south as one another. The pier base [62] on the west side measured 0.57m (east/west) by 0.62m (north/south), as revealed; the pier [63] on the east measured 0.91m by 0.83m, as revealed (Fig. 3). The roughly hewn stone in the constructions measured between 350x200x110mm and 160x110x60mm. The structure was bonded with a white lime mortar.

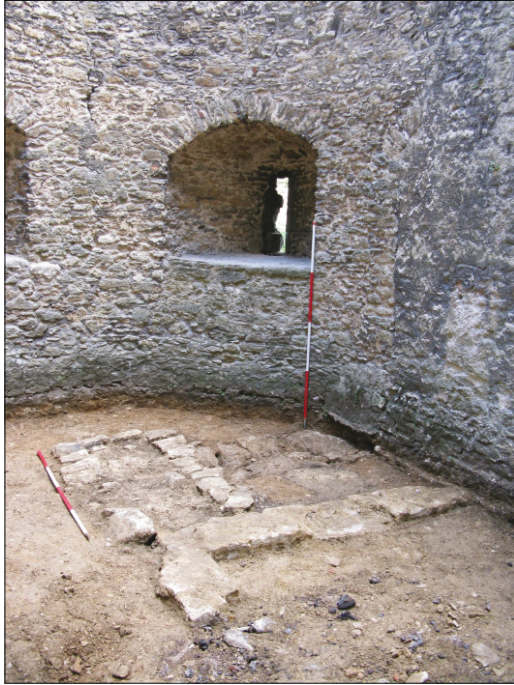
The structure [36] may well be the vault of a privy, but the limited access afforded by the recording action cannot confirm this; it predates the observed privy [29] and abuts the bastion wall and the footing [23]. The cut for the city wall [22], which was observed during the test-pit monitoring, was not seen to extend as far north as (28) within the bastion. The city wall footings [23] and rebuilt wall [58] bridge the structure [36], and do not appear to have impacted negatively upon the underlying structure. The footings [23] are described in detail below.

The walls measured 2.3m (north/south) and 1.3m (east/west) externally; it measured 2.05m by 0.62m internally. No mortar was apparent. The structure was a privy. The upper fill (37) of the privy, a mid grey brown silty clay with 10% fine gravel, yielded a date from the mid-18th century.

Feature 36; privy and later room

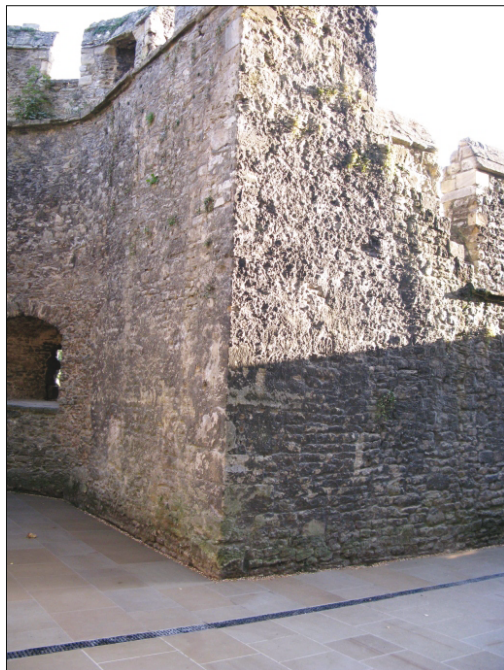
Corner of city wall and east wall of Bastion 11

Sealing the blocking [64] was the city wall [58]. The wall [58] was offset between 20mm and 130mm over the earlier phases of the wall. At the southeast corner of the bastion the footing [23] is flush with the wall [58]. Within the bastion the footing [23] and wall [58] are not regular, occasionally being flush with one another, at other points not. This new build was observed on the external north side of the city wall to extend 3.05m to the east of the door into Monk's Passage, where a building scar can be seen to extend from the top of the wall to the base. East of this scar the wall flares at the base; within the 'new-build' section the wall is nearly perpendicular to the ground.

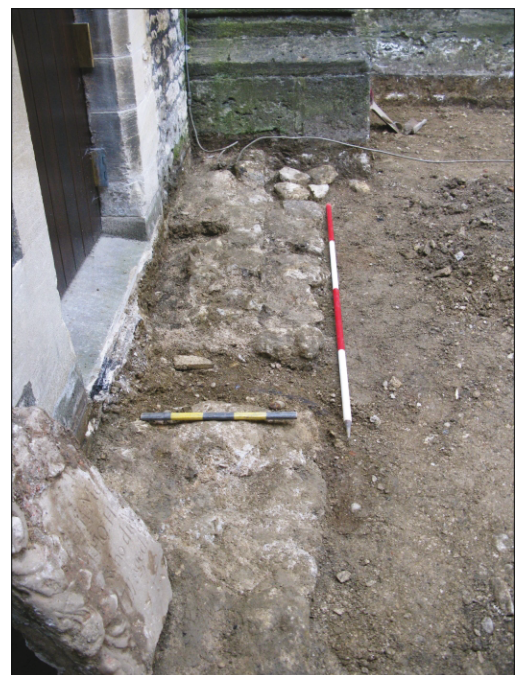
Walls [72] & [73]; looking south

At the east end of Monk's Passage were two sets of wall footings, [72] and [73]. The earlier of these [72] comprised roughly-hewn limestone pieces measuring between 200x120x40mm and 250x230x70mm, bonded with a hard yellow mortar. Only a single course of this wall footing was exposed, which was built against the buttress of the Long Hall to the south.

This wall was used as a footing by [73] which extended as far north as the city wall. This wall was similar to the earlier [72], which undoubtedly also extended as far; it was, however, overlain by [73] to the north. The wall make-up comprised limestone pieces, which were 260x200x80mm to 180x150x120mm with occasional smaller fragments c. 130x100x30mm in the core of the wall. The wall was bonded with hard white mortar containing small gravel and charcoal flecking.

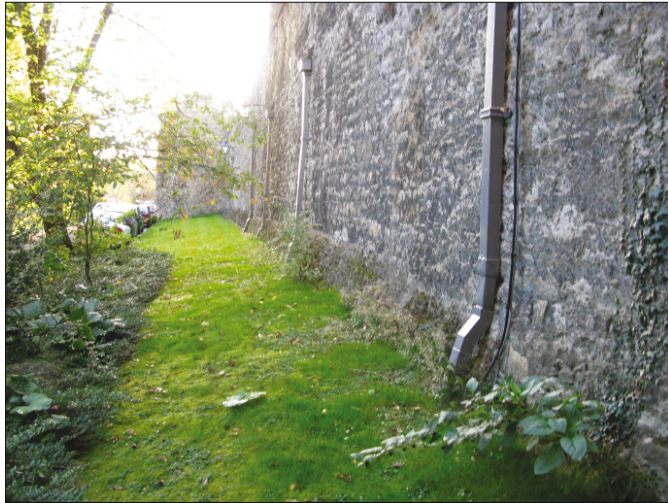
West of Bastion 11, on the external face of the city wall (Fig. 5), the batter starts at the junction of the bastion and wall, where it is 0.37m high rising to 0.7m north of the chapel and ending 3m from the Bell Tower, where it is c. 0.4m high. The extent of razing and rebuilding which this undulating line might indicate is unclear, as it may equally reflect underlying ground conditions as well. Without a fuller record of the wall fabric it is only possible to speculate.

Detail of batter on city wall
west of Bastion 11

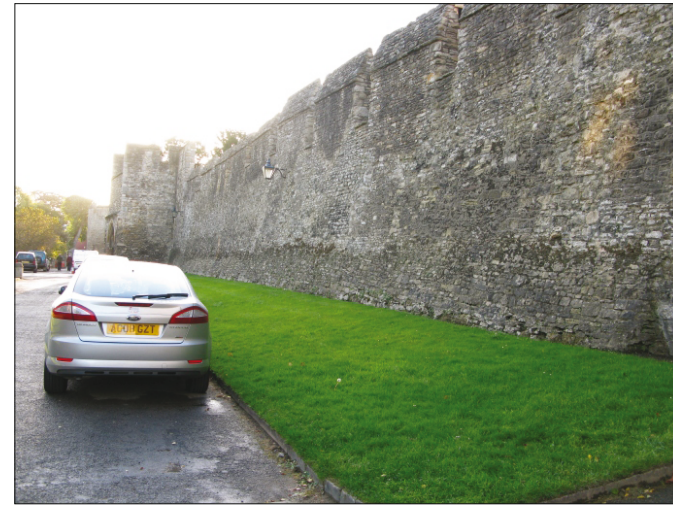
Detail of batter on city wall
between Bastions 11 & 12

The scar visible 3m east of the entrance into Monk's Passage on the north face evidences the rebuilding that has been carried out in the past. The most immediate aspect of the rebuilding is the absence of a batter west of the scar; indeed the face of the City Wall in the environs of Monk's Passage and Bastion 11 is almost vertical, whereas to the east of the scar and toward Bastion 12 – the entrance to the kitchens – the wall has a batter c. 1.2m high. This batter increases as it approaches Bastion 12, where it is 1.7m high.

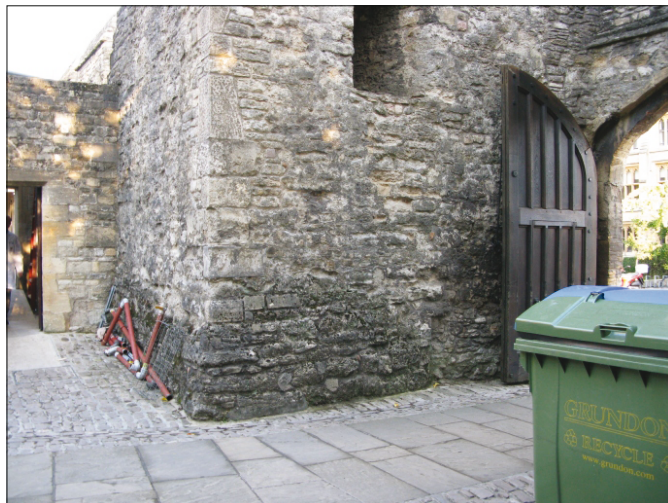
Detail of west wall Bastion 12

To the east, Bastion 12 has also undergone rebuilding (Fig. 5). Paul Booth's work (1995, 212-6) indicates a rebuild of the city wall 1.5m west of Bastion 12; JMHS observed the batter above ground 3.5m west of the bastion. Within the Kitchen Yard the batter is visible internally; the southwest corner of Bastion 12 shows a batter on both the south and east faces of the west side of the gate.

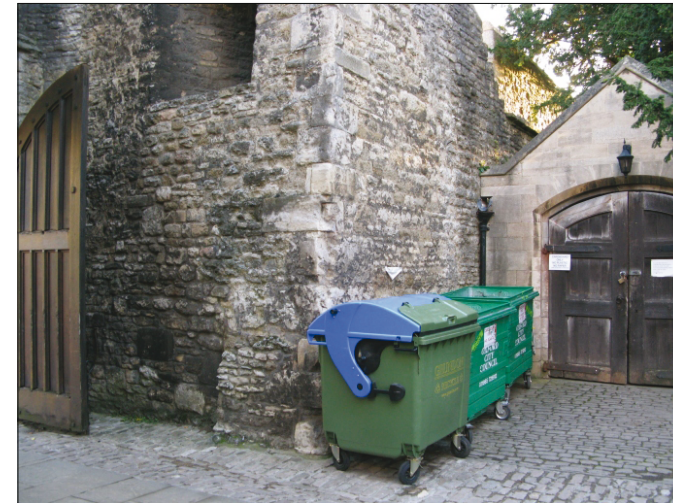
Detail of east wall Bastion 12

The batter is not replicated on the eastern side of the gate, which is offset on the internal side by 1.9m to the north. Building scars of the wall are visible on the internal bastion faces; that on the east face measures 1.35m wide, whereas that on the western face measures 3.03m.
