JOHN MOORE HERITAGE SERVICES

AN ARCHAEOLOGICAL WATCHING BRIEF

THE OLD FORGE, CHILTON

BUCKINGHAMSHIRE – 09/02467/APP

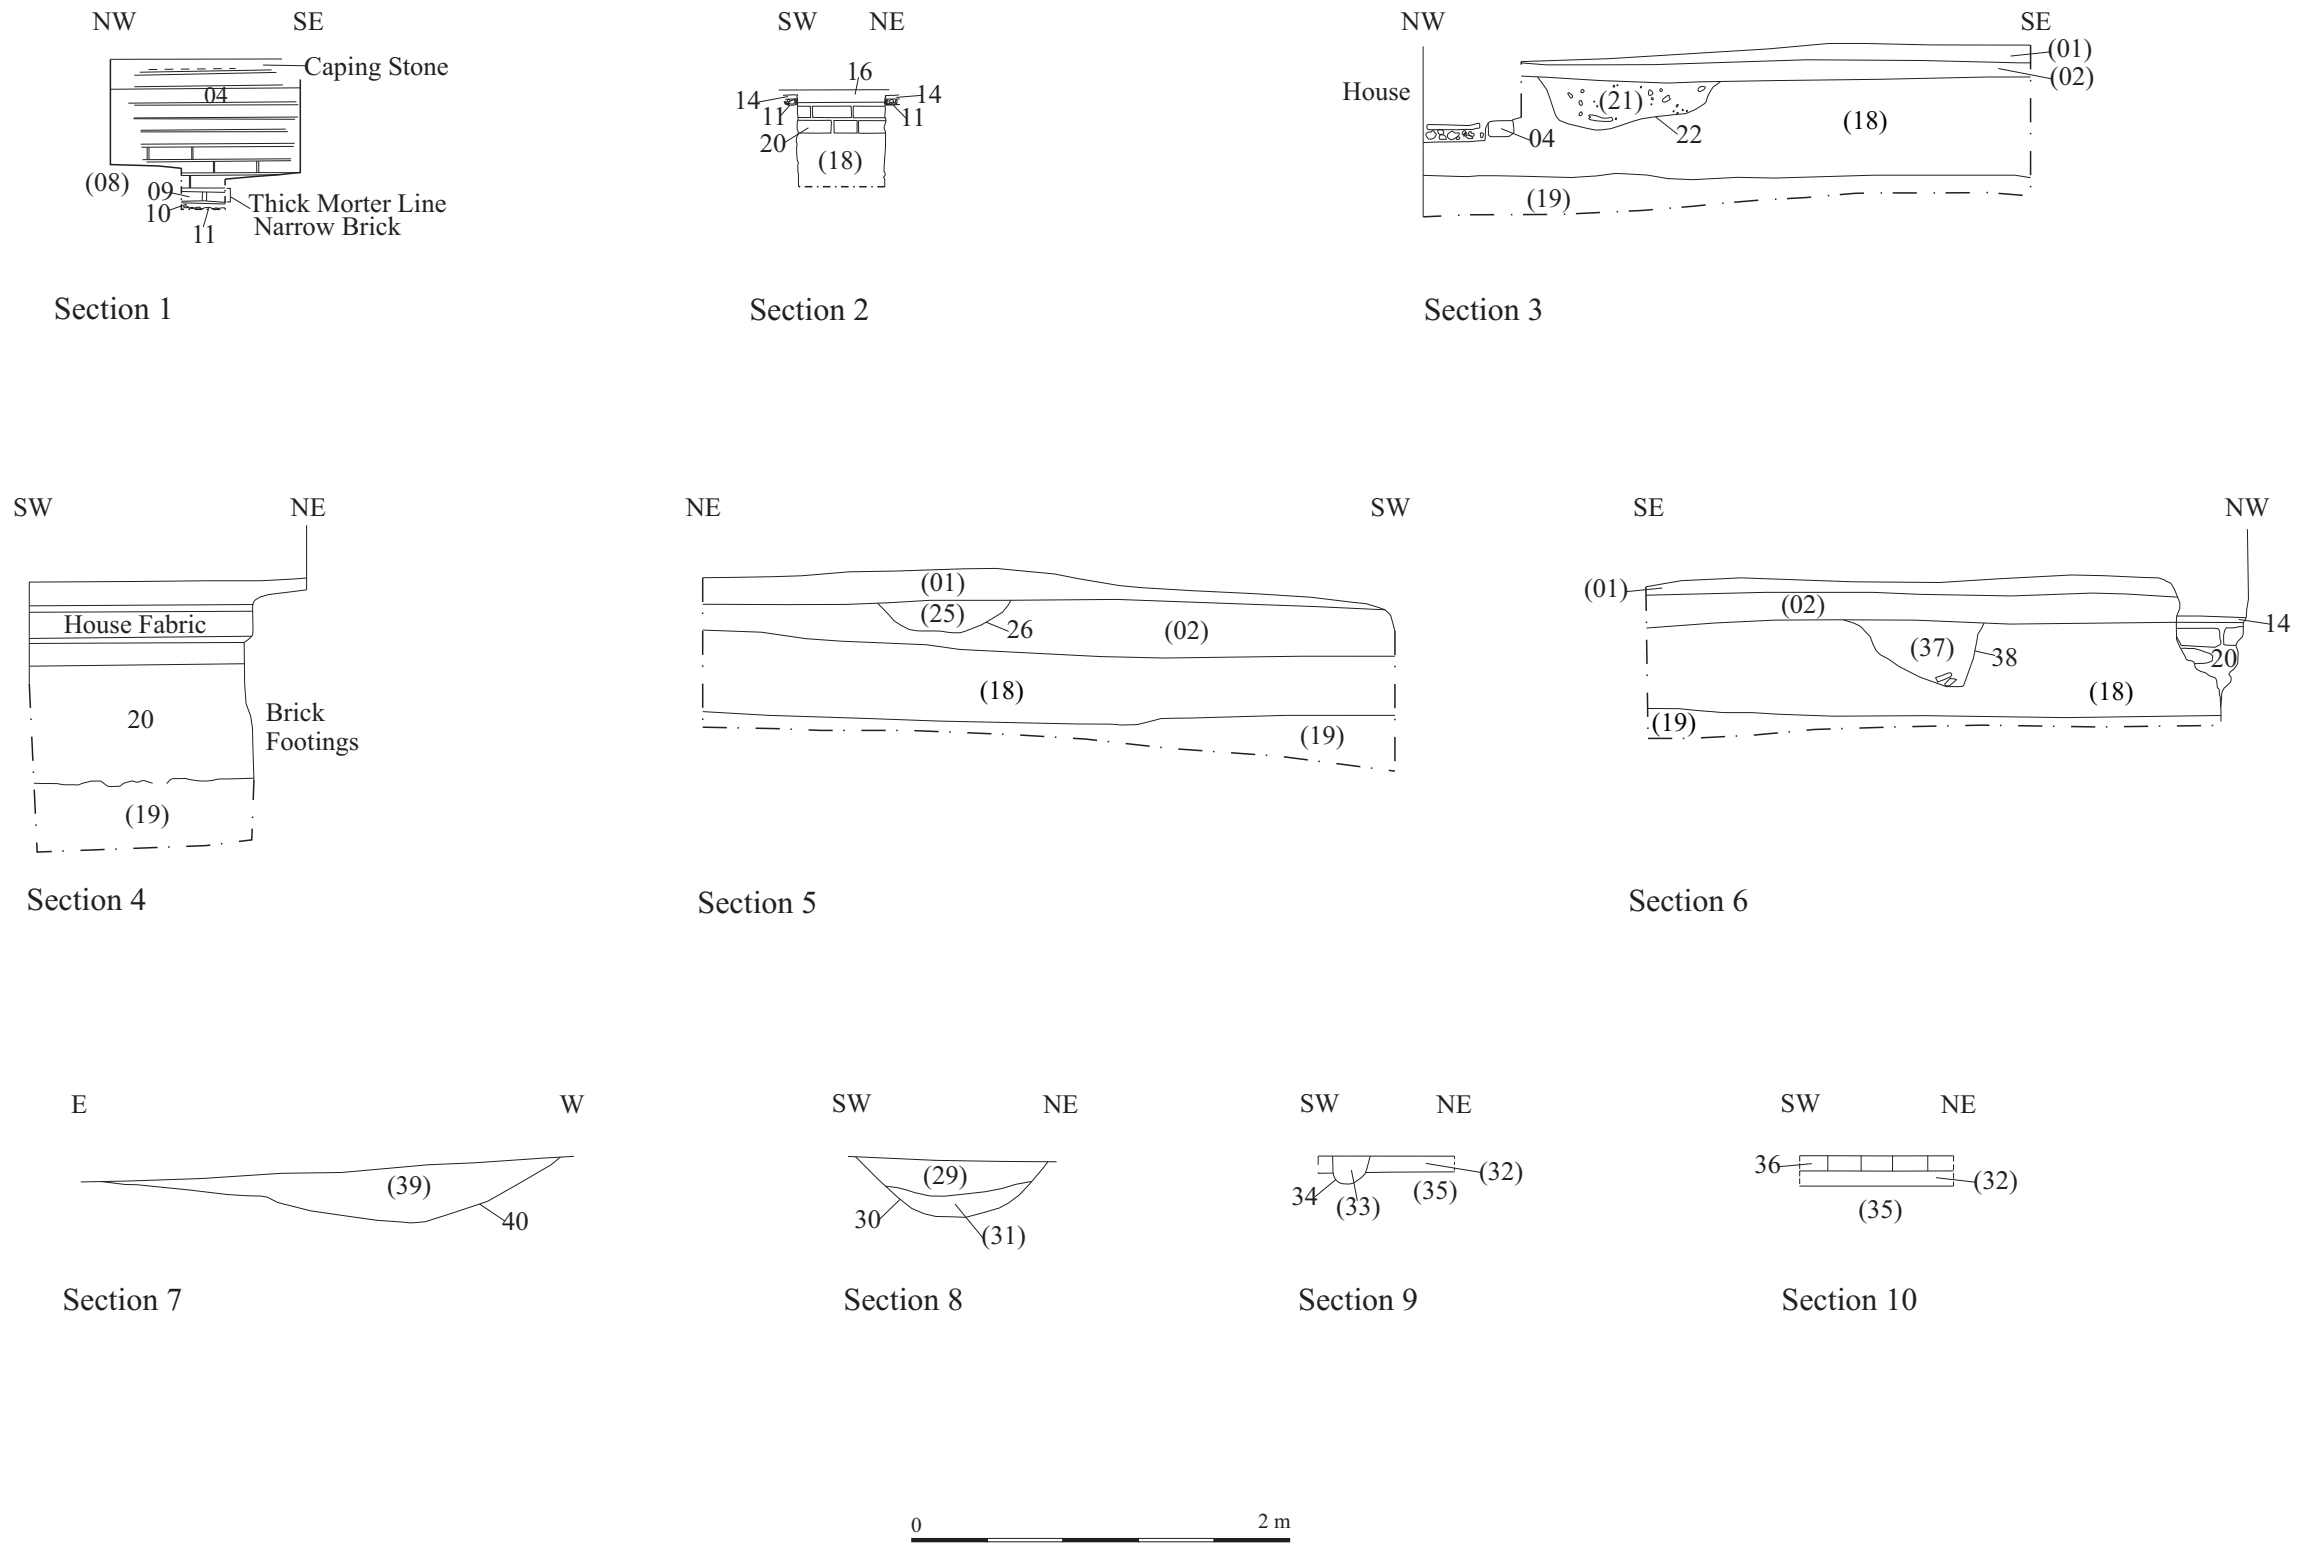
Figure 3. Sections

Pit 22 was seen as 0.92m wide and 0.26m deep with an irregular profile (Fig. 3, Section 3). The fill was dark brown-black clay silt (21). Pit 26 was 0.68m wide in section and 0.16m deep with a flat base (Fig. 3, Section 5) and filled by mid brown-black clay silt (25). Pit 28 was 0.74m wide, up to 0.34m deep with an irregular profile (Fig. 3, Section 6). It was filled by mid brown-green silty clay (27). Pit 30 was 1m in diameter and 0.30m deep with a rounded profile (Fig. 3, Section 8 & Fig. 6) and filled by dark grey-brown silty clay (29). Pit 40 was sub-circular 2.5m east-west by 1.7m north-south, 0.30m deep with an irregular profile (Fig. 3, Section 7 & Fig. 7). The fill was mid grey-brown silty clay (39).

The foundation trench on the southeast corner of the house revealed a series of footings to the south wall of the building. These were very different in character to those on the opposing southwest corner. The section (Fig. 3, section 4) records up to five or six courses of brick footings 20 as opposed to the two courses found at the southwest. Furthermore, these extensive footings appear to be slightly 'out of true' and appear to continue to the east under the existing pavement. Whether this was to facilitate the building being 'terraced' into the rising ground at the southeast or a mistake on the part of the builders is unknown. Excavation and recording was restricted to the foundation trench and no further investigations could be made. Another explanation for this discrepancy may be that the natural bedrock that was found as an outcrop to the west of the house (as seen in the modern service trench 7) may have provided a solid foundation. Therefore, the brick footings did not have to be as substantial as that of the southeast corner.

A posthole 34 that was 0.12m in diameter and 0.12m deep (Fig. 3, Section 9) was located in the eastern part of the floor surface (32). It was filled with black-brown sandy-silt (33). The posthole could not be dated, but it is probably contemporary with the use of the clay floor, indicating earlier internal features. Brick wall 36 was built directly on top of floor (32) (Fig. 3, Section 10).

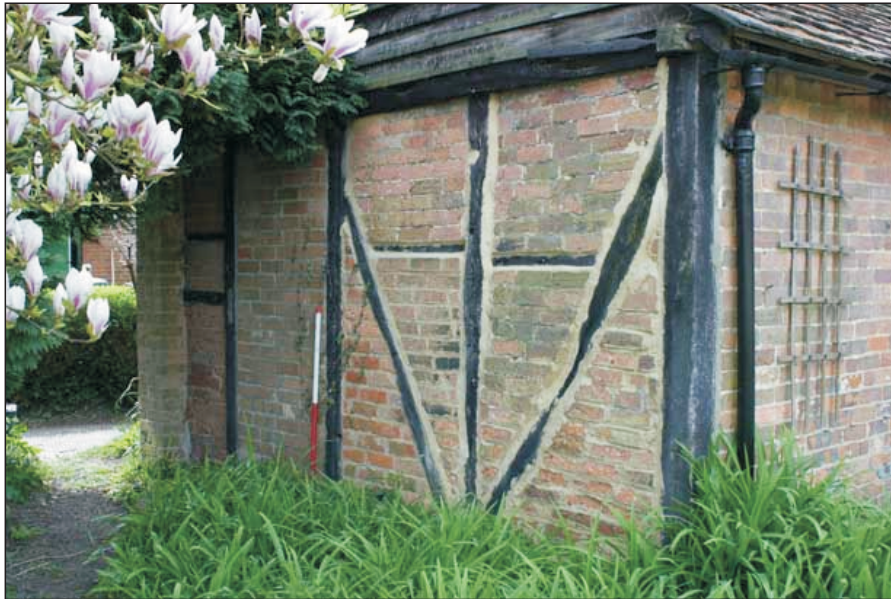
Figure 4. North-east wall of store

Views of the building are shown in Figs. 4 & 5
