**AN ARCHAEOLOGICAL EVALUATION
ON LAND TO THE REAR OF
THE WHITE HORSE PH, WHITCHURCH,
BUCKINGHAMSHIRE**

SP 80239 20773

*On behalf of
CgMs Consulting Ltd.*

OCTOBER 2010

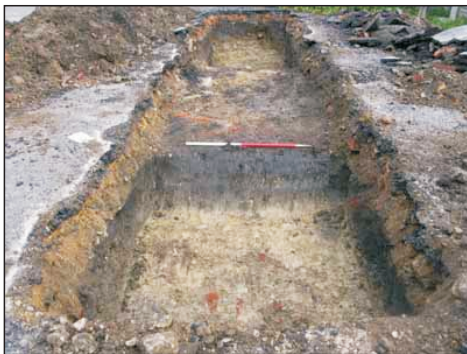
Figure 5. Trench 2; looking northeast

Trench 2 was located on the east side of the proposal site and was oriented northeast/southwest. It measured 10m by 1.6m and was a maximum depth of 0.8m

Natural Portland Stone Member (2/19) was seen at the north and south ends of the trench; the central part of the trench revealed archaeological remains at a much higher level, immediately below the tarmac. At the southern end of the trench the quarry pit 2/1 extended beyond the edge of the evaluation trench, and was 0.6m deep. The lower fill (2/16) was redeposited natural with a band of burnt stone and mixed CBM through it. Pottery from the deposit yielded a date after the middle of the 17th century. Overlying (2/16) was the deposit (2/2), which was a similarly redeposited natural, although it was markedly dirtier and contained pottery and brick. The pottery from this deposit indicated a 19th-century date. To the east of this feature was the small posthole 2/7, which was undated. It was sealed by a buried subsoil (2/6), which was undated.

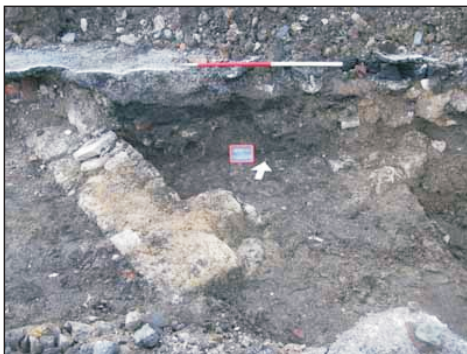
Figure 7. Stone building Trench 2.

The construction cut 2/17 for the wall 2/13 cut the subsoil 2/6. Wall 2/13 was located north of the quarry pit, comprising an approximately north/south and an east/west aligned length of stone built wall, three courses high, immediately beneath the tarmac. The stones were roughly worked. Pottery from the wall matrix yielded a 19th-century date. A dark grey-brown humic dump containing rubble, iron, ceramics, oyster shell, bone and glass (2/15), which butted up to the internal faces of wall 2/13, yielded a late 19th-century date; a pint-pot with an excise-mark, from this assemblage, dated from 1891.

Externally, the wall was butted by the charcoal rich deposit (2/20), which extended beyond the north end of the trench. The east face of wall 2/13 had been partly truncated and was sealed by the later dump (2/5), which comprised ironwork, pottery, slate, coal and glass (not all categories of find were retained) within a moist organic matrix; the dump (2/5) also sealed deposits (2/15) and (2/20), yielding a 19th-century date.

Rubble from within the structure indicates that it was razed after 1891 and probably not too long after that date as the pottery and other finds are more typically pre-First World War. The construction cut for the wall cut through an undated deposit, but all the other deposits in the trench were 19th century and were stratigraphically later than the wall.
