AN ARCHAEOLOGICAL WATCHING BRIEF

GUEST HOUSE, MANOR HOUSE,

SUTTON COURTENAY, OXFORDSHIRE

November 2010

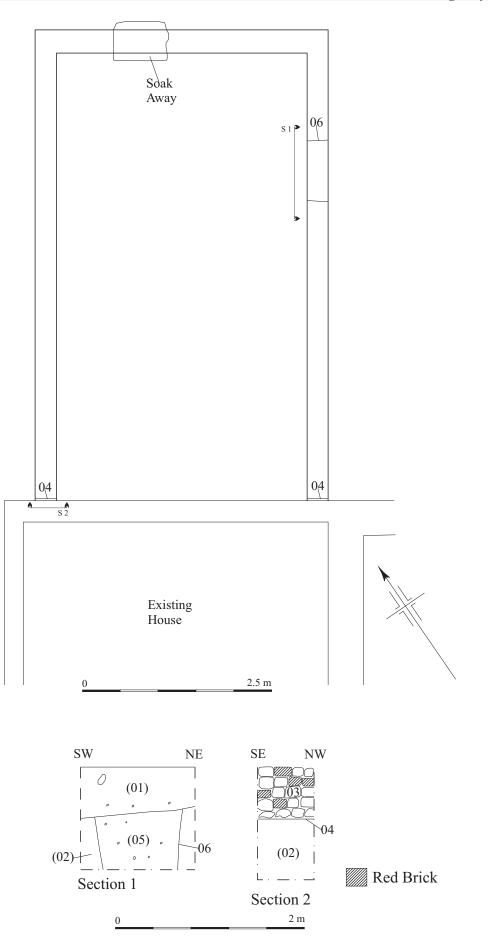
Figure 2. Plan and sections

Cut into the natural grey white gravel (02) was ditch/pit 06, which was 0.80m wide, 0.60m long and 0.62m deep as seen. It had concave edges, which sloped at an 80degree angle. It was aligned southwest-northeast. It was filled with a moderately compact dark grey-black silty clay (05), which contained around 15% small gravel no larger than 0.04m and circa 30% charcoal flecking. It contained pottery, animal bone and shell, although the shell was not retained. Only a small part of the feature could be seen, and it was not possible to determine whether it was a pit or part of a ditch. It was also not fully excavated as the base continued below the level of the foundation trench.

Also visible was the cut for the 20^{th} century extension wall foundation 04. It was 0.60m wide as seen. The fill of 04 was the wall for the building 03, consisting of red brick and limestone fragments no larger than 0.12m x 0.08m.

Abutted against this was deposit (01), a mixture of topsoil & rubble from the demolition of the extension. It was a mid red brown in colour, containing red brick fragments (15-20%) and small stone (<0.06m, 10%).

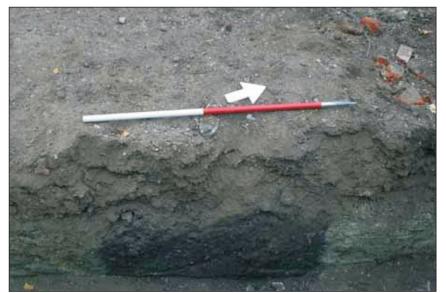
Plate 2. West Facing Pit/ditch 06.

The watching brief revealed pit/ditch 06, which contained a high degree of animal bone, pottery and shell. This feature most likely represents a domestic rubbish dump

from the $11^{th} - 12^{th}$ century phase of the medieval manor house, and not the later 16^{th} century Cottage.
