AN ARCHAEOLOGICAL WATCHING BRIEF

WALLINGFORD LIBRARY, HIGH STREET,

WALLINGFORD, OXFORDSHIRE

OCTOBER 2010

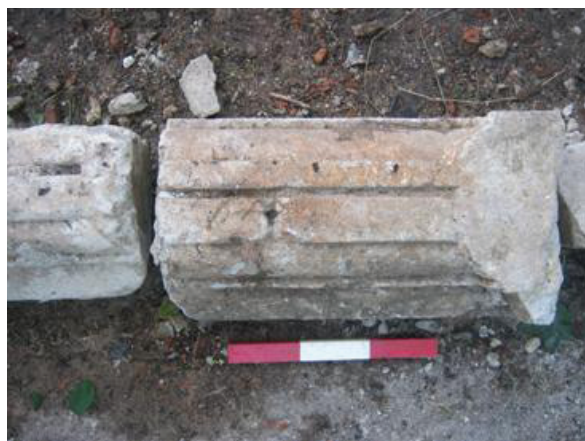
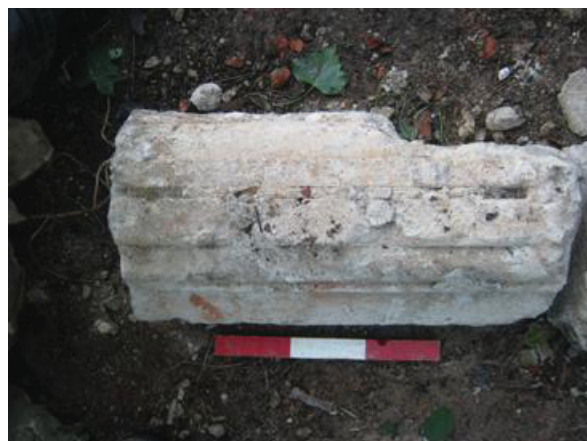
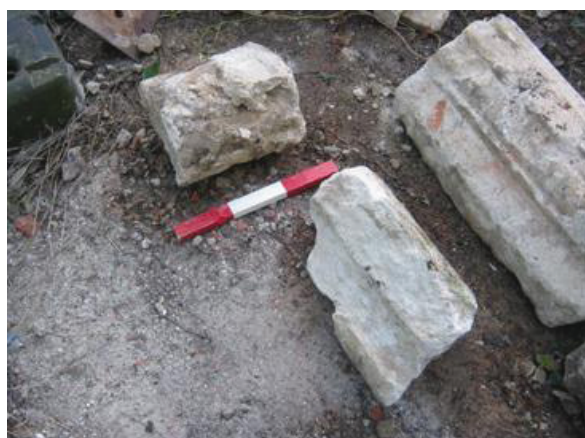
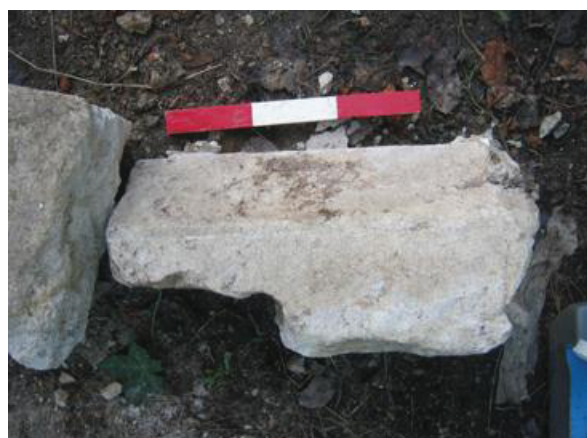
Several fragments of dressed sandstone blocks, quoins and mouldings were recovered from the fabric of wall (04). These pieces appear to be reused from the remains of the Priory that was dissolved in 1524-8 (VCH 1907). Representatives of the Wallingford Museum took these pieces prior to detailed recording.
