JOHN MOORE HERITAGE SERVICES

HISTORIC BUILDING RECORDING

28-32 SAINT MICHAEL'S STREET, OXFORD

JMHS Project No: 2263
Site Code OXSMS 10

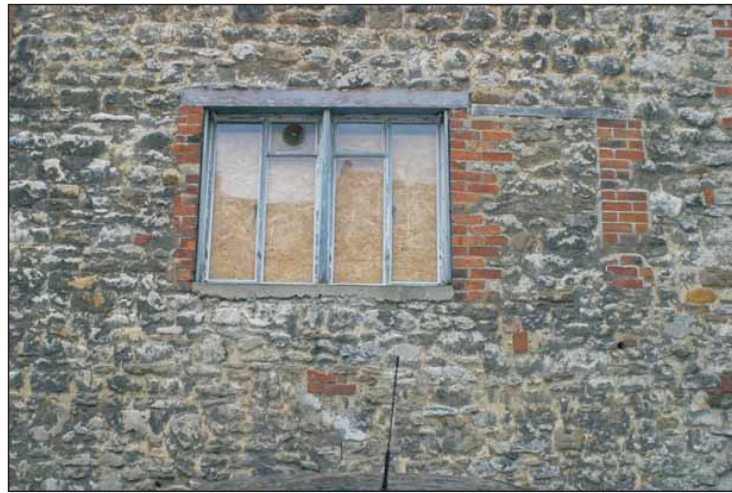
Plate 1. Rear of No. 28 St Michael's Street showing the two different window phases (wall A)

- 3.2.3 There is evidence that this wall has seen several window insertions over time that has drastically altered the configuration and original fabric of the city wall (Wall A and B). Only one window light may be part of an early feature, which is the small light near the junction of the bastion wall. Internally it would appear that this was long and narrow in shape and has been reduced in size with the bottom being blocked (Plates 2, and 5). Below this there is a further blocked window/entrance, which has pale bricks blocking internally and also below, alongside which are the remains of a roofline. The remaining windows have red brick surrounds with which they have been reset. The windows here have two types of characteristics, one group wooden frames with numerous small window lights, which are probably the earliest set of insertions. There is definitely one of these inserted into the curtain wall. A further window of this type may well have been inserted initially in the lower back wall of number 28, where only part of the brick surround and lintel survive. The second group of windows have large window panels and metal frames. There are two of these in the rear of number 28.

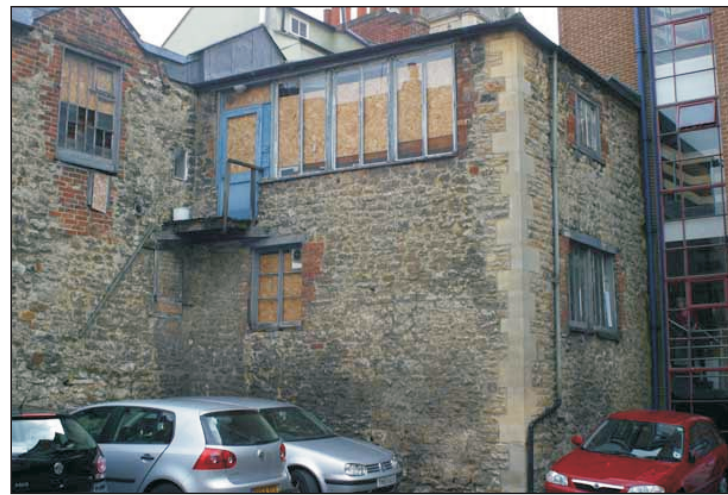
Plate 2. General view of Bastion 2 rear of 32 St Michael's Street (walls A & B)

- 3.2.4 Below the lower windows in the back wall there are brick infilling of repair or even locations where wooden features from a lean-to building could have been inserted (plates 2 and 3).

- 3.3.4 The interior of the bastion shows signs of wall movement, with evidence of cracking in the north Wall A and east Wall B. This suggests rebuild. In the ground floor it is probable that the windows here have been reset in their original positions of the bastions narrow arrow slits, though they have been considerably altered. The window in the east wall of the bastion has no brickwork showing internally. It may even be the case that the front of the wall was altered and the window may be the remains of an embrasure. The north window is also altered but this was considerably widened (see plate 2).

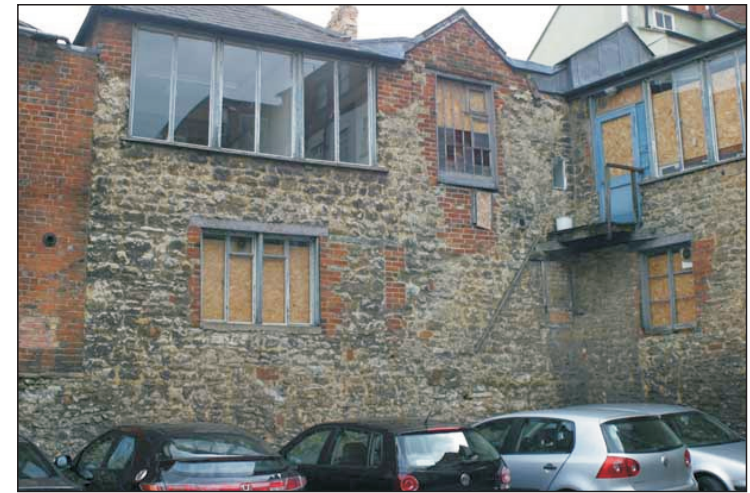
Plate 3. General view of the surviving city wall at the rear of No. 28 and No. 30 St Michael's Street (wall A)

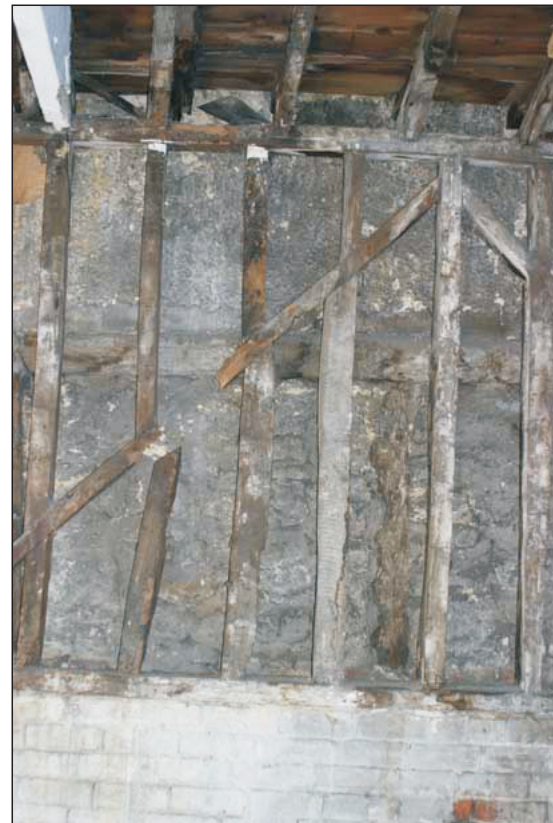
Plate 4. The west wall of No. 32 St Michael's Street showing the wooden frame to support boarding at No. 32's wall and also the timber frame wall onto which it is built of No. 34 (wall C)

- 3.4.2 The continuation of the west Wall C to the south, was also initially of stone rubble, this is evident in the first floor where some of the boarding has been taken away from the wall. The removal of boarding has revealed the earlier wall of number 34, which had a wooden framework with stone rubble infill. This continues to a height two thirds of the way up the first floor wall. Above this the wall has lathe work covered in render/plaster. Two earlier windows are probably blocked and rendered (plates 4, 6 and 7). During the construction of number 32 a single course of bricks were constructed a third of the way up the wall. The upper two thirds of this wall had a wooden frame onto which borders were attached.

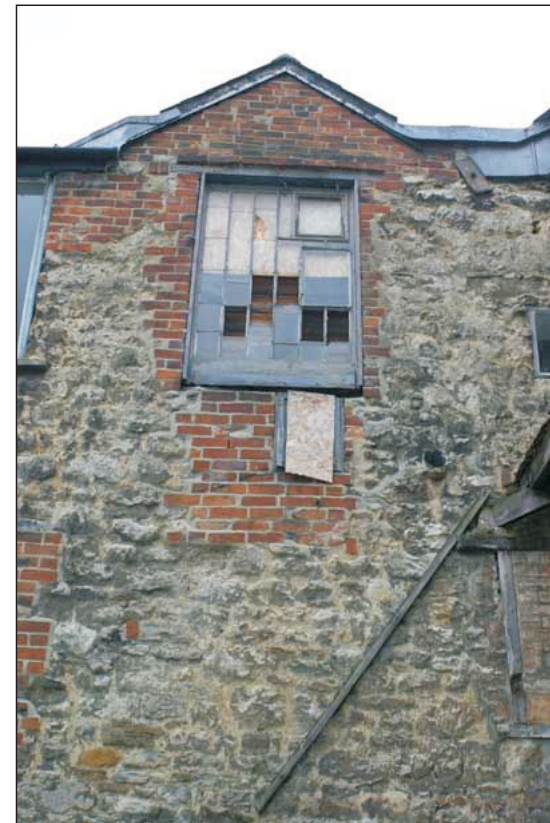
Plate 5. Insertion of window and building at the rear of No. 30 St Michael's Street (wall A)

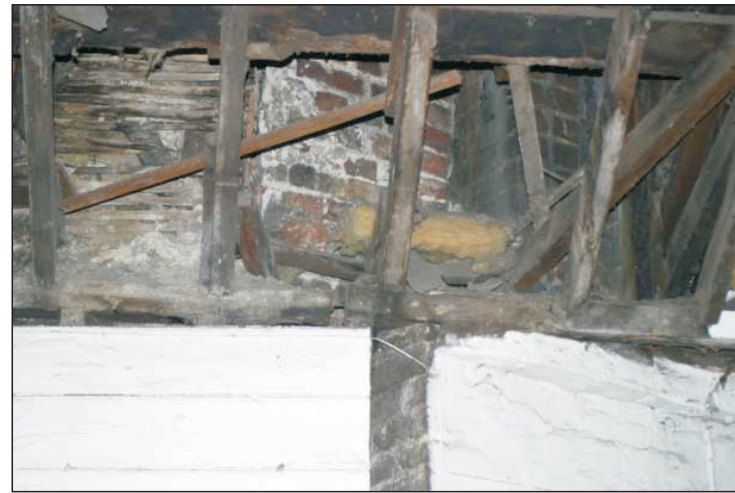
Plate 6. The lathe covered wall and brickwork of No. 32& 34 St Michael's Street evident in the roof space of No. 32 (wall C)

3.4.4 The removal of panelling in the roof space means that it is now possible to see a wall of brick 2m wide continue above the first floor ceiling behind number 34. It is also possible to see that there is also a structure of wood covered in lathes or that another form of walling is coated in lathes. A plan produced of the buildings along the line of Saint Michael's Street shows a block drawn across the diagonal section of wall in the bastion (Anon 2010) probably represents the last section of full sized wall between the New Inn Lane postern gate and the North Gate, though possibly hollowed for a chimney (see plate 6).

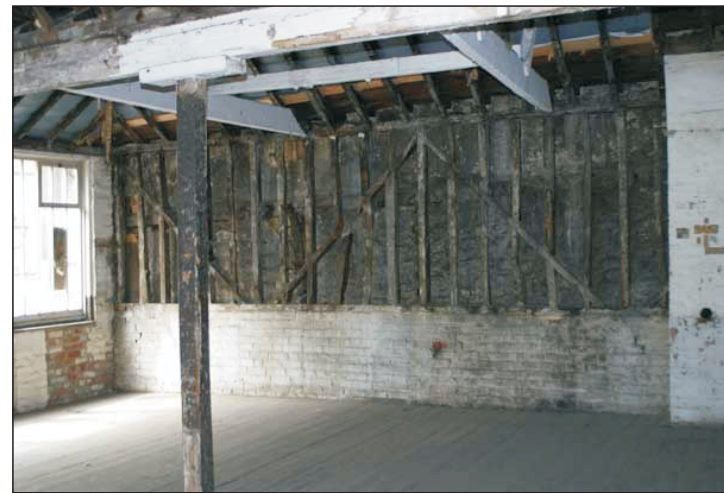
Plate 7. The west wall of St Michael's Street showing the frame for boarding and the wall of No. 34 built of timber with stone and mortar infill. Two windows have been blocked (wall C)

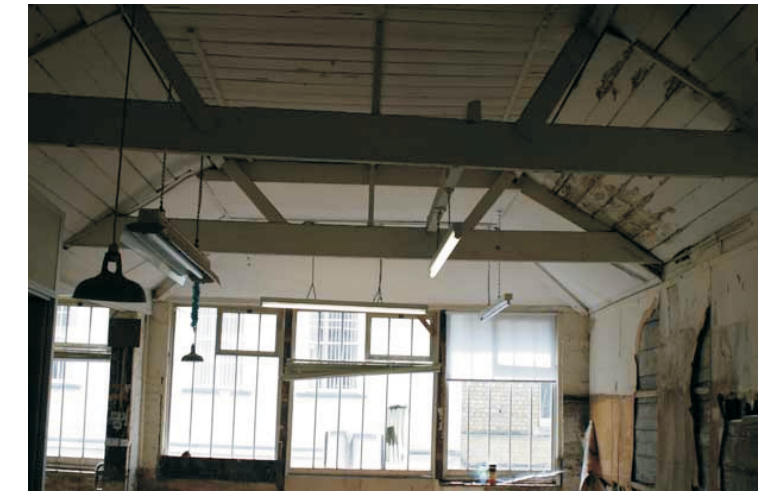
Plate 8. The roof space of No. 32 showing the tie beams and Queen Beam supports (cross-section G)

3.6.1 The roof is constructed of a wooden frame with three hipped slate roofs fronting onto Saint Michael's Street, see cross-section G (Fig. 5). On numbers 28 and 30 the rear part of the building is hipped. The roof on number 30 has a small dormer with gable extending from the hipped part of the roof to incorporate a large window inserted into the wall. In the case of number 32 the rear of the roofline has to line up with the bastion, thus there is a gable, which butts up against a further gable. The roof of the bastion is also hipped.

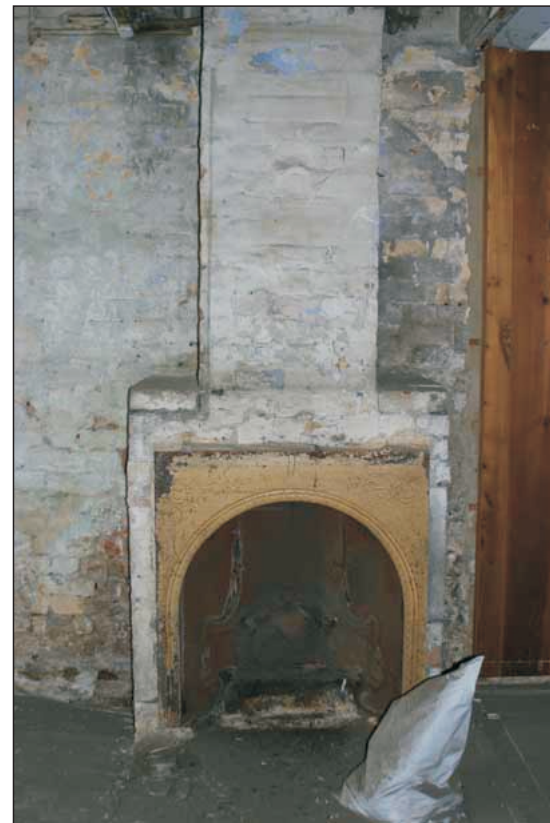
Plate 9. The mid - late 19th Century fire place and chimney breast butting up against the existing east wall (wall E)

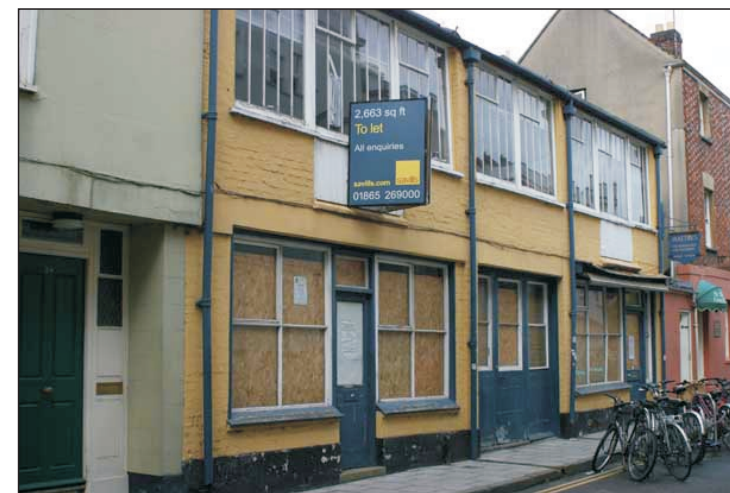
Plate 10. General view of No's. 28-32 St Michaels Street. The front of the building may have been replaced wholly or partially (Phase 7), (wall F)

3.5.2 Wall F forms the front of the building has been divided into three units, of which much of the face of each part has extensive areas of window and door area. The front of all the buildings is painted yellowish orange. Common features along the front of all buildings include a stylobate feature, probably created from rendering, along the base of the wall, which is painted black. This feature is cut by single doors that extend to the floor, with number 28 the door is offset to the right (east), while with number 32 the door is central with equal sided windows to the east and west. The central area of the building number 30 has a central door, but is flanked by two similarly designed doors. Numbers 30 and 32 have large lintels above, but this is not so evident as that on number 28 (see plate 10).

- 4.3.12 **Phase 7:** The Saint Michael's Street façade show signs of being replaced at least once (Wall F and Fig. 5). The reason for thinking this is that the front of number 28 looks as though it has been reset or reworked at a later date, due to the possible signs of rebuild internally and externally, but that its rebuild does not seem to correspond to the rebuild evident in the facades of numbers 30 and 32. The designs of the fronts of numbers 30 and 32 match in that they contain the remains of a large lintel above the ground floor windows and doors, a feature not apparent at number 28. Bricks in this build measure 230mm x 72mm x 105mm.
