A Historic Building Survey of Service Buildings  
at  
**FAWLEY COURT**  
BUCKINGHAMSHIRE

K A Rodwell  
JOHN MOORE HERITAGE SERVICES  
for  
Cherrilow Ltd  
August 2009

**A HISTORIC BUILDING SURVEY OF SERVICE BUILDINGS  
AT  
FAWLEY COURT, BUCKINGHAMSHIRE**

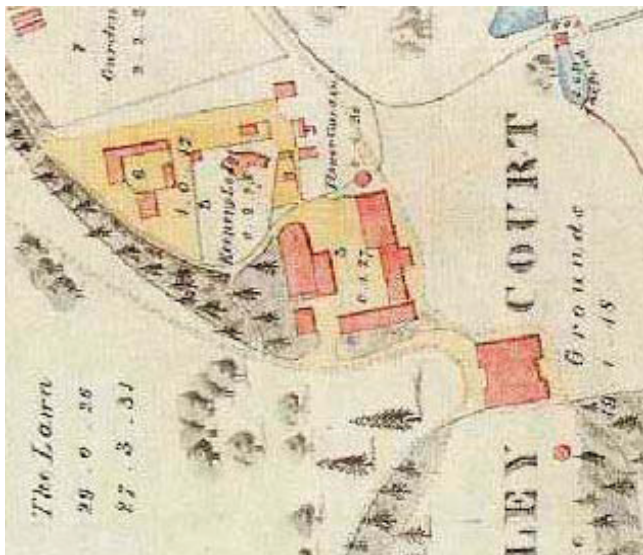
**Fig 1 Historic maps**

1783 estate map (Henley Museum)

early 19th century (left); from guide book (Orr, V, 1994 *Fawley Temple*)

1840 Tithe map (Centre for Bucks Studies)

1879 Ordnance Survey; surveyed 1875 (left)

1898 Ordnance Survey; surveyed 1897

The most useful primary sources in documenting the development of the service buildings are the cartographic evidence (Fig 1), original plans and elevations of the riding house (Figs 3-4) and sale catalogues of 1853 and 1952. The most useful secondary source is Geoffrey Tyack's article *The Freemans of Fawley and their Buildings* (Tyack 1982). No copy of the earliest of the large scale estate maps dated 1763 (ibid. 134) was available but there is a map of 1783 and another of early 19th century date. There is also the Tithe map of 1840; the first edition 1:2500 Ordnance Survey map surveyed in 1875 and the second edition surveyed in 1897; these indicate changes in the layout of the buildings (Fig 2).

In this area there is no clear correlation between the map evidence and the surviving fabric. The 1783 map shows a range of buildings abutting the riding house which are identified on the large scale plan as coach-houses and carpenters' shops, cowhouse, henhouse and cart shed. It appears to have been the intention to replace at least some of these when the riding house was built. There was a pair of yards to the east but one of these was the demolished stable court. By the early 19th century the range abutting the riding house had been reduced to the size of the present covered yard. The north boundary wall is shown but not the attached buildings and other divisions are not

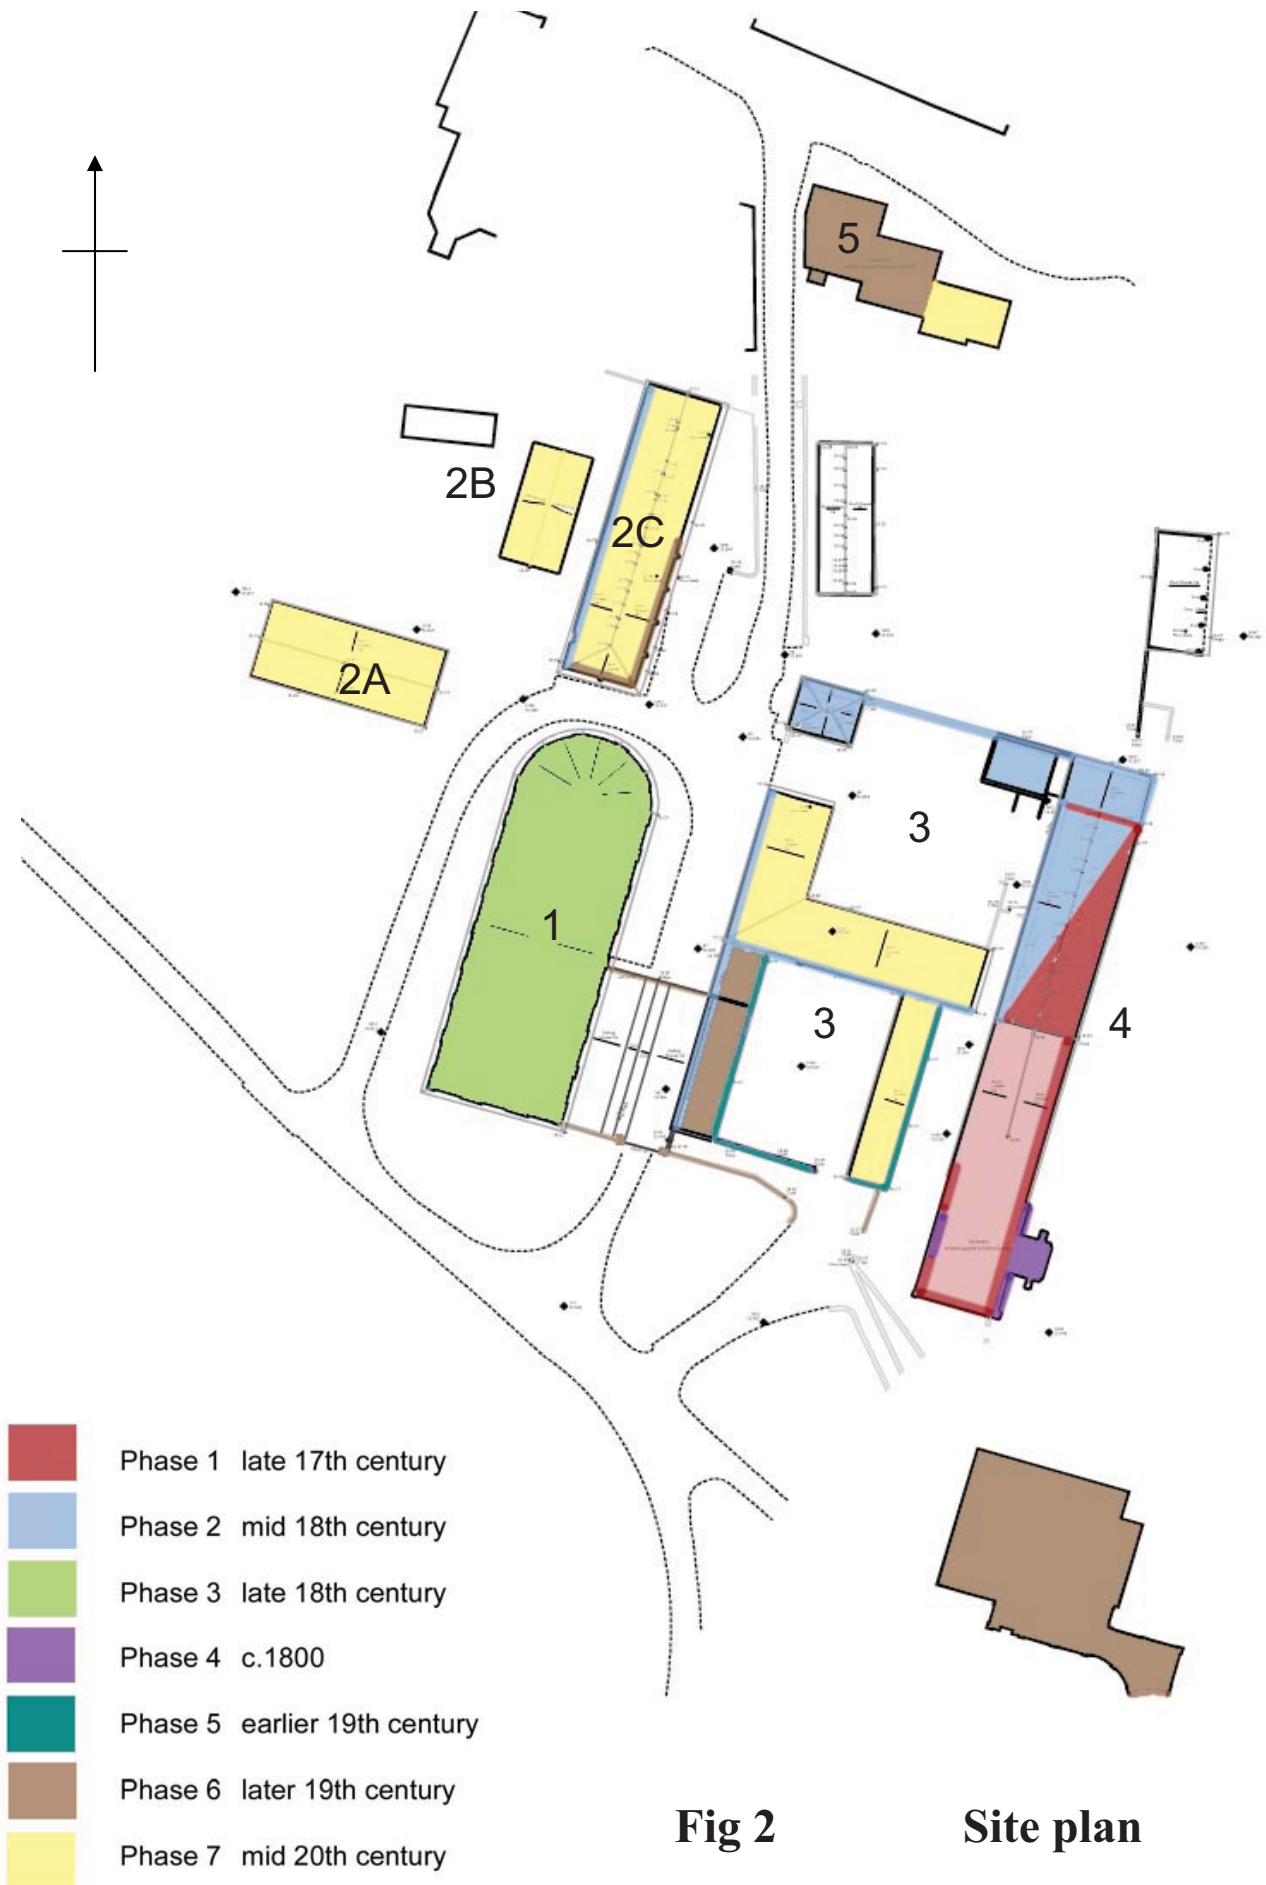
**Fig 2**

**Site plan**

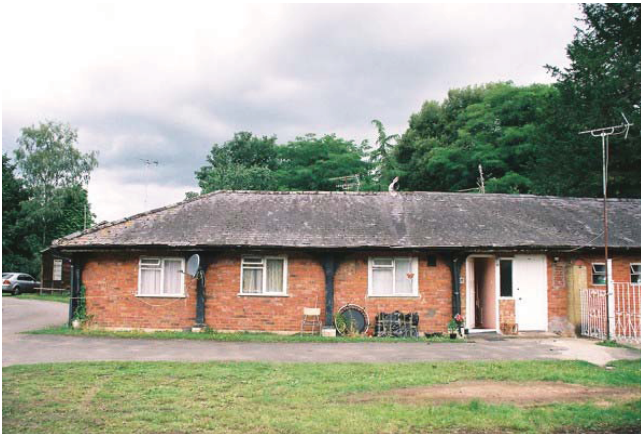
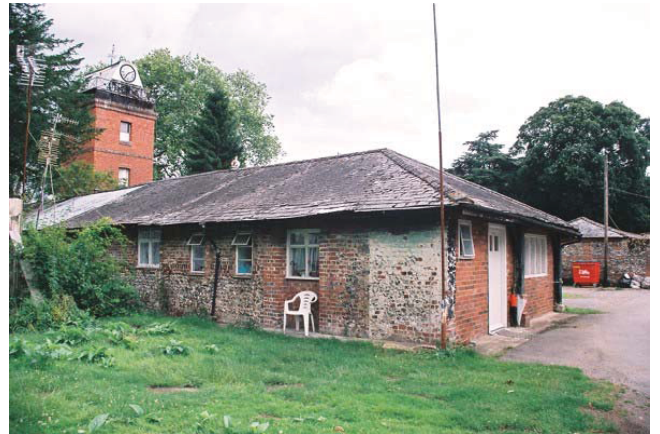
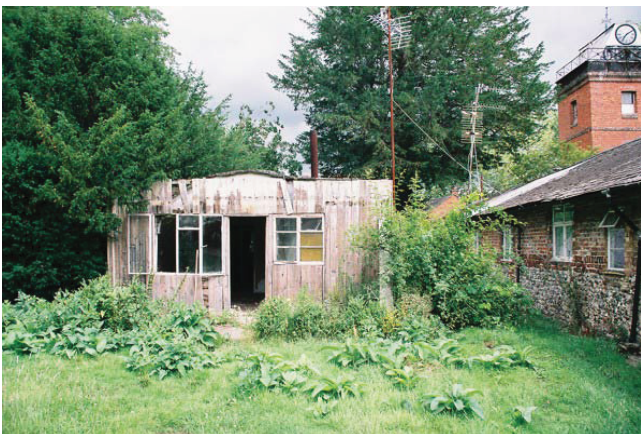
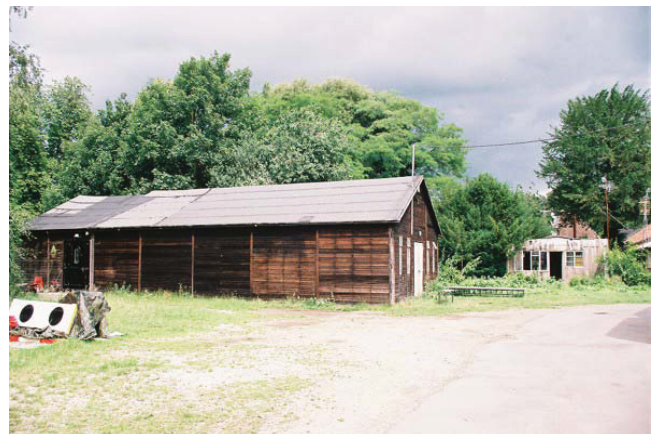
**Fig 5 Buildings 2A-C**

Building 2C elevations (see fig 2 for plan)  
West; East; South

- Building 2C; east elevation (left)
- Building 2C; from south-west
- Building 2B; Nissen hut from south (left)
- Building 2A; from south

To the west of the riding house at right angles is a detached wooden shed (2A) with a pitched roof of mid 20th century date. A plaque on the east gable reads Supplied by J Thorne & Sons Ltd, Bexleyheath Kent. To the north and aligned north-south is a derelict Nissen hut (2B) with a curved corrugated steel roof, a brick façade at the south end and a boarded north wall; there are three rooms inside.

North of the apse is a single-storey building (2C) with a hipped roof, partly Welsh slate and partly corrugated iron. The west wall has two distinct builds; the lower part to the height of c.1m is panels of flint rubble with brick dividers capped by three courses of brickwork, the top course edge-set. This has the appearance of a free-standing boundary wall and has been heightened in plain orange brickwork. Modern windows have been inserted at intervals but there appears to have been an original doorway, marked by brick piers at the mid-point. There is a wider brick pier at the south end and an area of modern infill below a window which may have originated as a door. The south and east elevations were originally open-sided with square timber posts at intervals. These have wooden base blocks set on brick piers and curved braces to the wall plate; a sequence of chisel cut carpenters' marks are visible with VI on the central south post and the numbers reducing northwards. The south elevation has two bays and the east three with surviving braced posts; the fourth bay is marked by a brick pier and there are two further posts to the north which appear to be reset. The whole structure has been infilled with 20th century brickwork and modern windows. The interiors were not seen.

The building to the north of the riding house (2C) was originally an open-fronted shelter with wooden arcades on the south and east sides and a solid rear west wall.

This appears to have been built up from a pre-existing brick and flint boundary wall and one is shown in this position on the 1783 map. The sequence of carpenters' marks shows that this building was originally four bays long and this is corroborated by its plan on the Ordnance Survey maps. The northern part of the range was originally half the width but shared a common west wall. Although the style of construction suggests a date in the earlier 19th century the building is omitted from the maps of this period; it is probably one of the detached horse or cartsheds mentioned in the 1853 sale particulars. The other two buildings on this part of the site are mid 20th century; the Nissen hut (2B) must have been constructed during the Second World War; the other (2A) may be slightly later.

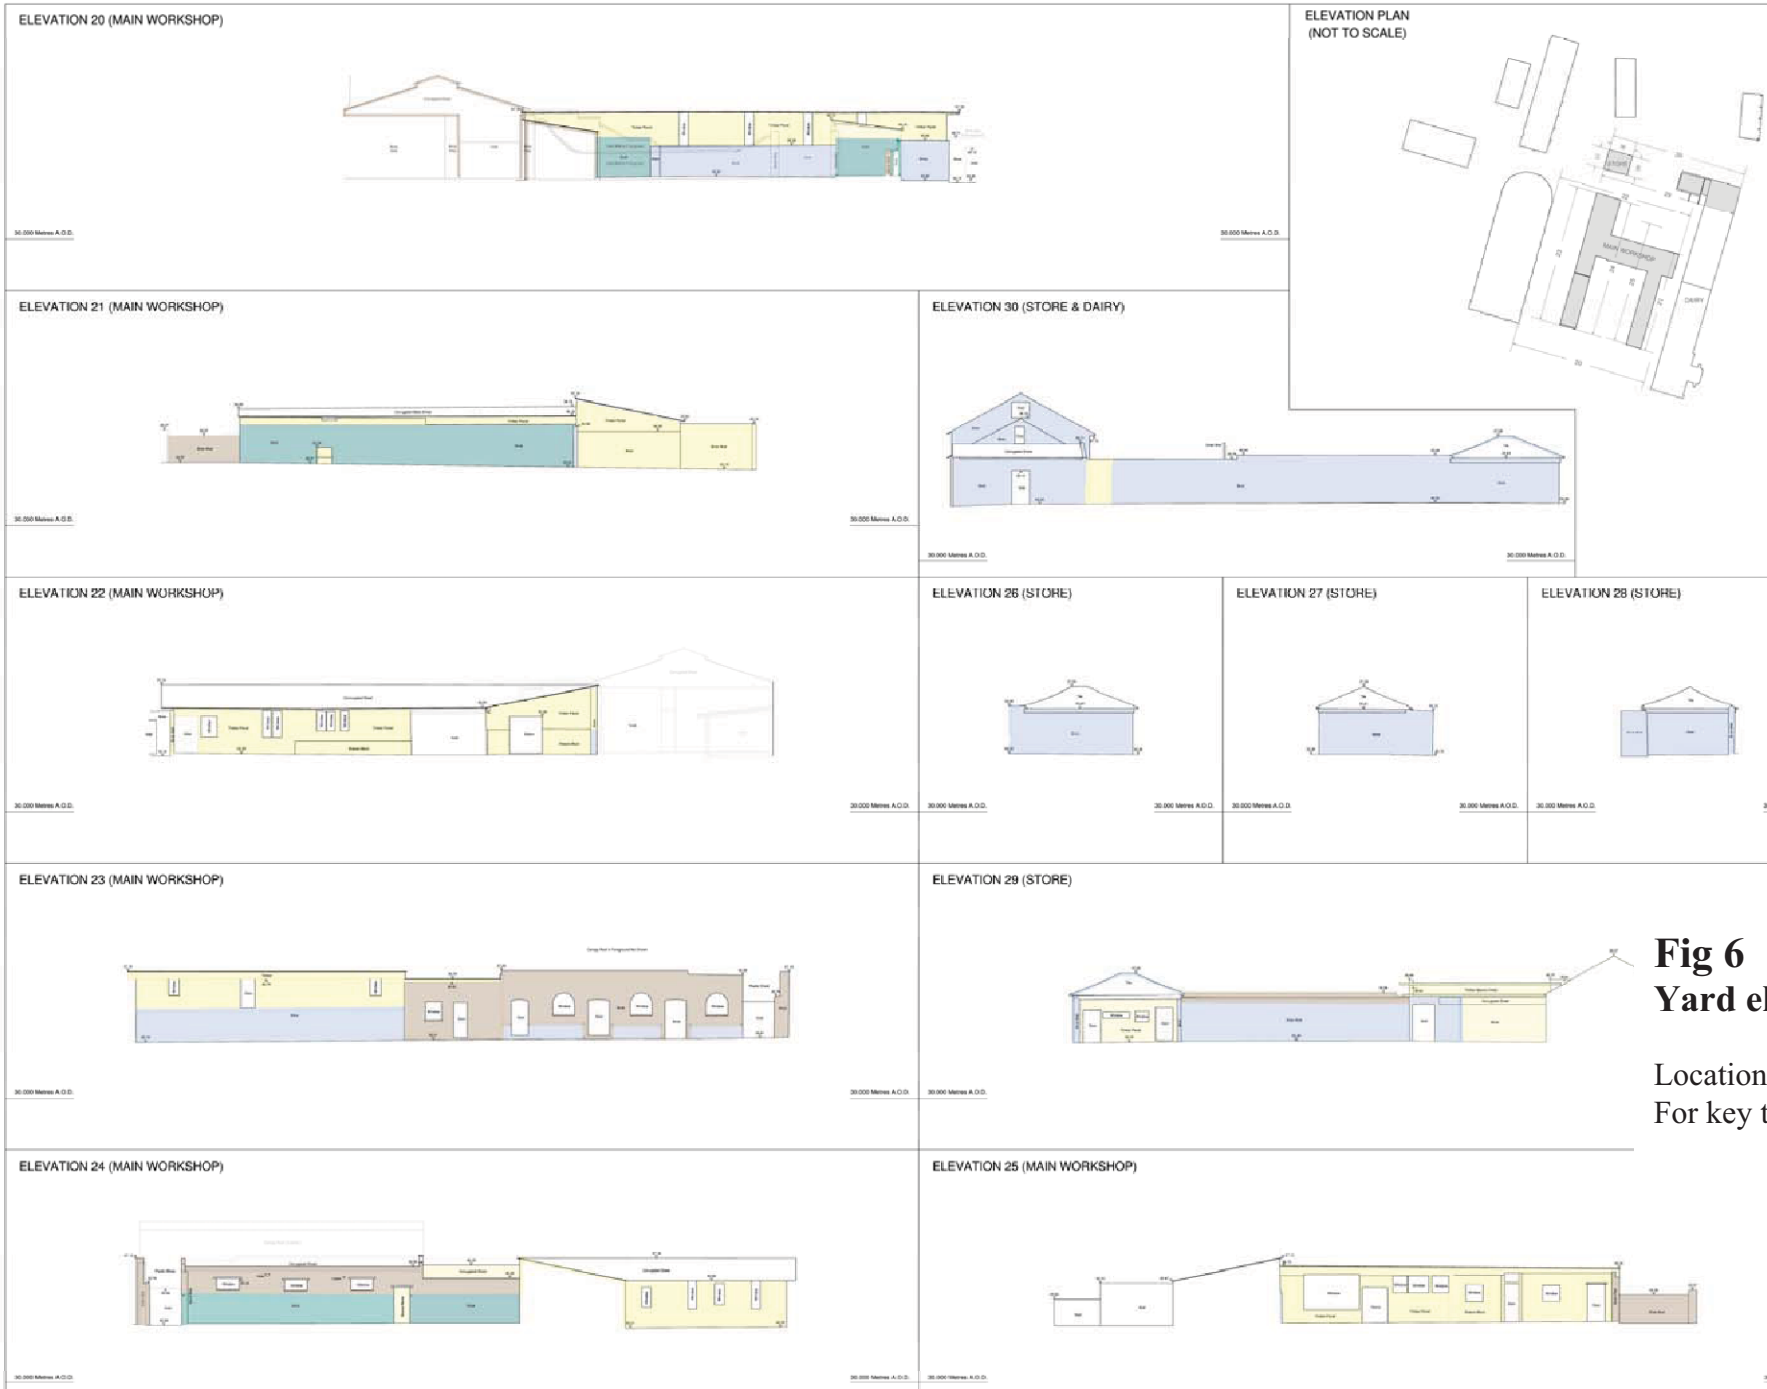
**Fig 6**  
**Yard elevations (3)**

Locations shown on key plan  
For key to phasing see Fig 2

On the east side of the riding house there is a part-covered yard with a pitched glazed roof extending halfway down the elevation. It is open to the north and has double gates at the south end set in a brick wall butted against the corner of the riding house. East of the gate the wall is ramped down and forms one side of a passageway leading to the service quarters in the main house. The south wall of an earlier court of service buildings to the north forms the other side. This has several builds; at the west end is the return wall of a range of buildings, largely Flemish bond brickwork on a brick and flint base. This has a straight joint to a boundary wall of brick and flint containing a blocked doorway and there is an inserted double gate at the east end. Beyond this the wall is heightened in brick to form the end of a 20th century outbuilding on the east side of the yard.

The building on the west side of this court backs onto the covered yard where the wall is flint-built to a height of c.0.5m and brick above. The southern end of the elevation has alternating doors and round-headed windows and there is a full height straight joint at the mid point (north of the gents' toilet). Beyond this the wall is banded brick and flint to a height of 1.5m and poor quality 20th century brickwork above. The wall terminates in a wide gateway into a second yard to the east. The building at the south end is used as a laundry and has modern interiors.

Inside the south courtyard the boundary wall has panels of tumbled flint and brickwork. This build standing c.1.6m high continues onto the west side where it has been heightened in Flemish bond brickwork to form the rear wall of the building described above; this has a monopitch 20th century roof of corrugated iron. The boundary wall continues to the north-west corner and returns along the north side where it is higher and has a rounded brick capping. The boarded rear wall of a wooden building in the yard to the north is set on top of it. A poor quality 20th century lean-to building, part wood, part blocks and part brick with a corrugated iron roof has been built in front of the east boundary wall which can be seen internally. The reverse of this wall is a uniform brick and flint build with a blocked arched doorway part way down.

The yard to the north has poor quality 20th century lean-to sheds built of lap-boarding and concrete blocks on the south and west sides stopping at the gate in the north-west corner. The rear wall of the building on the west side has been heightened in brick off an older boundary wall. In the angle north of the gate there is a small single-storied building with a hipped slated roof. It is open to the south but has an old brick east wall with a dentilled eaves course in bond with the north boundary wall. This is banded flint and brick and has been heightened by three courses with a rounded capping for a demolished lean-to building; there is a blocked doorway towards the mid point. A second similar building at the east end has original doors with segmental heads in the west and south walls and dentilled eaves to the west but has been heightened in 20th century brick to form a shallow monopitch roof and the east end was rebuilt at the same time.

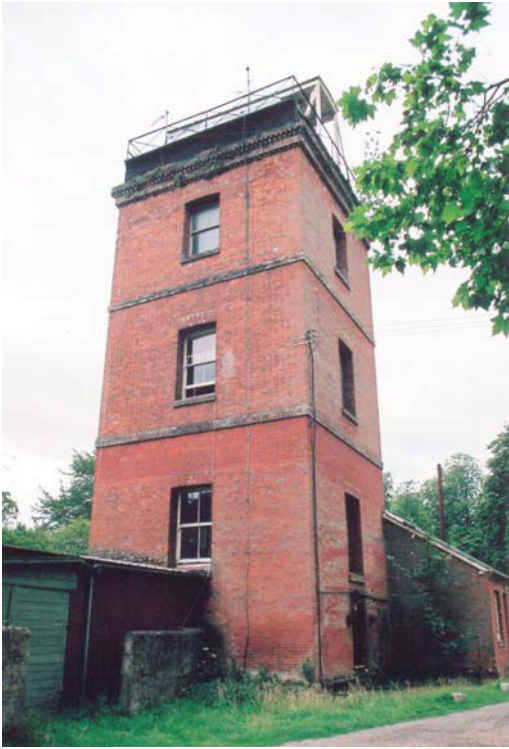
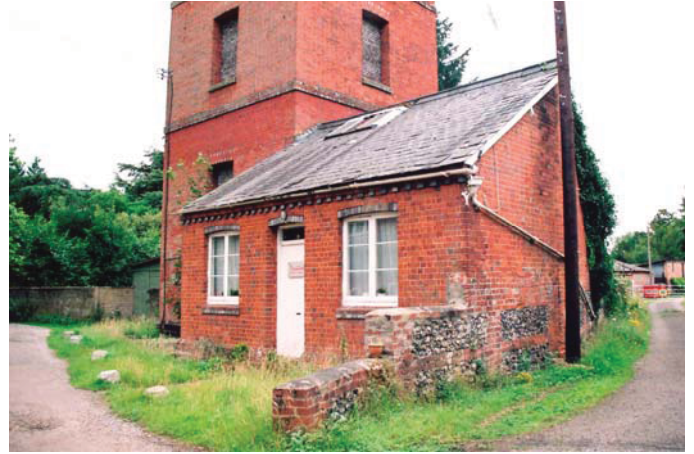
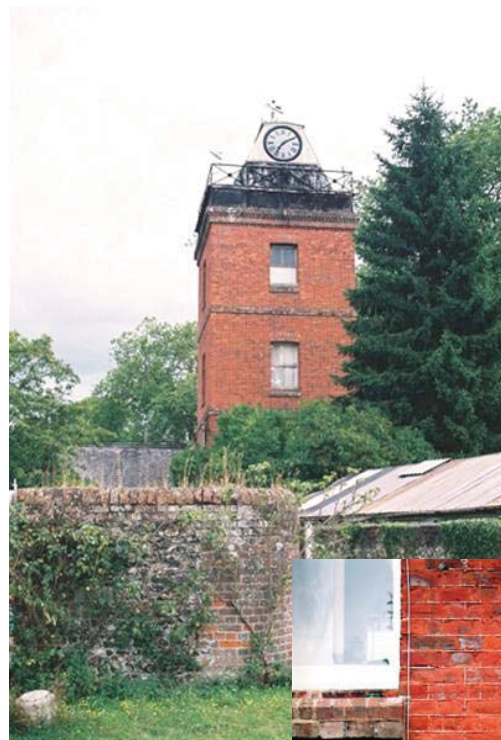
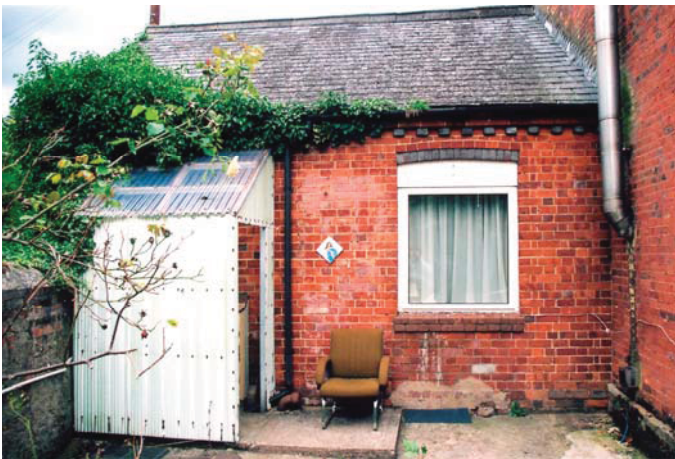
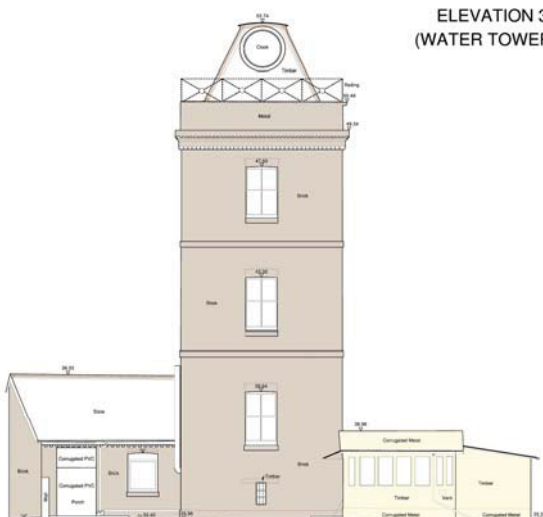
**Fig 8 Water tower (5)**  
(clockwise from top left)

- View from north-east
- View from north-west
- South elevation of tower
- Detail of tuck pointed brickwork
- South elevation (for key see Fig 2)
- South elevation of annexe

This lies some way to the north of the other buildings and consists of a square tower of three tall storeys with a single storey annexe to the west and a boarded extension to the east. It is built of hard red bricks in Flemish bond with tuck-pointed joints and traces of red colourwash. Each stage has a string course at storey height and a single central four-light sash window; on the side elevations some of these are blind. The top of the wall has two offset dentil courses below the iron tank which is surmounted by a balustrade and a steeply-pitched lead roof with a clock face capped by a weather vane. The annexe is built in the same style, incorporating an earlier boundary wall at the west end and it has a central door in the north elevation. The interior was not inspected.

This building is shown on the Ordnance Survey map surveyed in 1875 and stylistically is a later 19th century building. It is not mentioned in the 1853 sale particulars and must be one of the Mackenzie's improvements, combining a functional water storage tank for a new borehole with an ornamental clock tower. The annexe to the west is contemporary and the wooden structure to the east 20th century. The building has undergone minimal later alteration externally.

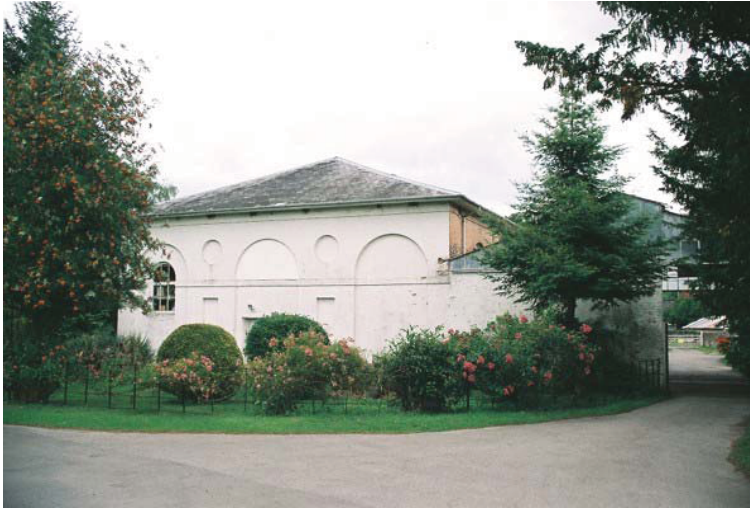
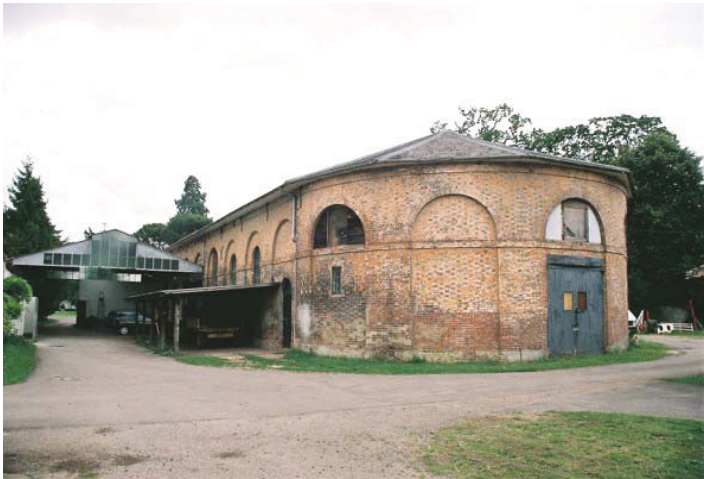
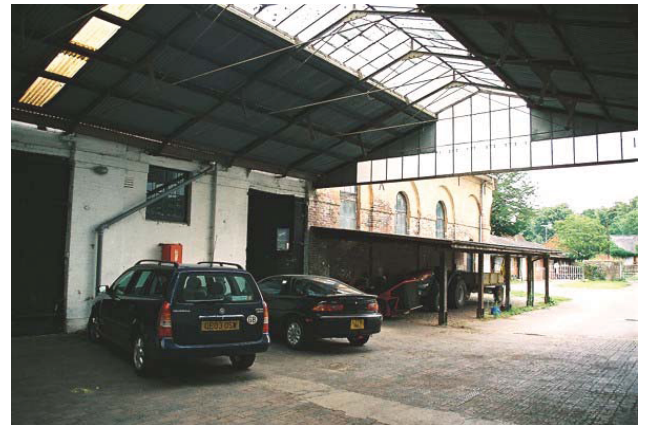
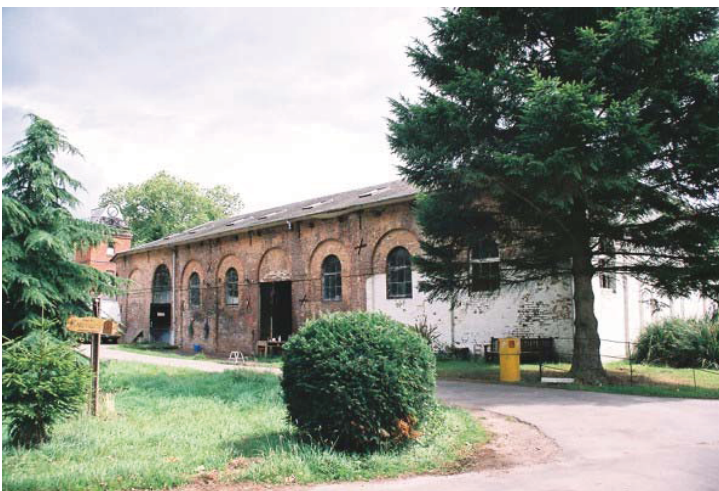
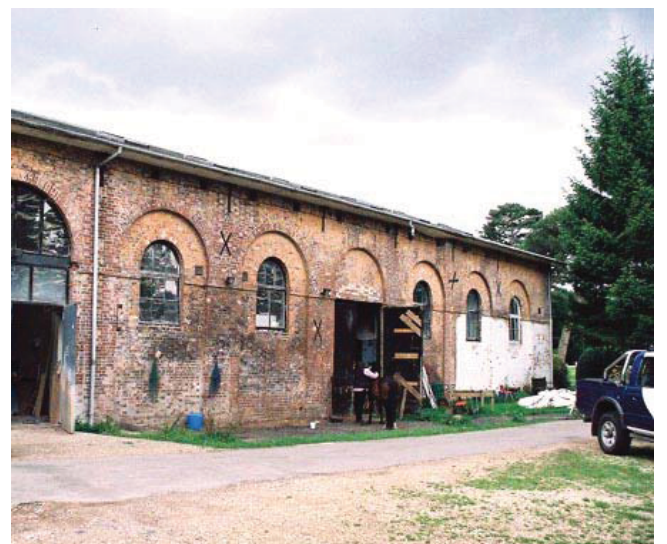
**Fig 9 Riding house (1)**  
(clockwise from top left)

South elevation

East elevation under covered yard

West elevation from north-west

West elevation from south-west

View from north

This is a long rectangular building with an apsidal north end. It is built of brick in Flemish bond with vitrified headers and has a low-pitched hipped Welsh slate roof with overhanging eaves. It consists of a single tall storey and the elevations have a continuous shallow blind arcade of round-headed arches with a plinth, a string band at impost level and another below the eaves. The south end elevation has three bays with blind rectangular recesses surmounted by roundels in the intervening piers. The east arcade is blind; the centre has a modern door and a boarded window in the arch above the string; the west has a symmetrically inset arched window of nine lights with narrow glazing bars. The whole elevation is whitewashed. A later screen wall is butted against the east end.

The west elevation has eight bays to the turn of the apse; bays 1-3 and 5-6 from the south end have inset arched windows, bay 4 has double doors below a blind arch, bay 7 is open with modern doors and glazing and bay 8 is blind. Under the eaves there is an irregular row of small square ventilators; these are not original as they are cut through the offset eaves band. The first apse bay has a boarded lunette window and a small rectangular secondary window at a lower level; the next has a modern door and the north end bay a blocked top light with double doors below under a curved lintel of vitrified bricks. To the east the next is blind and the last in the apse mirrors the first.

The east elevation has been painted cream and has the roofs of the adjoining covered yard and cart-shed butted against it. There are double doors in bays 1, 2 and 4 from the south end, inset arched windows in bays 6 and 7, later secondary windows in bays 3 and 5 and a doorway with an arched head in bay 8.

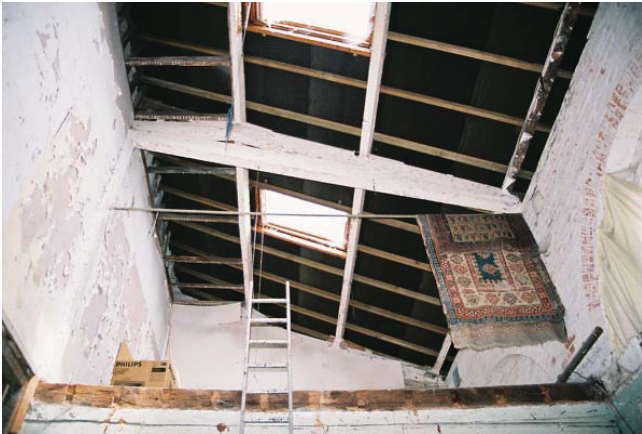
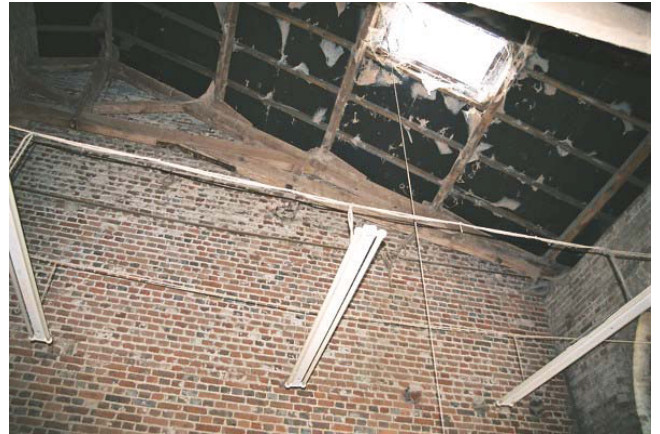
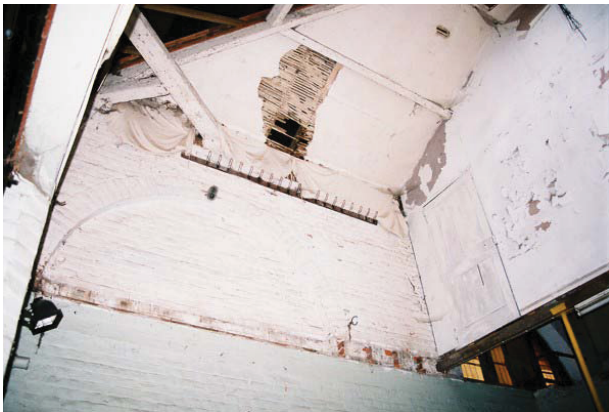
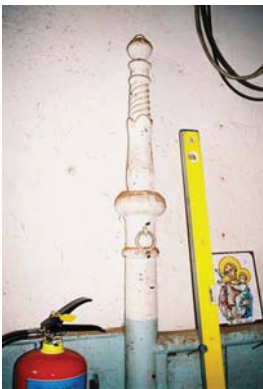
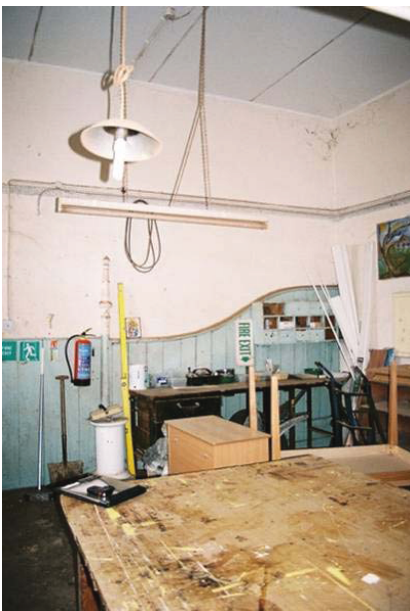
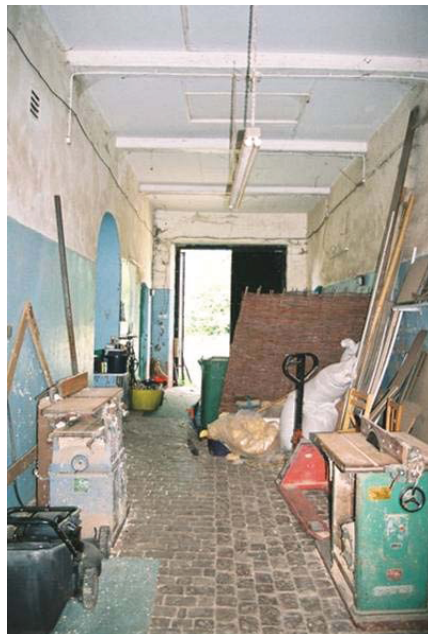
**Fig 10 Riding house (1)  
Interiors**

Roof truss at south end

Roof truss at north end

Roof truss looking into apse, north end

Cross passage looking west

Stable with boarded partition in end wall

Detail of stall finial

South wall showing former first floor

The interior is subdivided and largely ceiled. It is divided by a transverse passage in bay 4 and the space to the north is further subdivided by an off-centre longitudinal brick wall in English bond which is exposed in the room to the north-west used as a workshop. A second brick wall closes off the apse which has a ceiled room on the ground floor and is open to the roof structure above. Three pine roof trusses are visible; these have strutted kingposts with jowled heads set on a collar braced from below with long straight diagonal ties running to the wall plates. The joints were later strapped with iron. There is a ridge board morticed into the top of the king post and two tiers of edge-set purlins mounted on the backs of the principals. The north truss has been cut and there is an RSJ inserted underneath; there is an inserted tie beam below the next truss and the remains of a boarded partition. The external walls are bare limewashed brickwork.

The adjoining room to the east is a stable with plastered walls and ceiling. Stall partitions are built into the end walls. These are vertically boarded with curved top rails and ornamental cast iron finials. There is a wide panelled door with a segmentally arched head to the central passage and another of the same type at the west end; this leads into another stable with further partitions. The passage is paved with square setts and there are doors of the same type in the south wall. A small plain room at the east end has a fireplace and there is another stable to the west (not seen) separated by an internal passage running south. The south-east corner has been converted to a garage and there are traces of first floor rooms with lath and plaster partitions. Two more king post trusses are visible.

The building in its present form has been subdivided into a series of stables and other rooms opening off a central passage. The partition walls are built of a similar brick to the original construction and the insertion of new doors and windows of this period is carefully done so that it is difficult to distinguish the secondary work from the original, particularly beneath later paint and colourwashes. This conversion must have taken place when the earlier ranges of stables (Fig 3) to the south were demolished and the fabric indicates a date in the first half of the 19th century. The description in the 1853 sale particulars suggests that these alterations had taken place by then and makes no mention of a separate riding house or equivalent building although the accompanying plan shows the older arrangement. It was probably copied directly from the undated early 19th century estate map (Fig 1) which also seems to have

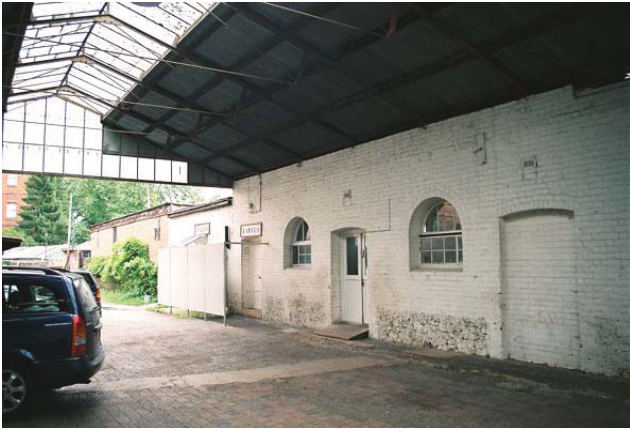
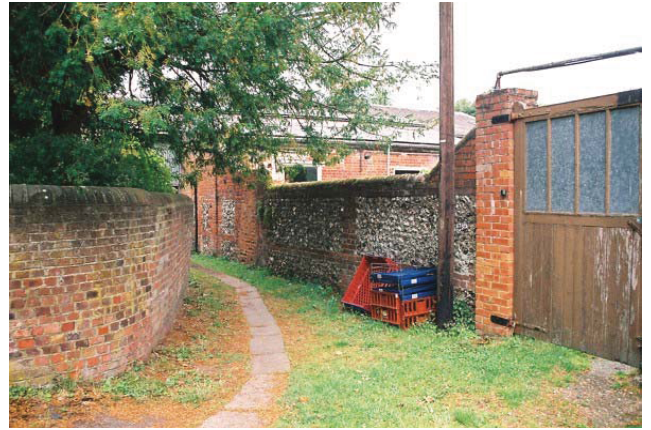
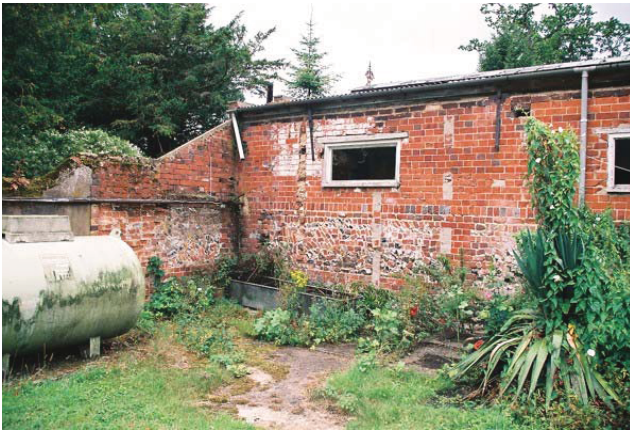
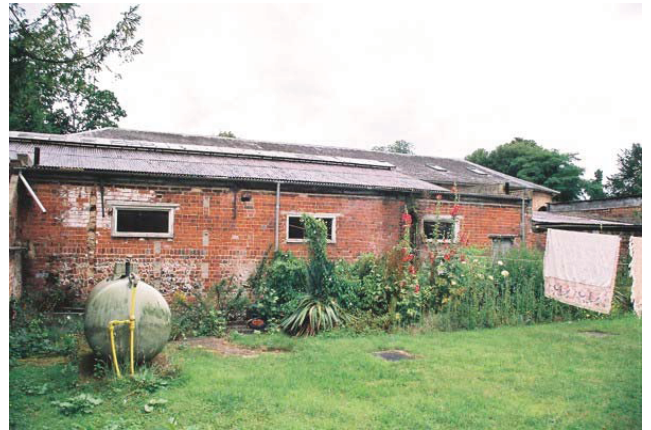
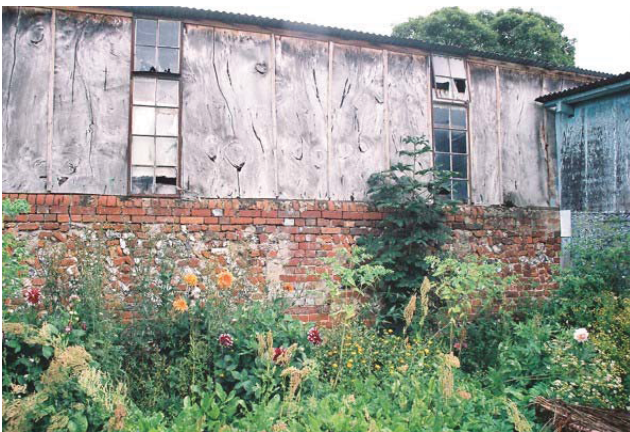
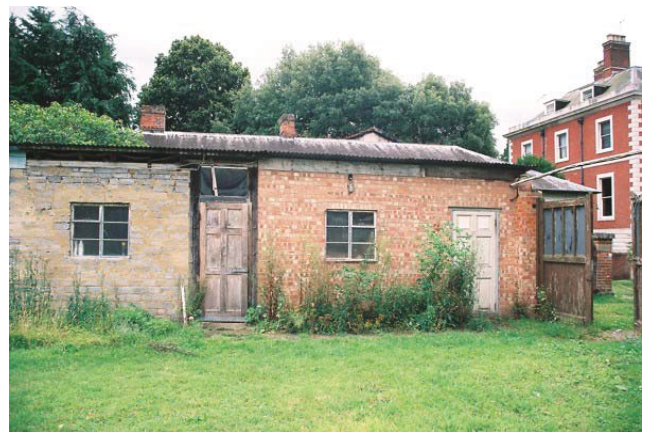
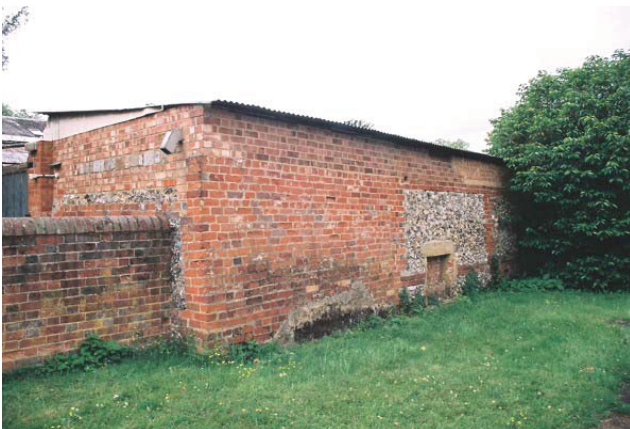
**Fig 11 South Yard (3)**

West wall from south-west in covered yard

Passage along external south wall looking west

East elevation of building on west side

West elevation of building on east side

External south-east corner

North wall, south elevation

Internal south-west corner

The yard to the south appears to be later and is not as wide. All three walls were originally free-standing without attached buildings and have distinctive tumbled brick and flint panels internally. The lean-to on the east side is 20th century and the gate in the south-east corner is secondary. The narrow range on the west side is built up off the boundary wall and dates to the later 19th century. It fronts onto the covered yard where the wall is also built off earlier foundations; this may be the remnants of the attached range on the east side of the riding house shown on the early 19th century maps.

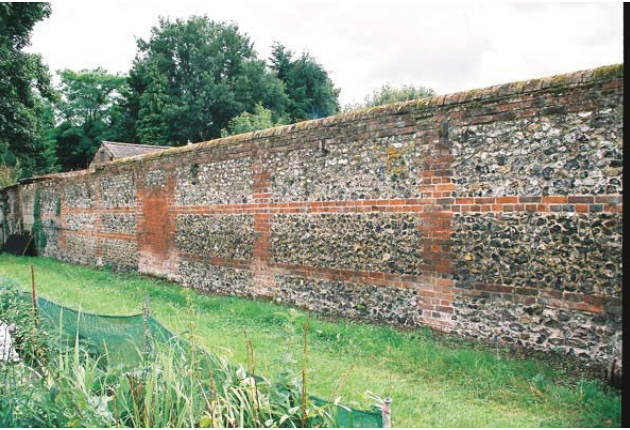
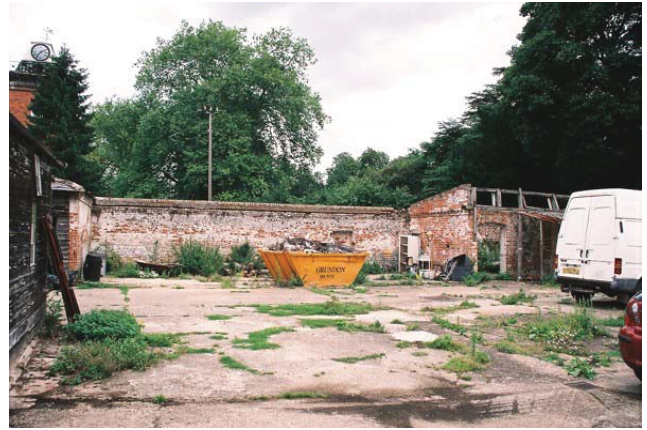
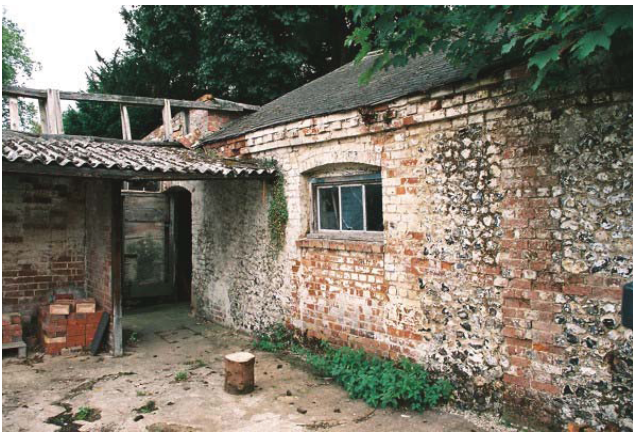
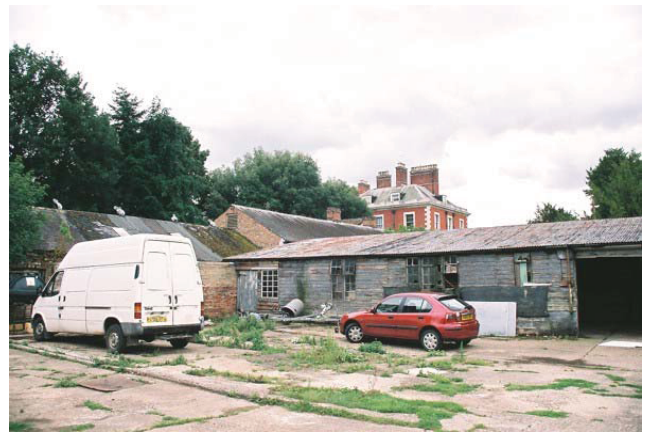
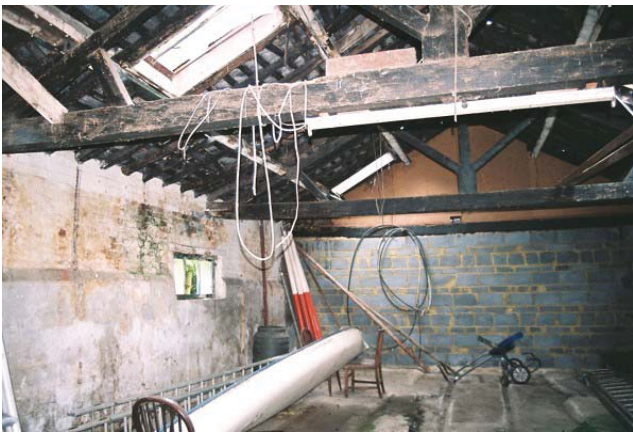
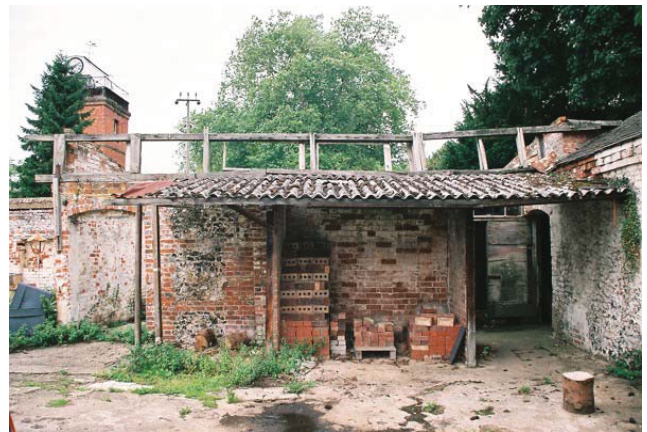
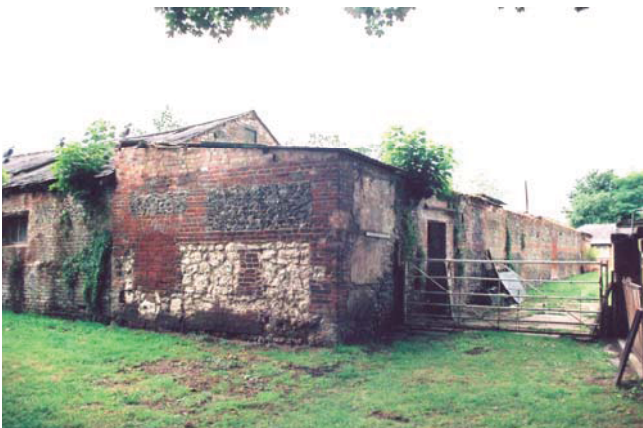
**Fig 12 North Yard (3)**  
(clockwise from top left)

- Exterior of north wall
- South elevation of north wall
- View looking south-east
- Building in north-east corner
- External north-east corner
- Interior of store at north end of dairy range looking south
- North end of dairy range west elevation looking north-east

The structural evidence indicates that there were two conjoined yards in the space between the riding house to the west and the dairy range to the east. The north wall of the northern yard and the two attached buildings at either end are of a piece with the rebuilt north end of the dairy range, the west wall in its lower stages is contemporary and so is the south wall. The buildings on the south and west sides of the yard are 20th century, utilising these older boundary walls.

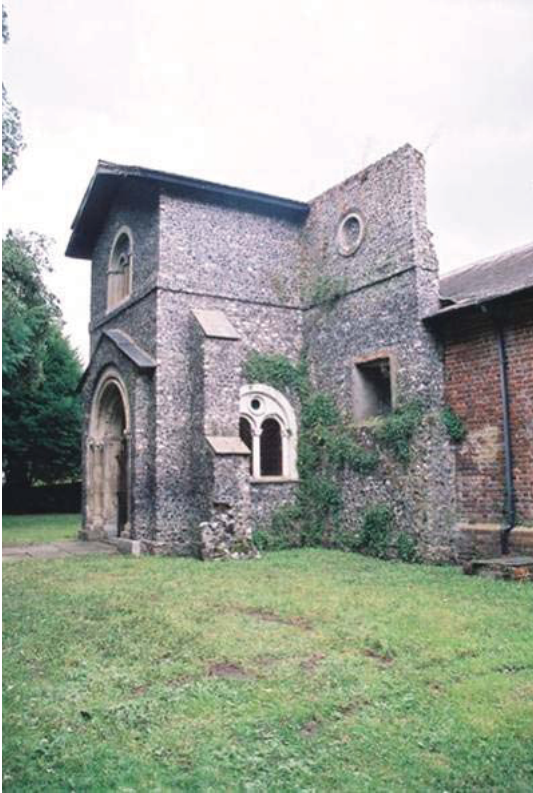
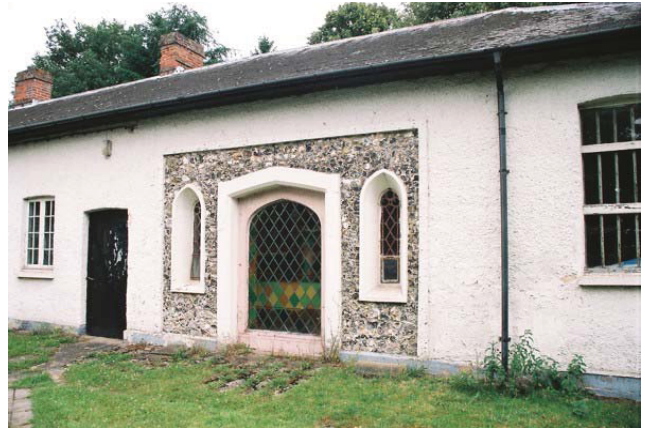
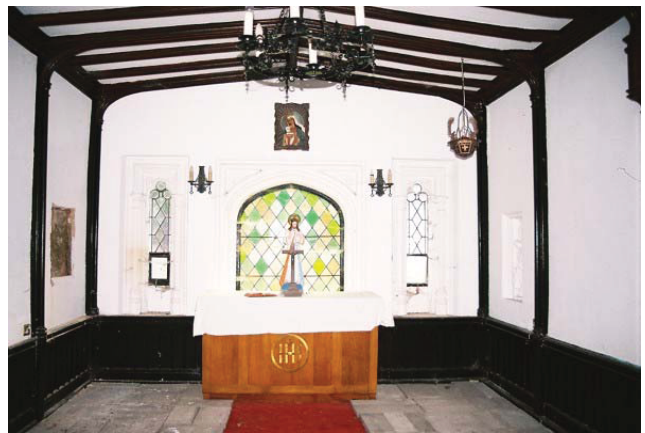
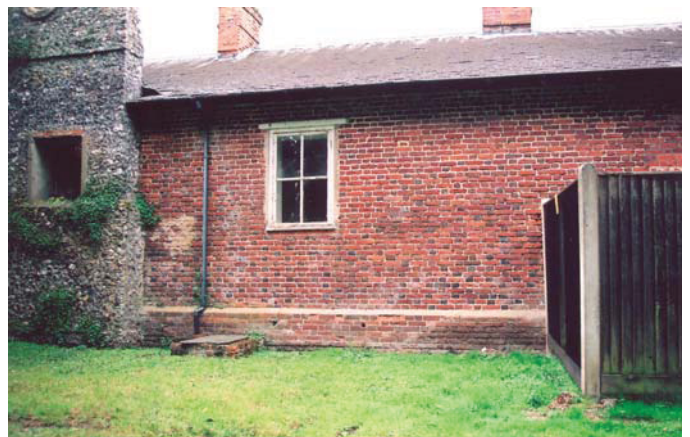
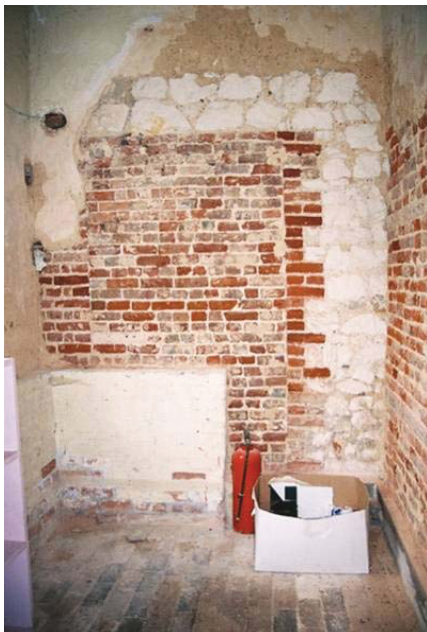
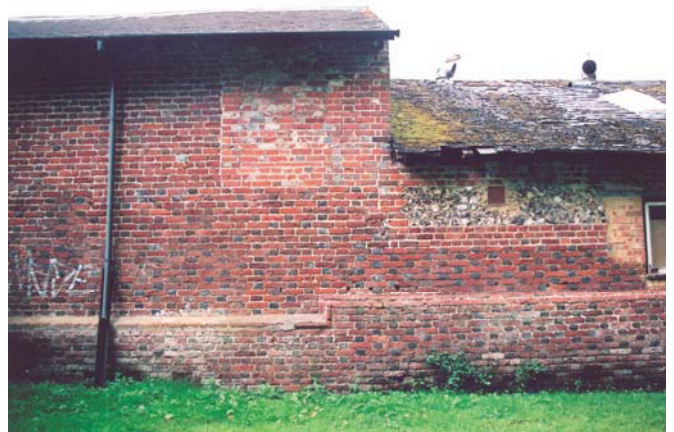
**Fig 13 Dairy range (4)**  
(clockwise from above)

Gothic porch to chapel with Norman doorway, from north  
West elevation of chapel  
Chapel interior looking west  
Junction of flint façade and brick wall east elevation  
Late 17th century brick wall with plinth, upper courses to right rebuilt in 18th century  
South wall of chapel (reverse) showing blocked door

The west elevation overlooks the pleasure garden and has a knapped flint garden facade in gothic style at its south end fronting the former dairy. It is two storeys high with plinth and string courses and a projecting central porch under an overhanging shallow-pitched tiled roof. This has a reset 12th century doorway of two orders with beak-head ornament on the inner arch, said to come from Hart Street, Henley (Tyack 1982, 141). At first floor level there is a blind ashlar two-light window in Romanesque style with a semi-circular head and there are similar wooden windows in the side walls which also have two-stage buttresses. The screen walls to either side are blind with recessed roundels in the top stage; one of these is filled with a 20th century mosaic. A 20th century window has been cut into the north screen wall. This façade stands proud of the roof to the main range and the reverse of the porch is boarded with two dove holes.

The chapel has a plastered porch with an inner four-centred arch. The main room has a wooden dado with arched panels; pairs of clustered colonnettes rise from this to a four-centred vault with wooden ribs in Tudor gothic style. The central east window is formed from a Perpendicular doorway with roll mouldings and foliate spandrels and is flanked by a pair of trefoiled side windows with an outer order of colonnettes. These are said to come from Crosby Hall in Bishopsgate, one of the Freemans' London properties (Tyack 1982, 130). A niche inside the door is also reused medieval work.

The Gothic façade appears to have been built by Strickland Freeman c.1800 to incorporate a Romanesque doorway brought from Hart Street in Henley (Climenson 1899, 89; Tyack 1982, 141, fn.86) and other reused architectural elements. Neither of the early 19th century maps appears to show this range very accurately; the porch to the dairy seems too far north and the north end is shown as significantly wider on the west side, which does not accord with the structural evidence. In 1853 the range was described as housing the meat and game larders, gothic dairy and dairy scullery, laundry, wash-house, brew-house. The late 19th century maps show the range in its present form and in 1952 it was described as ‘a block of roughcast and slated buildings, consisting of the former chapel, the dairy and the audit room, together with a room used by the Southern Electricity Board as a sub-station’.

The structural sequence indicates that the east wall is the oldest part of the range; the plinth and style of brickwork suggest that it is one of the original late 17th century outbuildings. The south partition wall of the dairy/chapel (exposed on the south side) appears to be contemporary; other subdivisions have later finishes. The corresponding west wall is hidden by render and its date is unknown but the northern half of the range is a uniform brick and flint build of 18th century date; this includes the north end bay and the upper part of the east wall, rebuilt on an older base. The centre of the range includes two chimney stacks, consistent with its former laundry and brewhouse functions. The range appears to have been re-roofed in the 19th century and the former laundry converted into a meeting room with a large fireplace in the late 19th century; this may be the audit room. The Gothic dairy was converted to a chapel although it is not certain when this took place. It appears to pre-date the acquisition of the house by the Marian Brothers as the Tudor Gothic woodwork of the vaulted ceiling seems later 19th century in style and the 1952 sale particulars refer to a former chapel.
