SAINT MARY'S CHURCH, NORTH MARSTON
BUCKINGHAMSHIRE

REPORT FOR AN
ARCHAEOLOGICAL WATCHING BRIEF

Report no. 351

March 2006

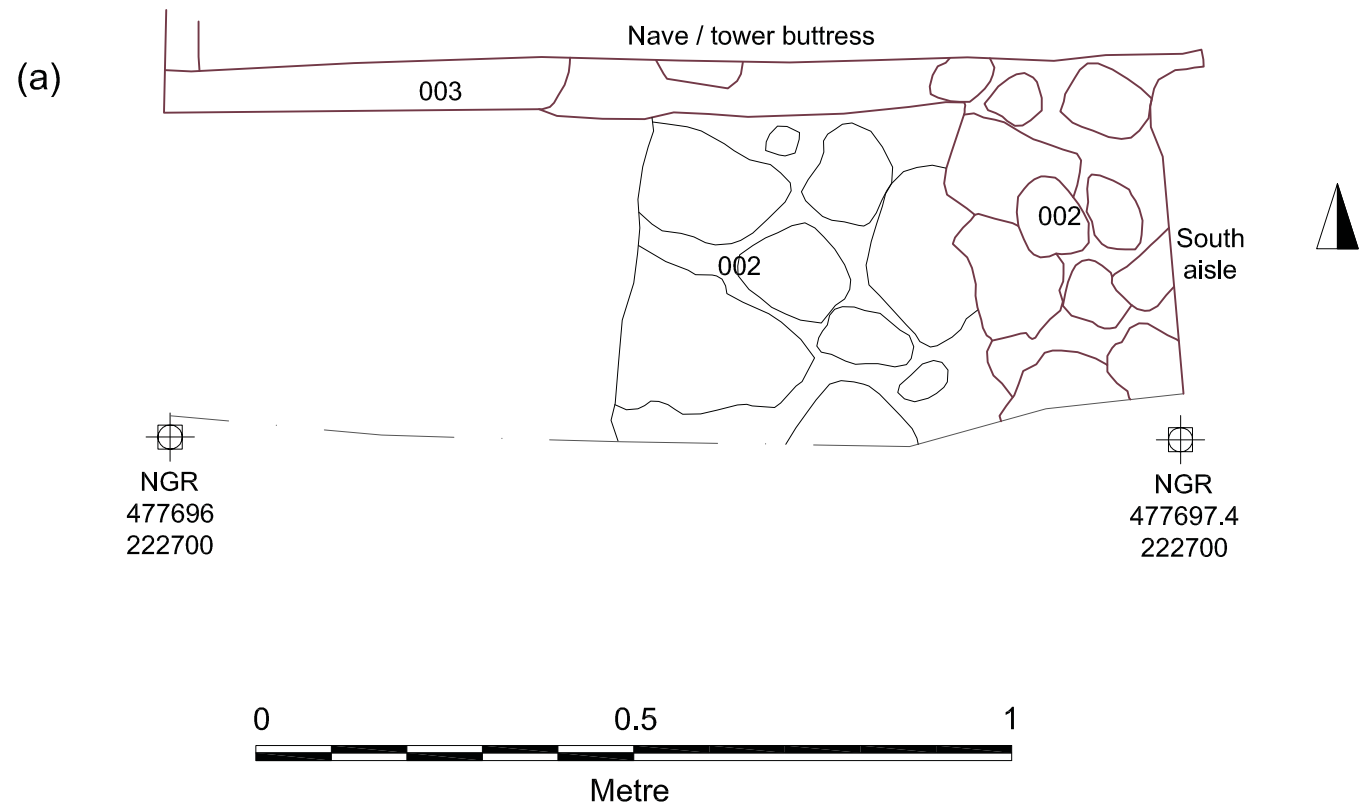
A concentration of limestone rubble, 002, with an orange-brown gritty clay mortar was revealed at the south-east corner of the tower (Figure 3). The rubble continued under buttresses 003 and 005, varying from 0.15m to 0.23m wide. The topsoil, 001, revealed a small quantity of early medieval and post medieval pottery and ceramic building material (CBM), as well as window glass, animal bone and a fragment of a human jaw.

The limestone rubble observed in context 002 predated the buttress footings (003) and both the north-west and south-east tower buttresses and walls (004 and 005). The rubble clearly ran underneath these structures, while under the western wall of the south aisle, the rubble appears to have been cut away. As no datable finds were recovered from these contexts to distinguish them from the building of the tower, it is assumed that the rubble deposits formed part of the stabilising or levelling for the south aisle and tower construction sometime between the 14th and 15th centuries.

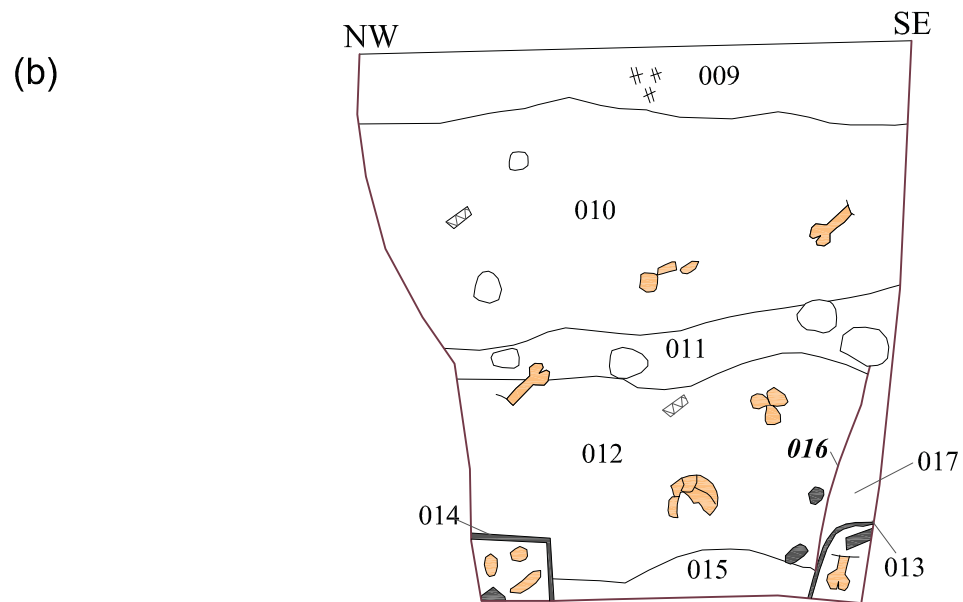
Several layers of disturbed soil were revealed during the excavation of the new soakaway, which was located c.6m north-west of the tower. The subsoil 010 revealed disarticulated human bones; long bones and skull fragments (charnel) were most numerous, but small amounts of rib bones and metatarsal or metacarpal bones were also observed. This layer contained a modest amount of early medieval to early modern pottery, glass and a stone marble.

Layer 011 was compact clay containing a large amount of small to medium sized limestone fragments. Disarticulated human bone fragments were recovered from this context, again displaying a higher percentage of charnel bones than other bone types. Other human bones included three vertebrae, a small number of teeth and metatarsal or metacarpal and a small humerus bone. Medieval to post-medieval pottery and CBM, clay pipe and two probable coffin nails were also recovered. More disturbed human remains were encountered in context 012, along with early to late medieval pottery and CBM, post medieval CBM, clay pipe, animal bone and more glass.

At the base of the soakaway were the waterlogged remains of two wooden coffins (NGR 477687 222713). Both coffins were oriented east to west, and the remains in coffin 014 were oriented with the skull to the east and appear to have been disturbed. A nail was recovered from the fill of this coffin. The second coffin, 013, was located approximately 0.65m to the east of coffin 014 and had collapsed but revealed what appeared to be the condyle end of a femur protruding from the section. The remains of this inhumation appear to have been oriented with the head to the east. A possible grave cut 016, although very faint was observed for this burial.

The top of the first and second coffins lay 1.3m and 1.26m respectively below the present ground surface.
