**LAND BEHIND 12 WRAGBY ROAD,
BARDNEY, LINCS**

Scheme of Archaeological Works

Report Number: 582

September 2011

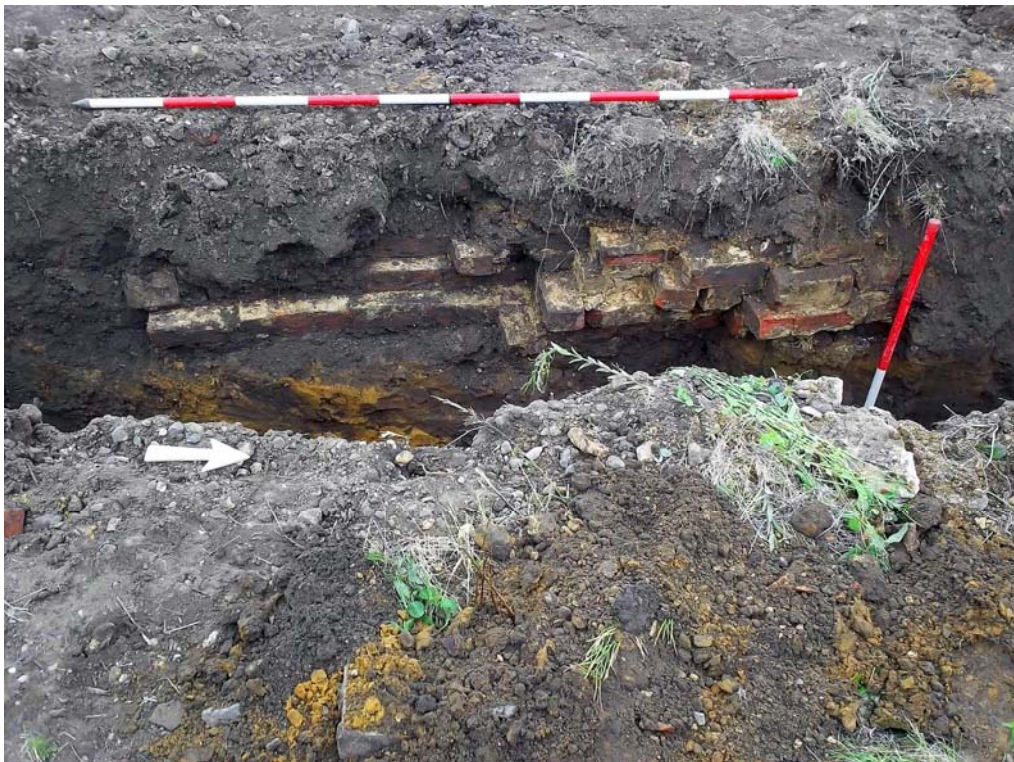
Plate 2: Plot 1, Wall 102

Located in the eastern part of Plot 1, wall **102** had a visible length of at least 3.3m, and was over 0.4m wide (Plate 2). This wall was built from unfrosted bricks that were bound by a soft brownish yellow sandy mortar. Wall **102** ran on a north-to-south alignment; this orientation, as well as the position of **102**, matched a wall scar visible on the back of the extant structure of 12 Wragby Road, located just to the north (Plate 3). It is therefore probable that wall **102** is the demolished remains of a former extension or outbuilding attached to 12 Wragby Road, and a 19th-century date seems likely.

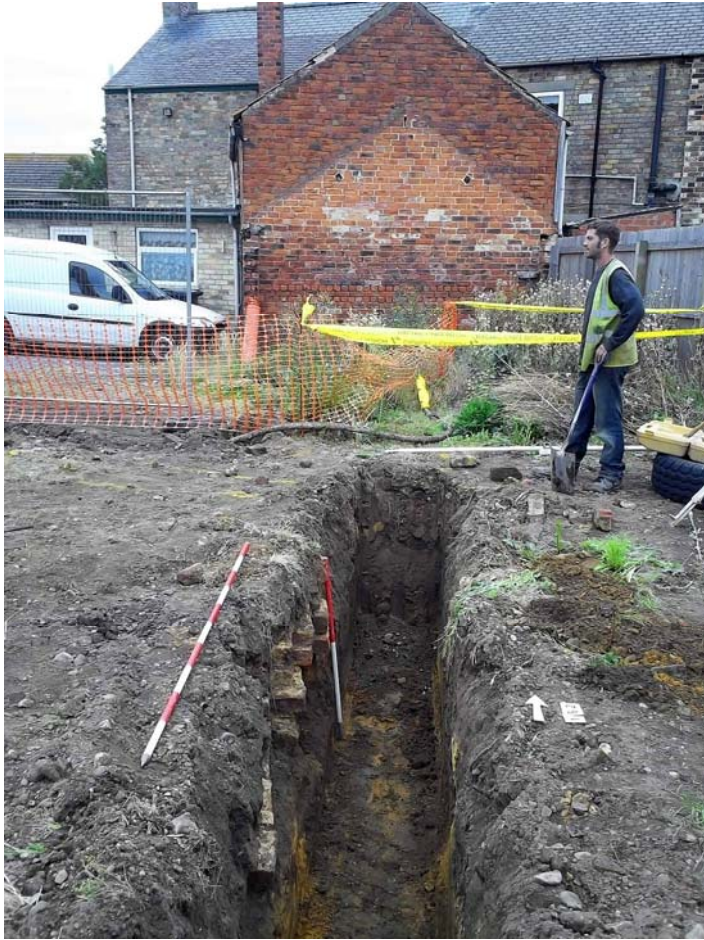
Plate 3: Wall 102, showing alignment with wall scar on standing building

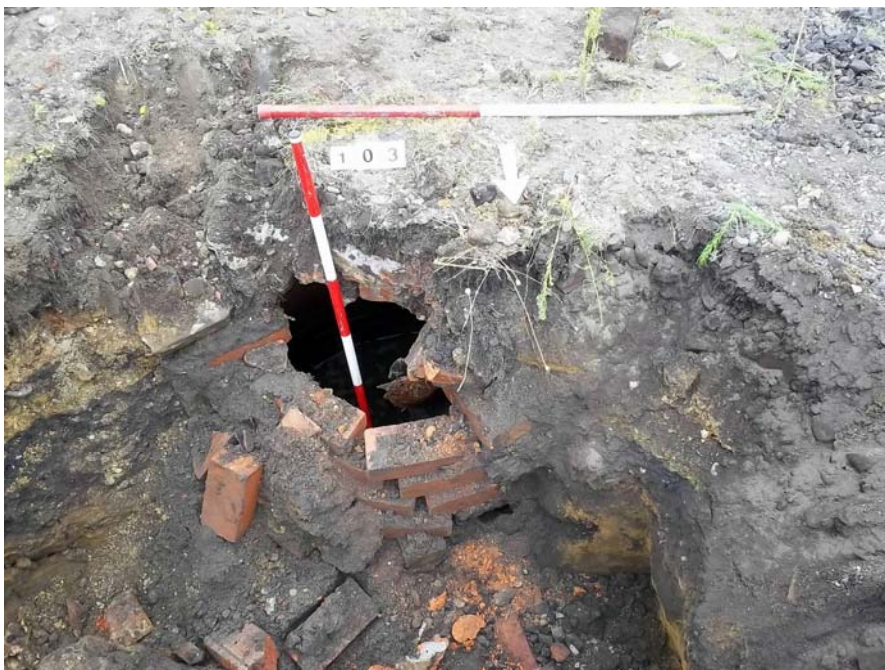
Plate 4: Plot 1, Well 103 as first found

A little to the west of wall **102**, well (**103**) was revealed in the sides of the foundation trenches (Plates 4 and 5). Well **103** was also brick-built, measured 1m in diameter, and was at least 1.7m deep. It was built from both frosted and unfrosted bricks and had been capped by corrugated iron and a pour of concrete. The well contained at least 0.5m of standing water when it was first found. This was later pumped out, to reveal brick and mortar rubble filling the base, along with an iron shovel head. This material was presumably dumped into the well shortly before it was decommissioned. Following recording, the well was entirely removed for reasons of structural stability.

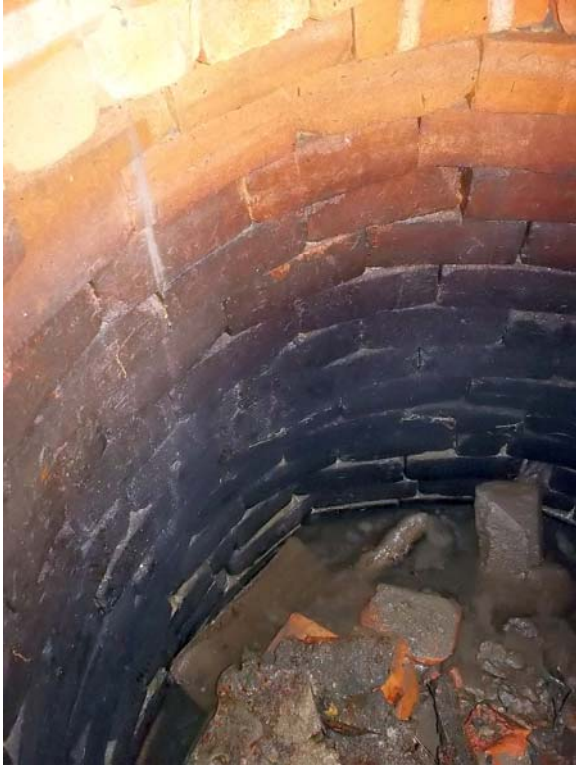
Plate 5: Well **103** after pumping, shovel visible in the base

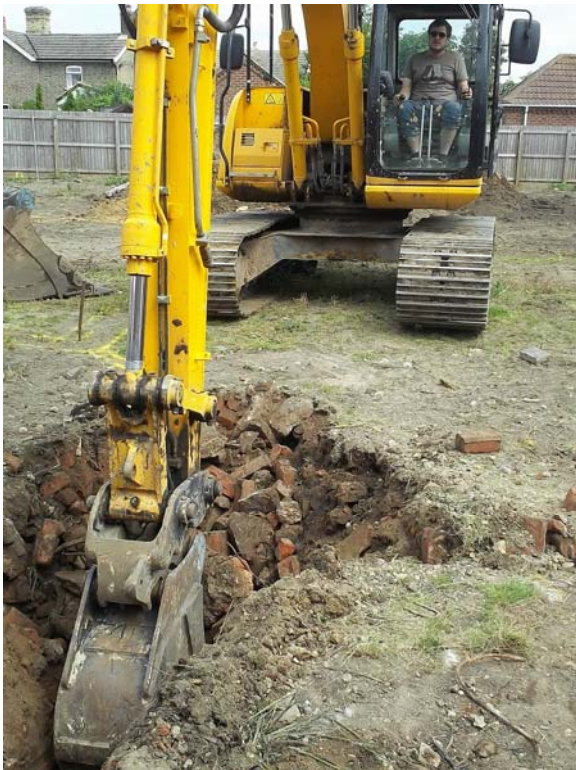
Plate 6: Plot 2, rubbly fill of **202**, as first encountered

Within Plot 2, natural material appeared as fine golden brown sand (201), again found at varying depths below the current ground surface. A modern structure, **202**, was found running through the middle of Plot 2; this had heavily disturbed the ground hereabouts. Structure **202** was a brick-lined slot that measured over 10.5m in length, 1.5m in width, and 1.1m in depth. It had been set below the ground surface, and its internal walls were plastered smooth with two coats of mortar rendering (Plate 7). Although the base of this structure could not be seen (due to waterlogging), the driver of the mechanical excavator reported that it probably consisted of concrete, due to the resistance it provided. Structure **202** had been backfilled with a large mass of bricks, concrete rubble and scrap iron (Plates 6 and 7). The likeliest interpretation for structure **202** is that it represented the remains of a vehicle inspection pit. Due to its considerable length, it is likely to have been built for heavy goods vehicles or agricultural trailers.

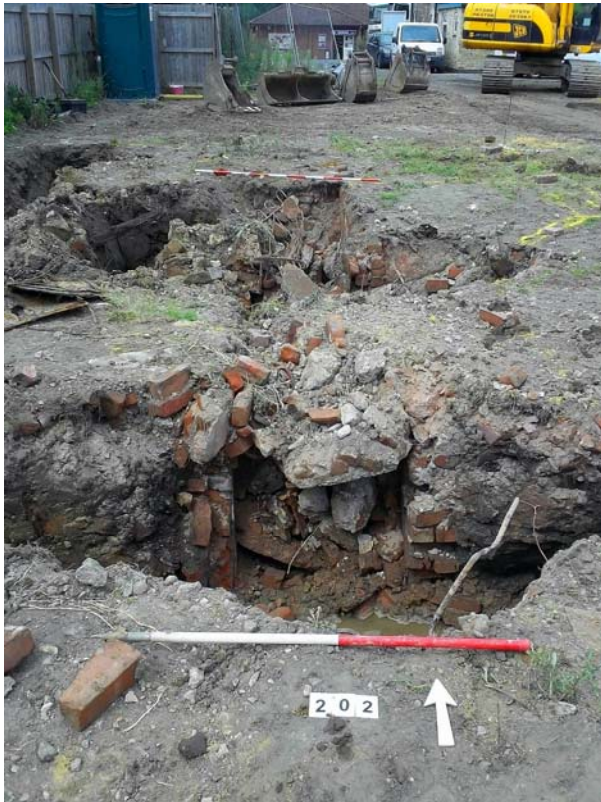
Plate 7: Plot 2, probable vehicle inspection pit **202**

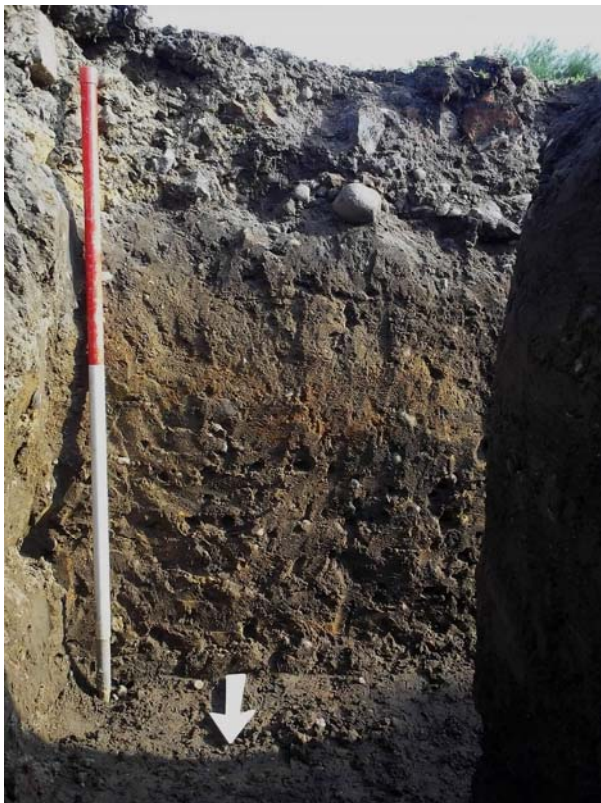
Plate 8: deposits visible in Plot 2

To the east of vehicle inspection pit **202**, the following sequence was recorded (Plate 8): the fine golden brown natural sand was overlain by 208, a 0.5m-thick deposit of soft, wet brownish grey sand; this was sealed by 209, a 0.2m-thick deposit of friable mixed grey and orange brown sand. This was in turn sealed by 210, a 0.18m-thick deposit of friable grey silty sand. Sandwiched immediately between this and the topsoil lay 211, a 0.09m-thick deposit of dark brownish grey friable sandy silt containing noticeable amounts of charcoal. The character of these deposits indicated that they represented fluvial sand, although the presence of post-medieval pottery and fragments of brick and tile throughout the sequence suggests that the material was redeposited relatively recently. A sherd of a glazed red earthenware bowl, dated to the 16th to 17th centuries (Appendix C), was retrieved from deposit 208, the lowest deposit, and so provides a *terminus post quem* for the rest of the sequence. The bands of colouring within the section, by which different context numbers were allocated, may represent weathering horizons within what is essentially the same material. An exception is deposit 211: the very dark colouration of this deposit, and the presence of charcoal and other material within it, suggests that it is occupation-related, perhaps a former yard or other crude ground surface.

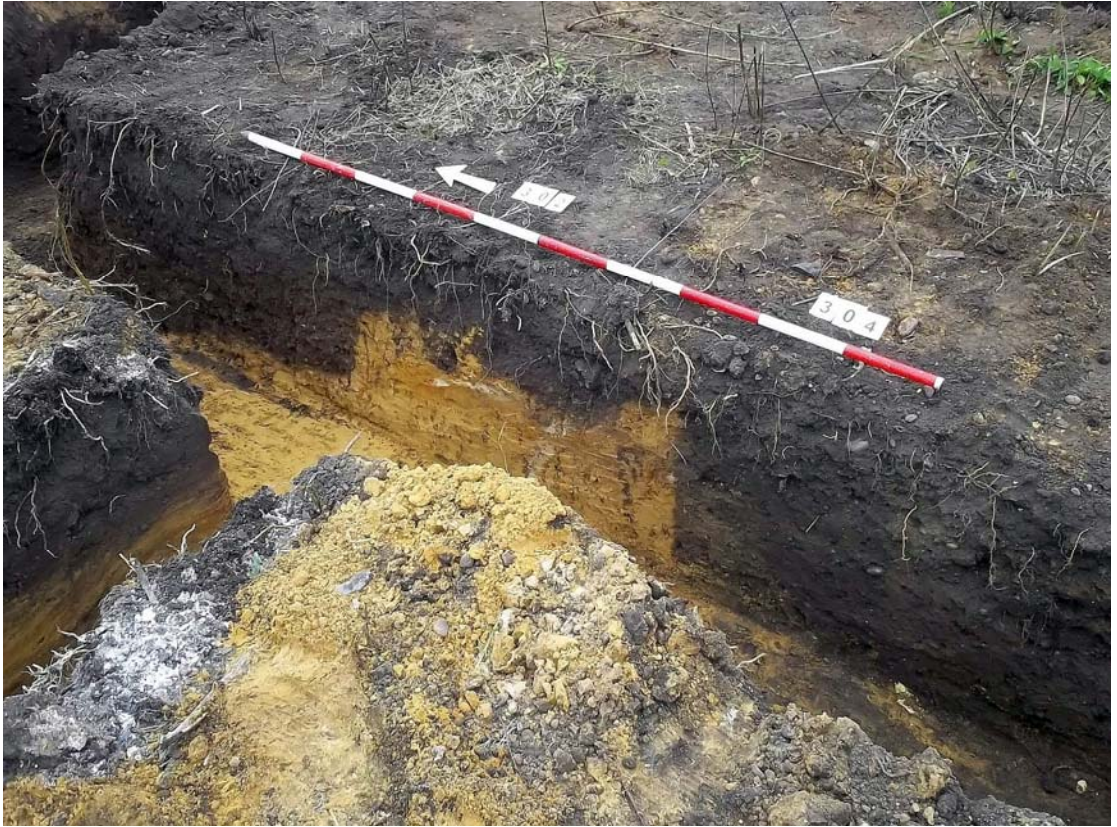
Plate 9: Plot 3, cuts 302 and 304

The smaller of the two cut features, **302**, measured at least 5m long, 2.5m wide and at least 0.4m deep. It was filled with a single fill, *303*, which was a friable brown silty sand containing frequent gravel inclusions. The function of this feature is unknown; it may represent either a pit, or some sort of truncation event, perhaps as part of a programme of recent landscaping.

To the south of **302** lay the larger feature, **304**. This was at least 9m in length; its full width could not be established within the available excavation area. Where photographed adjacent to **302** (Plate 9), this feature was relatively shallow; however, it became much deeper to the south and west, reaching 1.2m deep (Plate 10). The primary fill, *308*, was a 0.38m thick deposit of soft and wet light brownish grey silty sand. Mid-18th to 19th-century pottery was recovered from within this context, towards the upper surface (Appendix C). This material was sealed by *309*, a 0.2m-thick layer of soft and wet dark brownish grey silt, which was found to contain 19th to 20th century pottery and glass (Appendices C and D). This was in turn overlain by a 0.18m thick band of friable yellowish brown sandy silt: *307*. Overlying this was *305*, a 0.1m layer of gravelly, brown silty sand. Finally, this was sealed by *306*, a 0.18m-thick layer of compact and very dark grey sandy silt. This sequence may represent a former yard surface (context *305*), overlying redeposited natural sands containing 19th-century material, which has been backfilled into a cut of unknown function. However, it may also be related to landscaping or remodelling of the ground surface in this part of the site in the 19th and 20th-century.

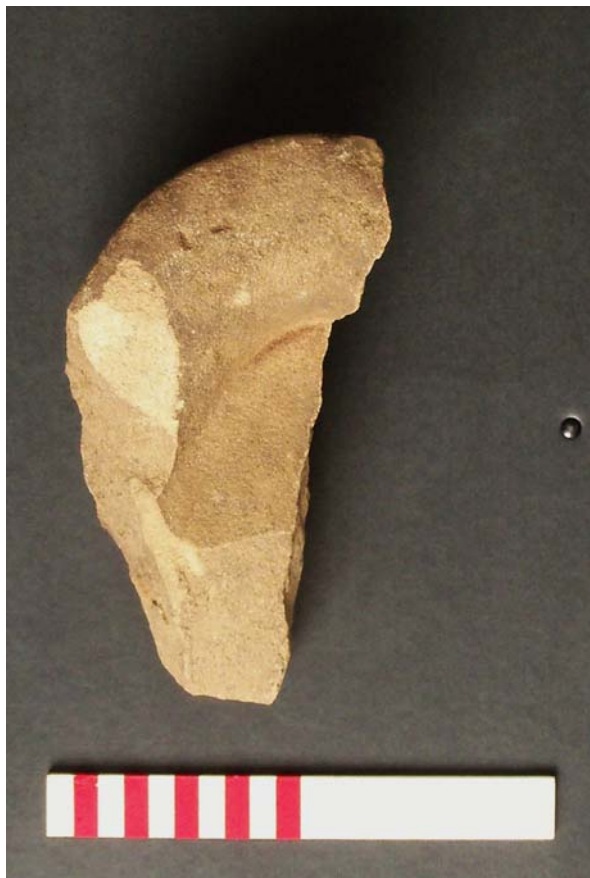
Plate 12: Fragment of probable trough or basin, plan view (20cm scale)

A fragment of partially dressed sandstone was also recovered from topsoil 300. This may represent a fragment of a curved, shallow trough such as were used widely in the post-medieval and later period for such things as animal feeding. However, it is in a highly fractured and chipped state indicating it has lain in the topsoil for some time and has been struck repeatedly by plough and more recently by machine including fresh scars.

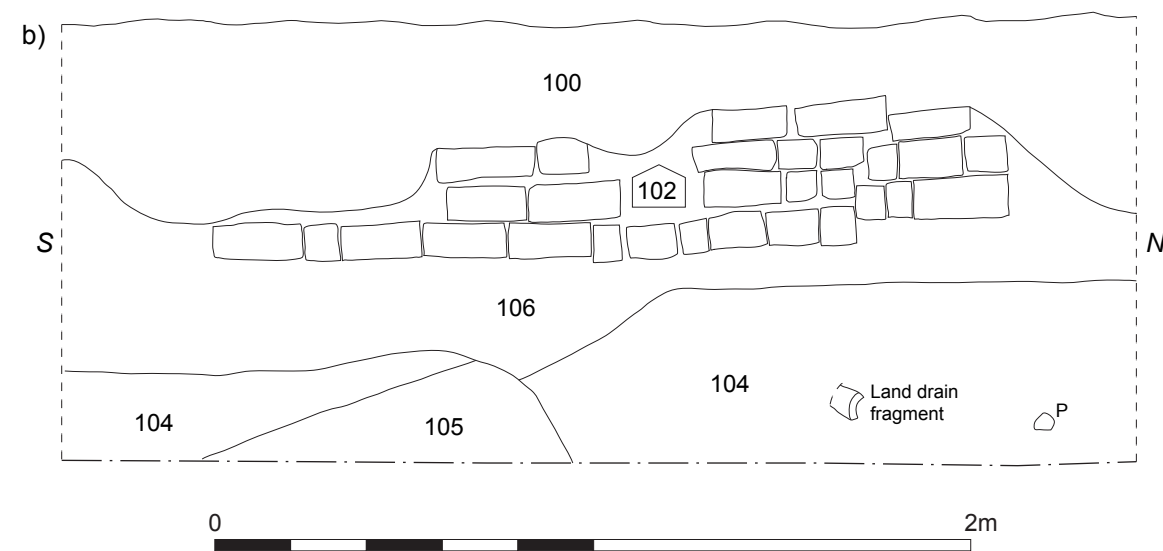
- a) Footings trench plan
- b) Section of wall 102

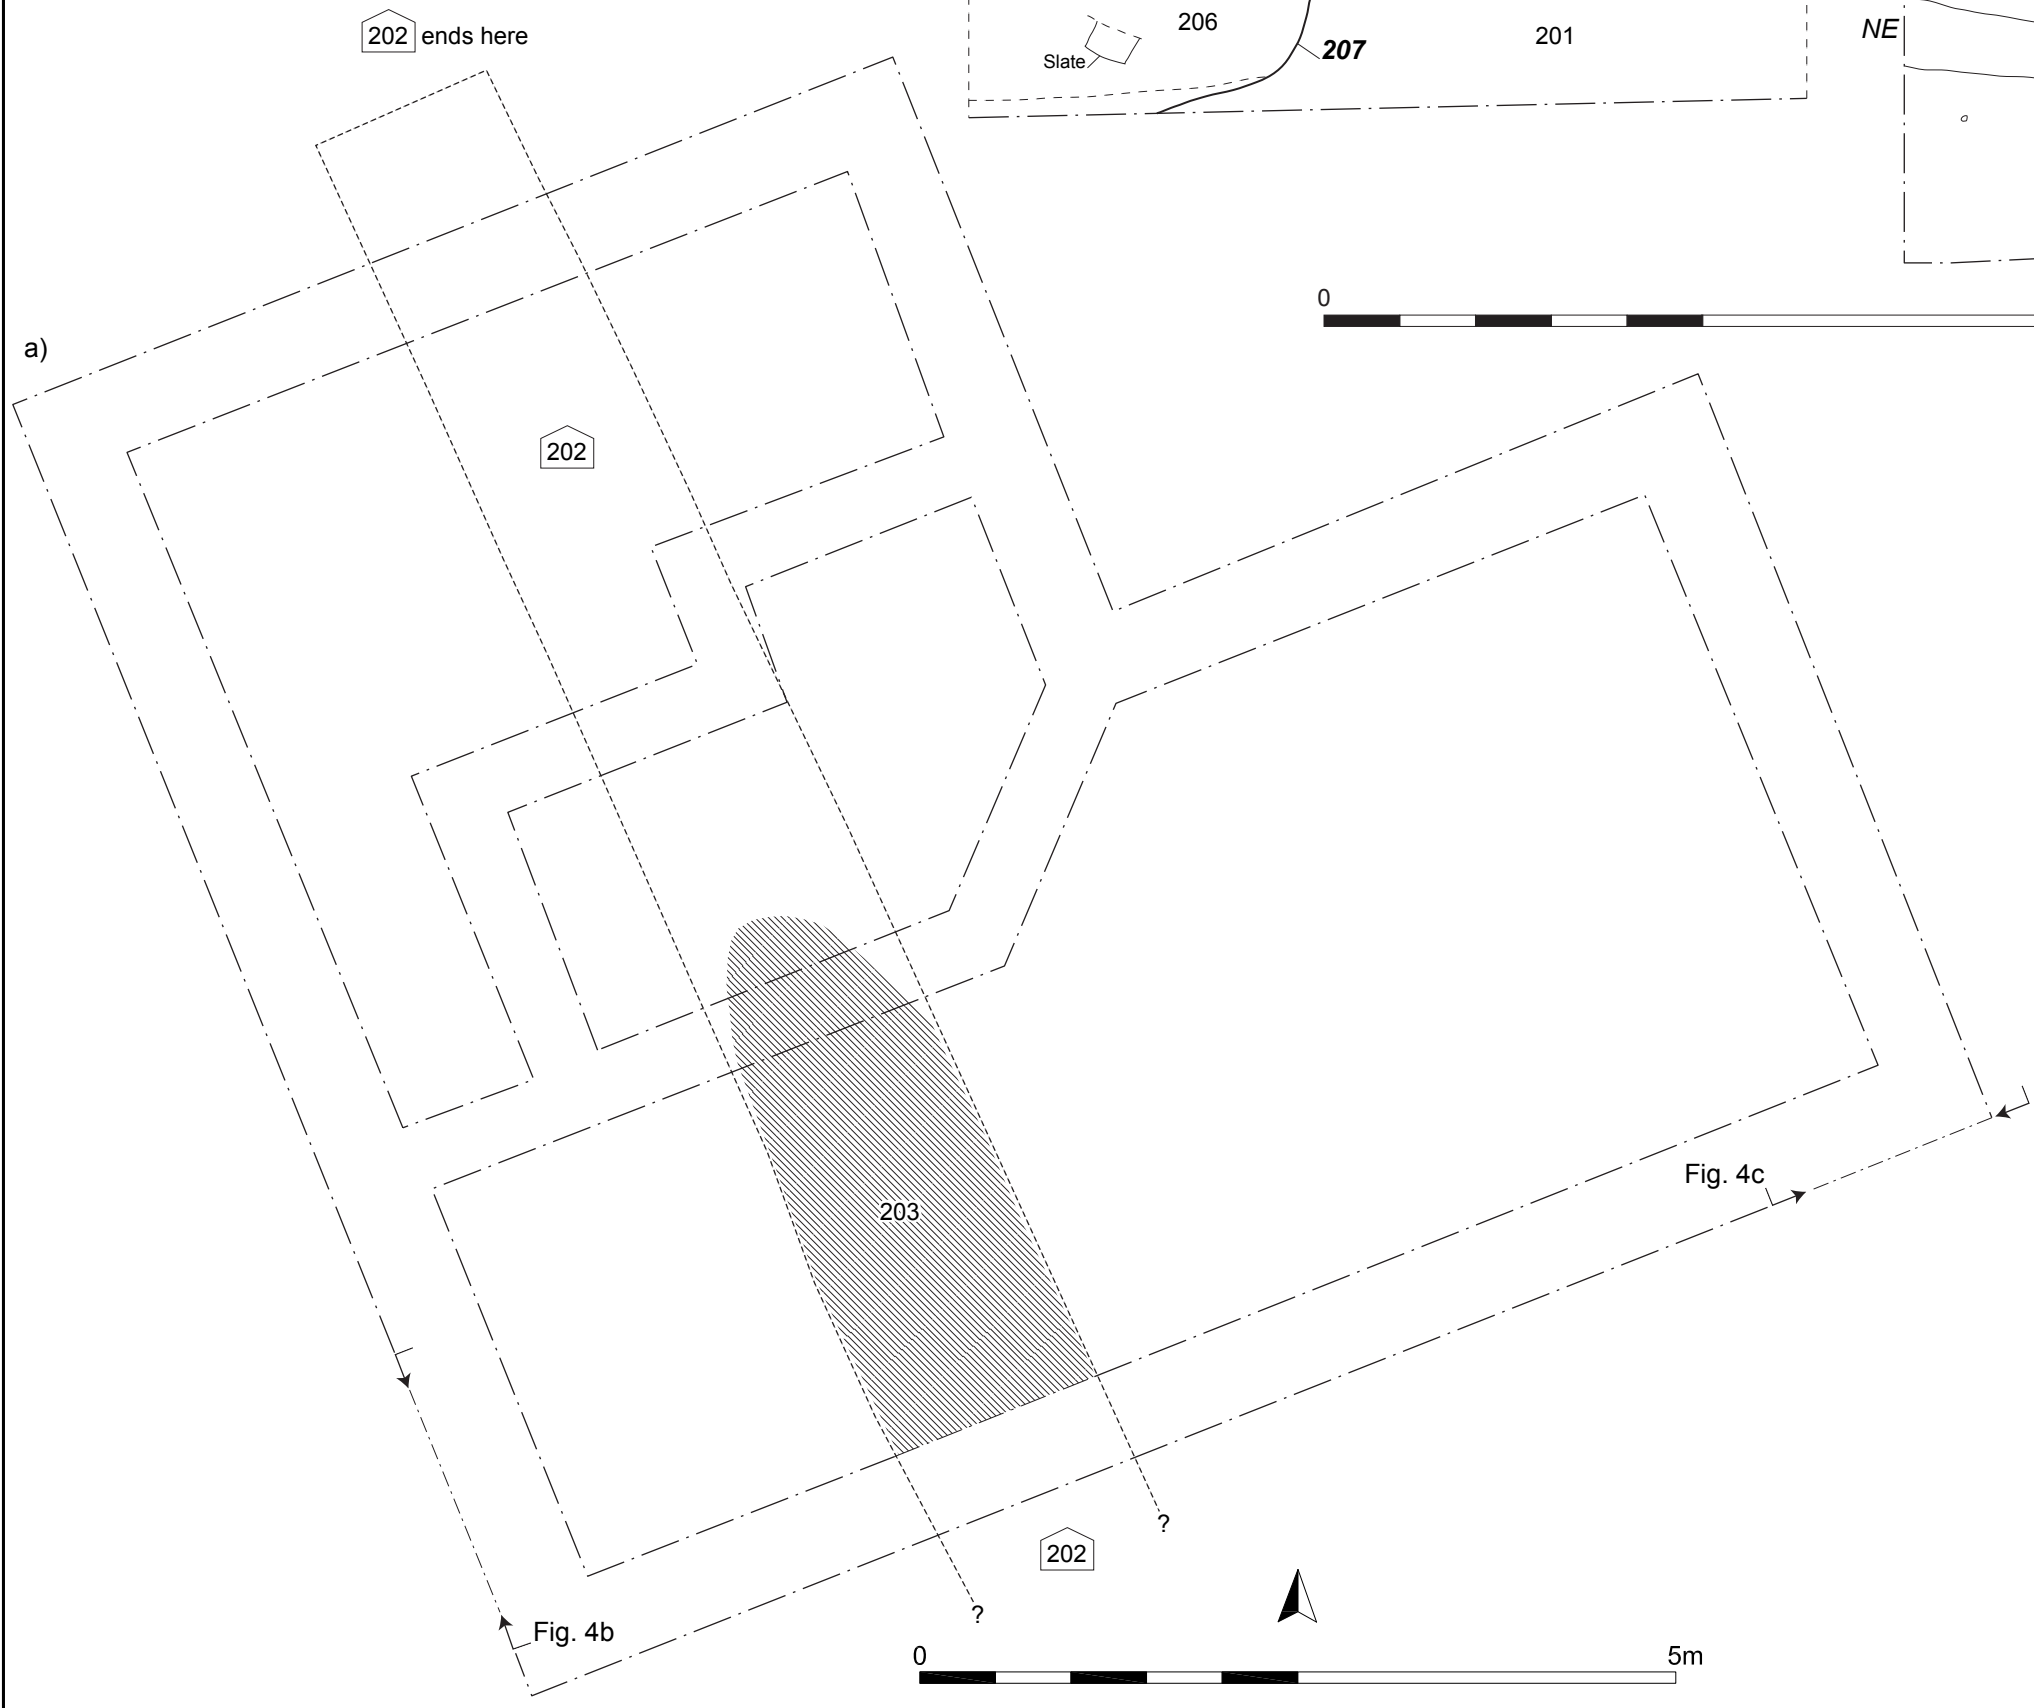
- a) Footings trench plan
- b) Trench section
- c) Trench section
