ST. PETER'S CHURCH, EAST DRAYTON
**Drainage improvements: Archaeological
monitoring and recording**

Project title	St. Peter's Church, East Drayton, Nottinghamshire				
Document title	Drainage Works: Archaeological Monitoring and Recording				
Report number	612				
Project code	EDC16				
Museum accession no. r					
County	Nottinghamshire				
Parish	East Drayton				
NGR(s)	Centred on NGR 477560 375315.				
Distribution	Secretary, East Drayton PCC, Jonathan Pickett (Southwell Diocesan Advisory Committee); Ursilla Spence (Nottinghamshire County Council)				
Document Comprises	Doc. Control Sheet	Tables of Contents	Text	Figures	Appendices
	1	2 pages	9 pages	11 pages	3

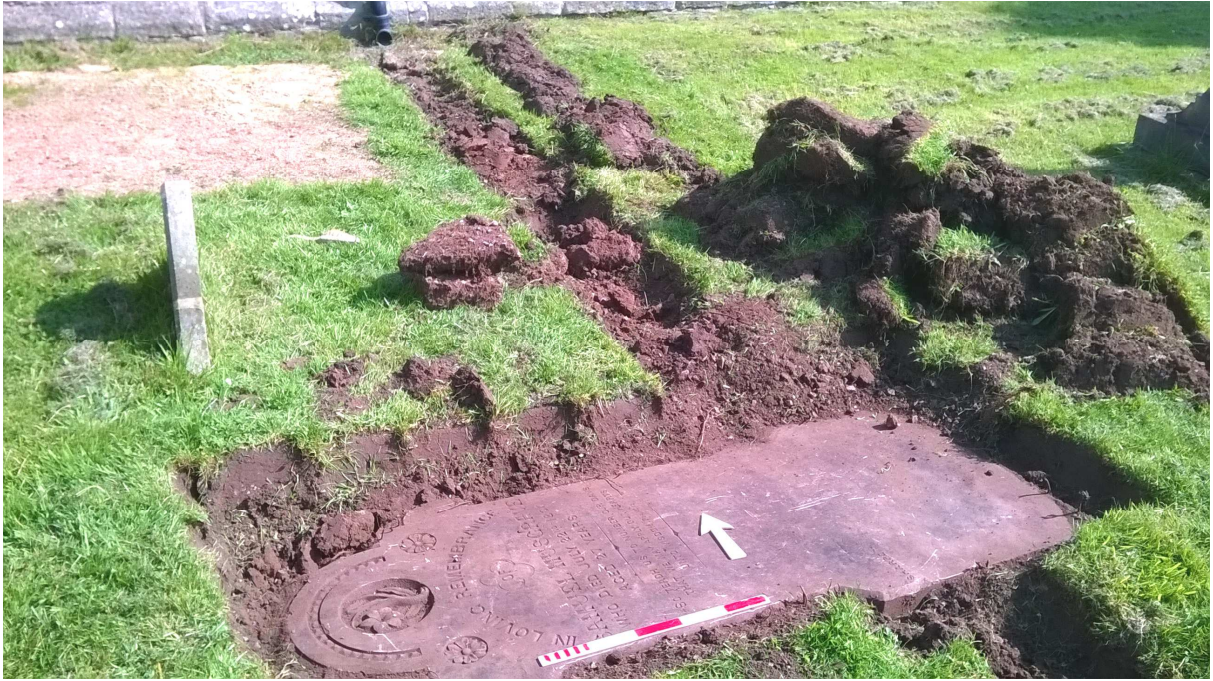
Figure 4: Headstone of Samuel Musgrave (101), as found, scale 0.5m

Grave furniture, not apparent on the surface, was revealed immediately below the turf layer. Particularly unexpected was a complete headstone (101; Fig. 4), commemorating Samuel Musgrave (died 22nd July 1880), lying so that its top was between the upstanding headstones of Harriet Musgrave (died 7th March 1910) and Joseph Newton (died 2nd Jan. 1926). It was clearly designed to have been set upright, with a large foot bearing the mason's name, Sharpe, close to ground level. However, the crispness of the carving suggests that it has not been exposed to the atmosphere for any extended period.

Of the grave markers with inscriptions still legible in this part of the churchyard, this is the oldest, and it may be that the stone was laid flat as part of a late nineteenth- or early twentieth-century landscaping of this area. On the rich loamy topsoil, it could have been rapidly buried by worm action if it was not actively maintained.

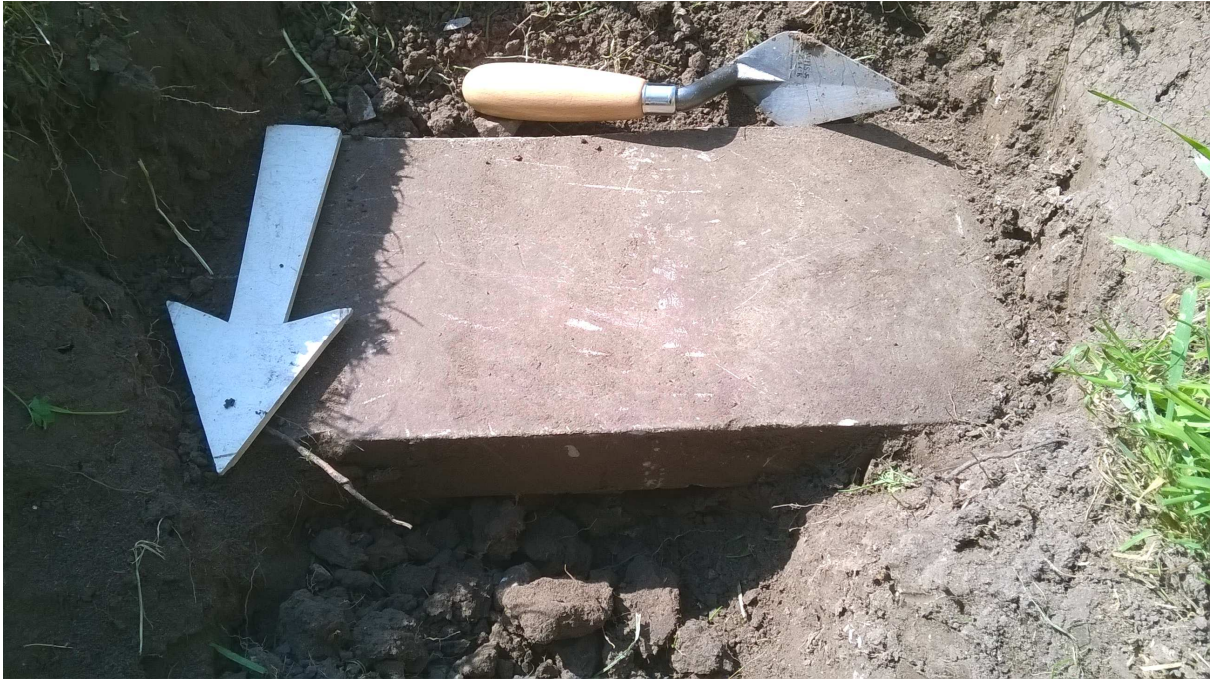
Figure 6: Grave kerb (102), on north side of grave of Harriet Musgrave

Stone kerbs around several of the graves had similarly become buried, leaving no visible trace on the surface. A matching pair, one metre apart, to the north of Samuel Musgrave's headstone, were in a fine-grained limestone with rectangular cross-section, 170mm wide by 60mm deep (Fig. 6). Although only a small length of each was exposed in the trench, their position implies that they form a surround for the grave of Harriet Musgrave.

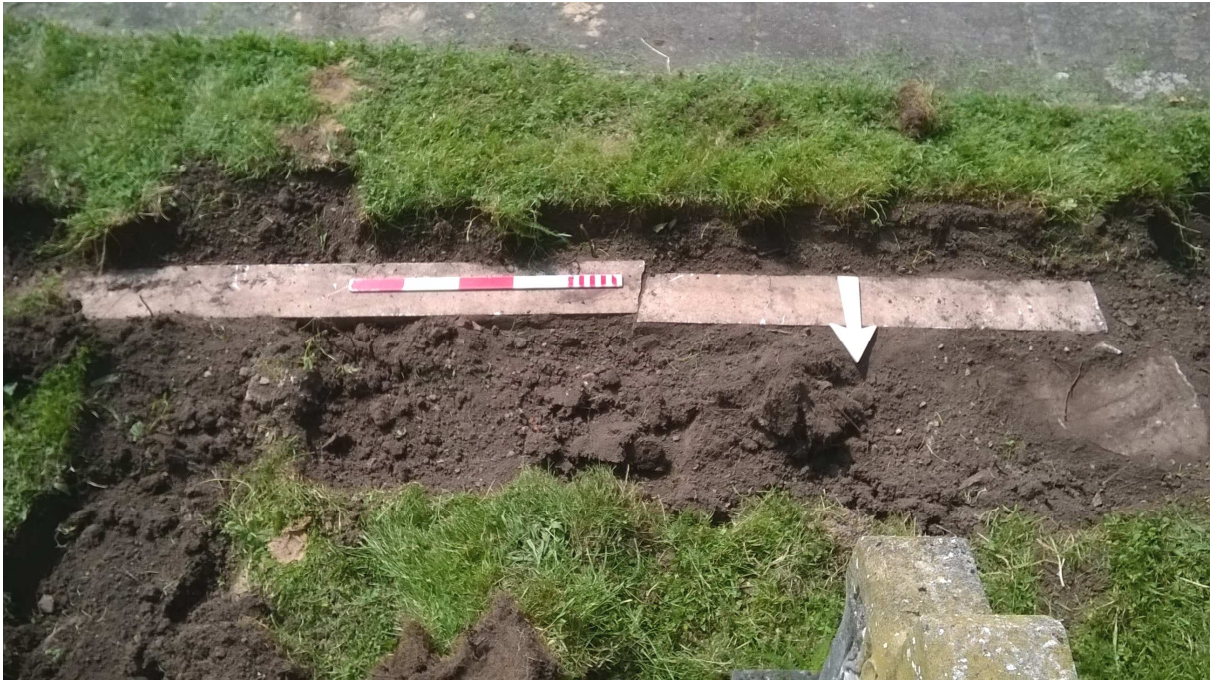
Figure 7: Grave kerb (103), between path and headstone of Joseph Newton, scale 0.5m

Close to the north edge of the path, a 1.98m-long kerb of similar dimensions, cracked into two pieces, was exposed (103). This was in a fine polished limestone with almost marble-like appearance. At its western end, a return to the north was partly exposed (Fig. 7), and a possible counterpart crossed the trench to the south of Samuel Musgrave's headstone. These kerbs probably marked the grave of Joseph Newton, whose headstone they surrounded, although the headstone was positioned to the north of the central axis of the enclosed area, raising the possibility that the kerbs were survivors of an earlier grave.

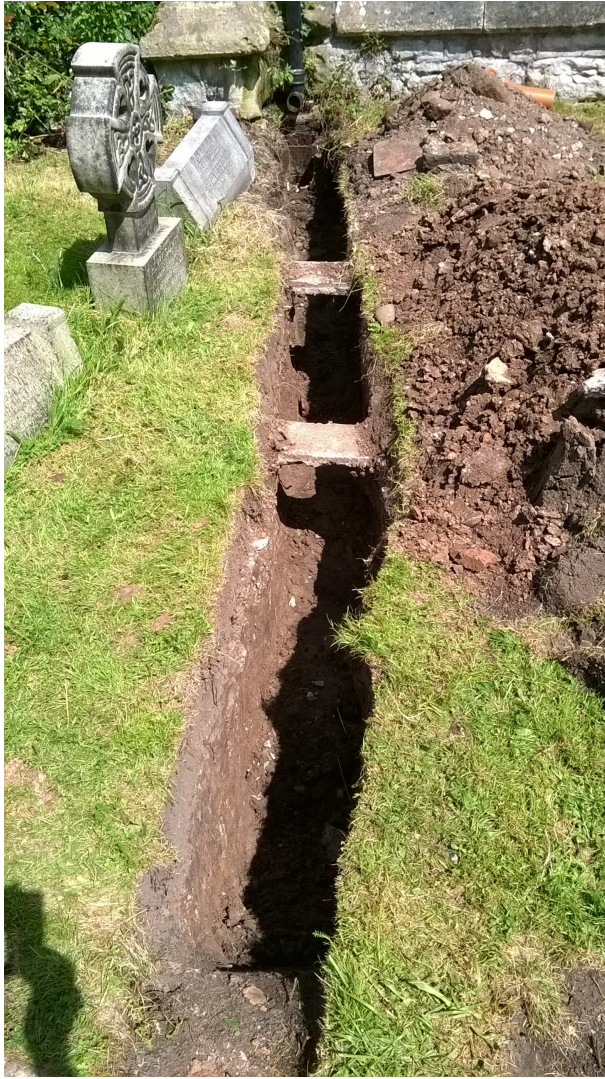
Figure 8: West trench, showing grave kerbs (107) either side of memorial to Henry Salmon

Crossing the western trench, two rough concrete beams (107), aligned either side of the headstone of Henry Salmon (died 14th March 1910) are perhaps best interpreted as the foundations for stone kerbs, which have subsequently been lost (Fig. 8). To the south, a similar, though even more roughly finished, concrete beam (108) was probably a foundation for a similar kerb around the grave of his eldest daughter Mary (died 2nd April 1906). Fragments of concrete of similar appearance noted in the trench to the north were probably the remains of a northern counterpart to kerb 108, possibly disturbed when Mary's father's grave was dug. Kerb 108 was removed to allow the installation of the drain, but the other features described above were left *in situ*, with the trench being excavated beneath them.

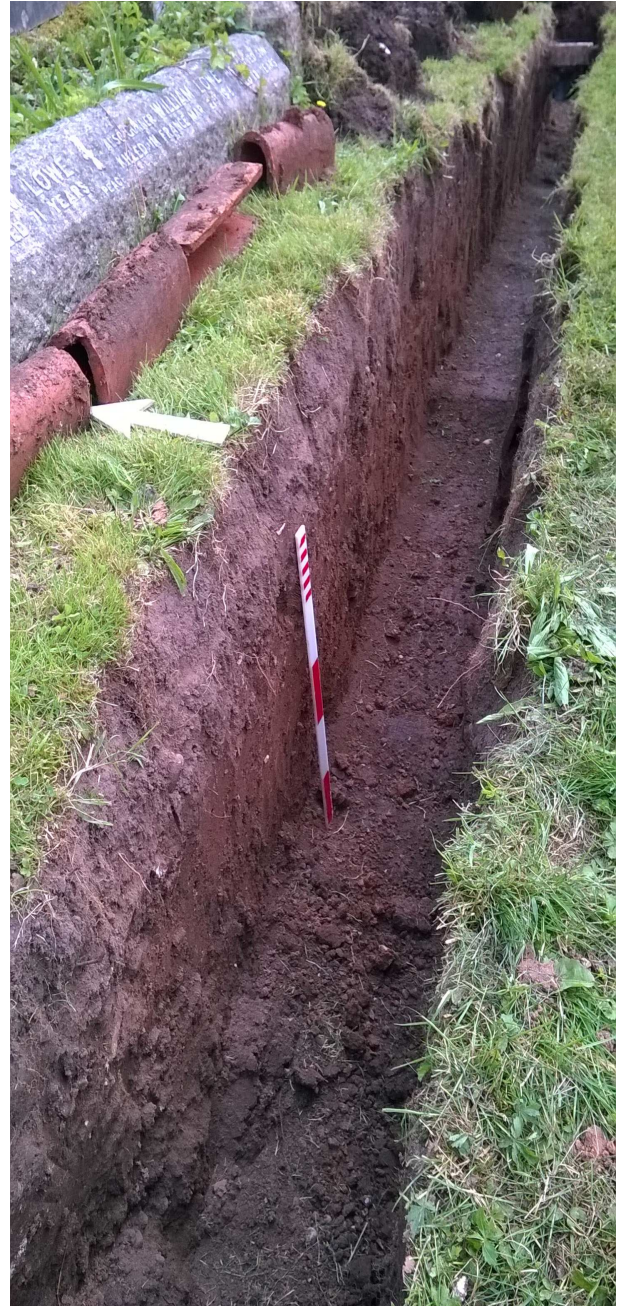
Figure 9: South trench, fully excavated, the south side of base disrupted by drain (130), scale 0.5m

The southern trench, running alongside the path from the inspection chamber to the main soakaway, produced rather more disarticulated human bone (109). To some extent, this is a reflection of the greater depth of this trench, especially at its western end, where its base was up to 900mm below the level of the path (Fig. 9). A skull and jaw (111), found 5.30m from the eastern extremity of the trench and at a depth of 800mm, may have been part of an articulated skeleton, probably of a young child, the rest of which was beneath the base of the trench. On almost the same alignment, an earlier cut (130) of similar depth, for a ceramic horseshoe drain, had disturbed the south side of the southern trench.

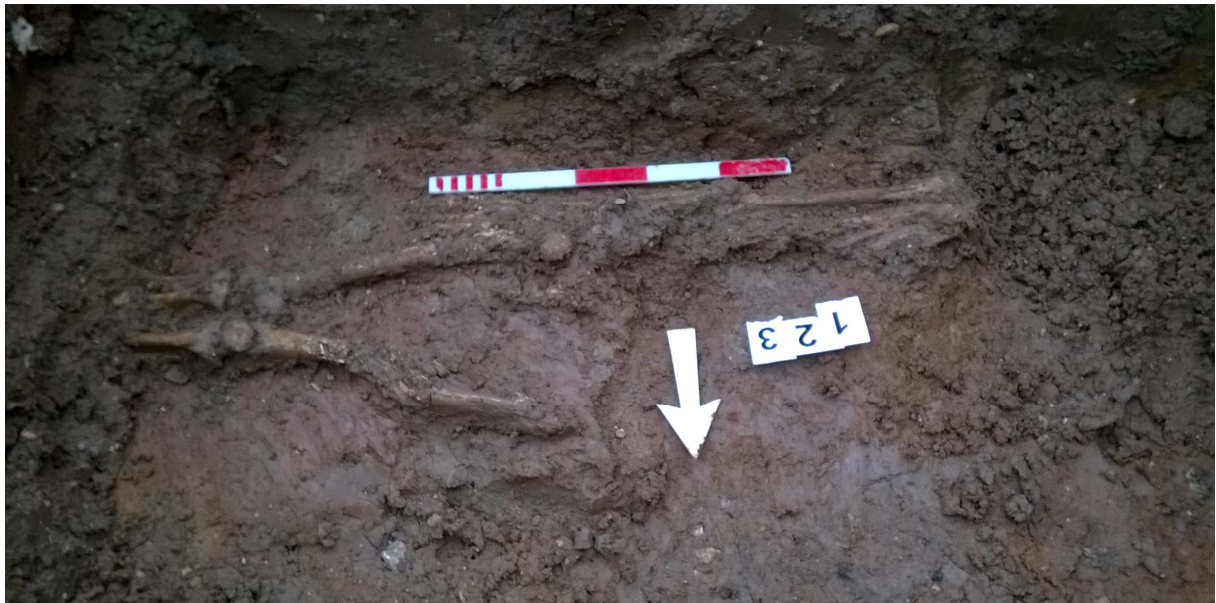
Figure 11: Skeleton 123, showing truncation from right shoulder to left hip by grave of skeleton 115, scale 0.5m

Three earliest skeletons, 123, 116 and 119 (Figs.11, 12, 13) had no stratigraphic relationships between them, and it is therefore not possible determine their order of burial, but all three were laid at a similar depth, of around 0.85m to 0.90m below the level of the path. They were also fairly evenly spaced, which might suggest that they belonged to the same phase of use in this part of the churchyard.

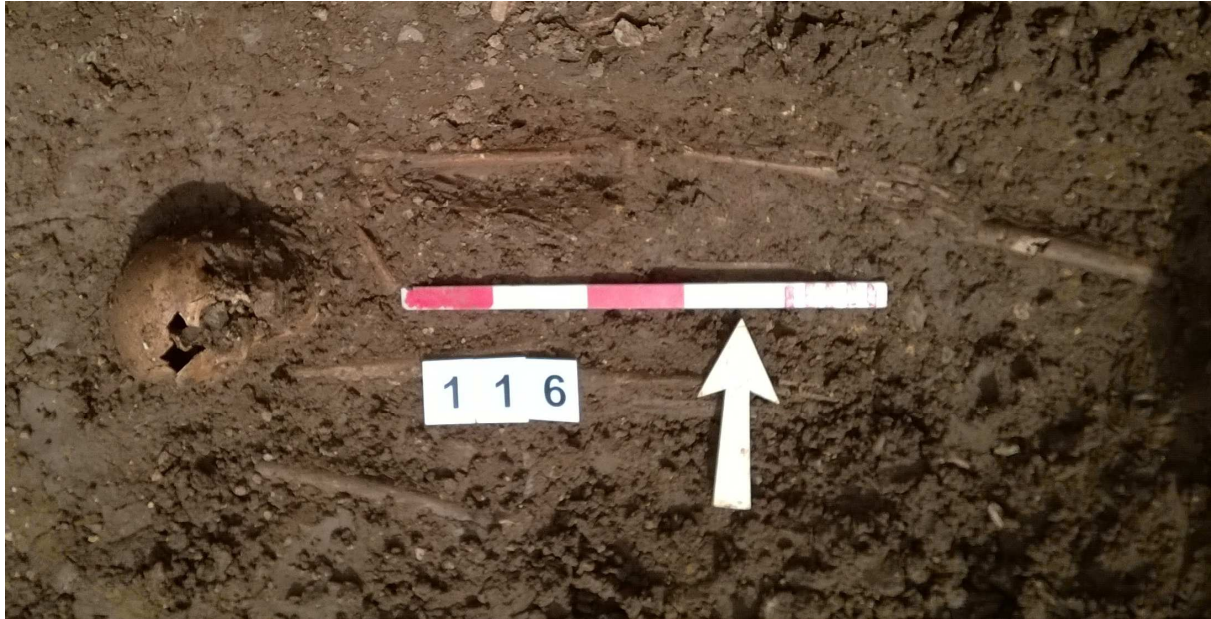
Figure 12: Skeleton 116: showing truncation from right humerus to left femur, by grave of skeleton 115 and probably another grave to the east, scale 0.5m

The skull, neck and left side of the body, from the right shoulder to the left knee, survived from skeleton 116. Around the skull, the remains of at least four tiny copper alloy pins were noted, only one of which was sufficiently robust to be lifted, the others being little more than green carbonate stains.

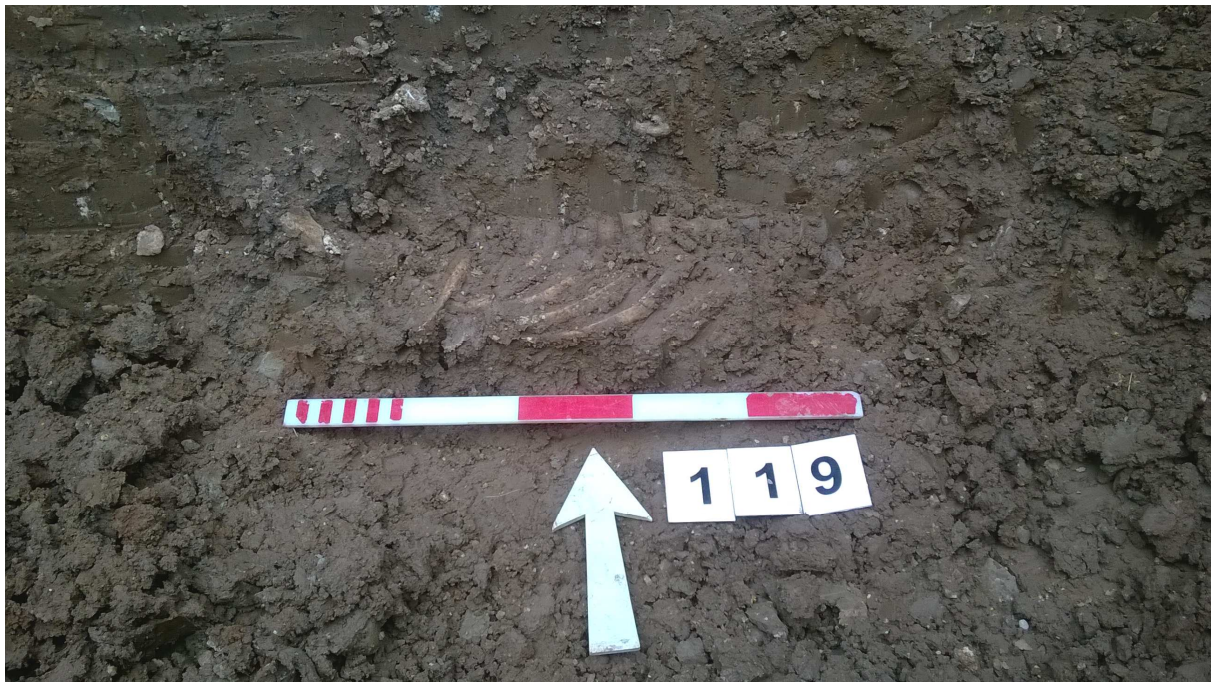
Figure 13: Mandible, right clavicle, scapula, ribs and vertebrae of skeleton 119, exposed in northern baulk of main soakaway pit, scale 0.5m

The position of the vertebrae of skeleton 119 corresponded to the northern baulk of the soakaway pit, beneath the edge of the path. Although the left side of the skeleton could therefore not be seen clearly there were indications that the skeleton had been truncated just behind this baulk, probably when drain 130 had been dug. Only the rib cage, clavicle, scapula, mandible and skull fragments survived of the right side of the body.

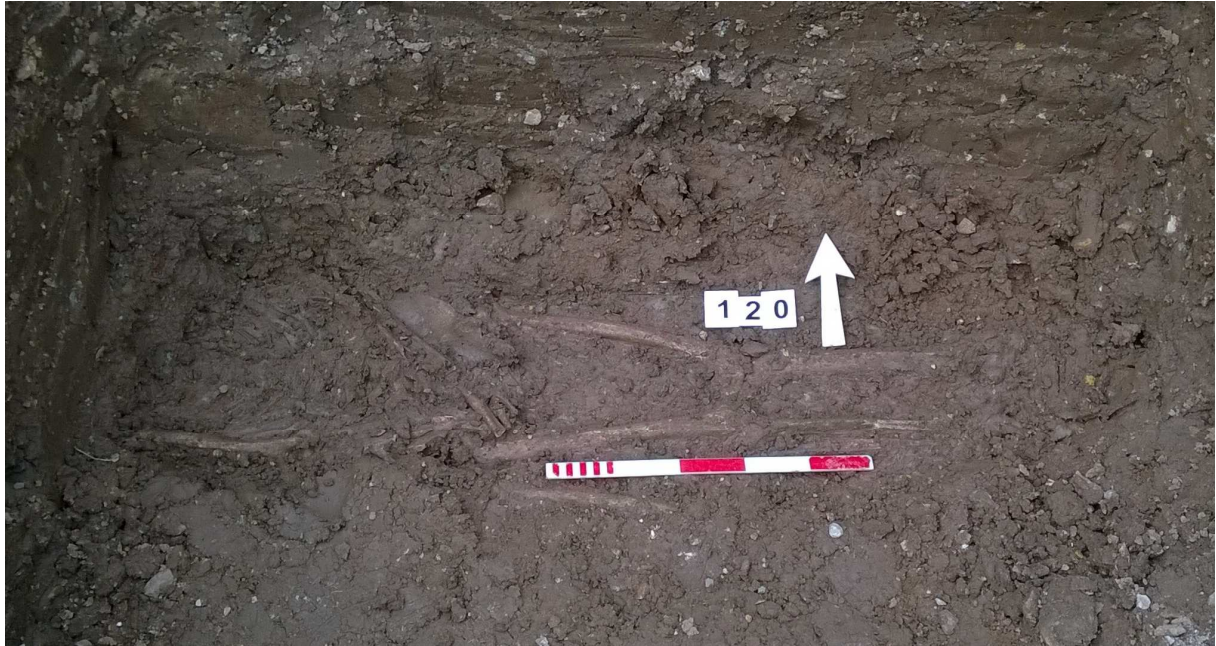
Figure 14: Skeleton 120, the deepest of the burials within the main soakaway pit, with disarticulated femur (122) to the south of the scale, scale 0.5m

Between skeletons 116, north of the centreline of the soakaway, and skeleton 119, in the northern baulk, a later grave, for skeleton 120, was deeper, to 1.10m. Skeleton 120 was the best preserved of the six recorded in the soakaway and was largely complete (Fig. 14), although its neck and skull, beneath the western baulk of the soakaway, were not exposed. A sherd of a mid- to late-eleventh- to mid- to late twelfth-century Stamford Ware pitcher (Young, Appendix 2, below) was found immediately above (fill 121) the left humerus of skeleton 120. A loose femur (122) beside the right leg of the same skeleton was probably deliberately placed, after having been disturbed during the digging of the grave, and may have originally belonged to skeleton 119.

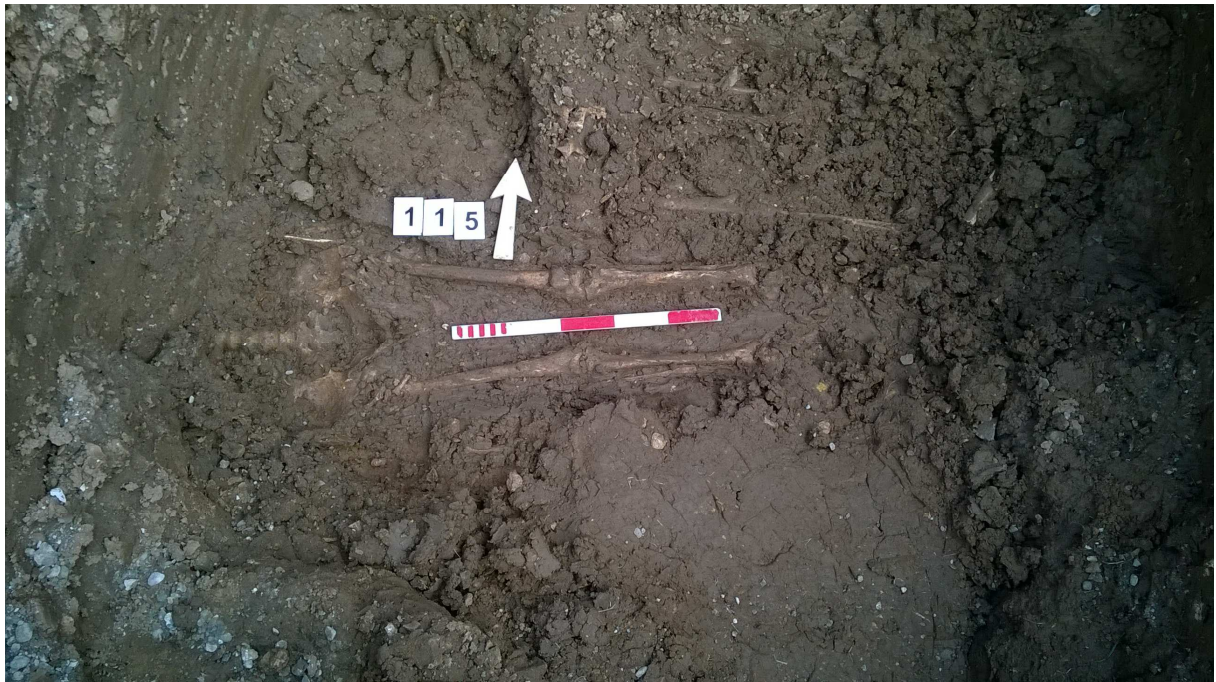
Figure 15: Skeleton 115 (with partially exposed skeleton 116 to the north and skeleton 123 unexcavated beneath the spoil in the south-east corner of the soakaway pit), scale 0.5m

Only the lower part of skeleton 115, lower vertebrae down through the hips and legs, was exposed, the upper body lying beyond the south-west corner of the soakaway pit (Fig. 15). The alignment of this skeleton was slightly oblique to the others, which were all on a nearly exact east-to-west alignment. As a result, the grave for skeleton 115 had truncated skeleton 123 from the neck to the left hip and had also probably truncated the lower right side of skeleton 116.

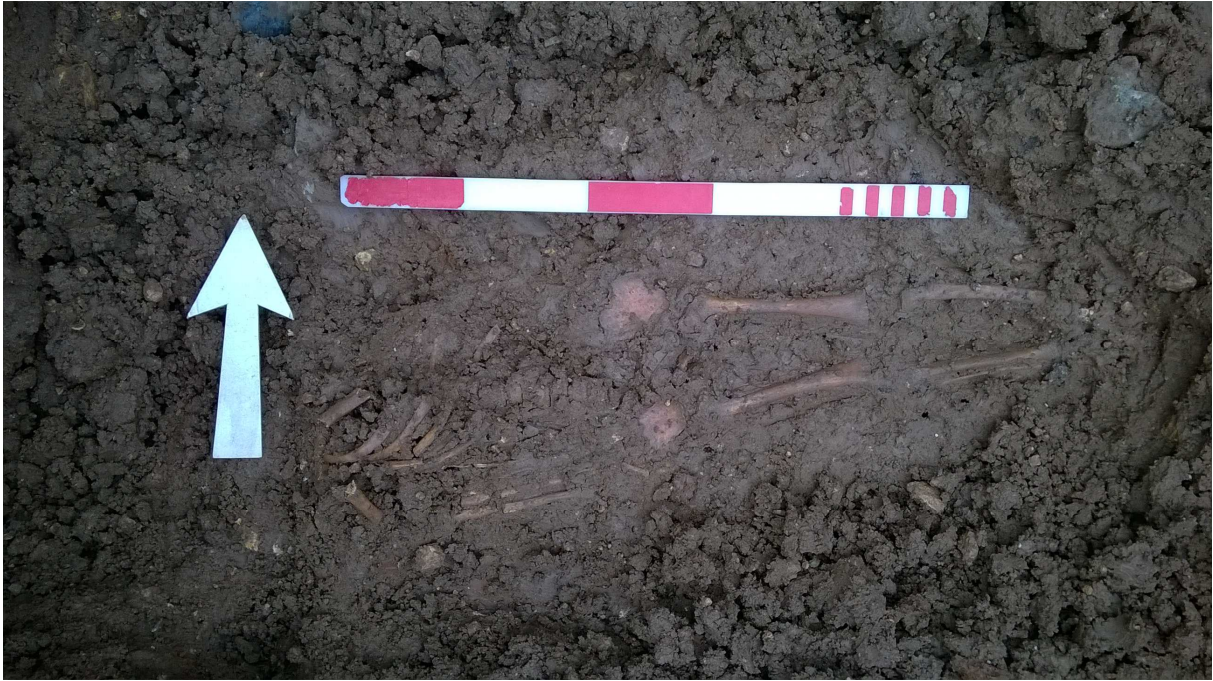
Figure 16: Skeleton 114, the shallowest of the burials uncovered in the main soakaway pit; the damaged skull of this infant skeleton was lifted in order to facilitate the excavation of the rest of the skeleton, scale 0.5m

In the south side of the soakaway pit and lying above skeletons 115 and 116, the skeleton of a young child, 114, was barely 0.70m below the level of the path (Fig. 16). The grave had probably disrupted the earlier graves, probably, for instance, accounting for the loss of arm bones from skeleton 115. The whole extent of skeleton 114 was exposed within the soakaway, the length from the top of the skull to the feet being no more than 1.10m. A ferrous metal object, possibly a clasp or coffin fitting, was found in the left shoulder region of the skeleton. A sherd of a late thirteenth- to fifteenth-century Humberware jug (Young, Appendix 2, below) was also recovered from the fill (118) just above the skeleton.

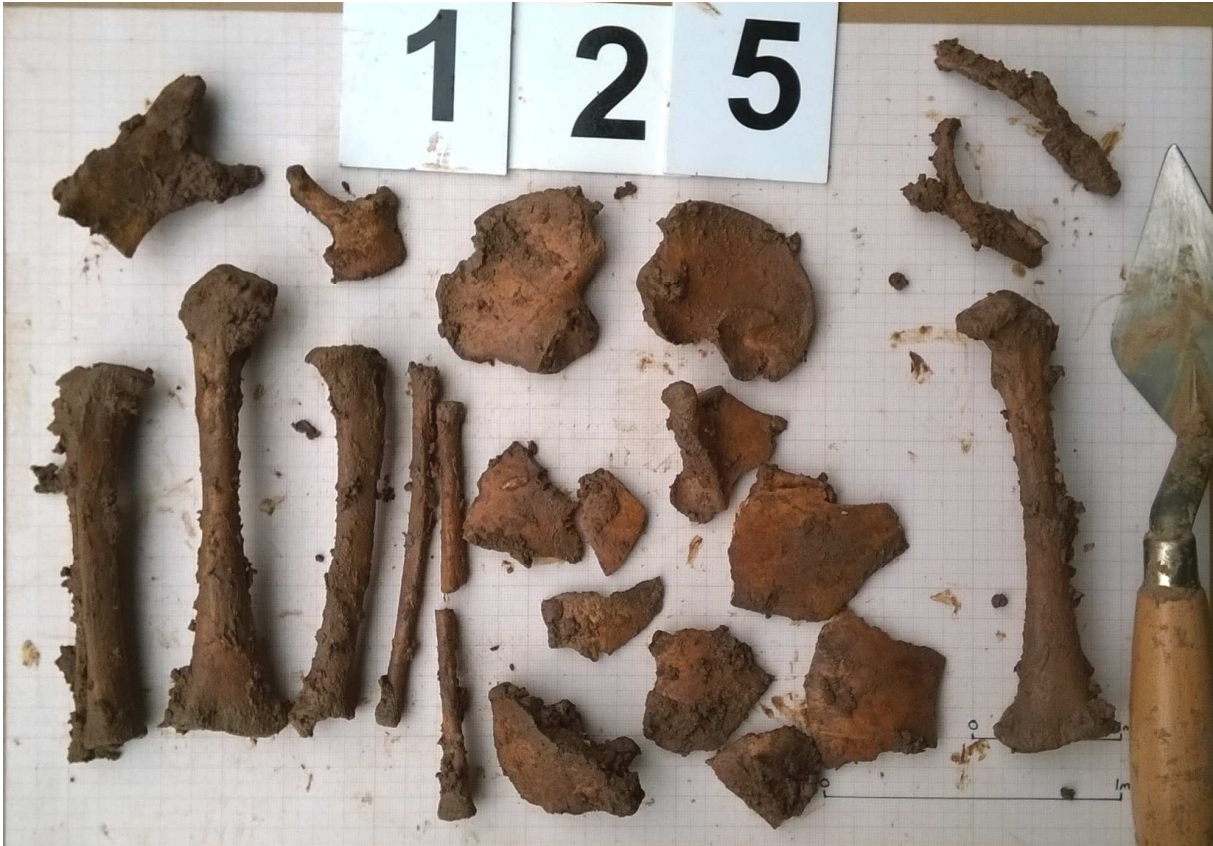
Figure 17: Bones from a young infant (125) found within the disarticulated bone collected during excavation of the main soakaway pit; these were clearly from a single individual and were reburied together

Among the disarticulated human bone recovered (113), a group that almost certainly belonged to the same individual, a young infant, were present. These were re-bagged and re-buried together, as skeleton 125 (Fig. 17). Although care was taken during digging of the soakaway, it is possible that this

skeleton had been disturbed in the course of the excavation, but the bones could equally have been disturbed during the original digging of one of the graves and incorporated into the grave backfill.

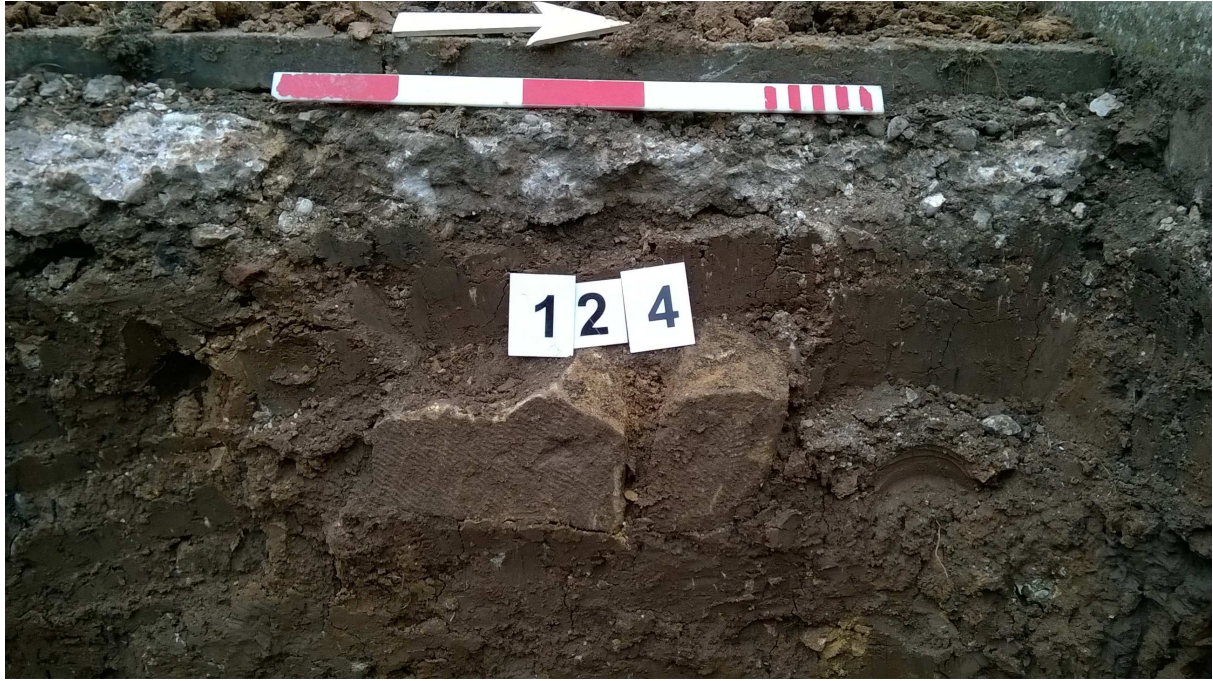
Figure 18: Piece of worked stone (124) visible beneath the path in the north-western corner of the main soakaway pit

Close to the north-west corner of the soakaway, a tooled limestone slab (124), split into two, was visible in the top of the western baulk (Fig. 18, 19). Its upright position suggests that this may have been the surviving base of a broken-off headstone or similar memorial.

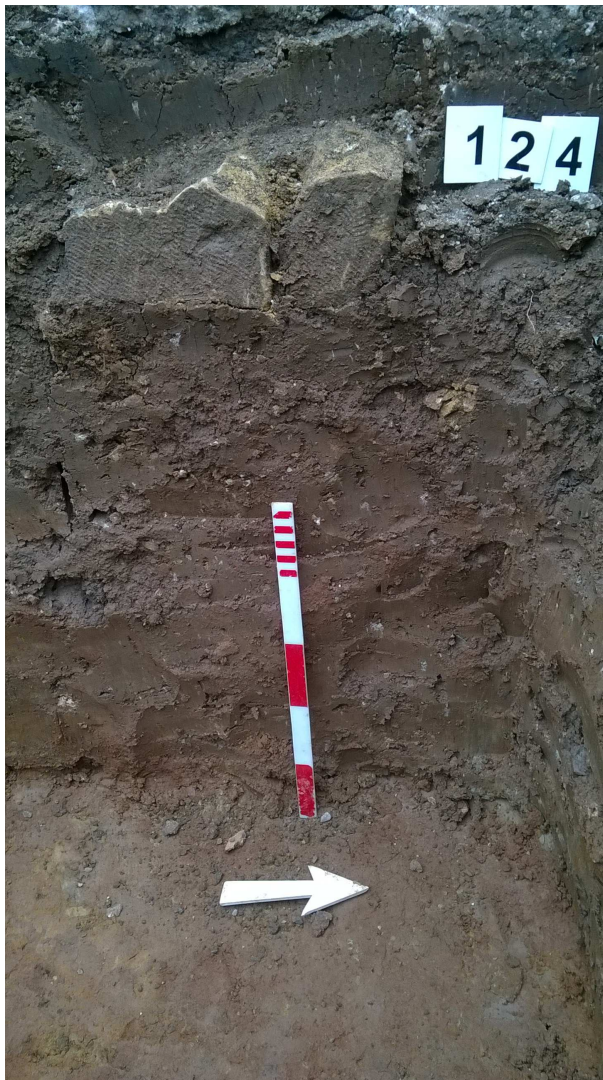
Figure 19: Worked stone (124), probably the remains of a headstone or other grave marker, showing its location in relation to the north-west corner of the soakaway pit, scale 0.5m

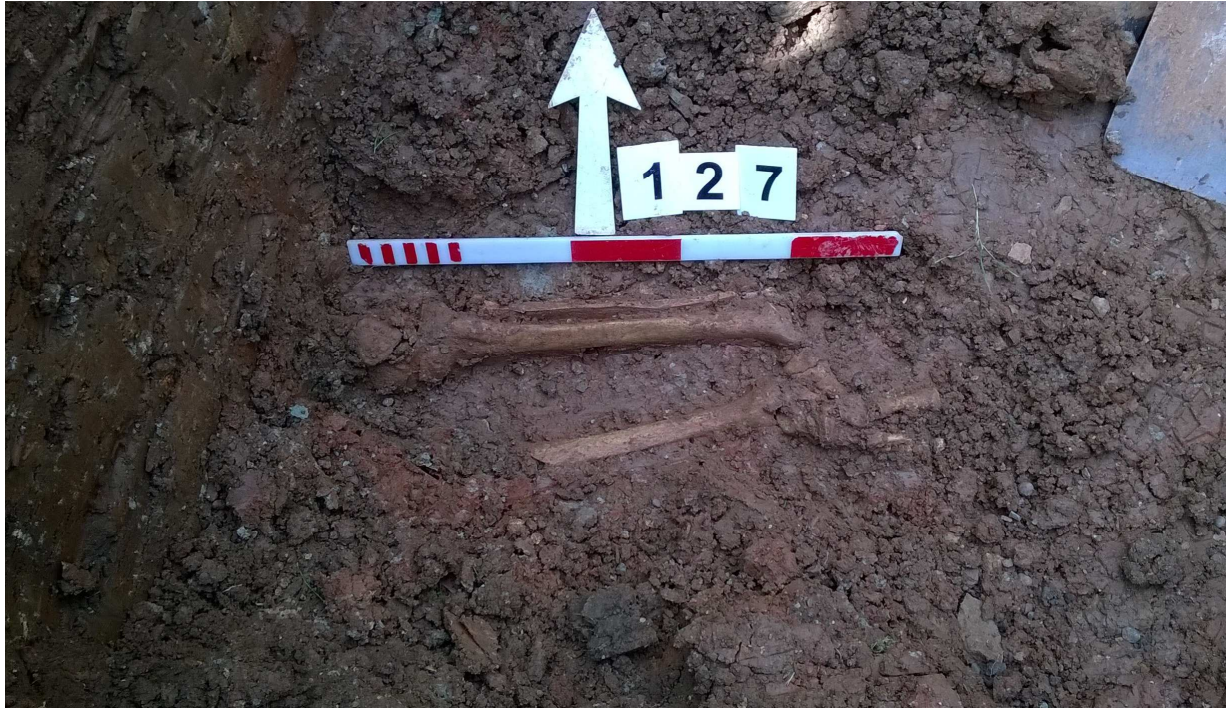
Figure 20: Skeleton 127, in the south-west corner of the smaller, western soakaway pit, scale 0.5m

Two further articulated skeletons were recorded in the smaller soakaway, to the west of the porch. Skeleton 127 lay largely beneath the western baulk of the pit, near the south-west corner of the pit, at a depth of 0.90m. Only the lower legs were visible (Fig. 20). The right tibia appeared to have been truncated just below the knee, presumably by another grave to the south-west.
