**A4146 STOKE HAMMOND AND LINSLADE
WESTERN BYPASS
Archaeological Watching Brief and recording
of historic boundaries and hedgerows**

NETWORK ARCHAEOLOGY LTD

Report no. 392

January 2007

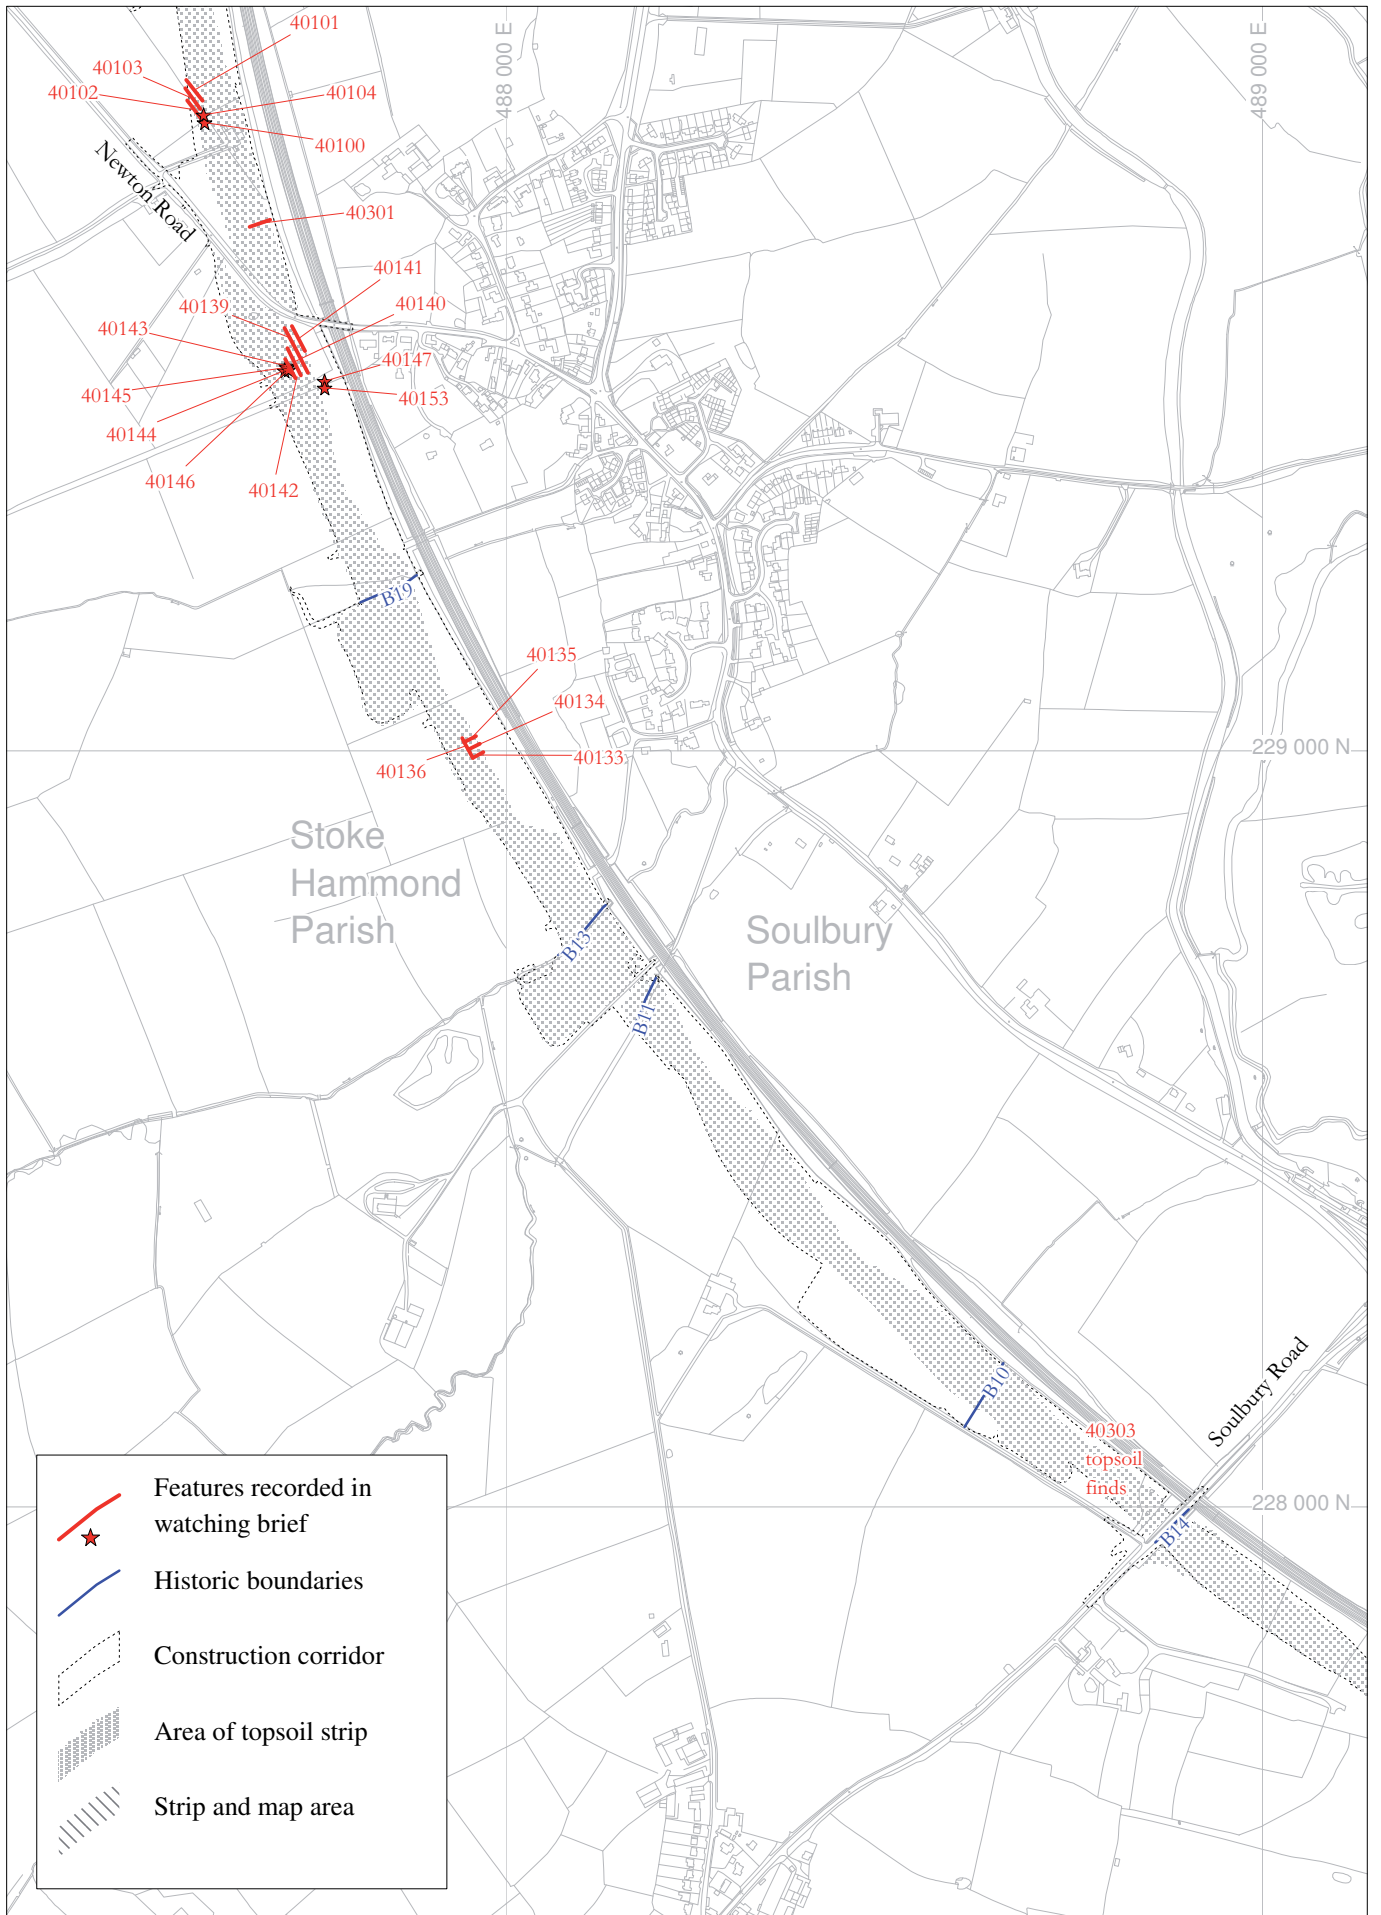
Figure 2b: Historic field boundaries and features recorded in the watching brief, north central part of road corridor, scale 1:10 000

The field to the south of Newton Road had the remains of field boundary (40139) which would have fallen out of use when the railway was constructed. There were parallel furrows or shallow ditches on either side of it. This area was also marked by large irregular pits, probably quarry pits associated with the railway.

Further to the south, three parallel furrows, perpendicular to a fourth (40136), were recorded, presumably a surviving fragment of the medieval fields to the west of Stoke Hammond.

Topsoil finds from this section included six pieces of struck flint and two sherds of medieval pottery.

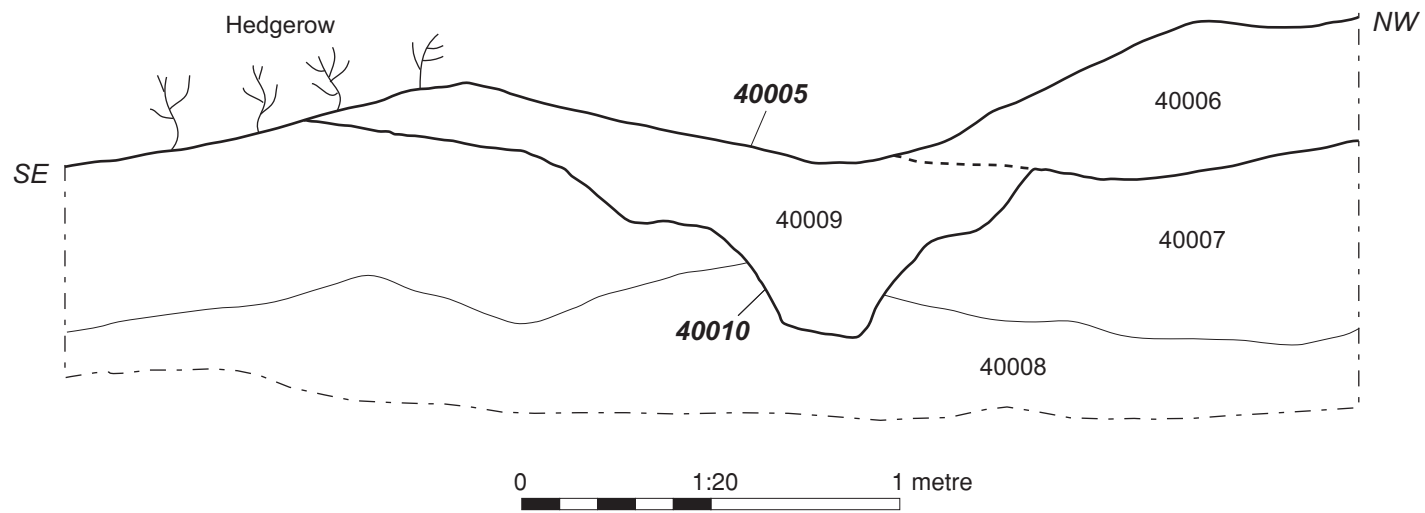
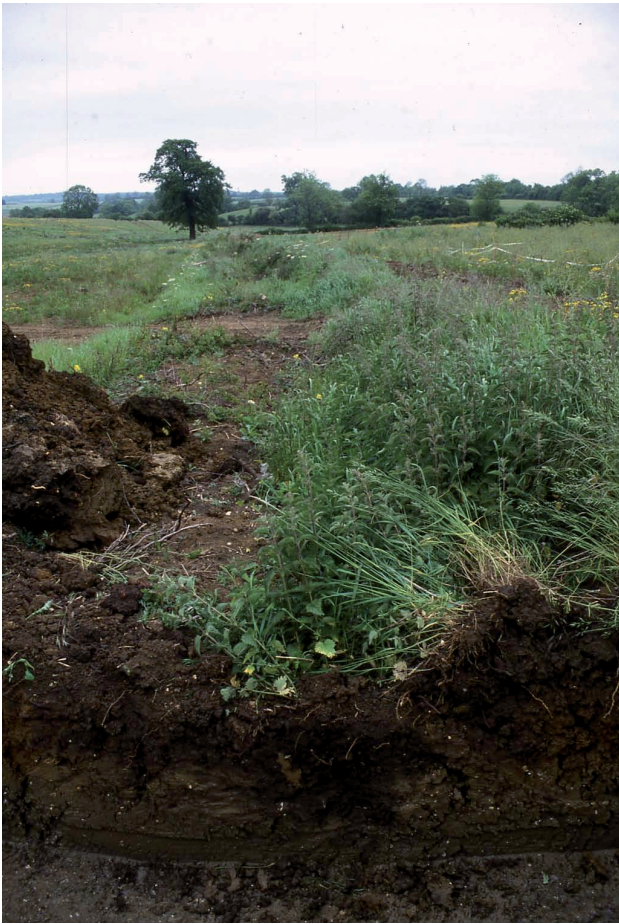
Figure 5: North-east facing section through Boundary B2.

Boundary B2 is aligned north-east to south-west, and was seen to comprise a shallow ditch, with a low bank on each side. The northern bank was topped by a hedge. The current, open ditch was only 0.5m deep, but investigation revealed that this was the recut of a more substantial precursor. The earlier ditch was 1.90m wide, and 0.94m deep, including the depth of the modern recut. Unfortunately, no definite dating evidence was present.

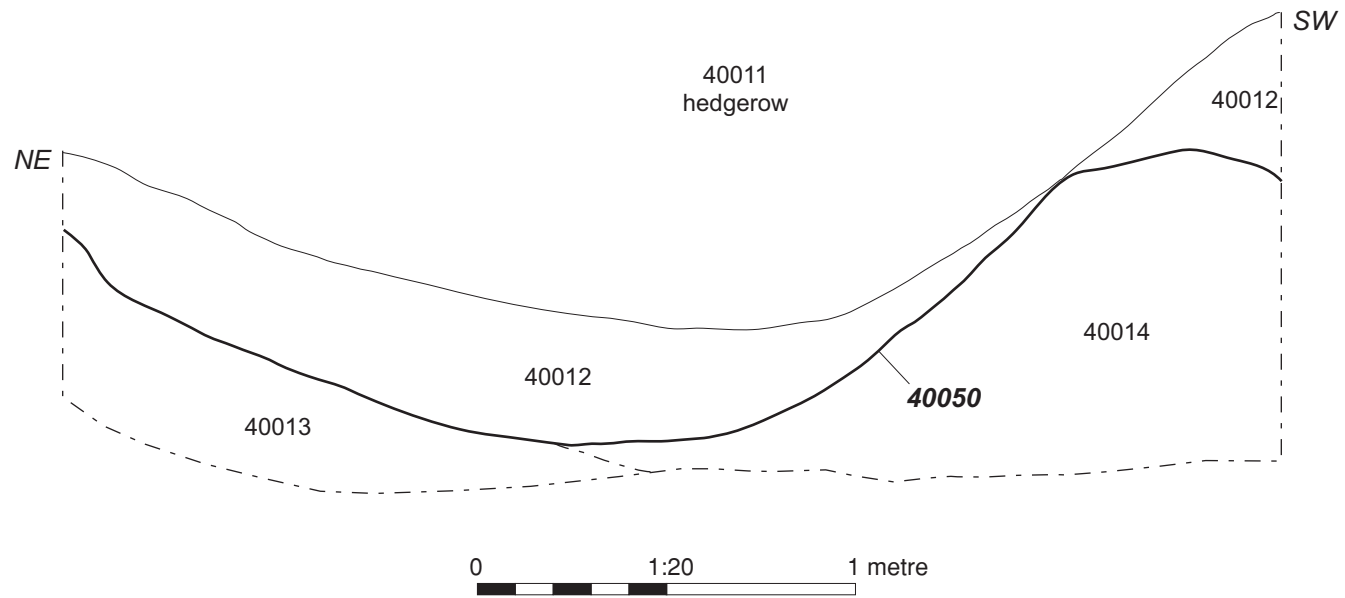
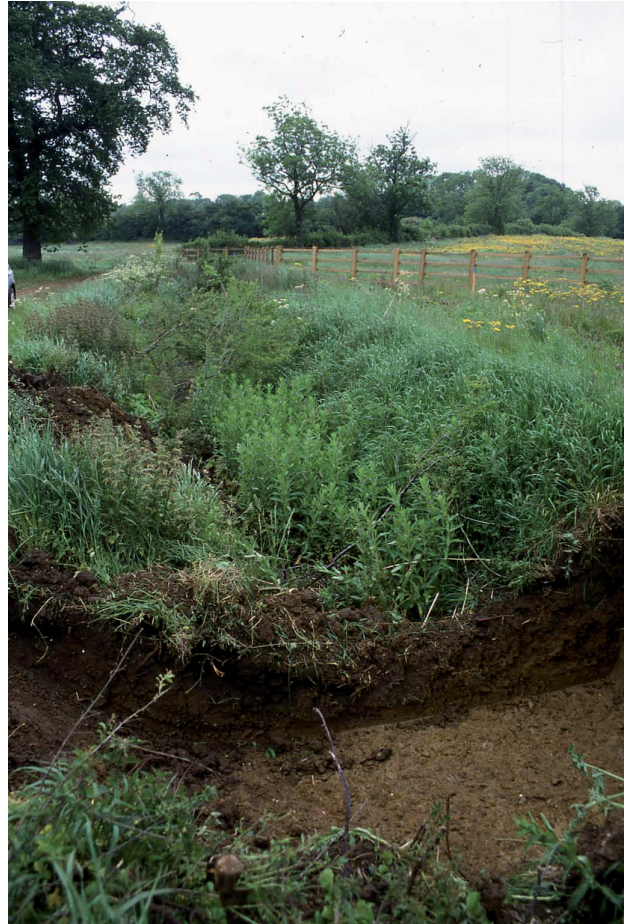
Figure 6: North-west facing section through Boundary B3.

Boundary B3 was only visible as a corner within the road corridor. It was aligned north-east to south-west then turned through a right angle to the south-east. It comprised a ditch with a low bank on either side. The ditch was 3.2m wide and 0.92m deep, but investigation revealed that a considerable slump of topsoil was visible on the north-western side. A sherd of Roman pottery was recovered from this deposit, although this was not a securely located find.

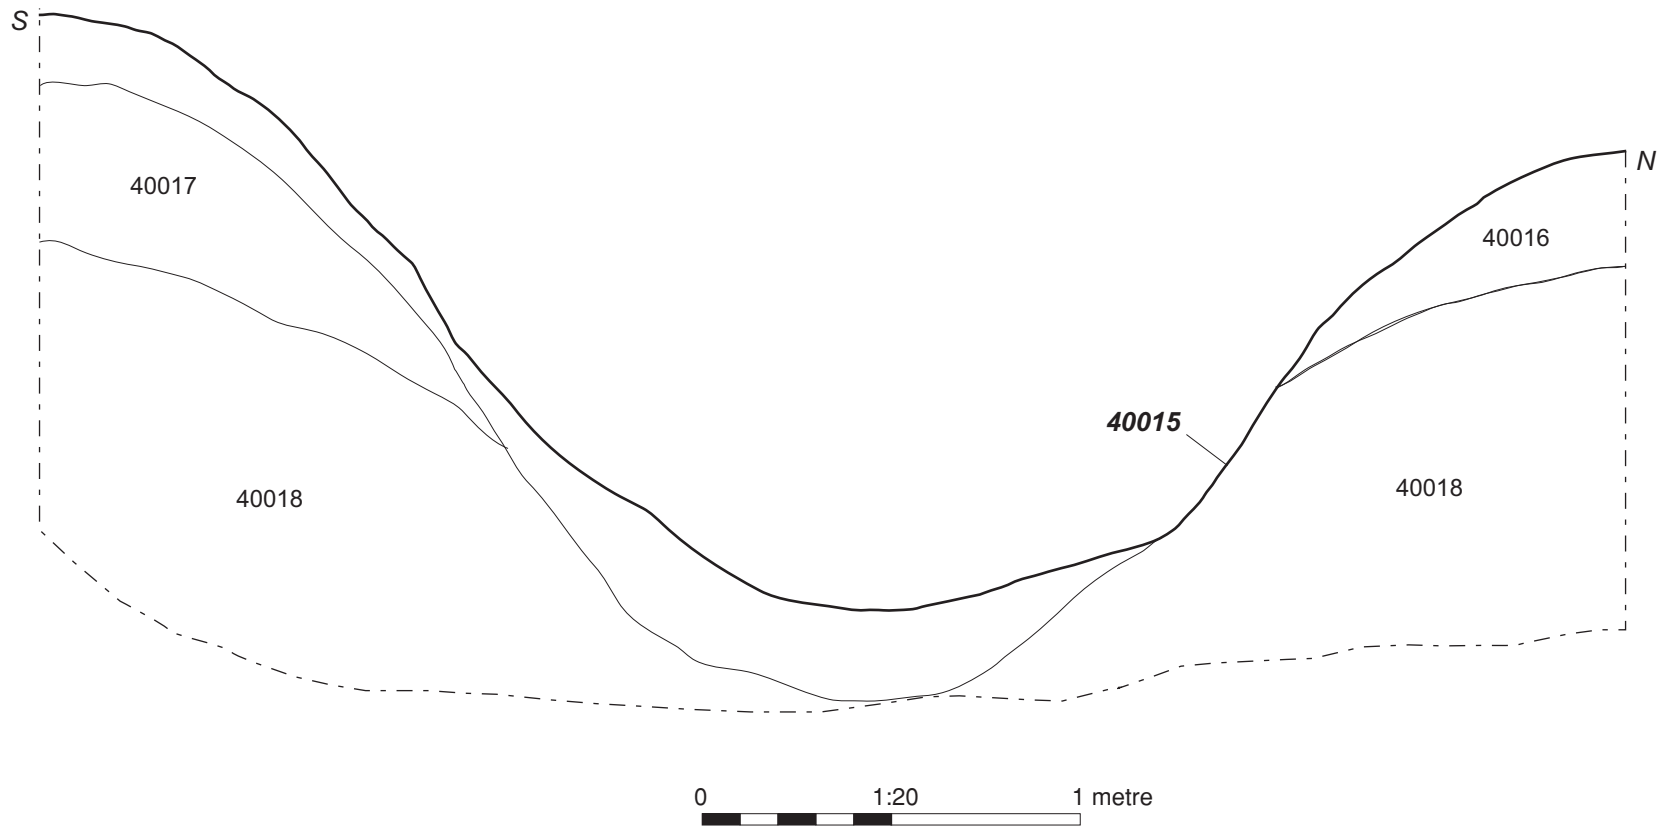
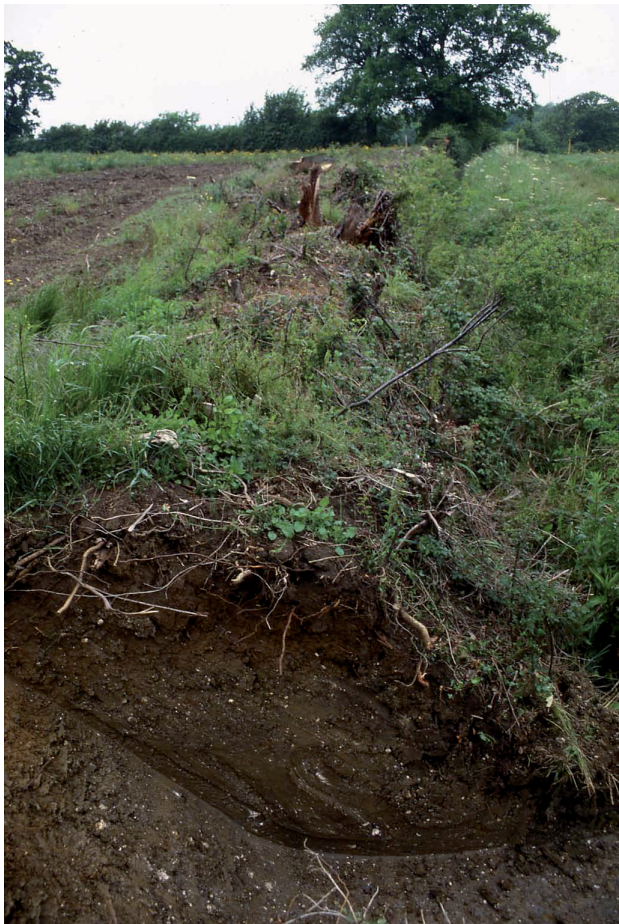
Figure 7: East facing section through Boundary B4.

Boundary B4 is on an east to west alignment, but curves gently to the north-west. It comprises a substantial ditch with a bank on either side with a hedge to the south-west. The ditch was 3.40m wide and 1.50m deep, and the base contained a substantial deposit of slumped topsoil. The hedgerow contained a number of mature oak trees, which suggests that this boundary is of some antiquity, at least early nineteenth century in date.

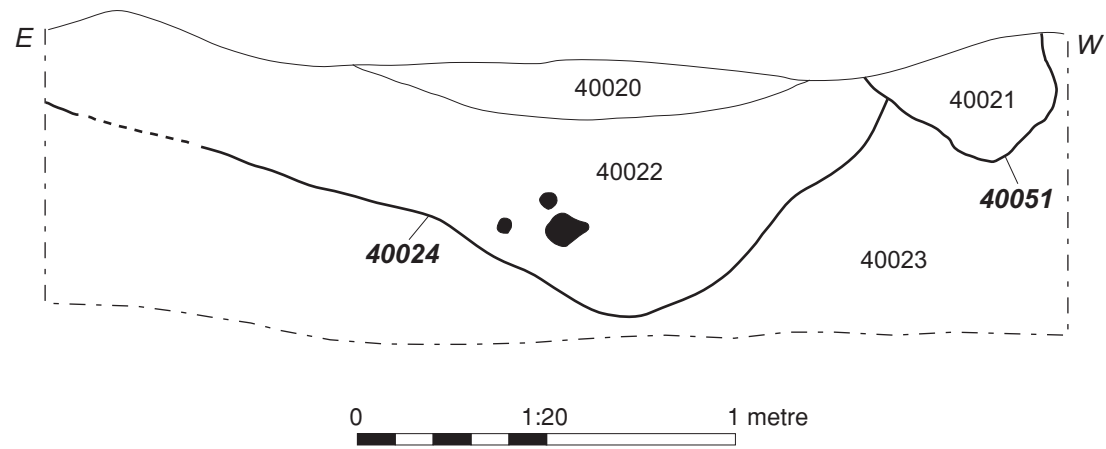
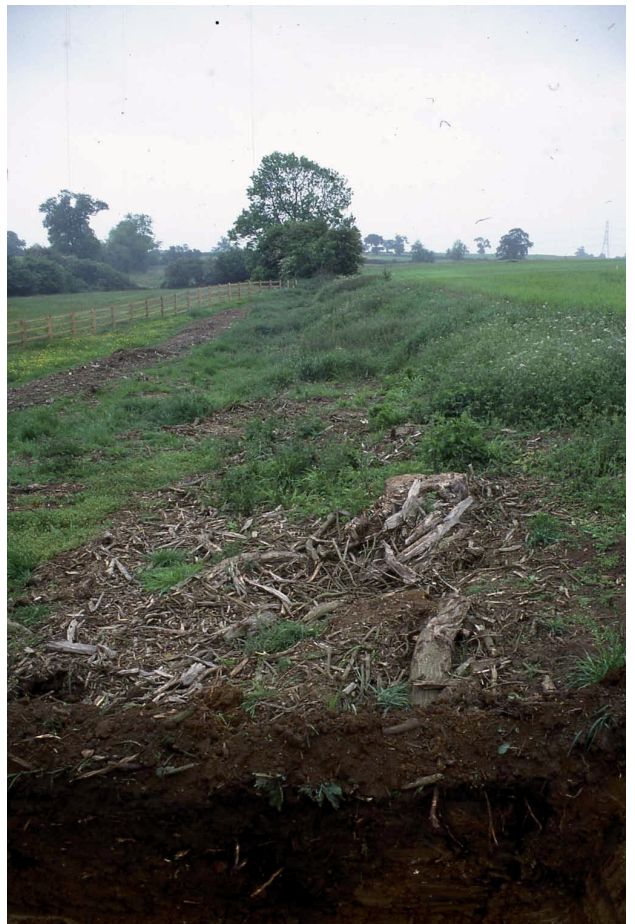
Figure 8: North facing section through Boundary B5.

Boundary B5 is aligned from north-north-west to south-south-east, and comprises two low banks and a hedge to the southwest. Investigation revealed that the two banks were above an older silted ditch. This ditch was 2.46m wide and 0.68m deep, and was filled with grey-brown silty clay. The top of the older ditch was truncated to the south-west by a substantial filled-in tree-throw hole. This suggests that this ditch is of some antiquity.

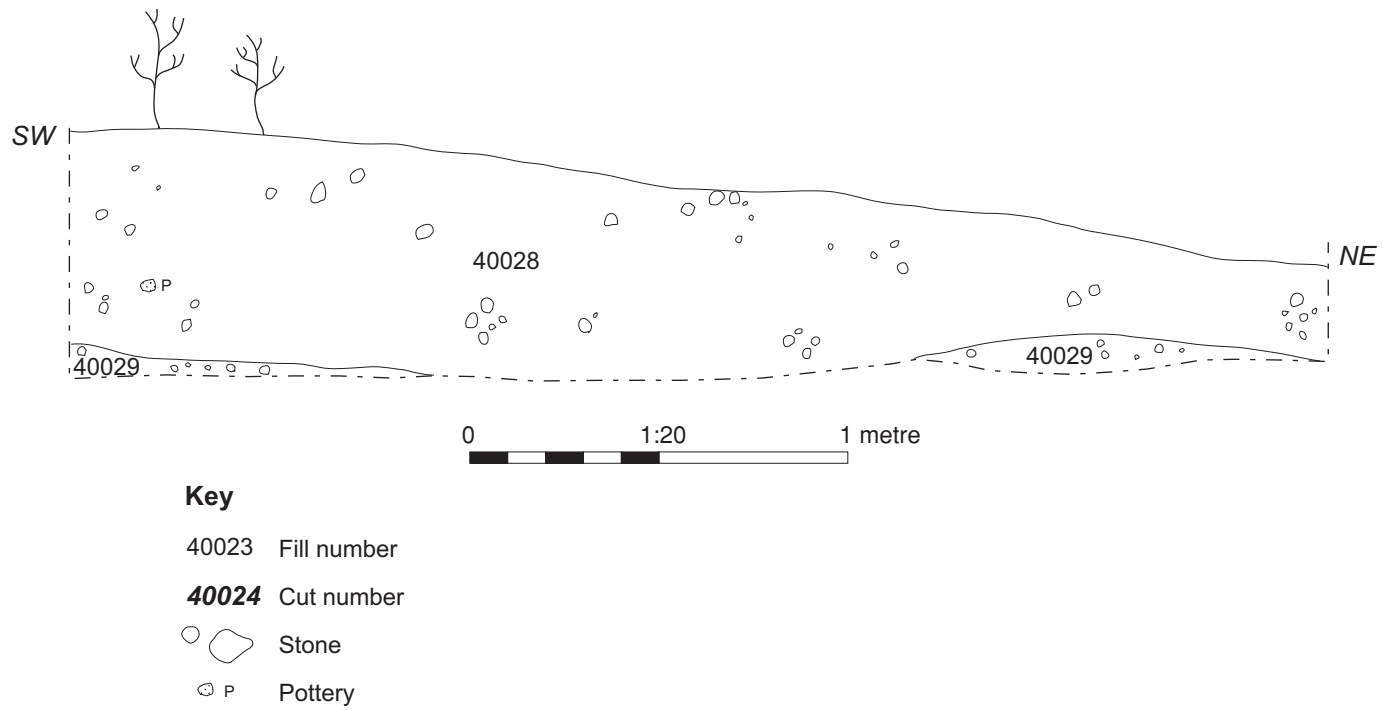
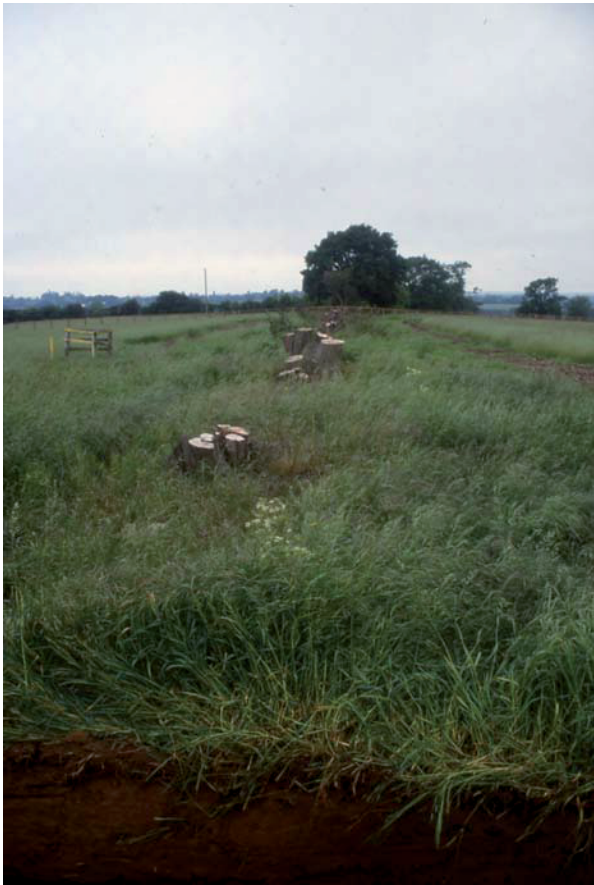
Figure 11: South-east facing section through Boundary B8.

Boundary B8 is aligned from north-west to south-east, and comprises a low, 0.68m high, bank topped by a hedge of small trees. A machine excavated section across the boundary revealed that the bank was made up of topsoil, which overlay the remnants of a ridge and furrow system on the same alignment. The bank material also contained a small sherd of post-medieval pottery. This evidence suggests that this boundary was constructed in the eighteenth or nineteenth century, as part of the enclosure of the open fields.

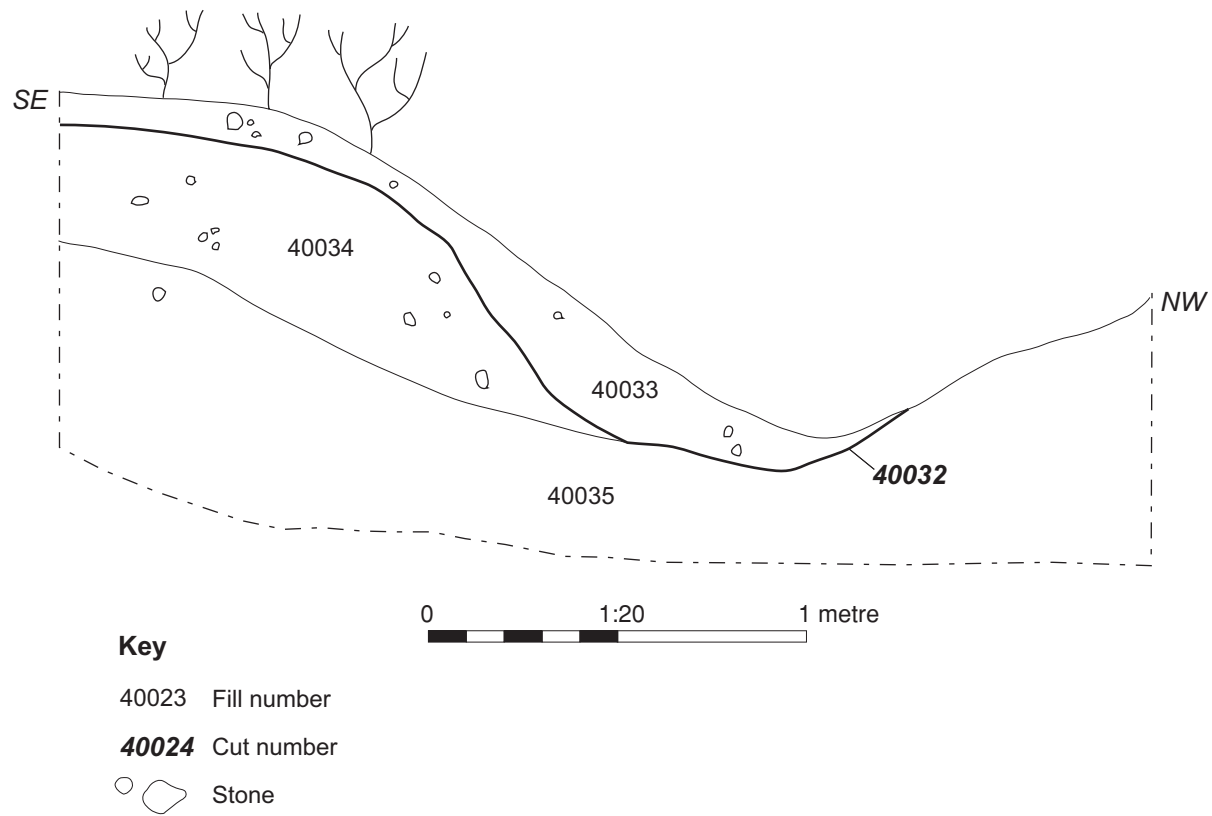
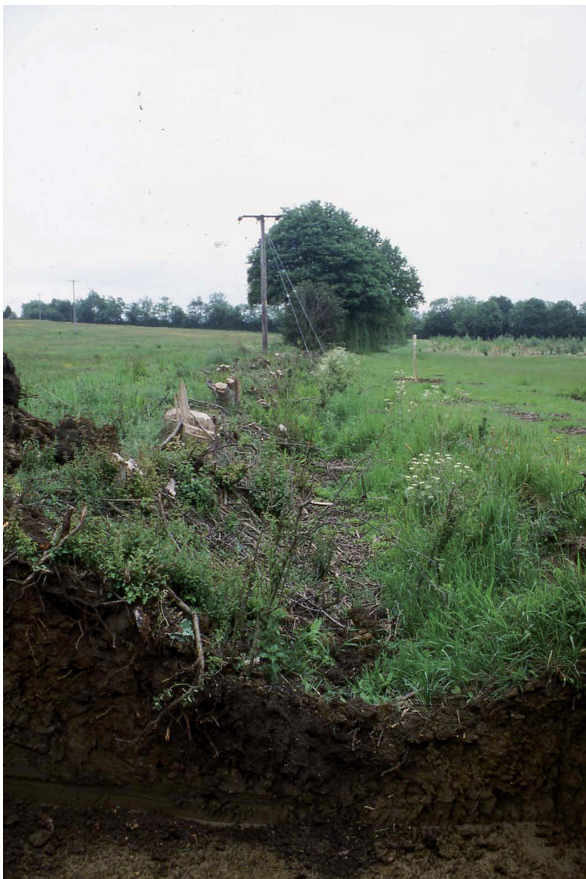
Figure 12: North-east facing section through Boundary B11.

Boundary B11 is aligned north-east to south-west, immediately to the south of the village of Stoke Hammond. It is part of the current boundary between the parishes of Soulbury and Stoke Hammond. It comprises a substantial, 2.6m wide and 0.8m deep, ditch between two banks, with a hawthorn hedge on the southern bank. There was a 0.3m deep deposit of topsoil material in the base of the ditch, which has slumped in from the southern side. No dating evidence was recovered.

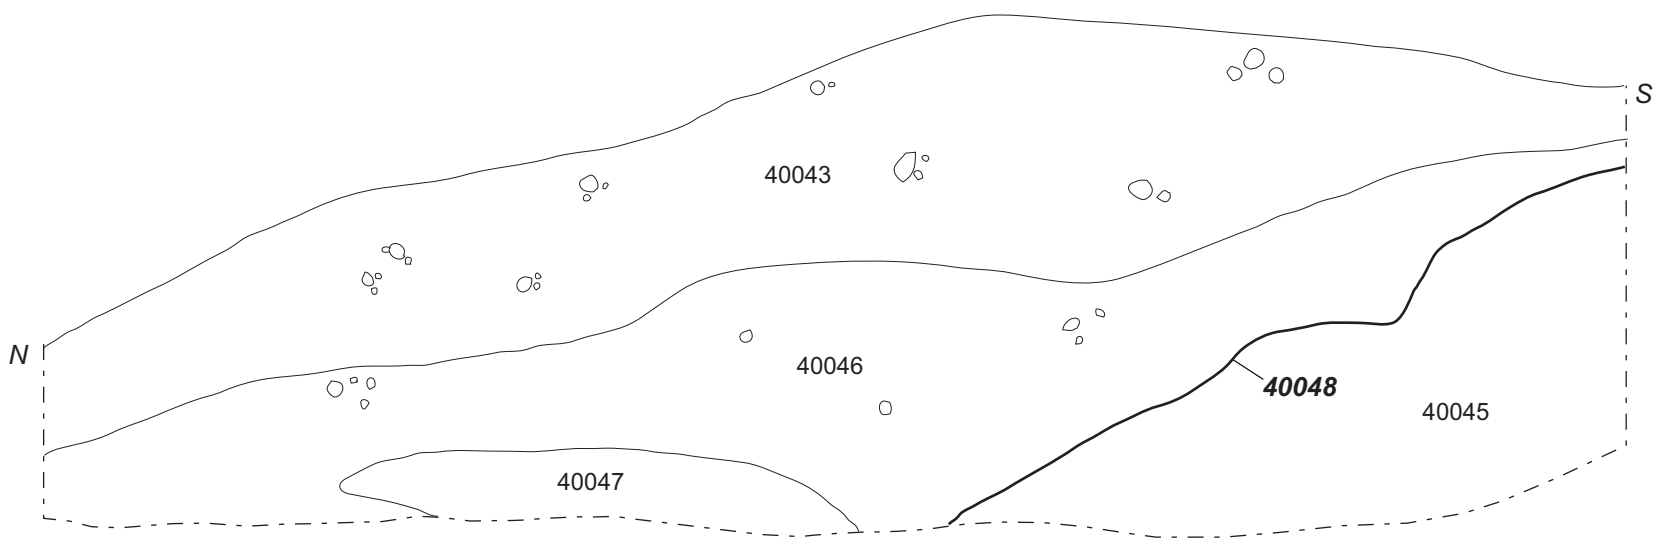
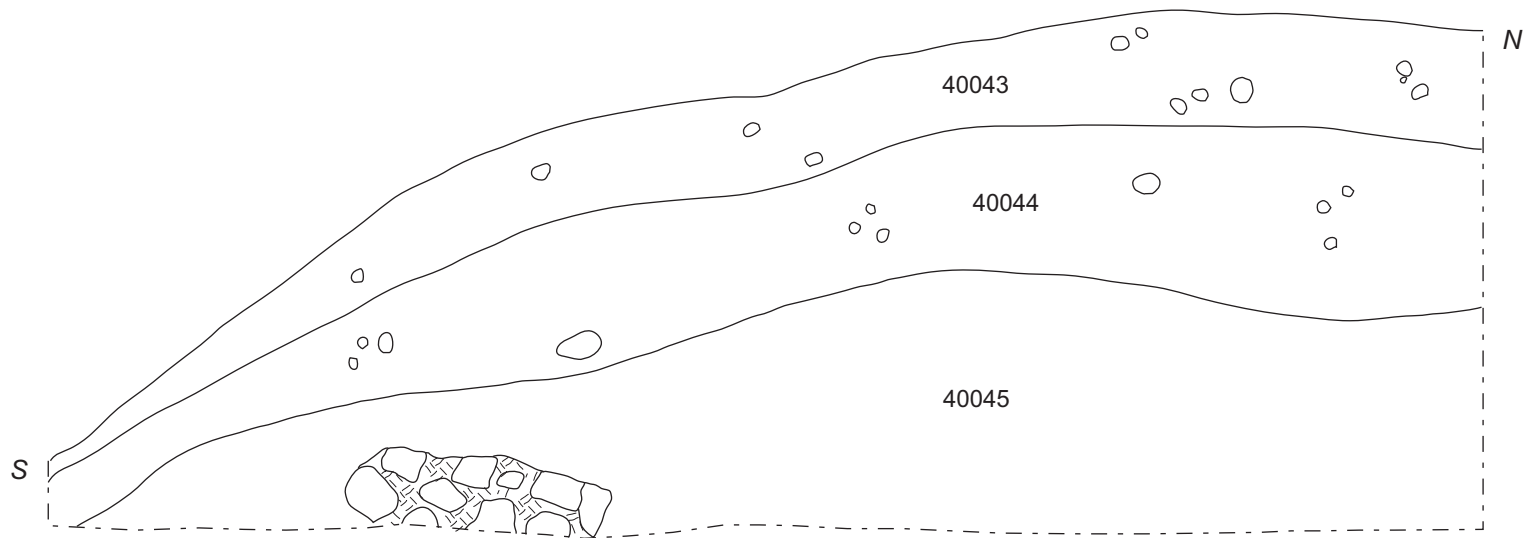
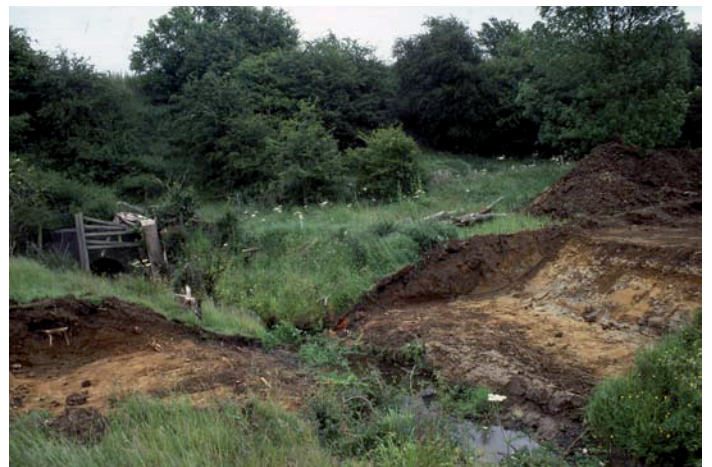
Figure 13: West facing section through Boundary B12.

Boundary B12 is aligned from north-east to south-west, and comprises a sizeable stream with a hawthorn and willow hedge on the northern bank. Machine investigation revealed a former stream channel within the southern edge of the ditch, suggesting that this was a natural stream used as a boundary, rather than a man-made structure. This boundary may be of significant age, but no definite evidence was found on site.

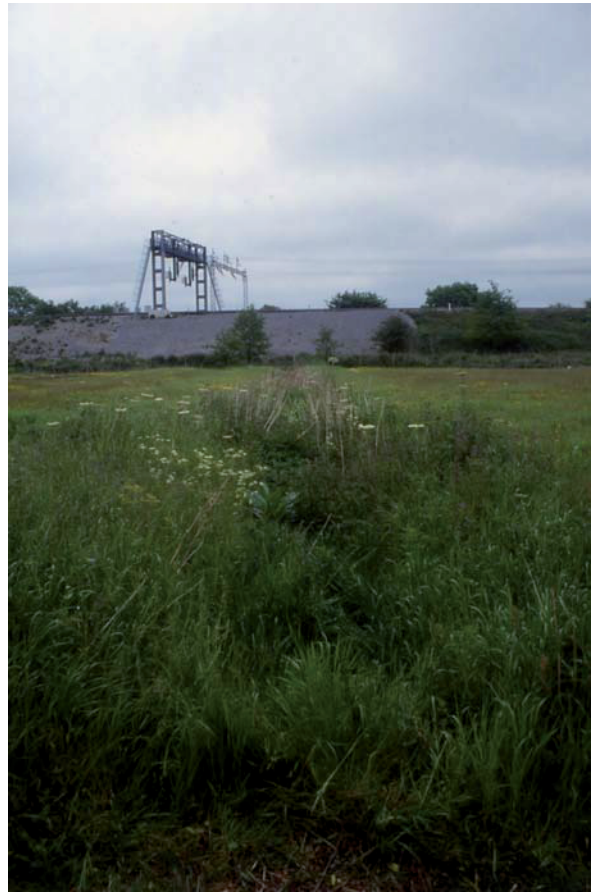
Plate 6: Boundary B10, looking north-east.

Boundary B10 is aligned north-east to south-west and comprises a small stream with an overgrown bank on either side. The stream is 3.7m wide, and 0.6m deep from the

tops of the banks. No intrusive investigation was undertaken because the stream was a possible habitat for great crested newts. The boundary has been identified as being marked on maps pre-dating 1845, and so is considered historically significant.
