# LEEDS FLOOD ALLEVIATION SCHEME 2 STEP 1: SOVEREIGN STREET FOOTBRIDGE, LEEDS, WEST YORKSHIRE

Archive Report for:  
Archaeological Monitoring (Watching Brief)

**Project Code: SVB16**

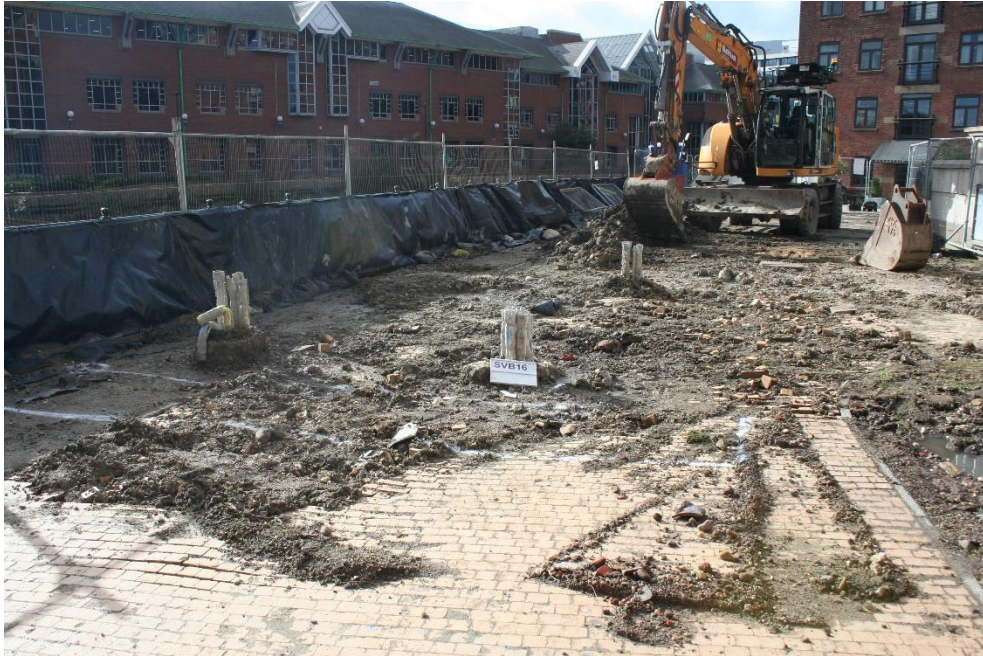
Photograph 1: Overview of the excavation area to the south of the river, facing east.

Trench 1 measured 4.5m x 7.1m and was located at the landing point of the bridge on the south side of the River Aire (Figure 2, Photograph 1). It was excavated to facilitate the erection of the piles to support the bridge.

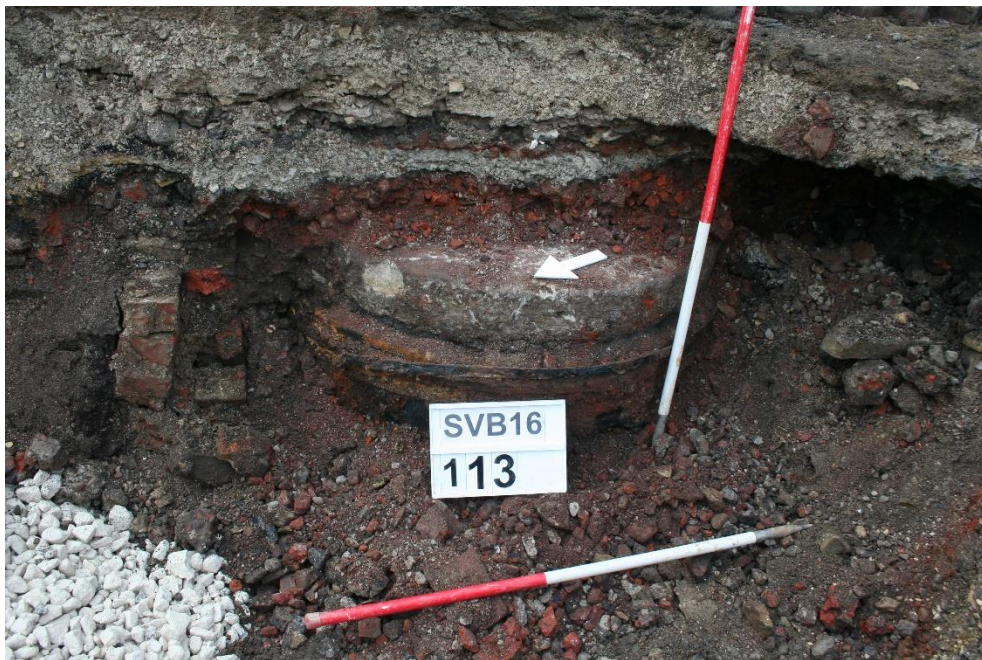
Photograph 2: Utility hole **100** (113 on board) and wall **101**, facing southeast.

Wall **101** was located in the southwest corner of the trench. It originated from the northwest-facing section of the trench and continued northwest for 1.5m, before turning southwest for 1.65m and continuing outside of the limit of excavation. Wall **101** was of brick construction, two courses in thickness and bonded with mortar. The wall enclosed a circular utility hole (**100**) of concrete and iron construction (Photograph 2).

Utility hole **100** and wall **101** were abutted by layer **103**, a dark greyish-brown silty sand containing approximately 50% bricks and limestone fragments. This layer covered the entirety of the trench and was excavated to a depth of 0.5m. Layer **103** was overlain by layer **102**, a 0.7m thick deposit of dark greyish brown silty sand containing bricks, limestone fragments and modern artefacts, including plastic.

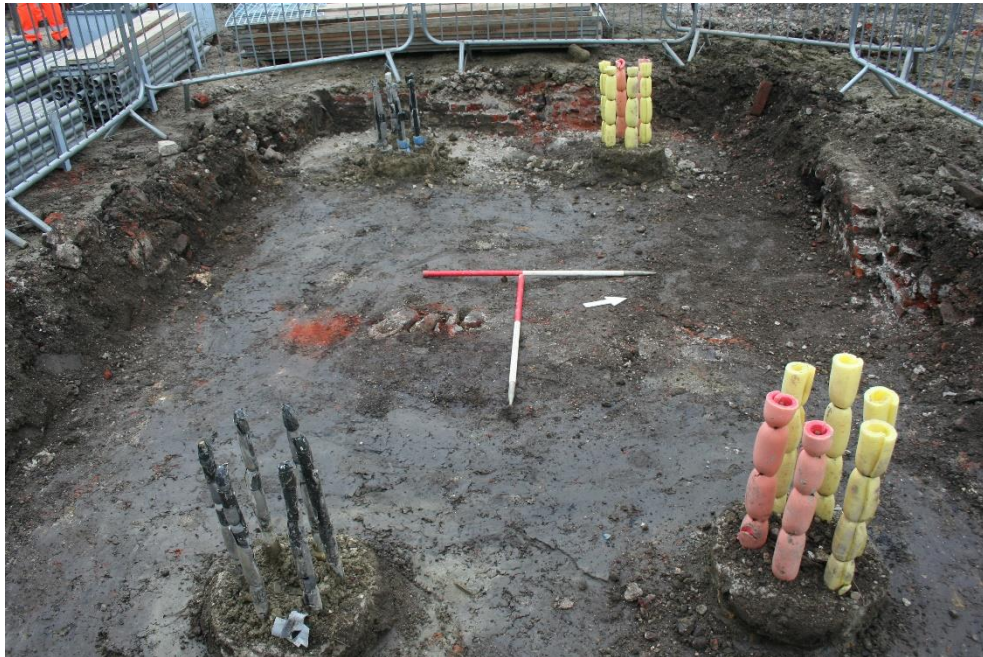
Photograph 3: Overview of trench 2, facing northwest.

Trench 2 measured 2.7m x 5.1m and was located 8m to the east of trench 1 (Figure 3, Photograph 3). It was excavated to facilitate the erection of the piles to support the bridge.

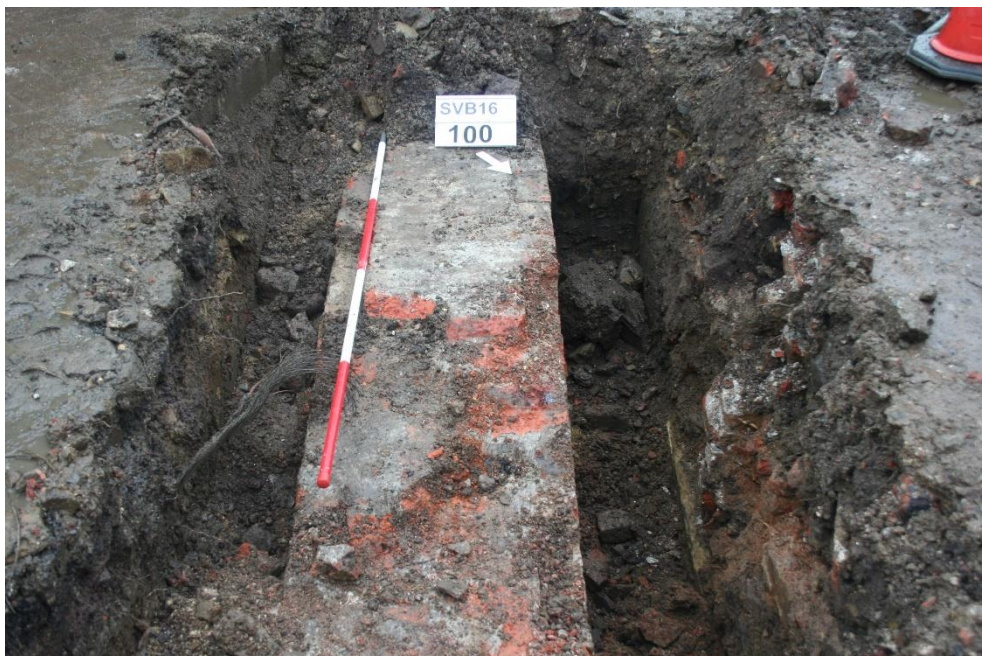
Photograph 4: Wall **200** (100 on board), facing southwest.

Wall **200** was located in the southern half of the trench (Photograph 4). It originated from the southwest-facing limit of excavation and continued approximately 2.6m southwest, continuing under the northeast-facing limit of excavation. The wall was 0.75m wide and was excavated to a depth of 1.5m (Photograph 5). The upper 1.1m of the wall was of brick construction, two-bricks thick, bonded with mortar. The lower 0.4 of the wall was constructed from limestone blocks, 1m wide x 0.3m deep.

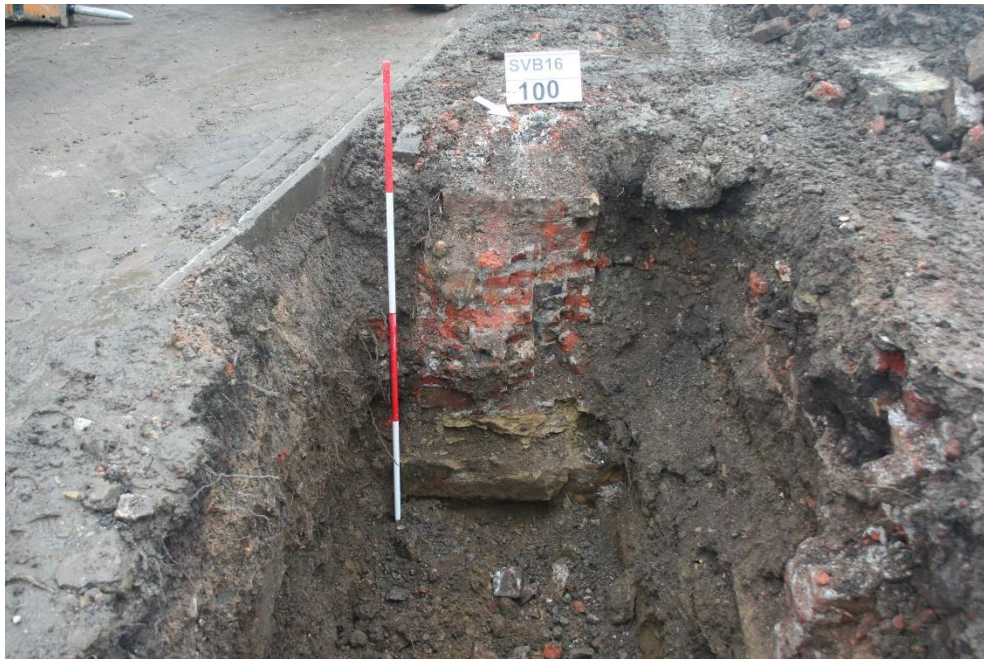
Photograph 5: Wall **200** (100 on board) partially removed, facing southwest.

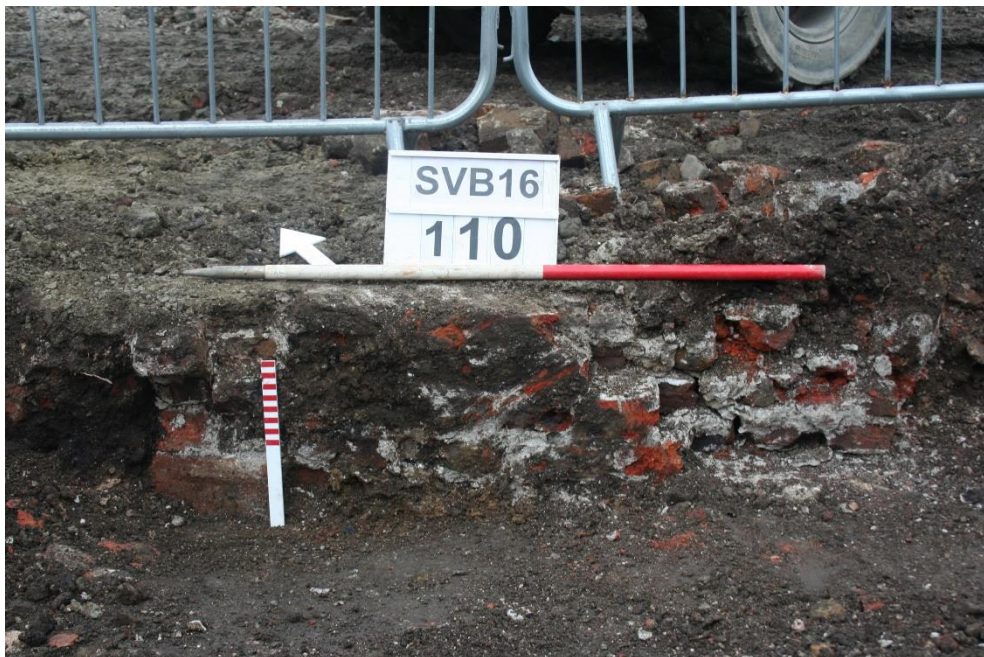
Photograph 6: Wall **204** (110 on board), facing northeast.

A short section of truncated brick wall (**204**) was recorded in the centre of the southwest facing section of the trench (Photograph 6). A length of approximately 1.45m of the walls was visible and it continued beyond the limit of excavation to the northwest. Wall **204** was situated approximately 1.4m to the northeast of wall **201** and ran parallel to it.

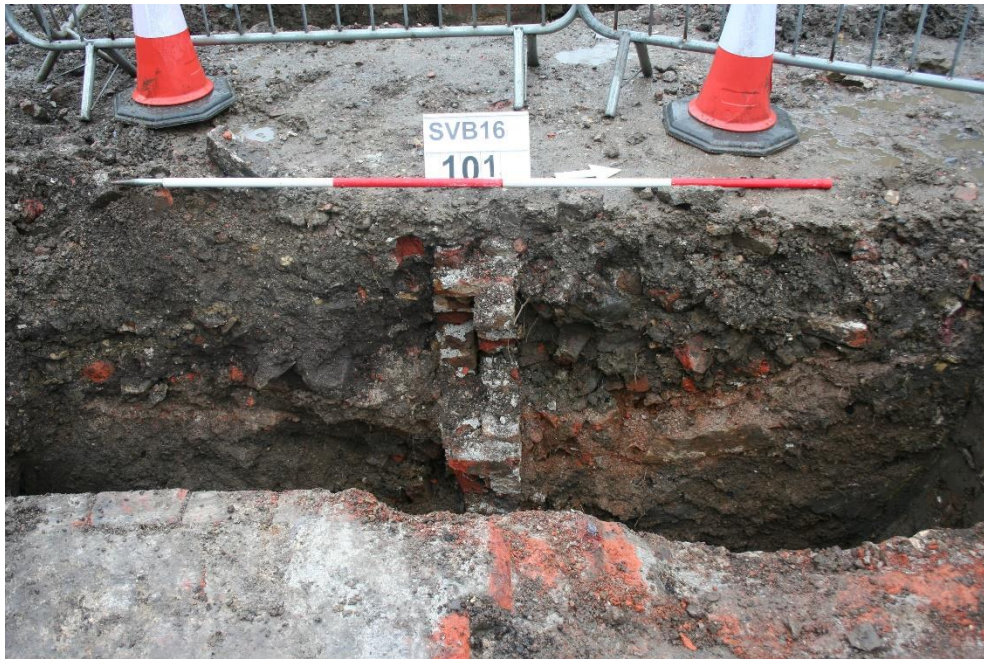
Photograph 7: Wall 300 (101 on board), facing northeast.

Wall **300** was recorded in the centre of the trench (Photograph 7). It originated from the northwest-facing limit of excavation and continued for approximately 4.8m to the northwest, continuing under the southeast-facing limit of excavation. The wall was approximately 0.7m wide and was excavated to a depth of 1.4m. The upper 1.1m of the wall was of brick construction, two courses thick, bonded with mortar. The lower 0.3m of the wall was constructed from limestone blocks, 1m wide x 0.2m deep. The wall was initially recorded in the northern half of the trench and was later found to continue to the south as wall **302**. Wall **300** abutted feature **305**, a perpendicular wall of limestone blocks 0.35m thick, which was partially visible in the north-western limit of excavation and which possibly forming the previous southern bank of the river (Photograph 8).

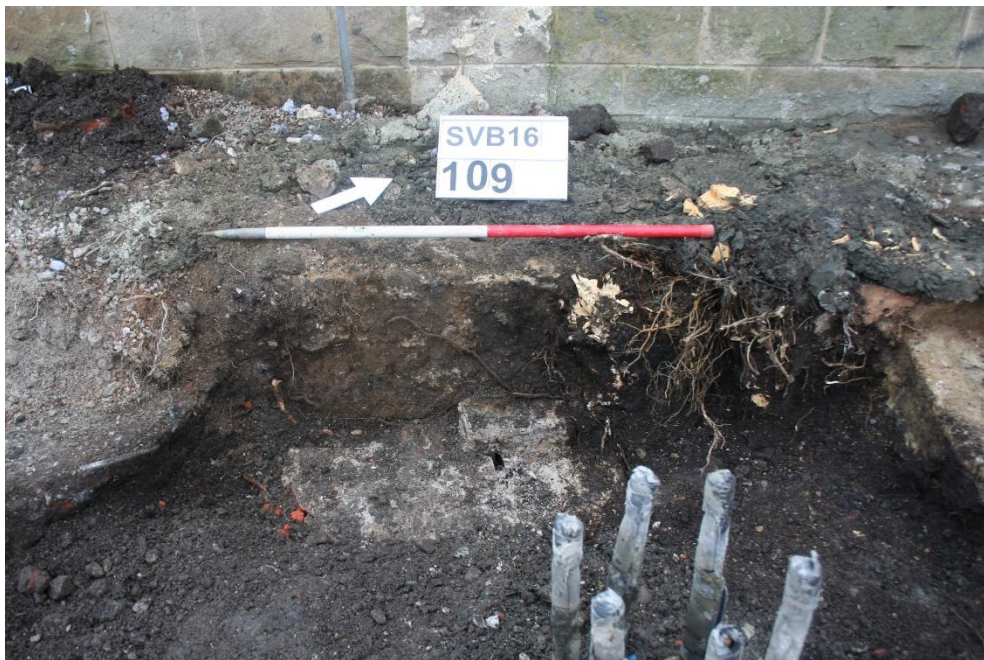
Photograph 8: Wall 305 (109 on board), facing northwest.

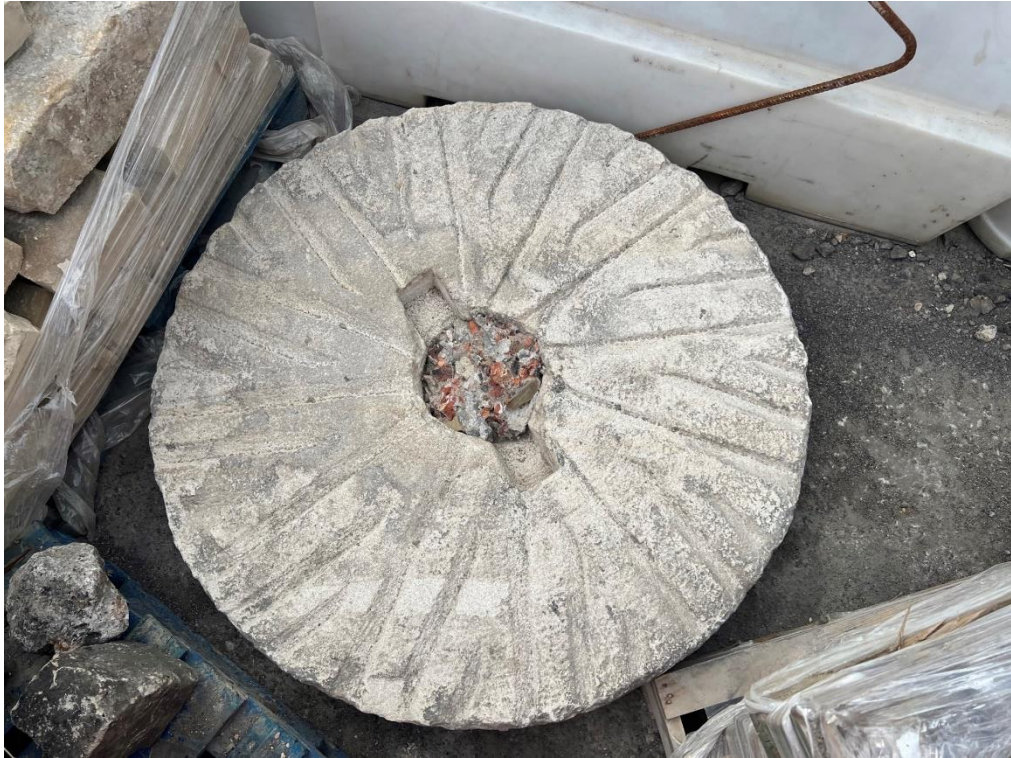
Photograph 9: Post-medieval millstone recovered by BAM during the removal of made-ground deposits during ground leveling

Following the curtailment of the watching brief through agreement with WYAAS, a post-medieval millstone was recovered by BAM during the excavation of foundation piles 2.9m south of trench 2 (Photographs 9 and 10, and Figure 3). The millstone was a single piece of flat disc shaped coarse sandstone 1250mm in diameter and 160mm thick. There is a circular hole or 'eye' through the centre measuring 250mm in diameter. The eye of the millstone was filled with a mixture of brick, stone and mortar that could not be removed without damaging the stone. The location of the stone, 2.9m south of trench 2, suggests that it comes from a similar context to

The millstone is of flat disc-shape and has a rectangular rynd chase and neat pronounced harped grooving. These features indicate a post-medieval date because medieval millstones tended to have curved rynd chases and cruder grooving (Watts 2002, 102).

Upper millstone. A large and complete monolithic stone of flat disc type with deep and wide harped grooving and two-armed rectangular rynd chase set into the grinding surface. The rynd chase measures 100mm in width and 400mm in length plus 60mm in depth. The eye is circular and measures 250mm in diameter and is filled with a brick/concrete mixture. The circumference is roughly tooled. The opposing face was not recorded due to being underneath. The millstone measures 1250mm in diameter x 160mm in thickness.

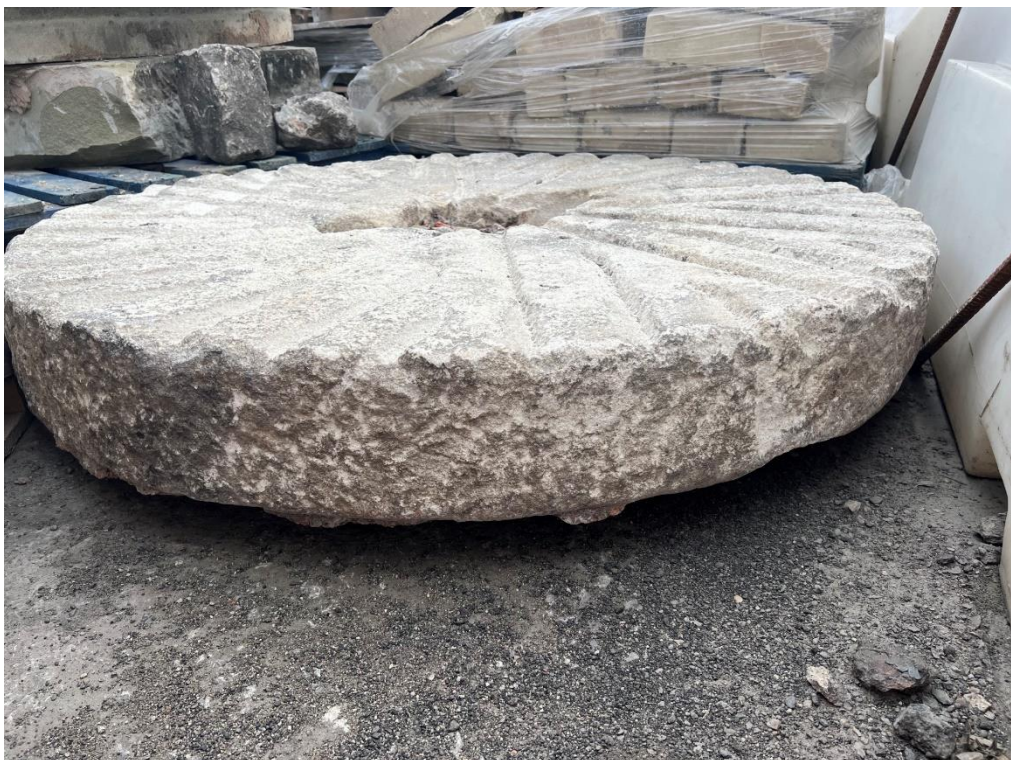
Photograph 10: Side view of the post-medieval millstone

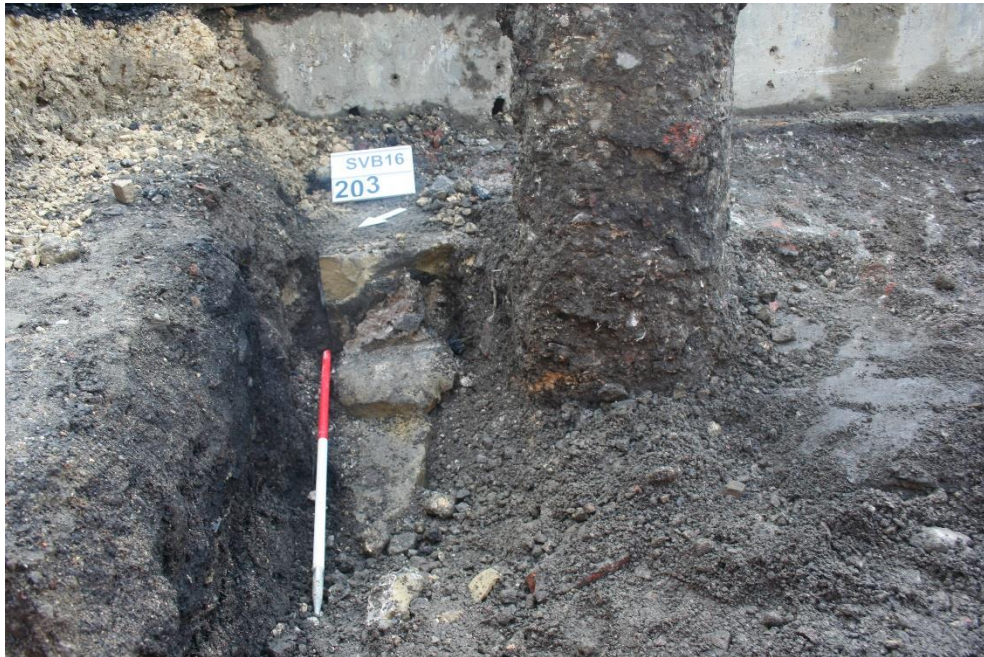
Photograph 11: Wall 403 (203 on board), facing southeast.

Wall **403** was located in the southeast corner of the trench and oriented northwest to southeast (Photograph 11). Approximately 1.5m x 0.5m of the wall was exposed within the trench and it continued under the northeast and southwest limits of excavation. Wall **404** ran along the southeast limit of excavation and was oriented northeast to southwest. Approximately 6.4m of the wall was visible in the northwest facing section of the trench and continued to the northeast to southwest and to the southeast. Walls **403** and **404** were both constructed from limestone blocks approximately 1m x 0.5m x 0.5m. Northwest-southeast wall **403** was jointed into wall **404**, suggesting that they are contemporaneous to one another.

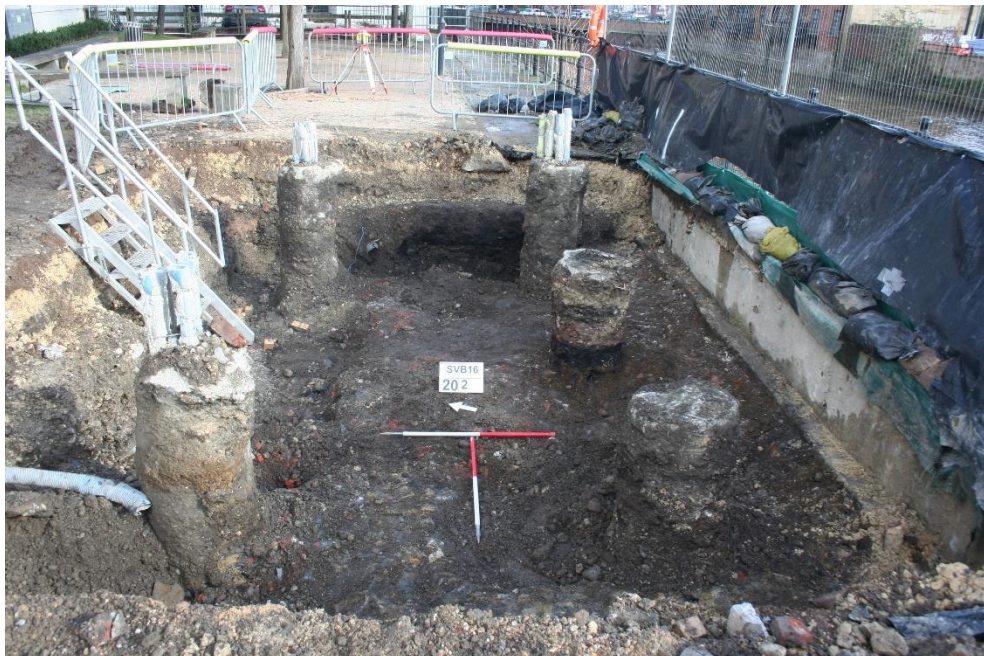
Photograph 12: Overview of made ground 402 (202 on board) in trench 4, facing east.

Walls **403** and **404** were abutted by a modern levelling deposit **402** (Photograph 12), a layer comprising bricks, mortar and concrete fragments, excavated to a depth of 0.2m-0.5m. Layer **402** was overlain by layer **401**, a 0.4m thick deposit of mixed black sand, limestone fragments and modern artefacts, including off-cuts of plastic pipe. The whole trench was covered with a brick pavement (**400**) and associated preparation layers of sand and crushed limestone. Layer **405** was recorded in the southwest facing section the trench following the partial removal of wall **403**. The layer was not excavated but comprised a dark grey and black coarse sand, visible in the section to a depth of 0.8m.
