## **TIRLEY TO DYMOCK**

## Proposed High Pressure Natural Gas Supply Pipeline

# FIELDWALKING, FIELD RECONNAISSANCE AND GEOPHYSICAL SURVEY

Report No. 279 January 2002

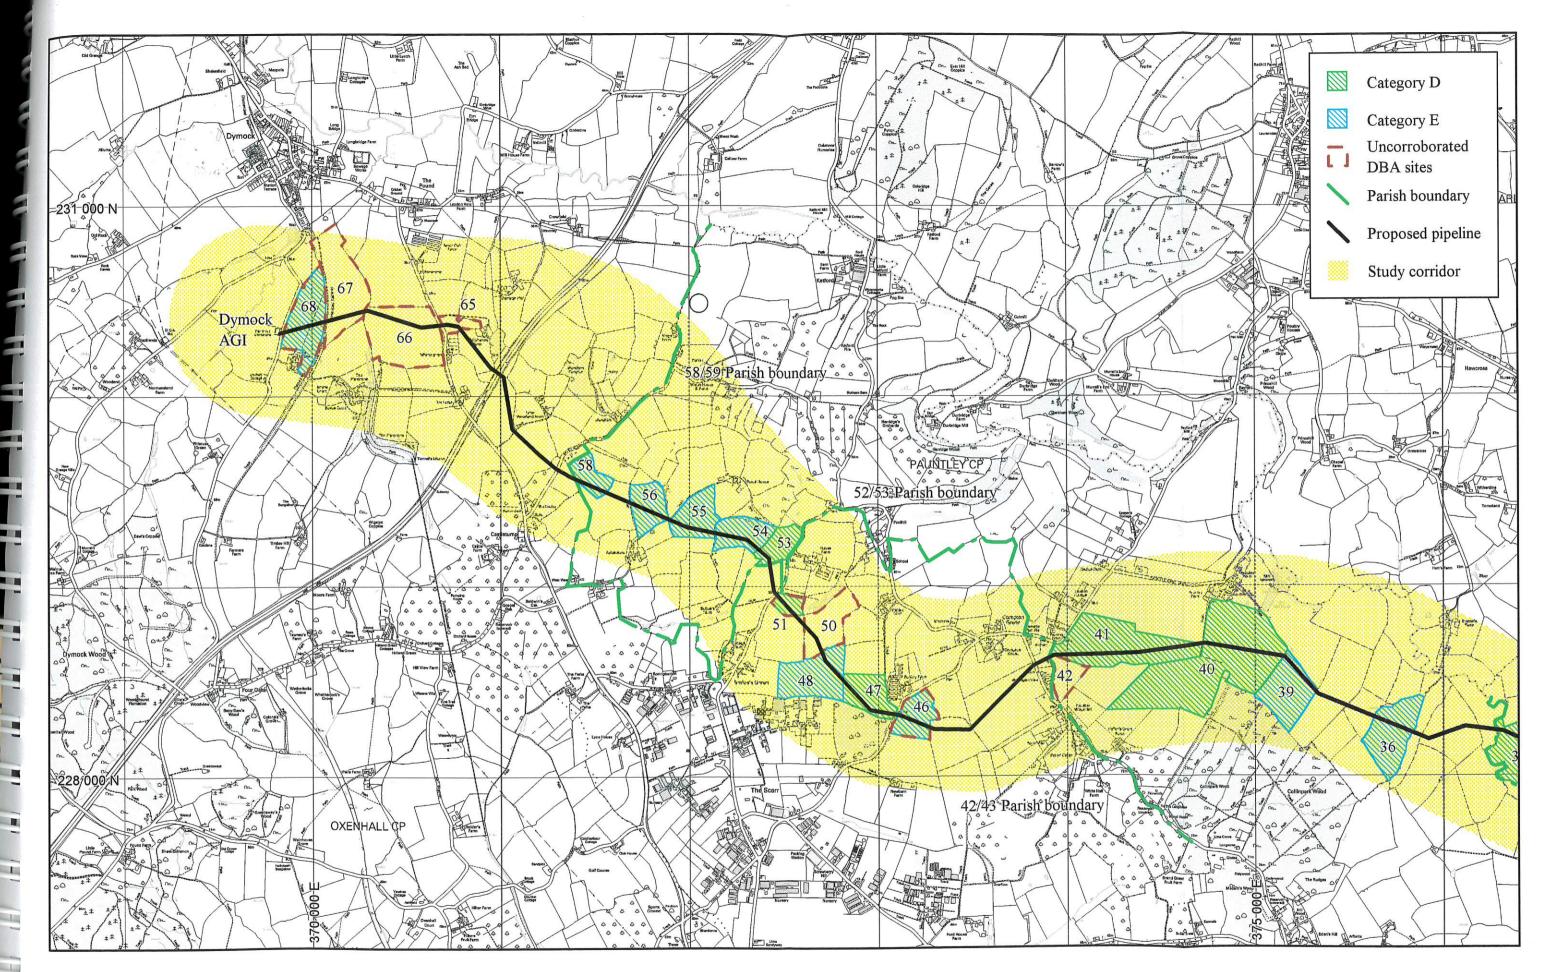
Figure 3: Proposed Tirley to Dymock pipeline and location of plots containing archaeology observed during field and geophysical surveys [Reproduced at 1:20 000 scale from Ordnance Survey Data with permission of the Controller of Her Majesty's Stationery Office. © Crown Copyright reserved. Licence number AL 52256A]

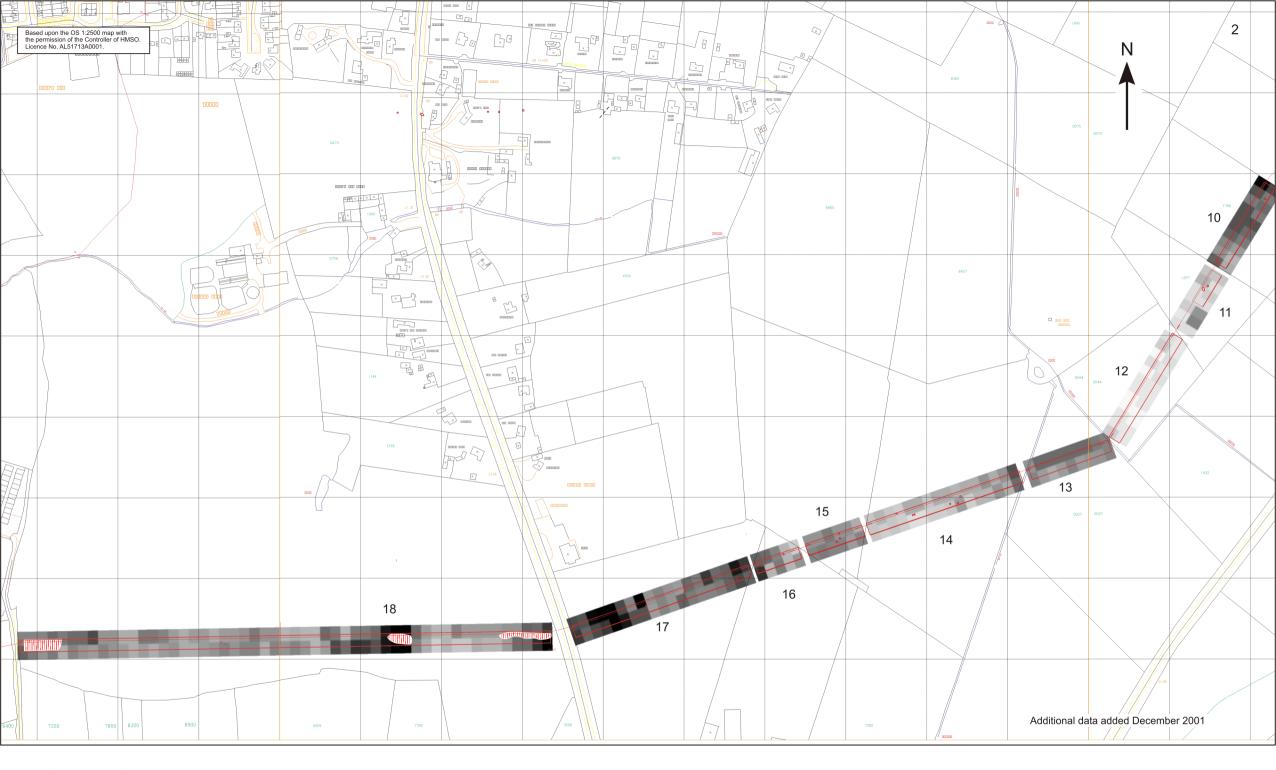
Tirley to Dymock, Gloucestershire Geophysical Survey of Gas Pipeline 2001 Figure 5: Magnetic Susceptibility Survey Fields 10 - 18 (with magnetometer survey findings)

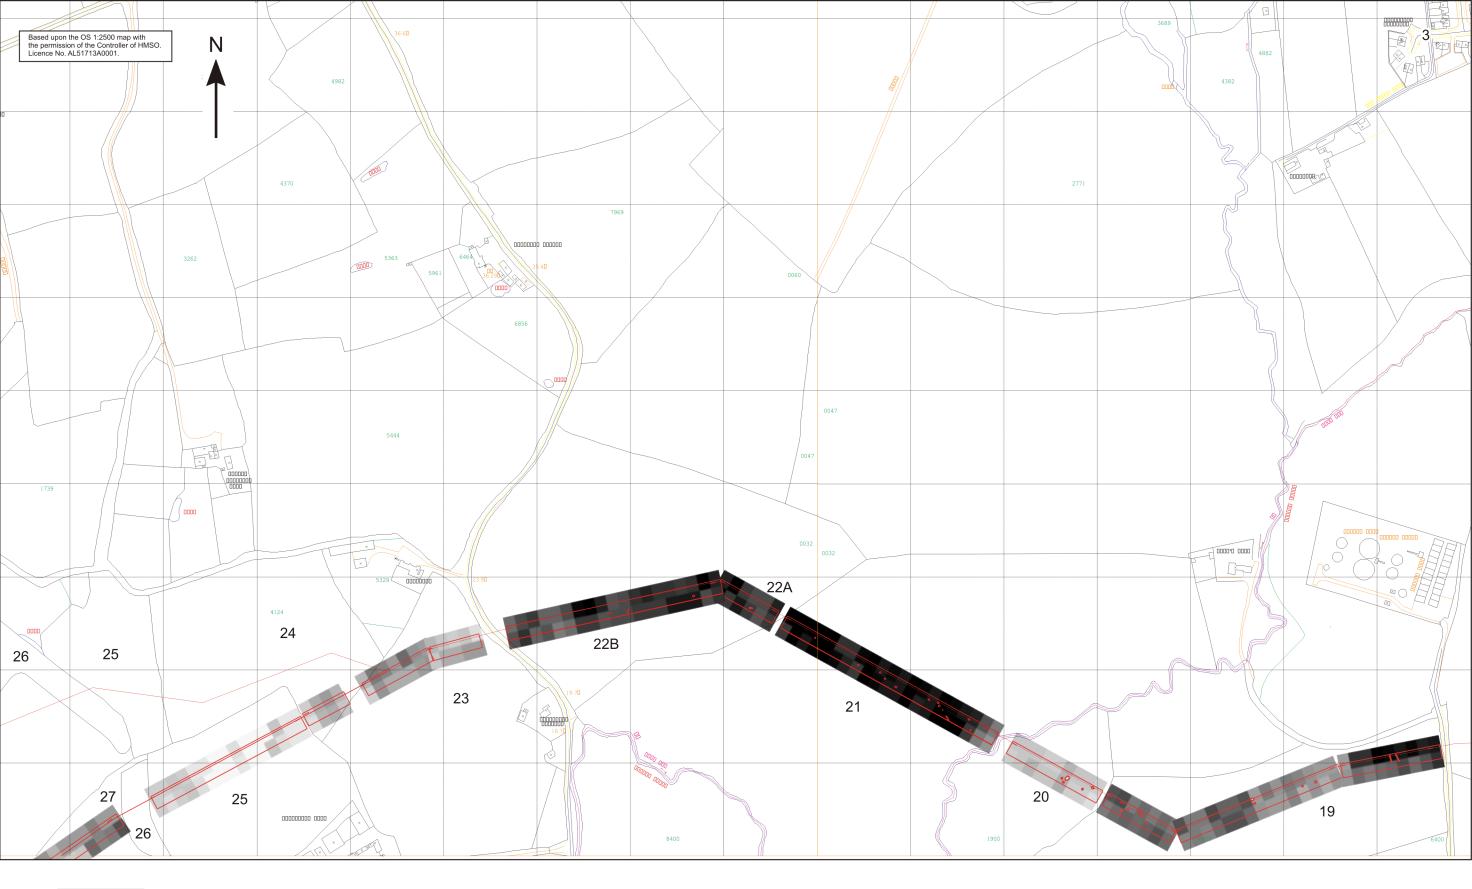
Tirley to Dymock, Gloucestershire Geophysical Survey of Gas Pipeline 2001 Figure 6: Magnetic Susceptibility Survey Fields 19 - 26 (with magnetometer survey findings)

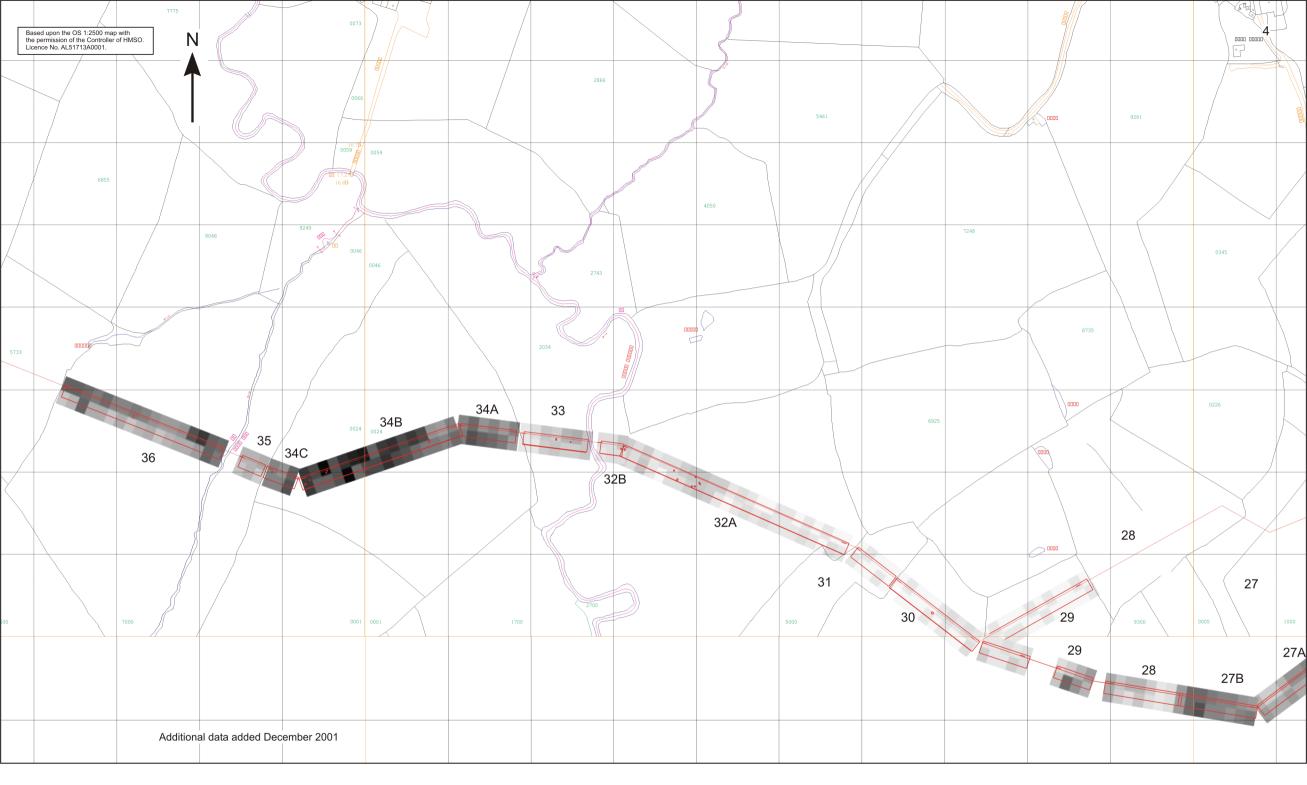
Tirley to Dymock, Gloucestershire Geophysical Survey of Gas Pipeline 2001 Figure 7: Magnetic Susceptibility Survey Fields 27 - 36 (with magnetometer survey findings)

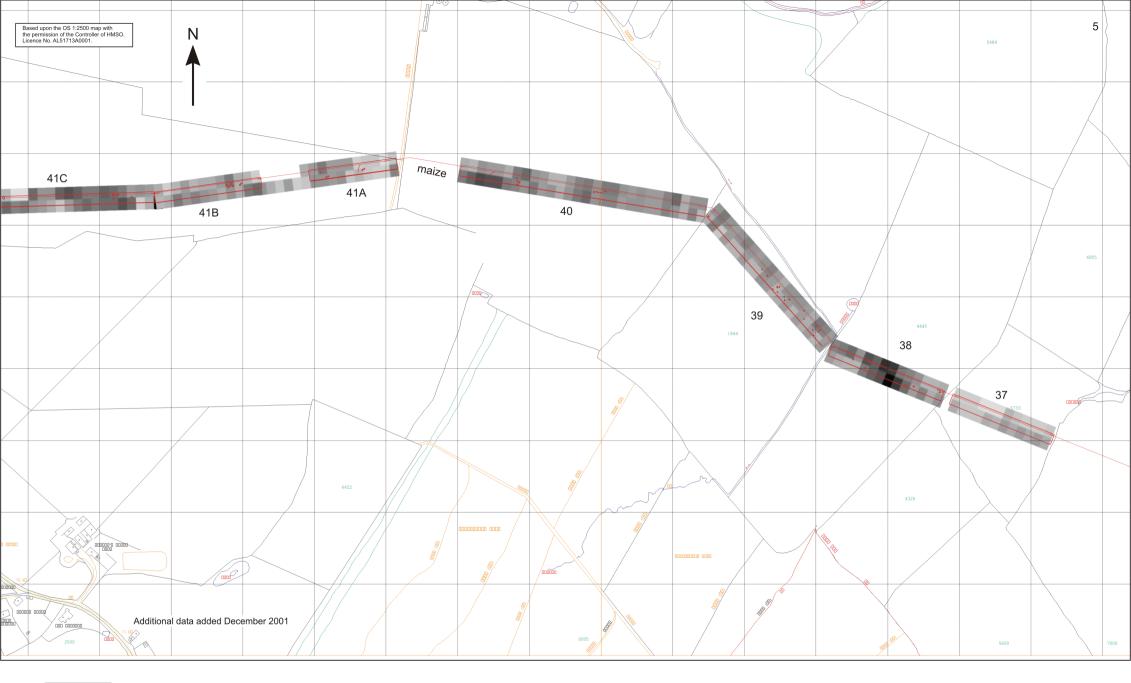
Tirley to Dymock, Gloucestershire Geophysical Survey of Gas Pipeline 2001 Figure 8: Magnetic Susceptibility Survey Fields 37 - 41 (with magnetometer survey findings)

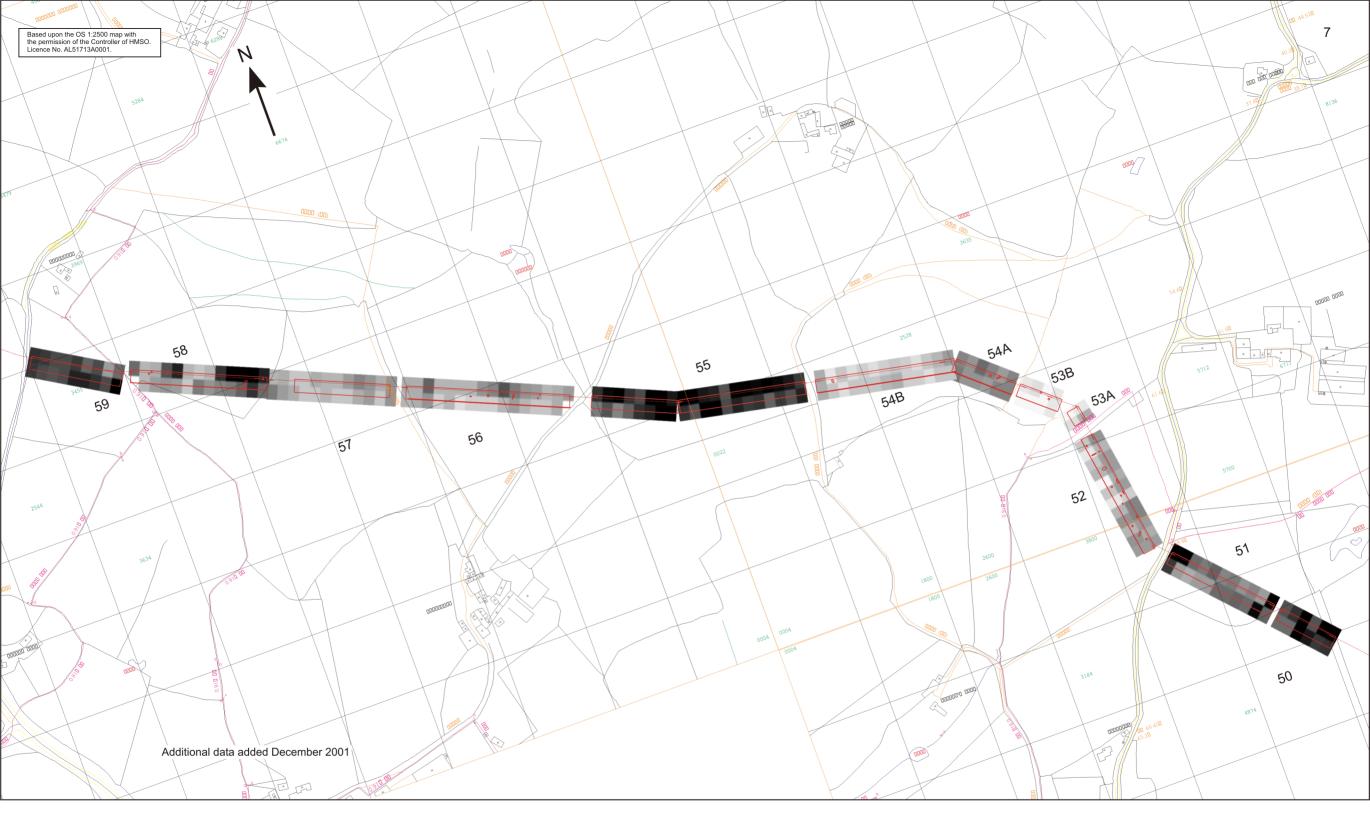
Tirley to Dymock, Gloucestershire Geophysical Survey of Gas Pipeline 2001 Figure 10: Magnetic Susceptibility Survey Fields 50 - 59 (with magnetometer survey findings)

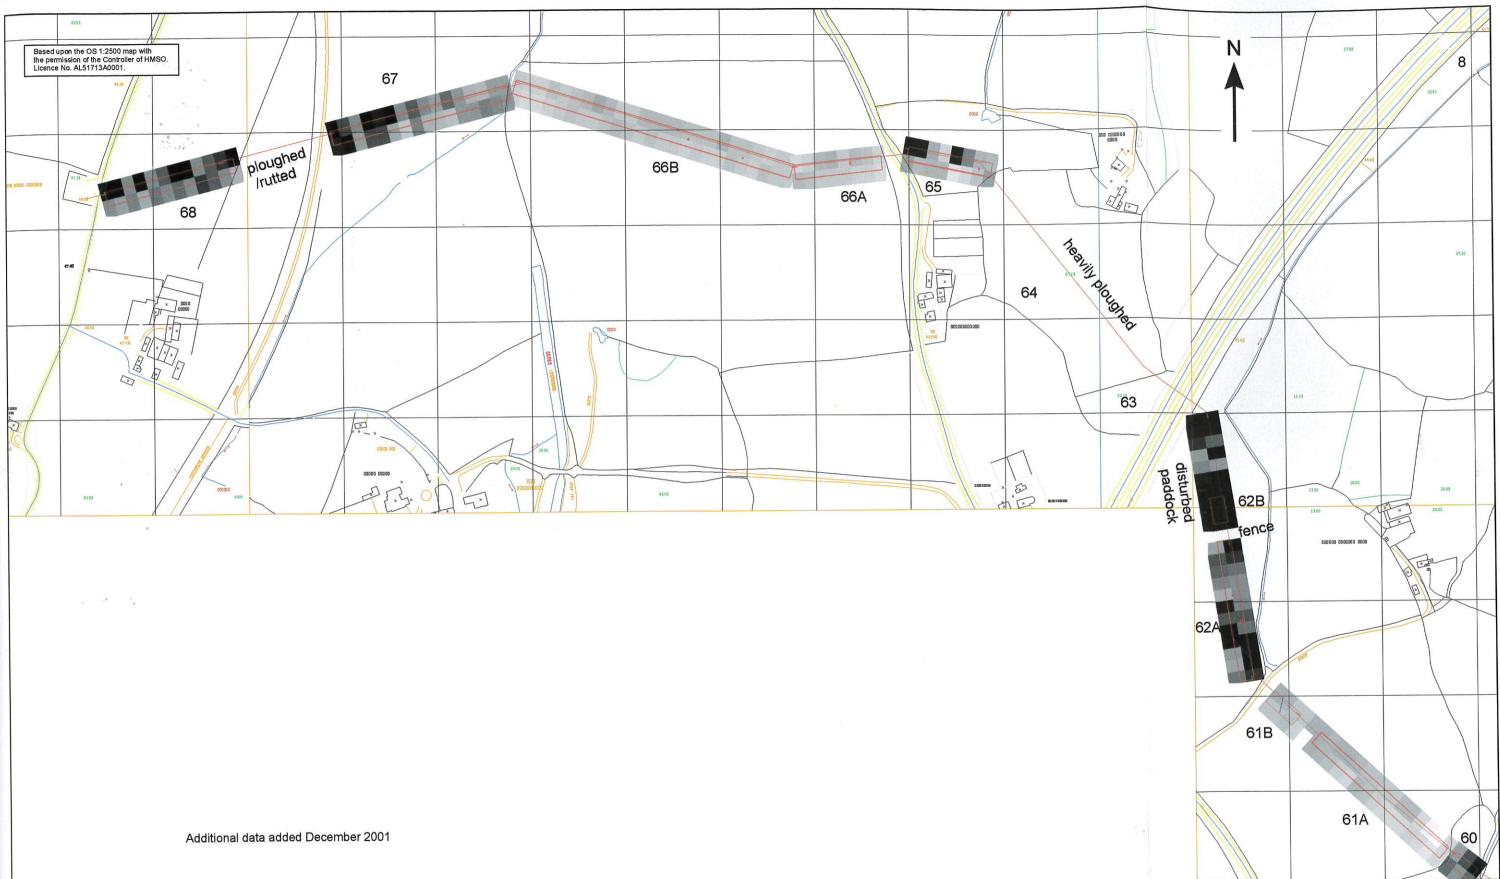
## Tirley to Dymock, Gloucestershire Geophysical Survey of Gas Pipeline 2001 Figure 11: Magnetic Susceptibility Survey Fields 60 - 68 (with magnetometer survey findings)

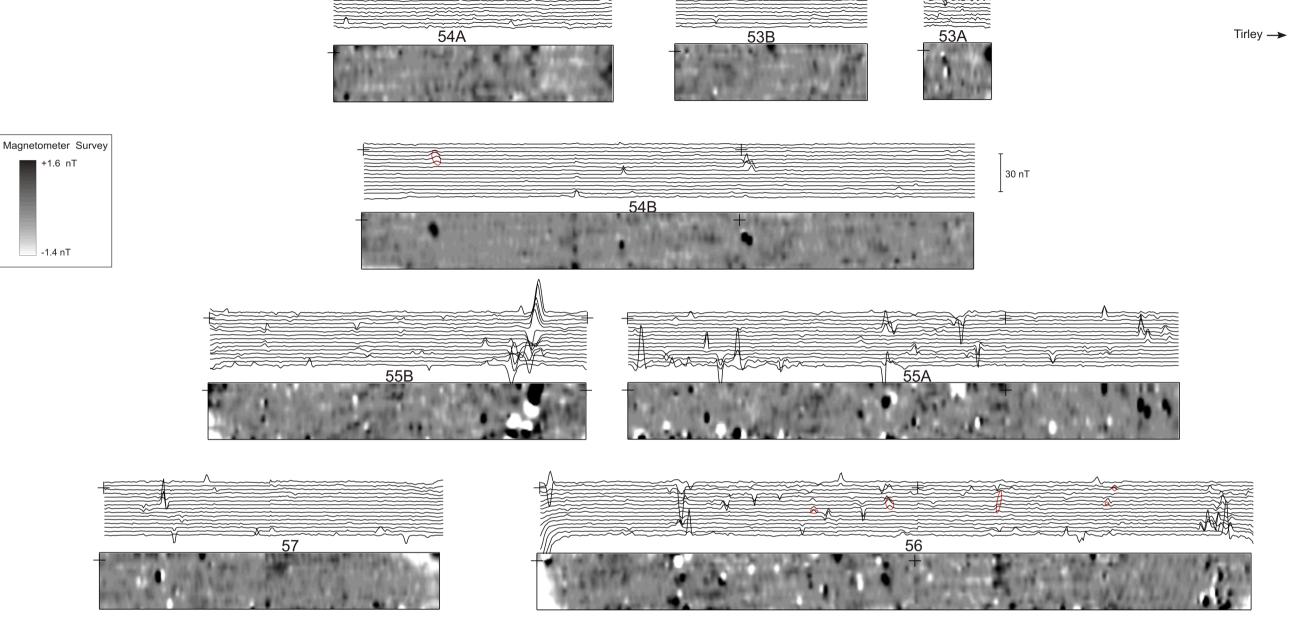
Tirley to Dymock, Gloucestershire<br/>Geophysical Survey of Gas Pipeline Route2001Figure 18:Magnetometer Survey - Fields 53 - 59Bartlett-Clark Consultancy1:1000
