EYDON STW, NORTHAMPTONSHIRE

Archive Report For:
Archaeological Observation, Investigation and Recording

Project Code: EYD 16

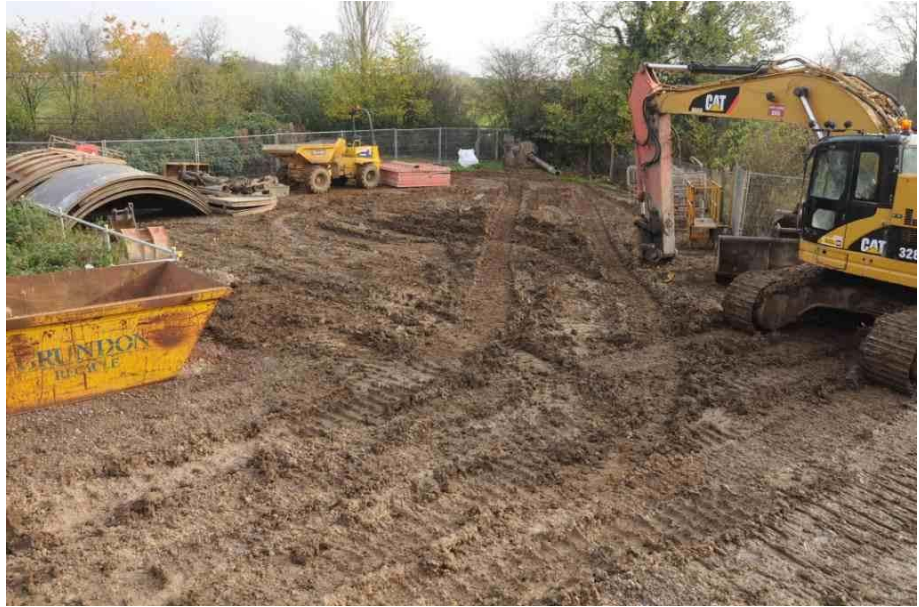
Plate 1: General view of humus tank area after topsoil strip. Camera facing southeast

The planned focus of archaeological observation was topsoil stripping of the working area and excavation of the humus tank (Plate 1, Figure 2). Deturfing and partial topsoil stripping of the working area, however, took place prior to archaeological attendance. A walk-over survey was, therefore undertaken over the stripped surface, and two spade-sized holes were hand-excavated to investigate the underlying soil stratigraphy (Plate 2, Figure 2).

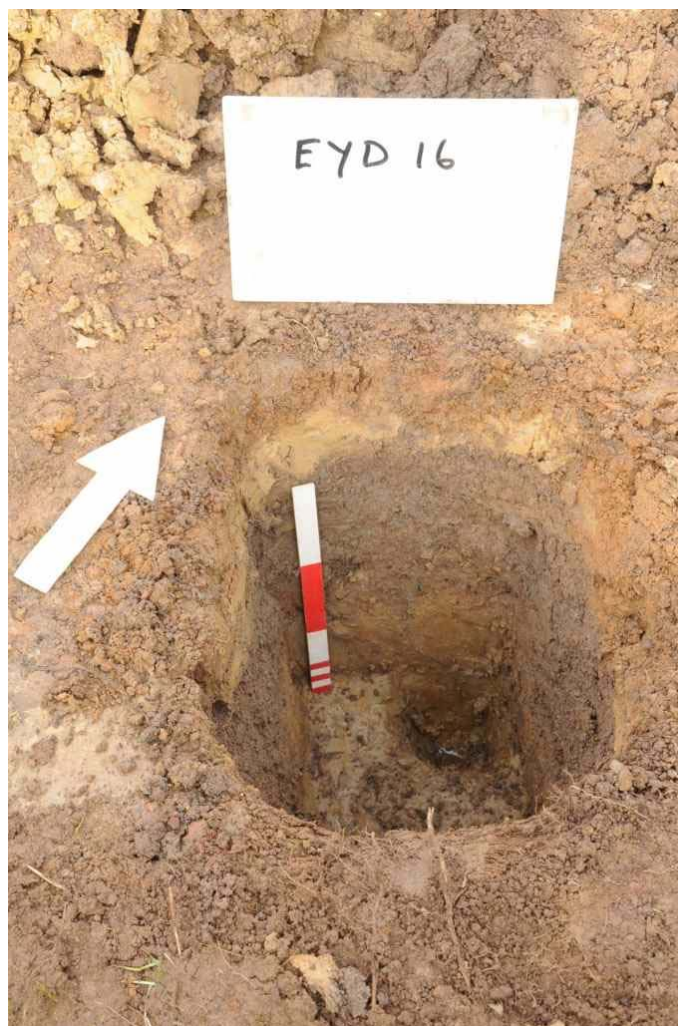
Within test-pit 1, the topsoil (001) overlay 0.11m of made-ground (002). Below the made ground was 0.2m of clayey silt alluvium (003) which overlay the natural clay geology (004) (Plate 2).

Plate 2: Test pit 1. Camera facing northwest

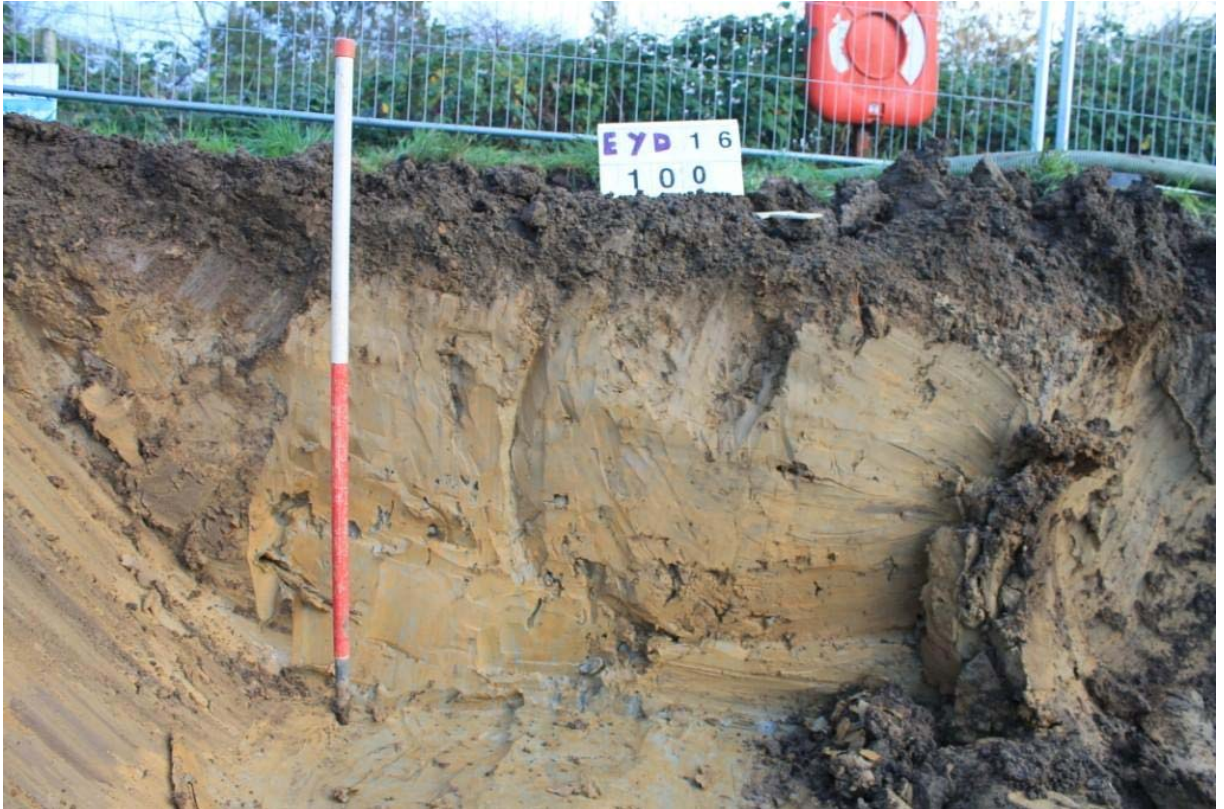
Within the area of the humus tank the general stratigraphy was topsoil (100) overlying 0.08m of subsoil (101). Below this was 0.18m of compact alluvial clay (102) which overlay the natural clay geology (103) (Plate 3).

Plate 3: Humus tank profile showing natural stratigraphy. Camera facing northeast

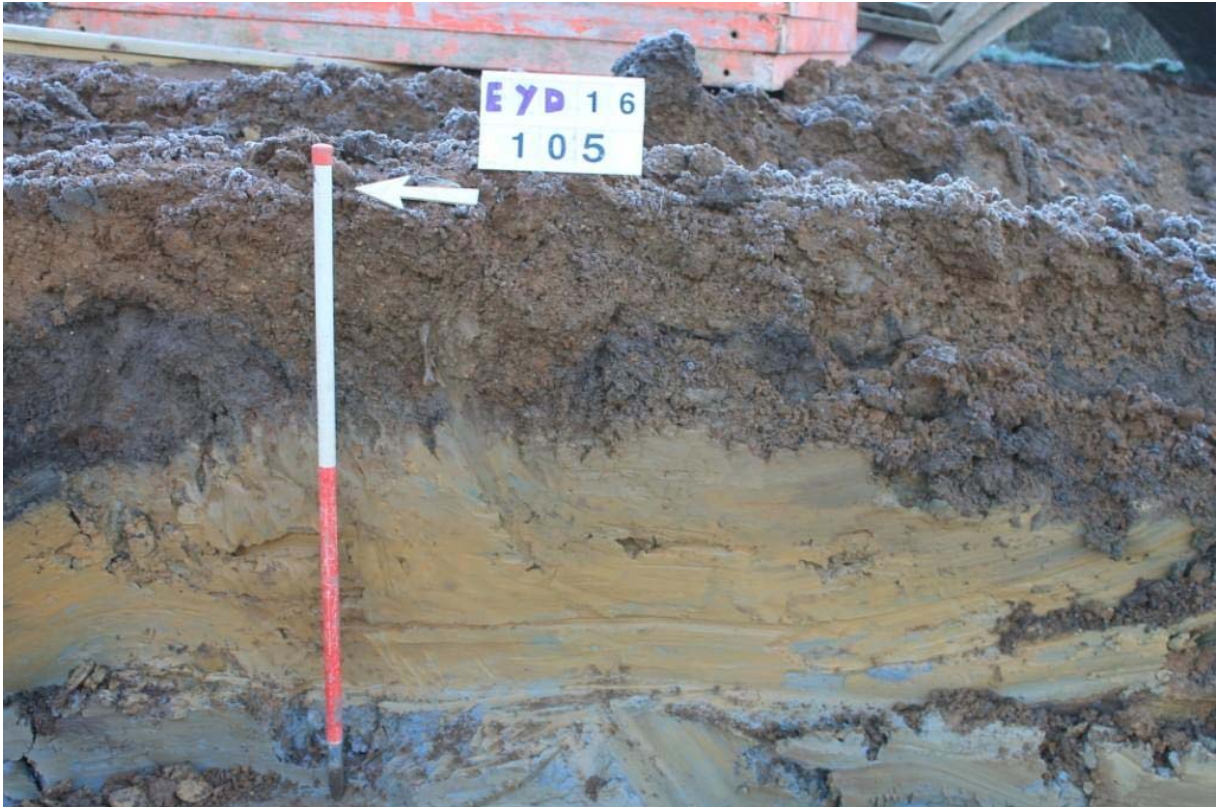
Along the eastern edge of the excavation, the topsoil (100) overlay 0.2m of made-ground (105) below which was up to 0.3m of buried topsoil (106). Below this was the alluvium (102) which overlay the natural clay (103) (Plate 4).

Plate 4: Humus tank profile showing buried topsoil 106. Camera facing east
