LEEDS FLOOD ALLEVIATION SCHEME 2 STEP 2: APPERLEY BRIDGE, LEEDS, WEST YORKSHIRE

Archive Report for:
Archaeological Monitoring (Watching Brief)

Report No: 23005

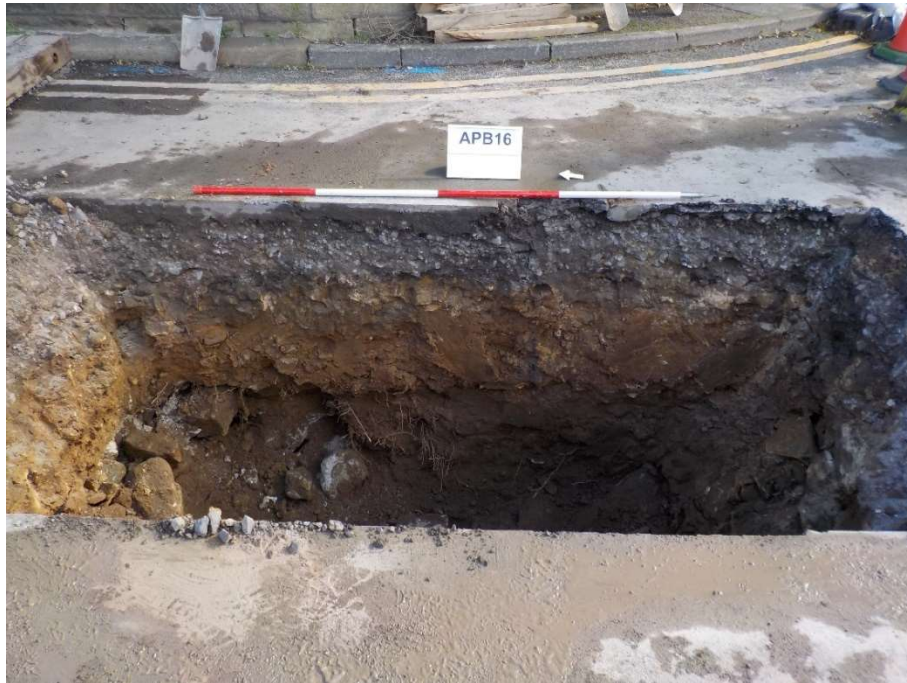
Plate 1: Test pit 1, facing east.

Test Pit 1 was located on the southern bank of the River Aire, 2m from the junction with Apperley Road and opposite the George and Dragon public house (Figure 2). The test pit measured 2.4m by 1.5m and was excavated to a depth of approximately 2.00m. A 1.6m deep deposit of silty rubble, 10002, was identified in the base of the test pit. This was covered by a 0.3m deep hardcore bedding layer, 10001, which supported the existing tarmac road surface, 10000.

No archaeological features or finds were encountered within the test pit.

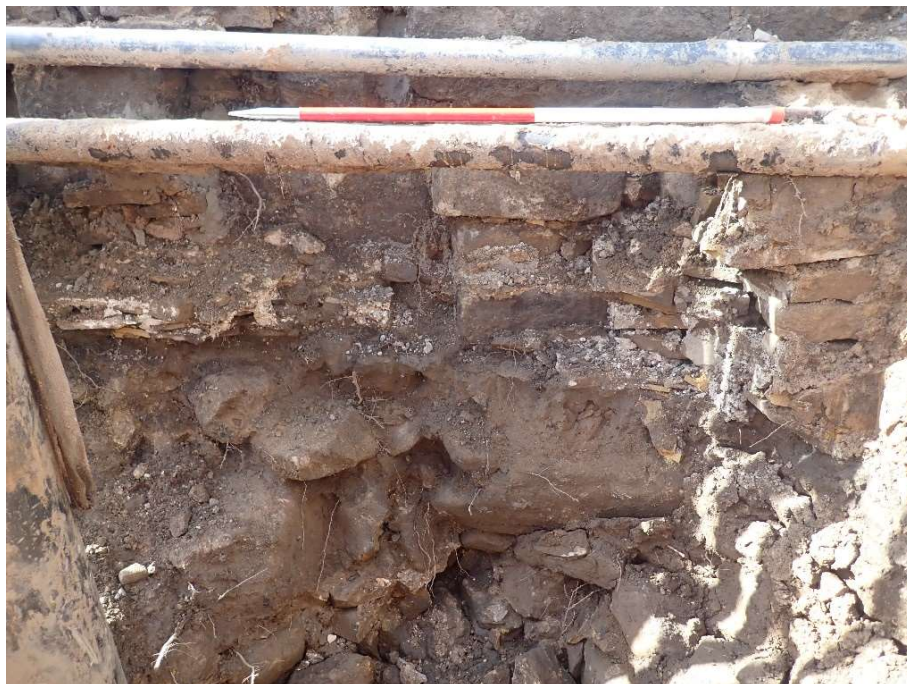
Plate 2: Deck fill excavation, North section, overview 100009, facing north.

The upstream section of the deck fill excavation measured 35.3m by 2.1m and was excavated to a depth of 50.1 mOD.

Excavation exposed a 0.15m to 0.75m deep deposit of bridge infill material, 100007. This deposit butted against the existing bridge parapet, 100009, and consequently is likely to be contemporary with, or to post-date, the 19th century rebuilding of the bridge. Deposit 100007 was sealed by a sandy deck fill 100005 which varied from 0.10m to 0.50m in depth.

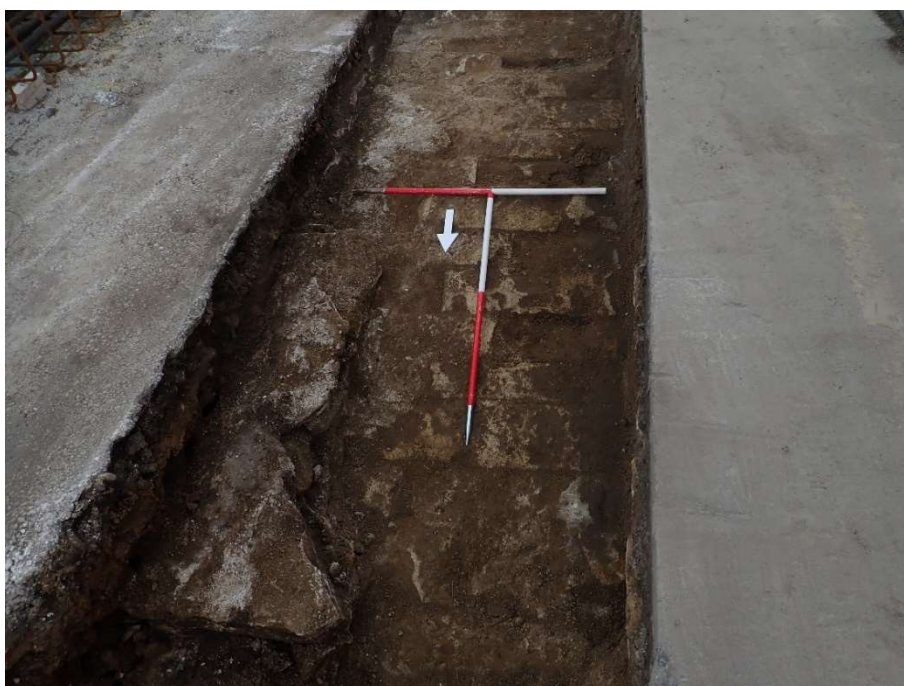
Plate 3: Deck fill excavation, Central section, Overview of bridge 17th C arches 100004 & possible spandrel wall 100008, facing south.

Excavations revealed the upper surface of the stonework forming the bridge arches, 100004. Bonded to stonework 100004 was a fragment of what appeared to be a spandrel wall, 100008. The spandrel of a bridge is the part that is built up over the arch to provide a reasonable grade for the roadbed. The spandrel walls are located above the arch.

Unless the arch is extremely flat, something must be done to make it practical to drive over. In some cases, spandrels are solid masonry, but they are usually hollow walls filled with dirt or

rock. It is likely that this feature represented the original eastern extent of the 17th century bridge structure, prior to its widening on the downstream (eastern) side.

Wall 100008 was sealed by a 0.15m to 0.75m deep layer of infill material, 100007. This was sealed by a similar 0.10 to 0.50m deep deck infill deposit, 100005.

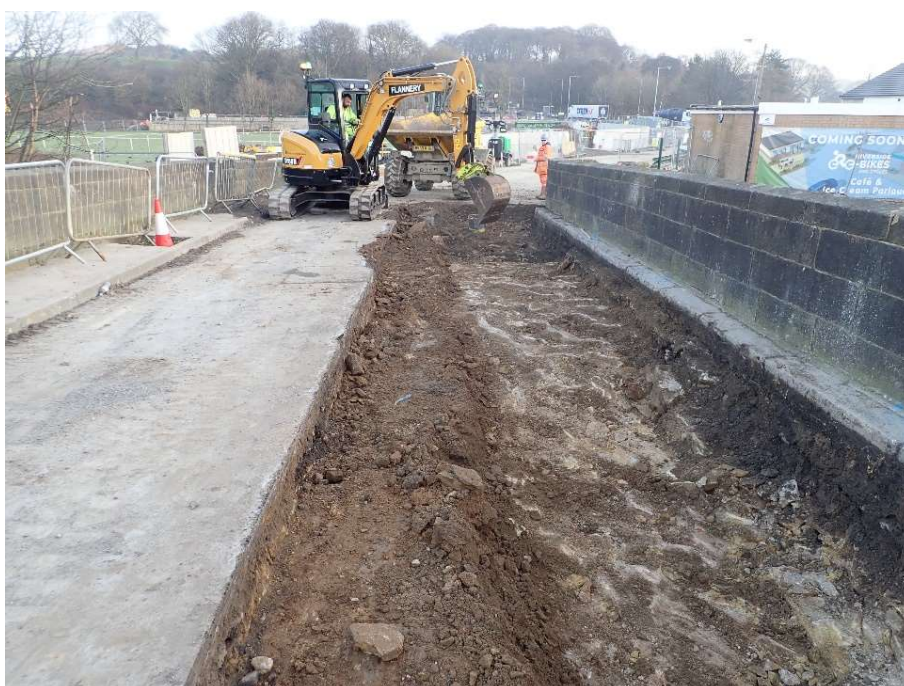
Plate 4: Deck fill excavation, South section, overview of 100004 & 100006, facing east.

Excavations revealed the upper surface of the stonework forming the bridge arches, 100004. Bonded to stonework 100004 was a 2m long continuation of the probable 17th century spandrel wall, 100008, which was also identified in the central section of the bridge.

Extending along the existing eastern edge of the bridge was a stonework structure 100006 formed of sandstone blocks measuring 0.40m by 0.33m by 0.20m at maximum dimensions. This feature appeared to be a compact infill deposit associated with the widening of the bridge. It acted as a foundation for the existing 19th century parapet, 100003.

Structures 100008 and 100006 were sealed by a 0.15m to 0.75m deep layer of infill material, 100007. This was sealed by a similar 0.10 to 0.50m deep deck infill deposit, 100005.

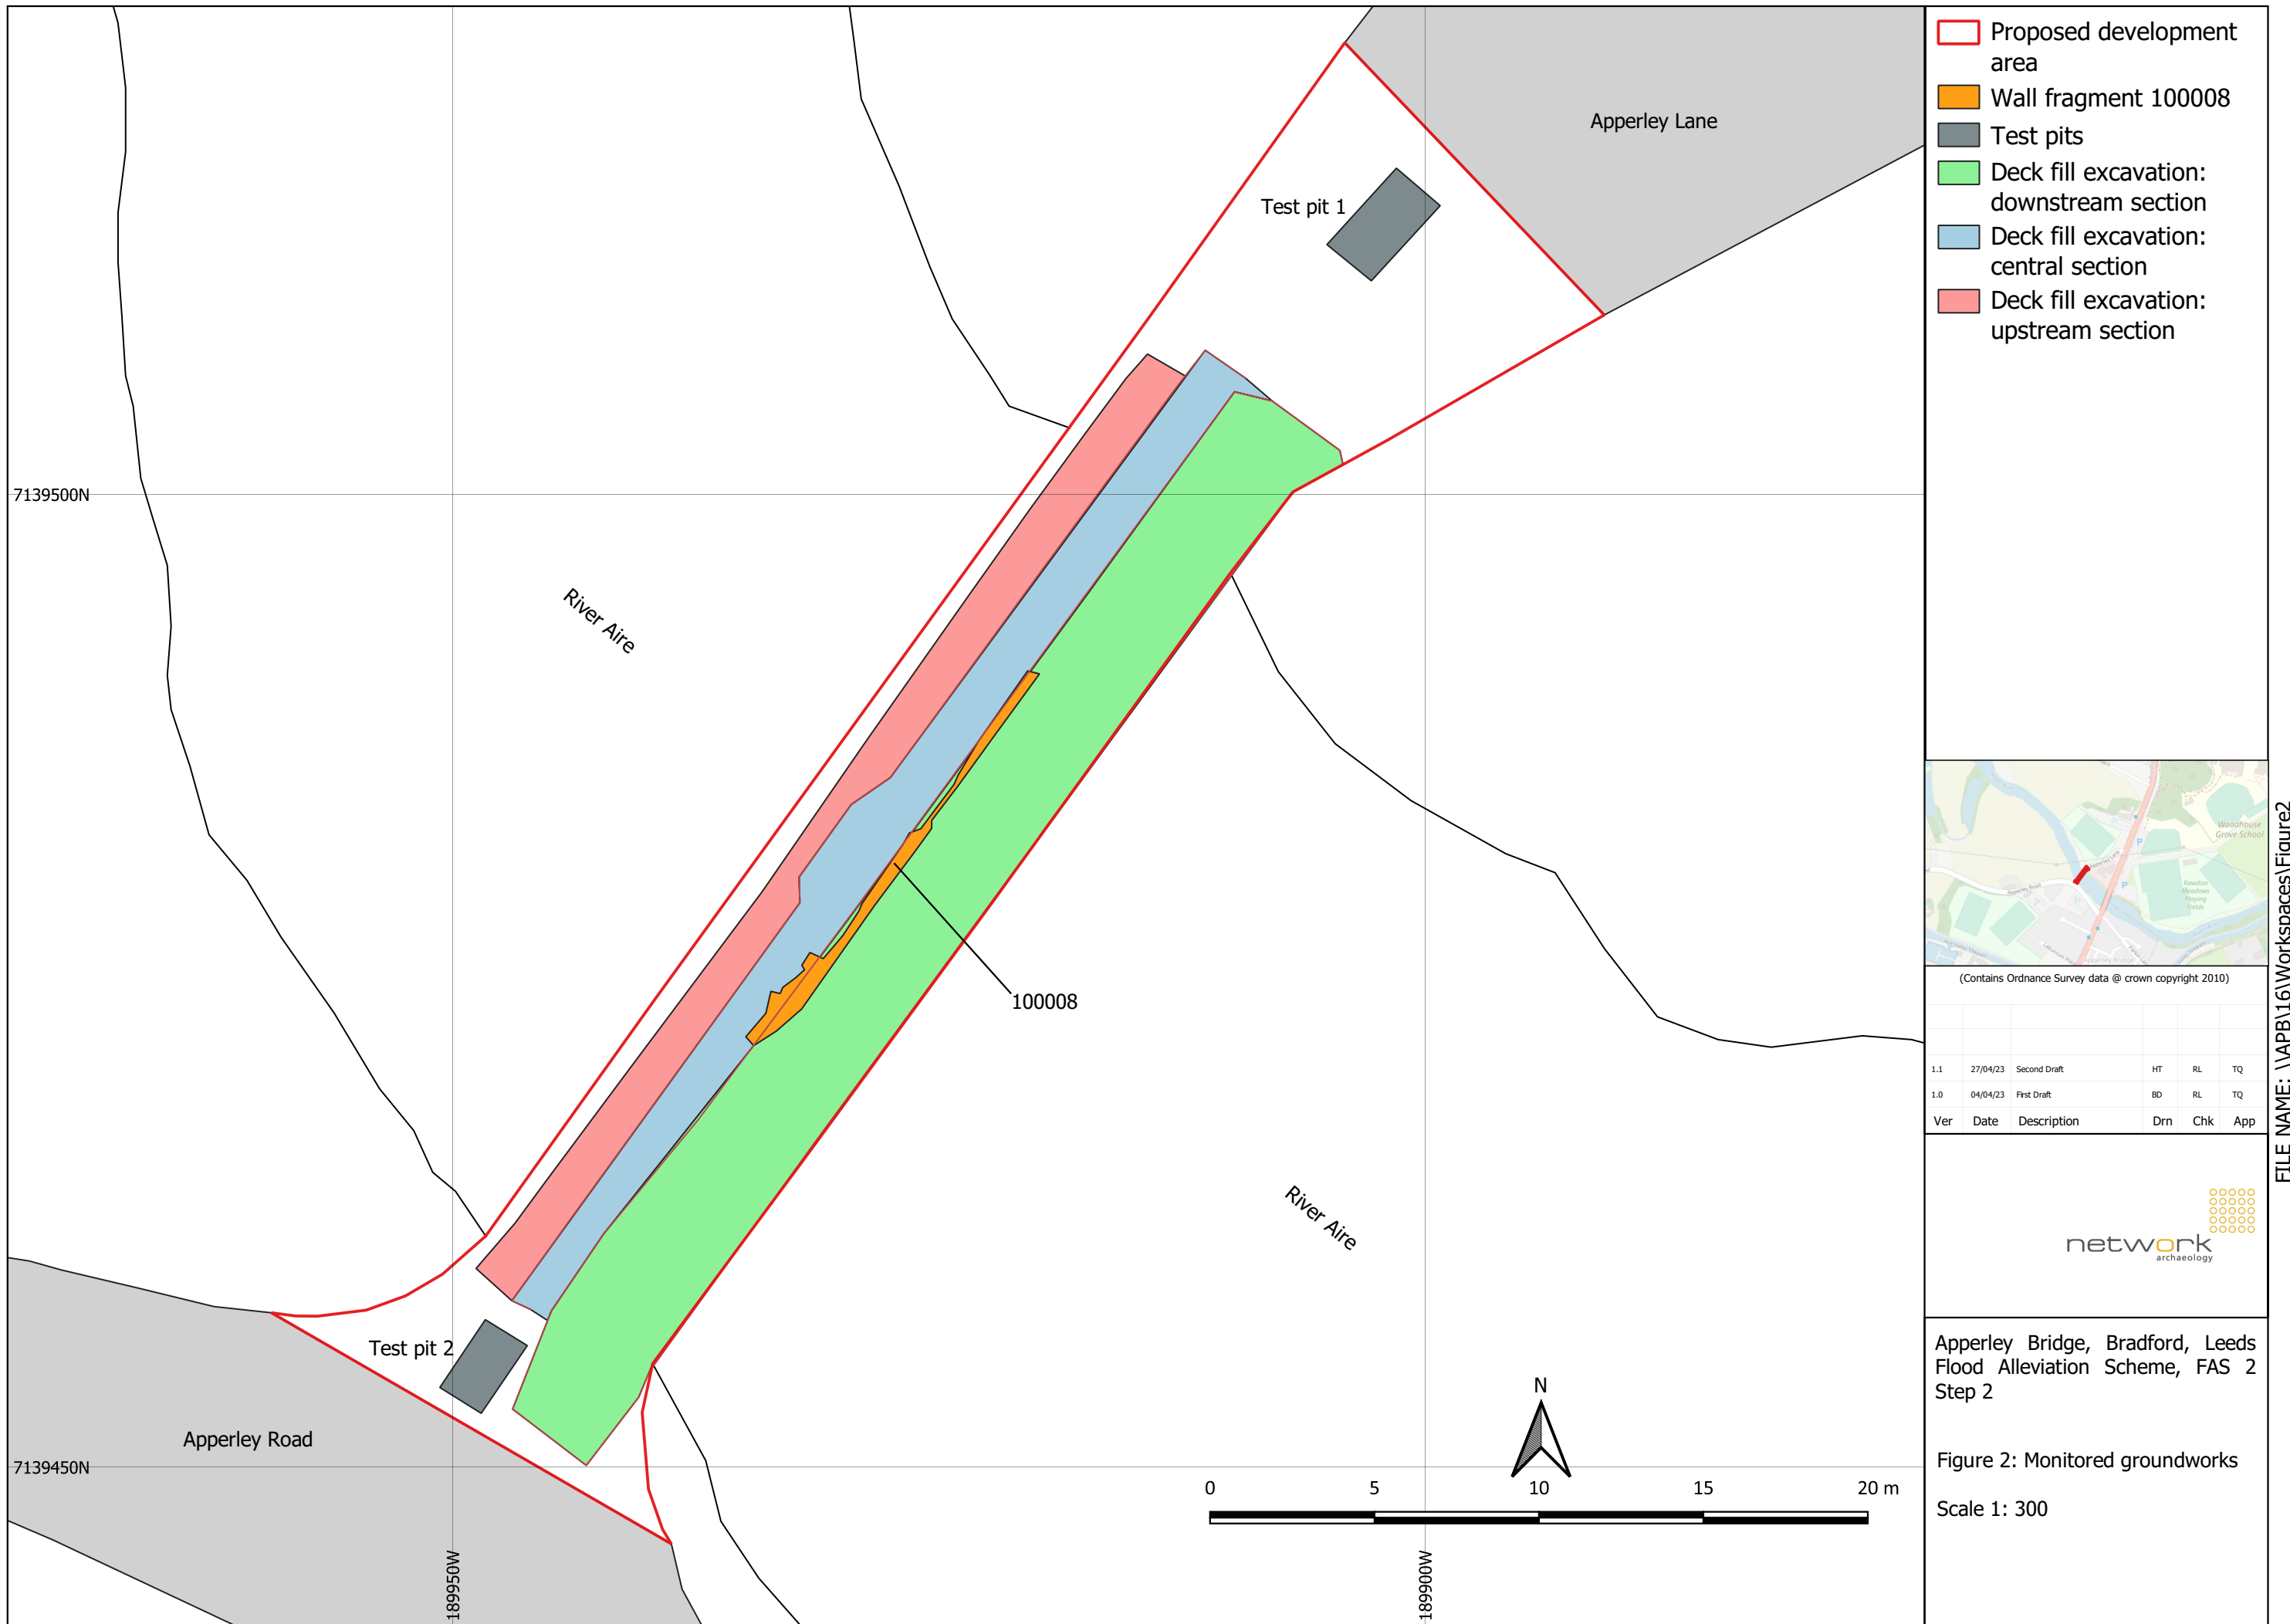
Figure 2: Monitored groundworks

The reduction of the bridge deck infill was accomplished in three discrete longitudinal strips along the length of the bridge deck (Figure 2). For ease of location, the strips are referred to here as the **upstream** section (located along the north-eastern side of the bridge,) the **central** section (located centrally within the bridge deck) and the **downstream** section (located along the south-eastern edge of the bridge).

- Proposed development area
- Wall fragment 100008
- Test pits
- Deck fill excavation: downstream section
- Deck fill excavation: central section
- Deck fill excavation: upstream section
