ALL SAINTS CHURCH, WELLINGORE, LINCOLNSHIRE

Archive Report for:
Archaeological Monitoring (Watching Brief)

Project Code: ACW16

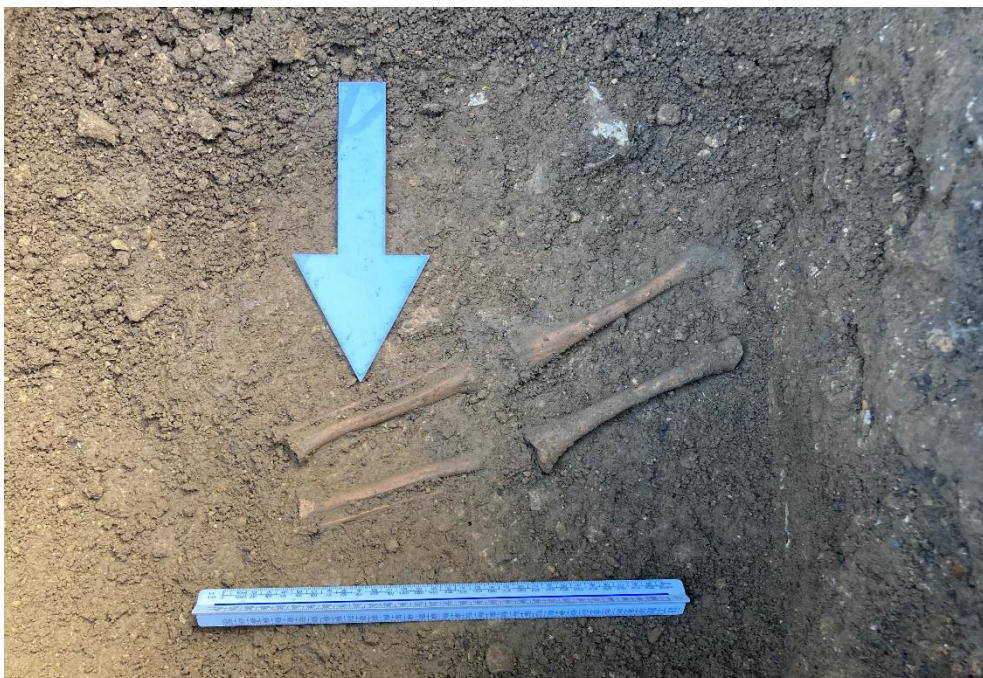
Photograph 2: Skeleton 1, facing south.

The service trench to the north of the church contained two burials (Figure 2). Skeleton 1 (Photograph 2) comprised the remains of an infant located approximately 1.5m north of the church porch and 0.2m north of where the trench turned southwest. It was found at a depth of 0.8m from the top of the trench (73.3m OD), at the base of a grave cut, 105, and overlain by grave fill 106. The remains of Skeleton 1 were recovered and reburied 0.3m deeper than the lowest point of the service trench, to keep them as close as possible to their original.

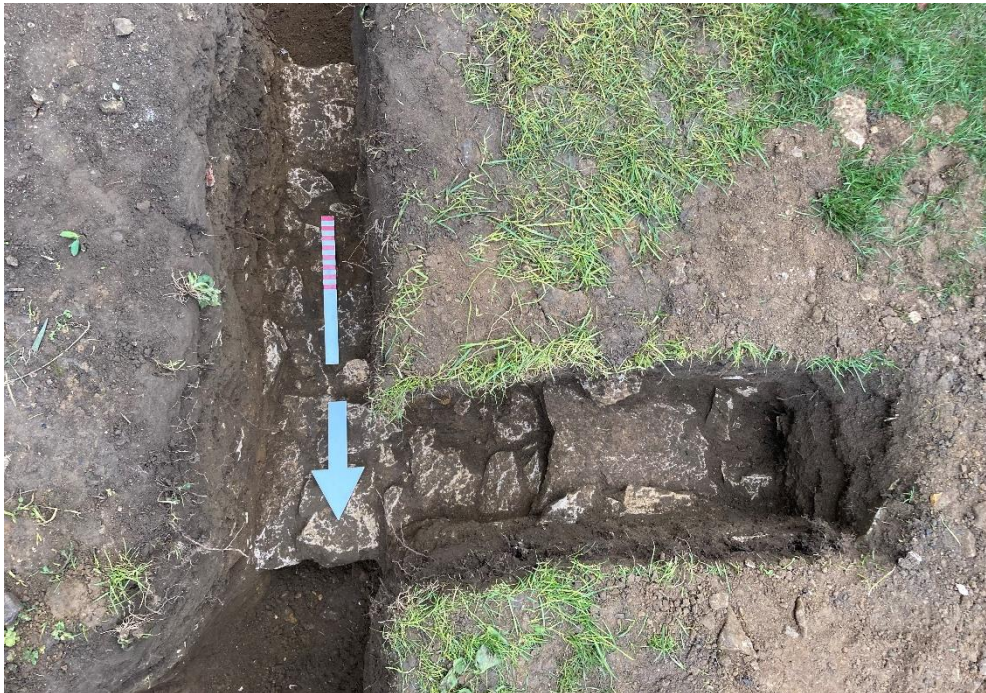
Photograph 6: Wall 109 to the west of the north aisle, facing south.

The 0.3m wide north-south oriented trench connecting the water supply to the west wall of the north revealed a short portion of wall (Figure 3 - Photograph 6). The wall, 109, was 1m wide and was excavated to a depth of 0.3m, continuing beyond the limit of excavation. The wall was constructed from limestone blocks, roughly dressed on the exterior faces, and filled between with limestone rubble, bonded with reddish yellow silty sand. The north-south oriented return of the wall (Photograph 7) was observed within the east-west trench running between the north aisle and the first observation chamber. This second wall, 110, was of identical construction to 109 and probably formed part of the same structure. The tops of both walls were recorded 0.55m below the top of the trench (73.8m OD).

It is likely that the walls represent a boundary wall to the church, predating the construction of the north aisle, which appeared to have been built over wall 109. The north-south return of the wall lined up with the west end of the church tower, which exhibited evidence of the removal of keyed stonework at the western limit, likely where wall 110 have once joined into the tower. Both walls were overlain by the same churchyard soil observed to the north of the church (104). It is possible that 104 had built up over time and comprised several layers, however, none were observed during the excavation.

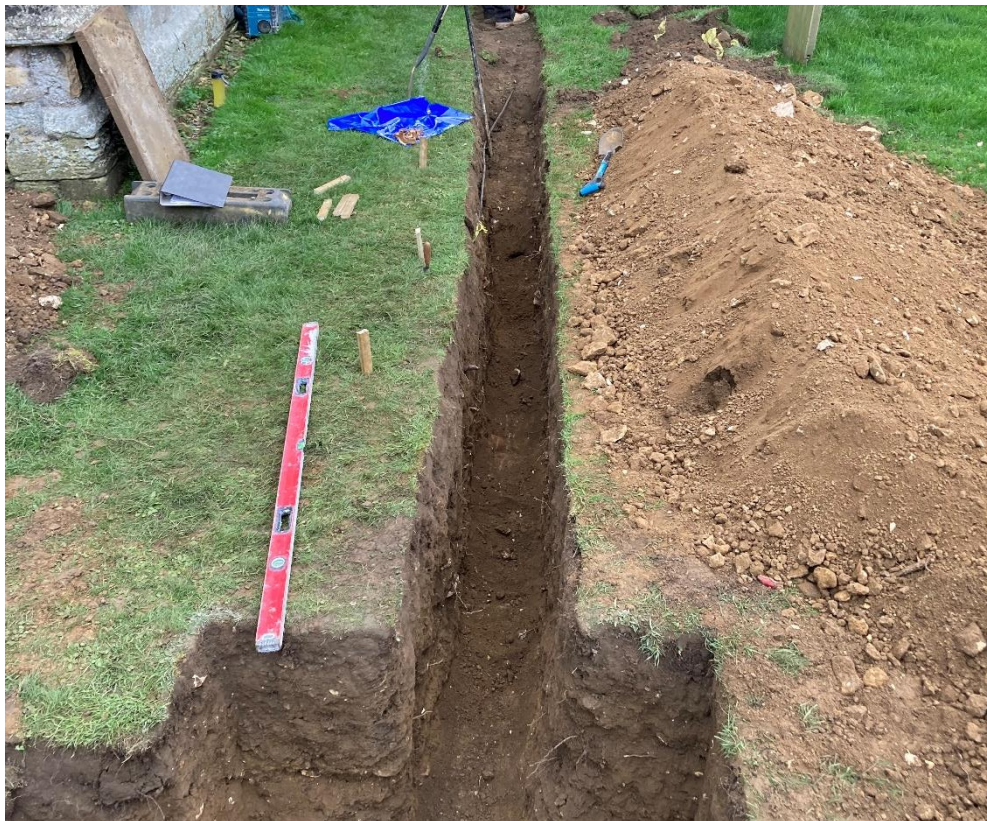
Photograph 8: General view of service trench west of tower, facing south.

The excavation of the service trench to the west of the church tower (Photograph 8) revealed the remains of a further three skeletons. Skeleton 3 (Photograph 9) comprised the remains of an adult skull located approximately 2.2m south of the northwesternmost observation chamber. It was found at a depth of 1.1m from the top of the trench (73 OD), at the base of grave cut 124 and overlain by grave fill 125. Due to its location, the skull could be avoided by the pipe, and was therefore recorded and then reburied.

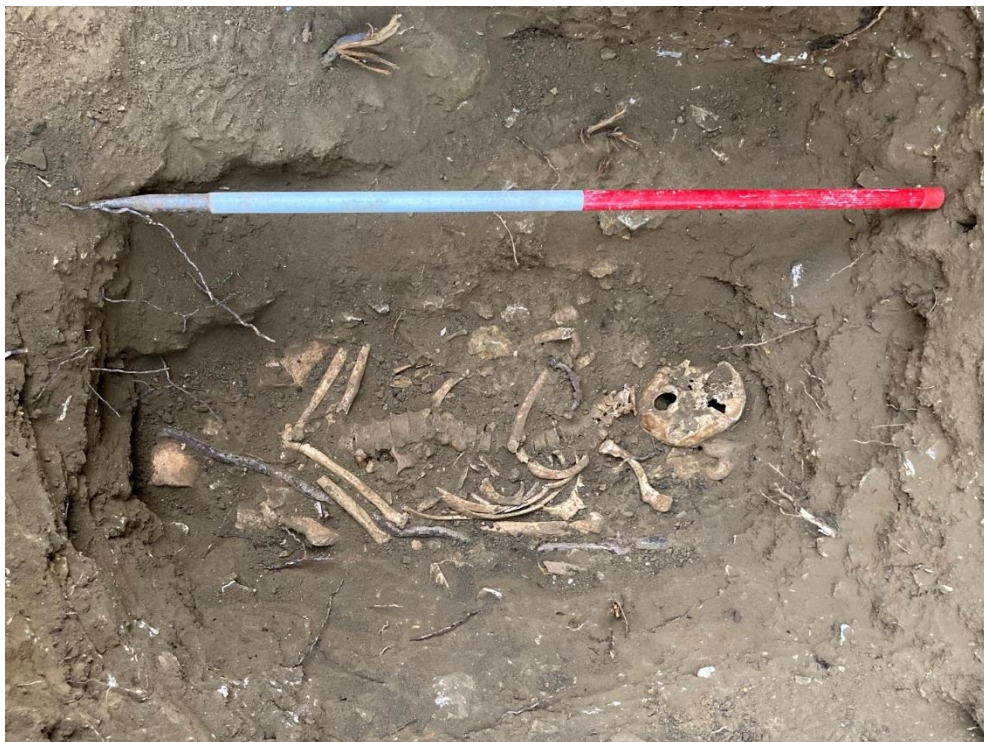
Photograph 10: Skeleton 5, facing south.

Skeleton 5 (Photograph 10) comprised the remains of an adult located within the inspection chamber to the southwest of the church tower. It was found at a depth of 1.15m from the top of the trench (72.95 OD), at the base of grave cut 128 and overlain by grave fill 129 and had been heavily disturbed by rooting from a nearby tree. The spine of the skeleton indicated the effects of disease or trauma, and spherical spurs of bone were observed on the middle vertebrae. Two iron handles and other coffin fittings were recovered from the grave, suggesting the body was originally buried within a coffin. Skeleton 5 was overlain by a mixed assemblage of human remains including the jaws of at least three individuals. It is likely that several earlier burials were disturbed when the grave for skeleton 5 was excavated and that these remains were placed on top of the coffin before it was backfilled.

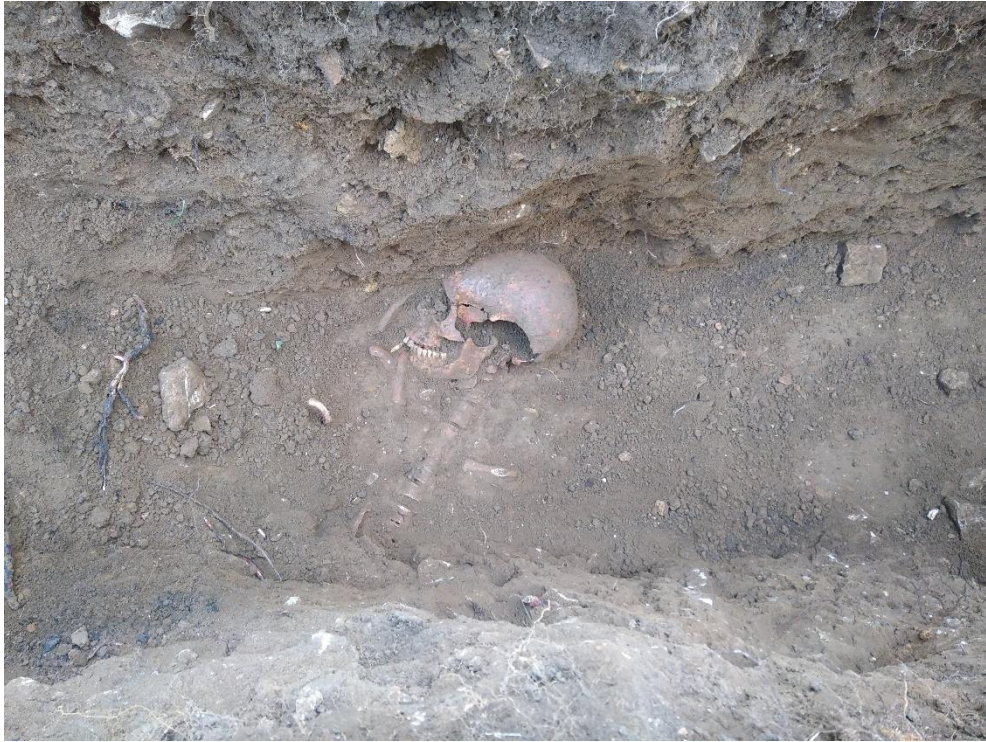
Photograph 11: Skeleton 6, facing southwest.

Skeleton 6 (Photograph 11) comprised the remains of an adult located 6m southeast of skeleton 5. It was found at a depth of 0.6m from the top of the trench (72.95m OD), at the base of grave cut 130 and overlain by grave fill 131. The upper 25% of the skeleton was visible within the trench and continued under the limit of excavation to the east. No evidence that the skeleton was confined were observed during excavation. Dental decay observed on the teeth may suggest a mature adult.

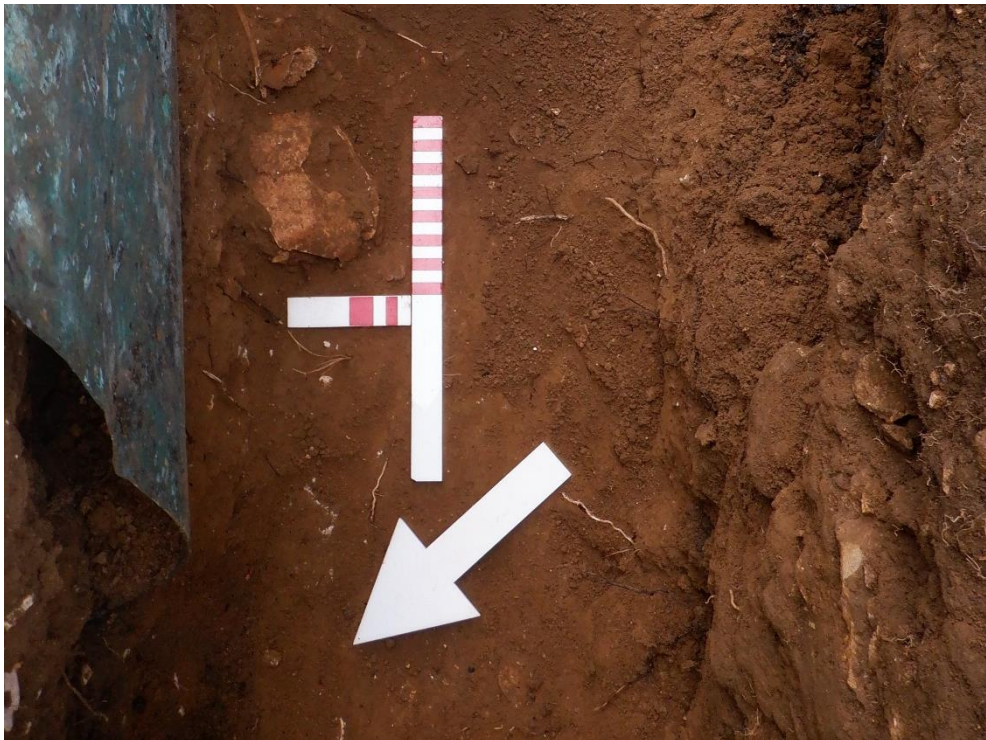
Photograph 12: Skeleton 7, facing southeast.

Skeleton 7 (Photograph 12) comprised the remains of an adult located 1.1m southeast of skeleton 6. It was found at a depth of 0.75m from the top of the trench (73.35m OD), at the base of grave cut 113 and overlain by grave fill 114. Only the upper half of the cranium (approximately 5%) was visible within the trench and the burial continued

beyond the limit of excavation to the east. No evidence that the skeleton was confined were observed during excavation.

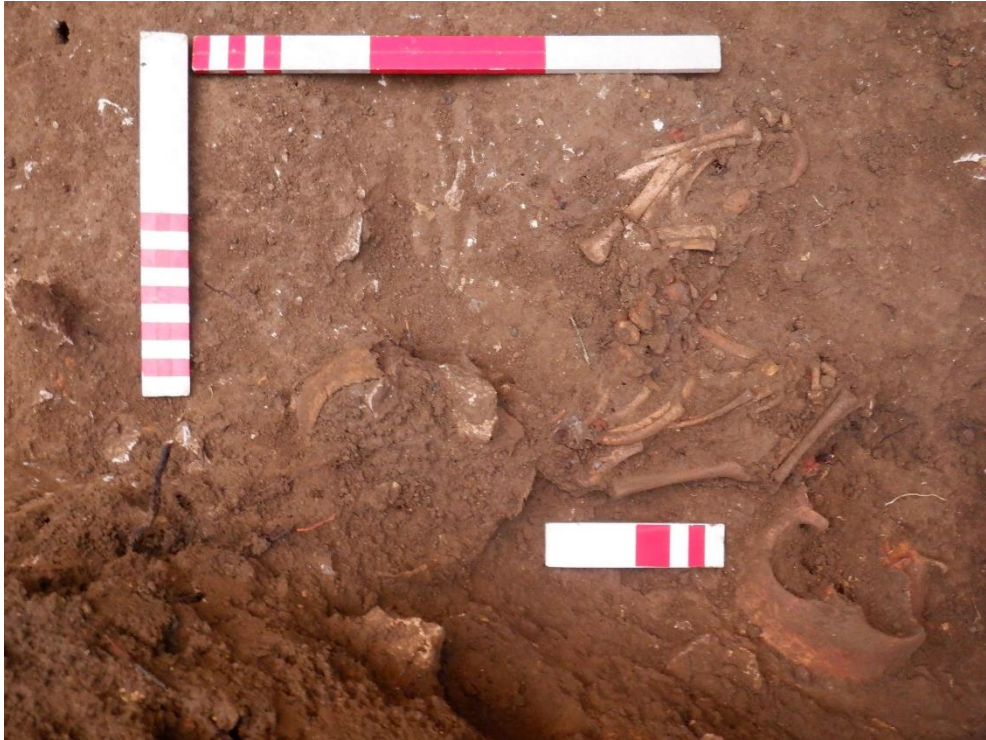
Photograph 13: Skeleton 8, facing southwest.

Skeleton 8 (Photograph 13) comprised the remains of an adult located 0.2m southeast of Skeleton 7. It was found at a depth of 0.63m from the top of the trench (73.47m OD), at the base of grave cut 115 and overlain by grave fill 116. The upper 40% of the skeleton was visible within the trench and continued beyond the limit of excavation to the east. Iron coffin nails and fittings were observed during excavation and retained for reburial at the request of the church authority.

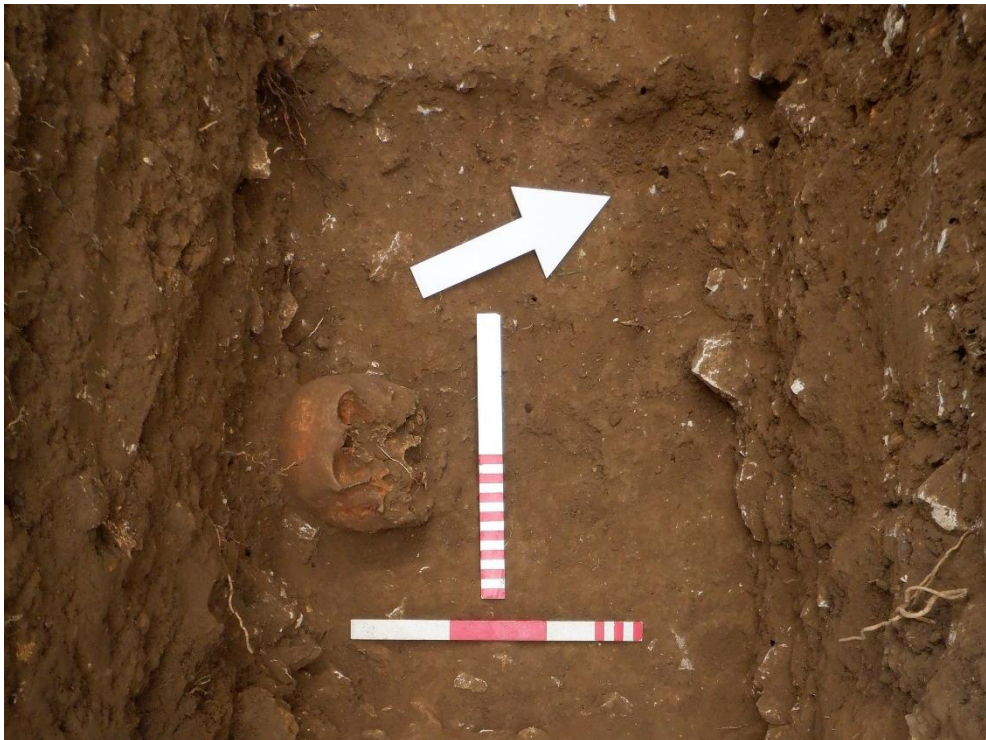
Photograph 14 Skeleton 9, facing northwest.

Skeleton 9 (Photograph 14) comprised the remains of an adult located 1.1m southeast of Skeleton 8. It was found at a depth of 0.66m from the top of the trench (73.44 OD), at the base of grave cut 117 and overlain by grave fill 118. The upper 0.05 of the skeleton was visible within the trench and continued beyond the limit of excavation to the east. No evidence that the skeleton was confined were observed during excavation.

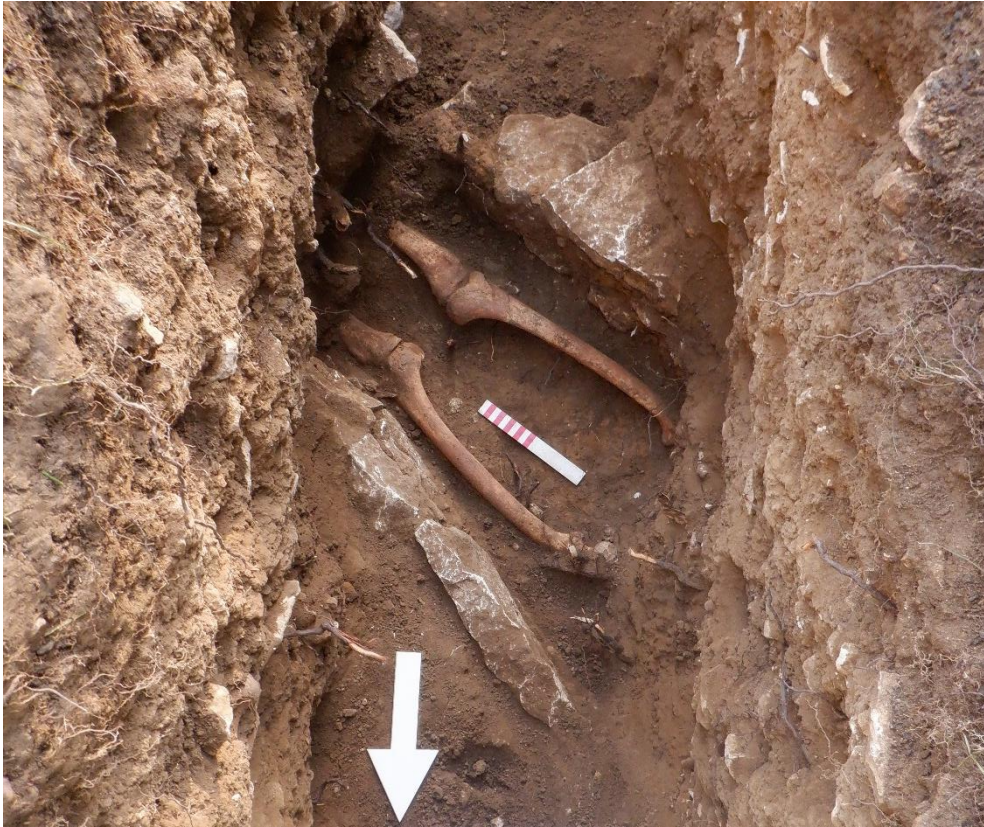
Photograph 15: Skeleton 10, facing southeast.

Skeleton 10 (Photograph 15) comprised the remains of an adult located 6m southeast of Skeleton 5. It was found at a depth of 1.12m from the top of the trench (72.98 OD), at the base of grave cut 122 and overlain by grave fill 120. The sides of the cut were lined with limestone blocks (119) bonded by yellow clay. The top of the burial was covered by limestone slabs (121) 90mm thick.

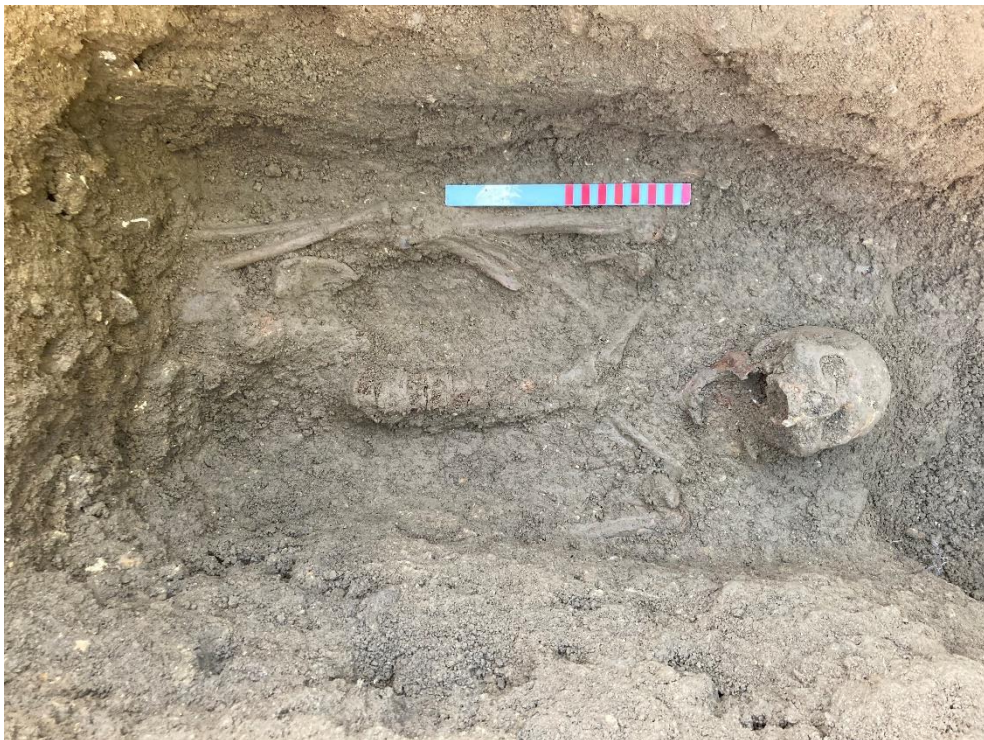
Photograph 16: Skeleton 11, facing south.

Skeleton 11 (Photograph 16) comprised the remains of an adult located within the inspection chamber at the north end of the drainage trench. It was found at a depth of 0.79m from the top of the trench (73.31 OD), at the base of grave cut 130 and overlain

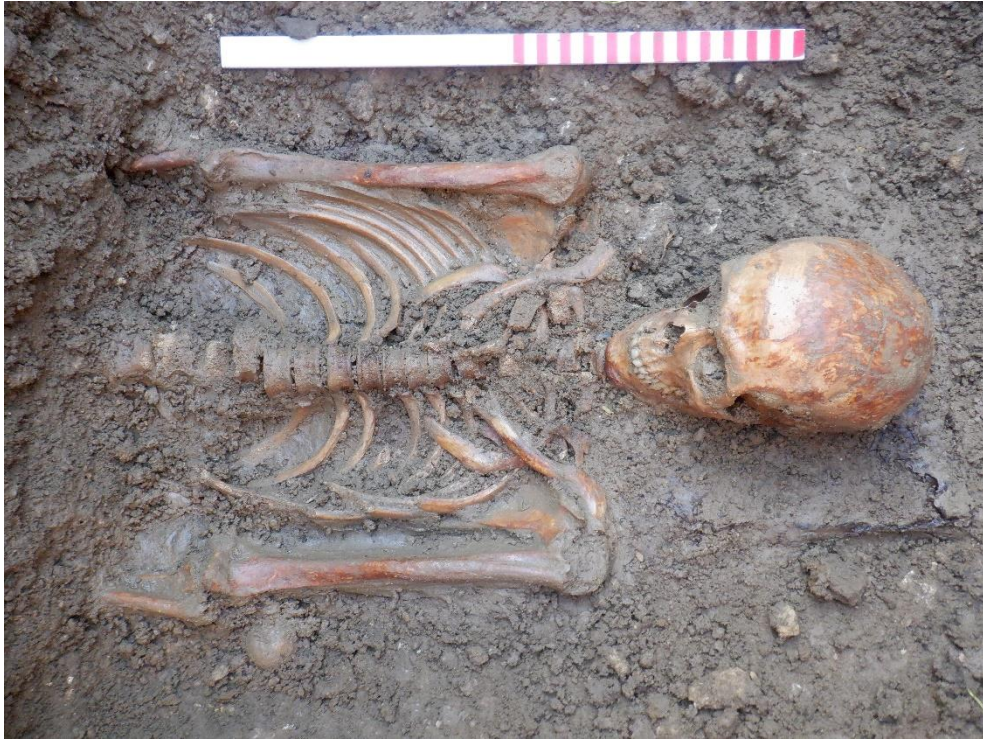
Photograph 17: Skeleton 13, facing south.

Skeleton 13 (Photograph 17) comprised the remains of an adult located 1.2m south of Skeleton 12. It was found at a depth of 1.5m from the top of the trench (72.6 OD), at the base of grave cut 136 and overlain by grave fill 137. The upper 30% of the skeleton was visible within the trench and continued under the limit of excavation to the east.

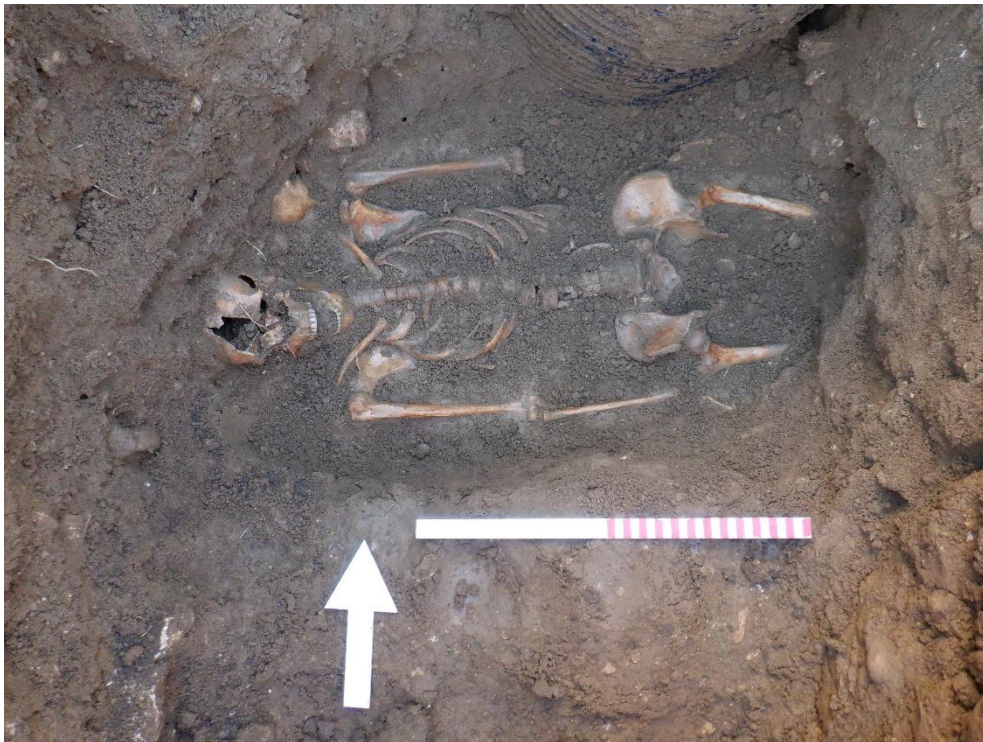
Photograph 18: Skeleton 14, facing north.

Skeleton 14 (Photograph 18) comprised the remains of an adult located 0.5m underneath skeleton 12. It was found at a depth of 1.3m from the top of the trench (72.8 OD), at the base of grave cut 138 and overlain by grave fill 139. The upper 60% of the skeleton was visible within the trench and continued under the limit of excavation to the east.

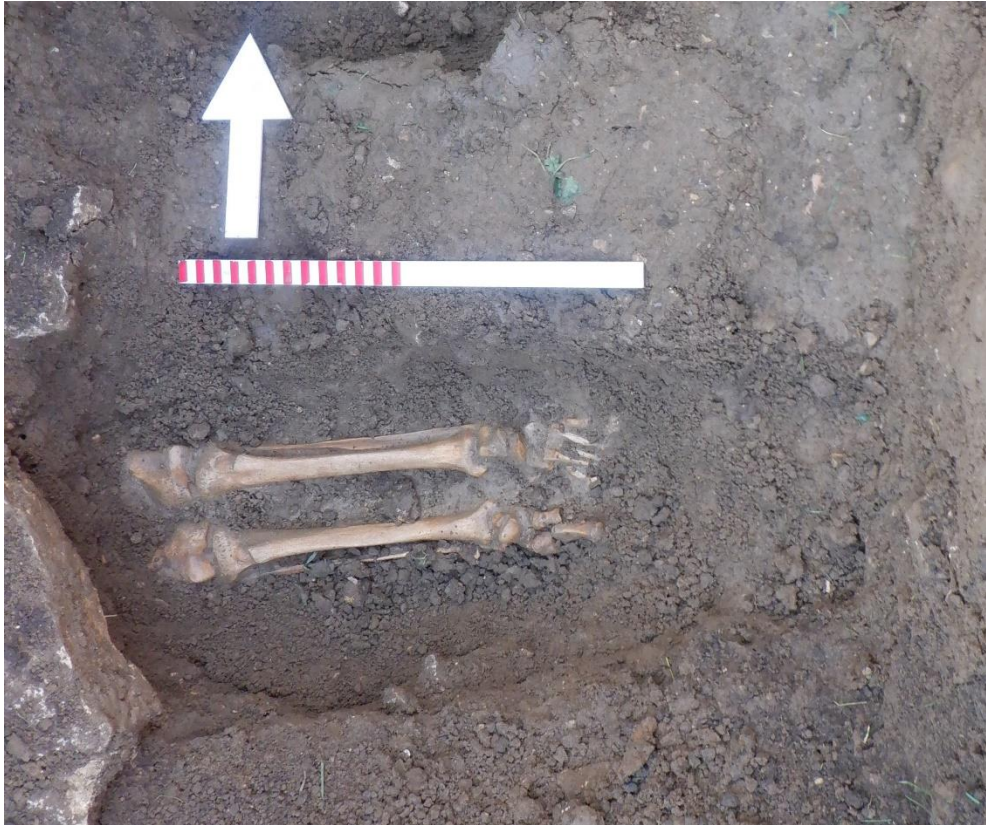
Photograph 19: Skeleton 15, facing south.

Skeleton 15 (Photograph 19) comprised the remains of an adult located 0.95m west of skeleton 13. It was found at a depth of 1.15m from the top of the trench (72.95 OD), at the base of grave cut 140 and overlain by grave fill 141. The lower 50% of the skeleton was visible within the trench and continued under the limit of excavation to the west. The sides of the grave were lined with irregular limestone blocks (170) and a single flat limestone block was found above the pelvis.

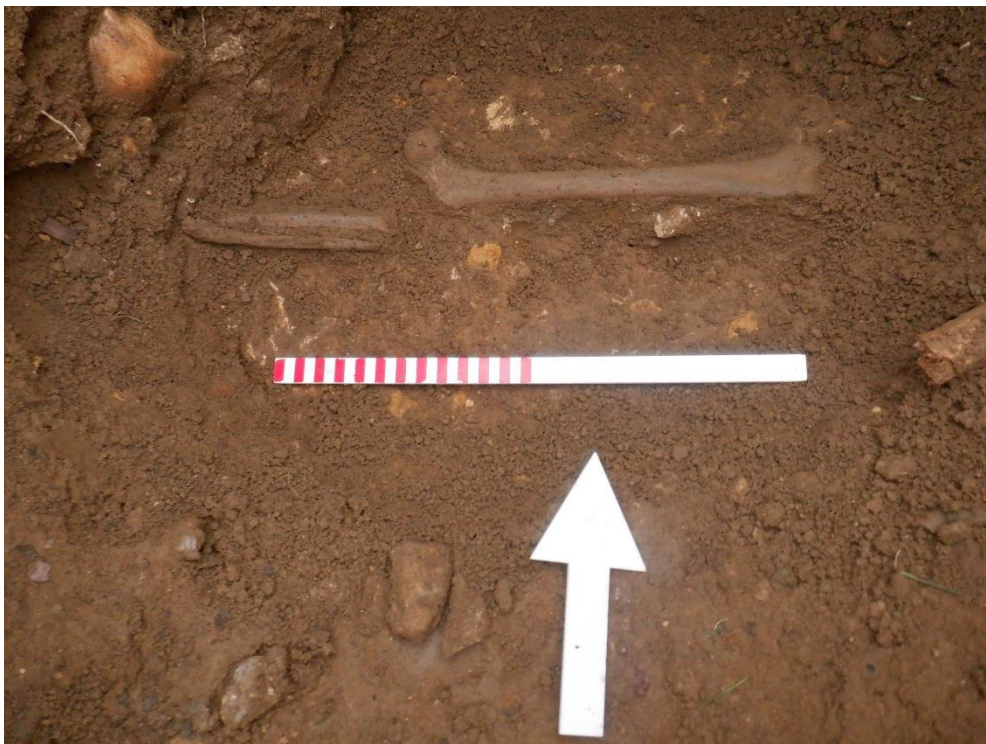
Photograph 20: Skeleton 16, facing north.

Skeleton 16 (Photograph 20) comprised the disturbed remains of a possible adult(?) located underneath Skeleton 12. It was found at a depth of 1.5m from the top of the trench (72.7 OD), at the base of grave cut 142 and overlain by grave fill 143. Only the right femur and humerus had survived, likely due to disturbance by the later burial of Skeleton 12.

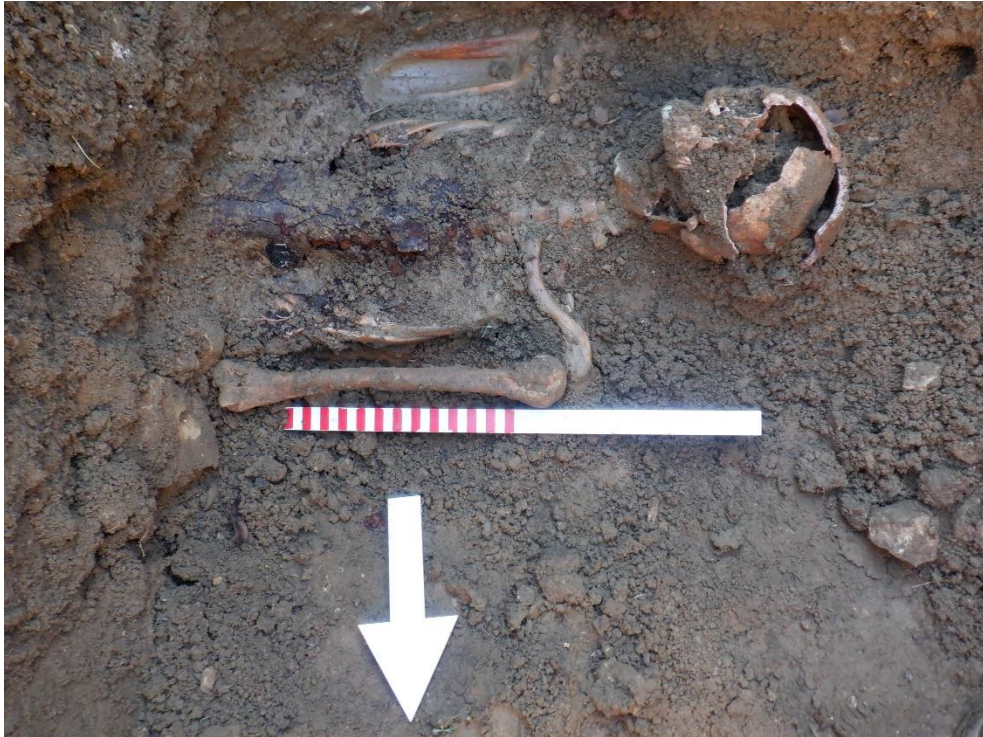
Photograph 21: Skeleton 17, facing south.

Skeleton 17 (Photograph 21) comprised the remains of an adult located 0.9m south of skeleton 13. It was found at a depth of 1.3m from the top of the trench (72.9 OD), at the

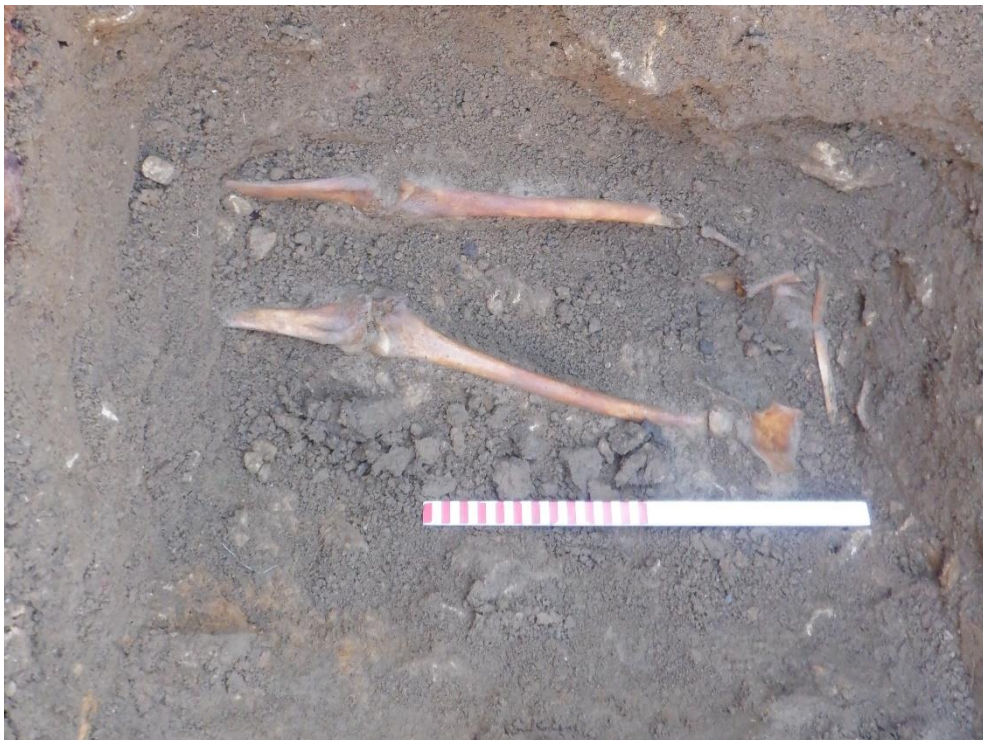
Photograph 22: Skeleton 18, facing north.

Skeleton 18 (Photograph 22) comprised the remains of an adult located directly south of skeleton 17. It was found at a depth of 1.5m from the top of the trench (72.7 OD), at the base of grave cut 146 and overlain by grave fill 147. The pelvis and legs of the skeleton were visible within the trench and the burial continued under the limit of excavation to the east and west. The sides of the grave were lined with irregular limestone blocks. There was no evidence of limestone capping over the top of the burial.

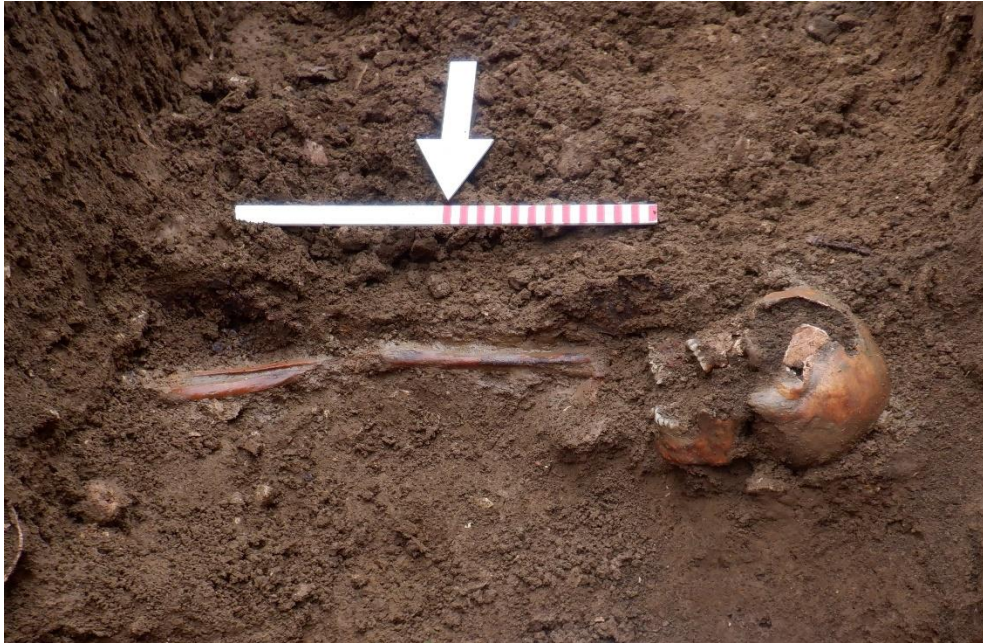
Photograph 23: Skeleton 19, facing south.

Skeleton 19 (Photograph 23) comprised the remains of an adult located directly south and partially underneath skeleton 17. It was found at a depth of 1.04m from the top of the trench (73.16 OD), at the base of grave cut 151 and overlain by grave fill 152. Part of the skull and the right arm survived, having been truncated by the grave for skeleton 17. The burial continued under the limit of excavation to the east.

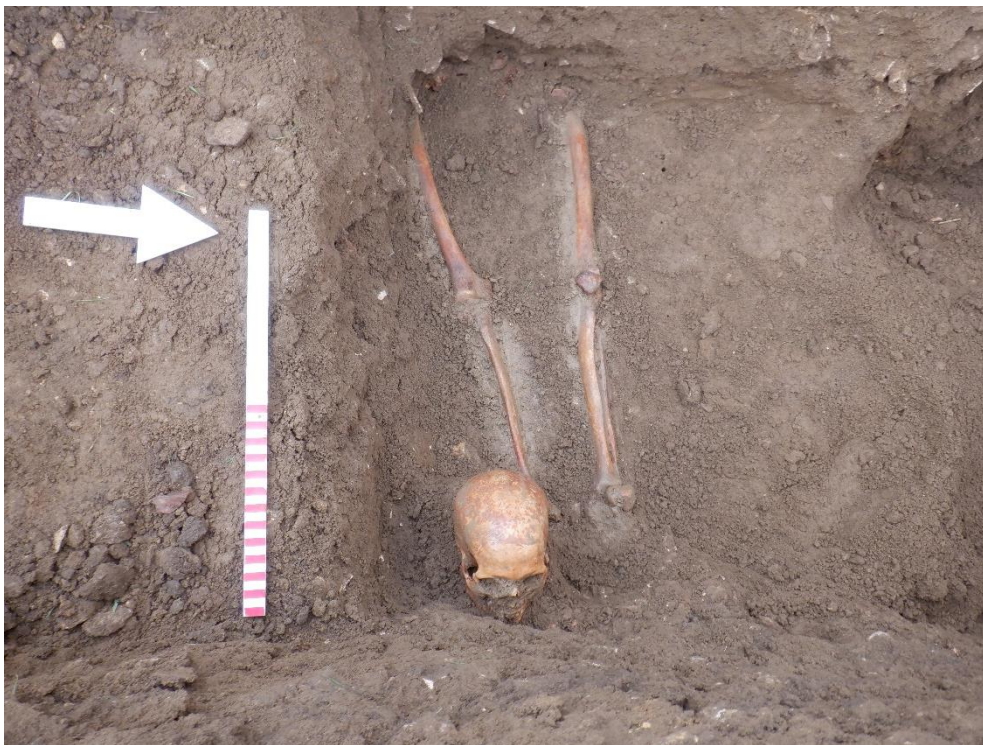
Photograph 24: Skeleton 20 and 21, facing west.

Skeleton 20 (Photograph 24) comprised the remains of an adult located directly south of skeleton 19. It was found at a depth of 1.0m from the top of the trench (73.2 OD), at the base of grave cut 153 and overlain by grave fill 154. Only the skull was visible within the trench and the burial continued under the limit of excavation to the east.

Skeleton 21 (Photograph 24) comprised the remains of an adult located directly west of skeleton 20. It was found at a depth of 1.22m from the top of the trench (72.98 OD), at the base of grave cut 155 and overlain by grave fill 156. The lower 35% of the skeleton, from the pelvis to the feet, was visible within the trench and continued under the limit of excavation to the west.

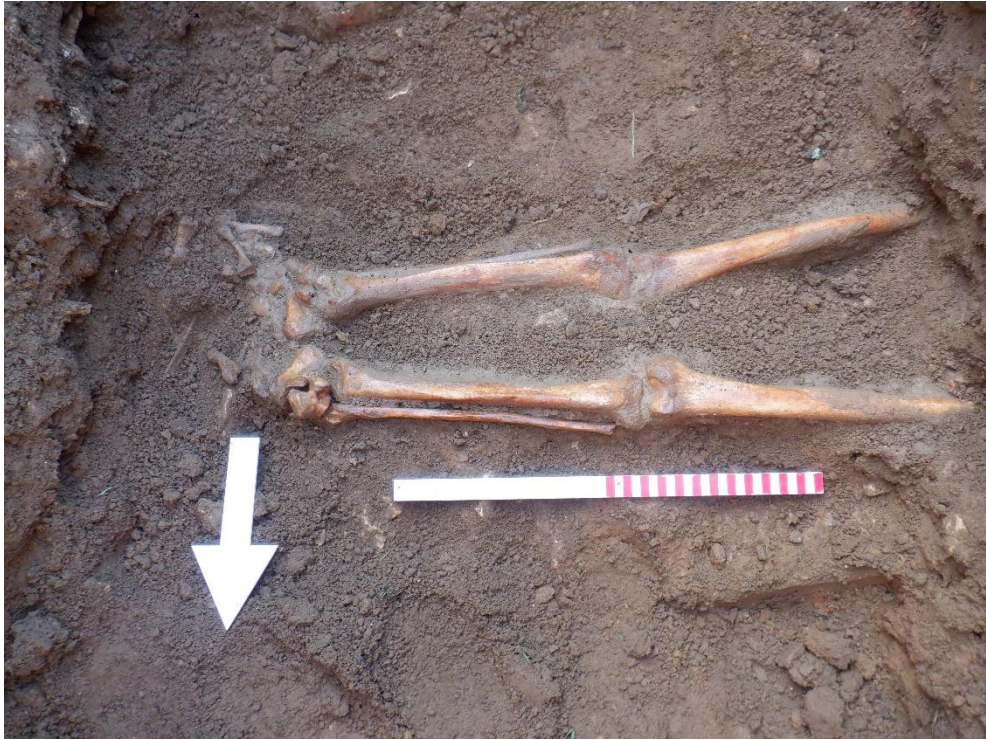
Photograph 25: Skeleton 22, facing south.

Skeleton 22 (Photograph 25) comprised the remains of an adult located directly north of skeleton 21. It was found at a depth of 1.43m from the top of the trench (72.77 OD), at the base of grave cut 157 and overlain by grave fill 158. The lower 40% of the skeleton, from the pelvis to the feet, was visible within the trench and continued under the limit of excavation to the west.

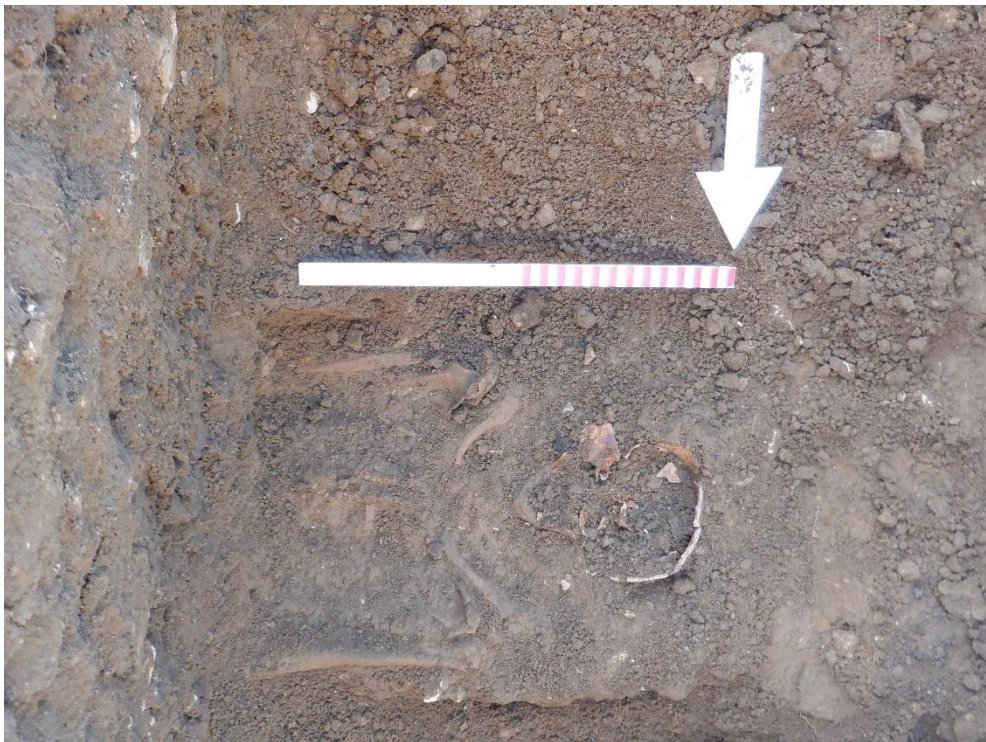
Photograph 26: Skeleton 23, facing south.

Skeleton 23 (Photograph 26) comprised the remains of an adult located 0.8m south of Skeleton 22. It was found at a depth of 1.14m from the top of the trench (73.06 OD), at the base of grave cut 159 and overlain by grave fill 160. The upper 45% of the skeleton, from the middle spine to the skull, was visible within the trench and continued under the limit of excavation to the east.

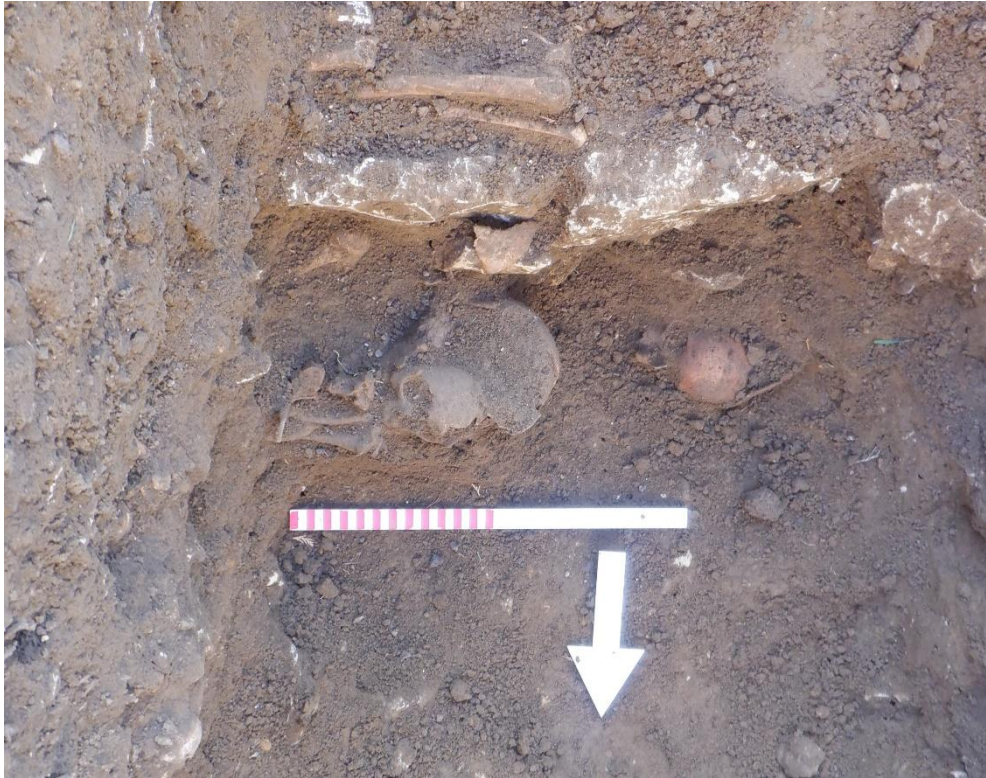
Photograph 27: Skeleton 24, facing south.

Skeleton 24 (Photograph 27) comprised the remains of a juvenile located directly north of Skeleton 23. It was found at a depth of 1.3m from the top of the trench (72.9 OD), at the base of grave cut 161 and overlain by grave fill 162. The upper 30% of the skeleton, from the ribcage to the skull, was visible within the trench and continued under the limit of excavation to the east.

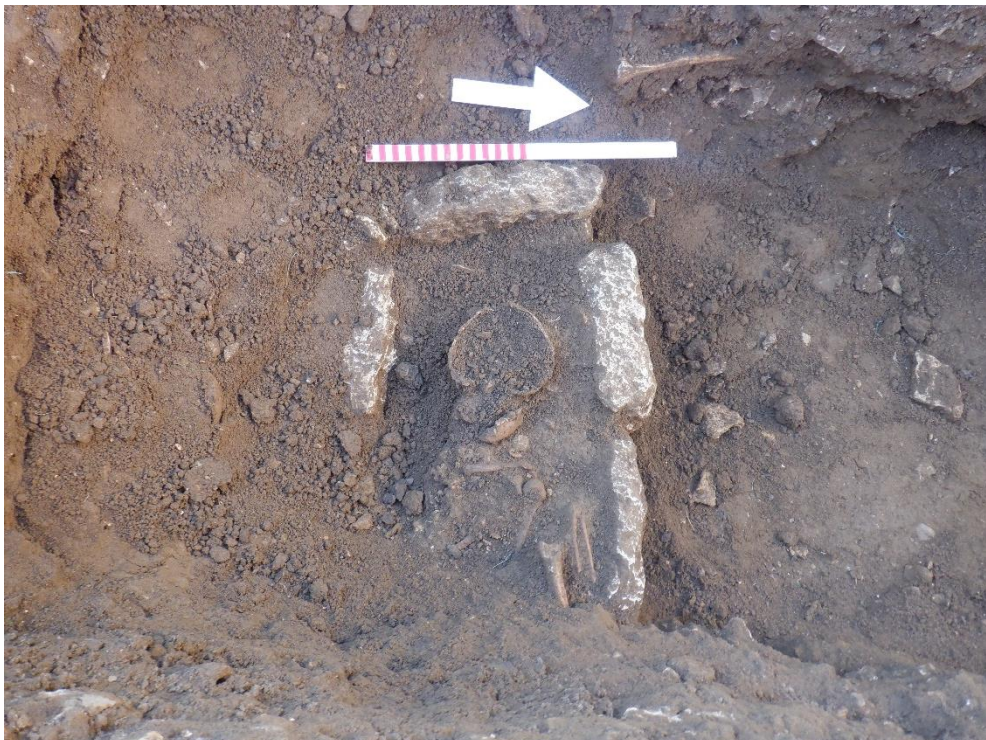
Photograph 28: Skeleton 25, facing west.

Skeleton 25 (Photograph 28) comprised the remains of an infant located directly south of Skeleton 24. It was found at a depth of 1.19m from the top of the trench (73.01 OD), at the base of grave cut 163 and overlain by grave fill 164. The side of the cut was lined with irregular limestone blocks (165) placed upright. There was no evidence of stone covering the grave. The skull, upper right arm and ribcage were visible within the trench and the burial appeared to continue outside of the limit of excavation to the east. The southern half of the burial had been disturbed against eastern limit of excavation, possibly by a later grave located outside of the trench. No evidence that the skeleton was confined were observed during excavation.

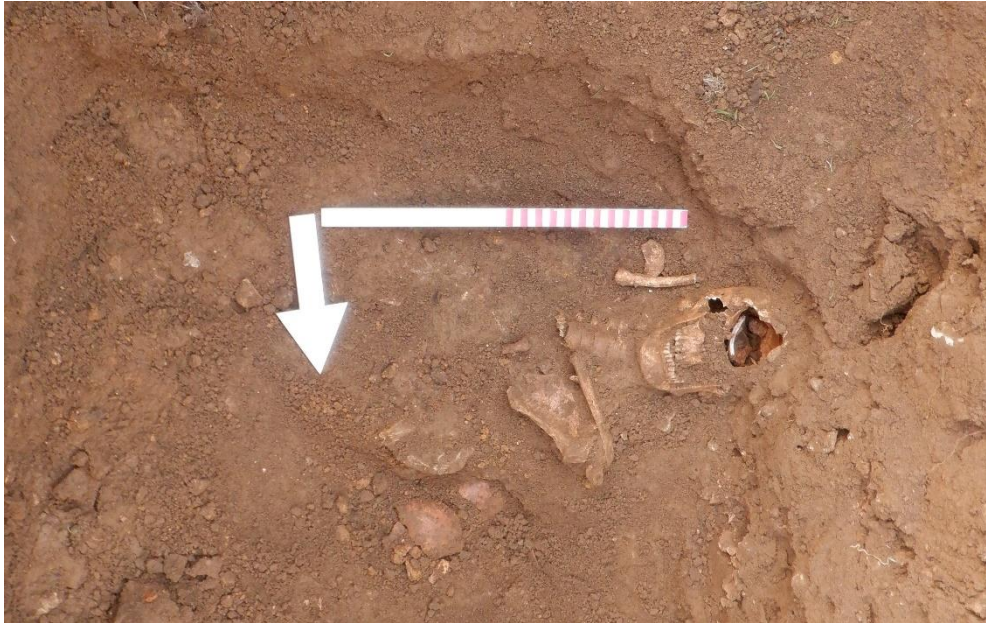
Photograph 29: Skeleton 26, facing south.

Skeleton 26 (Photograph 29) comprised the remains of an adult located south of skeleton 25. It was found at a depth of 1.14m from the top of the trench (73.06 OD), at the base of grave cut 166 and overlain by grave fill 167. The upper 25% of the skeleton, from the skull to the ribcage, was visible within the trench and continued under the limit of excavation to the east.

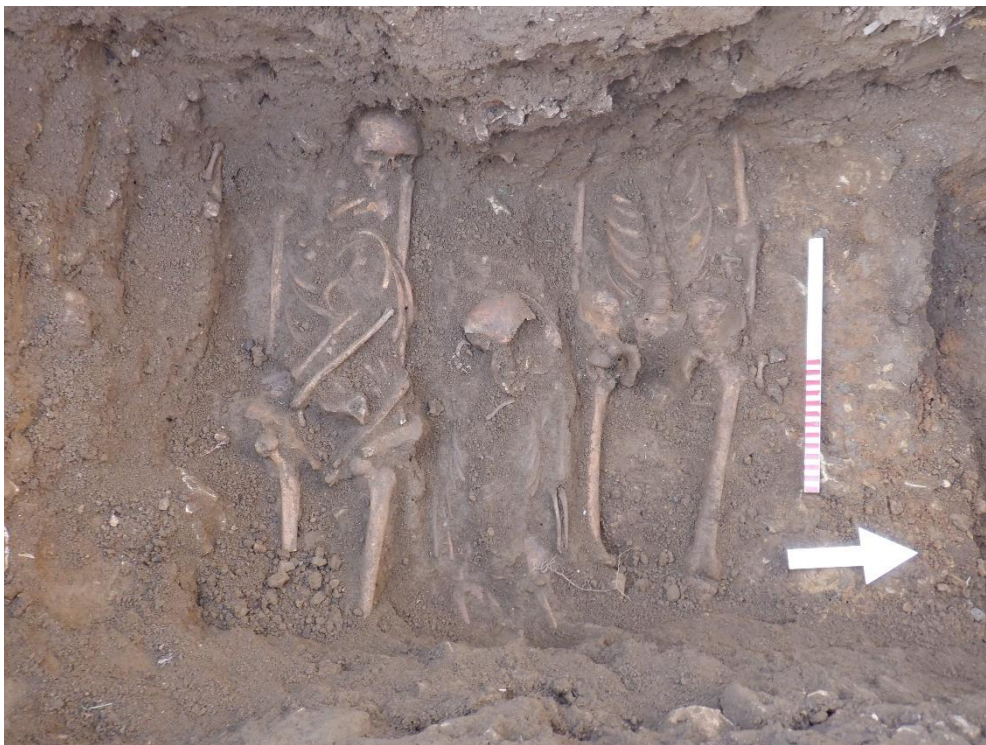
Photograph 30: Skeletons 27, 28, 29, facing west.

Skeletons 27, 28 and 29 were contained within a single grave (Photograph 30). The skeletons were located below burials 21, 24 and 26, 3m from the northern end of the drainage trench. The burials were found between 1.46m – 1.55m from the top of the trench (72.74 OD - 72.65 OD), at the base of grave cut 168 and overlain by grave fill 169.

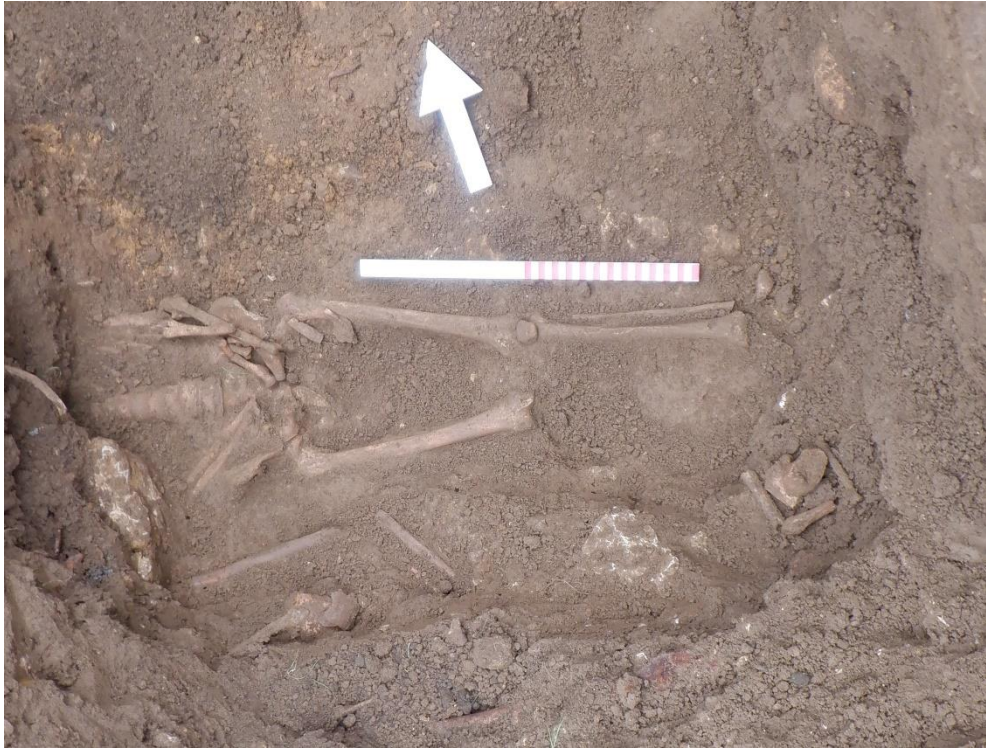
Photograph 31: Skeleton 30, facing northeast.

Skeleton 30 (Photograph 31) comprised the remains of an adult directly south of Skeleton 27. It was found at a depth of 1.53m from the top of the trench (72.67 OD), at the base of grave cut 172 and overlain by grave fill 173. Approximately 55% of the

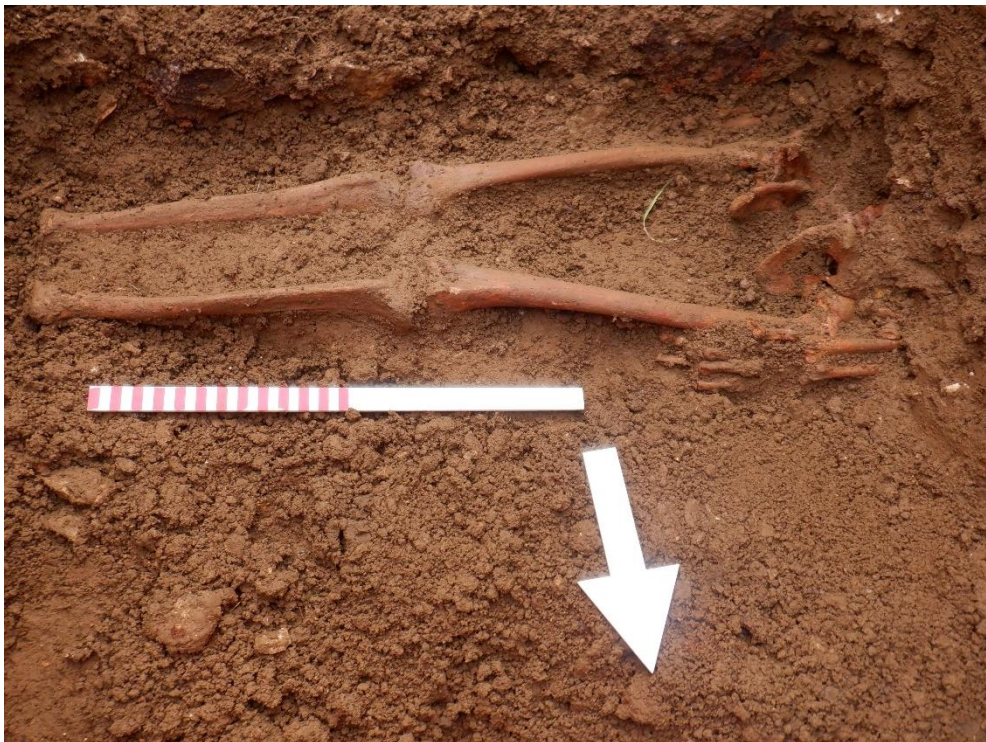
Photograph 32: Skeleton 31, facing south.

Skeleton 31 (Photograph 32) comprised the remains of an adult located directly south of Skeleton 30. It was found at a depth of 1.37m from the top of the trench (72.83 OD), at the base of grave cut 174 and overlain by grave fill 175. The lower 55% of the skeleton, from the top of the pelvis to the bottom of the tibia, was visible within the trench and continued under the limit of excavation to the east and west.
