ALL SAINTS CHURCH, WELLINGORE, LINCOLNSHIRE

Archive Report for:
Archaeological Monitoring (Watching Brief)

Project Code: ACW16

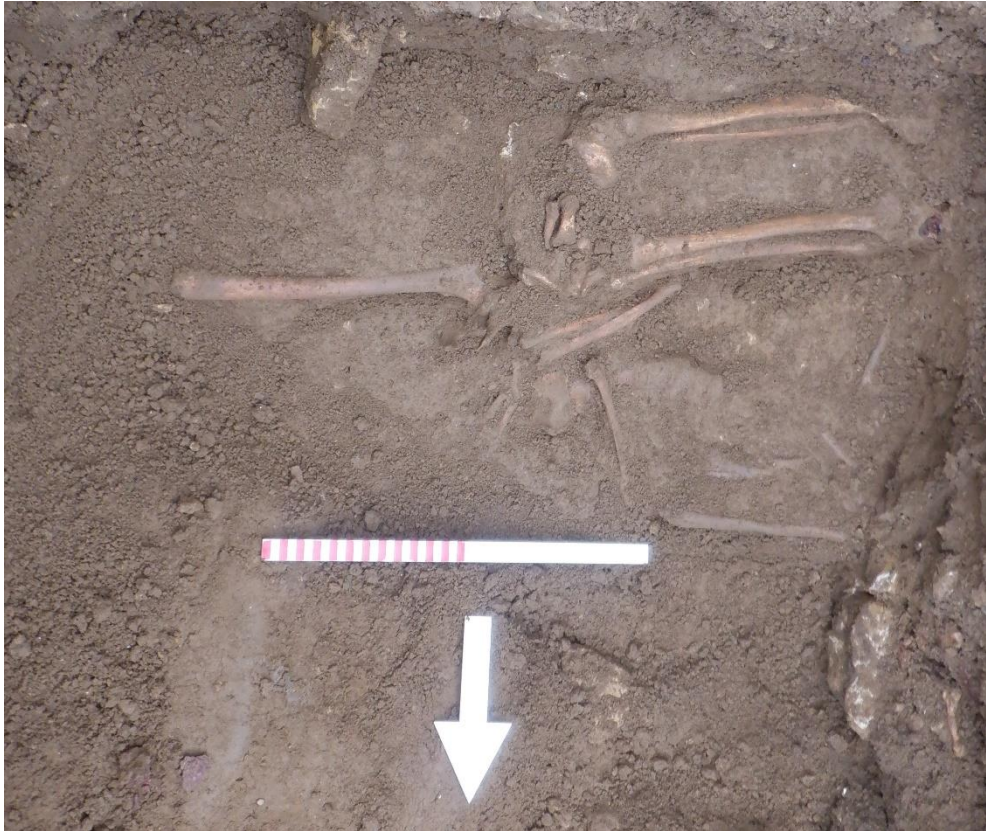
Photograph 33: Skeletons 32 and 33, facing northeast.

Skeleton 32 (Photograph 33) comprised the remains of a juvenile located directly north of skeleton 31 and south of skeleton 25. It was found at a depth of 1.14m from the top of the trench (73.06 OD), at the base of grave cut 176 and overlain by grave fill 177. Approximately 20% of the skeleton, including the lower left arm, pelvis and right arm, was visible within the trench and continued under the limit of excavation to the east and west. The lower left leg burial had been disturbed by the grave for Skeleton 25.

Skeleton 33 (Photograph 34) comprised the remains of an adult located directly south of Skeleton 32. It was found at a depth of 1.44m from the top of the trench (72.76 OD), at the base of grave cut 178 and overlain by grave fill 179. The lower 15% of the skeleton, from the top of the tibias to the feet, was visible within the trench and continued under the limit of excavation to the west.

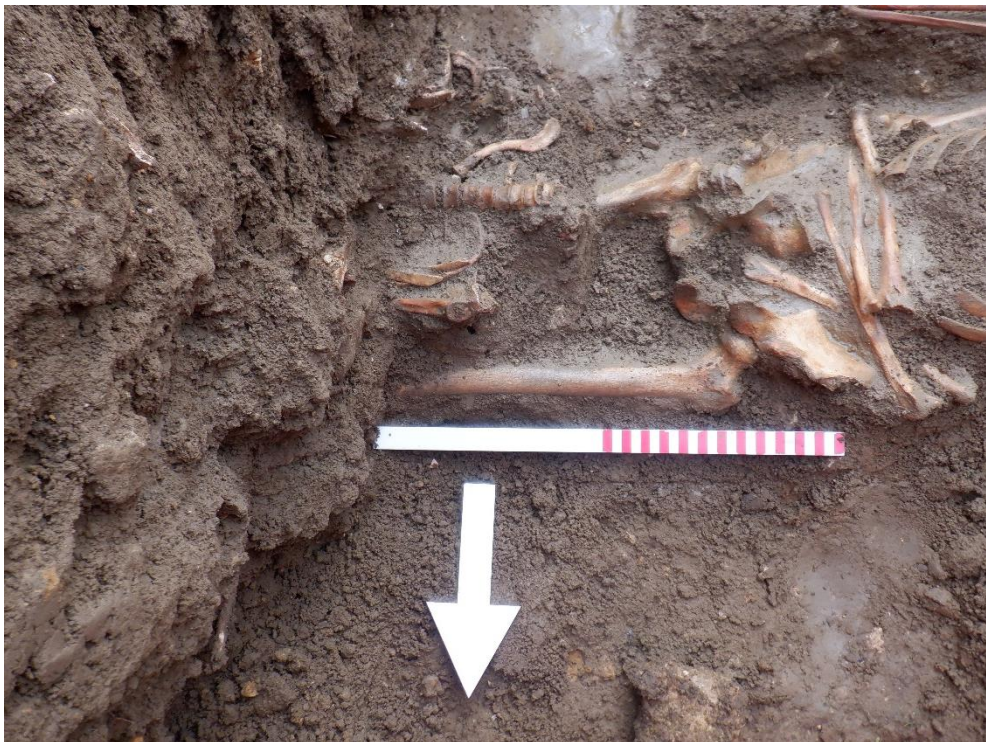
Photograph 34: Skeleton 34, facing south.

Skeleton 34 (Photograph 35) comprised the remains of an Adult located directly south of skeletons 31 and 33. It was found at a depth of 1.29m from the top of the trench (72.91 OD), at the base of grave cut 180 and overlain by grave fill 181. The upper 10% of the skeleton, from the skull to the bottom of the clavicles, was visible within the trench and continued under the limit of excavation to the east.

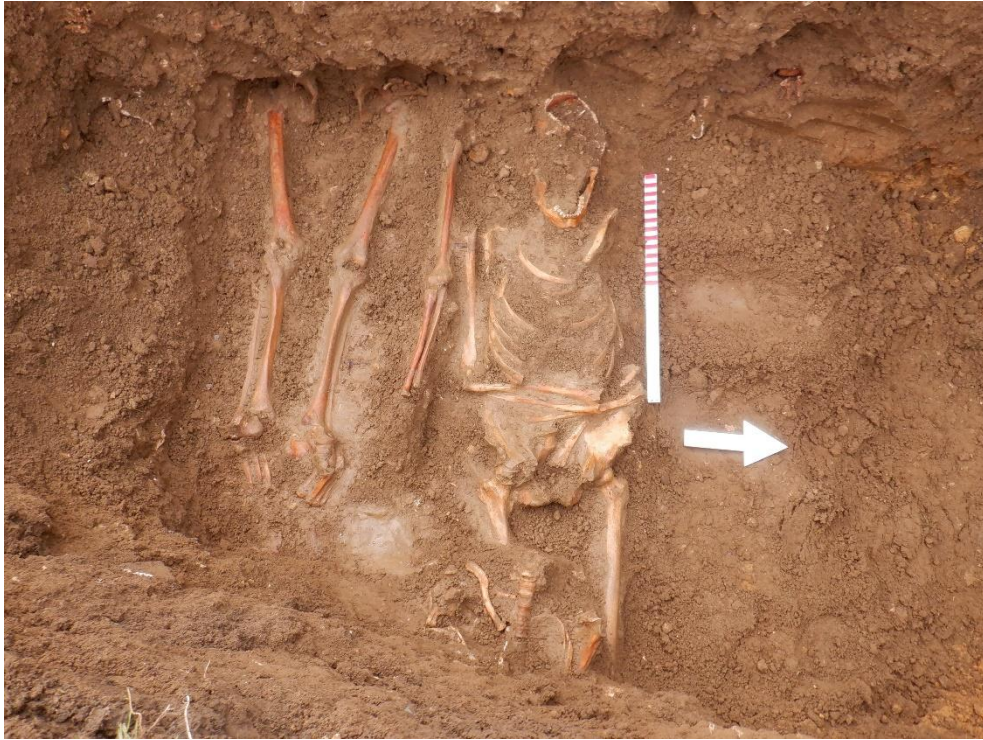
Photograph 35: Skeletons 35, 36, 37, facing west.

Skeleton 35 (Photograph 36) comprised the remains of an adult located south of skeleton 33 and underneath the skull of Skeleton 34. It was found at a depth of 1.38m from the top of the trench (72.82 OD), at the base of grave cut 182 and overlain by

Skeleton 36 (Photograph 37) comprised the remains of an adult located directly south of skeleton 35. It was found at a depth of 1.49m from the top of the trench (72.71 OD), at the base of grave cut 184 and overlain by grave fill 185. The lower 50% of the skeleton was visible within the trench and continued under the limit of excavation to the west.

Skeleton 37 (Photograph 38) comprised the remains of an Adult located directly north of and underneath Skeleton 36. It was found at a depth of 1.35m from the top of the trench (72.85 OD), at the base of grave cut 186 and overlain by grave fill 187. Most of the burial had been truncated by the grave for Skeleton 36 and only the long bones from the left arm survived in situ.

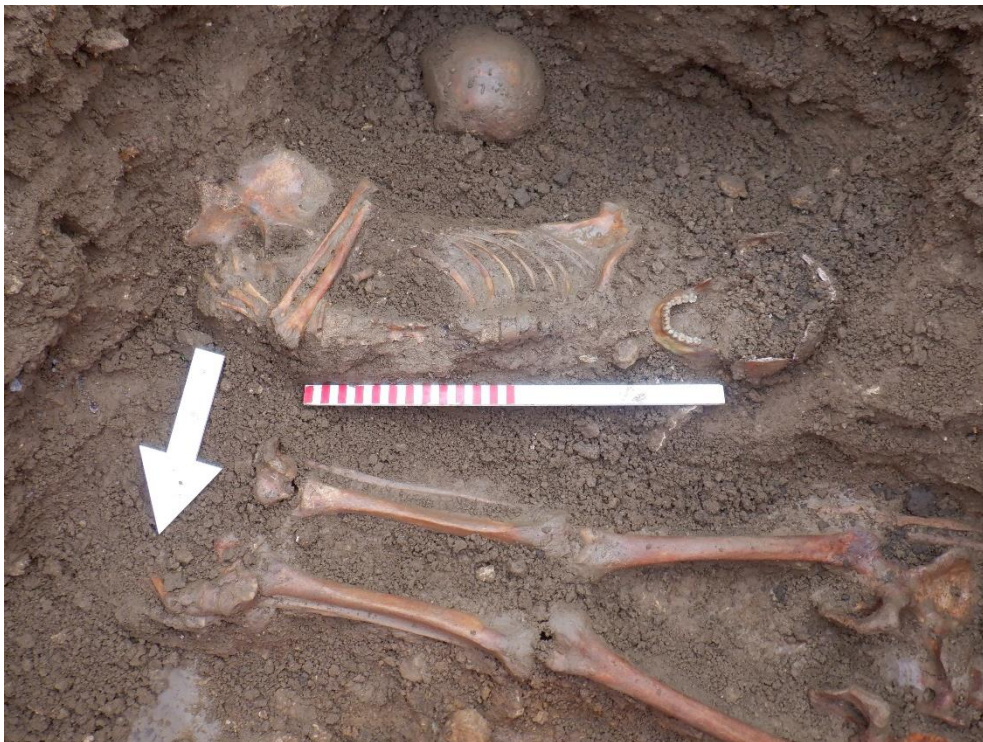
Photograph 36: Skeleton 38, facing south.

Skeleton 38 (Photograph 39) comprised the remains of an adult located south of and underneath Skeleton 36. It was found at a depth of 1.32m from the top of the trench (72.88 OD), at the base of grave cut 188 and overlain by grave fill 189. The left arm, hand, ribcage, the skull, spine, and pelvis survived, continuing under the limit of excavation to the east. The right arm and clavicle had been truncated by the grave of skeleton 37.

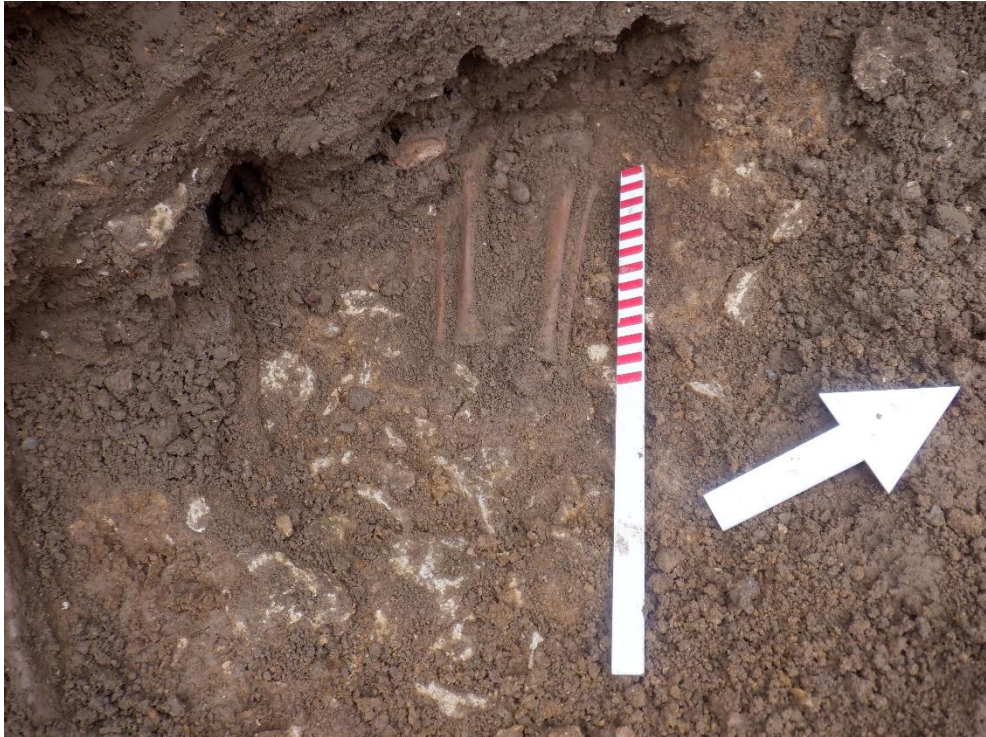
Photograph 37: Skeleton 39, facing northwest.

Skeleton 39 (Photograph 40) comprised the remains of an infant located north of skeleton 38 and underneath skeleton 36. It was found at a depth of 1.5m from the top of the trench (72.7 OD), at the base of grave cut 190 and overlain by grave fill 191. The lower 15% of the skeleton, from the top of the tibias to the feet, was visible within the trench and continued under the limit of excavation to the west.

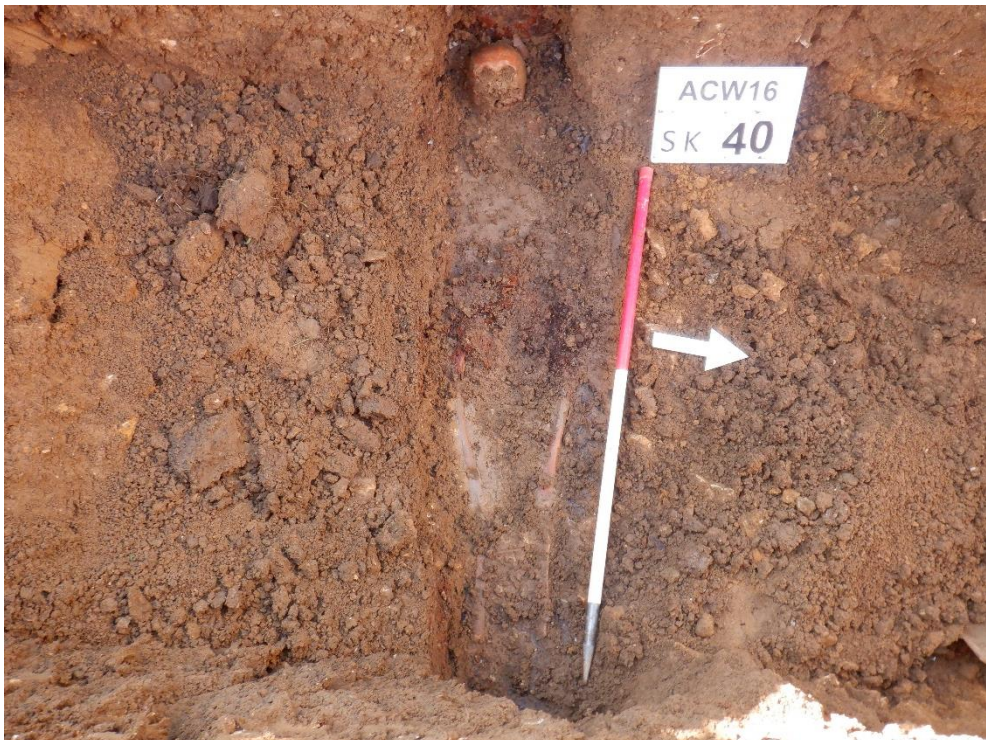
Photograph 38: Skeleton 40, facing west.

Skeleton 40 (photograph 41) comprised the remains of an adult located south of Skeleton 38. It was found at a depth of 1.61m from the top of the trench (72.59 OD), at the base of grave cut 192 and overlain by grave fill 193. The skeleton was very poorly preserved and only the skull and long bones of the legs survived. The remains of coffin fittings were recovered from above the body, suggesting that the lid may have collapsed and damaged most of the bones.

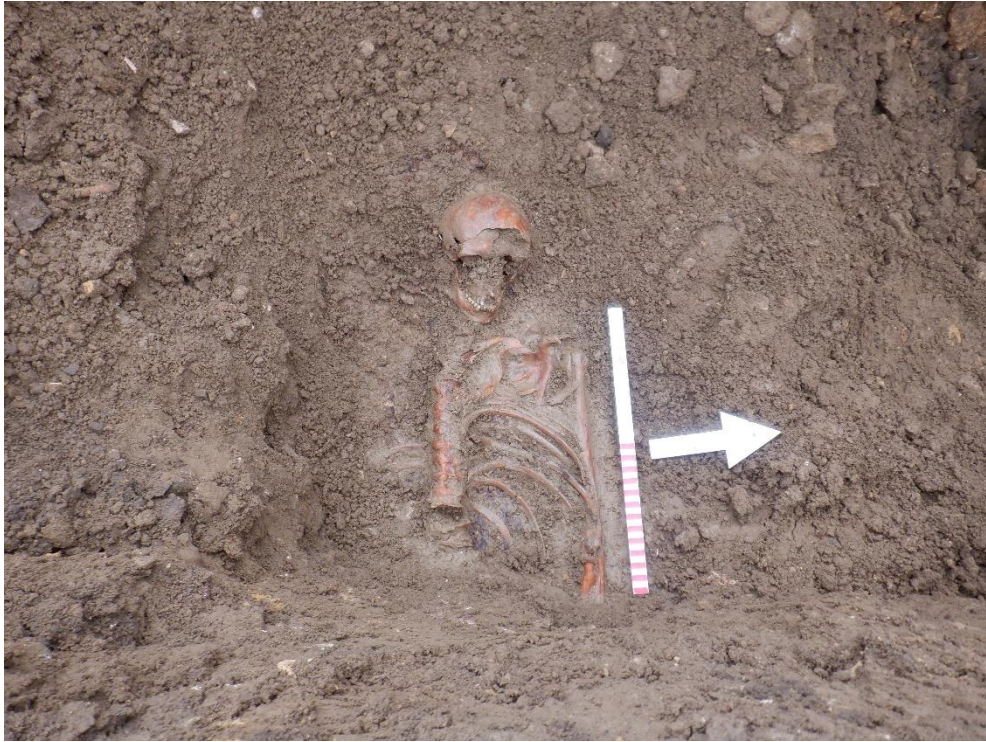
Photograph 39: Skeleton 42, facing west.

Skeleton 42 (Photograph 42) comprised the remains of an adult located south of Skeleton 41. It was found at a depth of 1.47m from the top of the trench (72.73 OD), at the base of grave cut 196 and overlain by grave fill 197. The upper-right 30% of the skeleton, including the skull, right arm, spine and right ribcage, was visible within the trench and continued under the limit of excavation to the east. The left arm, ribcage and clavicle had been truncated by the grave from Skeleton 43.
