# HOLY TRINITY CHURCH, ALLINGTON, LINCOLNSHIRE

Archive Report for:  
Archaeological Evaluation and Monitoring

**Project Code: HTA16**

**Report: 22018**

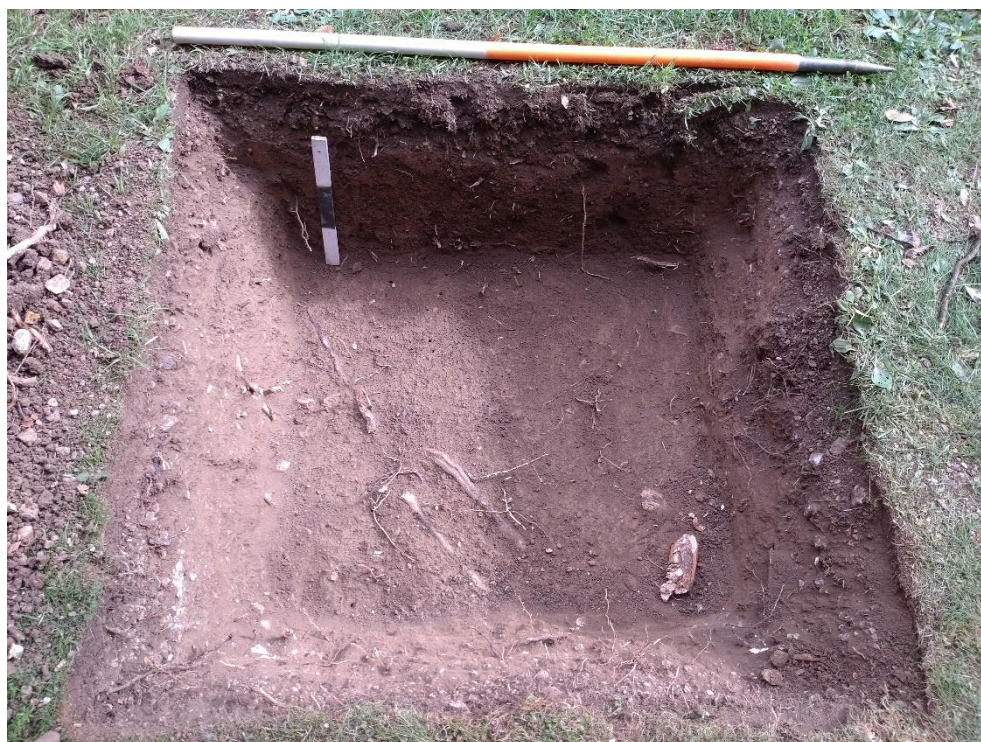
A layer of mid-greyish-brown sandy silt (*02*) was encountered at a depth of 0.2m. Layer *02* was excavated to a depth of 0.2m to achieve the 0.4m depth stipulated within the WSI and continued below the level of excavation (Photograph 1). The deposit was sealed by the 0.12m thick gravel and sand path (*01*), which was overlain by a 0.08m thick layer of turf (*03*). No artefacts were recovered from the excavated layers.

Photograph 1: Test pit 1, facing northeast.

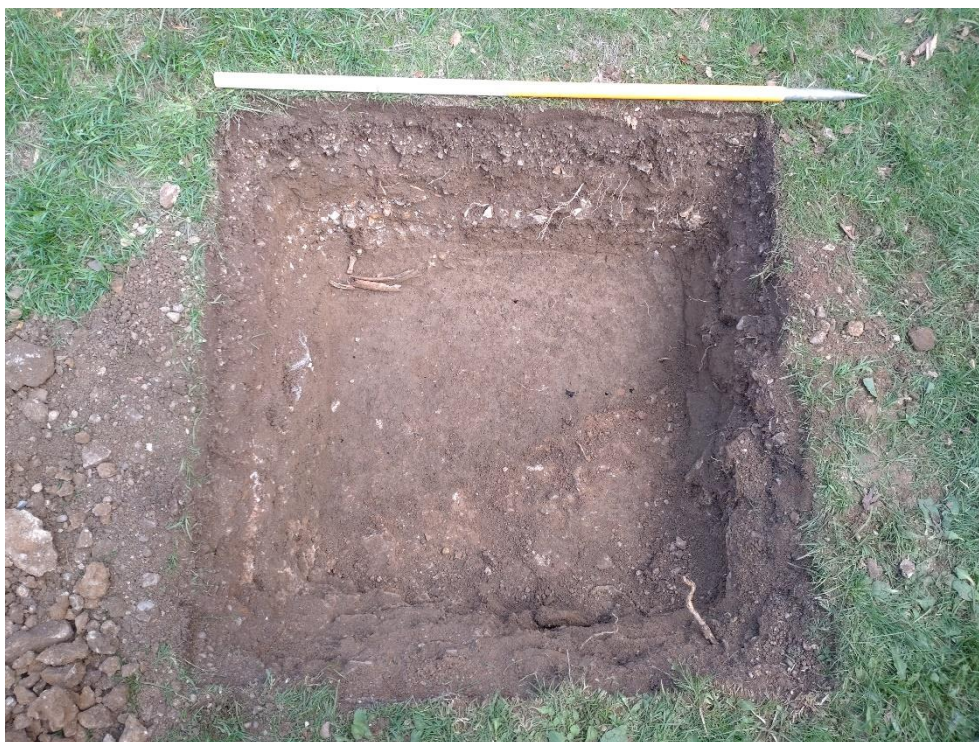
Layer *02* was also encountered within Test Pit 2 at a depth of 0.2m and was excavated to a depth of 0.2m (Photograph 2). It has been truncated within the southwestern half of the test pit by a steep linear northeast-southwest aligned cut (**05**). Cut **05** was filled by a loose light-yellowish-brown fine sand with frequent small stone inclusions (*06*). Fill *06* was excavated to a depth of 0.2m to achieve the 0.4m depth stipulated within the WSI and continued below the level of excavation. Fill *06* was sealed by the 0.12m thick gravel and sand path (*01*), which was overlain by a 0.08m thick layer of turf (*03*). No artefacts were recovered from the excavated deposits. Evidence of possibly articulated human remains, comprising five ribs and two metacarpals, were recorded within layer *02* at a depth of 0.4m.

Photograph 2: Test pit 2 containing feature **05** with possibly in situ human remains (top left), facing northeast.

The evaluation of Test Pits 1 and 2 revealed a ubiquitous layer of cemetery soil covering the area within the historic churchyard (04). No chanel, or loose, disarticulated bones were recovered from this layer during the groundworks. Possible articulated remains were recovered at a depth of 0.4m within later 04 within Test Pit 2. The linear cut (05) recorded within Test Pit 2 may represent the top of a backfilled grave, or a ditch or foundation trench associated within an earlier boundary.

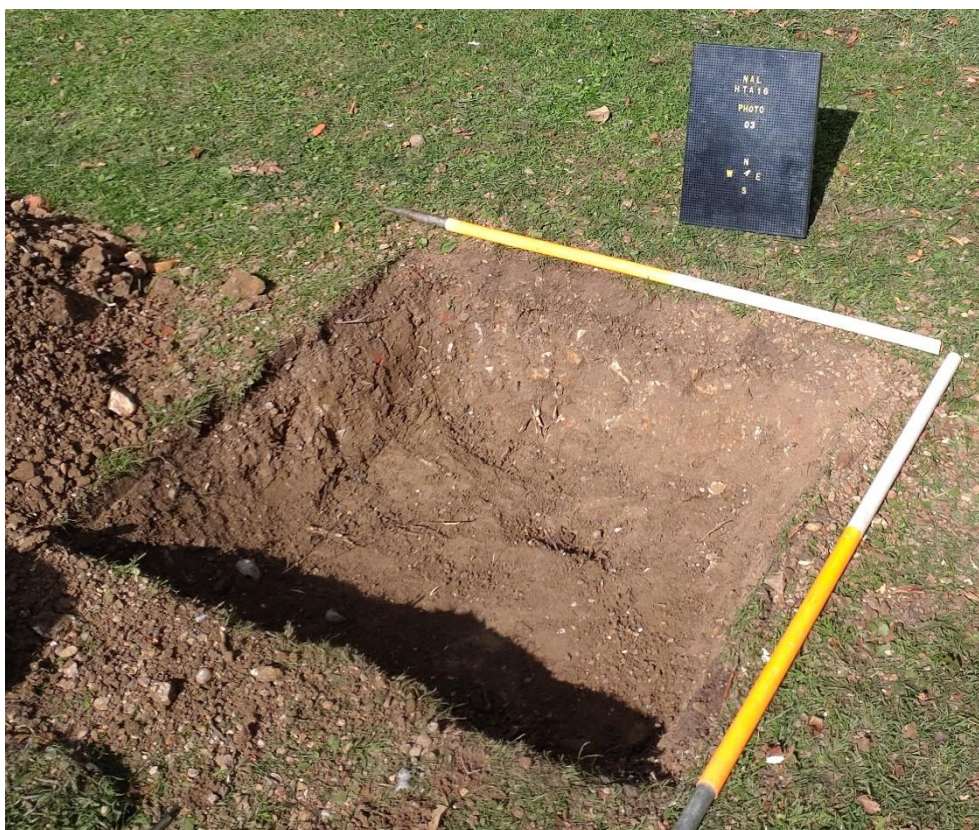
A natural substrate of light-brownish-yellow sand (*04*) containing frequent stone and fossil inclusions was encountered at a depth of 0.1m. This was a natural deposit and continued below the level of excavation (Photograph 3). Layer *04* was sealed by the 0.15m thick gravel and sand

path (01), which was overlain by a 0.05m thick layer of turf (03). No artefacts were recovered from the excavated layers.

Photograph 3: Test pit 3, facing north.

Test Pits 3 and 4 suggest that the southern half of the land containing the path has been landscaped and its level reduced. This has resulted in the natural substrate being directly below the c. 0.15m thick turf and topsoil (03).

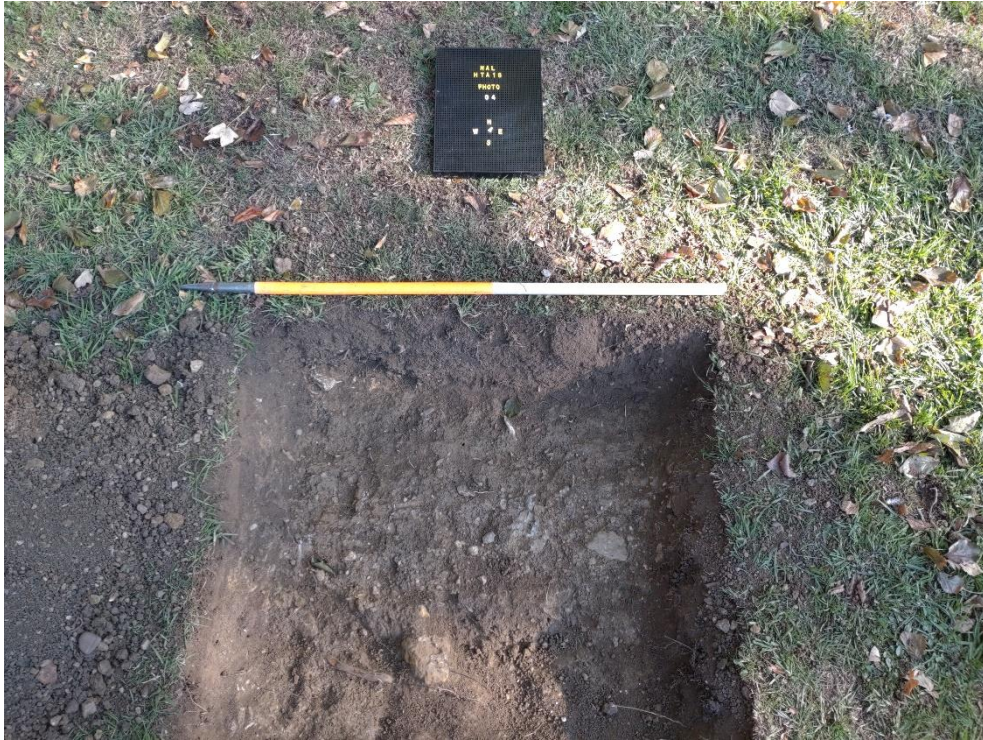
A natural substrate of light-brownish-yellow sand (04) containing frequent stone and fossil inclusions was encountered at a depth of 0.1m and continued below the level of excavation (Photograph 4). Layer 04 was sealed by a 0.15m thick layer of turf (03). No artefacts were recovered from the excavated layers.

Photograph 4: Test pit 4, facing northeast.

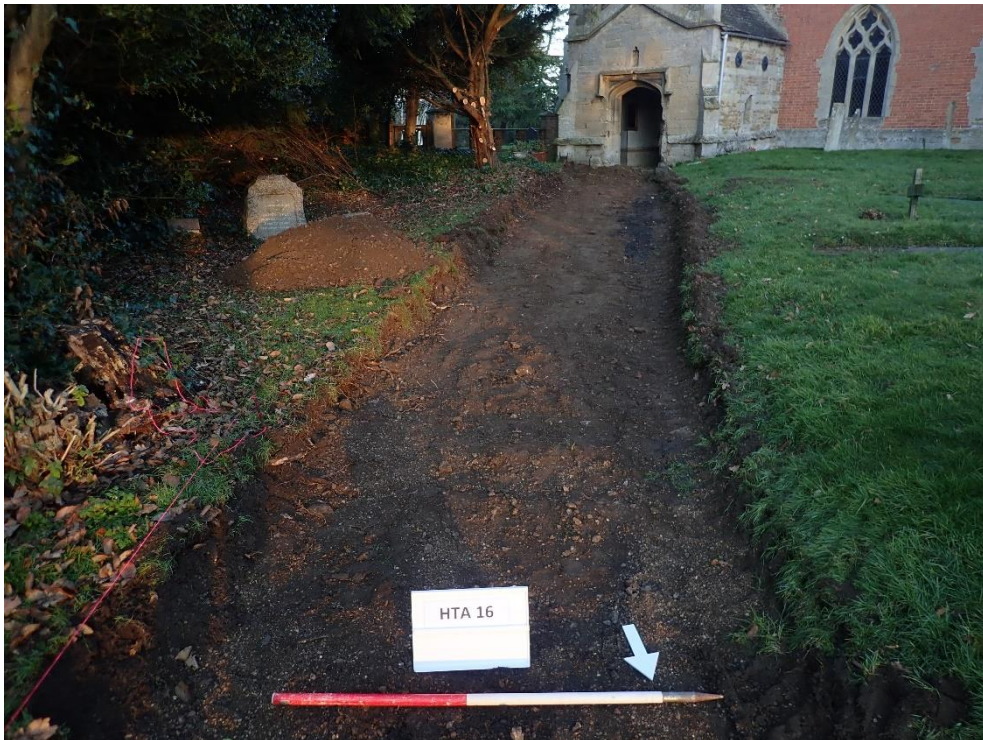
The foundation trench for the new pathway was approximately 1.2m wide and 0.25m deep along the entire length (Photographs 5 and 6). Layer 02 was exposed in the base of the trench following the removal of the old path (02) and sealed by a thin layer of turf (03). A partial section of ceramic drain, probably 19<sup>th</sup> century, was recorded approximately 3m south of the church entrance (07- Photograph 7). A collection of unworked stone was recorded directly outside the entrance, likely used to consolidate the existing path (08).

Photograph 5: Stripping of the pathway within the churchyard, facing south

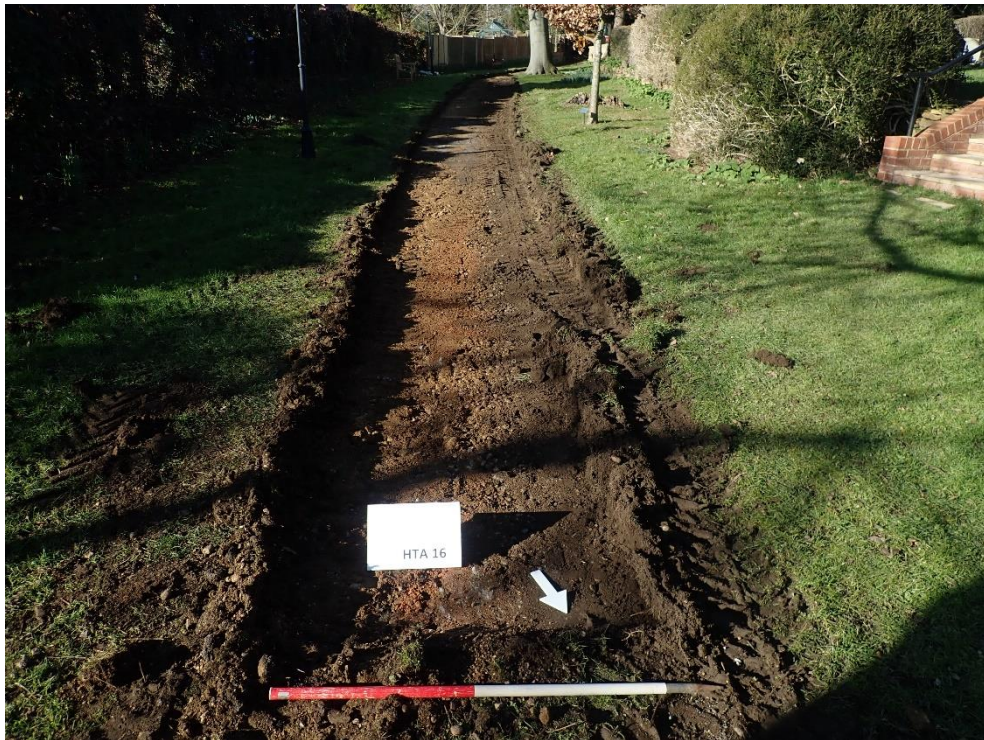
Photograph 6: Stripping of the pathway to the southwest of the main access, facing southwest

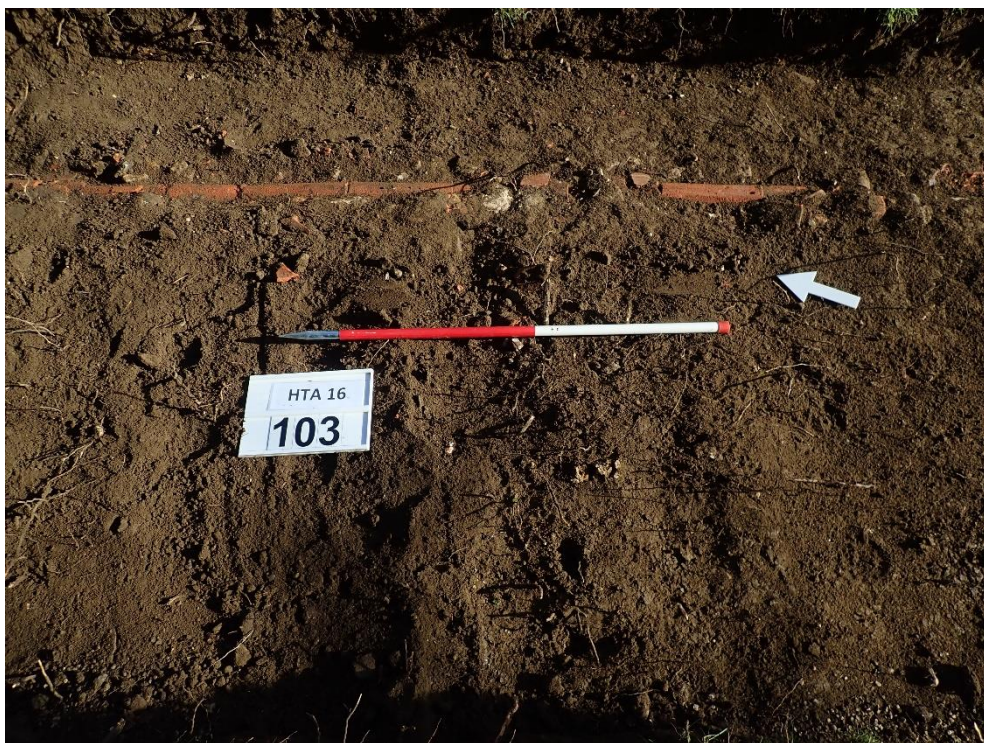
Photograph 7: Post-medieval drain **07** to the south of the church , facing northeast

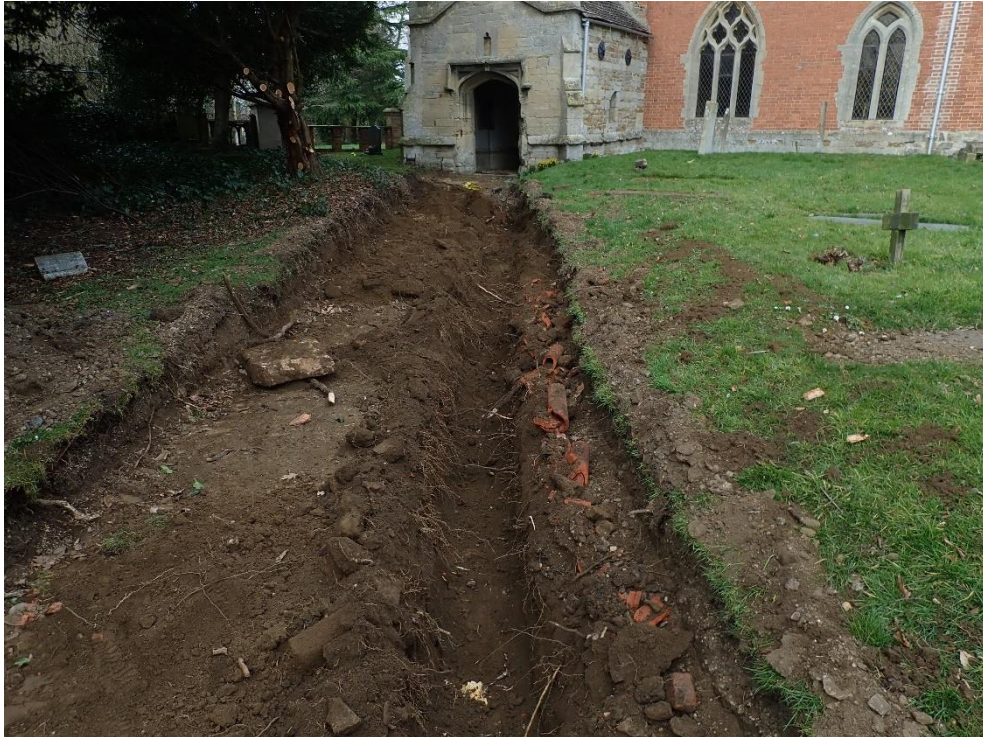
The conduit trench was approximately 0.2m wide and 0.4m deep. To the south of the church, the route of the conduit trench was excavated through the ceramic drain (08) to minimise potential impact on in situ burials (Photograph 8). The same layer of natural sand (04) observed during the evaluation was exposed at within the southern half of the conduit trench (Photograph 9) following the removal of the old path (02) and the turf (03).

Photograph 8: Stripping of the conduit to the north of the church, facing south

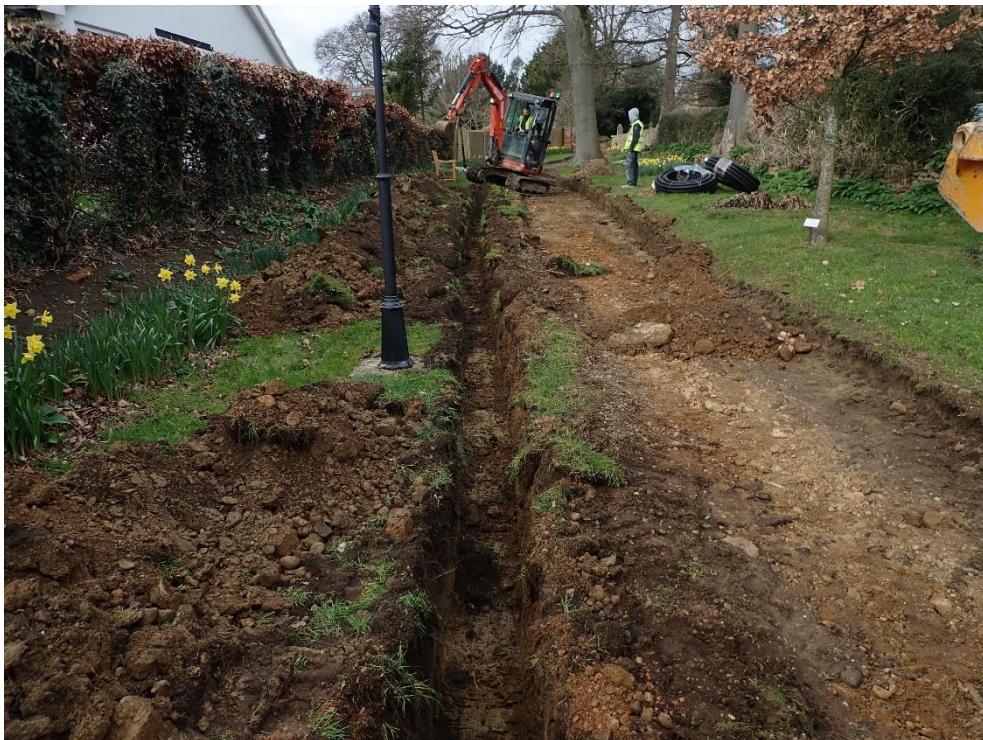
Photograph 9: Excavation of the conduit trench, facing southwest
