HEATHER QUARRY

Archaeological Watching Brief

NETWORK ARCHAEOLOGY LTD

Report no. 524

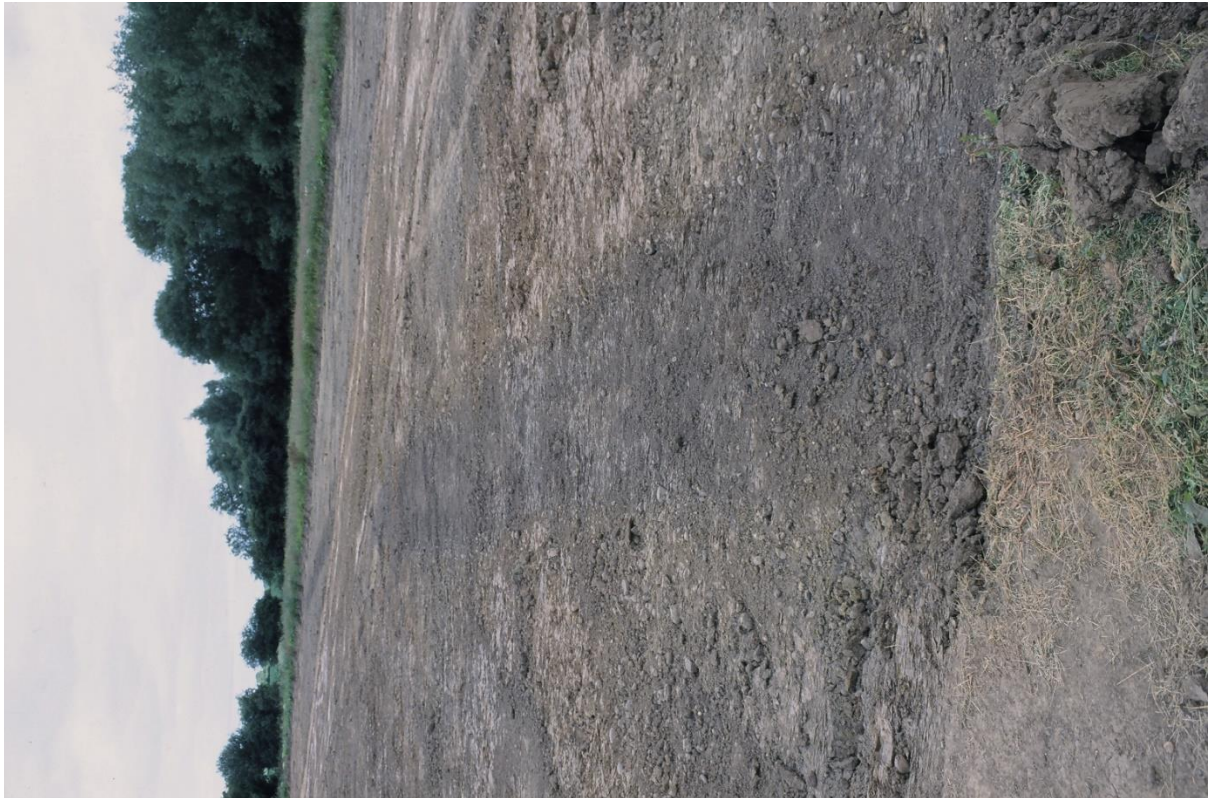
HEA05 Film 1 Shot (1)

Project Code		Film Type	ASA	Loaded By	Film No.	
HEA ⁺ 05		CS	200	CT 19/05	1	
Neg	Shot	Contexts	Description	Sub-div	Sign Date	X ref
	1	001 - 004	General, ditch looking SW	/	19/05	
	2	"	" " "	/	"	
	3	"	" " NE	/	"	
	4	"	" " NE	/	"	
	5	"	" " SW	/	"	
	6	"	" " SW	/	"	
	7	"	Detail (plan of ditch, looking SW)	/	"	
	8	"	" " " " " " SW	/	"	
	9	005	kerb in joining ditch SW	/	"	
	10	005	" " " SW	/	"	
	11	005	" " " W	/	"	
	12	"	" " " W	/	"	
	13	"	" " " E	/	"	
	14	"	" " " E	/	"	
	15	007, 009	ditch + ditch/furrow, " SE	/	27/05	
	16	" "	" " " NW	/	"	
	17	003	ditch, with bricks in bp SW	/	"	
	18	"	ditch with bricks " " NE	/	"	
	19			/		
	20			/		
	21			/		
	22		<i>KIP05</i>	/		
	23			/		
	24			/		
	25			/		
	26			/		
	27	GENERAL SHOT OF SOUTHWEST EXTENSION TO QUARRY LOOKING N/SW		/	21/5/05	✓
	28	" " " " " "		/	"	✓
	29	[REDACTED]		/		
	30	[REDACTED]		/		
	31	[REDACTED]		/		
	32	[REDACTED]		/		
	33			/		
	34			/		
	35			/		
	36			/		
	37			/		
	38			/
