WATERLOO KILN, SWINTON

Archive Report:
Archaeological Monitoring (Watching Brief)

Project Code: WKS16

Report Number: REP2409

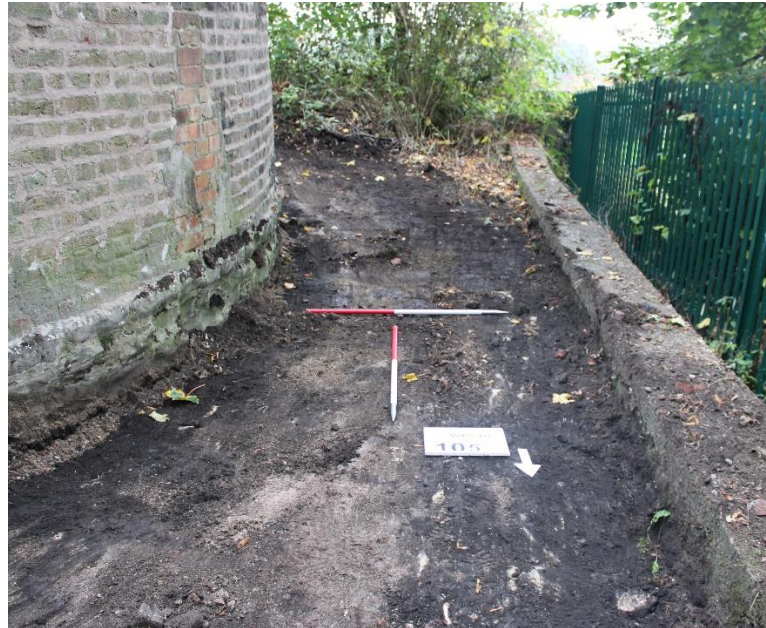
Reduction of the overburden *100* revealed a layer of sandy silt *105* which contained brick rubble, mortar and clay lenses, stones, glass fragments and ash. Deposit *105* represented the formation level on the north-western, south-western and south-eastern sides of the kiln and was exposed over an area of 60m². No other features were identified in these areas.

Plate 1: Layer 105, facing south.

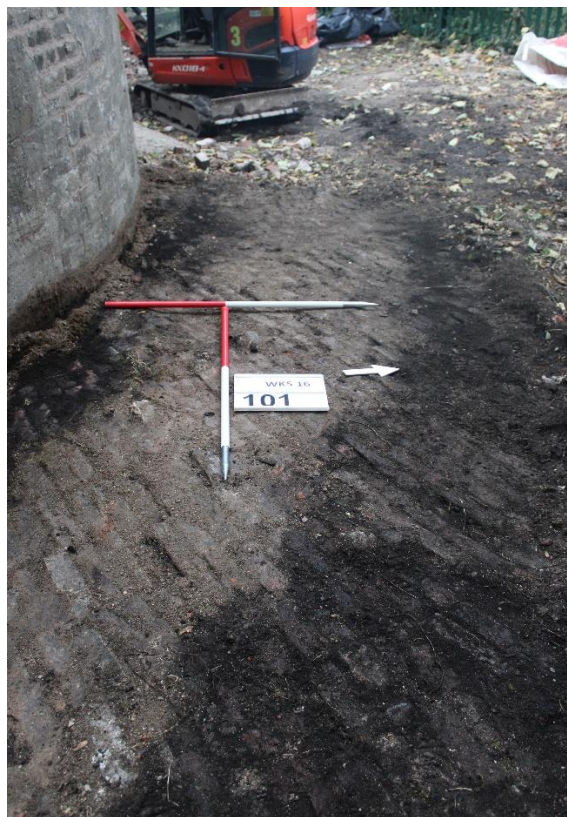
On the north-eastern side of the kiln, deposit *105* formed the bedding layer for a fragment of brick floor *101*. Floor *101* butted the eastern side of the kiln and was formed of unfrogged red bricks measuring 240mm by 110mm by 70mm in size. The courses of brickwork forming the floor consisted of unbonded edge-laid stretchers, which were aligned approximately north-west to south-east. A 5.70m by 2.40m area of the floor was exposed during the groundworks, but it is clear that it extended to the north and east, beyond the limit of the current excavation. In general, the appearance of floor *101* was very similar to the brick floor found in association with a bottle kiln base during the 2019 community excavation of the pottery works (ArcHeritage 2019; contexts 303 and 305, figs 7 and 8). For this reason, it is interpreted as a working or yard surface contemporary with the operation of the kiln.

Plate 2: Floor 101, facing north-west.

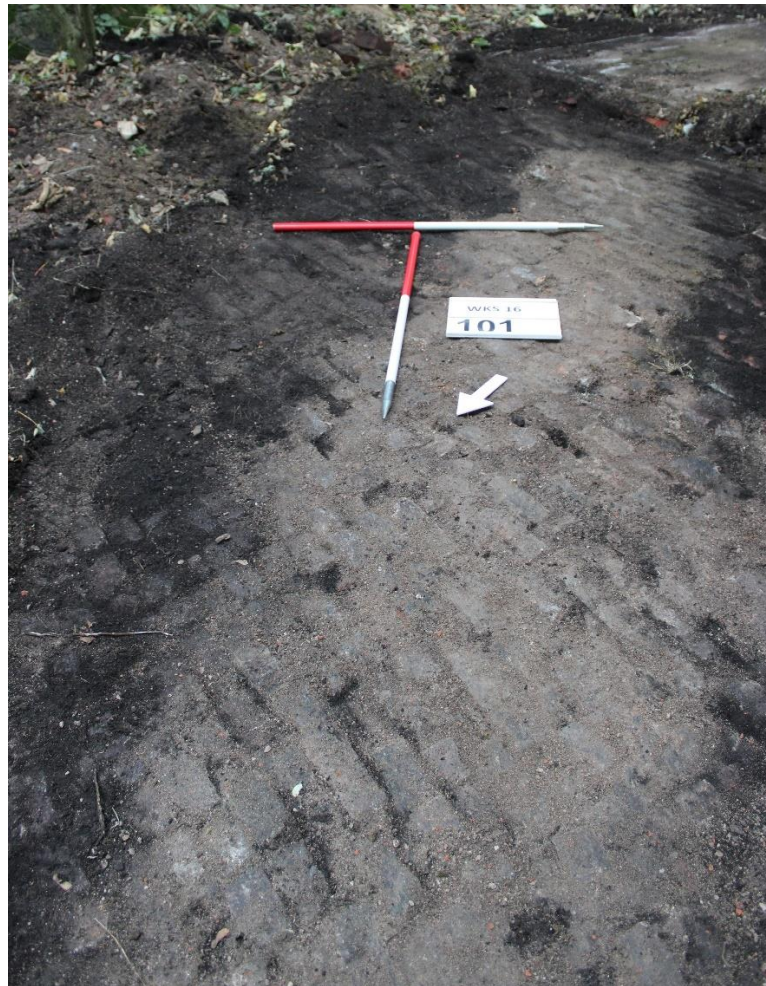
Plate 3: Floor 101, facing south-east.

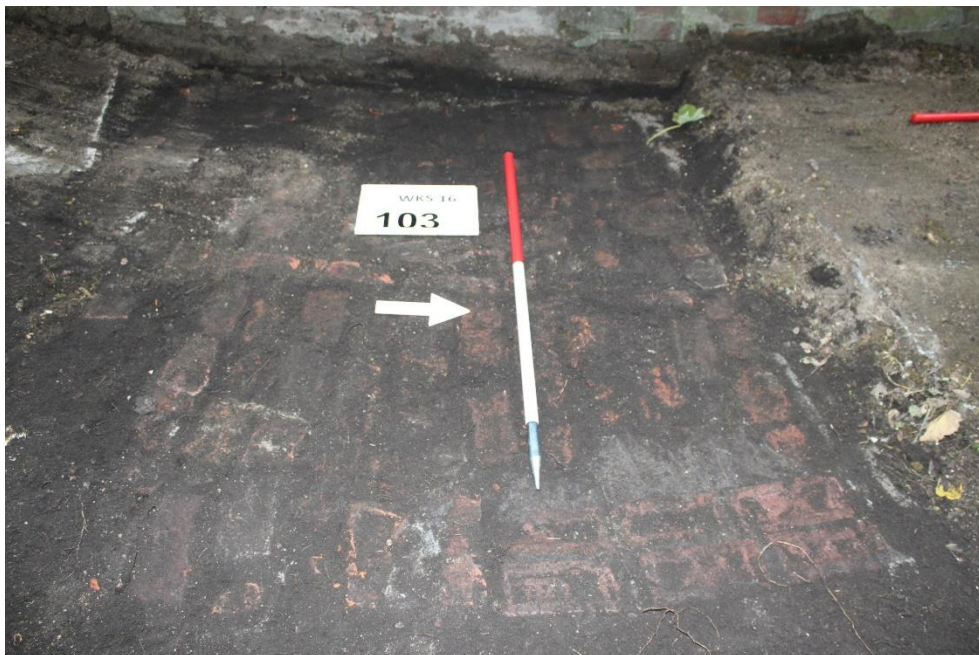
A second fragment of brick flooring *103* was located to the south of floor *101*. Floor *103* consisted of machine moulded, frogged red bricks measuring 230mm by 110mm by 90mm in size. No makers' stamps were evident on the bricks, which were bonded with a compact grey cement mortar. The floor was 2.90m long and 1.90m wide and the bricks appeared to have been laid randomly, with no obvious pattern of coursing. Both the materials and manner of construction indicated that floor *103* was of a later build than floor *101*. It may therefore represent a repair to the earlier floor or perhaps post-use consolidation of the kiln.

Plate 4: Brick floor 103, looking west

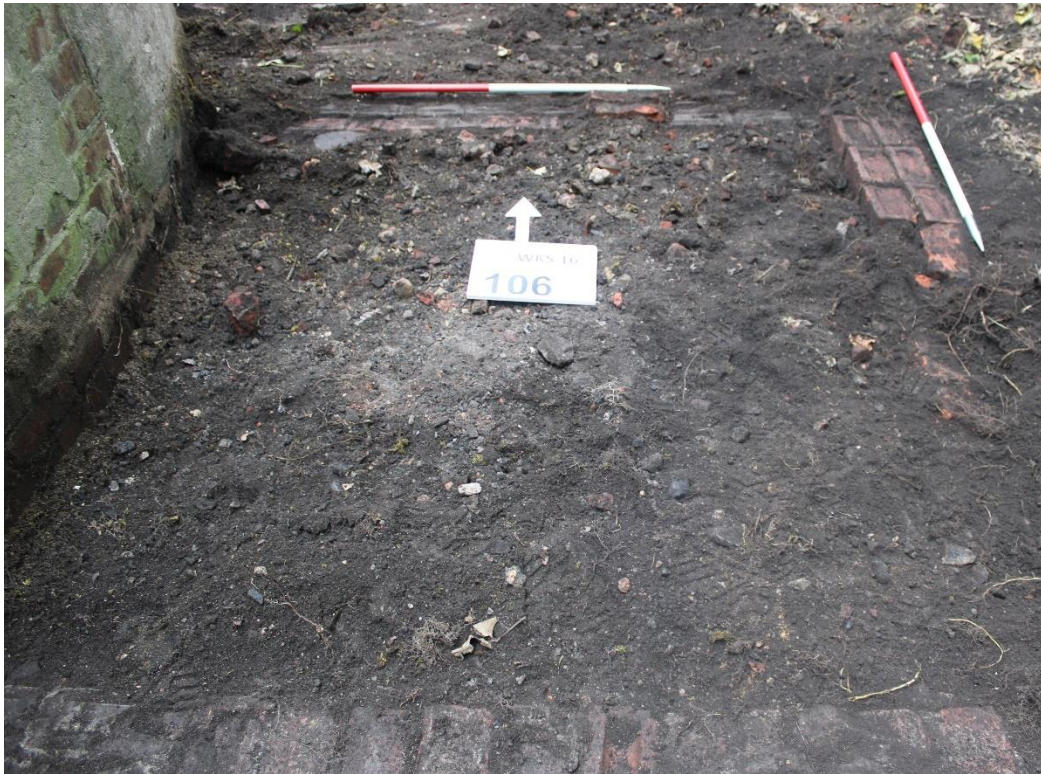
Both floors *101* and *103* were truncated by a 2.50m wide, 2.90m long rectangular pit cut **108**. Pit **108** contained a brick lining *106* on its northern, eastern and southern sides, with the western side of the cut abutting the kiln wall. Brick lining *106* consisted of moulded, frogged red bricks measuring 240mm by 110mm by 80mm. None of the bricks had a makers' stamp. The bricks were laid in alternate courses of headers and stretchers, and although the pit was not excavated, it was at least two courses of brickwork deep. The brickwork was bonded by a compact cement mortar.

The interior of brick-lined pit **108/106** was filled by a silty sand deposit *107*. This deposit contained ash, brick fragments, glass, clinker and slag. It was very 'industrial' in nature and appears to have been waste material sourced on the site which had been subsequently used as infill.

The function of the pit itself is somewhat unclear; it was clearly of a later build than the kiln and is therefore unlikely to have been directly associated with pottery production. However, it may have been associated with the later conversion of the kiln into a smallpox isolation hospital, perhaps representing a manhole associated with services provision to the structure. In this regard, it is important to note that the pit was situated adjacent to the blocked-up eastern doorway of the kiln, which itself is thought to be a later insertion into the structure.

Plate 5: Pit 108 showing brick lining 106, facing north.

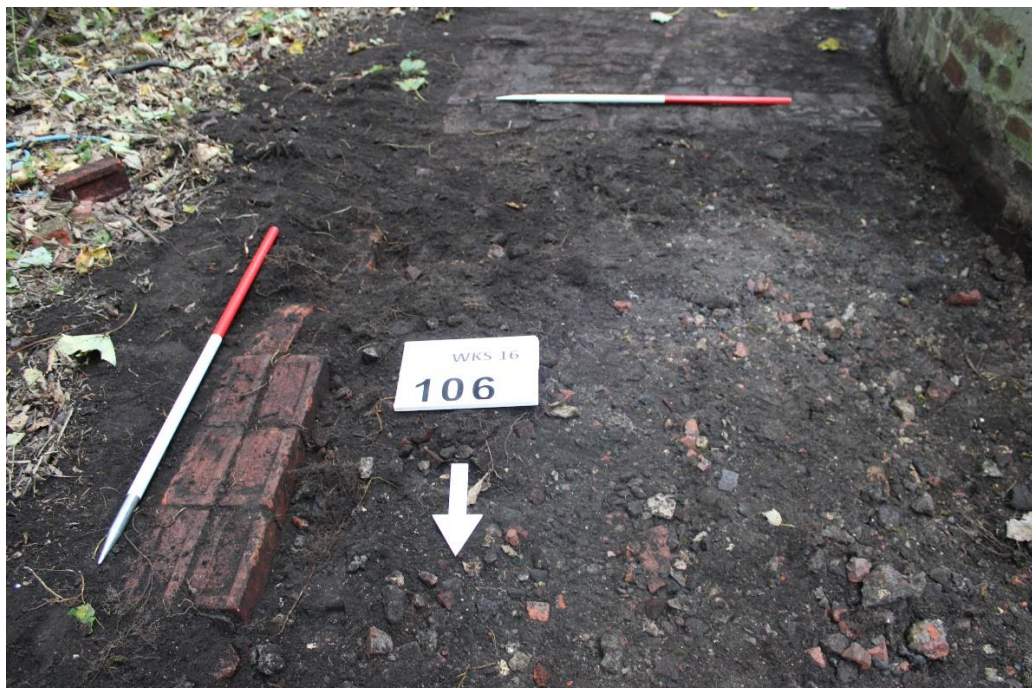
Plate 6: Pit 108 showing brick lining 106, facing south.

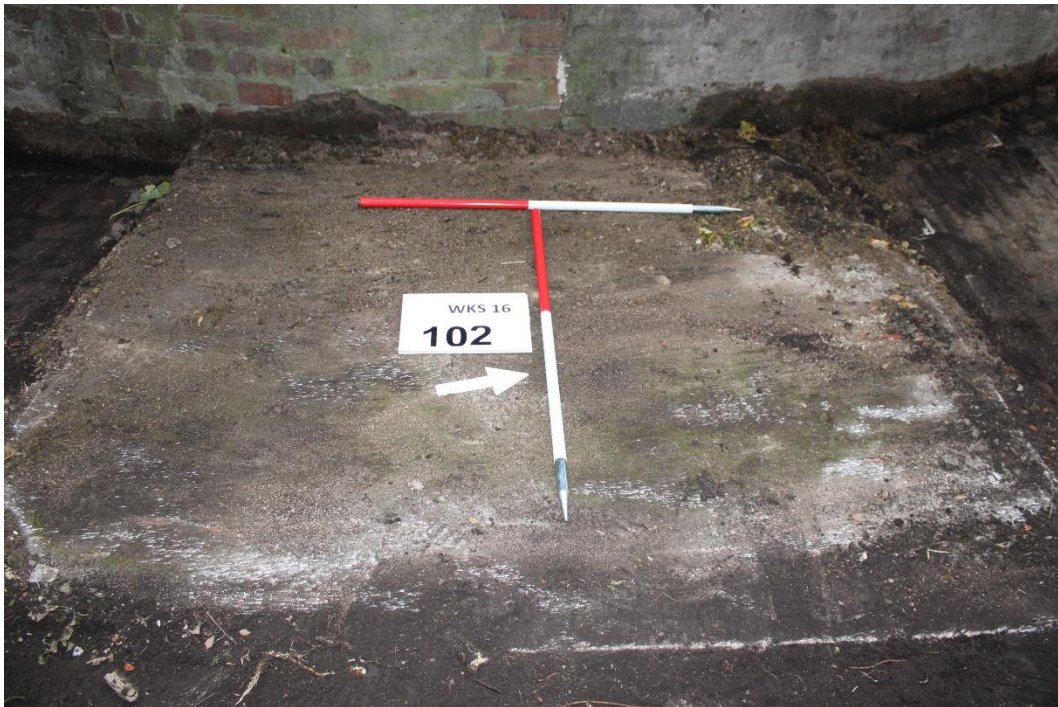
Pit fill 107 was capped by a 0.15m deep layer of modern concrete 102. This feature is likely to be associated with the post-use consolidation of the kiln.

Plate 7: Concrete layer 102, facing west.

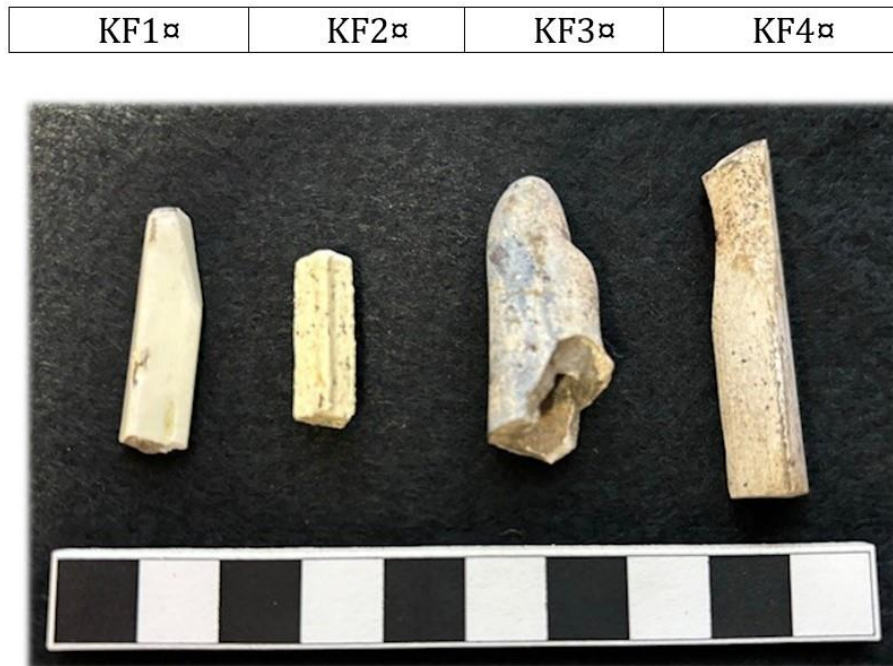
Photograph 1: Kiln Furniture

KF 1 is a fragment of a spacer bar with a white earthenware body and a cream glaze. It has four sides, two of which have been trimmed to create a taper at one end. Bars of this sort were multi-purpose in their function when spacing pottery for firing in the kiln.

KF2 is a fragment of a 'pin' end, with a cream glaze, and is hexagonal in section. The pin was placed in the wall of the saggar and was designed specifically to facilitate the placing of flatware for 'glost' firing. The pin shows evidence of repeated use, with its fabric being near vitrified.

KF3 is hand-rolled in white clay. It tapers to a rounded point and shows evidence of burning. Fragments of this type of kiln furniture, known as rods, have been previously discovered on this site (Chris Cumberpatch - pers. comm.) and were probably used to assist with the placing of wares in the kiln. This type of kiln furniture is probably earlier in date than the other three pieces.

KF4 is a complete spacer bar, triangular in section, formed by extrusion and is 45mm in length. There are semi-circular cut outs at the apices at one end of the bar. Like KF1, the bar probably had multiple uses within the firing process.

The kiln furniture dates from the 1770s onwards and will have been used in the firing of pottery at the kiln.

All the kiln furniture recovered shows signs of use and is evidence of the manufacture of the pottery on site. Kiln furniture is not particularly well researched, and this small assemblage should be retained to further our understanding of the manufacturing processes at that time.

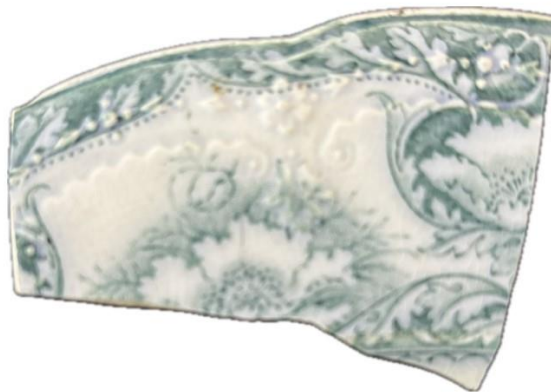
Photograph 2: Pearlware dish sherd

The dish has a green transfer-printed border around the edge with a floral design around the flange in a repeating pattern (Photograph 2). The rim is scalloped with moulded floral decoration. There is a fine ash deposit on the underside of the dish.

The five pearlware sherds from the same dish, with a wide-flange rim and green transfer decoration, should be retained as no exact parallel for this vessel has been identified. The remaining sherds of pearlware and the stoneware recovered from the brick-lined rectangular pit date from the 1830s onwards and are likely to be associated with the habitation on site after the pottery works closed in the 1840s. No further work is required on these pottery sherds and this material may be discarded.

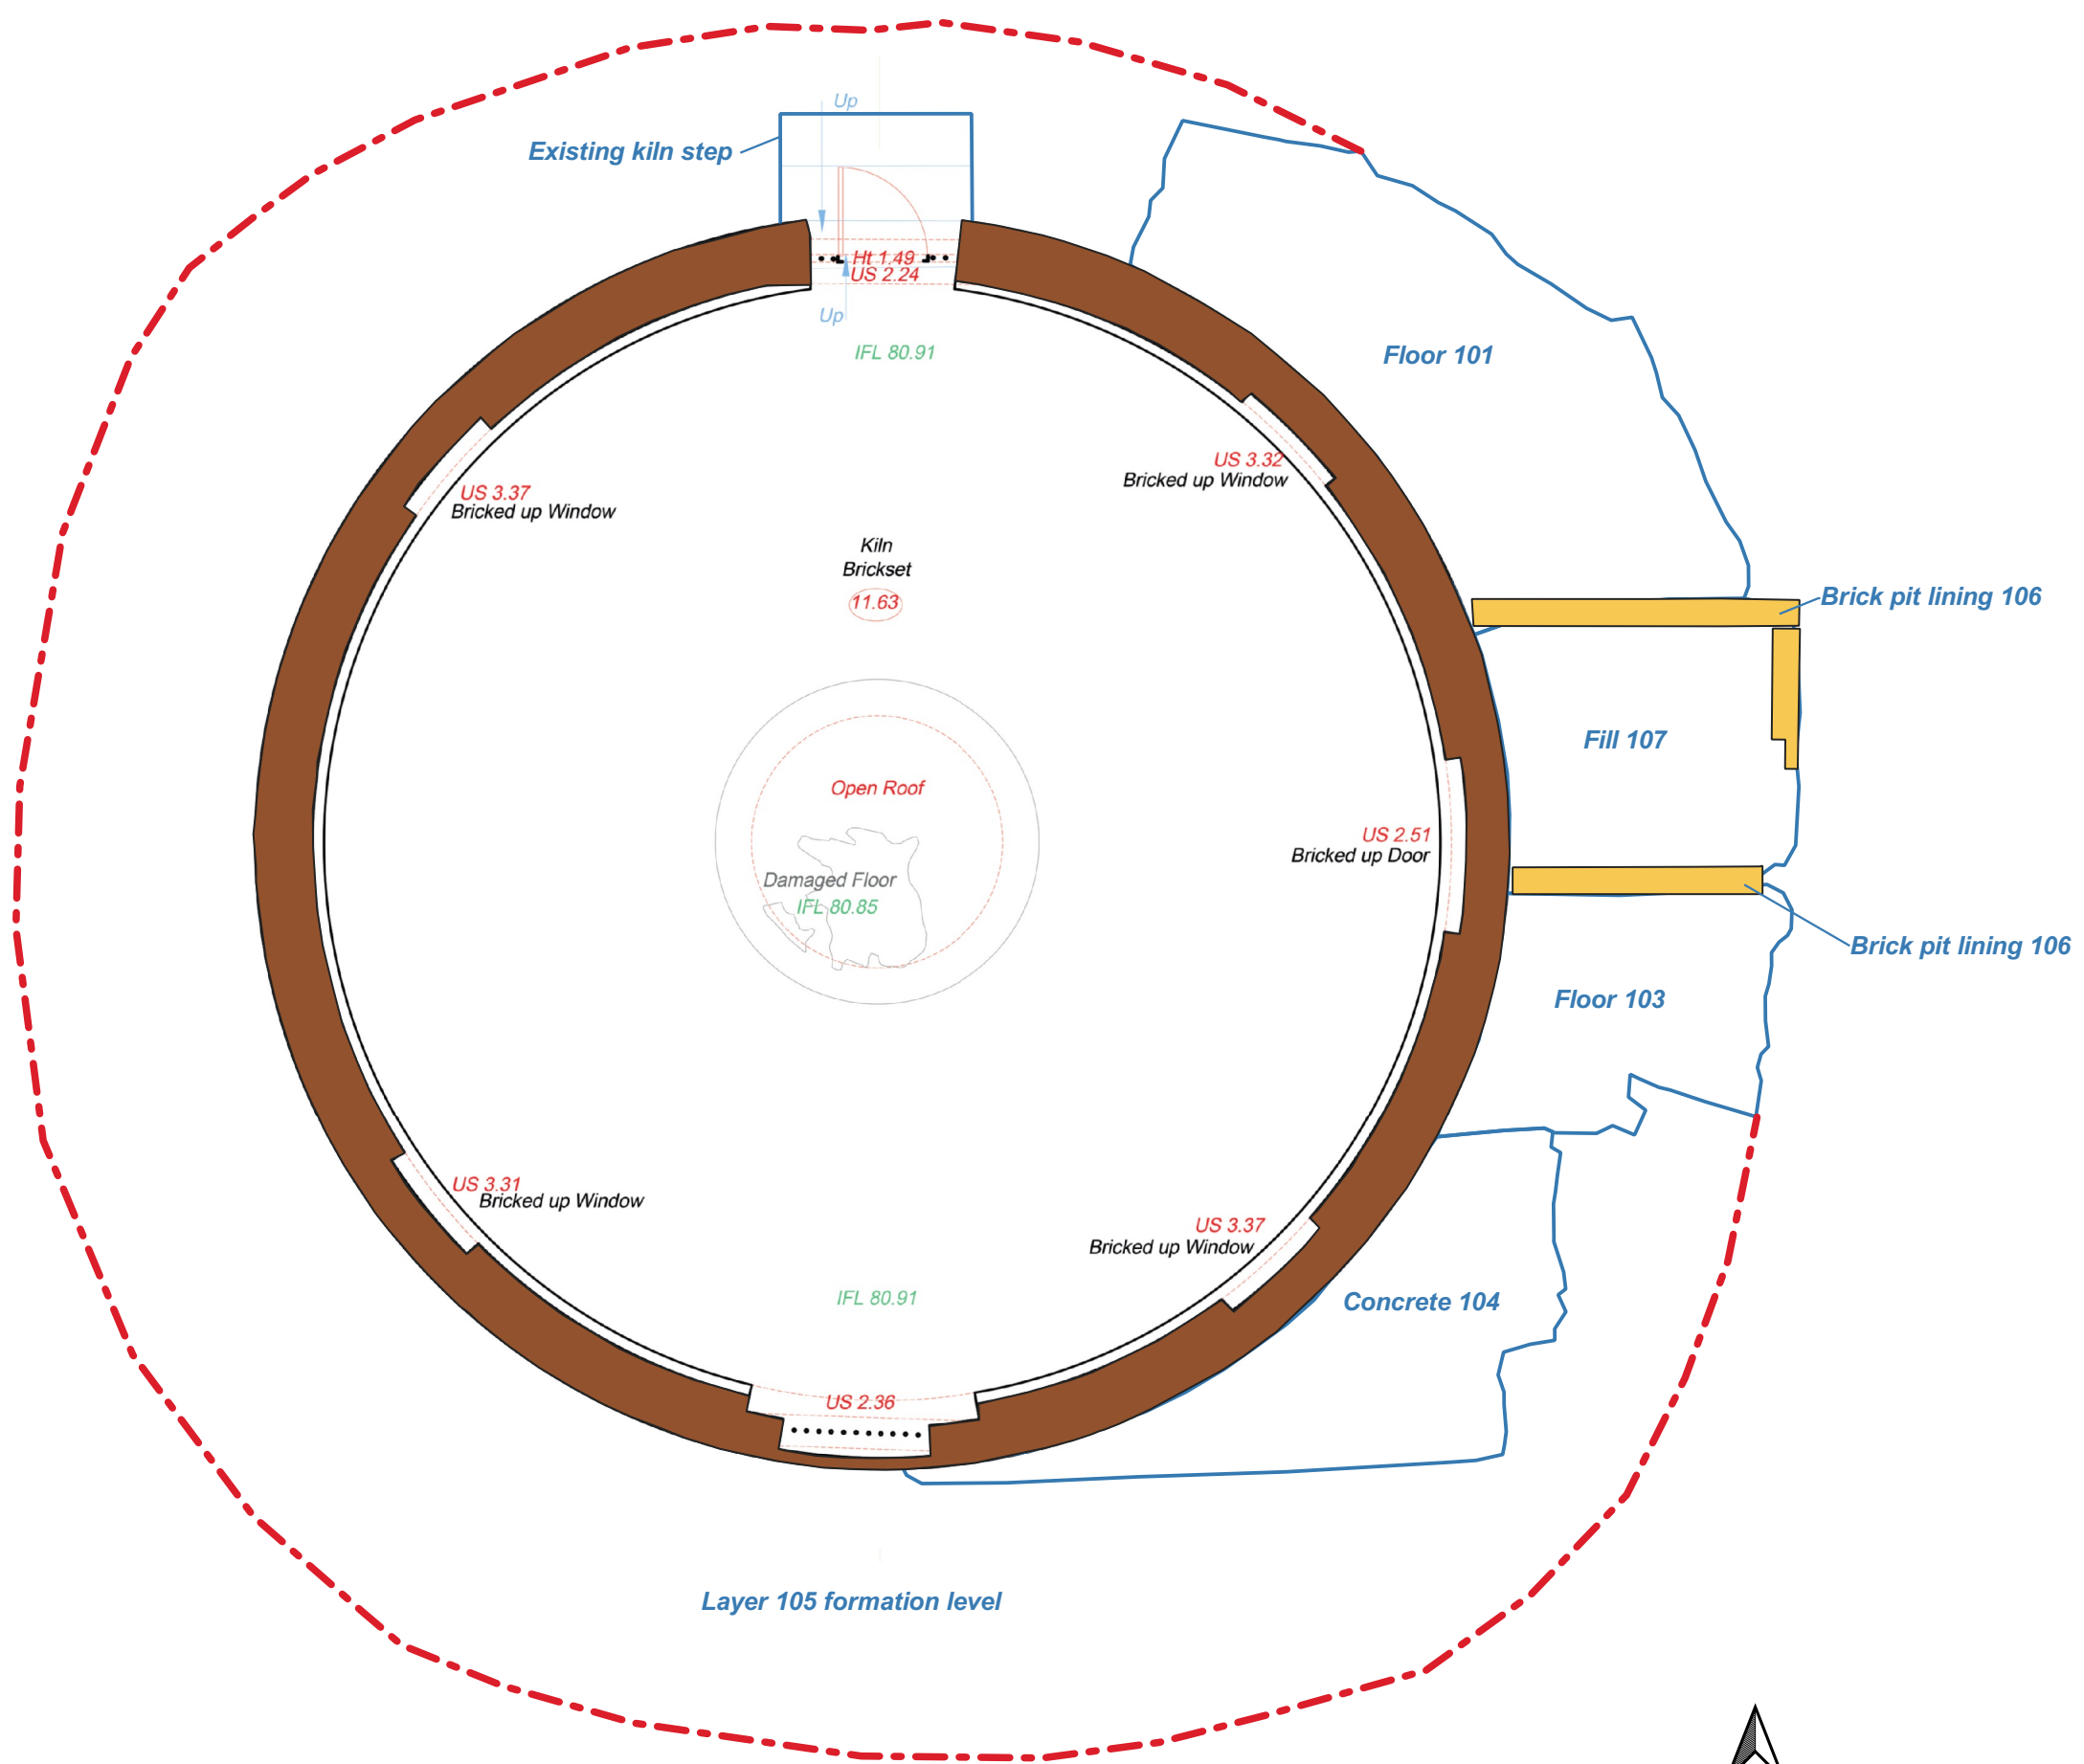
Waterloo Kiln, Swinton
 Figure 2 Monitoring area results
 Scale 1:60

- - - LOE
- Brickwork
- Kiln structure
- results
