Horncastle Water Mill

Watching brief on construction footing trench

Network Archaeology Ltd

Report no. 555

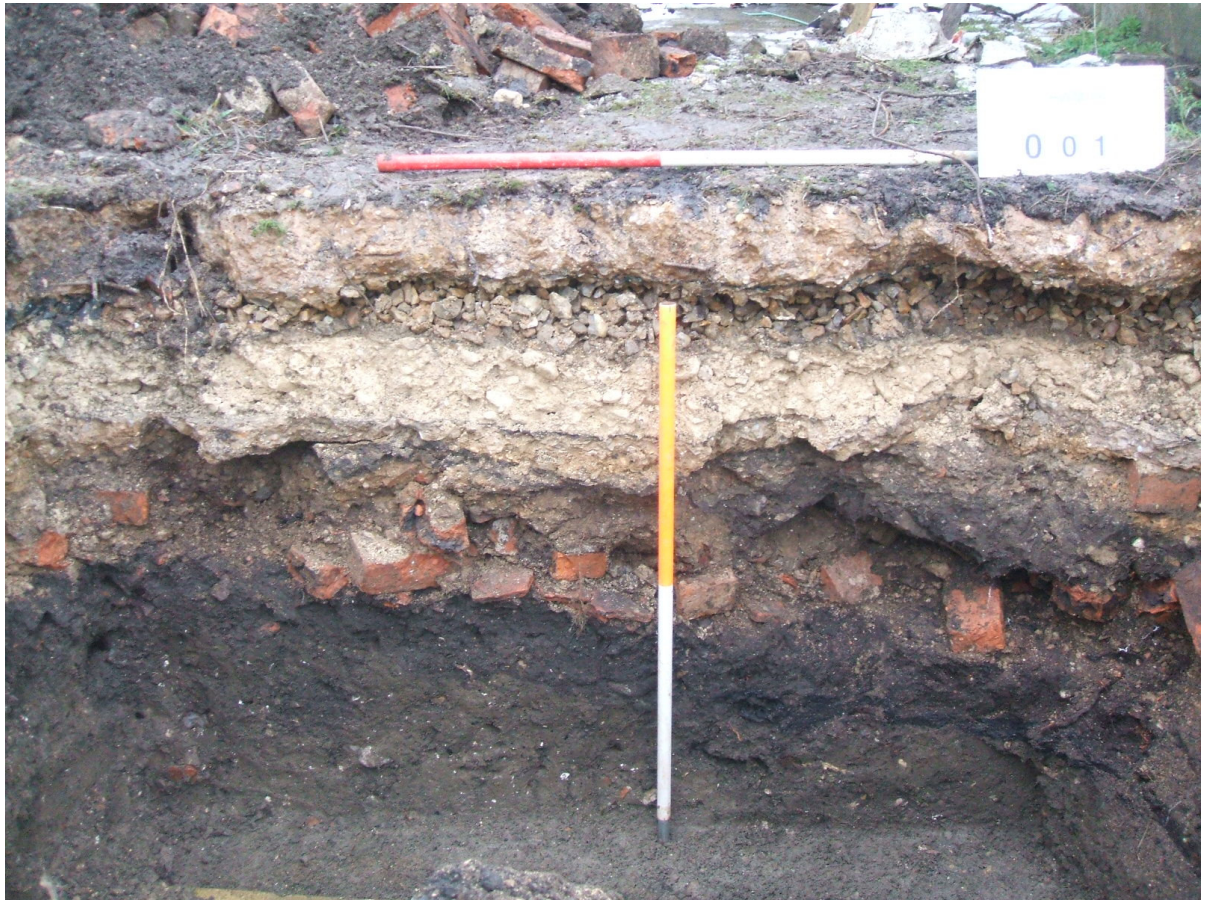
Plate 1 East-facing trench profile.

Few archaeological remains were identified during the excavation of the trench. The deposits exposed appear to have been deliberately deposited in the last 200 years to create a surface conducive to building close to the River Bain (Figure 3). The depositional sequence exposed during the digging of the foundation trench is summarised below.

The concrete layer (001) on the surface and the five layers beneath all probably relate to the same phase of construction to level the ground. The profiles of contexts (004), (005) and (006) have the appearance of having been rolled flat or may have been mechanically flattened. As all of these contexts gradually create a flat surface, it suggests that they were contemporary. The consistencies of these deposits were what would be expected of materials which would be associated with the levelling and raising of the ground.
