Thatched Cottage, Lowthorpe Road,

Southrey, Lincolnshire

Archaeological Watching Brief

Report no. 568

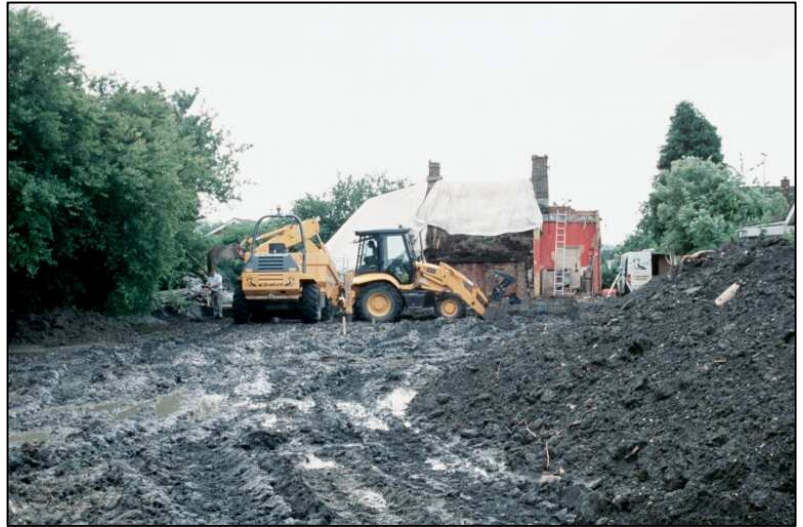
Plate 1: Site location shot taken from the northern site boundary looking south, with 'Thatched Cottage' in the background.

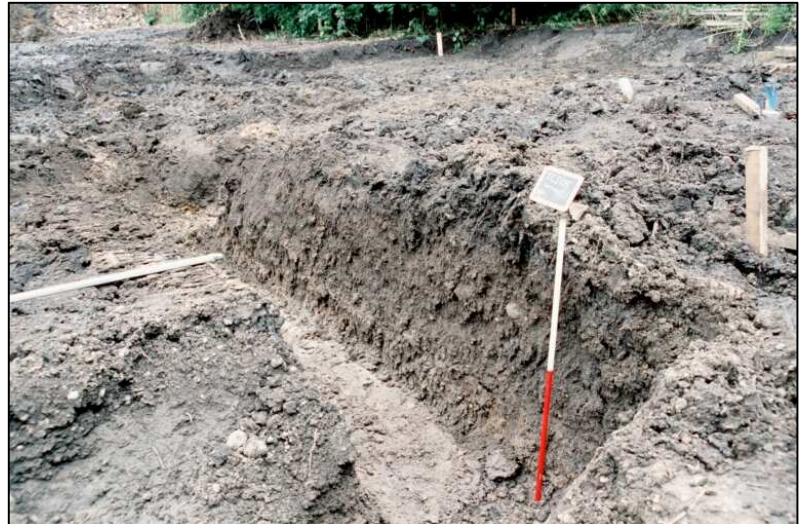
Adjacent to the cottage, excavation of the footings to c.0.96m below the base of the stripped topsoil (01) revealed a substantial deposit (c.0.9m deep) of grey clayey silt with a moderate abundance of small and medium-sized rounded pebbles, 05 (Figure 3a). This layer, which has been identified as having formed in a wet environment over time, contained a number of pottery sherds that upon inspection were identified as being of medieval date. The earliest sherd proved to be a thirteenth-century Lincoln Glazed Ware, although the majority – Toynton, Bourne D and Late Humber types – were of fifteenth- to sixteenth-century date (see Appendix C). Layer 05 sealed 02, a light brown silty sand with moderate small gravels that was devoid of artefacts. 02 was likely to have been a ‘subsoil’ that had formed naturally. A naturally formed alluvial horizon 03, comprising soft yellowish-grey sand with some small gravels, was exposed at the base of the north end of the recorded section.

Plate 2: Extension footings. West-facing section through deposit 05, looking south-east. Vertical scale is 1m.

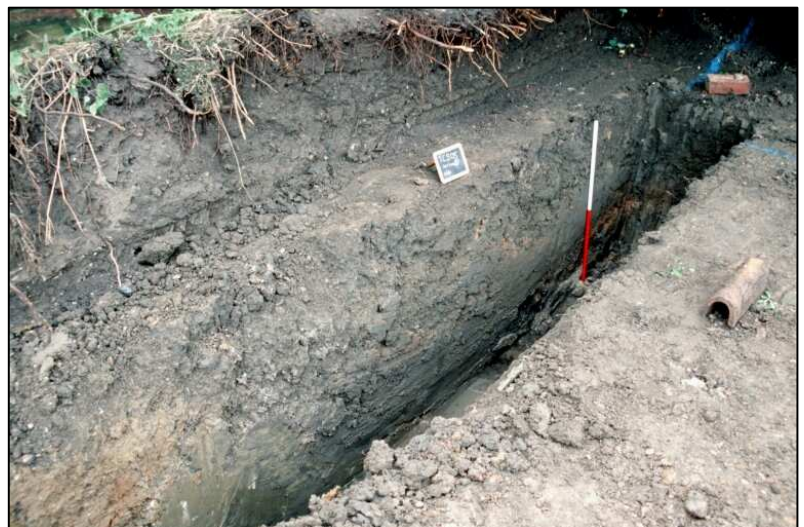
Approximately one-third of the garage footings were found to truncate a former pond that had partially silted up before being backfilled (Figure 3c). The pond, 06, which had a steep, concave, northern side, was not fully excavated due to health and safety requirements, although the break of slope at the base of the trench suggested it was not much deeper than the 1.1m depth of the footings. The lowest exposed fill, 09, was saturated, dark brown coarse silty clay that was clearly distinguished from all other deposits exposed on the site. It is suggested that the layer was a ‘pond mud’ that had formed during the use of the pond. This ‘mud’ was sealed by an olive-grey slightly silty clay, 08, that had formed gradually under little or no energy conditions, and was identified as the gradual silting of the pond, perhaps after it had gone out of use. The pond was then backfilled with 07, grey clayey silt with occasional small and rounded stones. The presence of flecks and pieces of charcoal within the backfill indicates that some

Plate 3: Garage footings. West-facing section through pond 06, looking south-west. Vertical scale is 1m.
