**Pannal to Nether Kellet
Natural Gas Pipeline**

**ARCHAEOLOGICAL SURVEYS, EVALUATIONS,
EXCAVATIONS AND WATCHING BRIEF**

**POST-EXCAVATION ASSESSMENT
VOLUME 2
APPENDICES**

NETWORK ARCHAEOLOGY LTD
for
ENTREPOSE INDUSTRIAL SERVICES LTD
on behalf of
NATIONAL GRID
Report No 544
June 2009

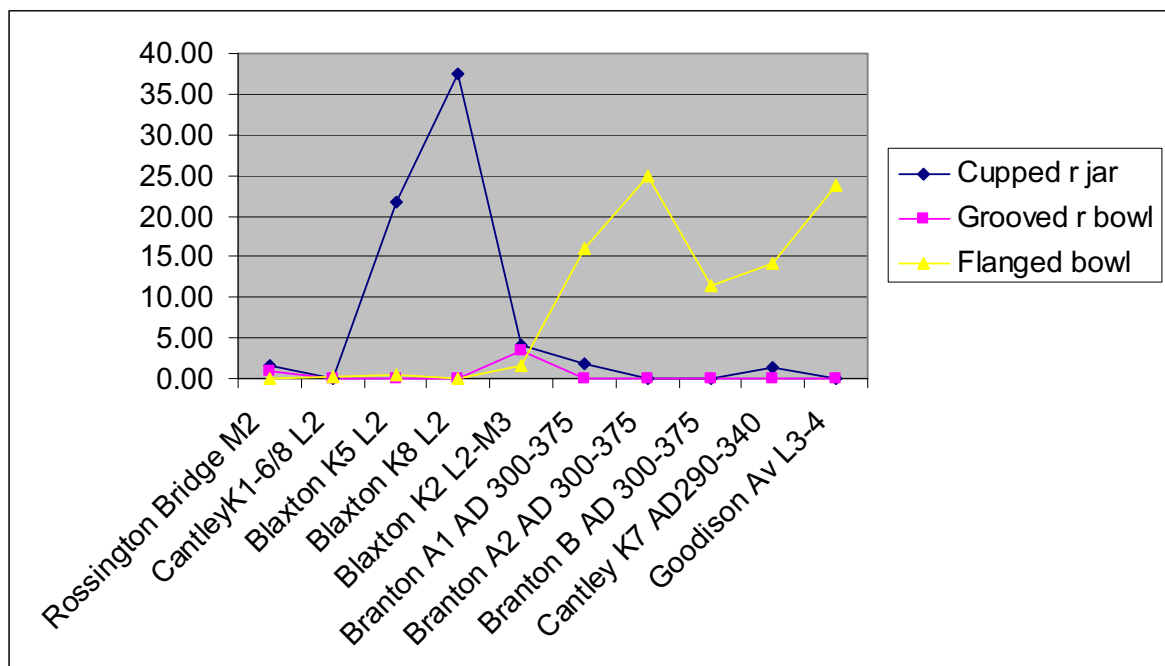
Figure 1: Key forms at South Yorkshire kiln groups. Blaxton, Buckland and Dolby 1980, Branton, Buckland 1976, Cantley, Annable 1960, Goodison Ave, Buckland and Magilton 2005.

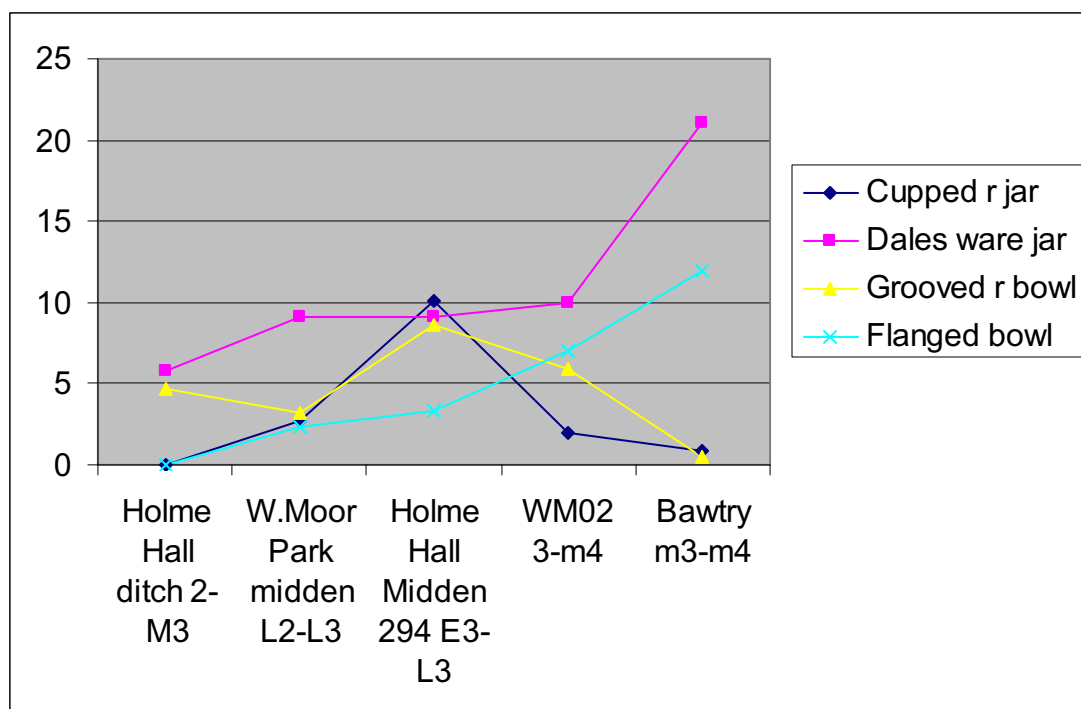
Figure 2: Key forms in rural settlement assemblages in South Yorkshire sites (Holme Hall, Stainton, Leary 2005b, Bawtry, Leary 2006, WM02 West Moor Park 2002 in prep.)

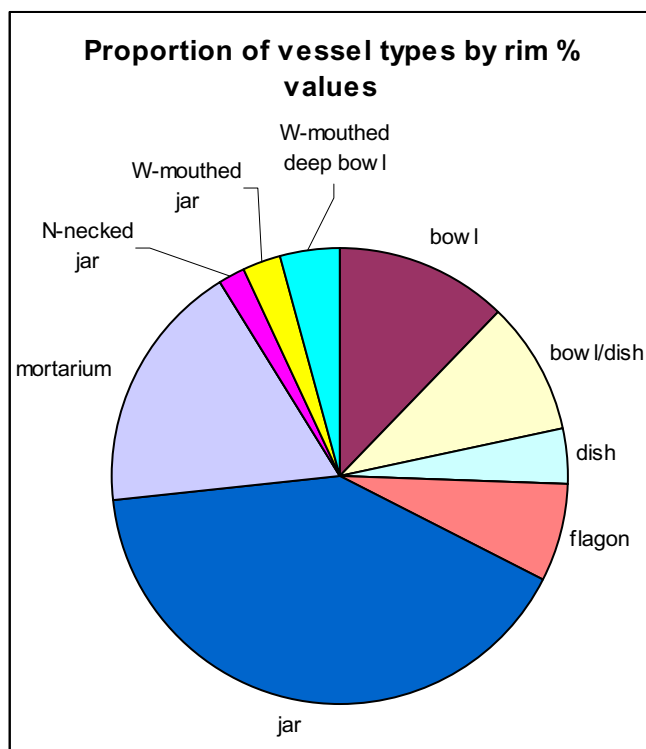
Figure 2: Quantification of vessels by vessel types by rim % values

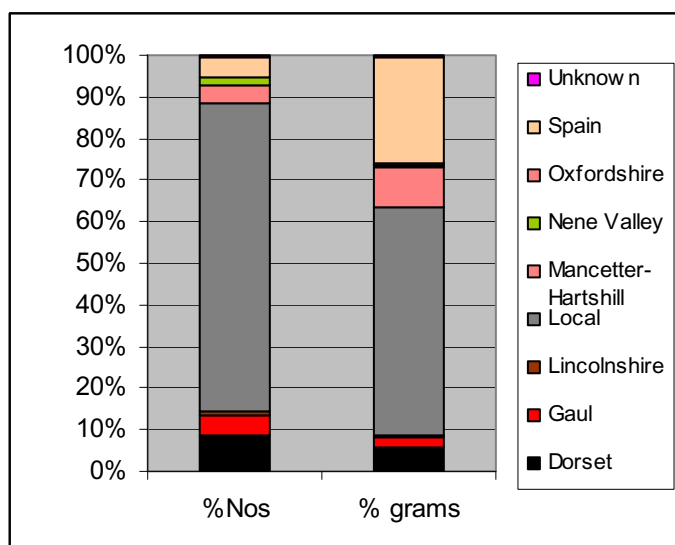
Figure 3: Quantification of sherds by source using sherd count and weight values

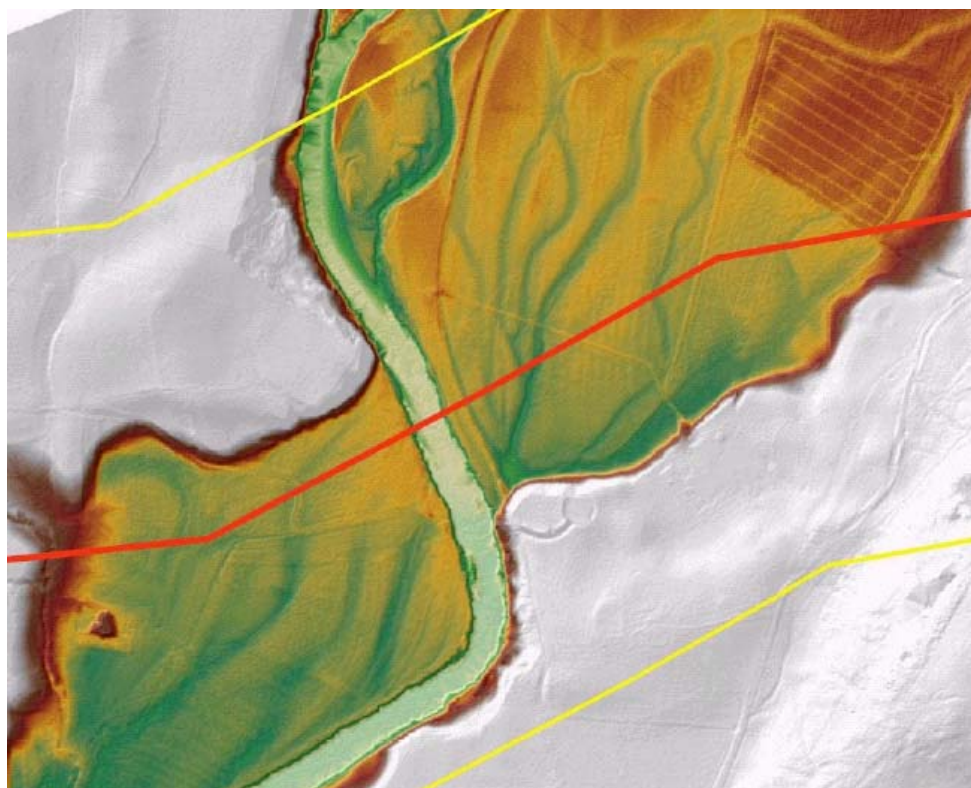
Plate 1: LiDAR plot of the Lune crossing taken from Challis 2006, Fig. 22 (no scale)

At the Lune crossing the length of floodplain crossed by the pipeline is approximately 1.25 km. and the LiDAR shows several channels (Plate 1). There are three clearly visible channels on the north bank, two in Plot 52-6 (the northern one is illustrated in Plate 2) and one in Plot 53-1 with a possible second. The western channel in Plot 53-1 appears to be a former channel of the tributary stream running in from the west while the second possible channel to its east appears to be part of the Lune system. The two channels in Plot 52-6 reflect channels associated with the main river. A borehole sunk in the hollow of the channel illustrated in Fig. 2, the western of the channels in Plot 52-6, was cored to a depth of two metres. The top 1.75 metres was composed of brown oxidised silts, with the lower 0.25m becoming progressively more sandy. The auger was stopped by stone at 2.0m. There were no palaeoenvironmentally important deposits in this sequence, and the water table was not reached.

On the south bank of the Lune, the LiDAR suggests at least five palaeochannels (Plate 1), all of which are visible on the ground. Three of these channels lie in Plot 52-5, two appearing to meet at a point that the pipeline crosses the field (plate 4). These may relate to the main channel of the river, although they appear on the LiDAR plot to derive from a subsidiary stream entering the valley from the east,

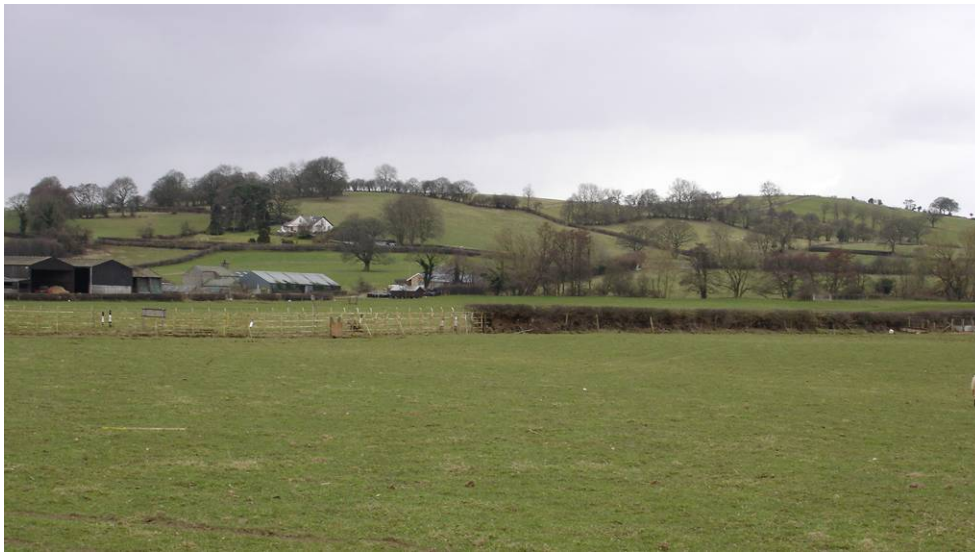
Plate 2: Plot 52-6, looking north-west. A palaeochannel crosses the picture from the sheep in the centre right to the fence line on the roadside.

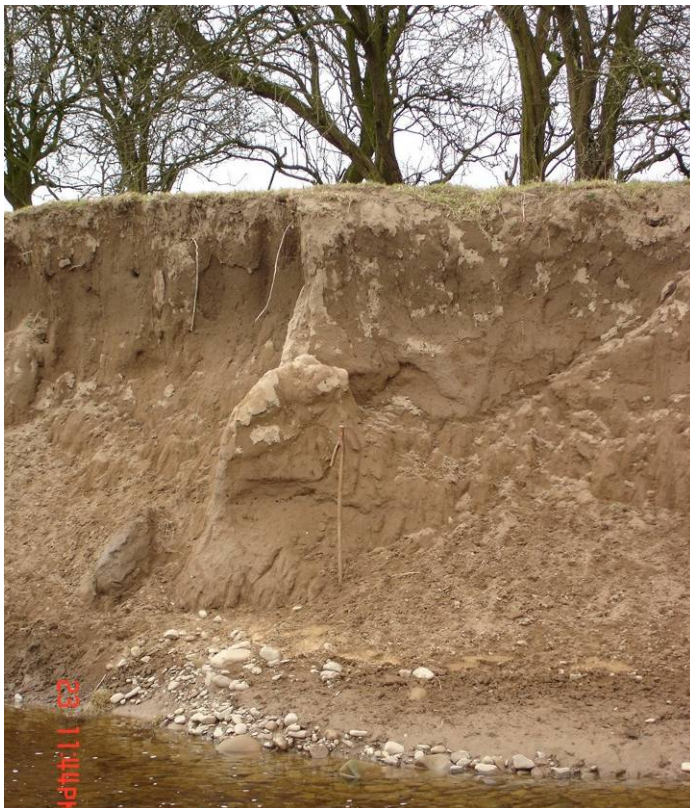
Plate 3: Exposed section of the bank of the River Lune just west of the proposed crossing point, illustrating over two metres of brown alluvial silts with occasional cobbles, overlying beds of cobbles and pebbles.

The walking-stick placed in the centre of the picture as a scale is 1m long.

An exposure in the present river bank gives a good illustration of the upper 2.5m of alluvial sediments on the floodplain floor (Plate 3). Approximately 2.5m of the profile is made up of brown alluvial silts with rare cobbles. Beneath these silts, beds of river cobbles are visible, evidence of rapid flow or spate conditions, probably representing an earlier river bed now being eroded out by the modern river.

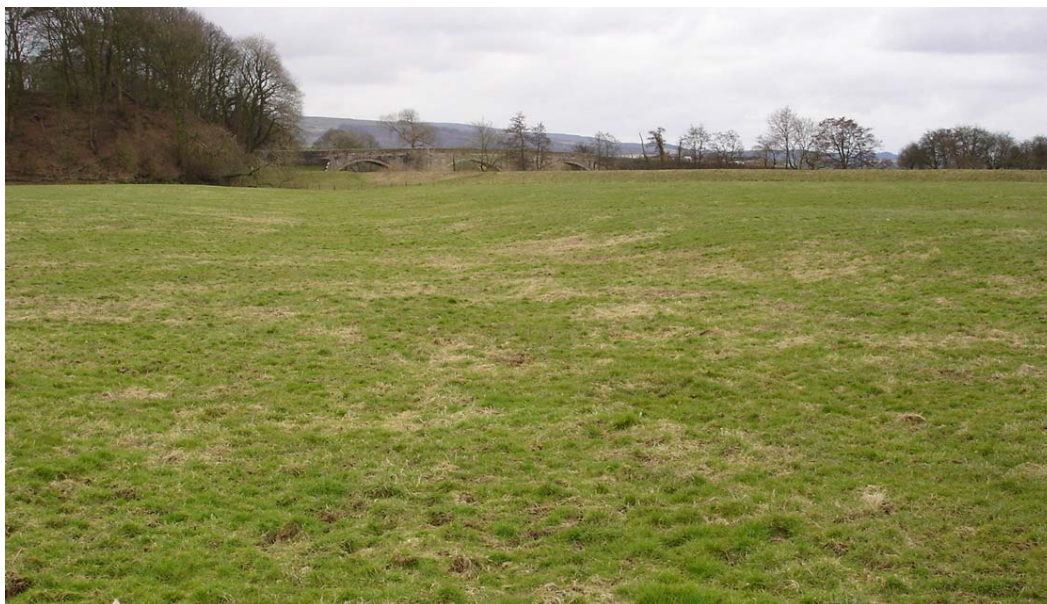
Plate 4: The palaeochannel runs down the centre of the picture west towards the bridge; a second is visible in the grass to the right. The pipeline crosses where these two channels meet.

The channel visible in Plate 4 was augered to a depth of 1.7m through clean brown silts with no evidence for any anaerobic conditions.

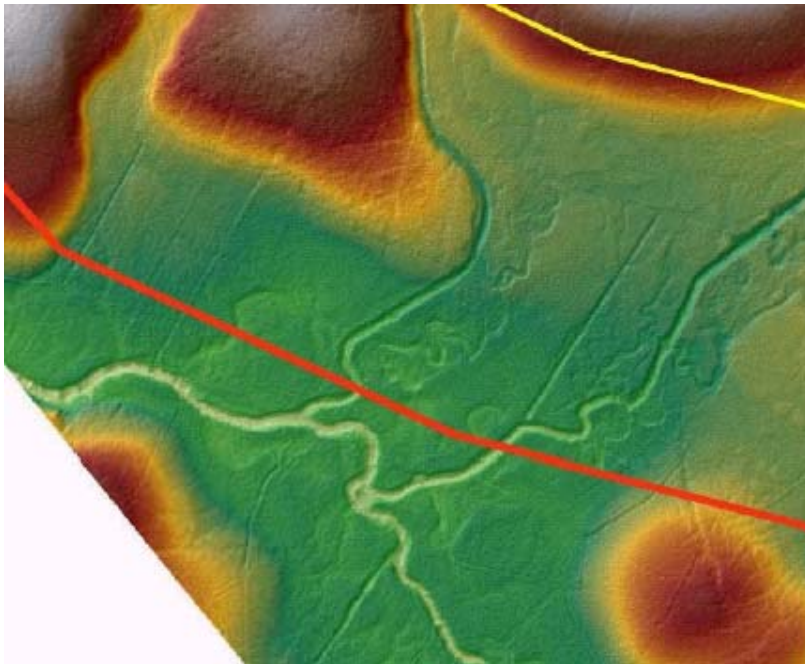
Plate 5: LiDAR plot for the Clapham and Austwick Becks, taken from Challis 2006, Fig. 24 (no scale)

The ADBA, the LiDAR and the geophysical survey all indicate the presence of palaeochannels at the point where the pipeline crosses the Clapham and Austwick Becks on the northern floodplain of the Kettles Beck, a tributary of the River Wenning (Table 1, Plate 5). This stretch of the pipeline route, approximately 720m in length, was walked through Plots 36-5 to 36-7. Plot 36-7 lies at a slightly higher elevation than Plots 36-5 and 36-6, and has two former channels that drained what is now a dry valley immediately north. In Plot 36-6, a series of meanders are visible from the LiDAR and on the

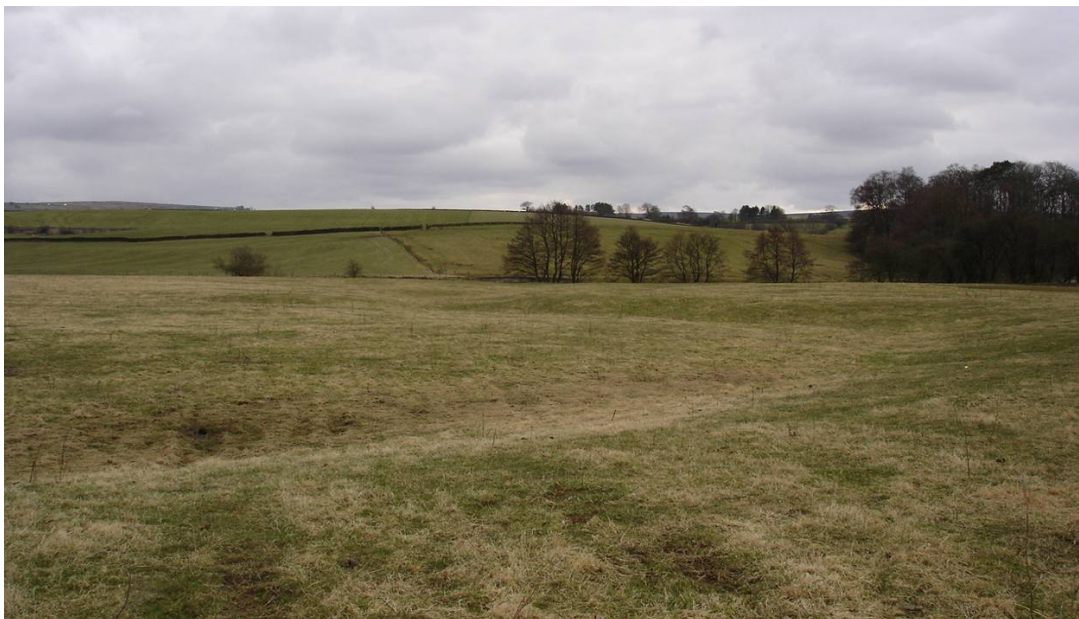
Plate 6: Palaeochannel meander of the Clapham Beck in Plot 36-6. The Kettles Beck lies in the middle distance where the trees are, and the pipe route crosses at the far end of the bend.

ground (Plate 6), indicating a former course of the Clapham Beck crossing the floodplain of the Kettles Beck.

This channel was hand-augered, revealing brown silts onto sandy silts, and stopped by stones at approximately 0.7m. No evidence of unoxidised waterlogged sediments was evident. Where the pipeline crosses the Clapham Beck the deposits are visible in section (Plate 7). Only 0.5m of silts were visible, overlying water-rolled pebbles and cobbles.

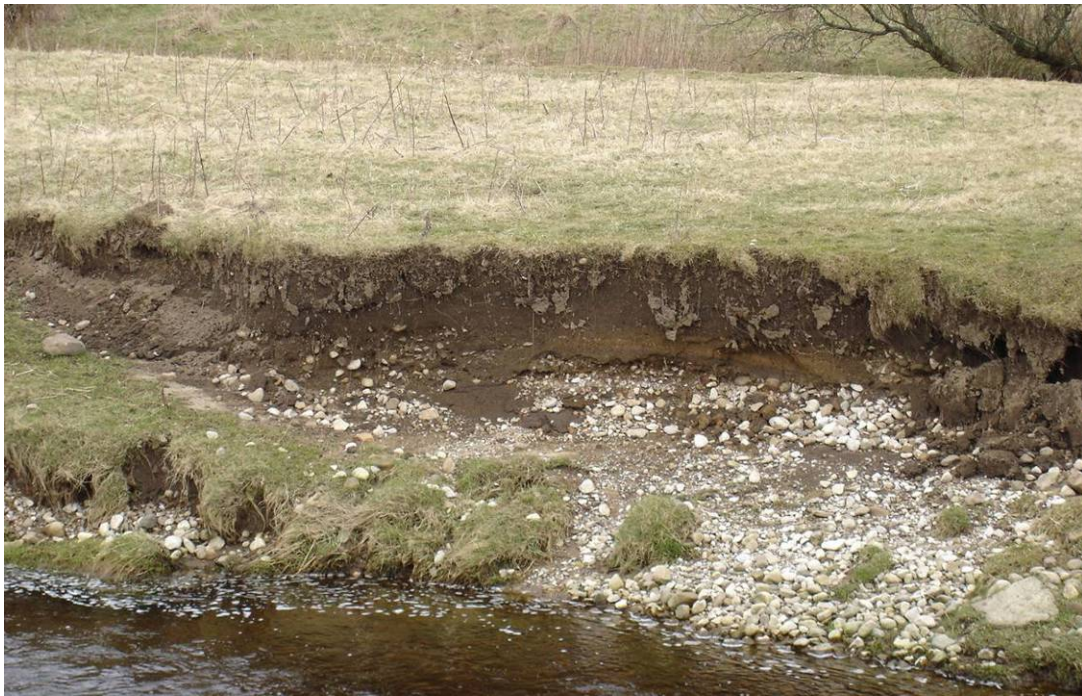
Plate 7: Section exposed in the bank of the Clapham Beck, showing 0.5m of silts over well-rounded pebbles and cobbles.

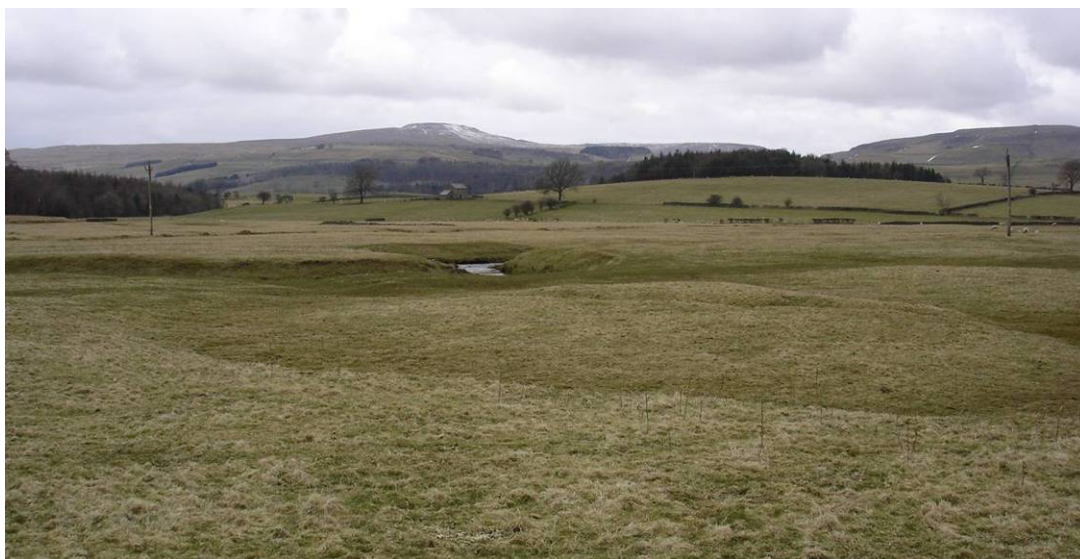
Plate 8: A former meander of the Austwick Beck, with the present stream visible behind.

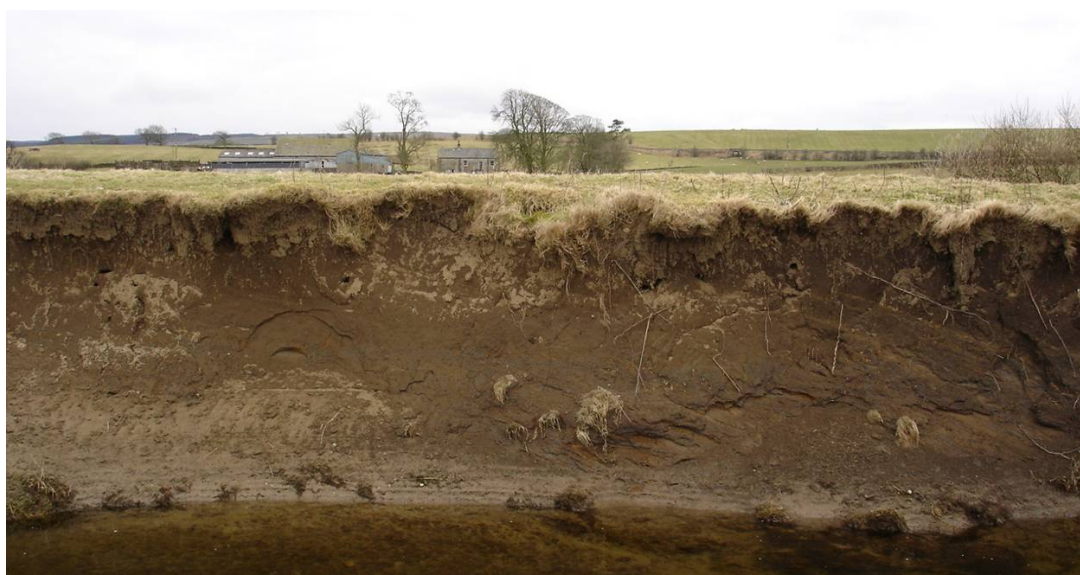
Plate 9: The east bank of the Austwick Beck, several metres above its confluence with the Kettles Beck. The bank comprises approximately 2m of brown silts with the bedding dipping to the south (right), indicating that the sediments were deposited by the Kettles Beck as it migrated southwards.

Although Plate 9 (above) illustrates that over 2m of silts occur on the floodplain of the Kettles Beck, the deposits are probably shallower a little to the north, where the pipeline crosses the fields. The channels at this site are clearly former courses of the two becks joining the main channel, which have been cut off, probably through artificial straightening in an effort to drain the adjacent fields, and a former channel of the main river. This drainage and the land drains may well have resulted in the loss of any organic sediments that developed in the palaeochannels after they were cut off.

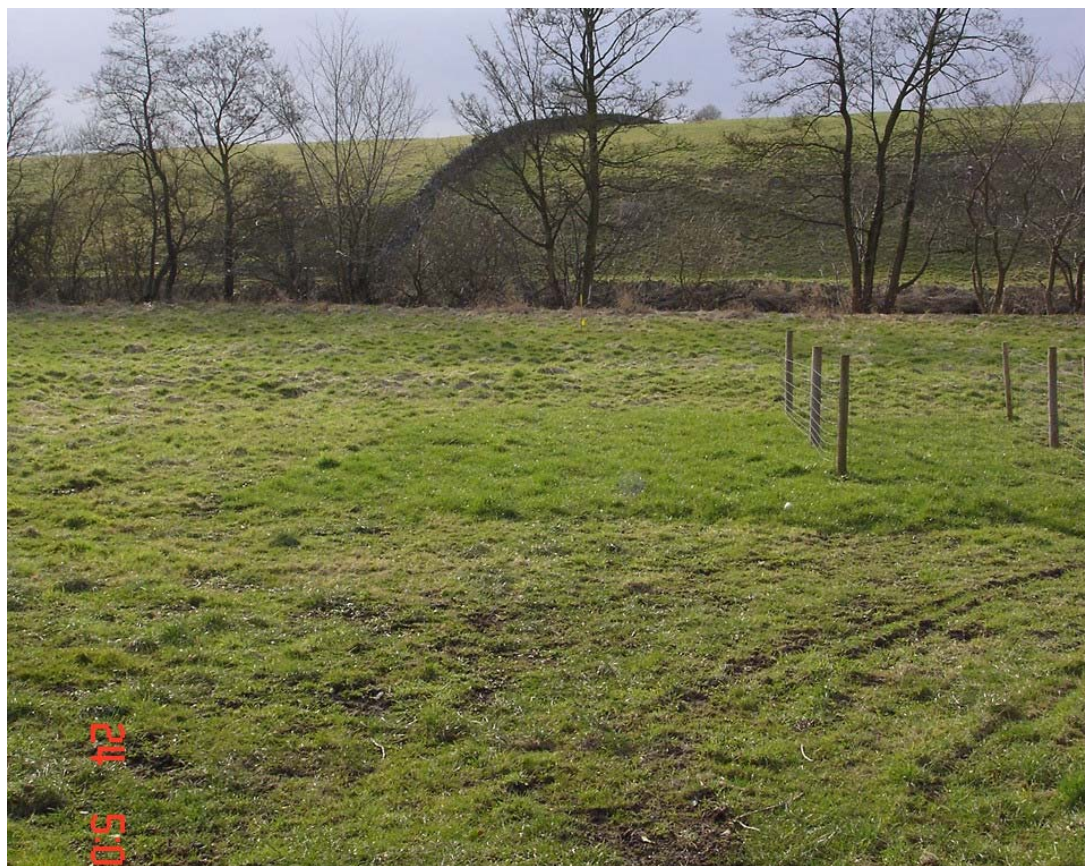
Plate 10: The extent of the Ribble floodplain at the pipeline crossing at Swinden.

At the Ribble crossing at Swinden, the valley narrows: there is only 40m of floodplain on the east side of the river, and no more than 5-10 metres on the west side (Plate 10). At the pipeline crossing point, the Mallardale Beck enters the Ribble from the east, and is likely to have disrupted any channel deposits of the main river at this point. The auger penetrated through 0.8m of brown silts before hitting stones, and the present river level at the time of the visit was approximately 1.5m below the surface of the floodplain. It is very unlikely that any channel deposits survive at this location, since the main channel will have moved by lateral migration depositing against its banks, but some organic sediments within this sequence cannot be ruled out.

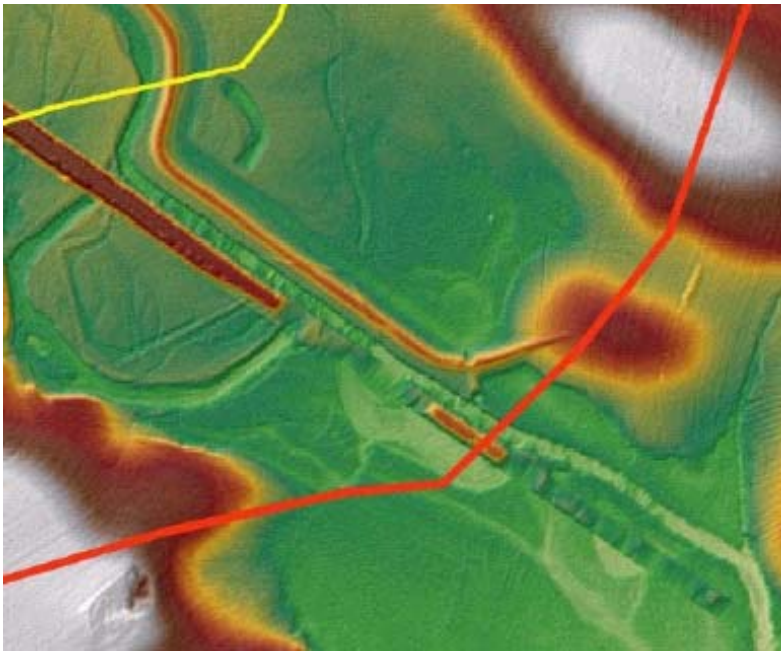
Plate 11: LiDAR plot of the Aire Crossing, taken from Challis 2005, Fig. 28 (no scale)

The pipeline route crosses the Aire valley just north of Broughton Copy Farm, towards Thorlby on the north side of the valley. At this location, the route crosses approximately 500m of the floodplain of the River Aire, including the railway embankment and the canalised river on the north side (Plate 11). The valley was only walked on the south side of the railway line. The LiDAR plot shows that the route crosses two minor channel features and one major palaeochannel of the River Aire. Cut-off oxbow palaeochannels of the River Aire are prolific in this stretch of the valley, north-west of the pipeline route, but only one major channel is evident on the route, in Plot 20-7 (Plate 12). This channel was augered, but penetration was only possible through the top 0.8m before stone was encountered. The ground surface on the floor of this channel was wet, and the deposits extracted from the core included dark grey, unoxidised, slightly organic silts. This same channel was flooded at the time of the LiDAR Survey.

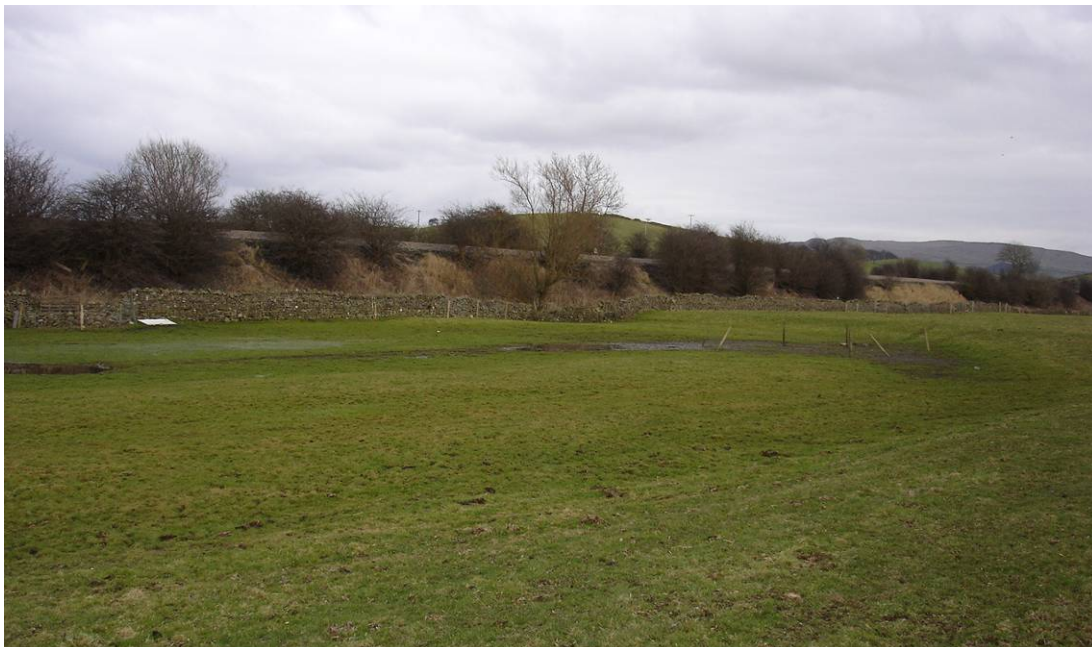
Plate 12: The eastern end of a palaeochannel meander of the River Aire in the southern floodplain. The whole of the area between the bank in the foreground and the railway embankment lies in the channel.

The palaeochannel visible in Plate 12 is the only major former course of one of the main rivers that appears to have remained sufficiently wet to preserve organic sediments in its upper fills. It is quite clearly a cut-off channel, but it may not be very ancient, and may represent the course of the river prior to its canalisation north of the railway embankment. The putative channel to the north of the modern river is likely to have similar conditions.

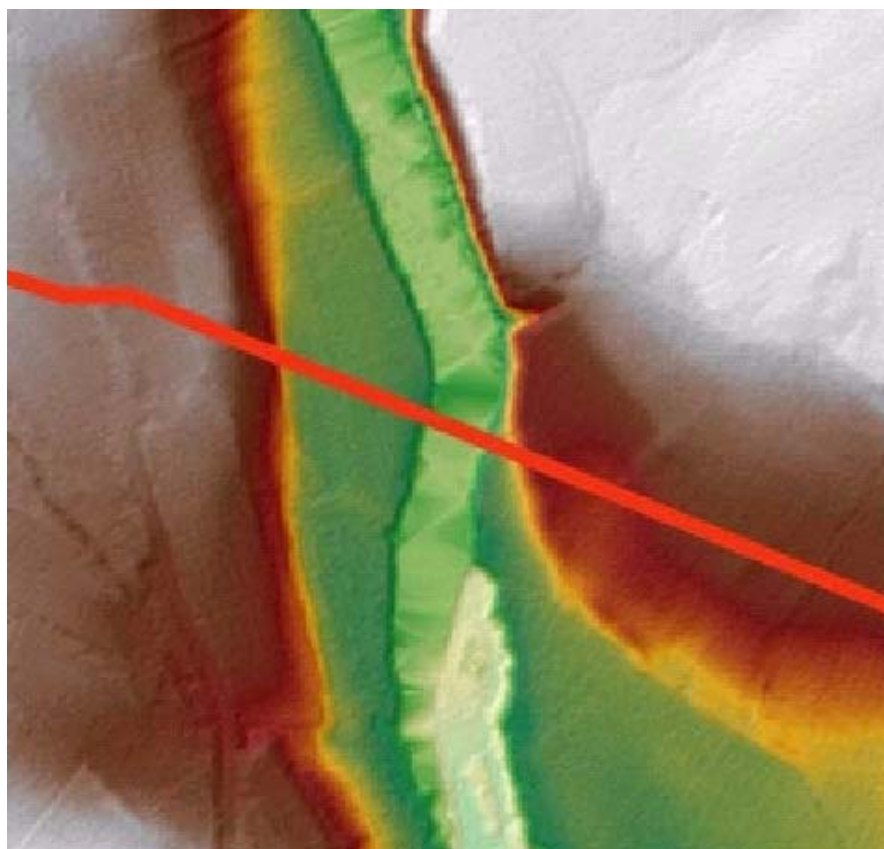
Plate 13: LiDAR plot of the River Wharfe crossing point.

The pipeline crosses the Wharfe just north of Addingham, at a pinch point in the valley where the floodplain, with the river, is no more than 130 metres wide (Plate 13). On the western side, the 90m floodplain shows no evidence for channels on the LiDAR survey, and, with the valley so narrow at this point, the situation is similar to the Ribble crossing (Plate 14). The river migrates from side to side of the floodplain, but with insufficient space to create any cut-off channels. The floodplain on the eastern side of the river is very narrow. The present river level lies approximately 1.5m below the floodplain, and there is some evidence for ridge-and-furrow on the western floodplain, although this cannot be seen in the LiDAR plot.

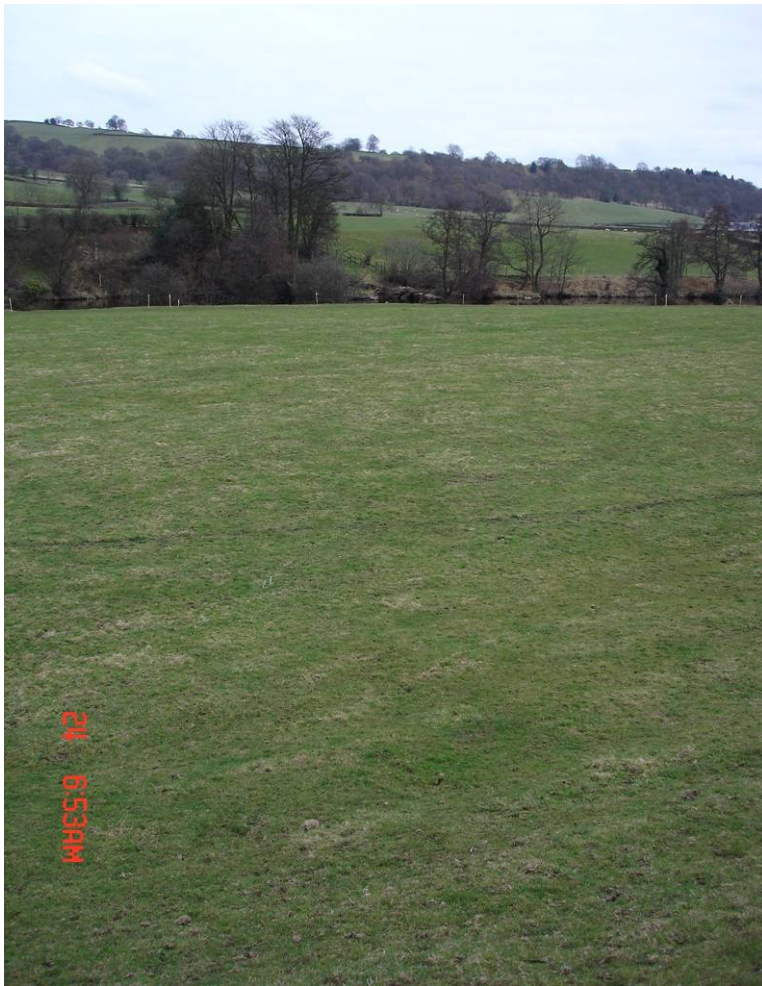
Plate 14: The western floodplain of the River Wharfe at the crossing point, looking east. The photograph has been taken from the sharp terrace edge on the western edge of the floodplain.

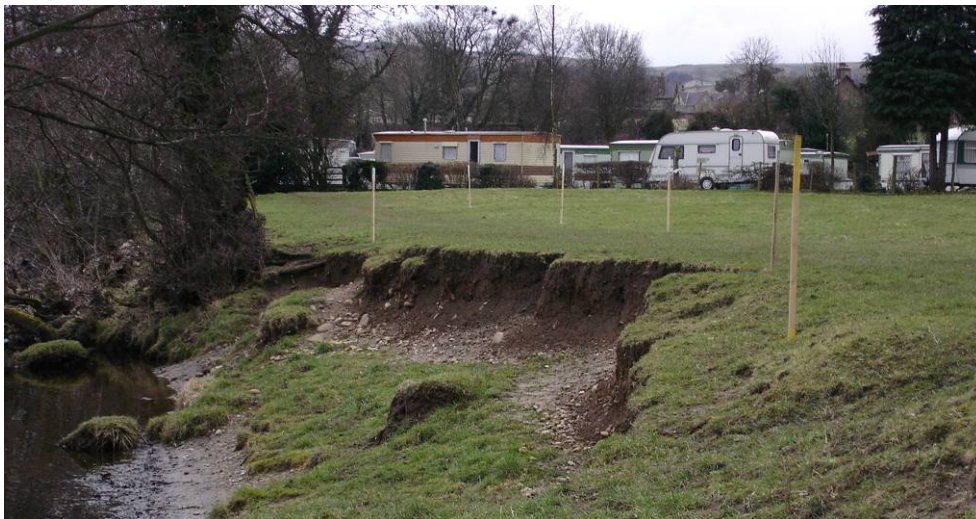
Plate 15: The sediment exposures on the west bank of the River Wharfe at the crossing point: silts overlying river cobbles and pebbles.

The deposit sequence visible in the river bank at the crossing point shows brown silts over river cobbles (Plate 15).
