TOWER STREET, DUDLEY

ARCHAEOLOGICAL TRIAL TRENCH EVALUATION

Report Number: 575

June 2011

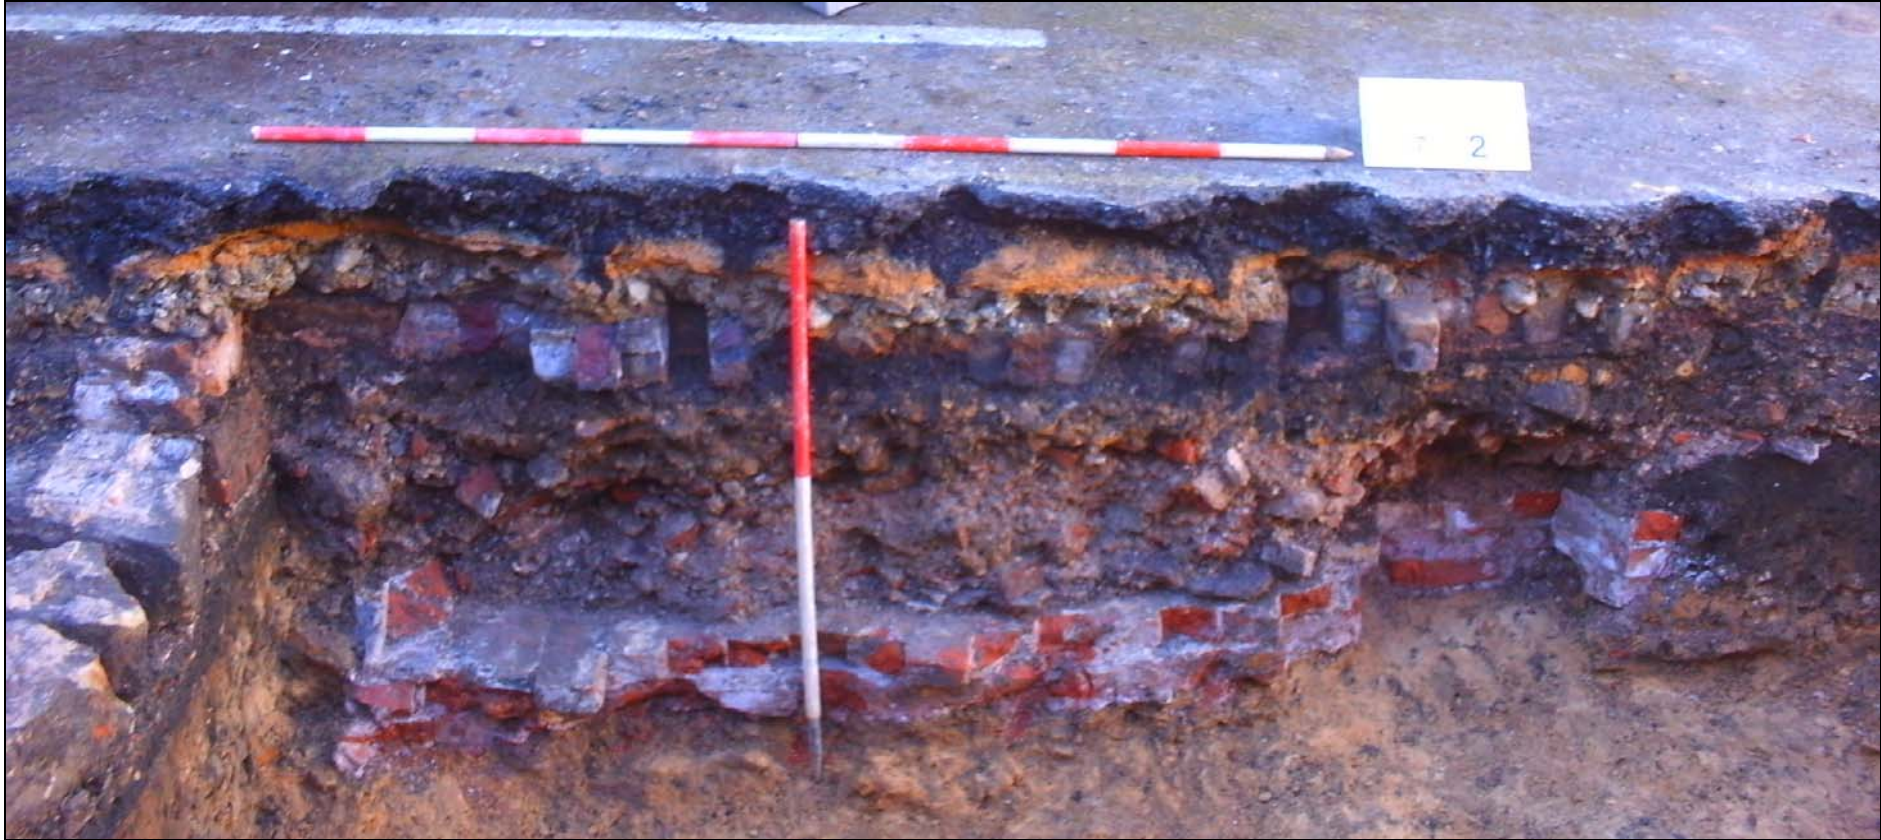
Plate 4: Representative section through deposits in Trench 1

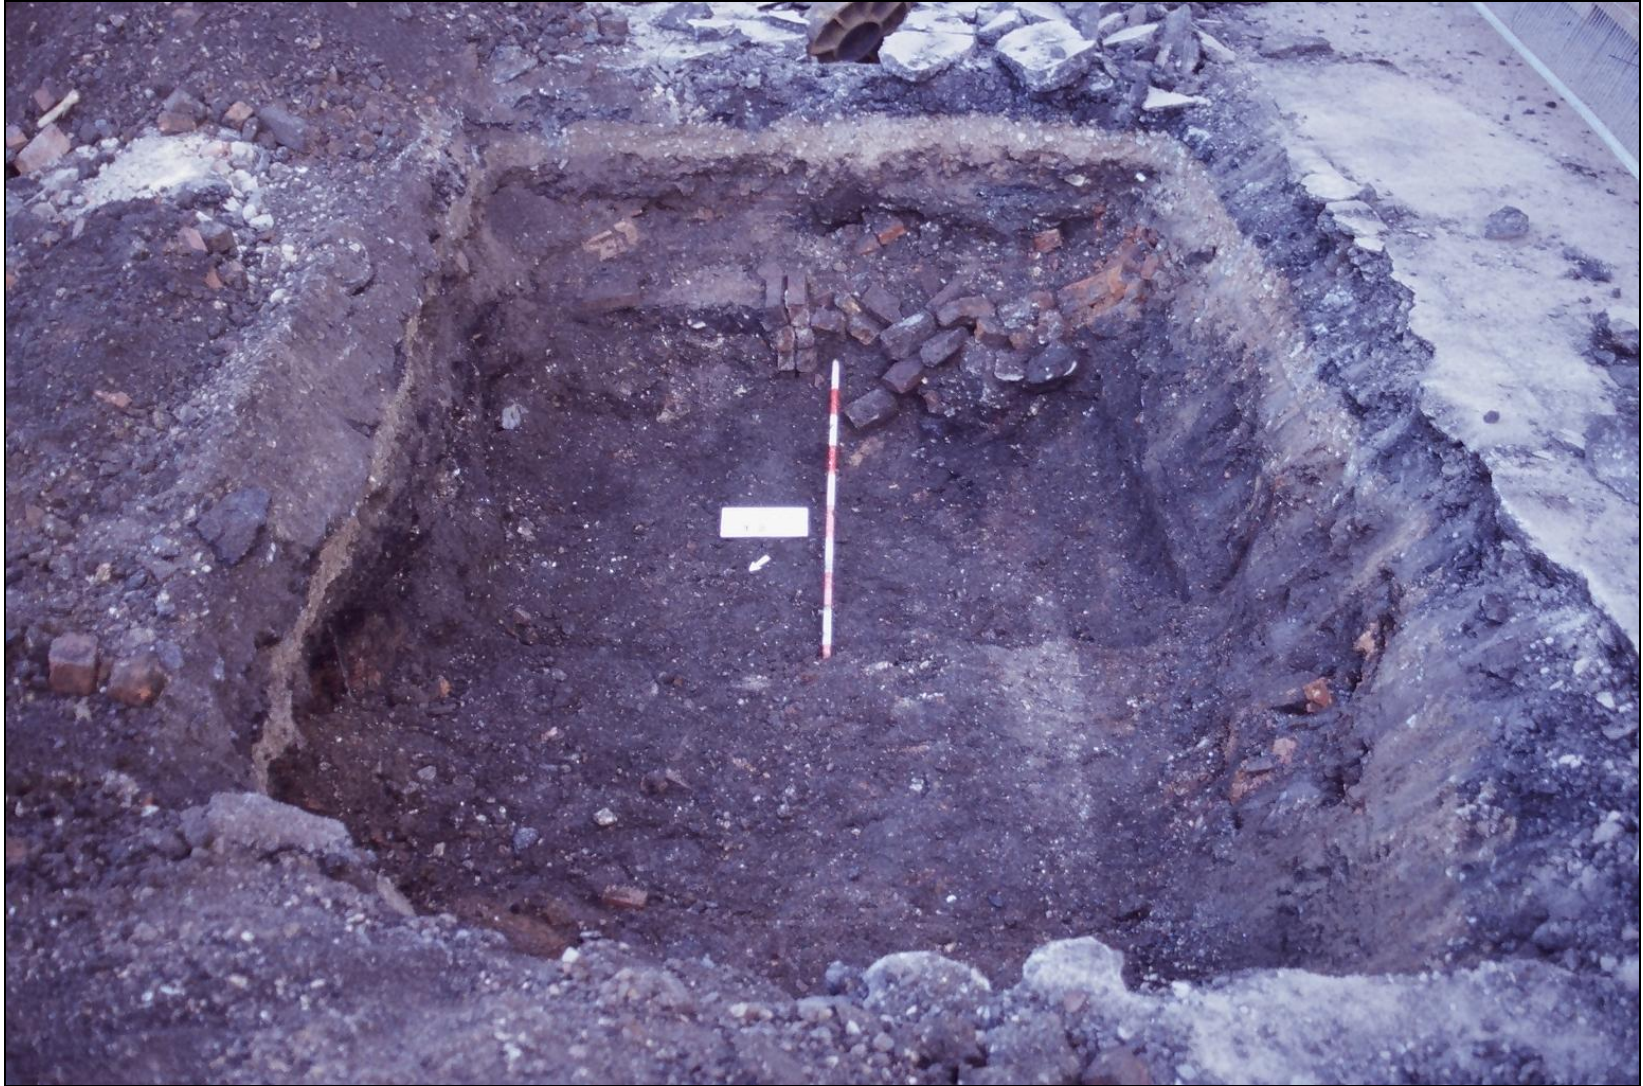
Plate 5: Trench 3. Camera facing south east

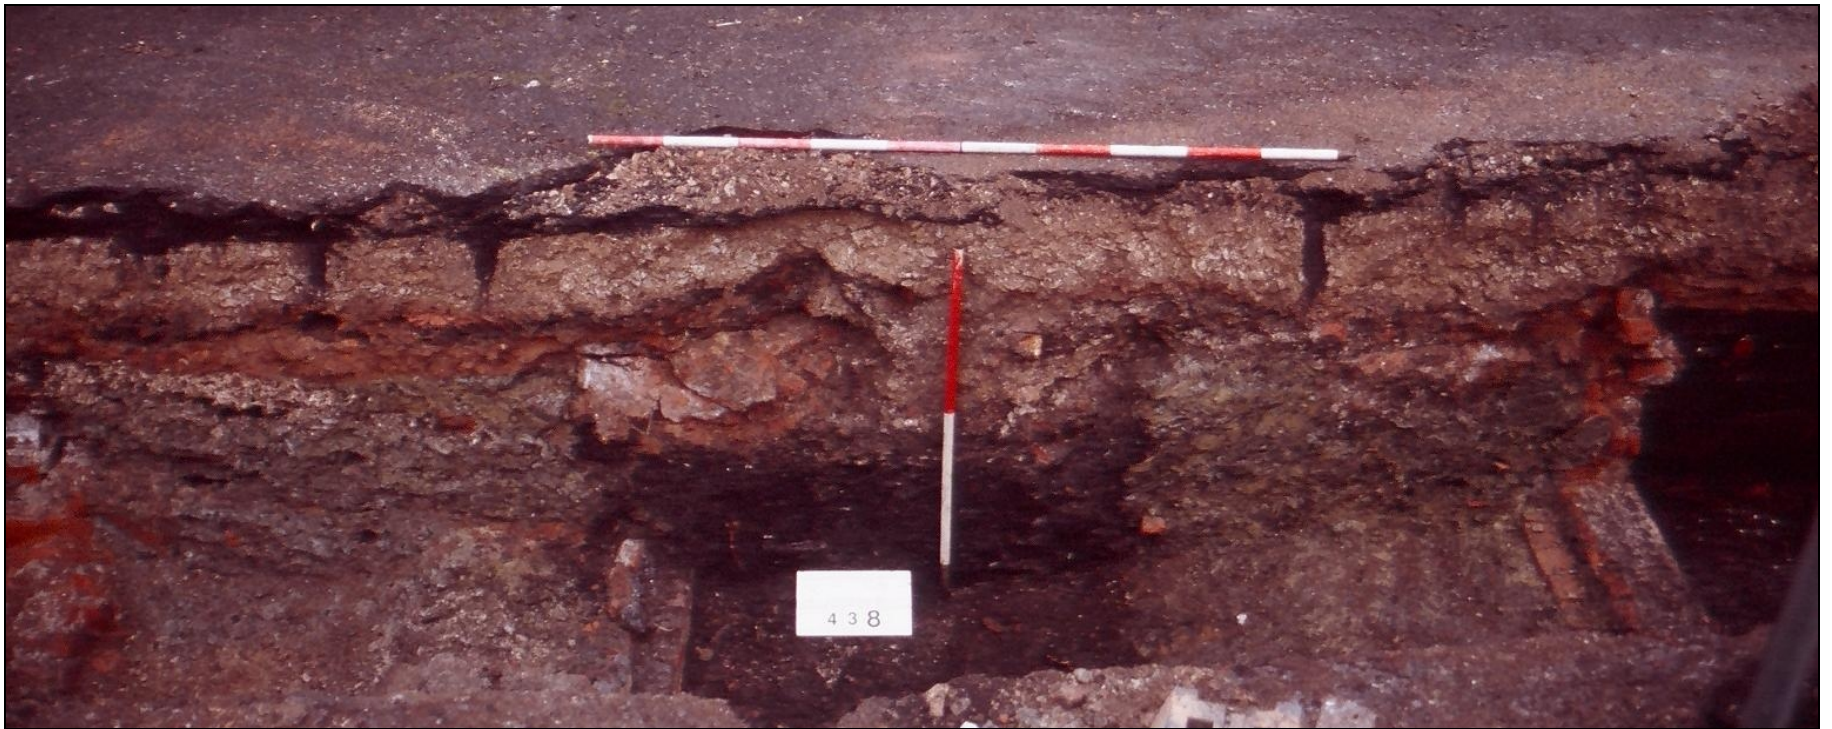
Plate 8: Representative section through deposits in Trench 4

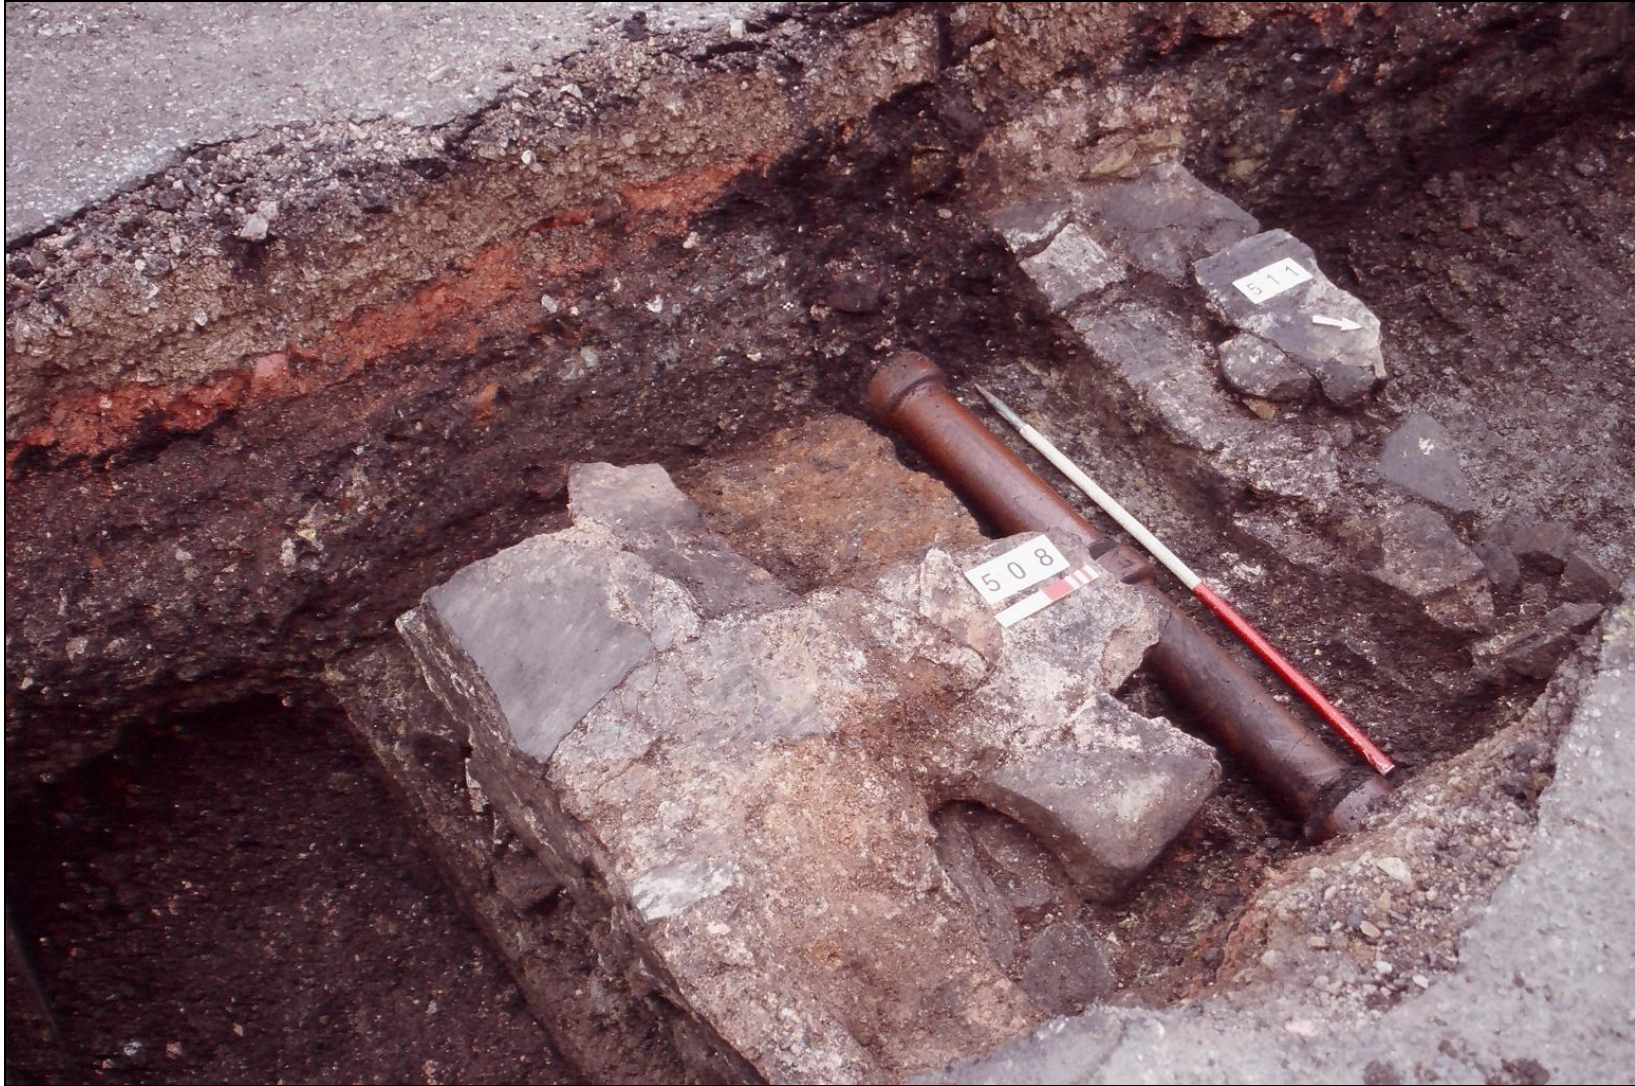
Plate 13: Walls **508** and **511** in Trench 5

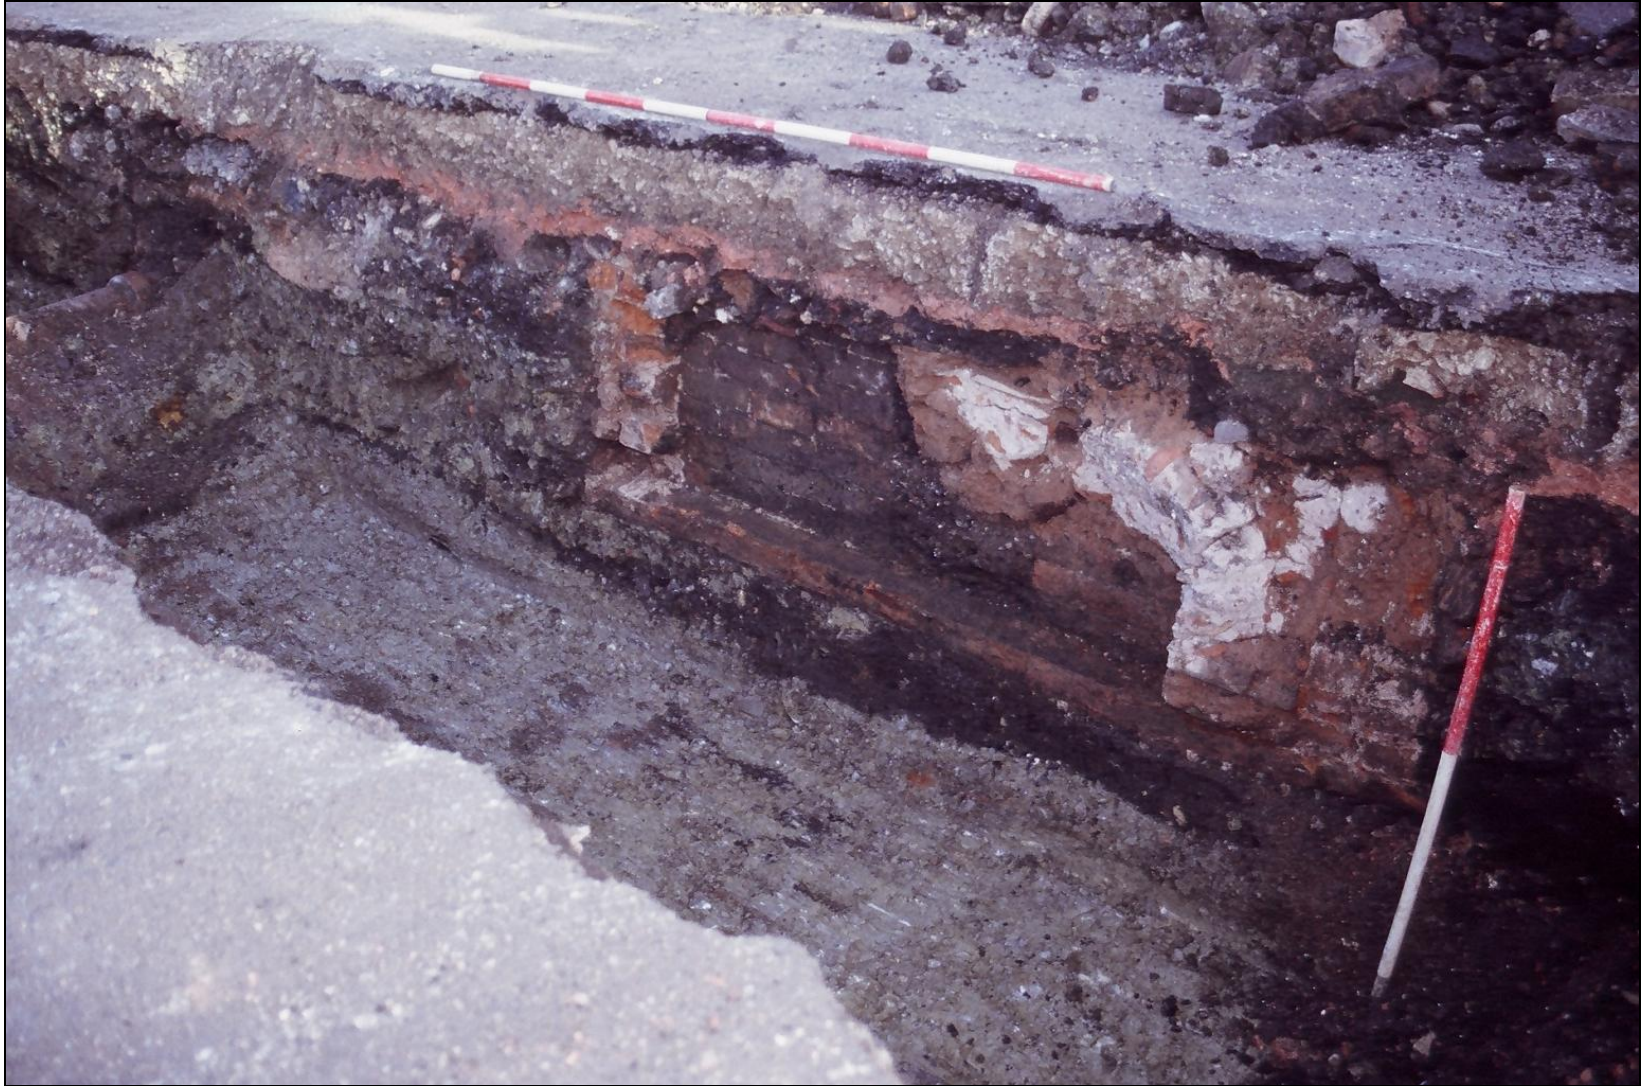
Plate 14: Structure **507** in Trench 5

meant that it was not possible to determine a relative sequence between it and sandstone walls **508** and **511**. Structure **507** was rectangular in plan, measured 2.2m in length and was 0.5m wide (Plate 14). Its walls were two bricks thick and survived to a height of 0.6m; its base was brick-lined. Structure **507** may have originally functioned as a soakaway or cess tank and was filled with **506**, a loose black gritty sand containing frequent fragments of bricks, and also whole bricks. The deposition of context **506** post-dates 1862, as revealed by the date printed on a largely intact marmalade jar found within it (Appendix C).

The disuse of structure **507** appears to be marked by a deposit of very hard, brownish orange mortar, **505**, which had been 'poured' into it and over its south eastern wall (Figure 5c, Plate 14). The surface of this mortar was very flat and smooth, and it has been interpreted as a foundation block for a building that was constructed above the demolished remains of structure **507**. It is assumed that this hard mortar material was contemporary with similar deposits revealed in Trench 4 (**404**, **405**, **444**, **406**, **419** and **420**), and formed part of the same building or range of buildings. The cartographic evidence would appear to support this, as mortar **505** appears to have formed part of the footprint of this building (Figure 8e).

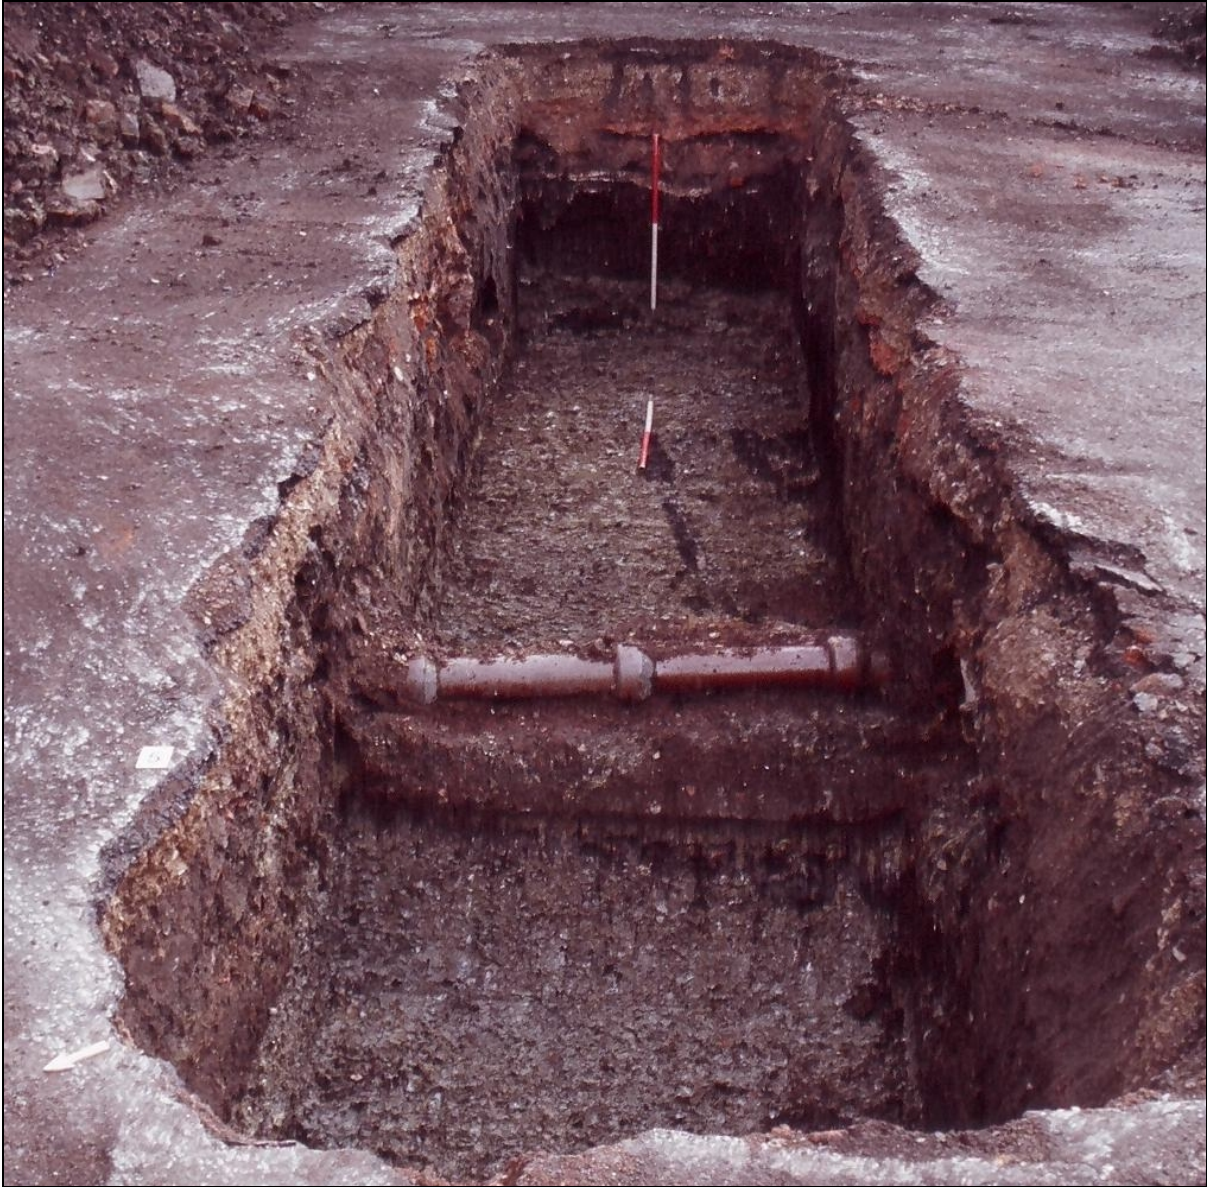
Plate 15: Trench 5 following second phase of machining. Camera facing south east

The stratigraphically earliest deposit recorded in Trench 5 was a pale greenish grey clay, **512** (Plate 15), which contained occasional brick or tile fragments and a single partially glazed coarseware base-body sherd from a jar of likely 18th century date (Appendix C). This deposit was found throughout the trench, and was generally present at a height of 193.25m OD. The base of this deposit was not seen, but machine investigation revealed it to be at least 0.5m thick at the north western end of Trench 5. Context **512** has been interpreted as a substantial levelling deposit; its depth and extent would seem to represent considerable remodelling of the land surface in the past. This material may equate with deposit **422** from Trench 4.

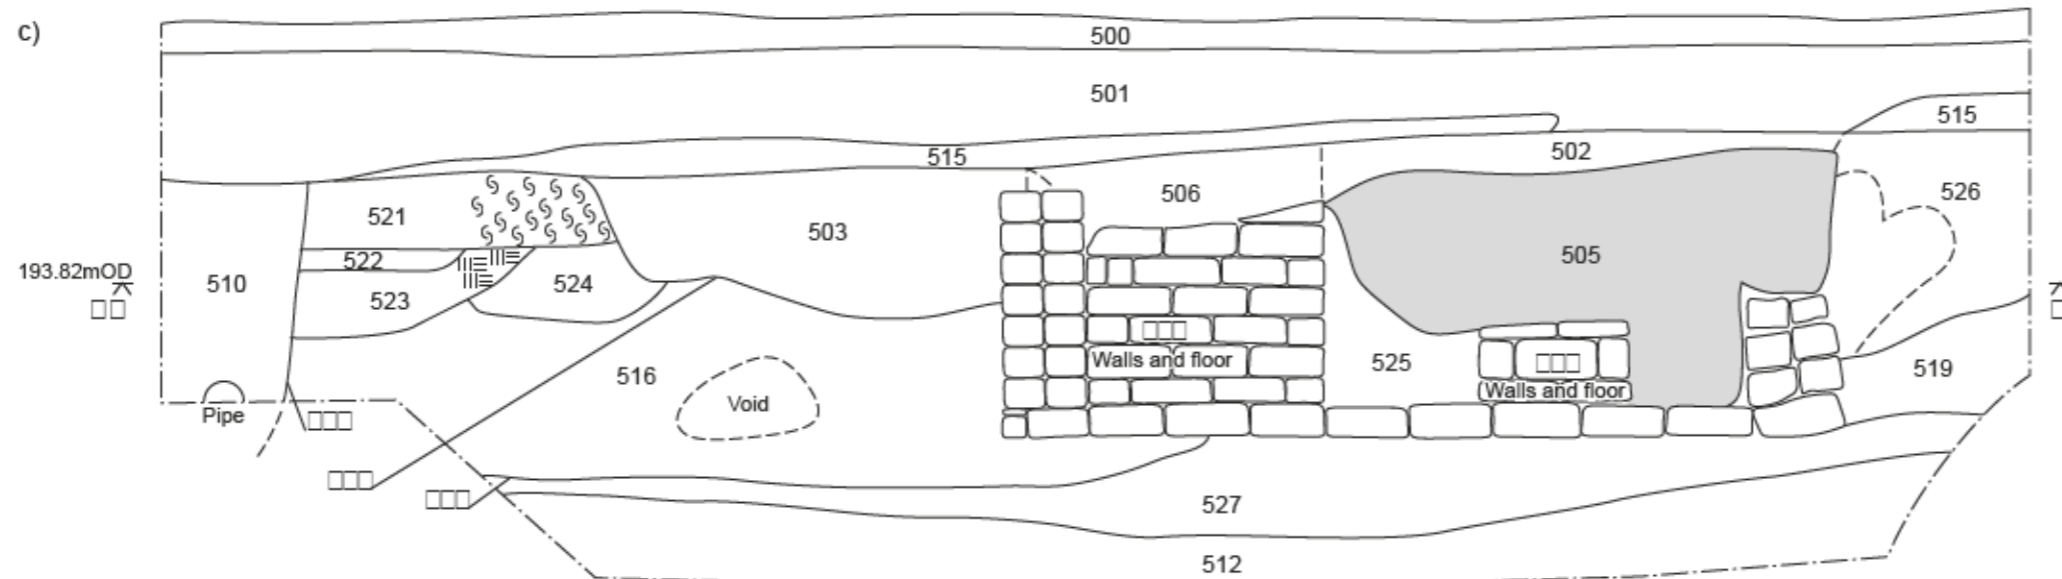
a) Plan of Trench 5
b) Section of features, Trench 5
c) Section of wall 507, Trench 5
