Standing Building Survey

Balgownie Mill, Eassie, Angus

29th August 2011

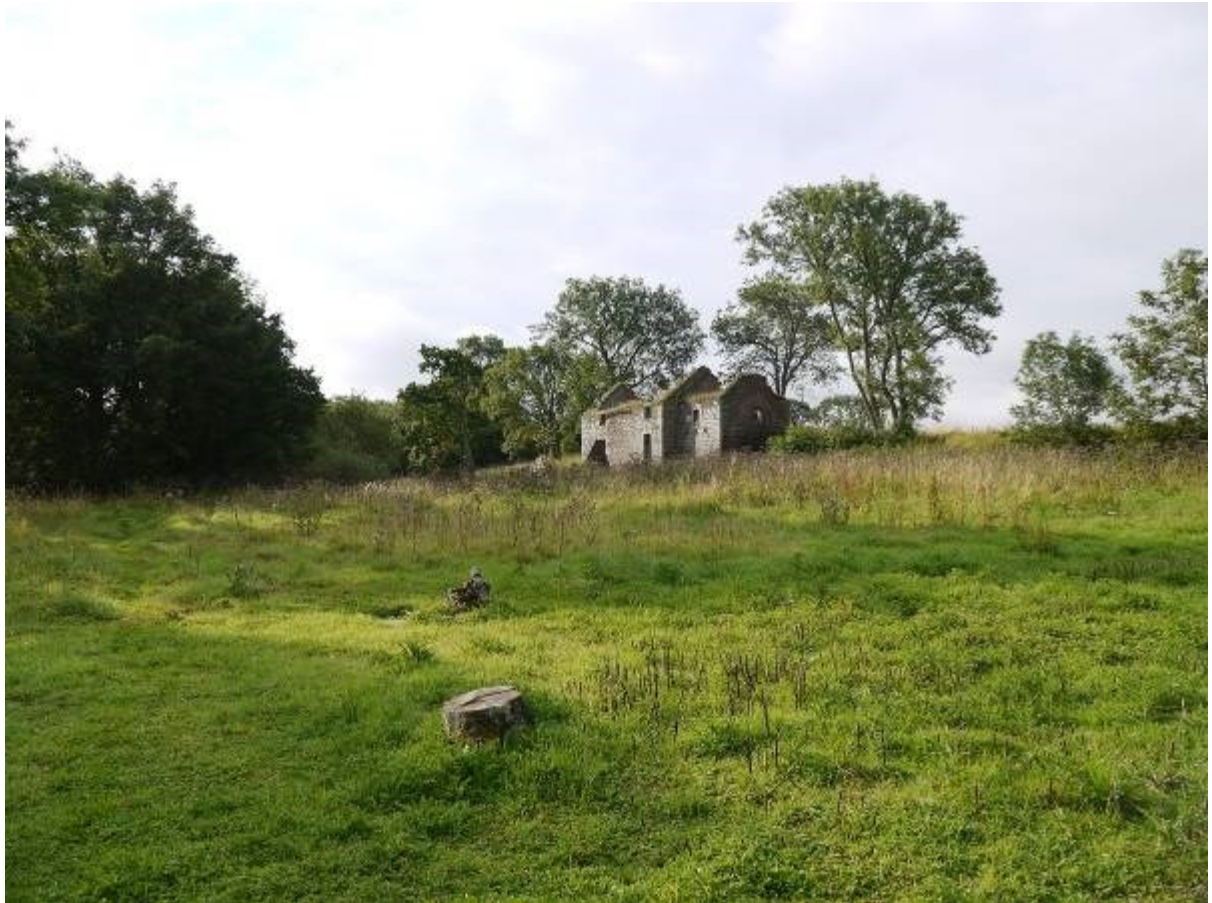
The roofless remains of the two buildings that represent the former mill at Balgownie lie on the Western side of the former mill lead that runs North towards Eassie. The main building is aligned North to South and is split into two sections (A and B) and has another smaller structure (C) butted against its Eastern side that is aligned East to West.

Illustration 6 General view of former mill building looking South East

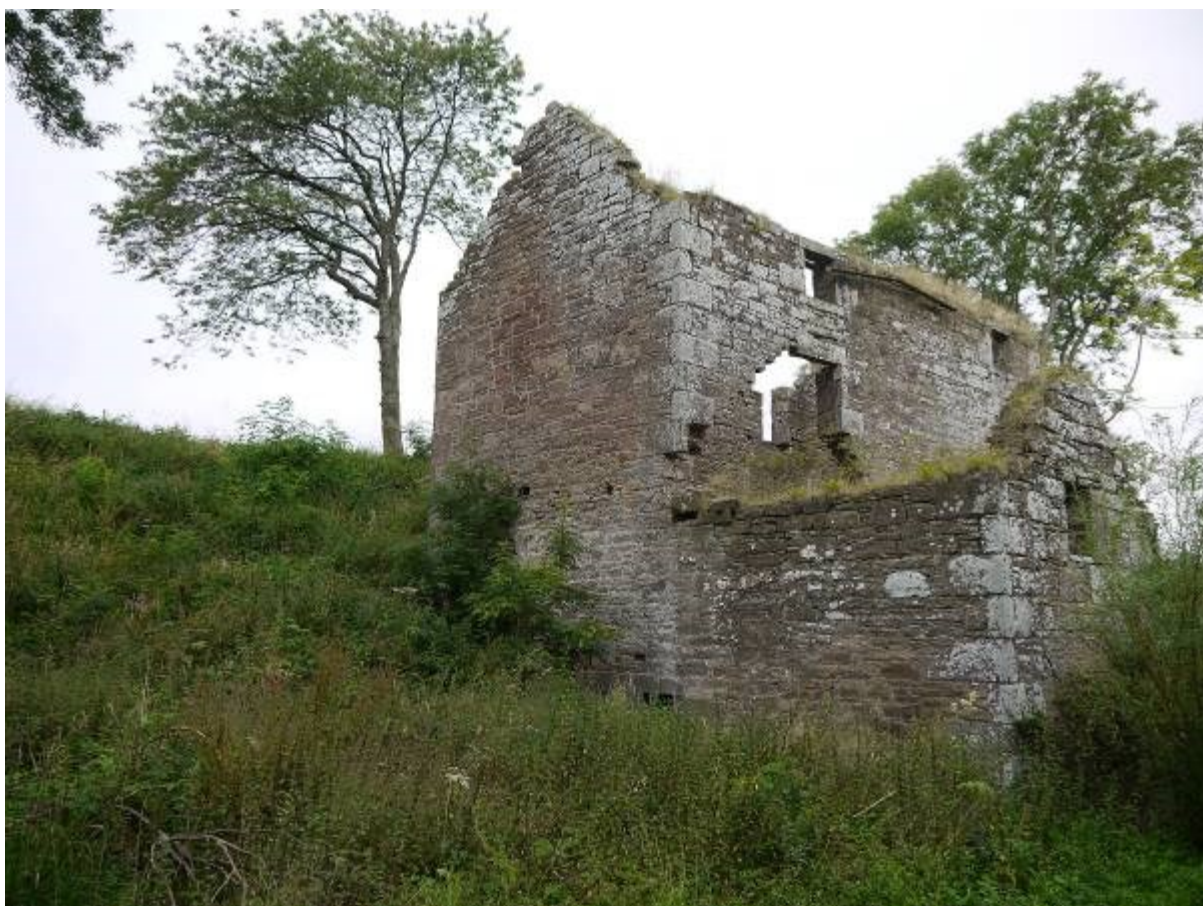
This gable elevation is blank and is constructed of mortar bonded red sandstone blocks, it comprises both Southern end gable wall of building A and the Southern side wall of building C. A circular hole for the water wheel shaft is visible in the wall of building A and there is a small square hole visible just below and to the East of the shaft hole whose function is unclear. The wheel pit stands 1.2m to the South of the Western end of this elevation (see below).

Illustration 7 Southern elevation of Buildings A and C looking North West

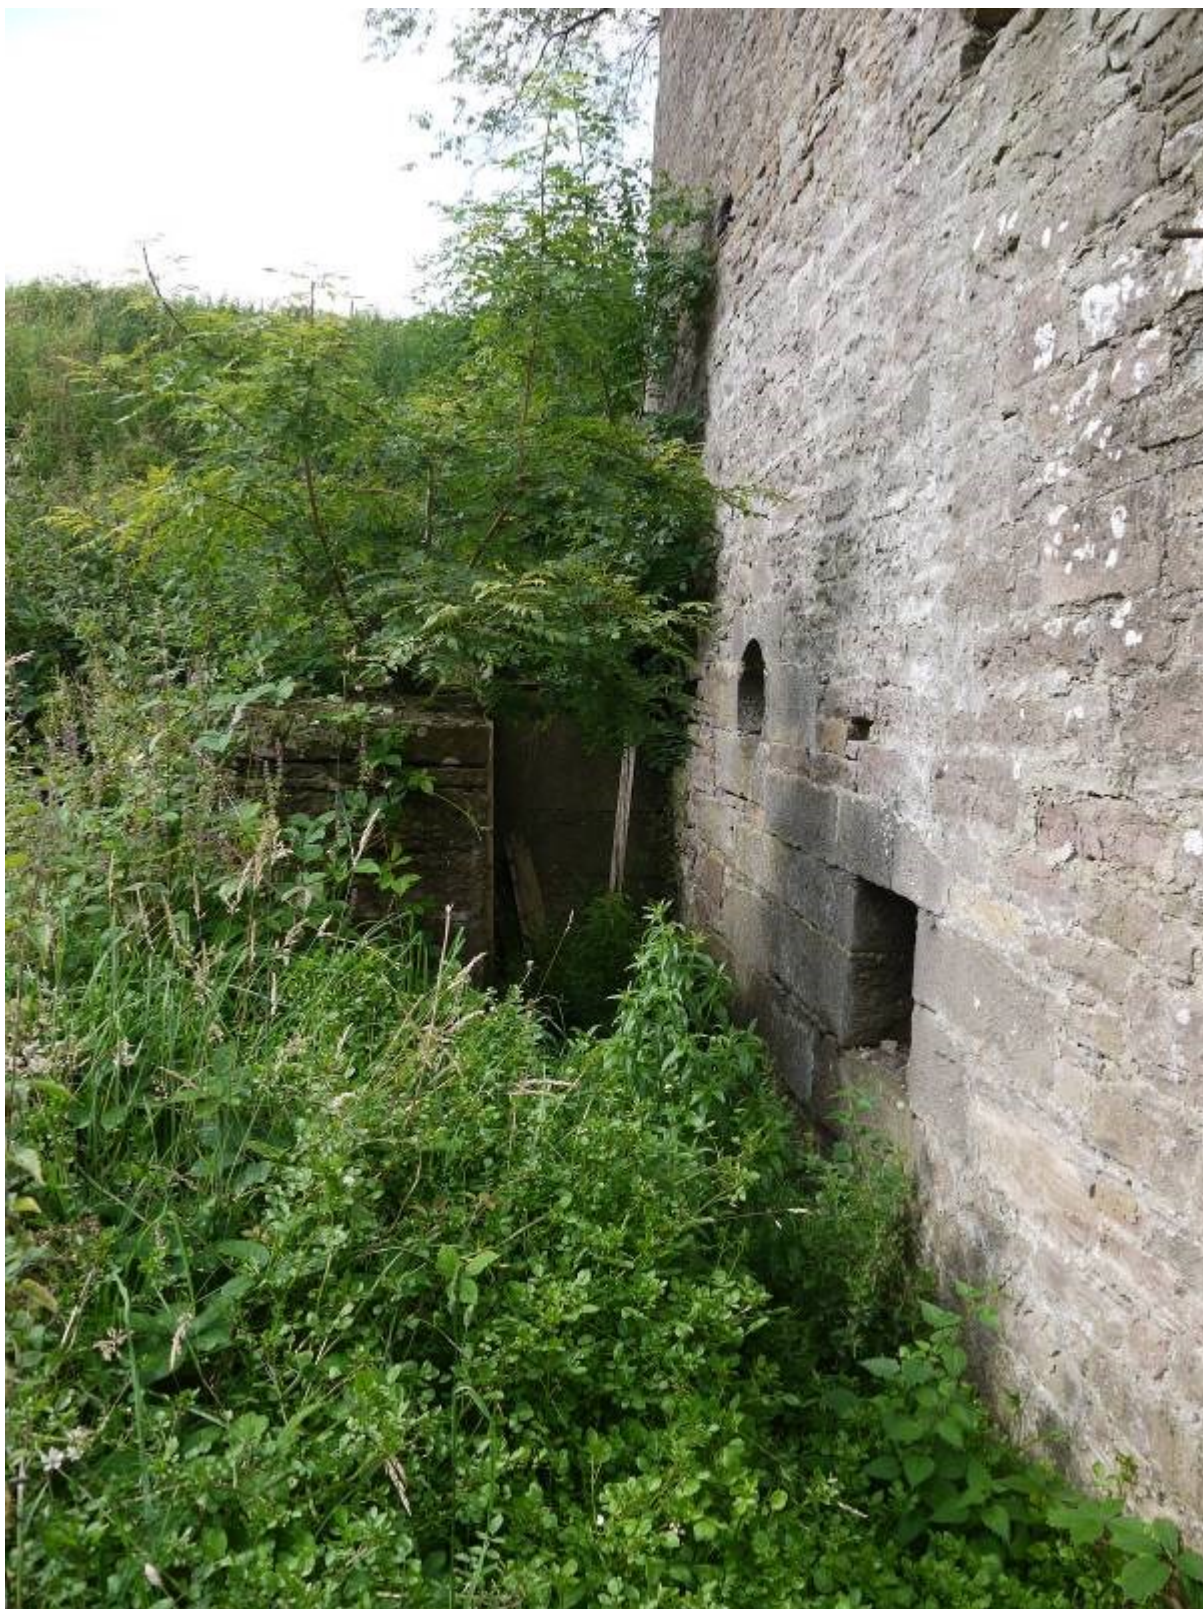
This feature is 1.2m wide and at least 1.75m deep, it is currently full of water and some collapsed rubble so may be slightly deeper. The Western end of the pit has a curving sloped end and was obviously fed with water from that end. The external wheel pit wall contains a semi-circular hole directly opposite the wheel shaft hole in the wall of building A which would have supported the other side of the wheel shaft.

Illustration 8 Wheel pit looking West

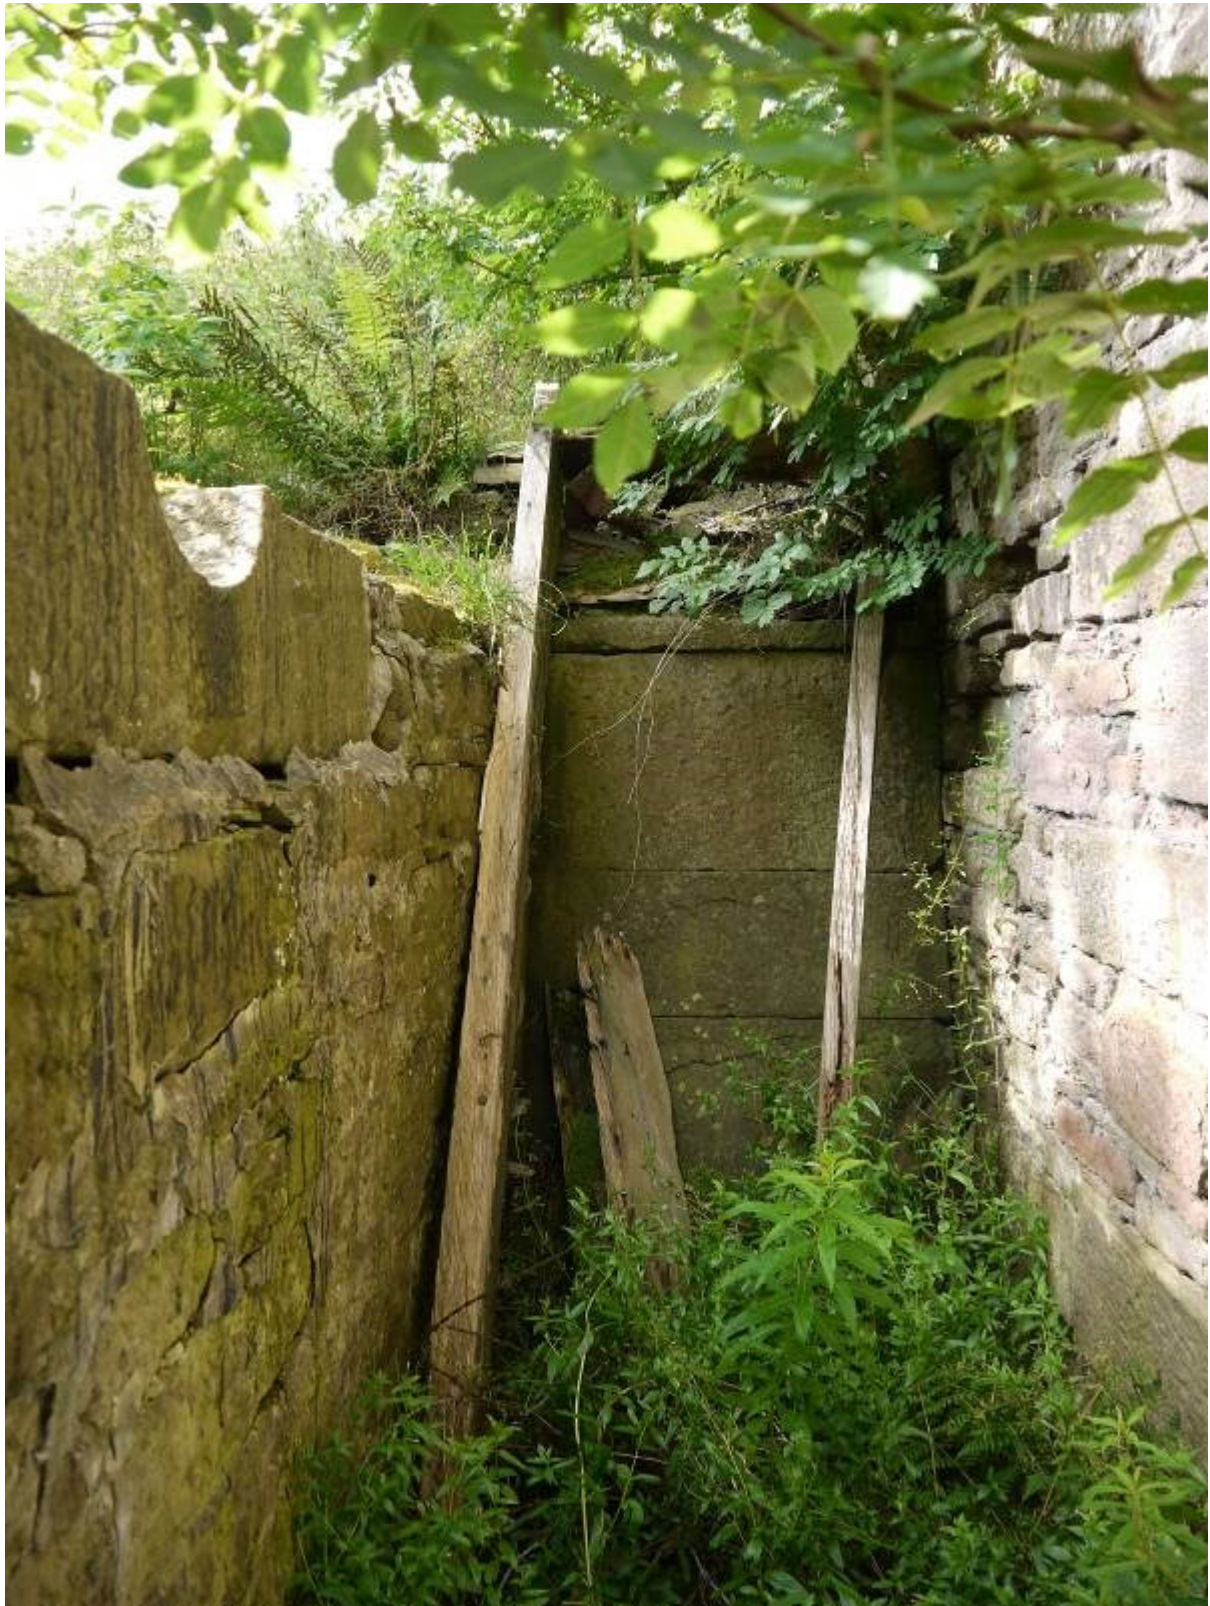
Illustration 9 Outer support for waterwheel shaft and sloping end to wheel pit looking West

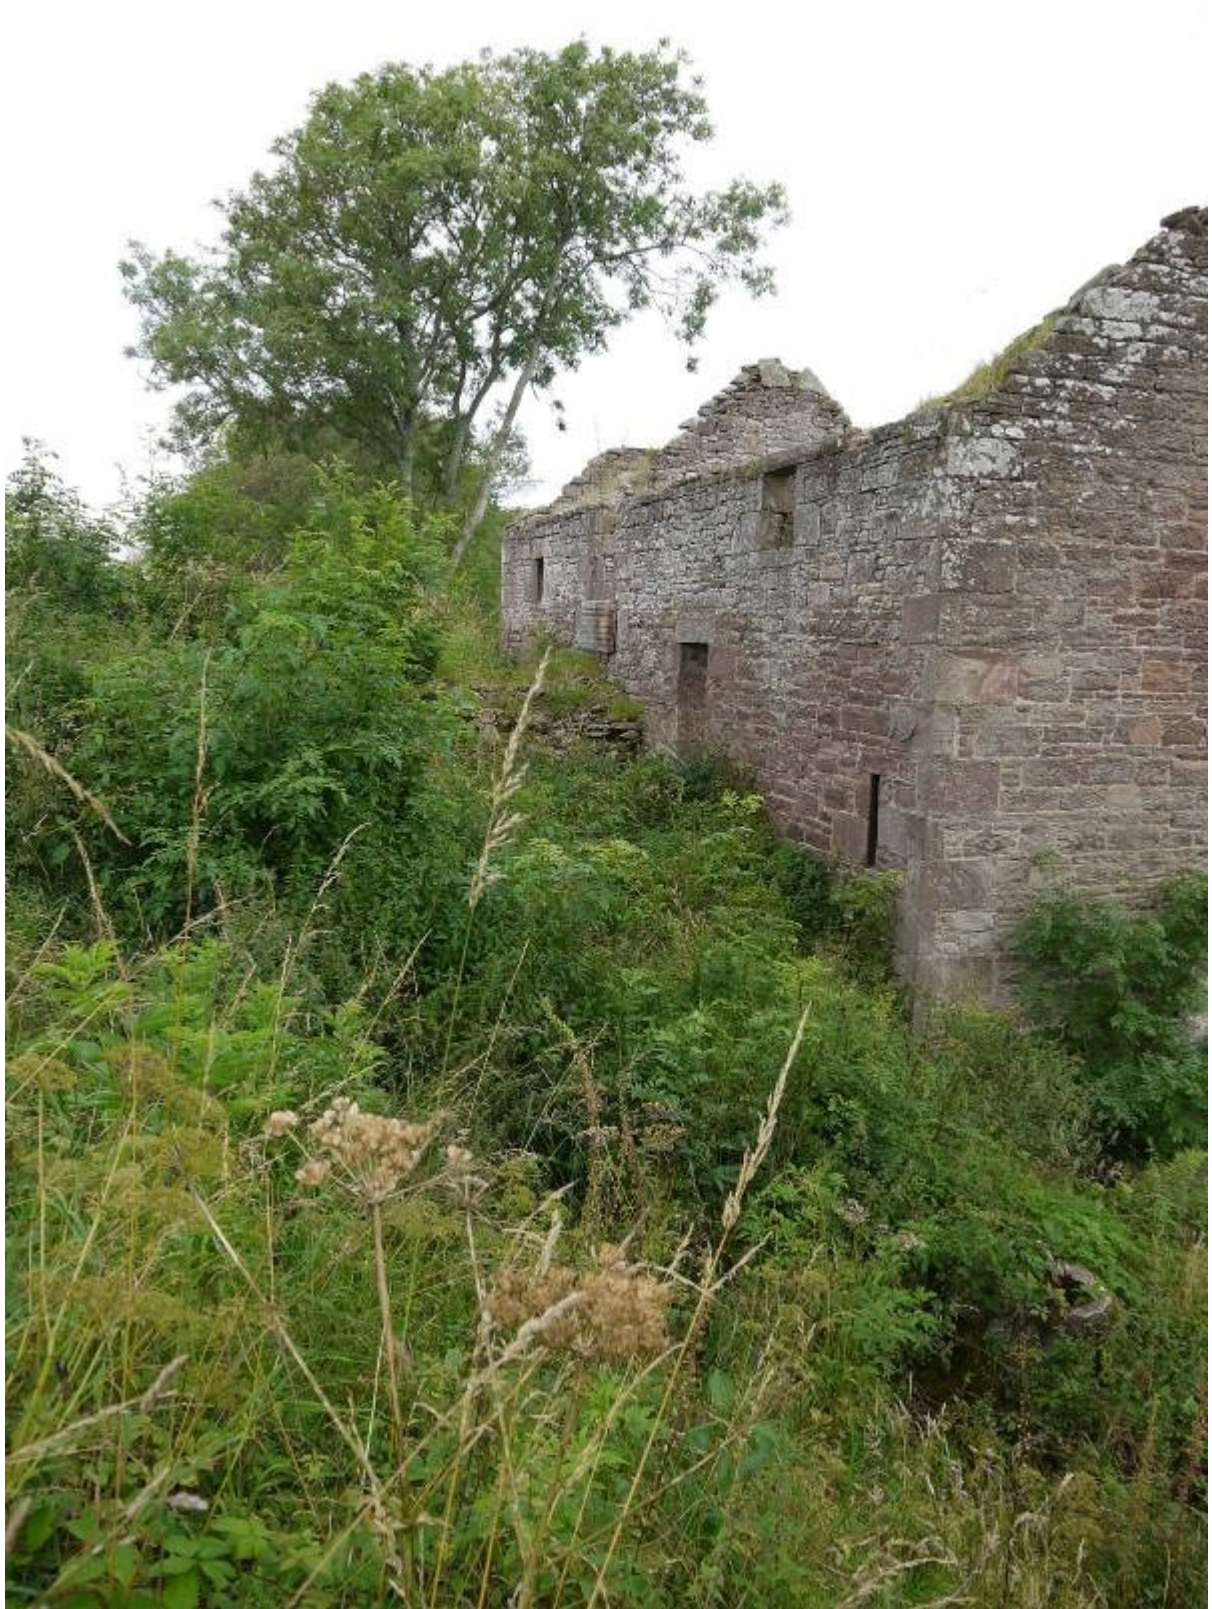
This elevation is constructed of mortar bonded red sandstone blocks, it comprises both the Western side walls of buildings A and B. It has a small window at its Northern end (B), a doorway that would have accessed first floor level in building A and another small window at its Southern end (A). Towards the Southern end of this elevation there is another doorway at ground floor level and a narrow slit window close to the gable end (both in A). There is a substantial dump of rubble against this elevation which has created a platform allowing access to first floor level in building A.

Illustration 10 Western elevation to Buildings A and B looking North North East, narrow slit window visible beside Southern gable and top of rubble dump providing access to doorway at attic floor level

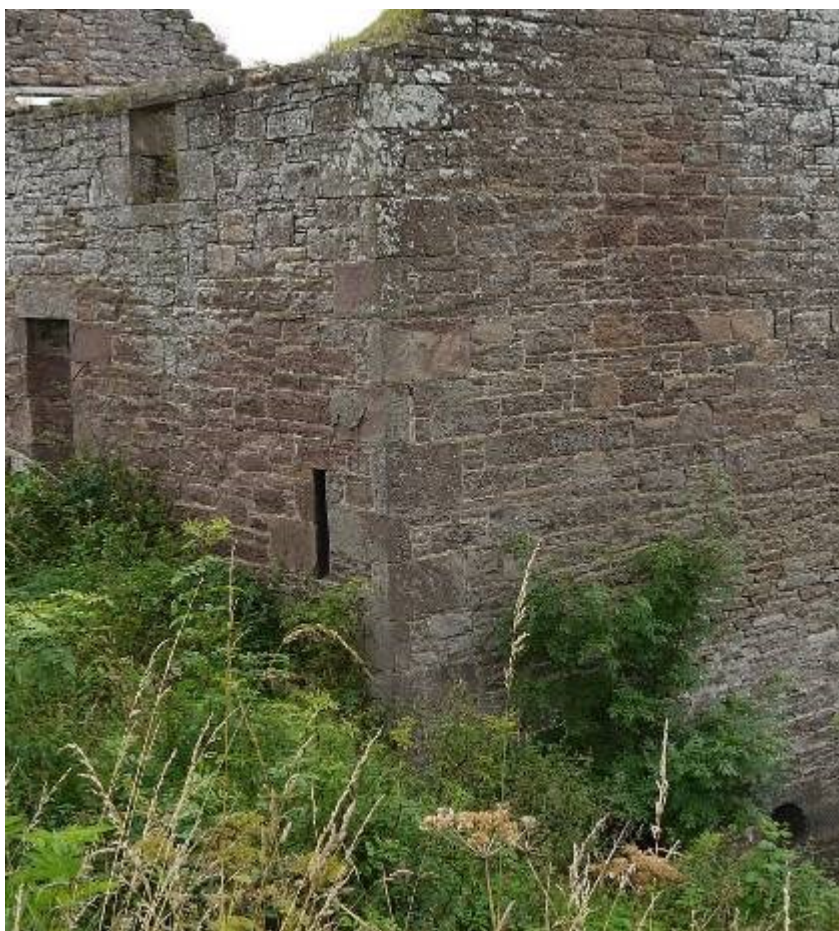
Illustration 11 Detail of location of slit window in Western elevation

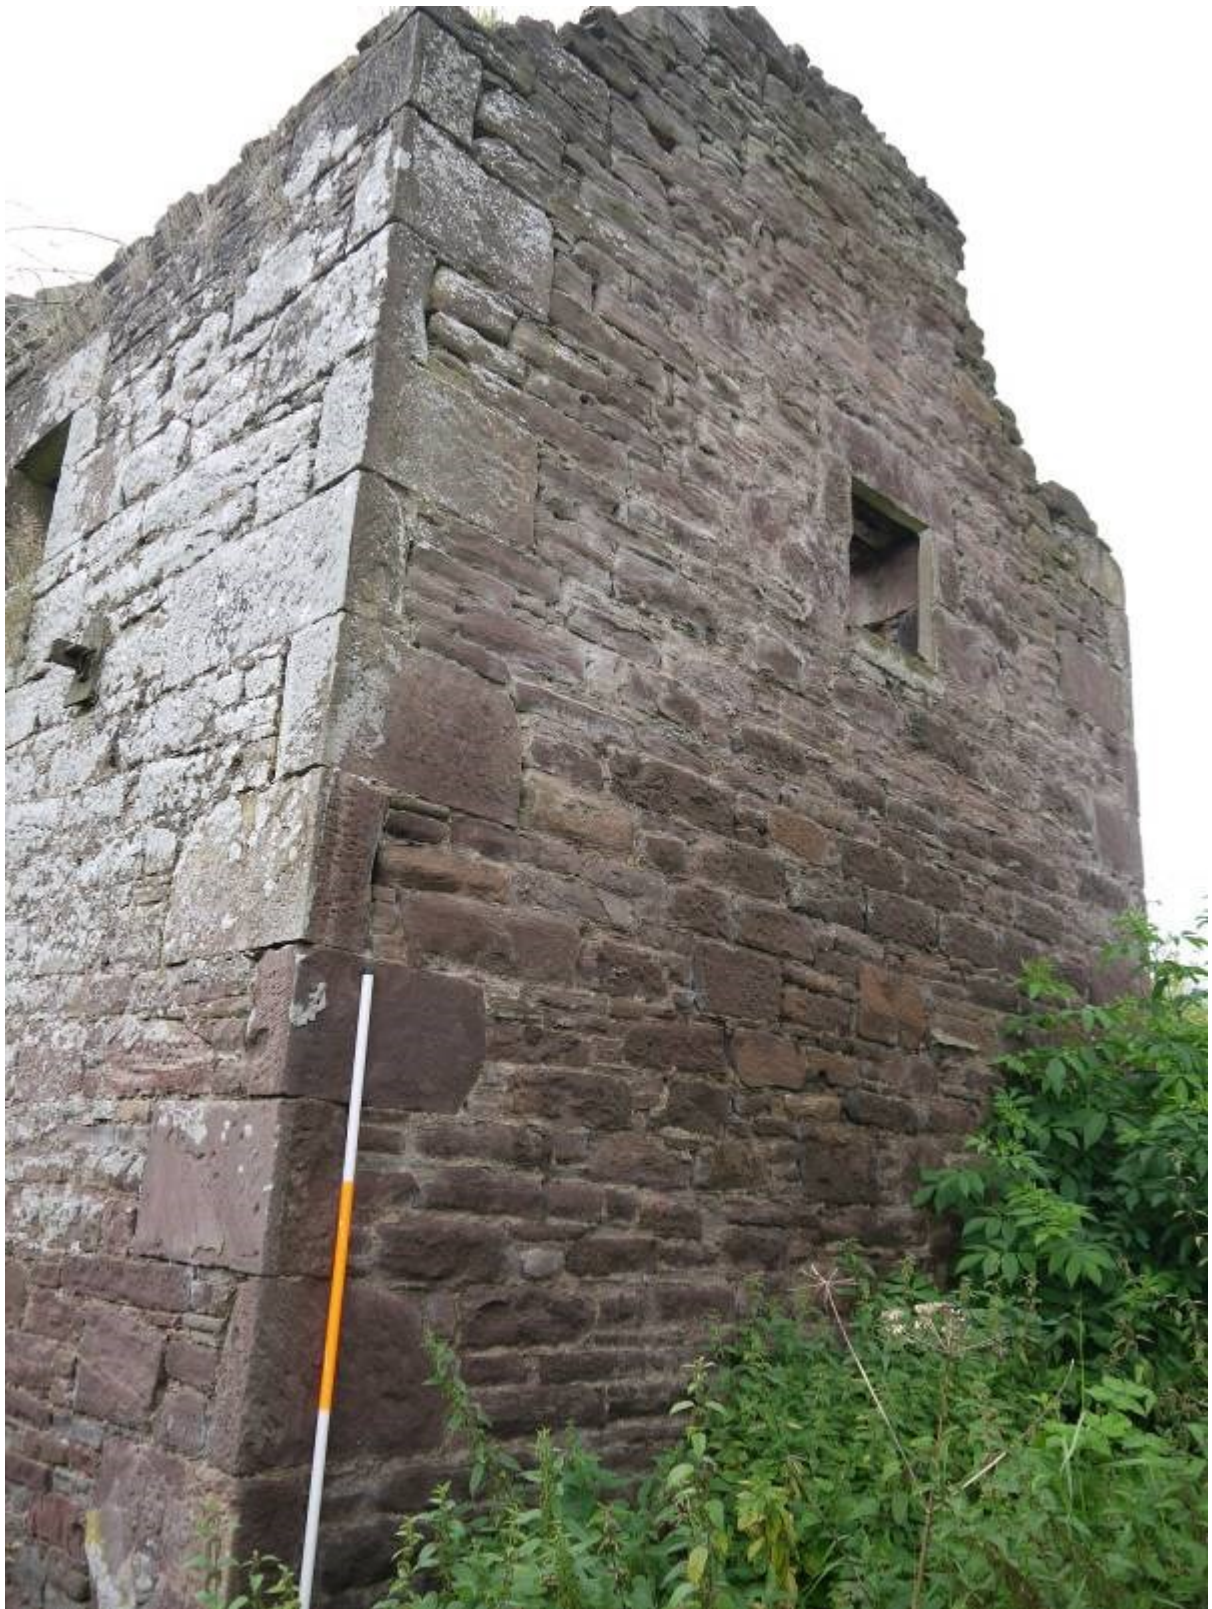
The northern gable elevation of Building B is constructed of mortar bonded red sandstone blocks and has a single small window. Both wall corners at the end of the gable have alternate shaped red sandstone quoins.

Illustration 12 Northern elevation of Building B looking South West

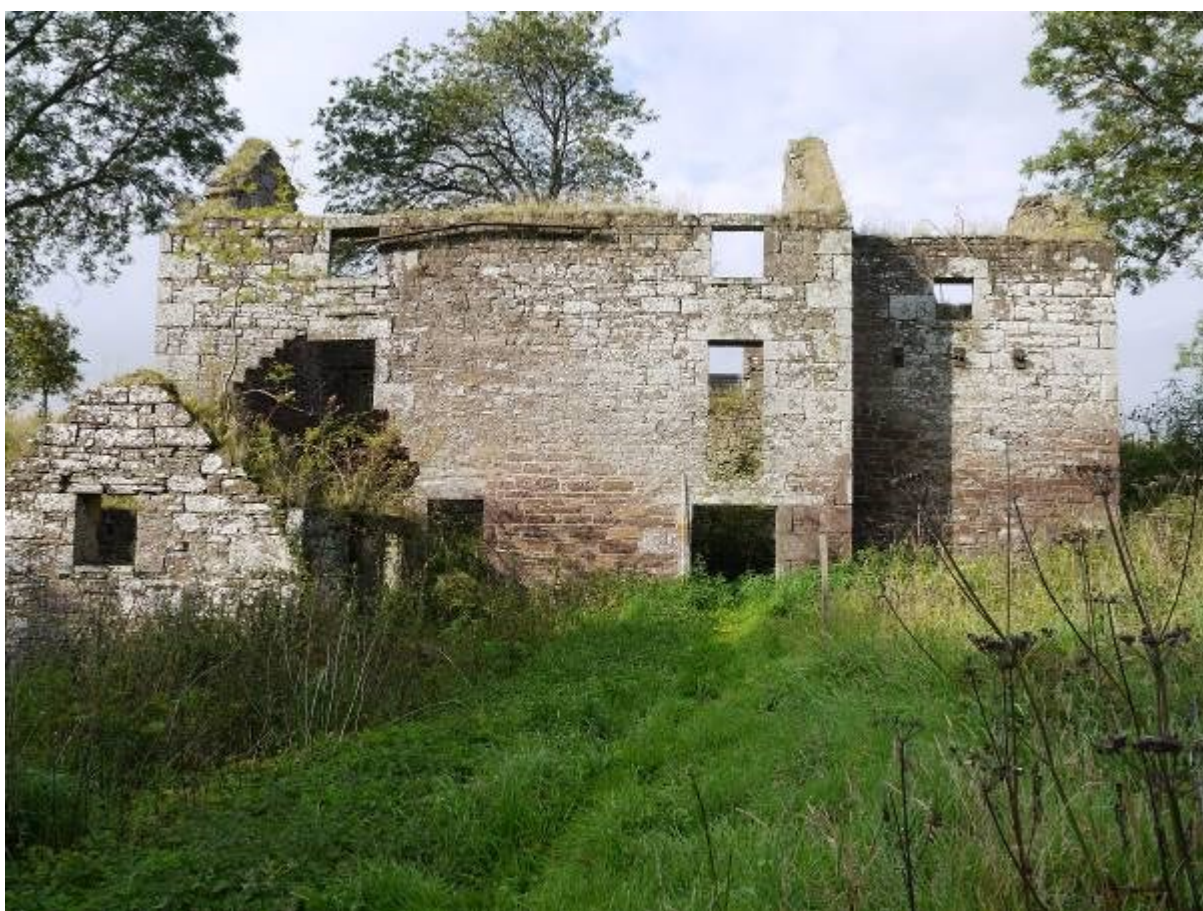
This elevation is constructed of mortar bonded red sandstone blocks and comprises the side walls of buildings A and B. The second building in this complex (C) is butted against the Southern end of this elevation. Buildings A and B are one and a half storeys high with three small windows at 'attic' level (two in A and one in B). Building A has two doorways at first floor level, the Southern one of these just survives on the edge of a substantial wall collapse. Building A has another doorway at ground

Illustration 13 Eastern elevation of Buildings A, B and part of eastern gable end of Building C looking West

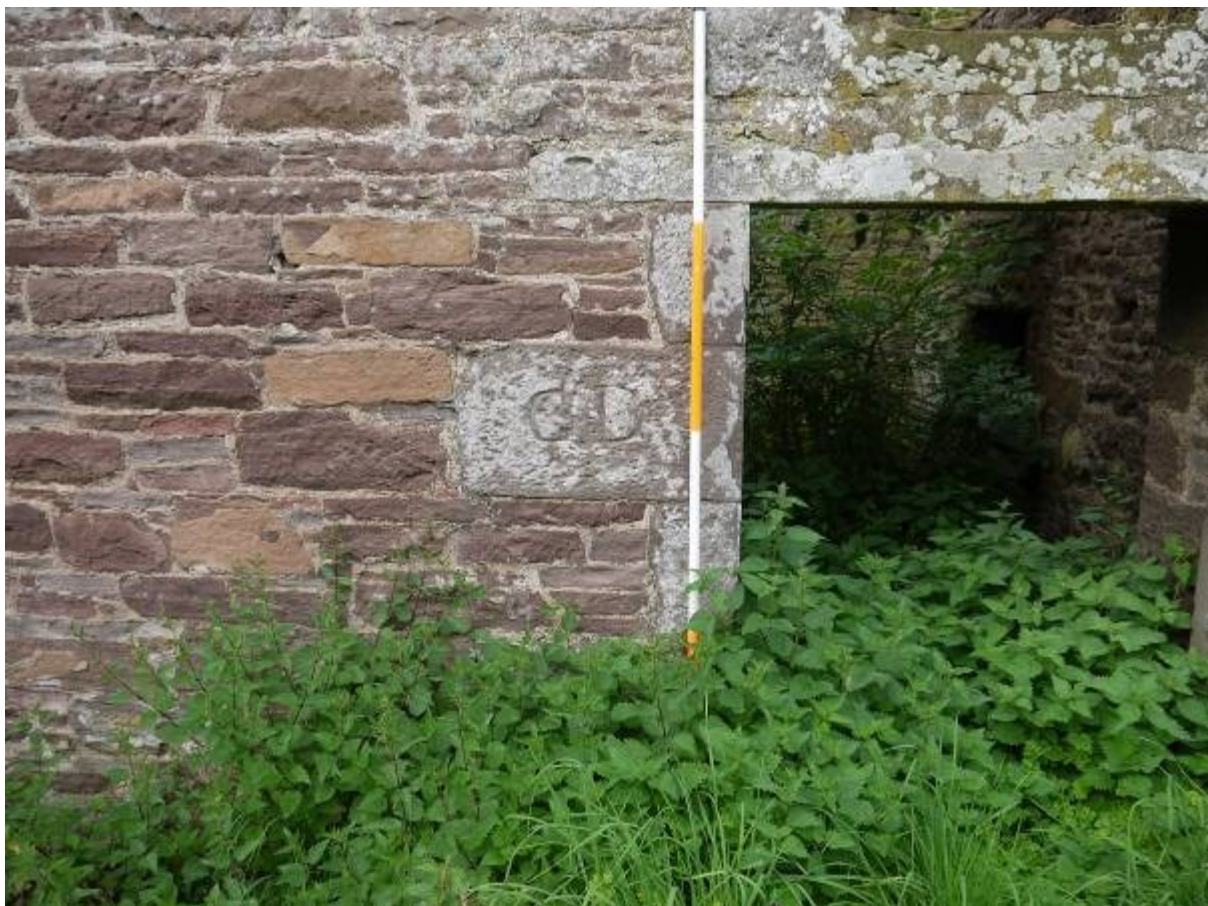
floor level and a small window just beside its junction with Building C. One of the quoin stones on the Southern side of the doorway has the initials 'GD' carved into it, similar initials are also carved into the Northern side wall of the doorway (see Historical Background). The Eastern wall of Building A steps out 1.2m from the Eastern wall of Building B.

Illustration 14 Initials 'G D' carved into stone beside doorway into Building A looking West

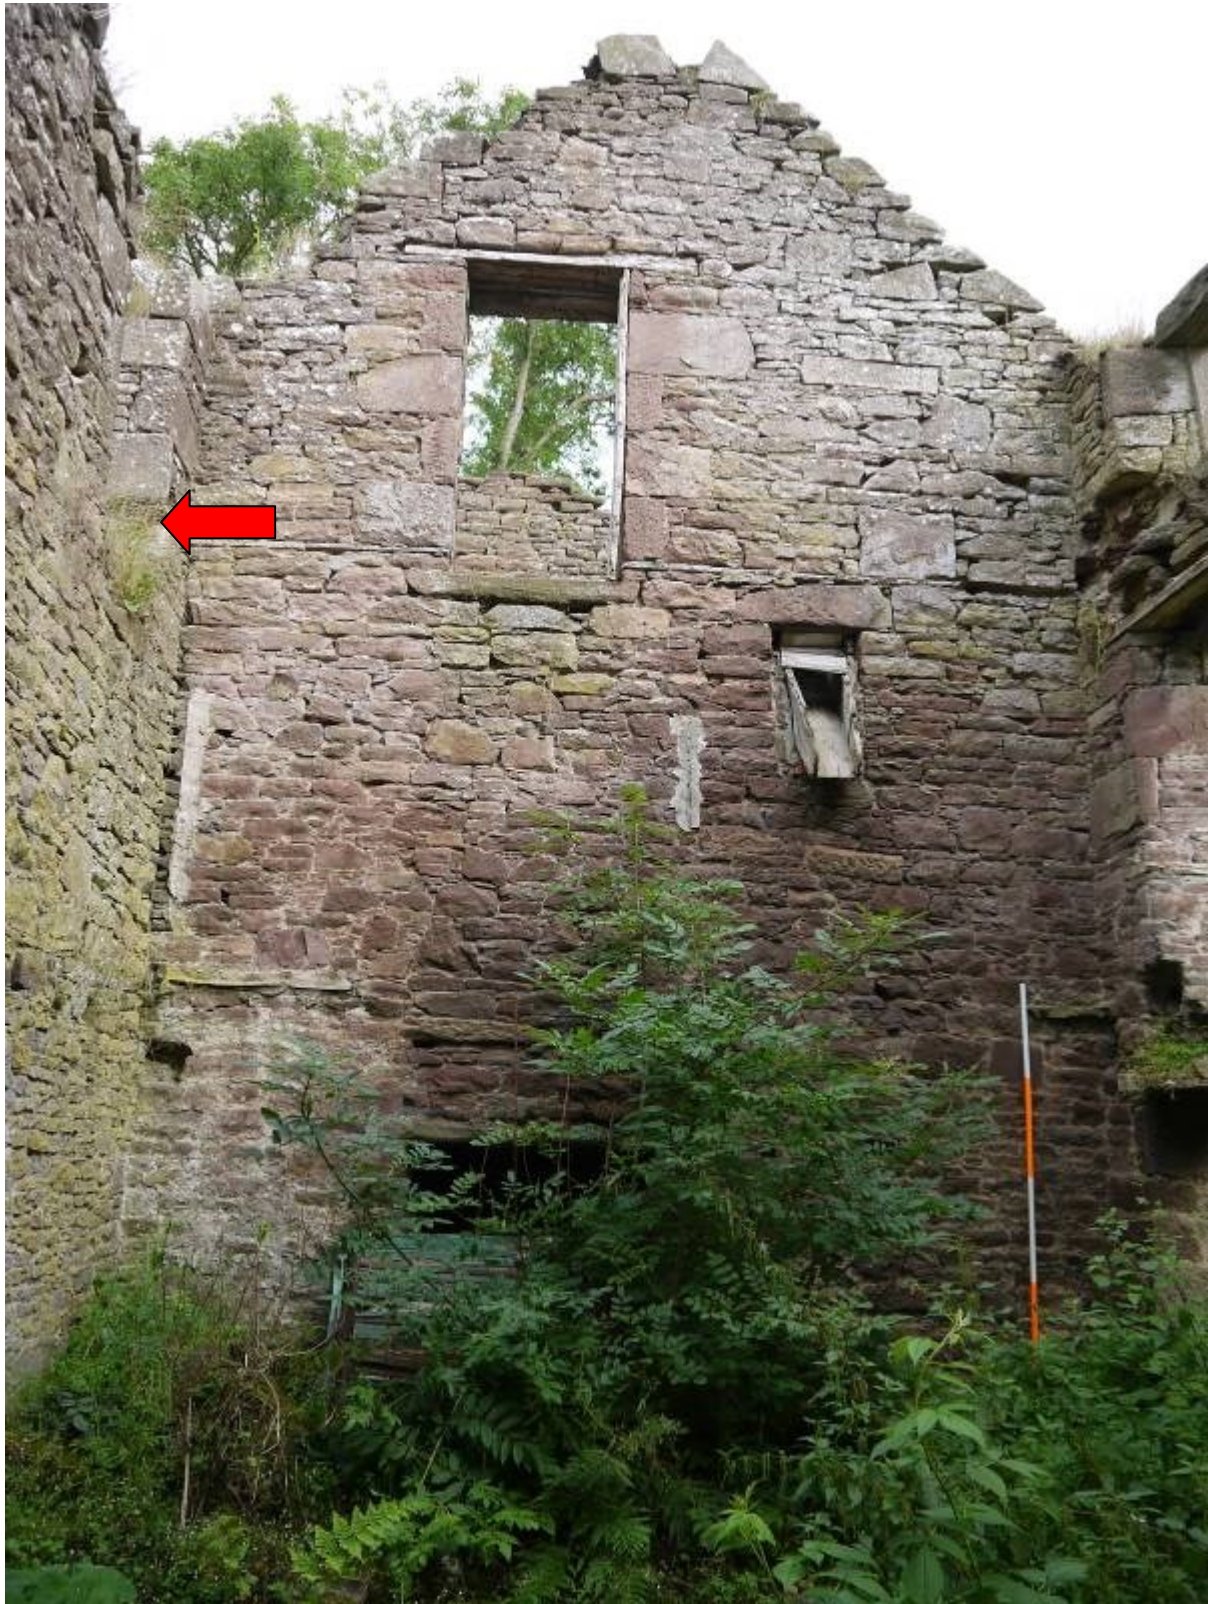
Illustration 15 Interior of South elevation of Building A, showing grain chute and fireplace behind small tree and corrugated iron sheet, red arrow indicates attic floor access through doorway in Western elevation

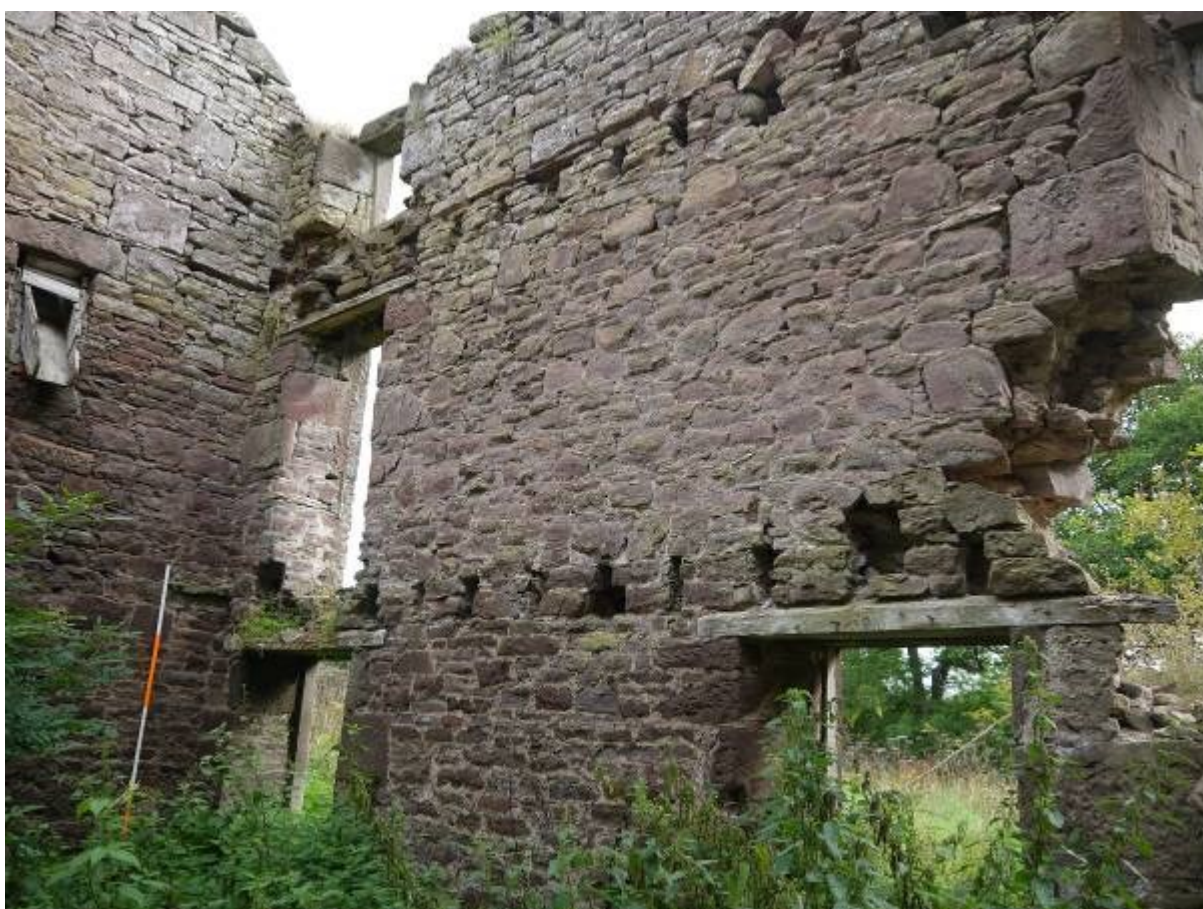
Illustration 16 Interior of Northern half of Western elevation of Building A showing joist holes for first floor and attic floor levels, wooden lintels visible in interior sides of two windows and doorway

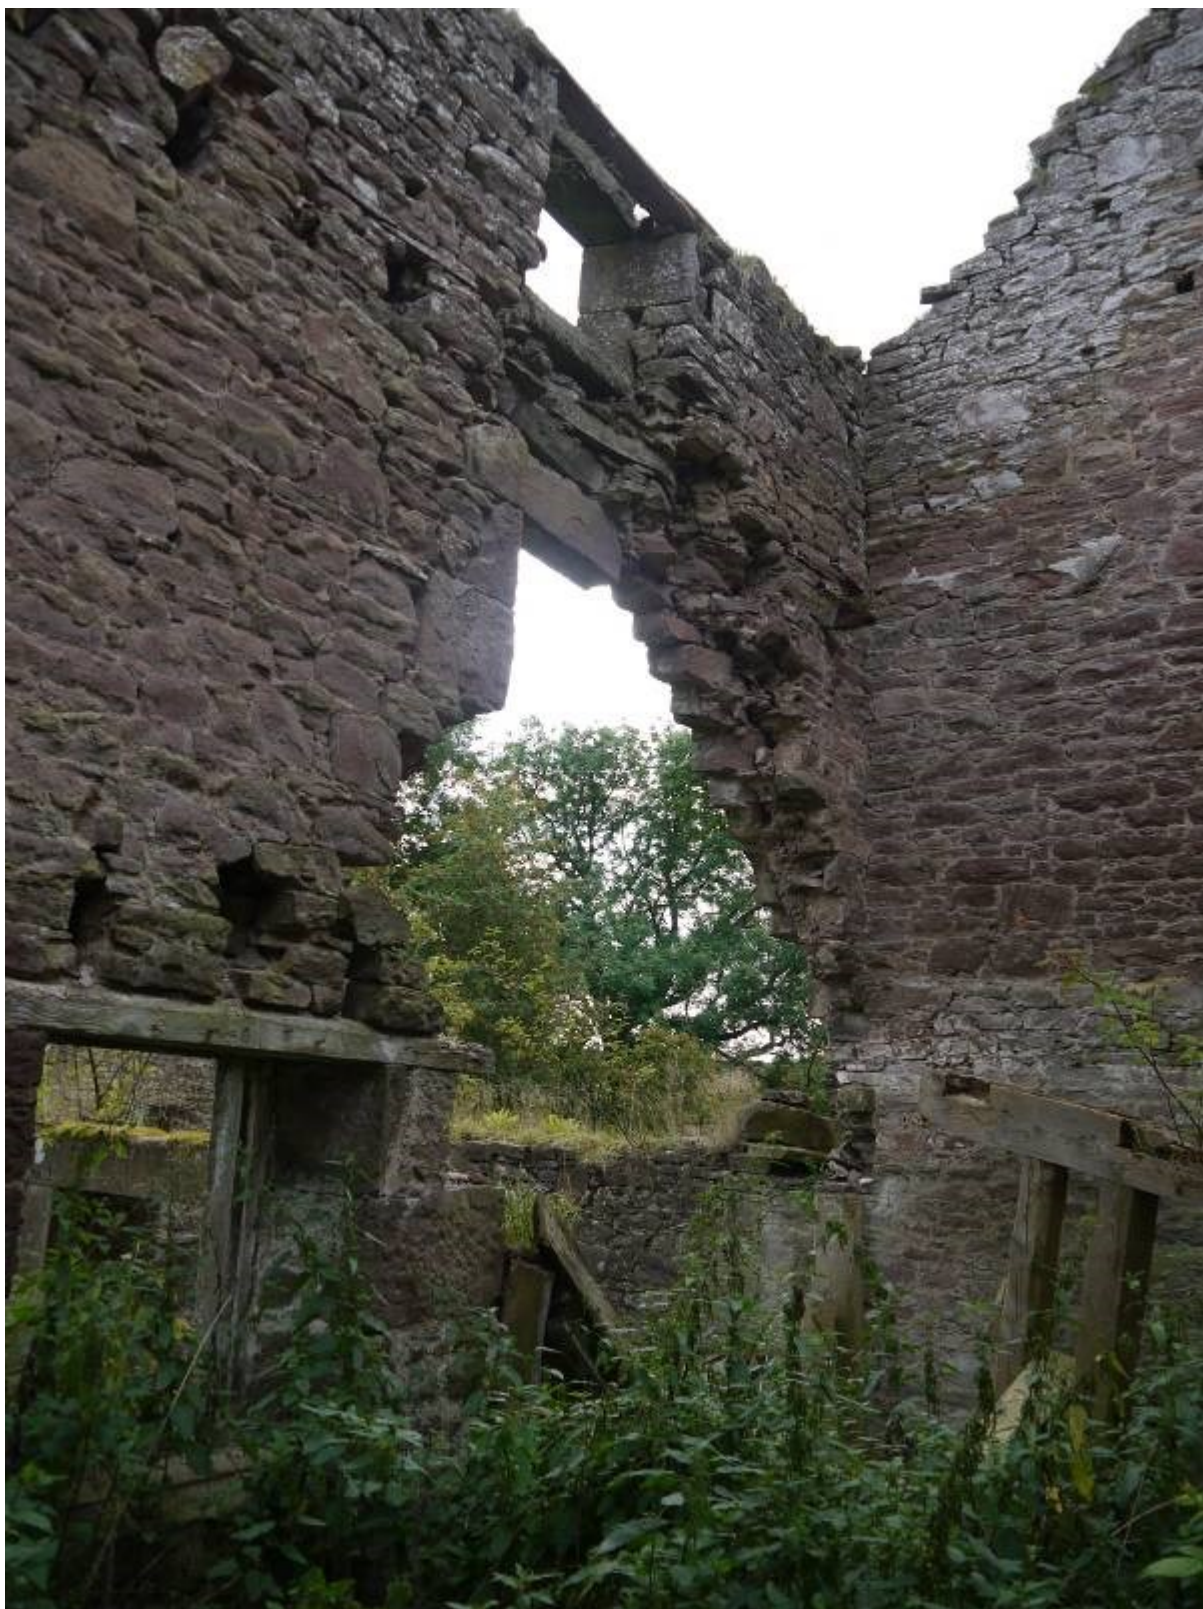
Illustration 17 Interior of Southern half of Western elevation of Building A showing partial wall collapse and open end of Building C

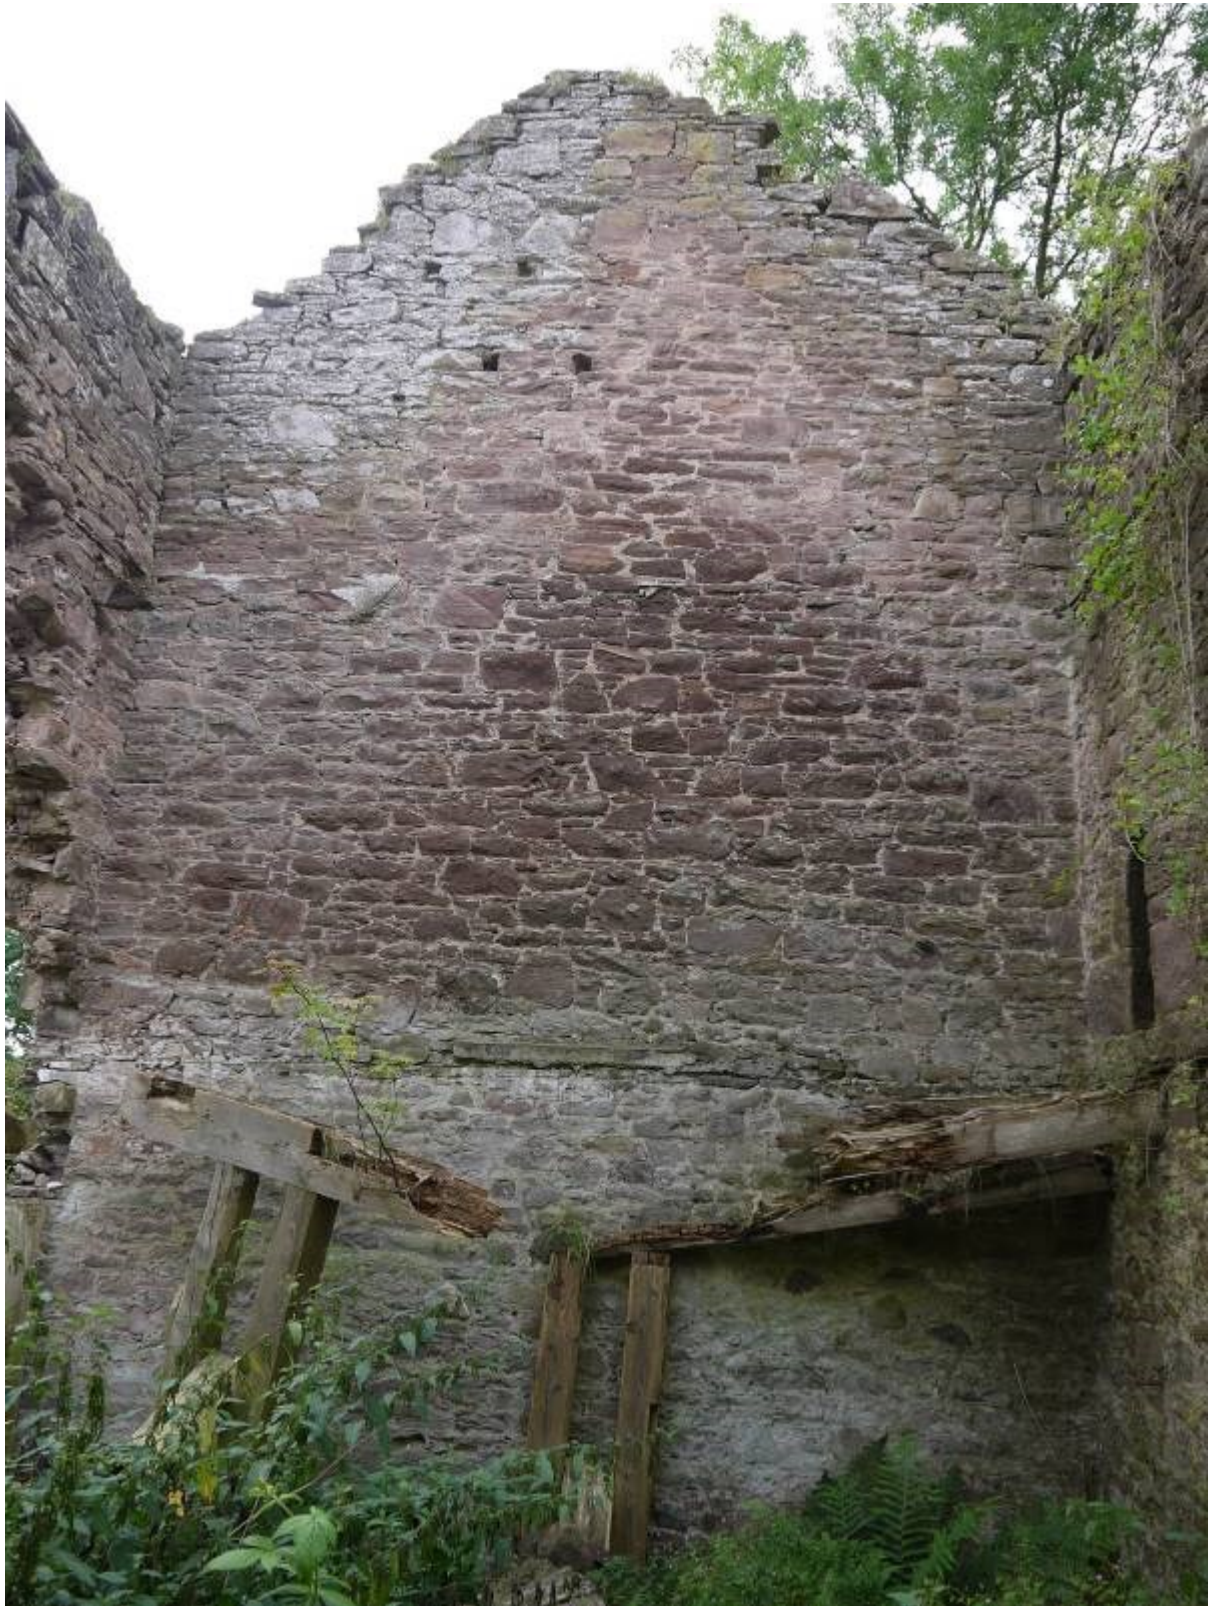
There is no visible floor level in the interior of this building which is full of rubble, nettles and a small tree. At its Southern end there are the collapsed remains of a timber structure which seems to be associated with the millstones which lie on the ground within it. Joist holes are visible in the Eastern and Western walls for two floor levels (one an attic), there are no joist holes in the Northern and Southern walls but there are lines of concrete visible at first floor level and timber planking at attic level on the Northern wall. The Southern wall has a circular hole in the wall to take the end of the wheel shaft and the Western wall has a narrow angled slit window at first floor level. The Northern wall has a wooden chute at attic floor level and a 'fireplace' at ground floor level that has no chimney, this represents a system for heating up the air in Building B (see below). The Northern wall is butted against the Western and Eastern faces of the buildings side walls.

Illustration 18 Interior of Northern elevation of Building A showing collapsed wooden frame (formerly housing millstones?)

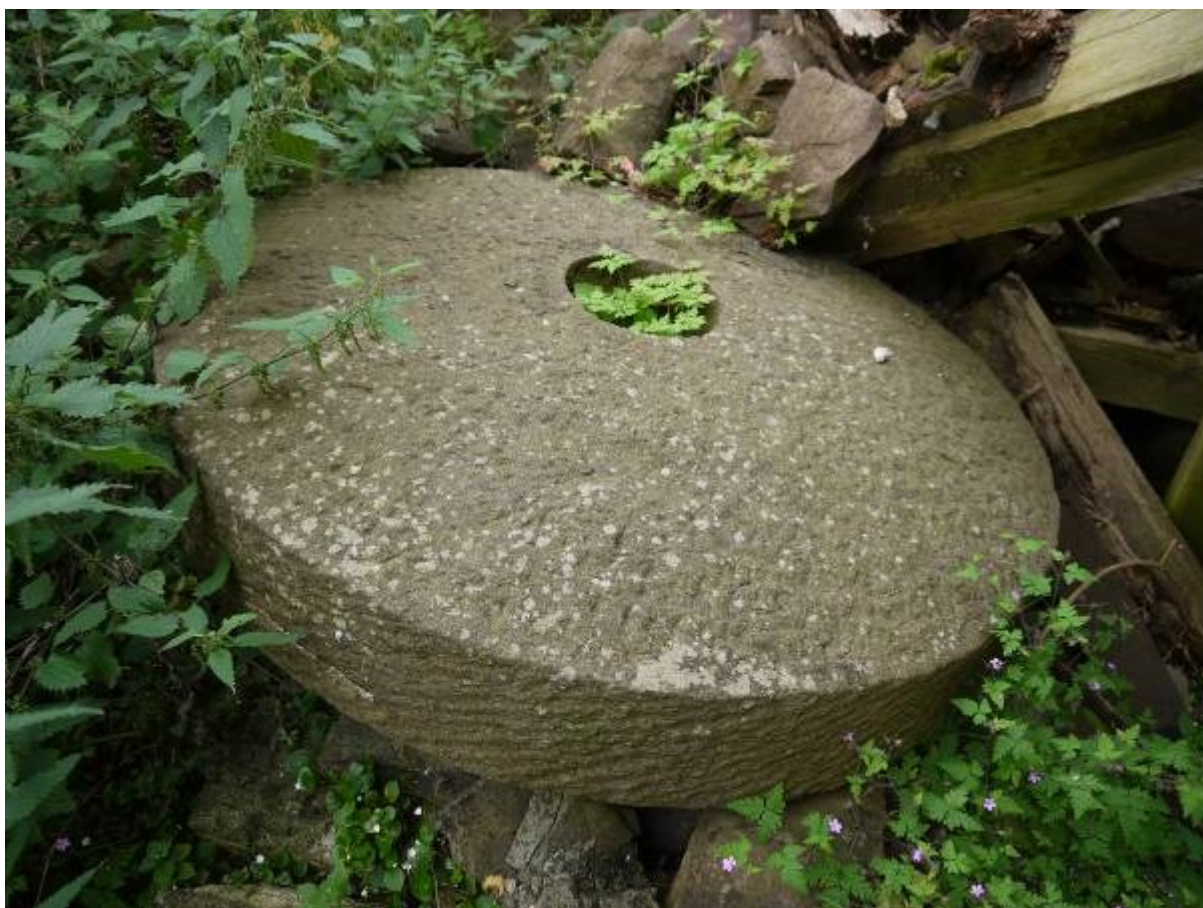
Illustration 19 Millstone lying on ground in front of Northern elevation of Building A (see Illus 2 for location)
