Standing Building Survey

Balgownie Mill, Eassie, Angus

29th August 2011

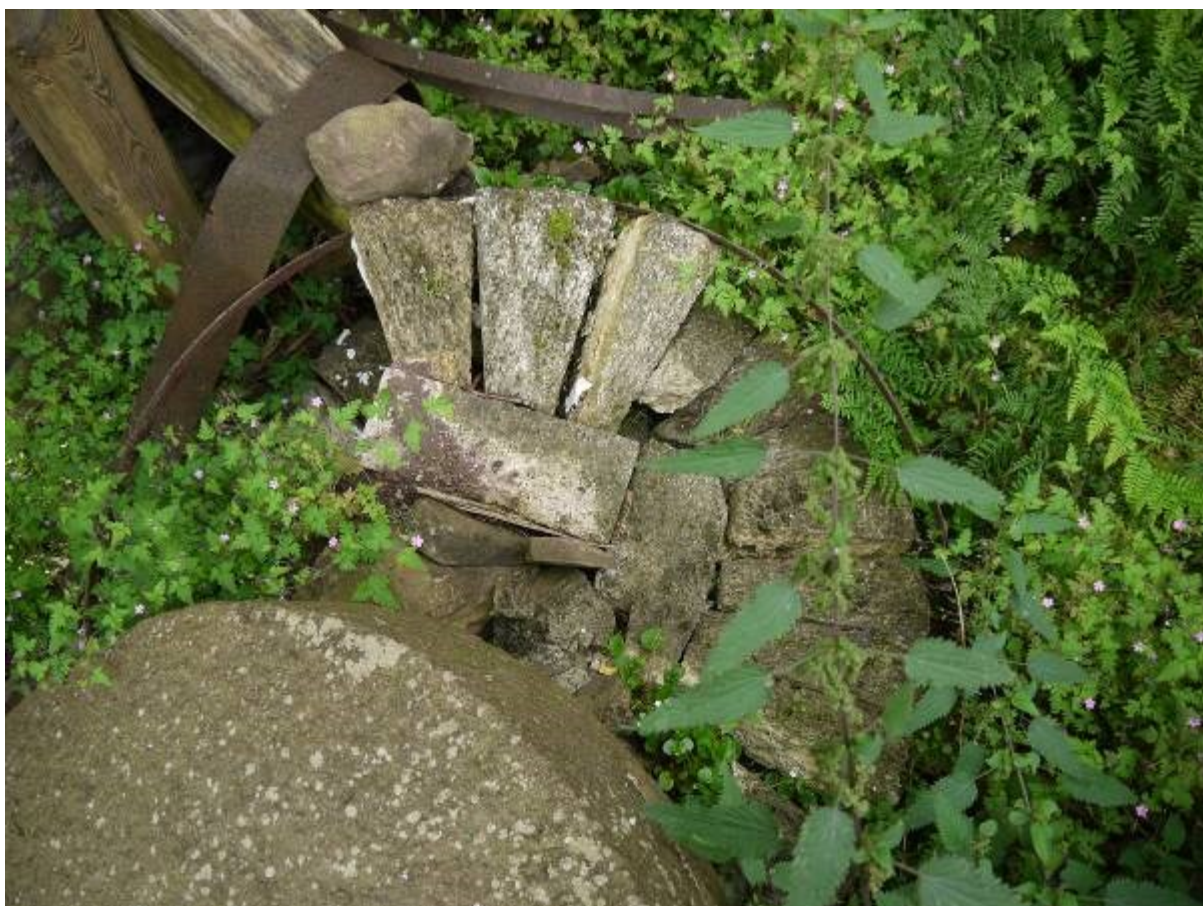
Illustration 20 Lower iron bound millstone lying below other millstone in front of Northern elevation of building A

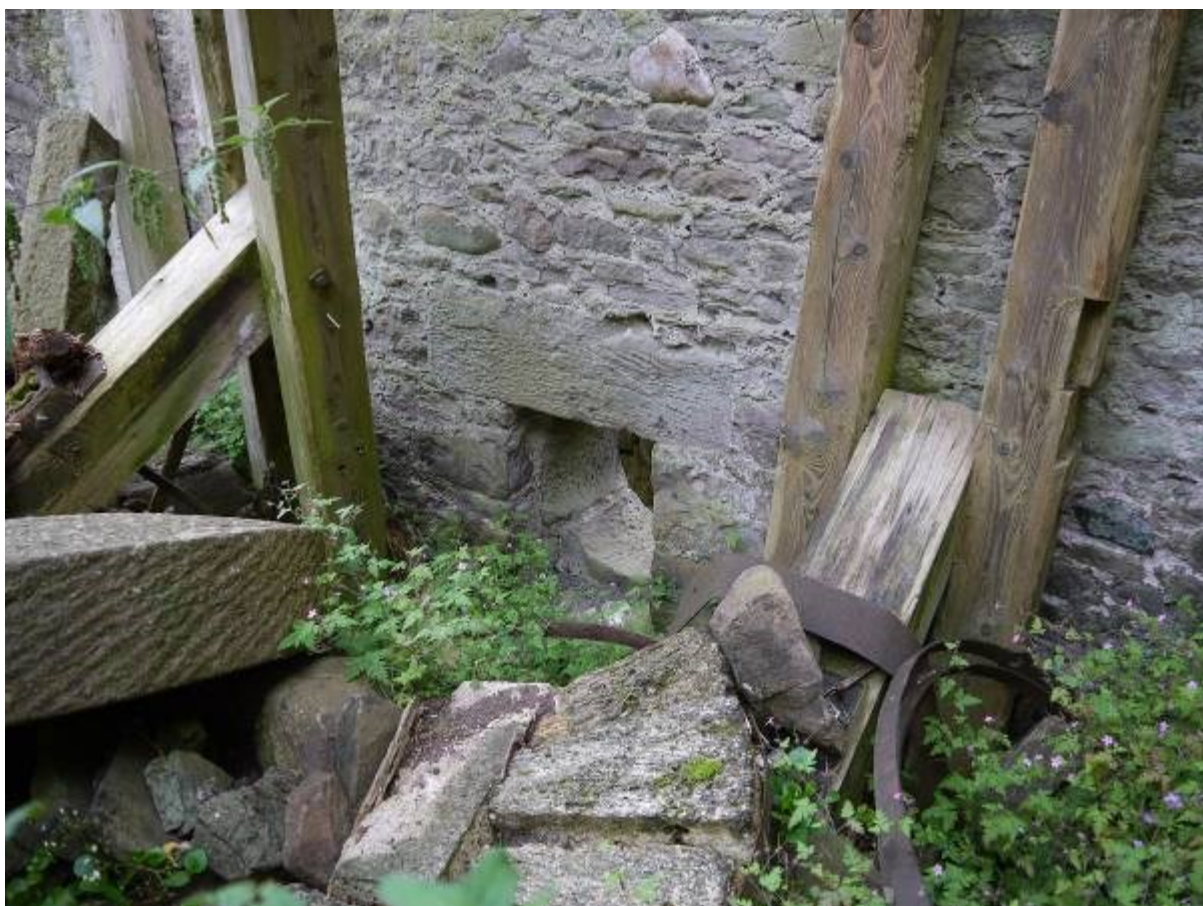
Illustration 21 Interior view of hole for waterwheel shaft adjacent to collapsed millstones and timber framework

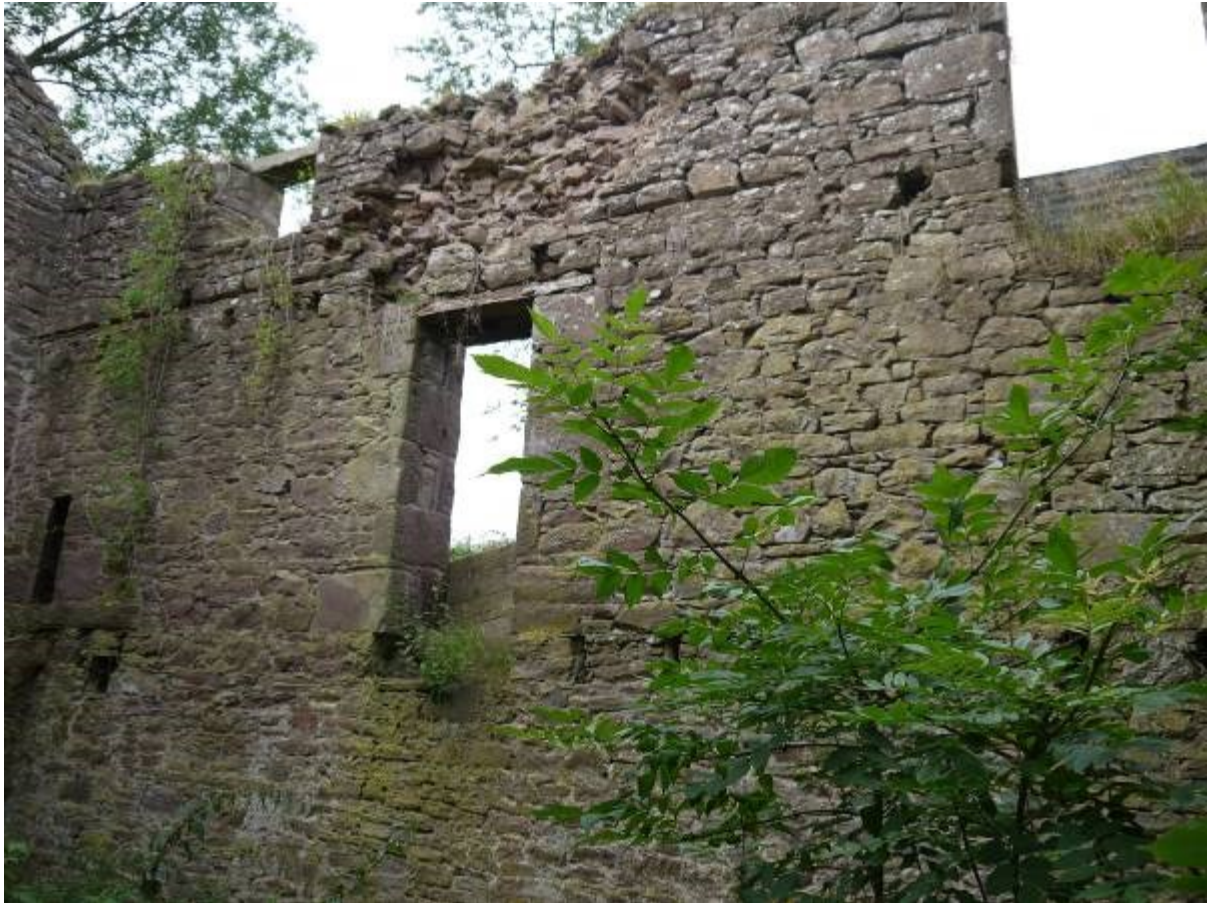
Illustration 22 Interior of Eastern elevation to Building A showing angled slit window to left, doorway access to first floor level, doorway access to attic floor level top right, joist holes also visible for first floor and attic floor levels

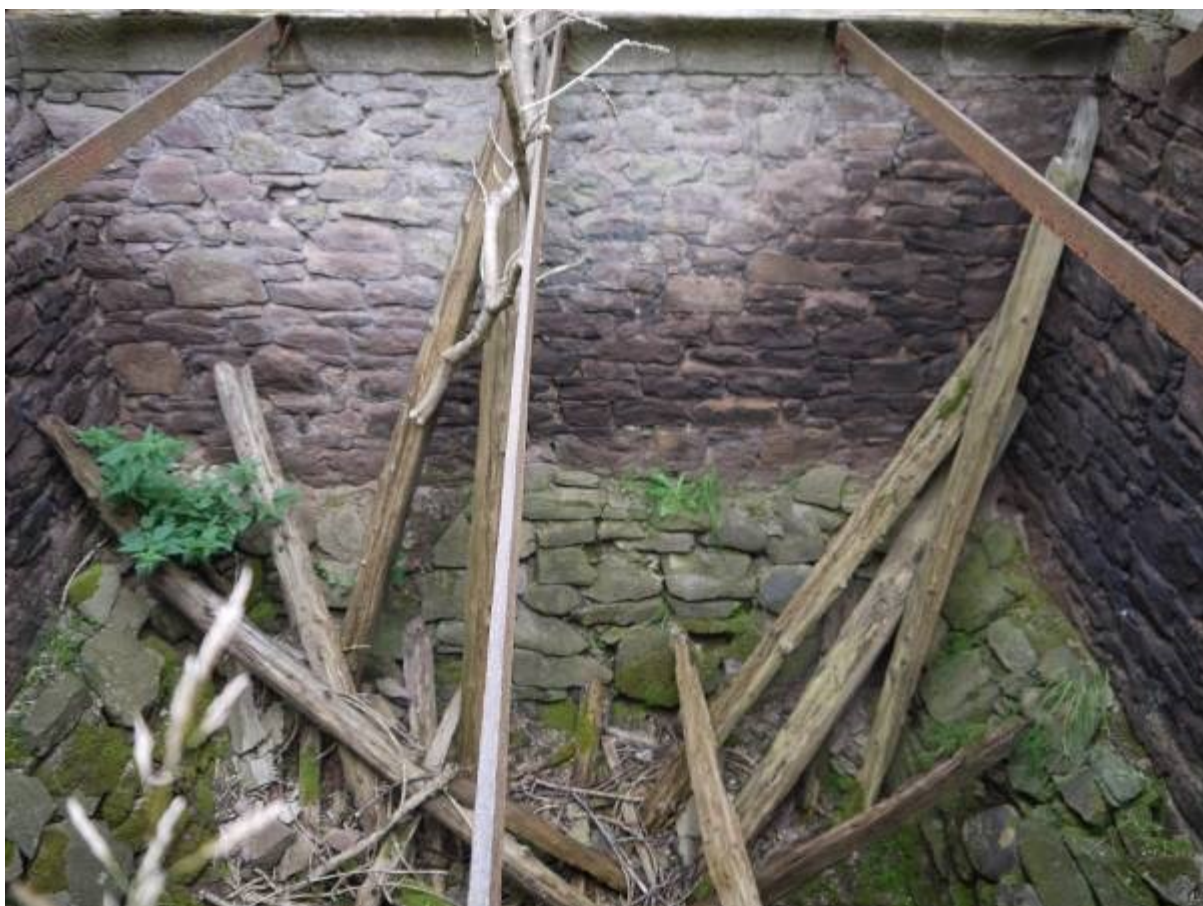
This building has no obvious means of access and at ground floor level is occupied by the base of a kiln, this is heated up from the fireplace visible in the Northern interior wall of Building A. At attic floor level three narrow iron 'planks' run through the Eastern and Western walls and are chocked in place on the external Eastern side, the chocks are missing on the external Western side. Some of the attic floor planks still survive in situ the rest have fallen down onto the top of the kiln. There is a line of shaped sandstone blocks visible at attic floor level in the inside faces of the walls. A door in the Southern wall allows access to the 'attic' floor level of Building A. The wooden chute starts at attic floor level in this building and leads into Building A.

Illustration 23 Drying Oven/Kiln at ground floor level in Building B looking East

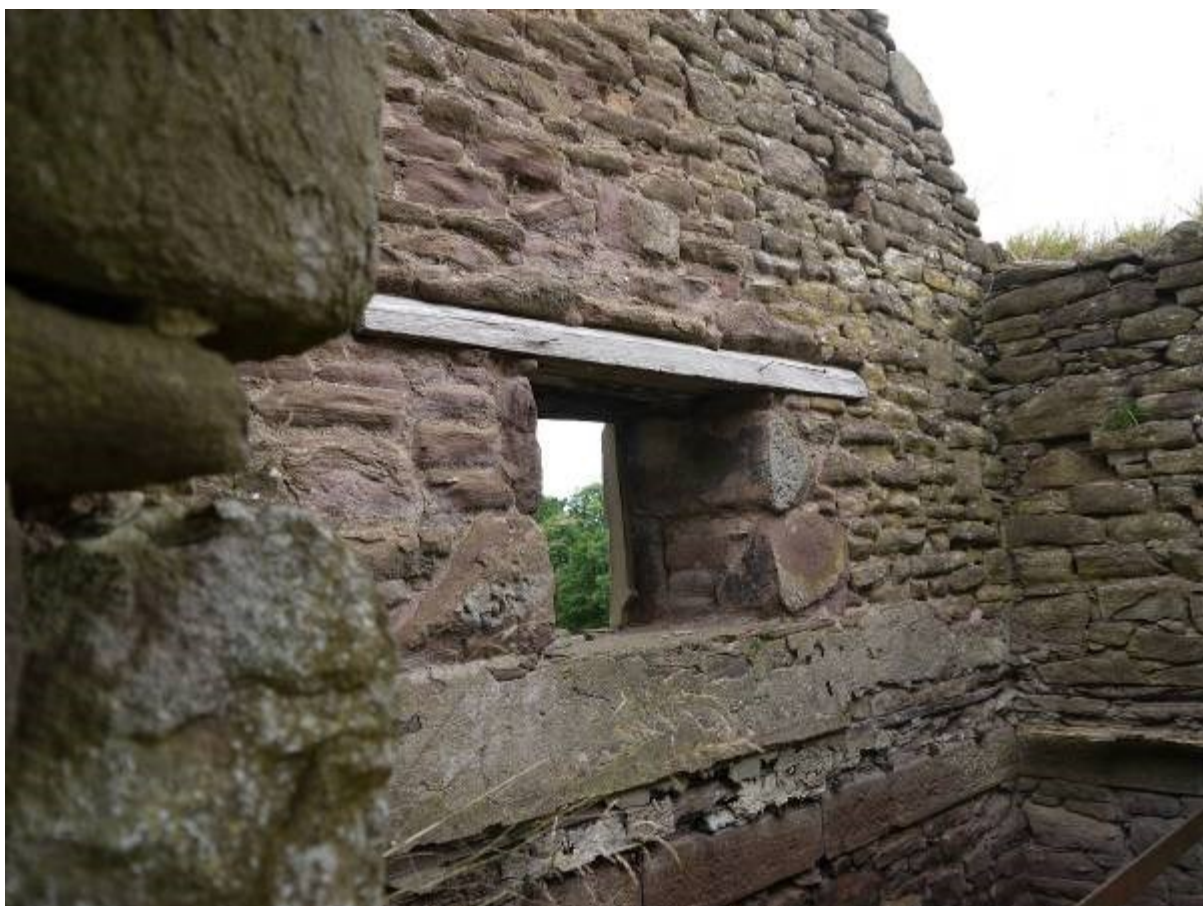
Illustration 24 Top of internal Southern elevation of Building B showing internal wooden lintel in window, remains of attic floor level just visible

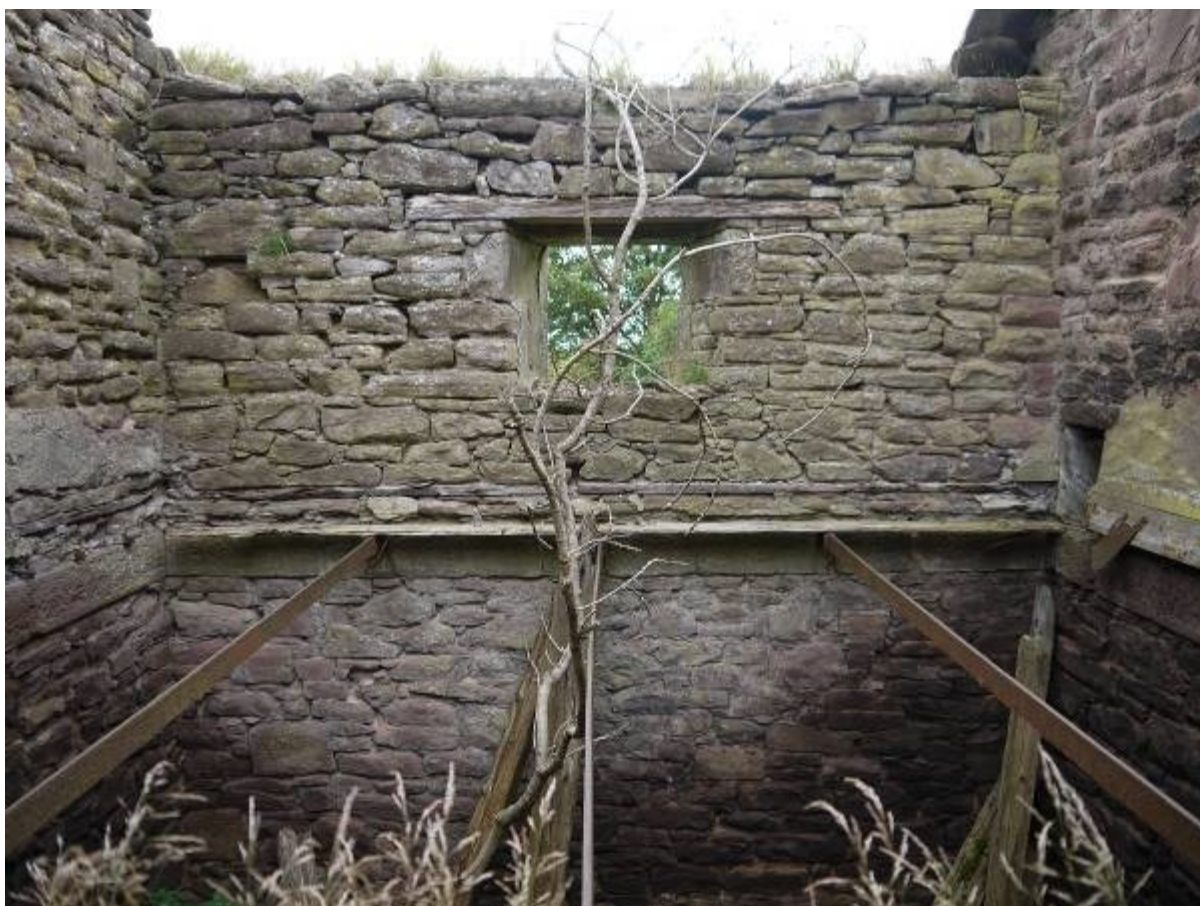
Illustration 25 Top of internal Western elevation of Building B showing window with wooden lintel and collapsed wooden attic floor with metal supports, entrance to grain chute visible to right

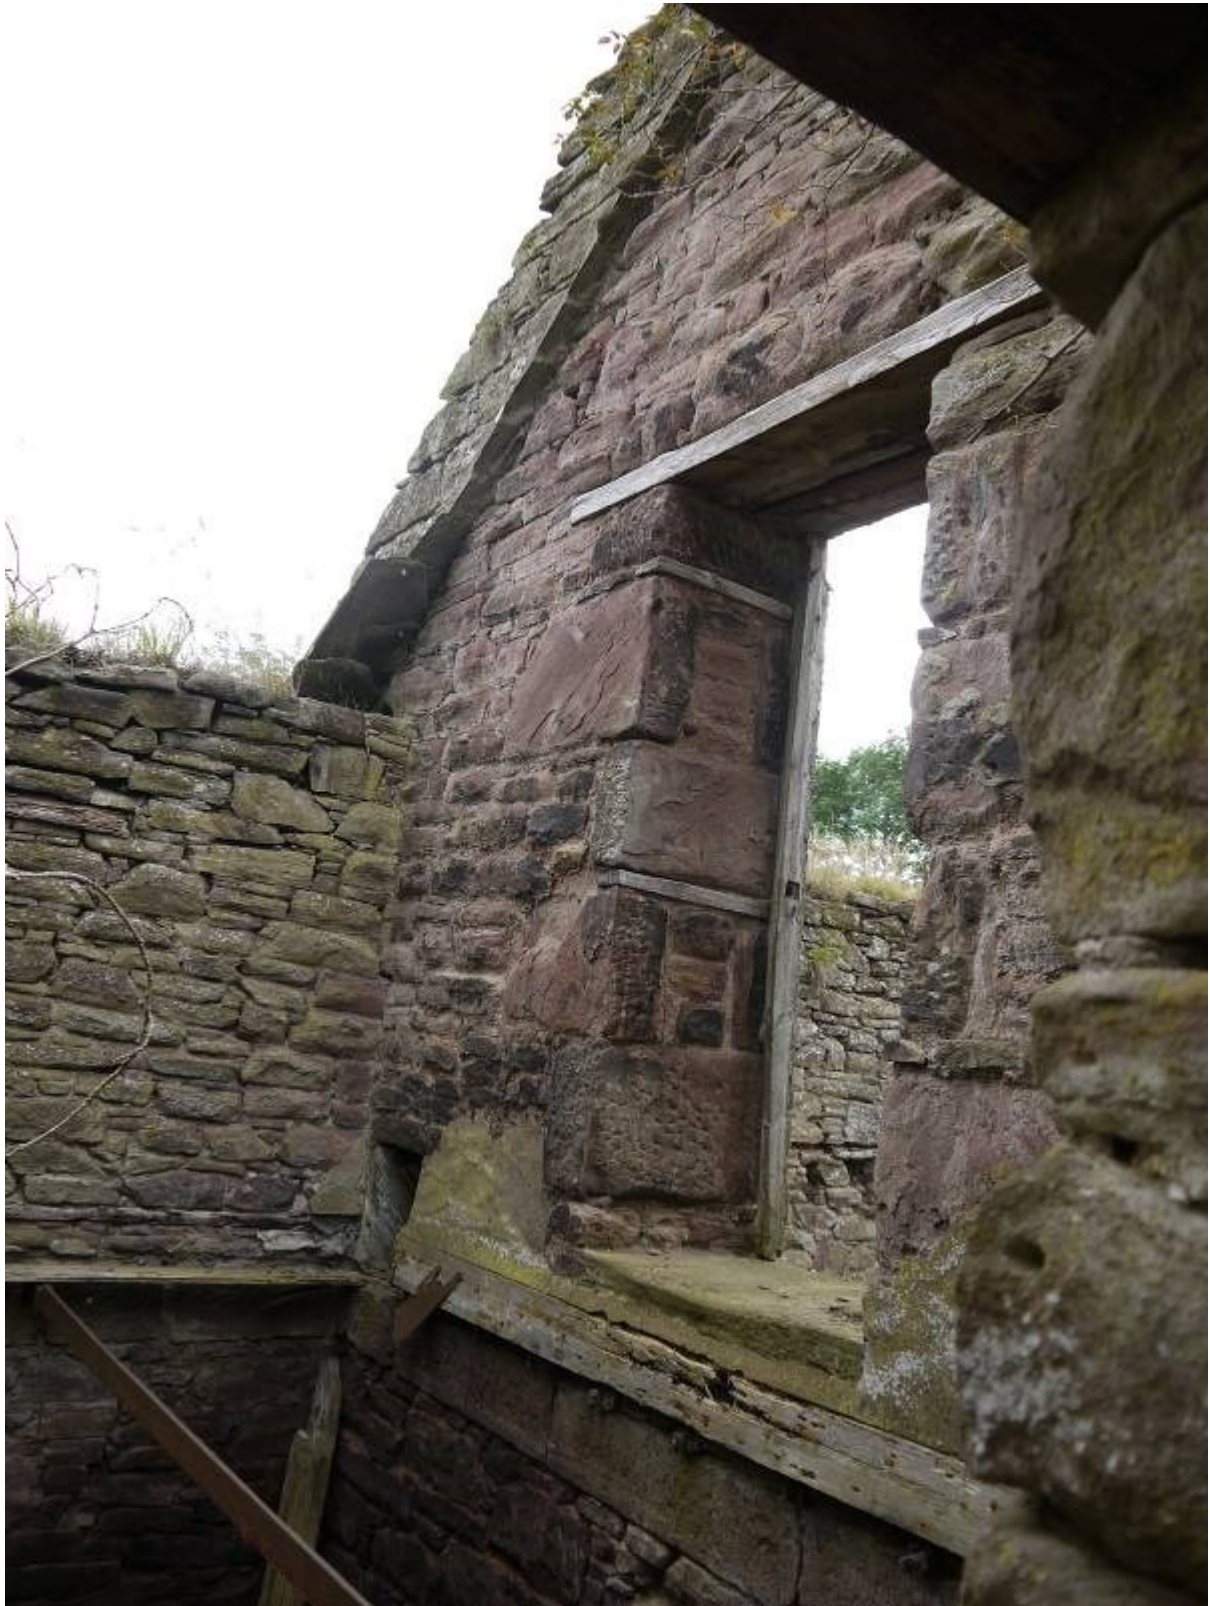
Illustration 26 Top of internal Northern elevation of Building B showing door access into attic floor level of Building A, remains of collapsed attic floor and entrance to grain chute.

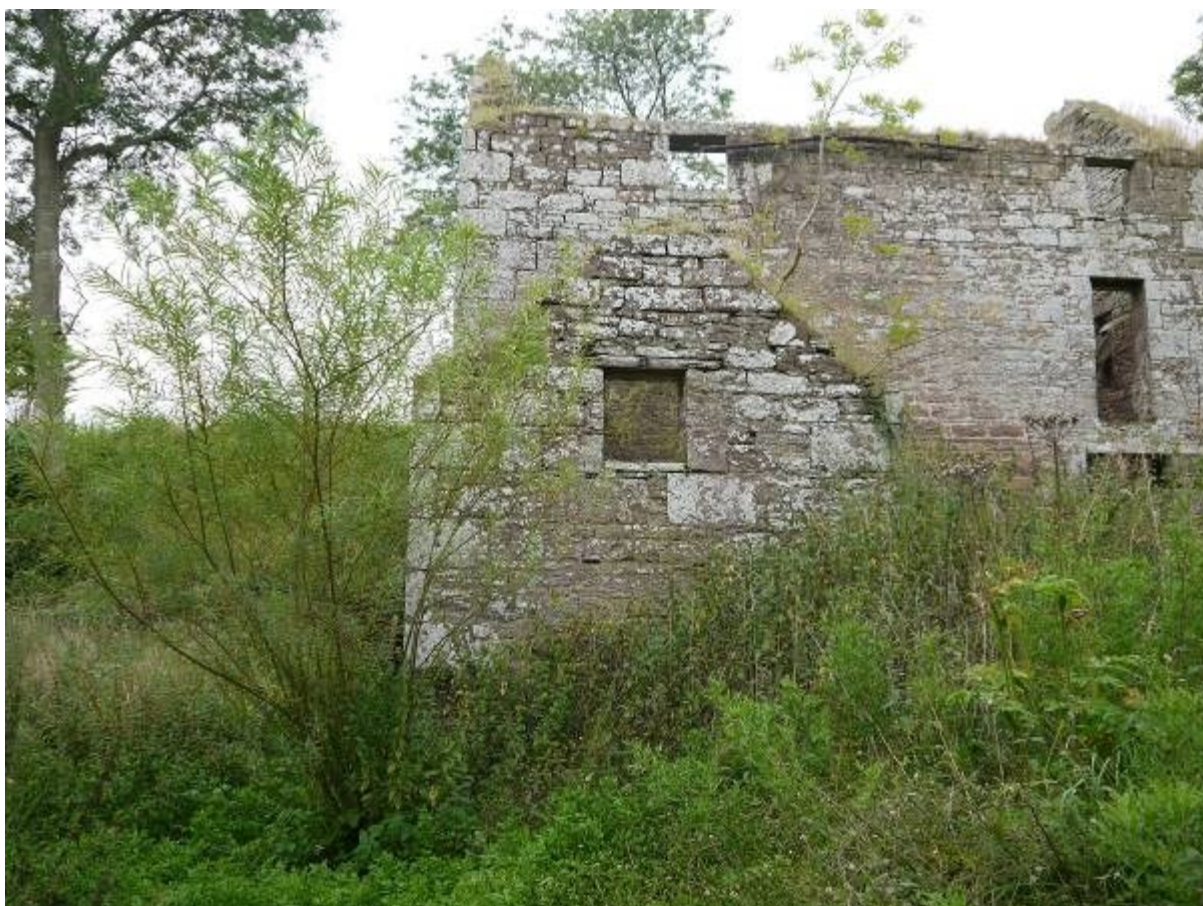
Illustration 27 Eastern gable elevation of Building C looking West

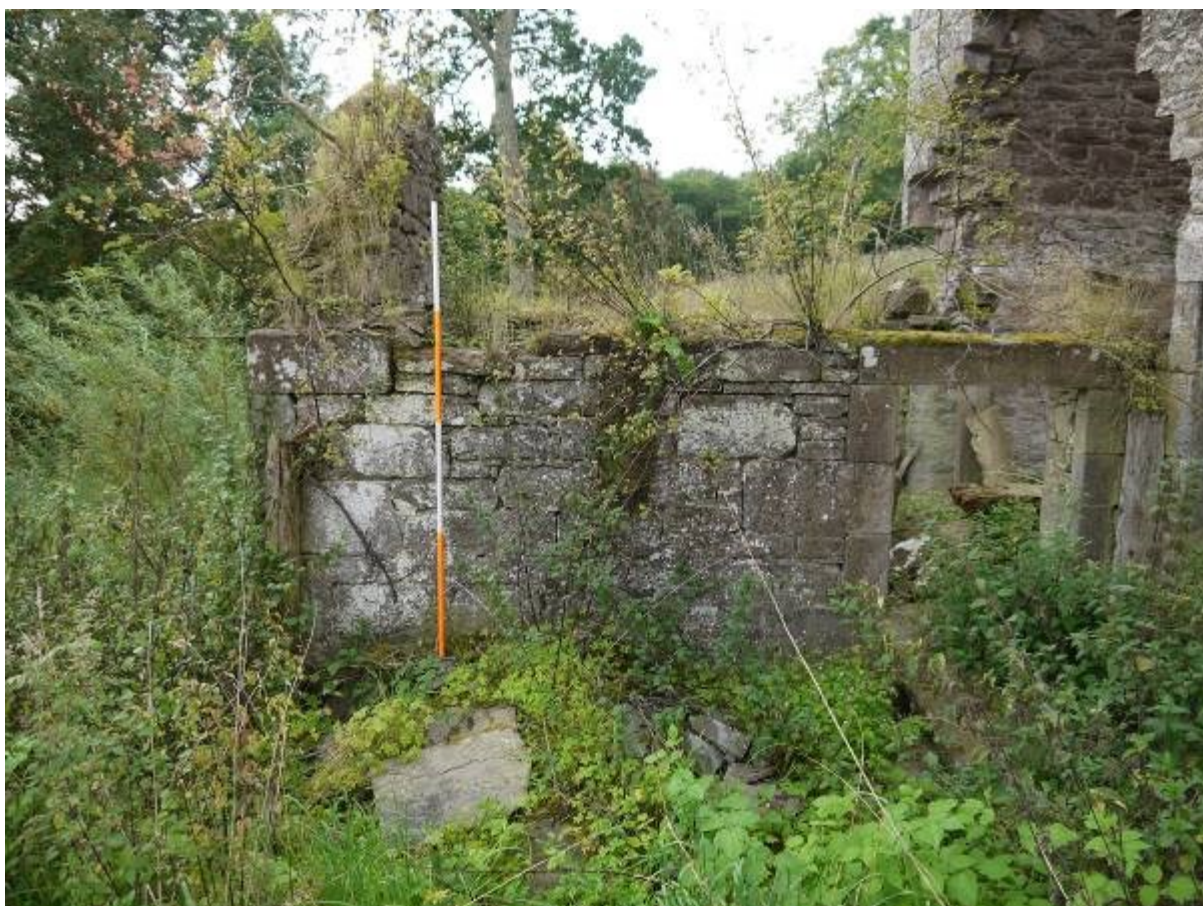
Illustration 28 Northern elevation of Building C looking South

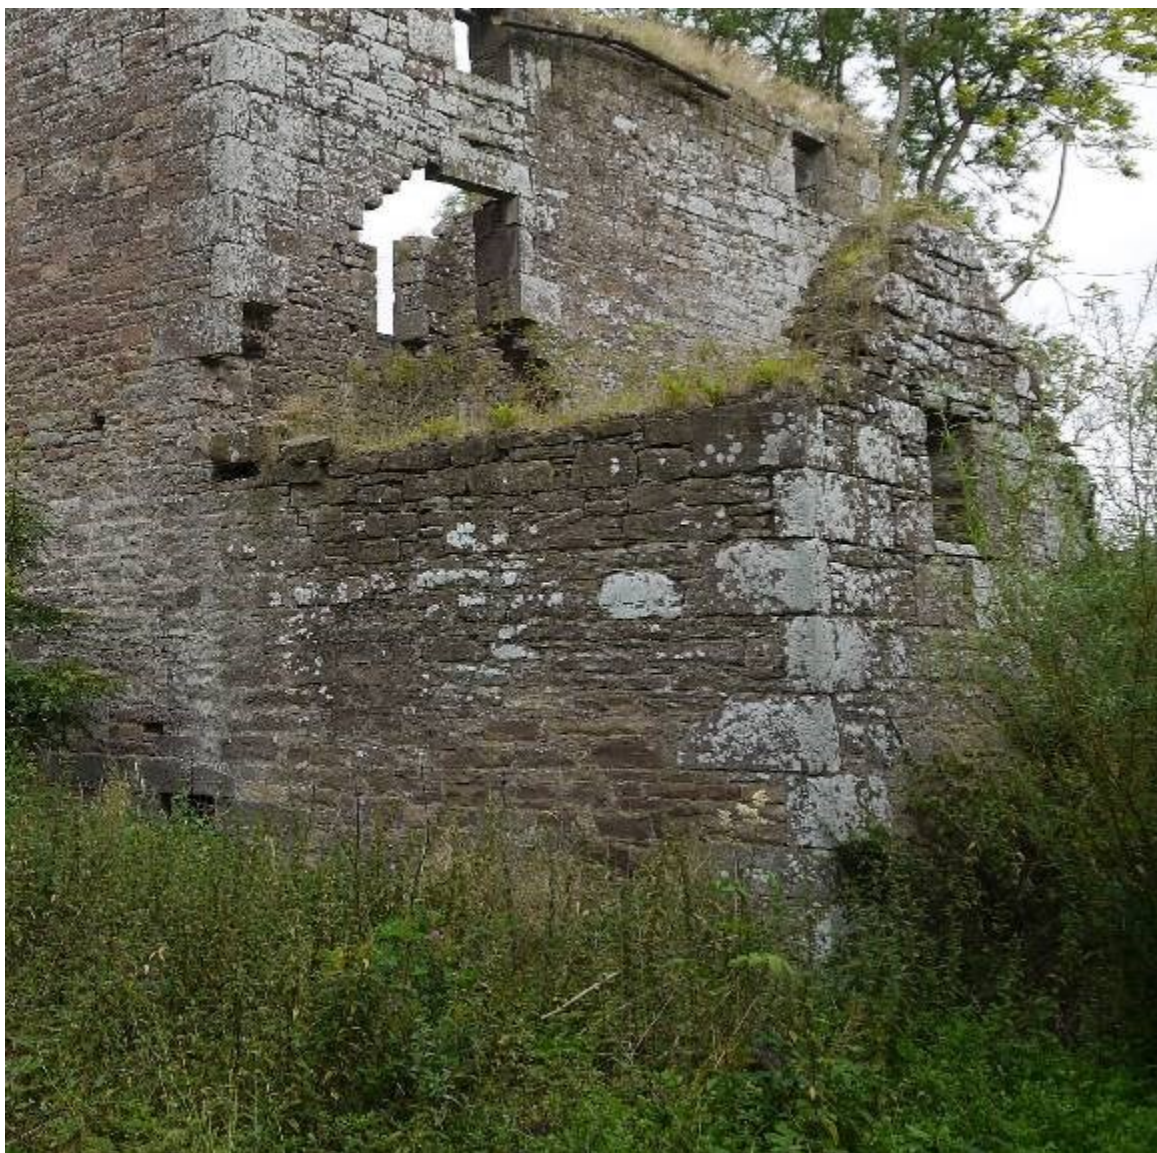
Illustration 29 Southern elevation of Building C looking North West

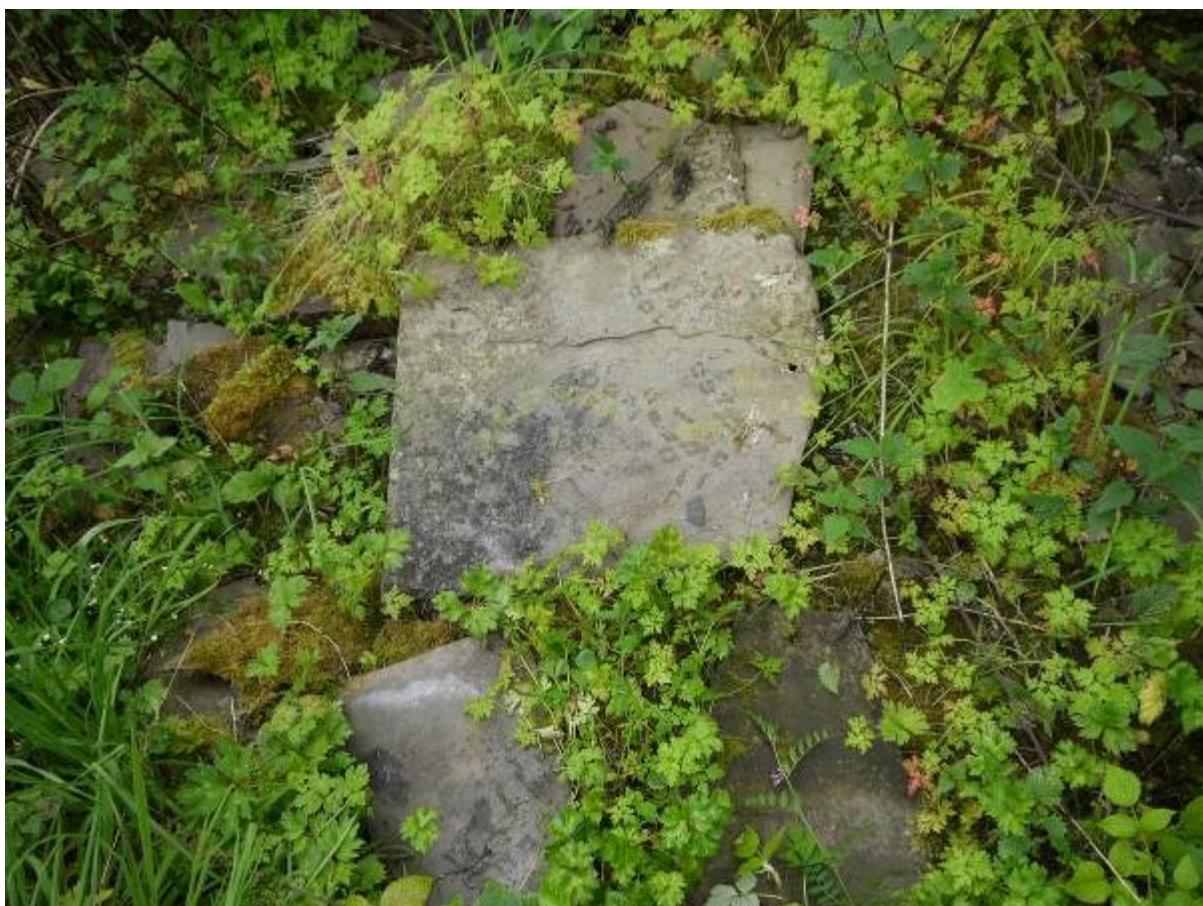
This single storey structure is butted against the outer face of Building A at its Southern end. It is open ended at its Western end and is full of rubble, there is no floor level visible. There is a pile of large roof slates dumped on its Northern side.

Illustration 30 Pile of large roof slates visible on North side of Building C
