Further Standing Building Survey
45, 47 and 49G High Street,
Brechtin, Angus

Interior of first floor level 49G High Street following the removal of panelling and party walls

14th December 2011

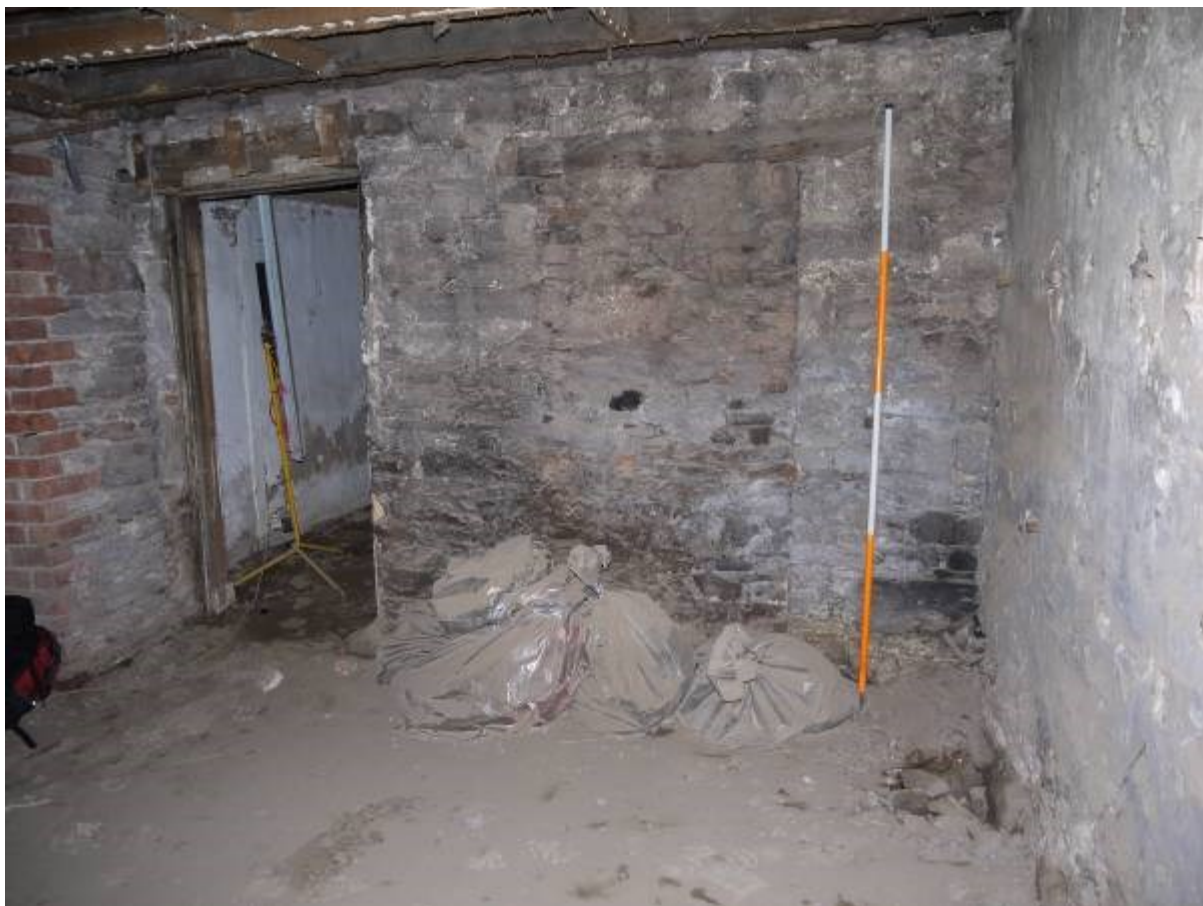
Following the removal of the wooden panelling from the face of this internal elevation a blocked doorway was revealed to the South of the existing doorway. This blocked door had a wooden lintel and was filled with a mixture of mortared small and flat stones.

Illustration 5 Blocked doorway with wooden lintel at ground floor level of 47 High Street

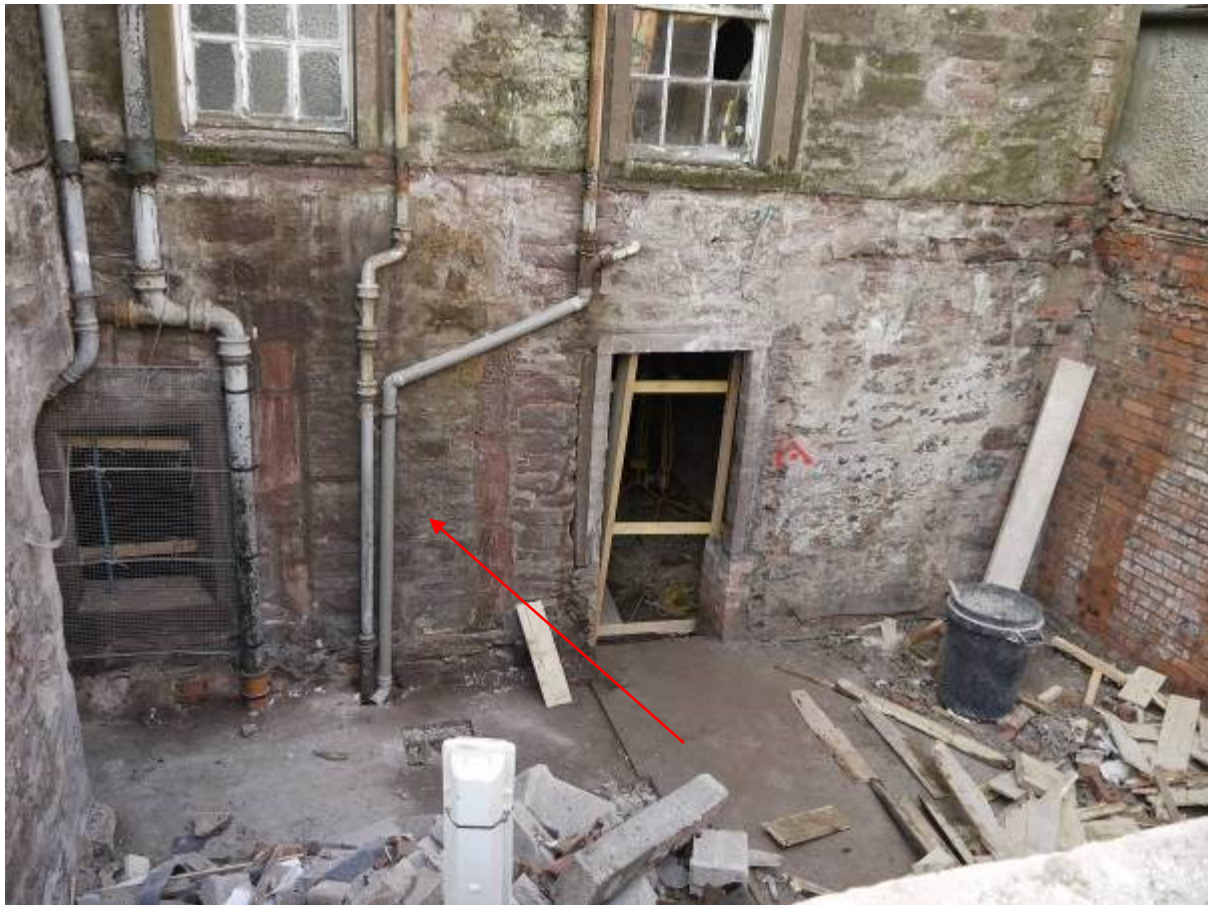
Following the demolition of the low level extension to the rear of the buildings it was possible to get a better view of the blocked doorway that had already been identified by the author as part of the first survey.

Illustration 6 Eastern rear elevation of 45, 47 and 49G High Street following demolition of extension, blocked former doorway indicated by red arrow

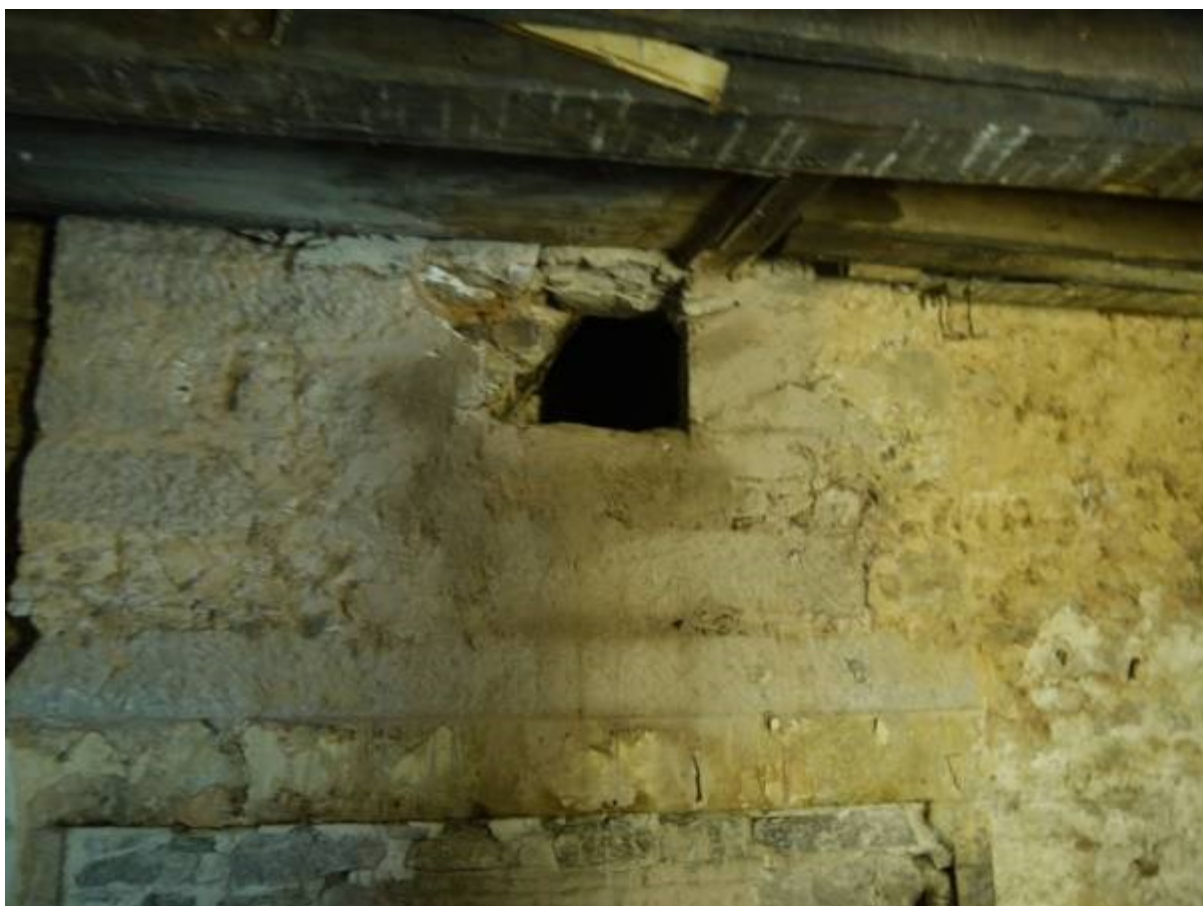
The further exposure of the fireplace in this elevation showed that it had been built in at least two phases and covered a sizeable flue that led up into the gable end.

Illustration 8 Blocked flue and chimney entrance visible above fireplace in room 1 of 49G High Street

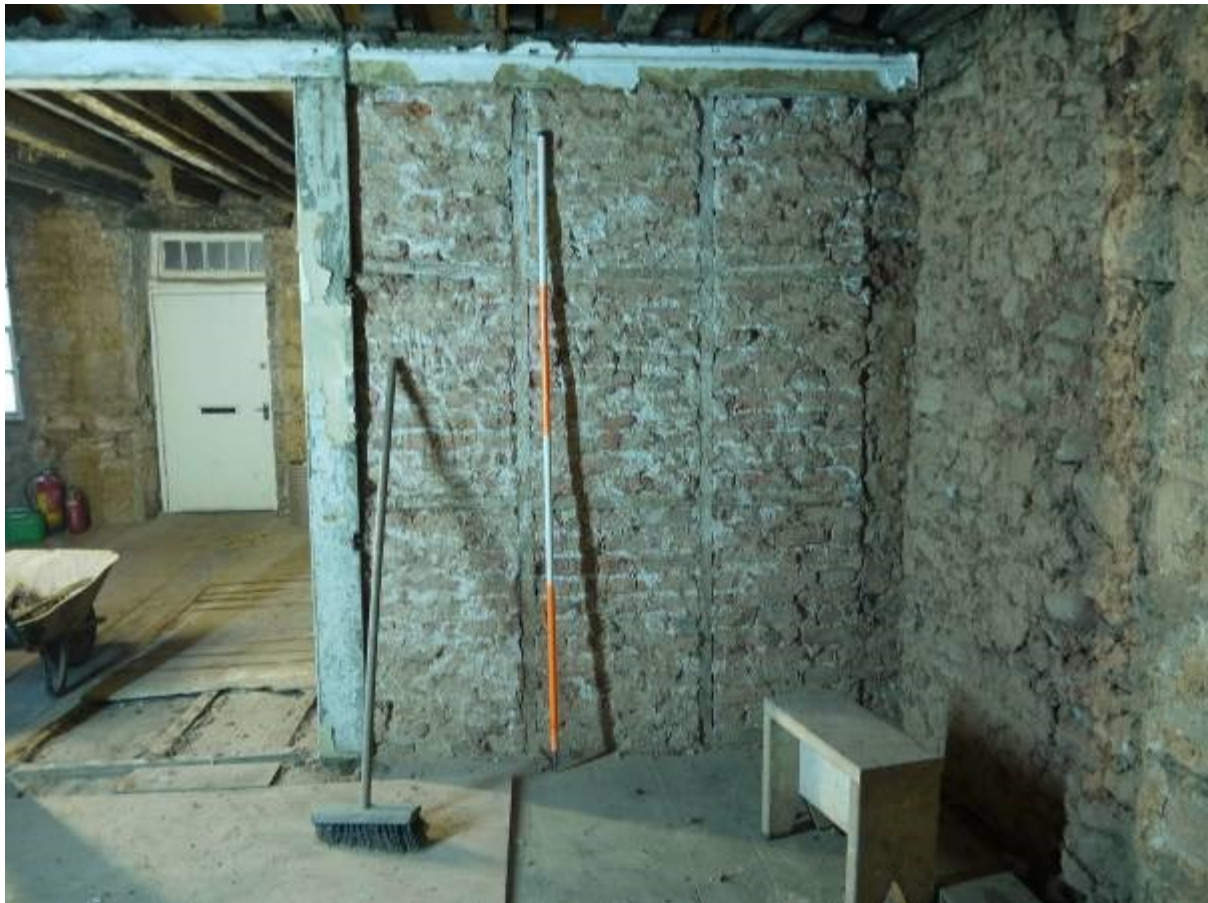
The removal of the wall coverings from the Eastern and Southern elevations of this room revealed that both walls were built of small handmade red bricks which were inserted into timber framed panels.

Illustration 10 Timber framed wall built of hand-made clay bricks between Rooms 1 and 3, blocked doorway also visible to right of wooden stool

Following the recording of the structural elements revealed after the removal of the panelling and wall coverings on the ground and first floors of these buildings the author feels that no further archaeological work needs to take place as part of this redevelopment. Some consideration should be given to submitting several of the hand-made bricks from Room 1 for chemical analysis in an attempt to identify their source.

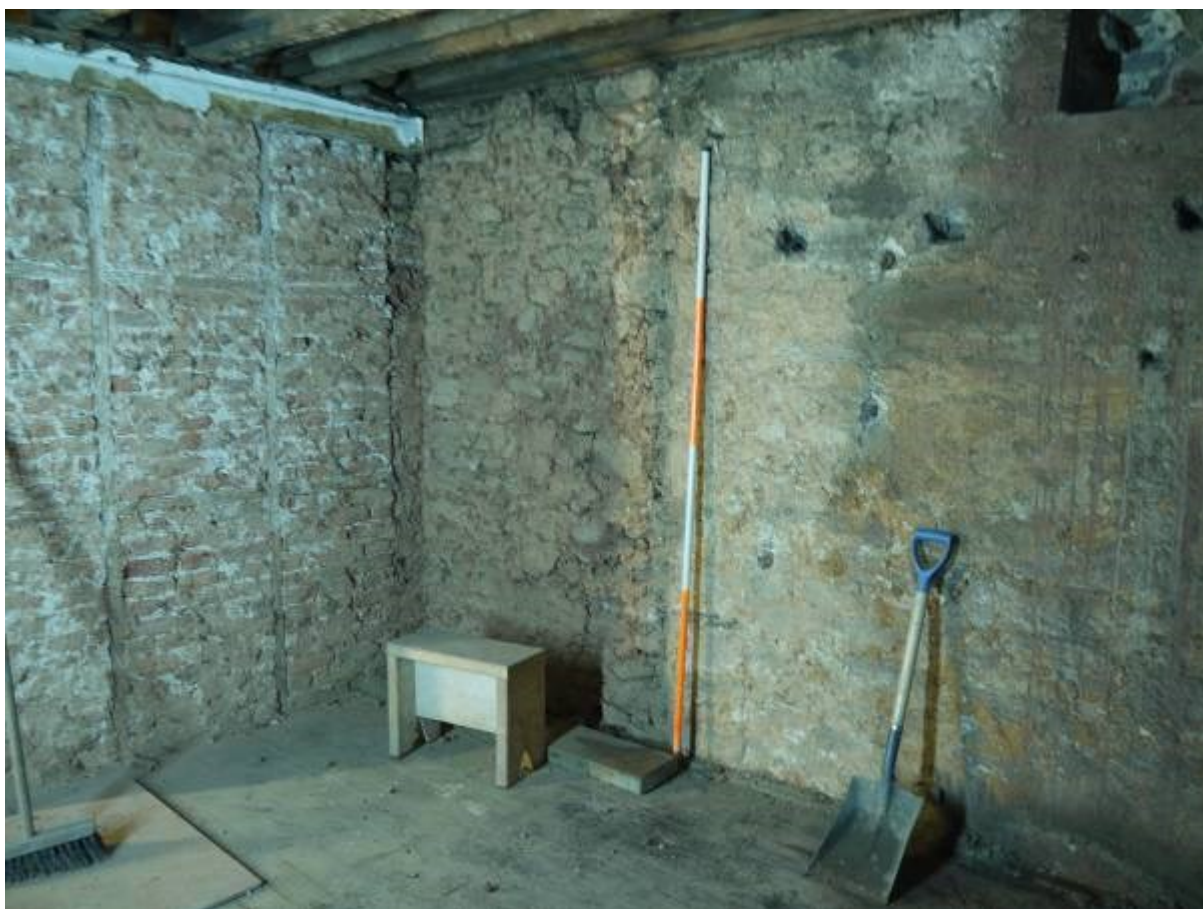
A blocked doorway is visible in this elevation which is partly covered by the timber framed Eastern elevation of Room 1. This doorway has a narrow stone lintel and has been filled in with clay and stones in a similar a manner to the blocked doors in rooms 4 and 5.

Illustration 11 Blocked doorway in Northern elevation of Room 3 49G High Street

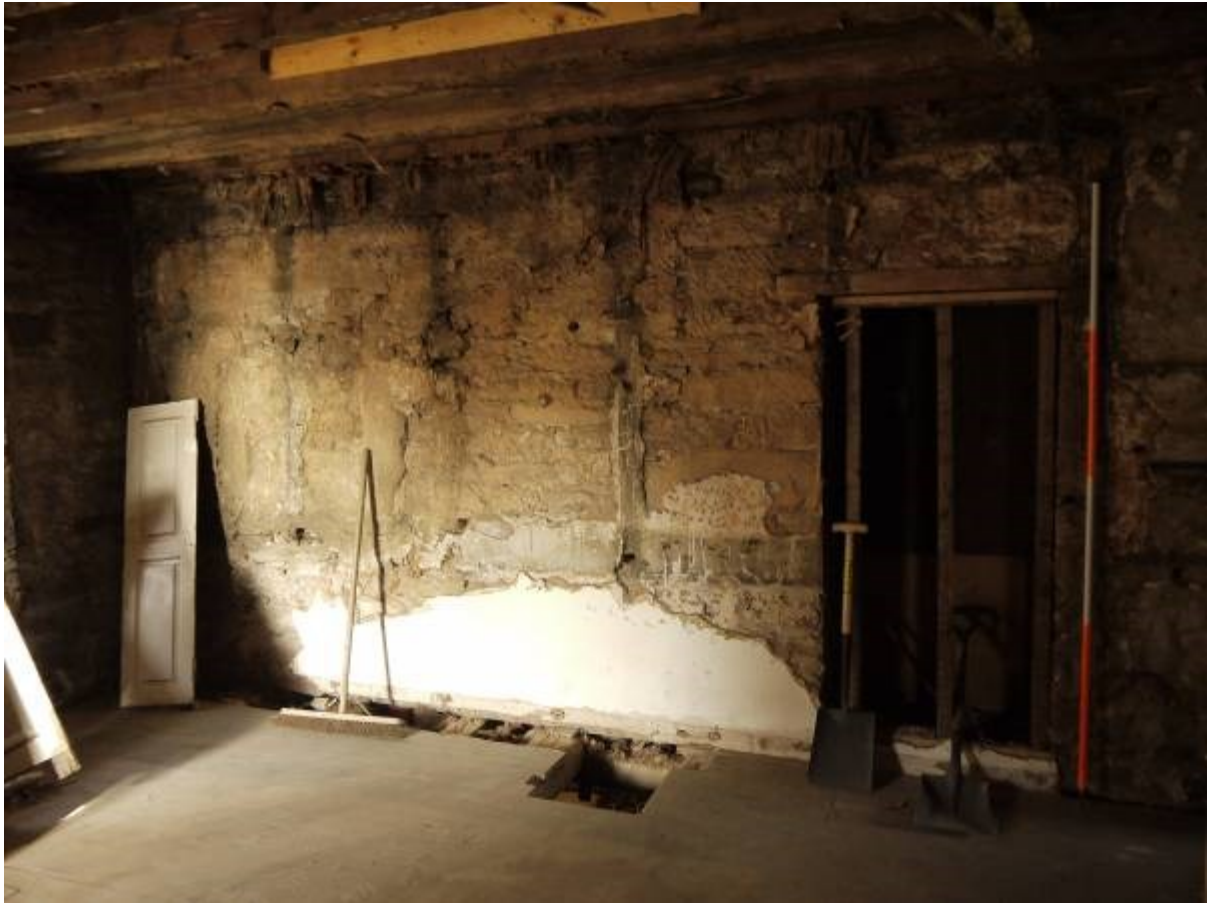
This elevation contains a slightly narrower blocked doorway at its Eastern end and there is a small blocked window on the Western side of this doorway.

The location of further blocked doorways and a single blocked window at first floor level in 49G High Street have further added to the complicated sequence of historic building events on this part of the High Street. The blocked doorway in the Southern elevation of Room 3 presumably leads out into the covered pend that has access to the High Street via a set of stairs and the blocked doorway in the Northern elevation of Rooms 1 and 3 must lead into the neighbouring United Presbyterian church although this must have gone out of use when the subdividing timber laced brick walls were built against it.

Illustration 12 Blocked doorway partially opened up, blocked window behind broom leaning against wall Southern elevation of Room 3

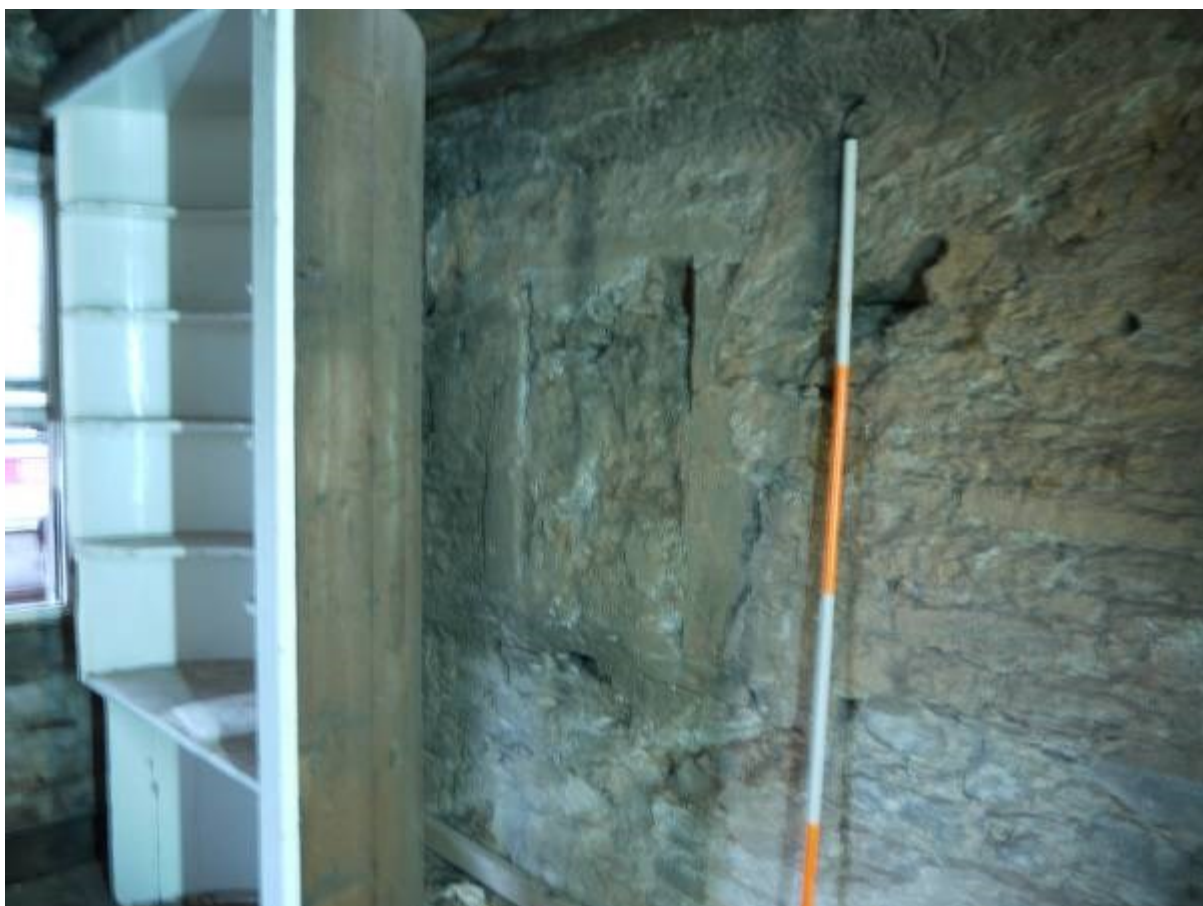
It is harder to interpret the blocked window in the Southern elevation of Room 3 as this would seem to imply that this wall was formerly an external face to the building. The erection of the United Presbyterian church to the South sometime after 1847 has meant that it is now difficult to interpret the phasing of the construction of the buildings that stood on the site previous to that. The discovery of the timber laced handmade brick internal walls in Room 1 is of interest and is a rare survival of this building technique.

Illustration 13 Blocked window in Southern elevation of Room 3

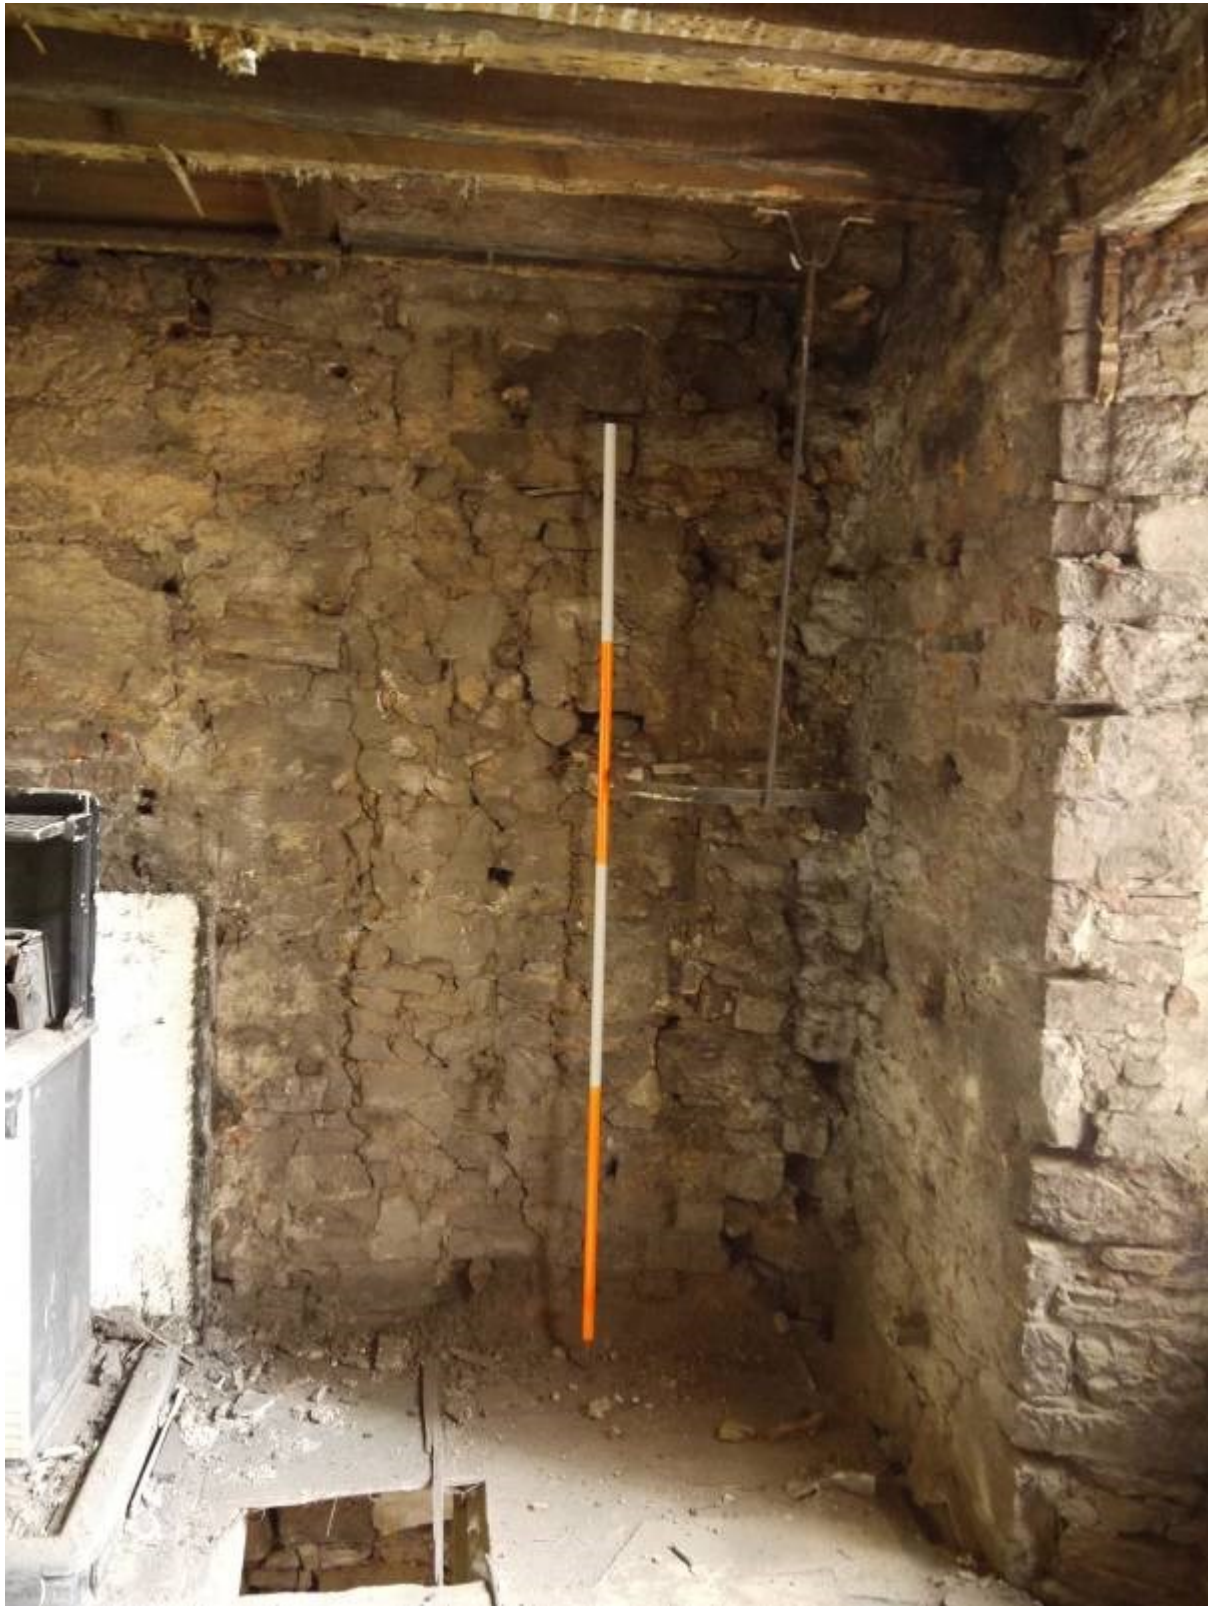
The removal of the wall coverings revealed a blocked doorway at its Eastern end that was filled with small stones and clay.

Illustration 15 Detail view of further blocked doorway in Southern elevation of Room 5 at first floor level

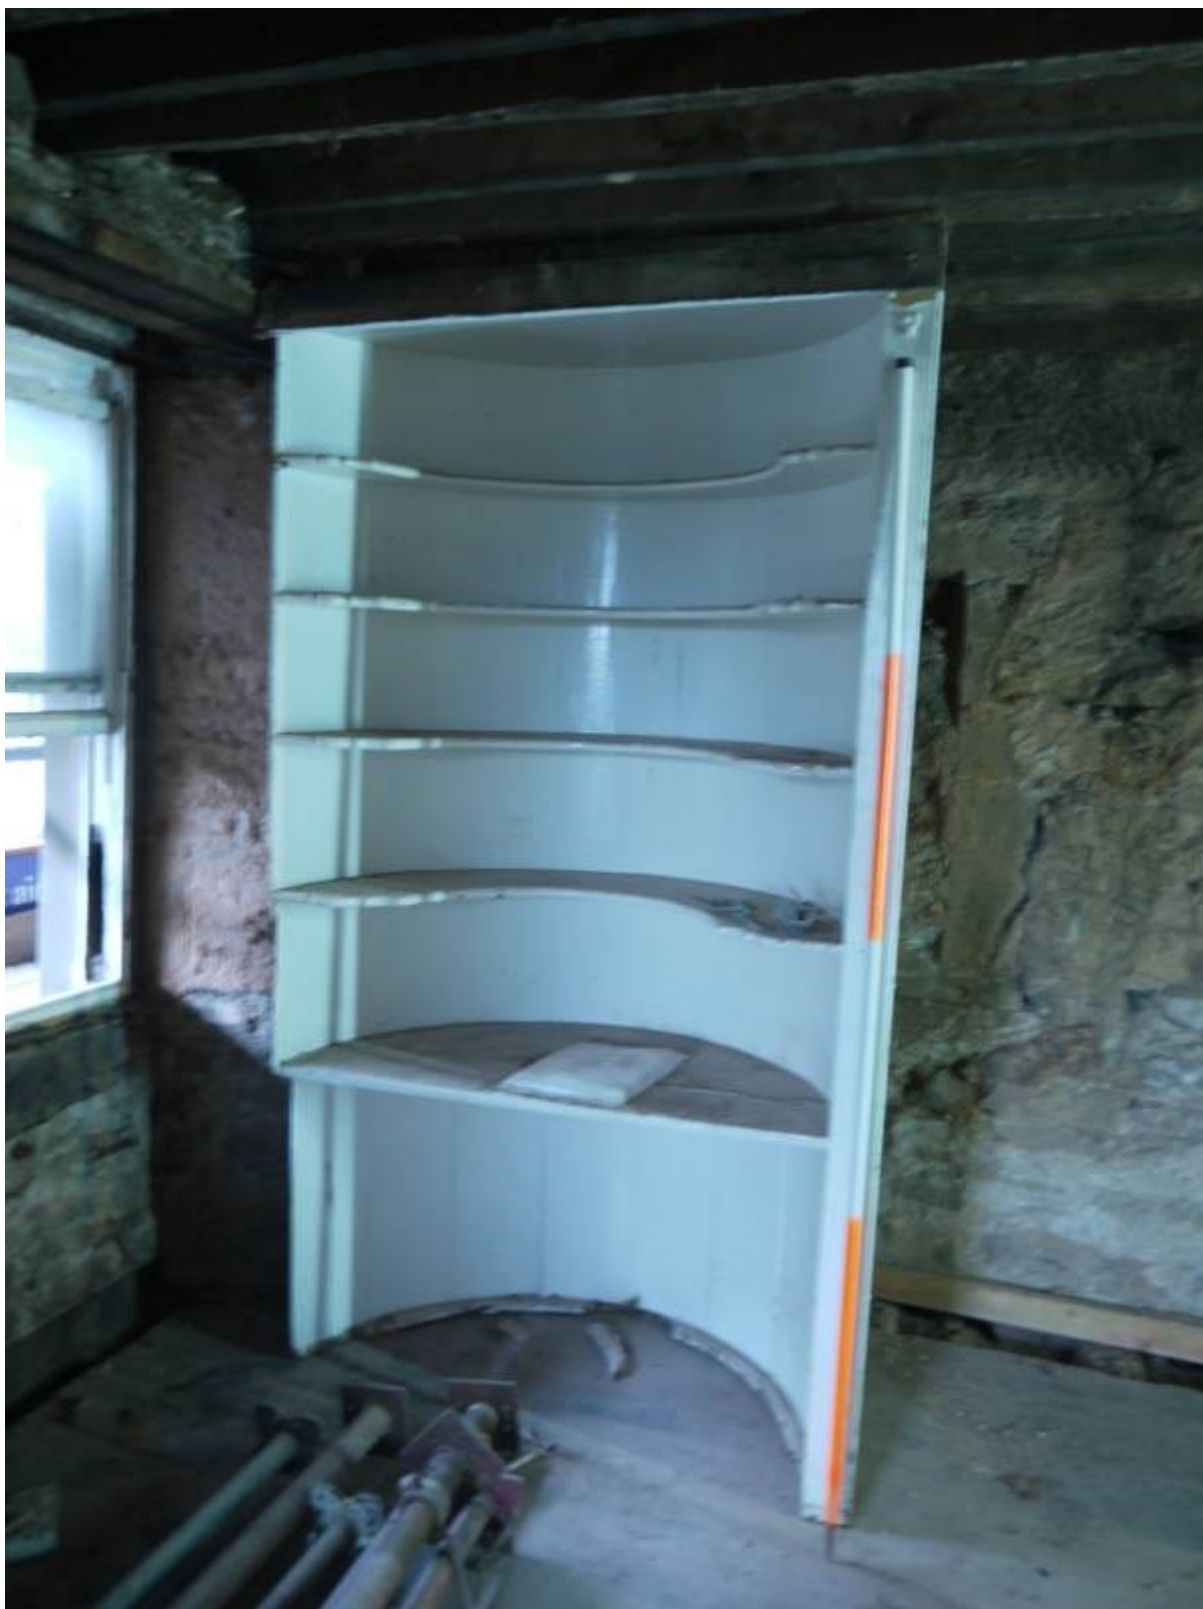
Illustration 16 Wooden shelving formerly built into Western elevation of Room 3

The piece of integrated shelving formerly built into the western elevation of Room 3 has been carefully removed for future use. Both wooden doors into the upstairs flat and former outhouse are good survivals of original furnishings and should also be retained.

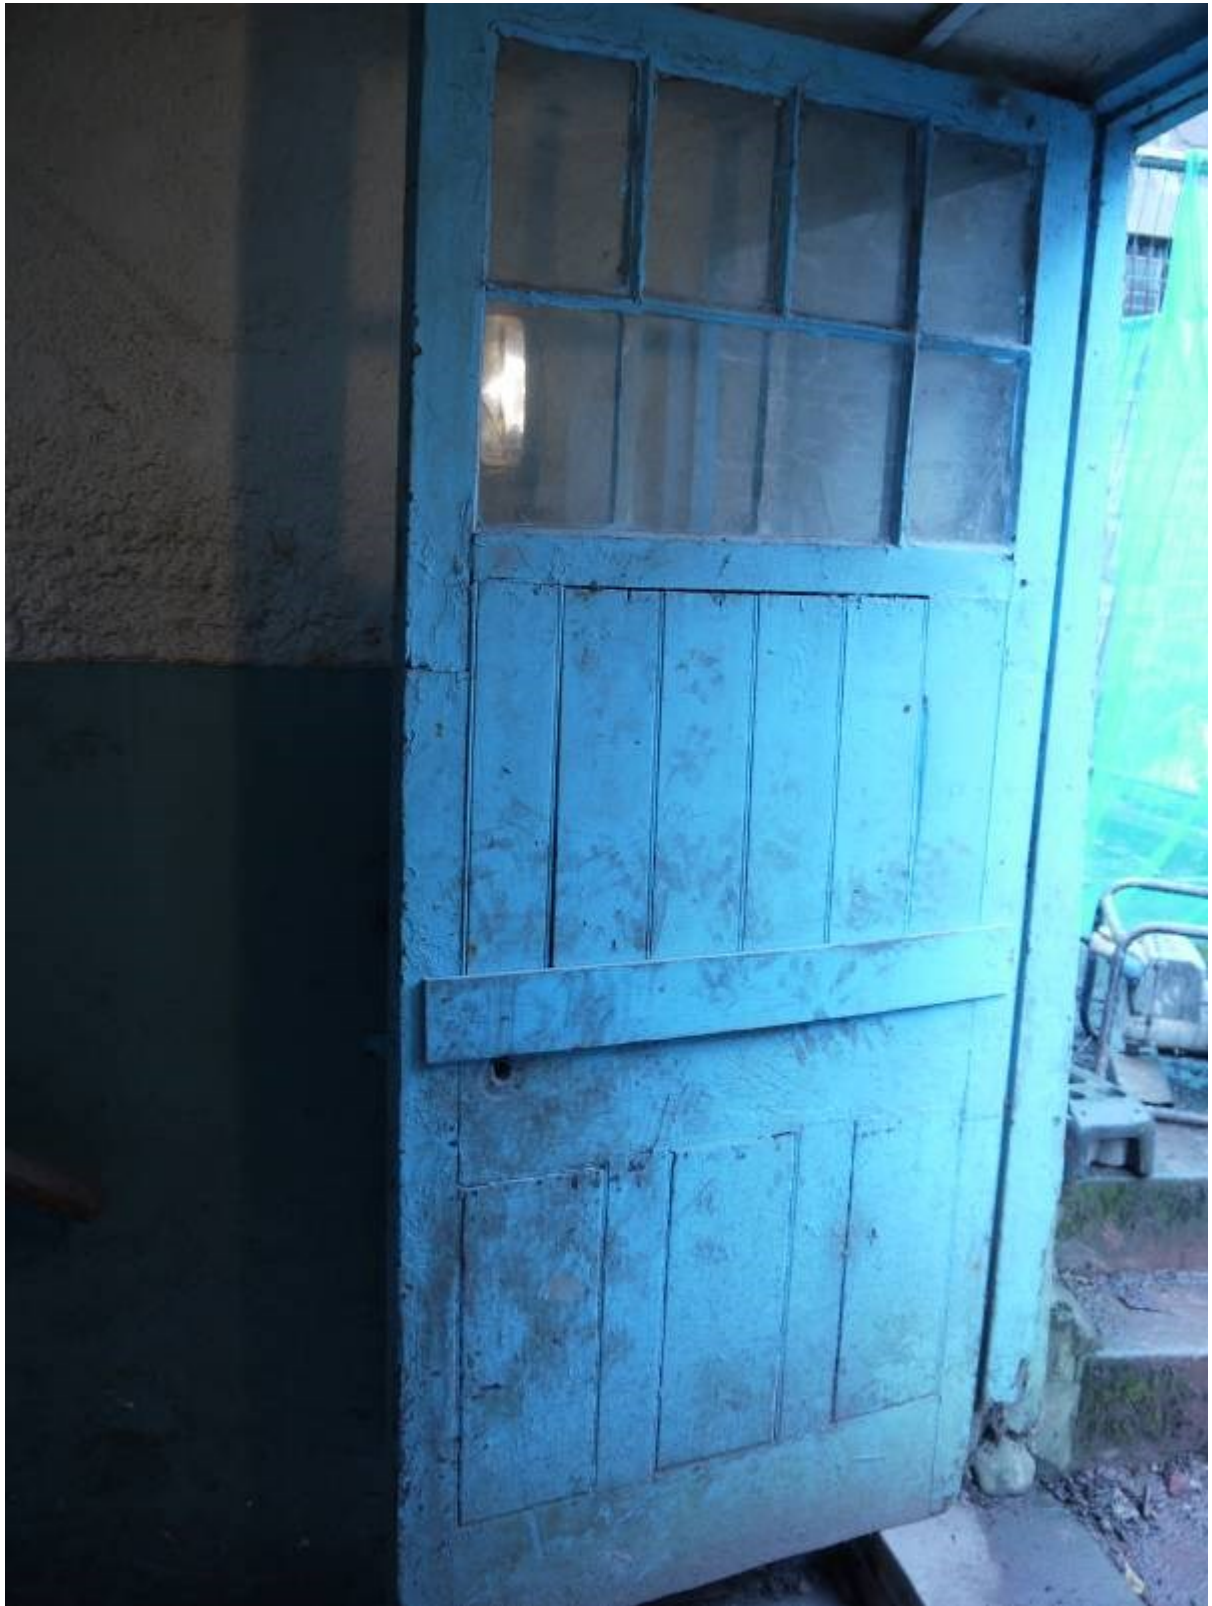
Illustration 17 Wooden door into rear entrance of 49G High Street

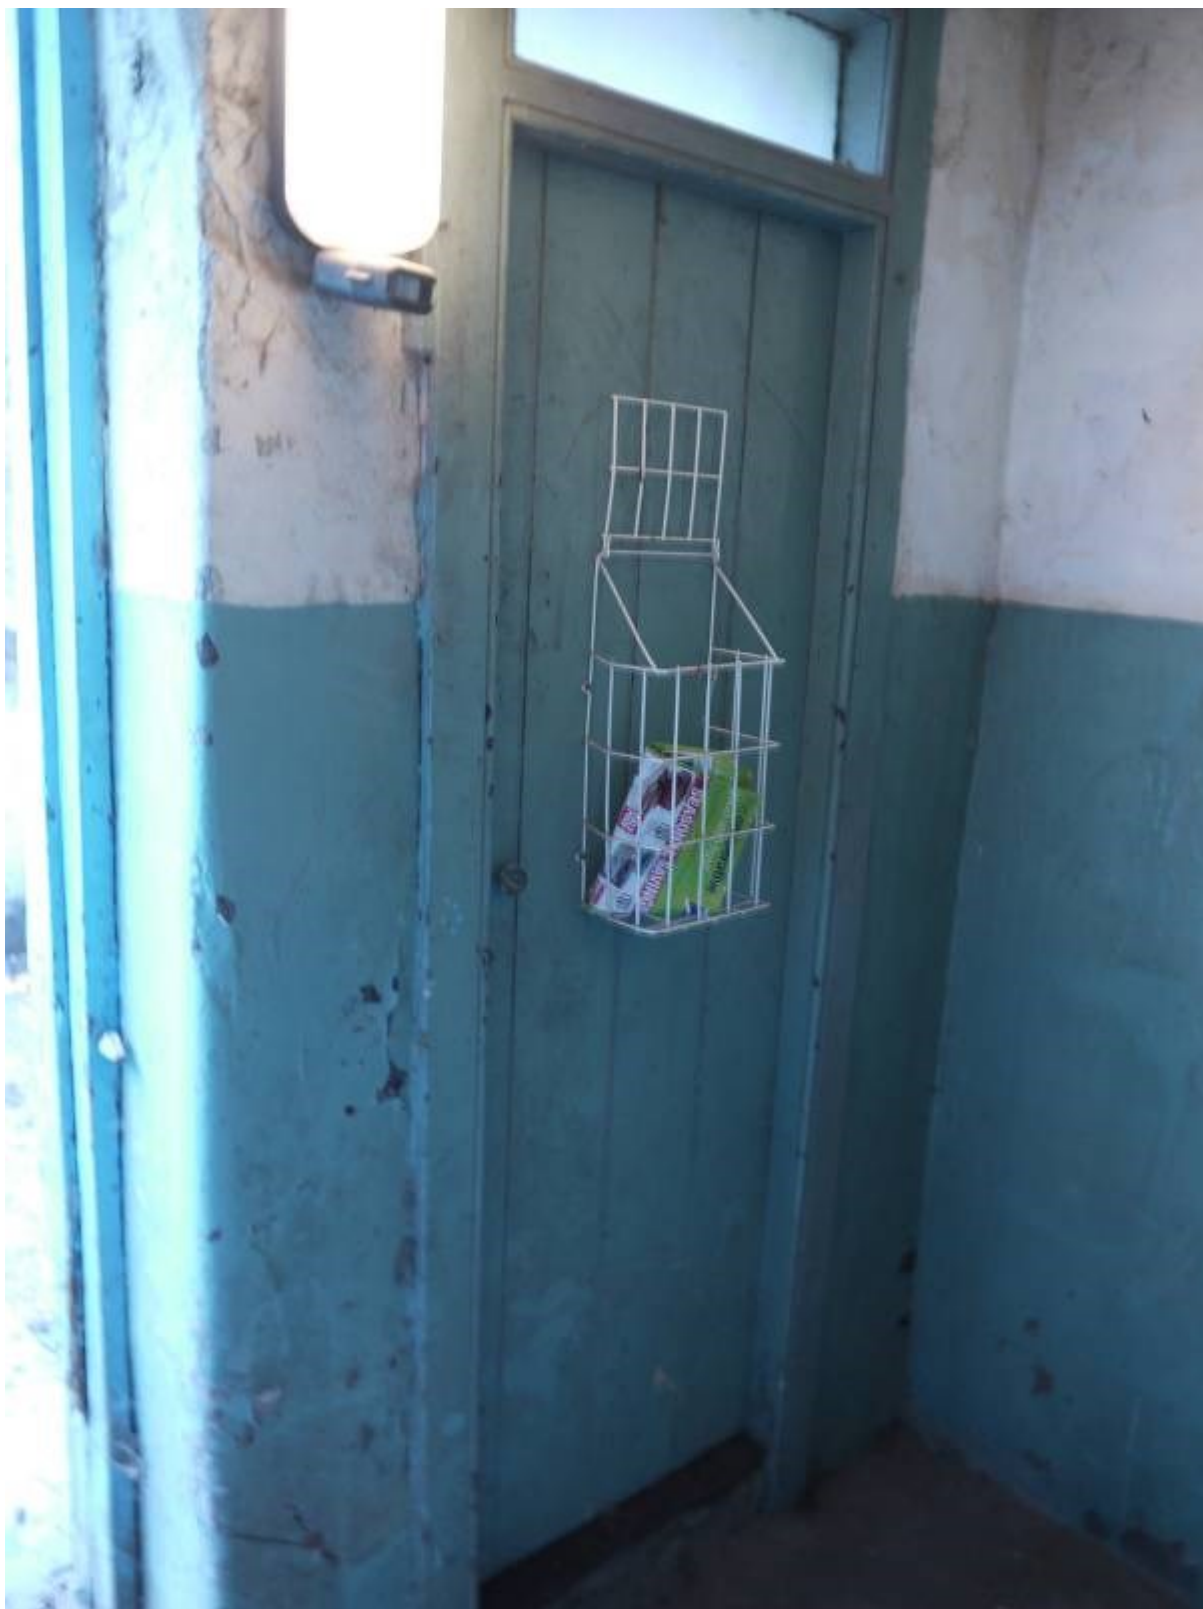
Illustration 18 Wooden door into former outhouse attached to back of buildings
