Archaeological Watching Brief

on engineers test pits

Robert Gordon's College, Schoolhill, Aberdeen

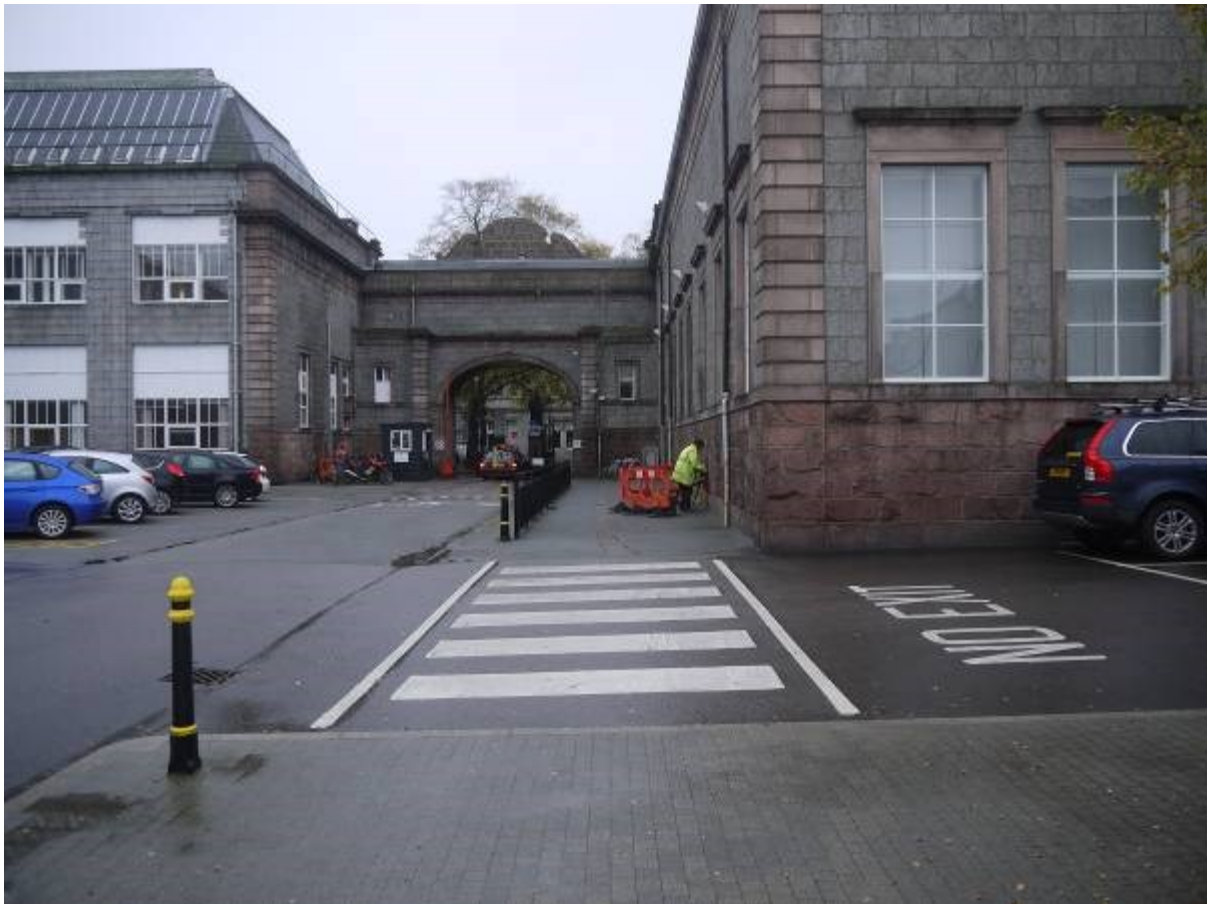
Site of Test Pit 2 looking South

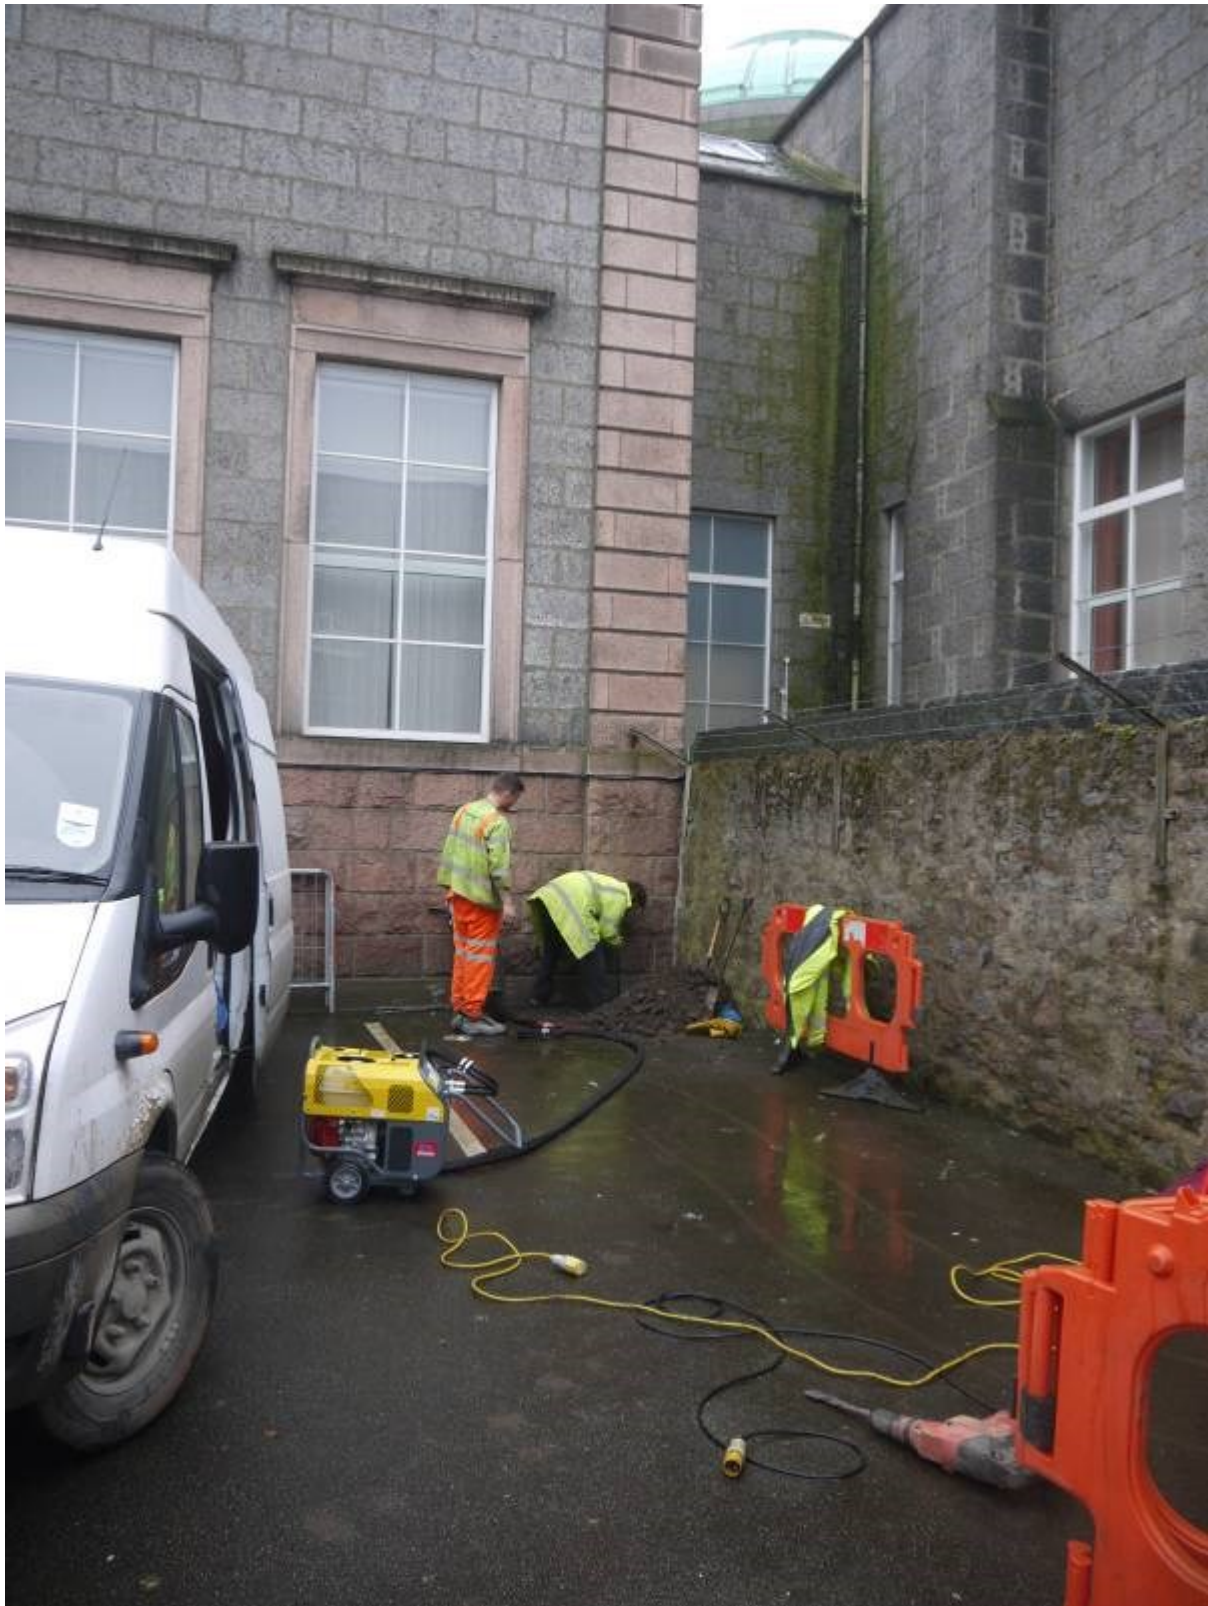
Illus 4 Test Pit 1 under excavation looking South

This test pit measured 0.50m by 0.50m and was dug in angle of the junction between the Northern wall of the Art Gallery and a property boundary wall that heads to the North. A layer of tarmac (100) 0.10m thick was removed onto a layer of concrete (101) 0.20m deep which overlay a deposit of moderate grey brown silty clay and stones with occasional fragments of broken ceramic drain and mortar flecks (102) which was encountered to the bottom of the test pit at 0.90m below current ground level. The southern wall of the Art Gallery was built of red granite blocks (103) to a depth of 0.55m where it changed to rough sandstone blocks bonded with a lime mortar (104). This different foundation continued to the base of the pit. The excavation of the test pit was halted at a depth of 0.90m when a deposit of sizeable rounded sandstones was encountered (105). These stones had lime mortar adhering to their faces. No finds were recovered from this test pit.

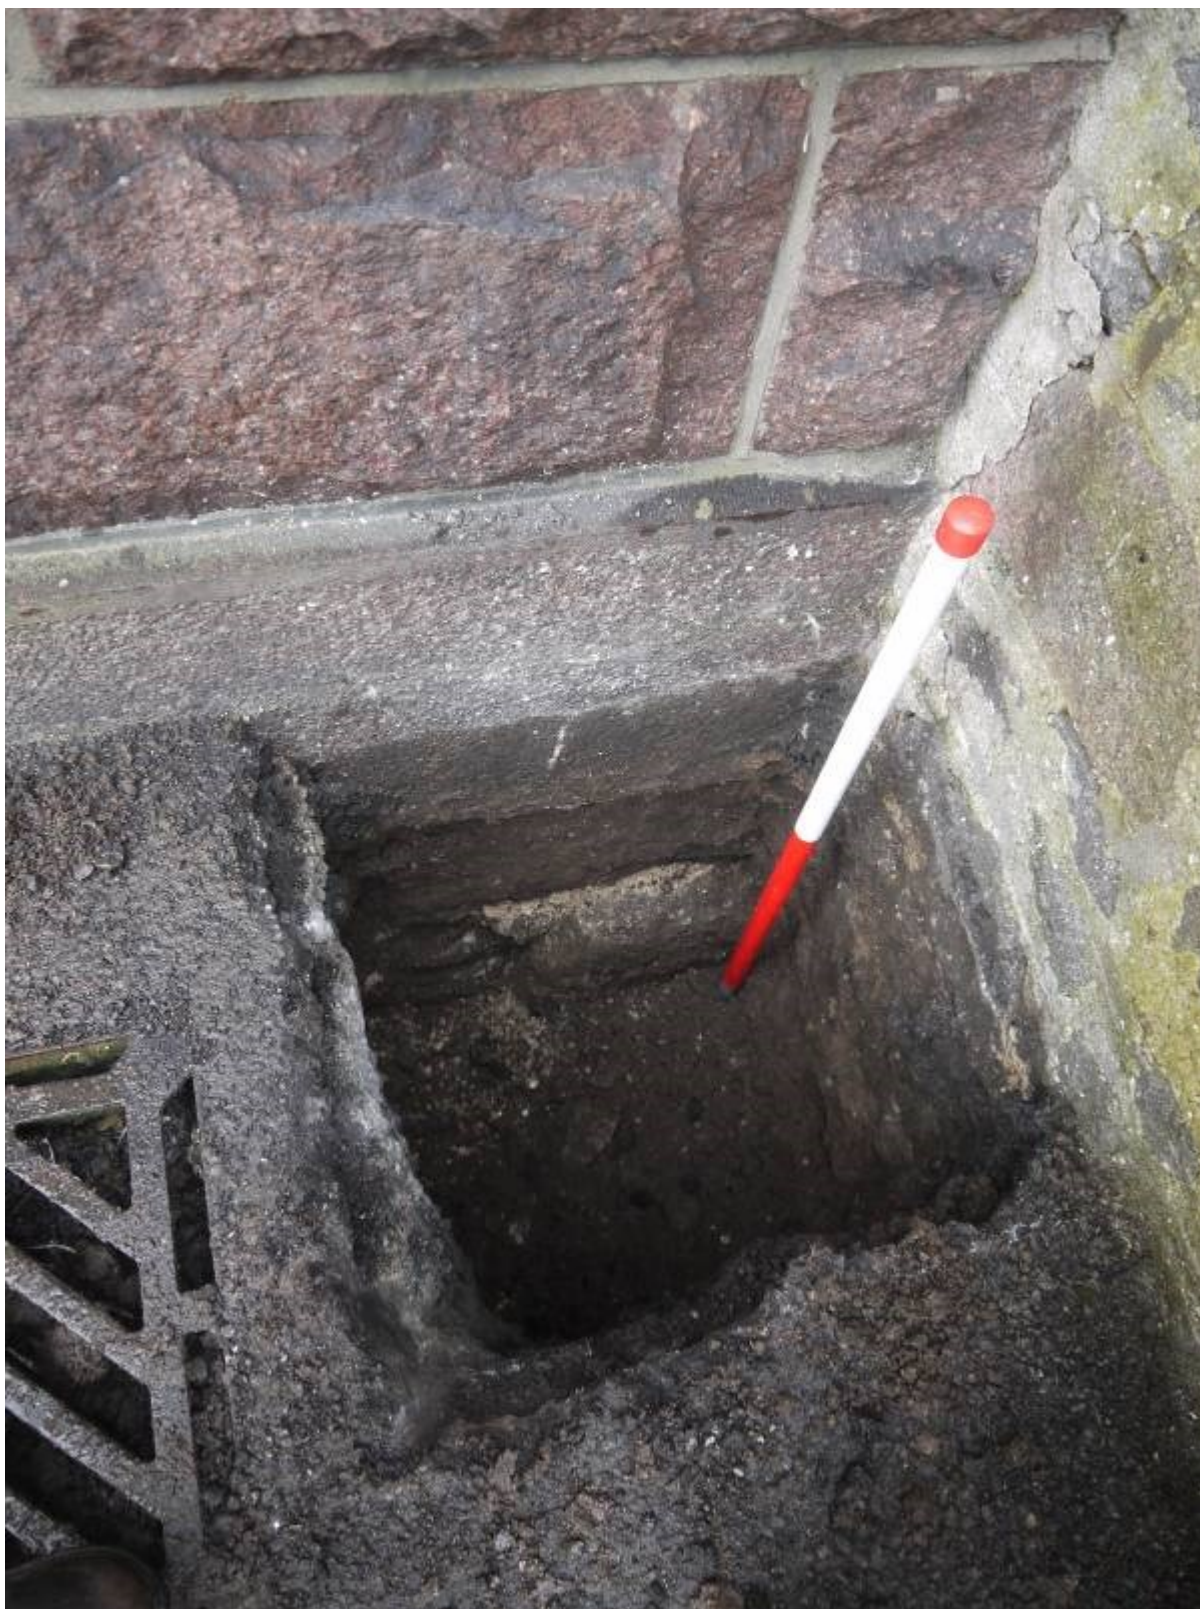
Illus 5 View of excavated Test Pit 1 showing difference in wall foundation (where lime mortar is visible to left of scale).

Both of the excavated test pits were in the fill of the foundation trenches for the eastern and northern walls of the Art Gallery but do indicate that archaeological deposits exist to a depth of at least 0.90m below current ground level. There seems to be a suggestion in Test Pit 1 that the Northern wall of the Art Gallery is built on top of a much earlier lime bonded sandstone foundation, this may relate to buildings that shown in this area prior to the construction of the Art Gallery in 1885. The back fill of the foundation trench in Test Pit 2 contained a floor tile fragment of medieval date which must originate from the Blackfriars monastery which formerly stood in the vicinity.

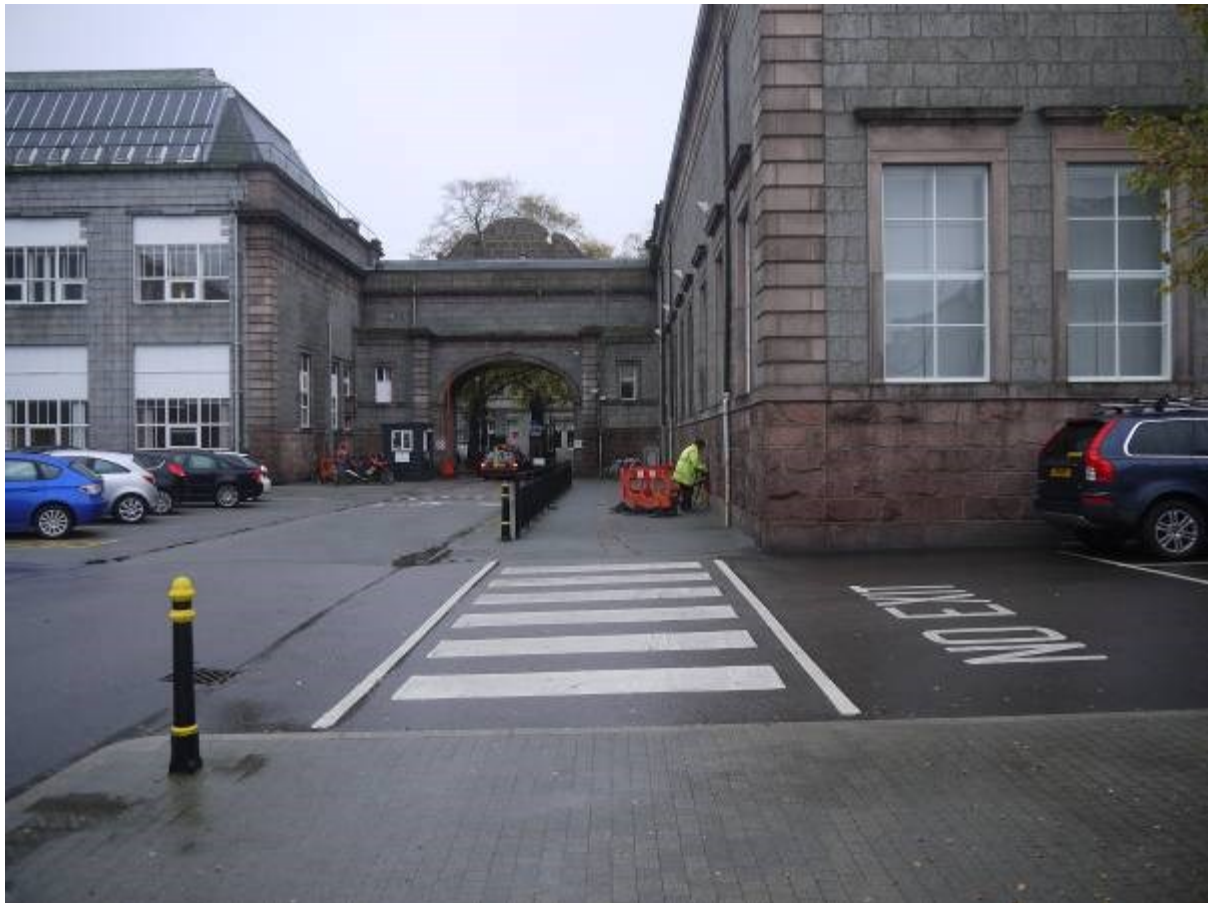
Illus 8 Location of Test Pit 2 looking South

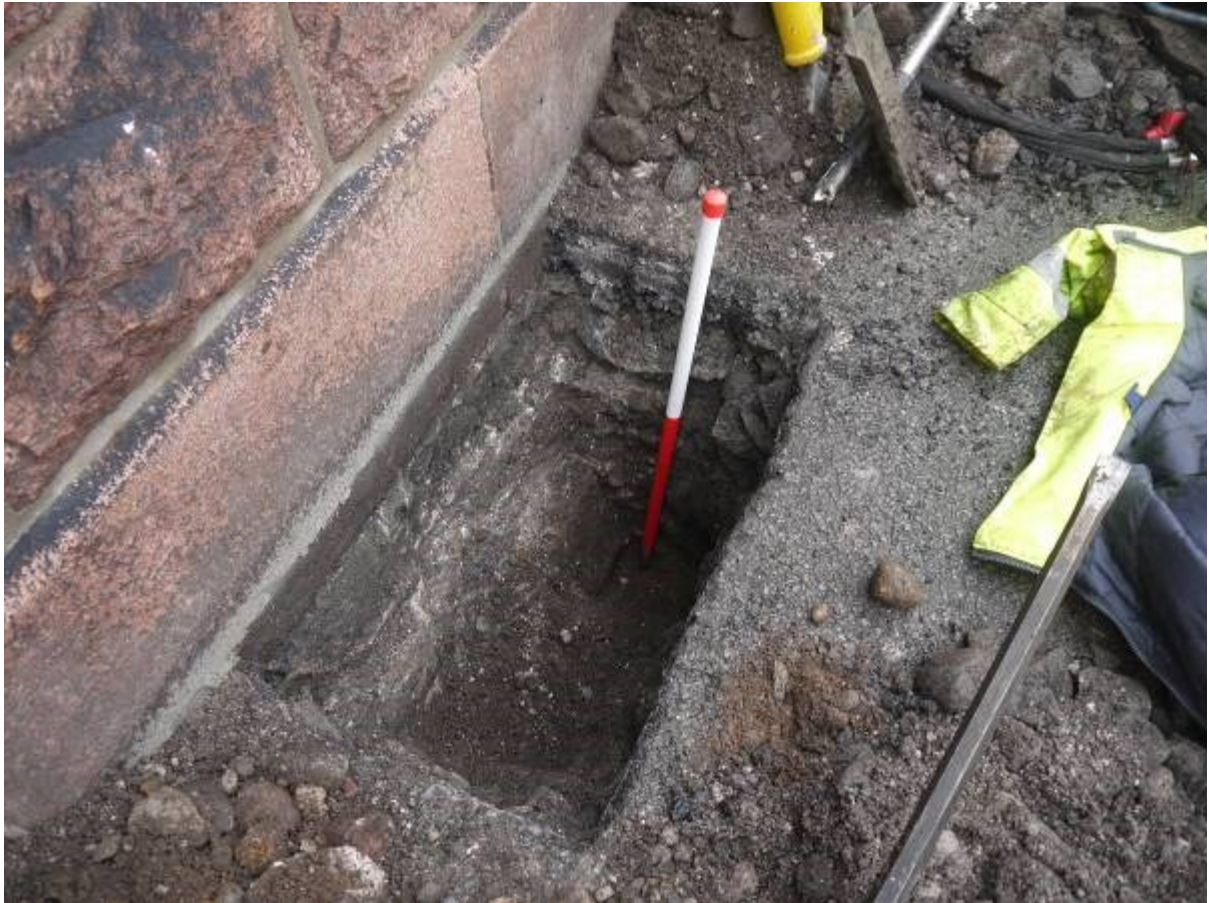
Illus 9 View of excavated Test Pit 2 looking North with stepped wall foundation visible to left of scale.

This test pit measured 0.85m from North to South by 0.50m East to West and was dug against the main Eastern wall of the Art Gallery at a distance of 9.30m from its junction with the North wall. A layer of tarmac (1) 0.10m thick was removed onto a layer of granite rubble (2) 0.35m thick which overlay a deposit of grey brown sandy clay with frequent mortar flecks and abundant stones (3) which was 0.55m thick and overlay a deposit of orange brown sandy gravel which appeared to be natural (4). Context 3 contained a fragment of splash glazed redware floor tile, a redware brick and two pieces of animal bone; an iron nail was also recovered from this deposit. This section of the Art Gallery wall (5) has a stepped foundation (6) lying directly above the natural ground level.

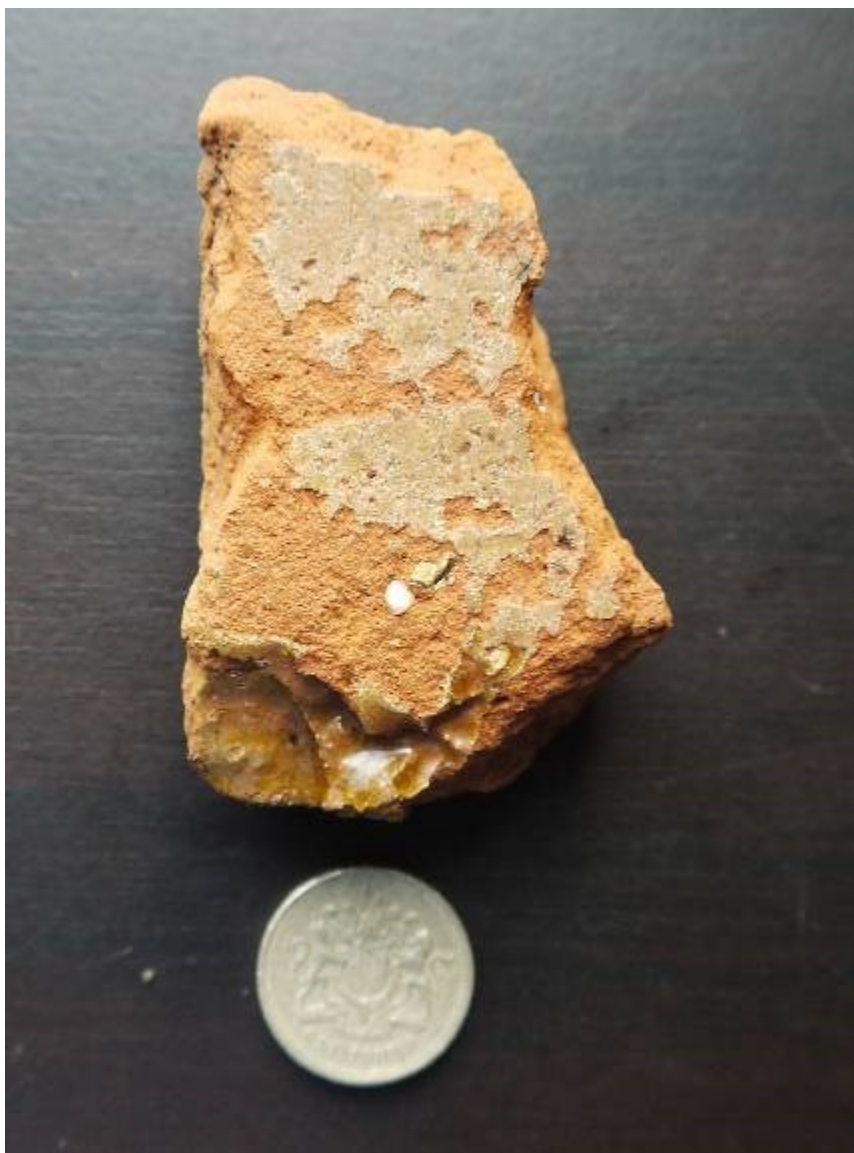
Illus 12 Fragment of glazed redware floor tile from Context 3 in Test Pit 2 (Pound coin as scale)

One broken piece of glazed floor tile in a Redware fabric (13th/14th century date) (Illus 11)

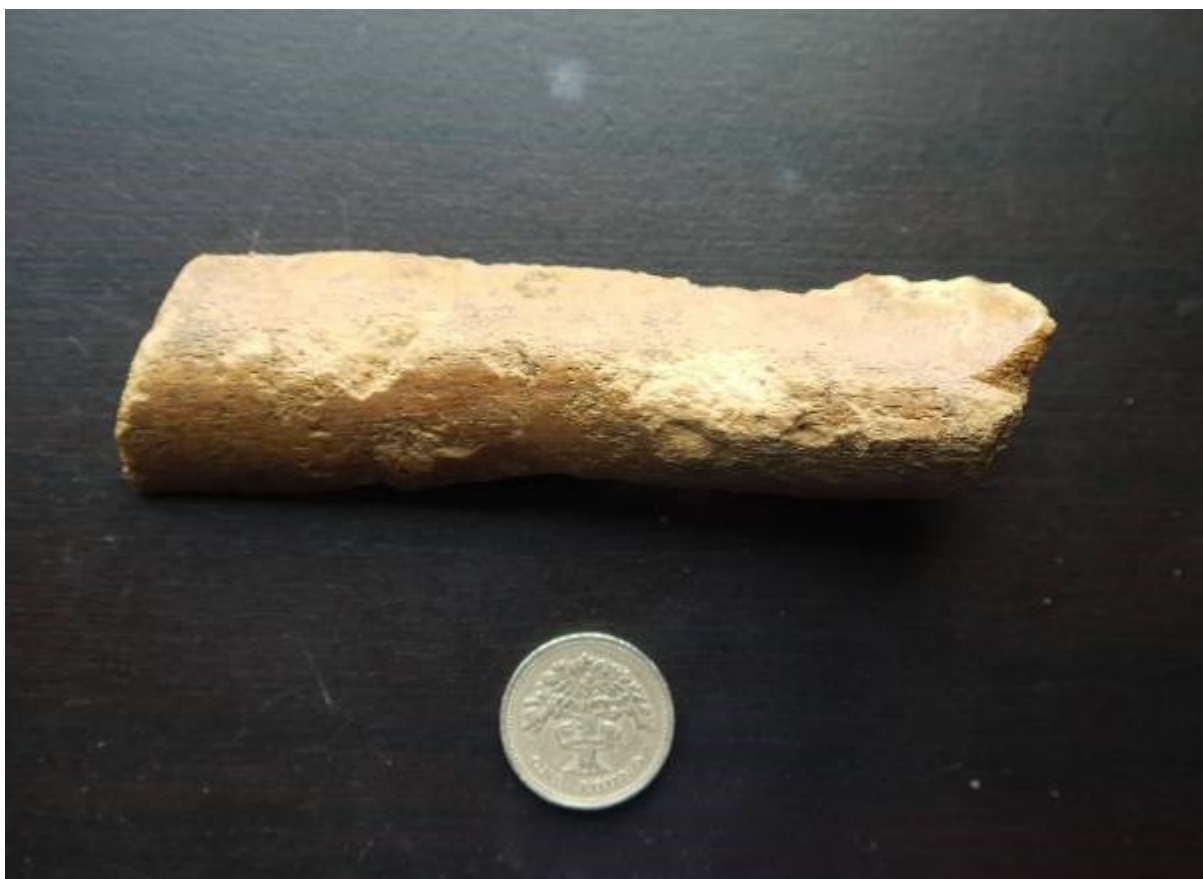
Illus 14 Piece of animal bone with sawn ends from context 3 in Test Pit 2 (Pound coin as scale)

One fragment of sawn animal bone (large ungulate) (Illus 13)
