Standing Building Survey
Whitehill Steading by Dalkeith,
Midlothian

28th November 2012

Introduction

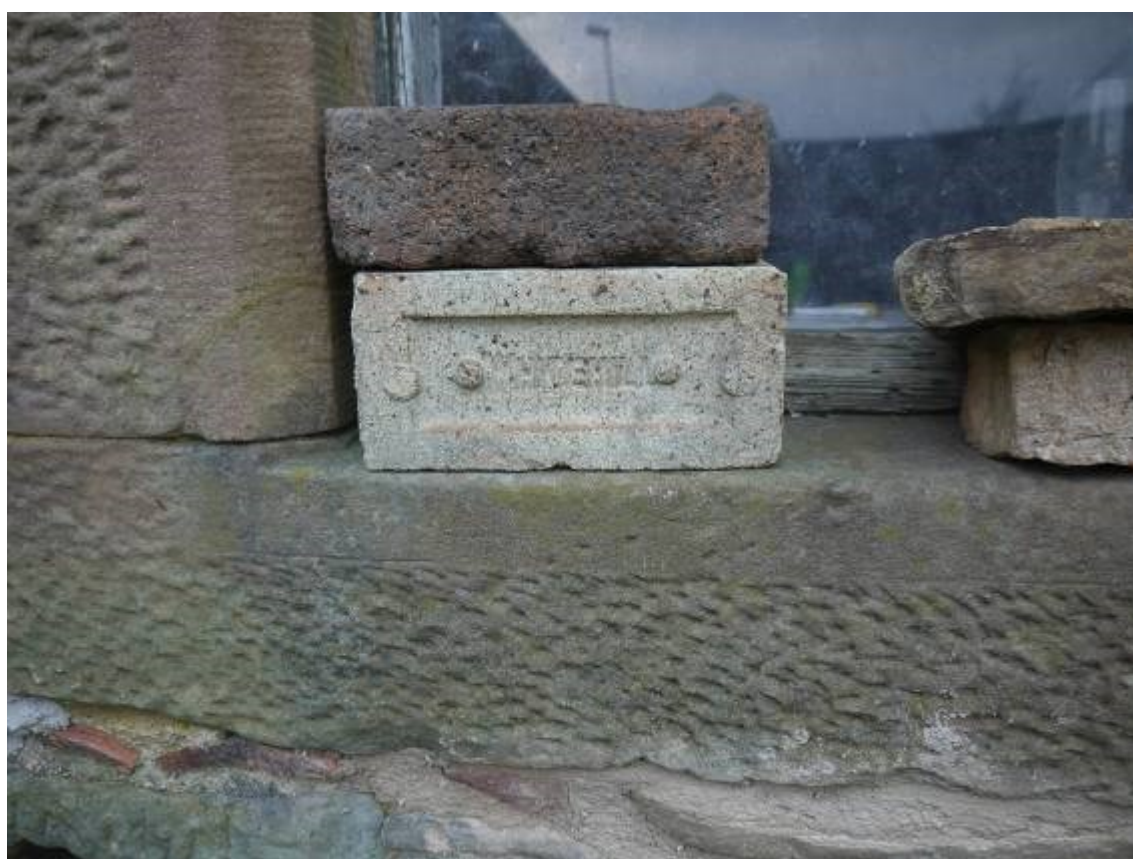
Brick marked 'Whitehill' on window sill of Building A of steading

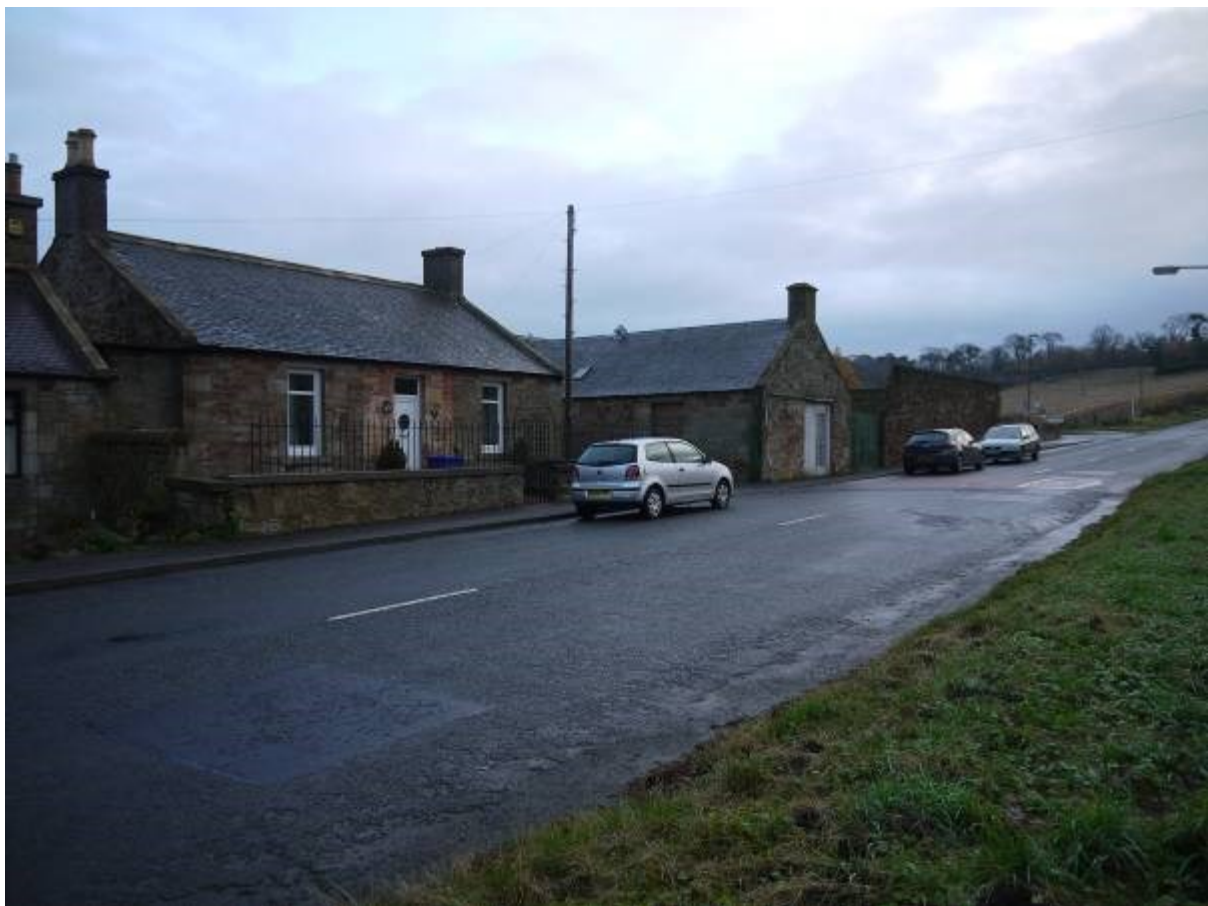
Illustration 6 Whitehill Farmhouse and steading looking North East

The steading stands on the North side of a minor road heading East off the A6106 towards Edgehead. The group of buildings is laid out around a central courtyard with access onto the road and has excellent views across Dalkeith to the South West.

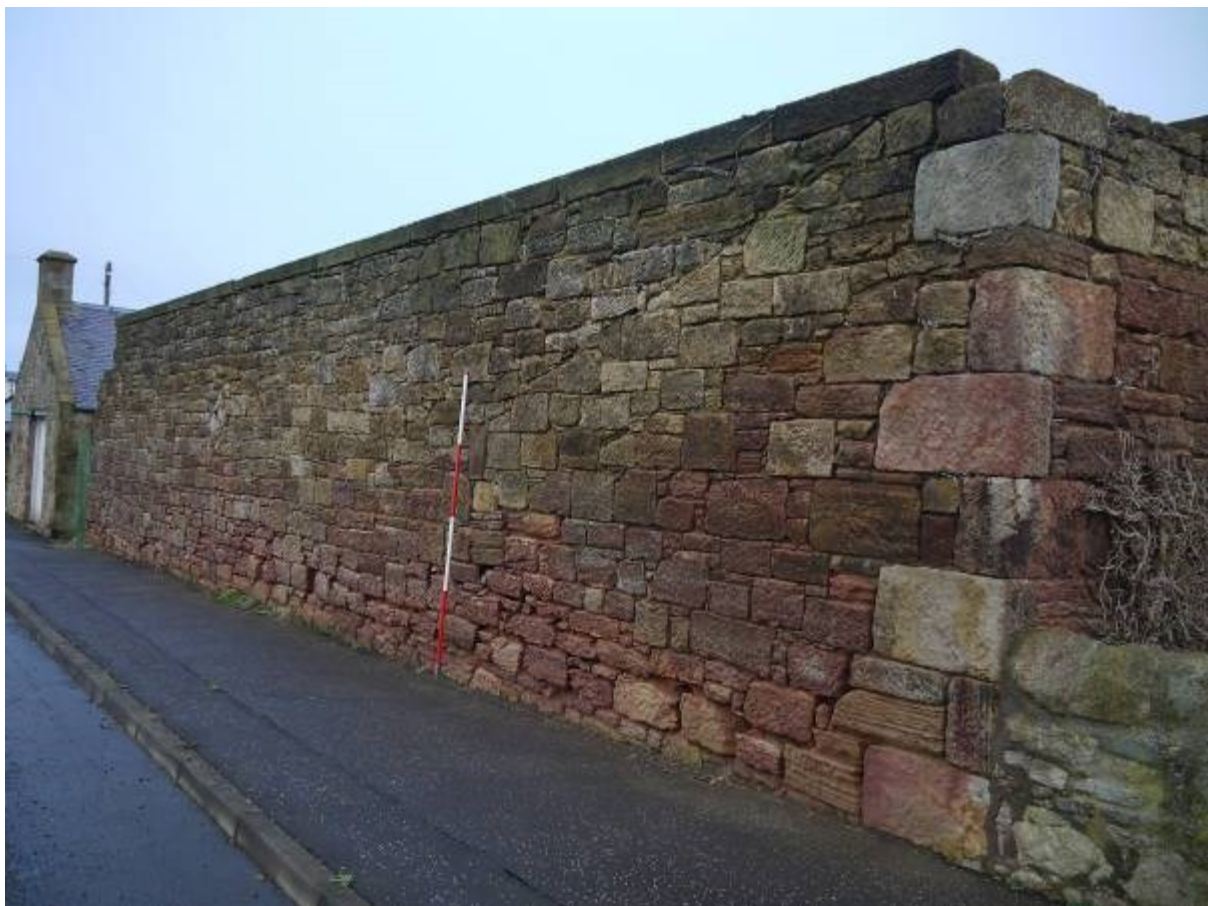
Illustration 8 South West facing elevation of Steading looking North North West, roof raggle visible in wall face gable end of Building A visible in background

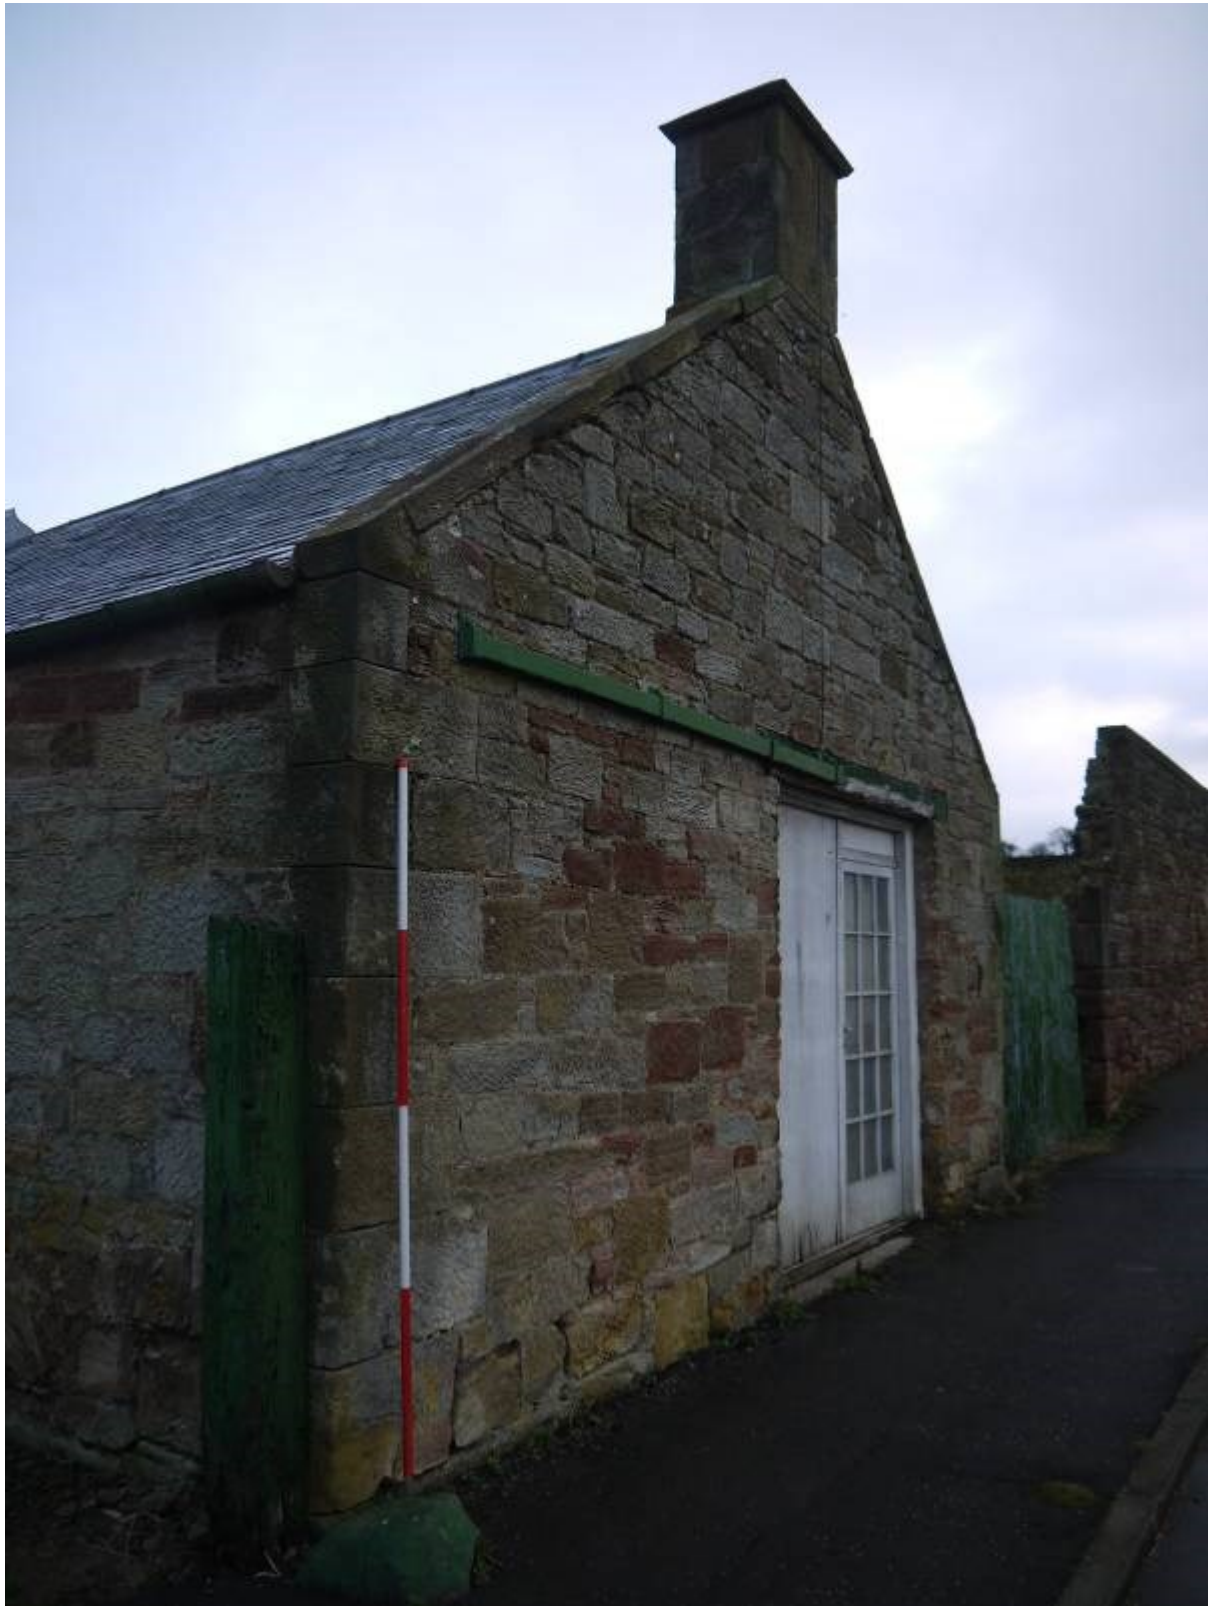
The south western elevation comprises the gable end of Building A which has a single door 2.4m wide by 2.50m high which now contains a wooden door. The sliding mechanism still visible in this wall face indicated the former existence of a sliding door. This gable has a chimney at its apex. To the East of this gable is an entrance into the internal courtyard that is 3.30m wide with a corrugated iron gate. The boundary wall to the end of this elevation is blank but has a roof raggle visible at its Eastern end. The gable end of Building A is built of mortar bonded shaped red, yellow and occasionally grey sandstone blocks. The boundary wall is of a similar build but is capped with a single course of flat stone slabs.

Illustration 9 Gable end of Building A (Phase 2) looking North North East, gateway into courtyard also visible

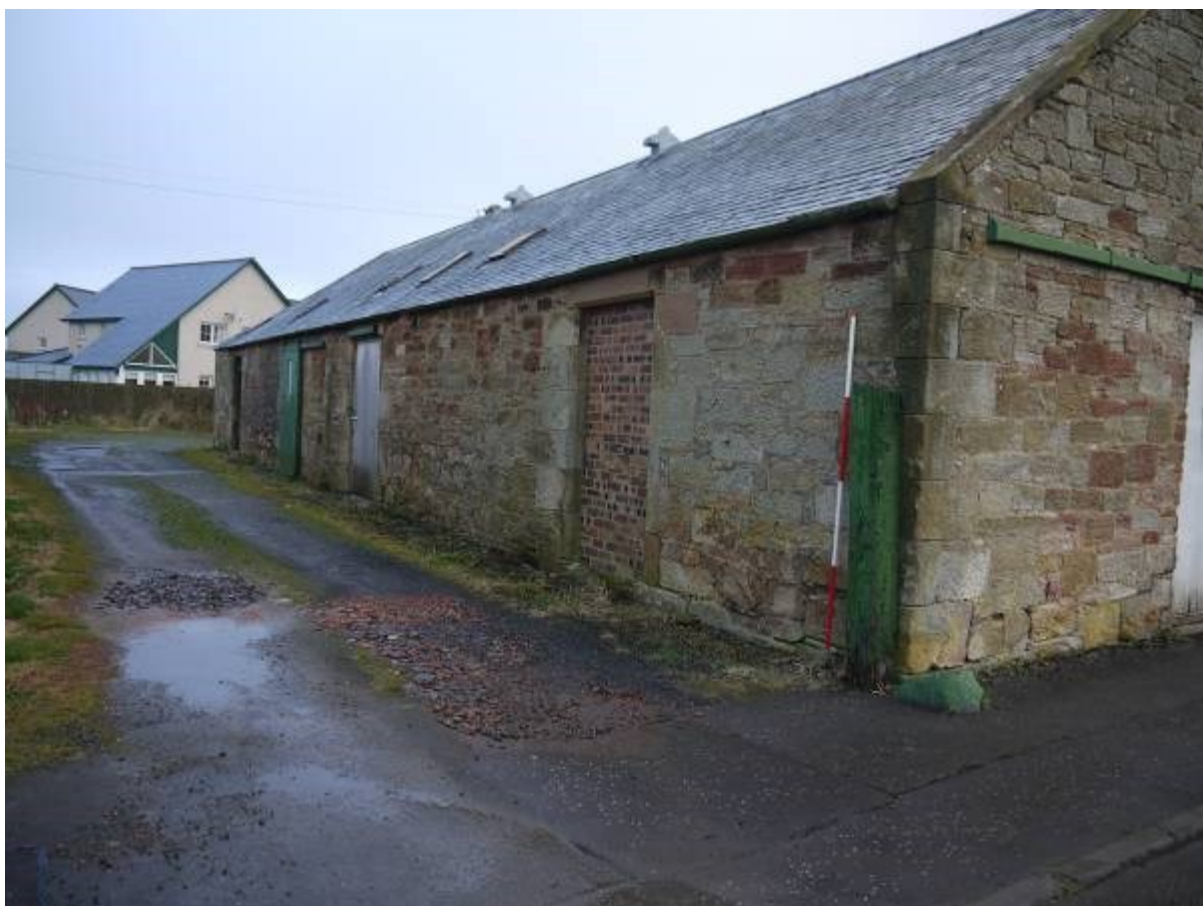
This comprises the side wall of Building A and contains four doorways one of which is blocked up with mortared bricks. The other three doorways have wooden doors, one of which is still on a sliding mechanism, another one of these doors has a sliding mechanism still surviving but not in use. The roof of this elevation is constructed of slates and has five small skylights and two metal

ventilators in its ridge line. This wall is built of mortar bonded red, yellow and occasionally grey sandstone blocks.

Illustration 10 North Western elevation of Building A (Phase 2) looking North

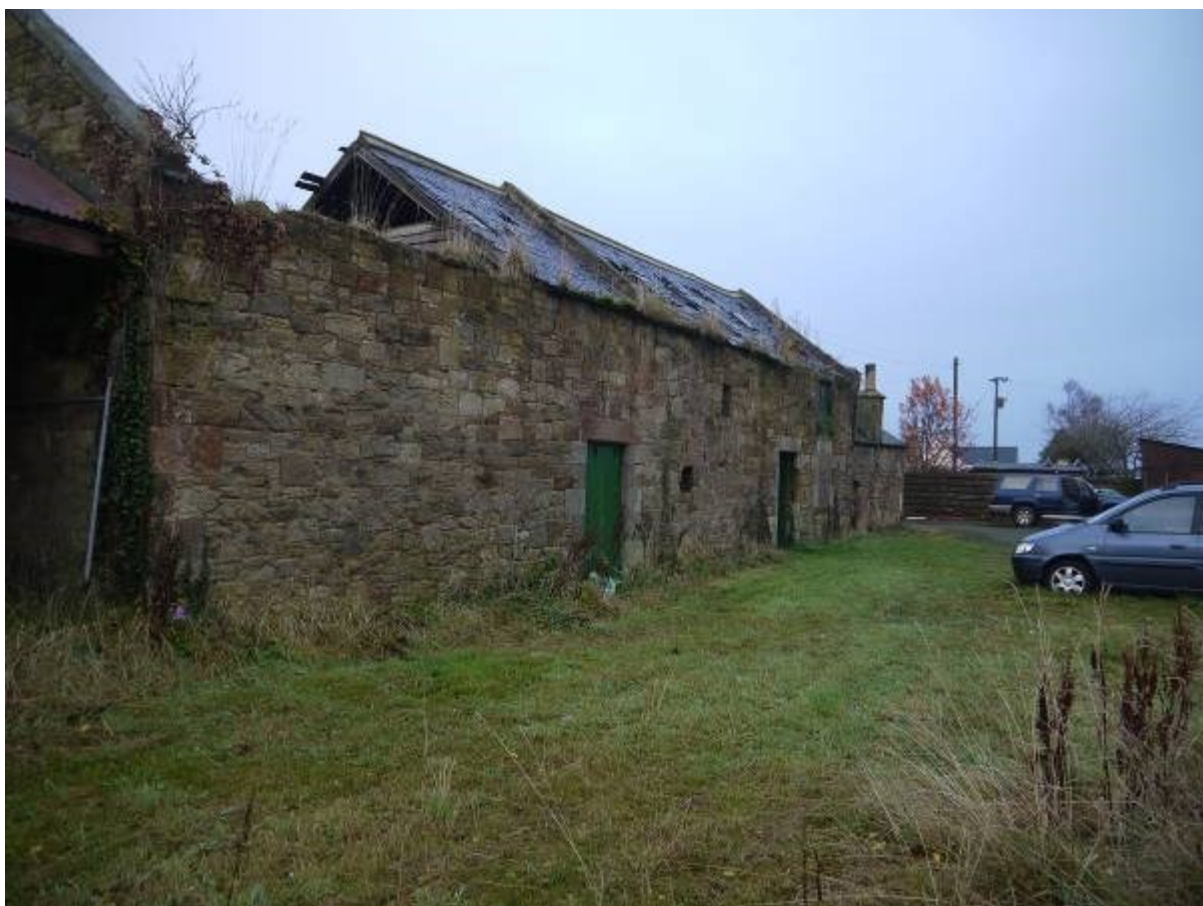
This comprises the North Western end wall of Building A which contains a single small doorway with a wooden door, there is a small blocked hole in the wall on the North side of this doorway. This end wall has a chimney halfway along its length and a pitched slate roof. The end wall of Building A is butted against the North western gable wall of Building B which is two storeys high and contains two windows at its Northern end. The lower of these is blocked with mortared bricks, the upper one has wooden shutters. There are two doorways at ground level the first of which has a split wooden door, the second has a wooden door with two small ventilation holes at its top. A small square hole is visible in this wall to the South of the second doorway which allows access to a piece of farm machinery inside the building (see below). The roof of most of this elevation is made of slate and is collapsing, it contains three skylights. The roof section at its Southern end has gone. A timber built shed/garage with a corrugated iron roof is built against the end of this elevation.

Illustration 11 North Eastern elevation of Building B (Phase 1) looking South West

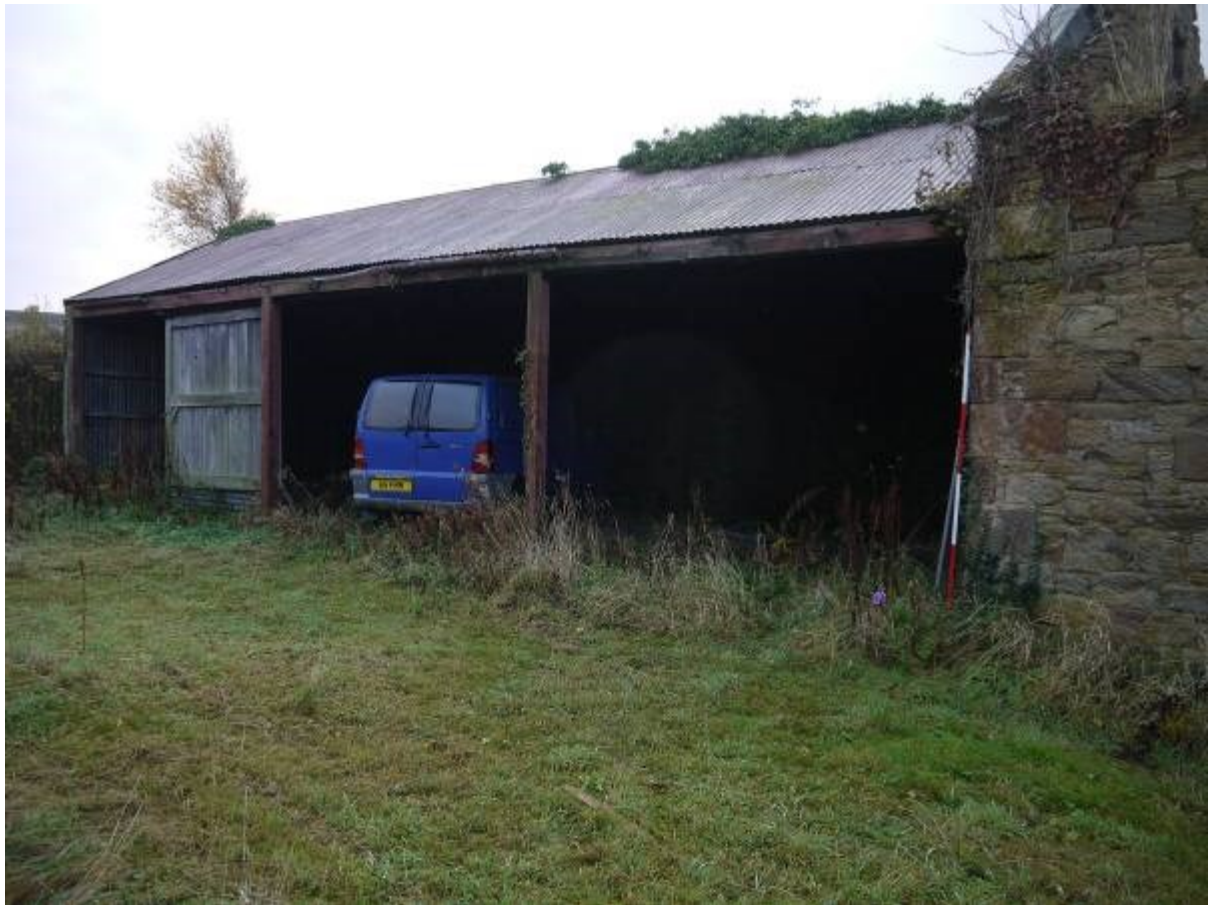
Illustration 12 Shed with corrugated iron roof (Phase 4) attached to Eastern end of steading looking South East

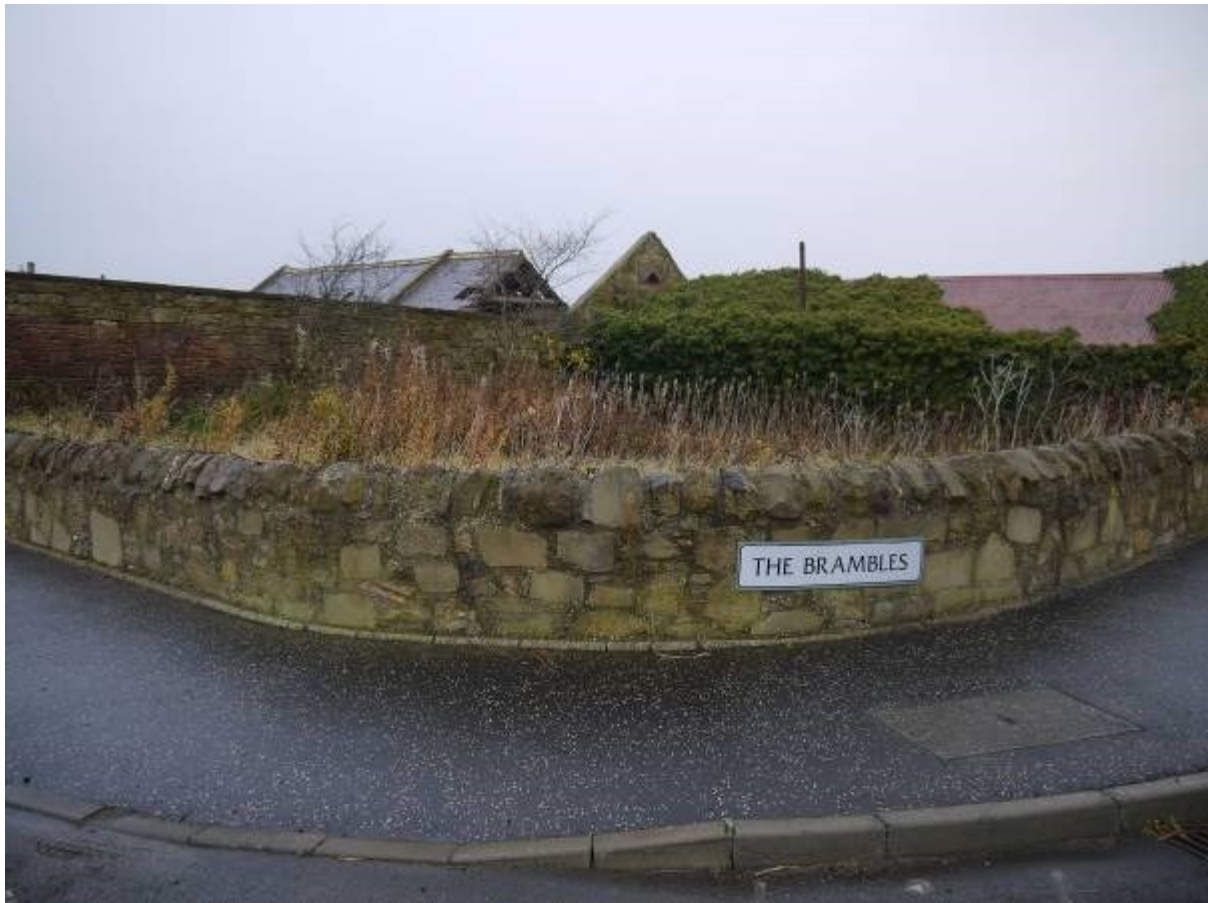
The South Eastern end wall has a blank face and is built of shaped red, yellow and occasionally grey sandstone blocks. It is capped with a single course of flat stone slabs.

Illustration 13 Eastern wall of steading complex looking North West, corrugated roof of shed (Phase 4) visible and walled off waste ground

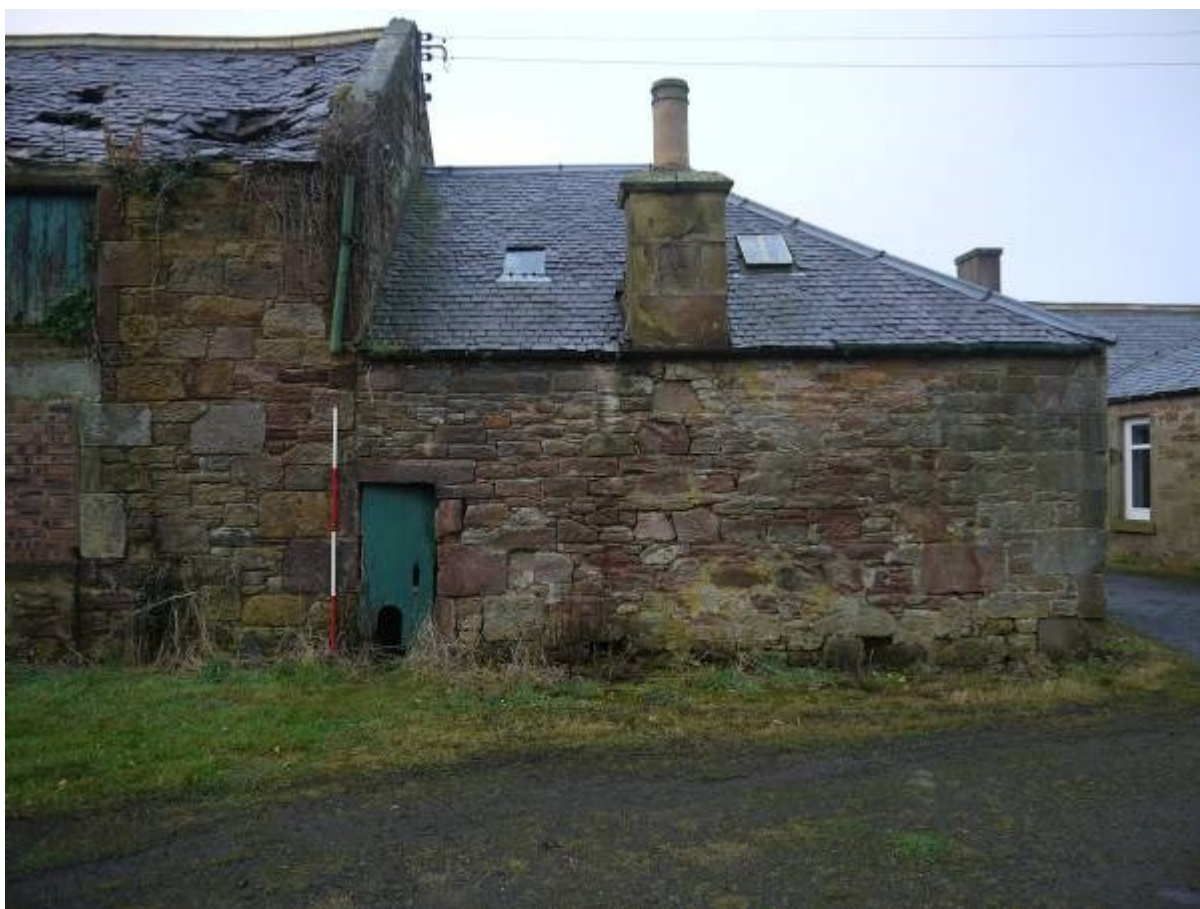
Illustration 14 North Eastern facing elevation of Building A (Phase 2) showing butt joint with building B (Phase 1) and chimney in middle of elevation

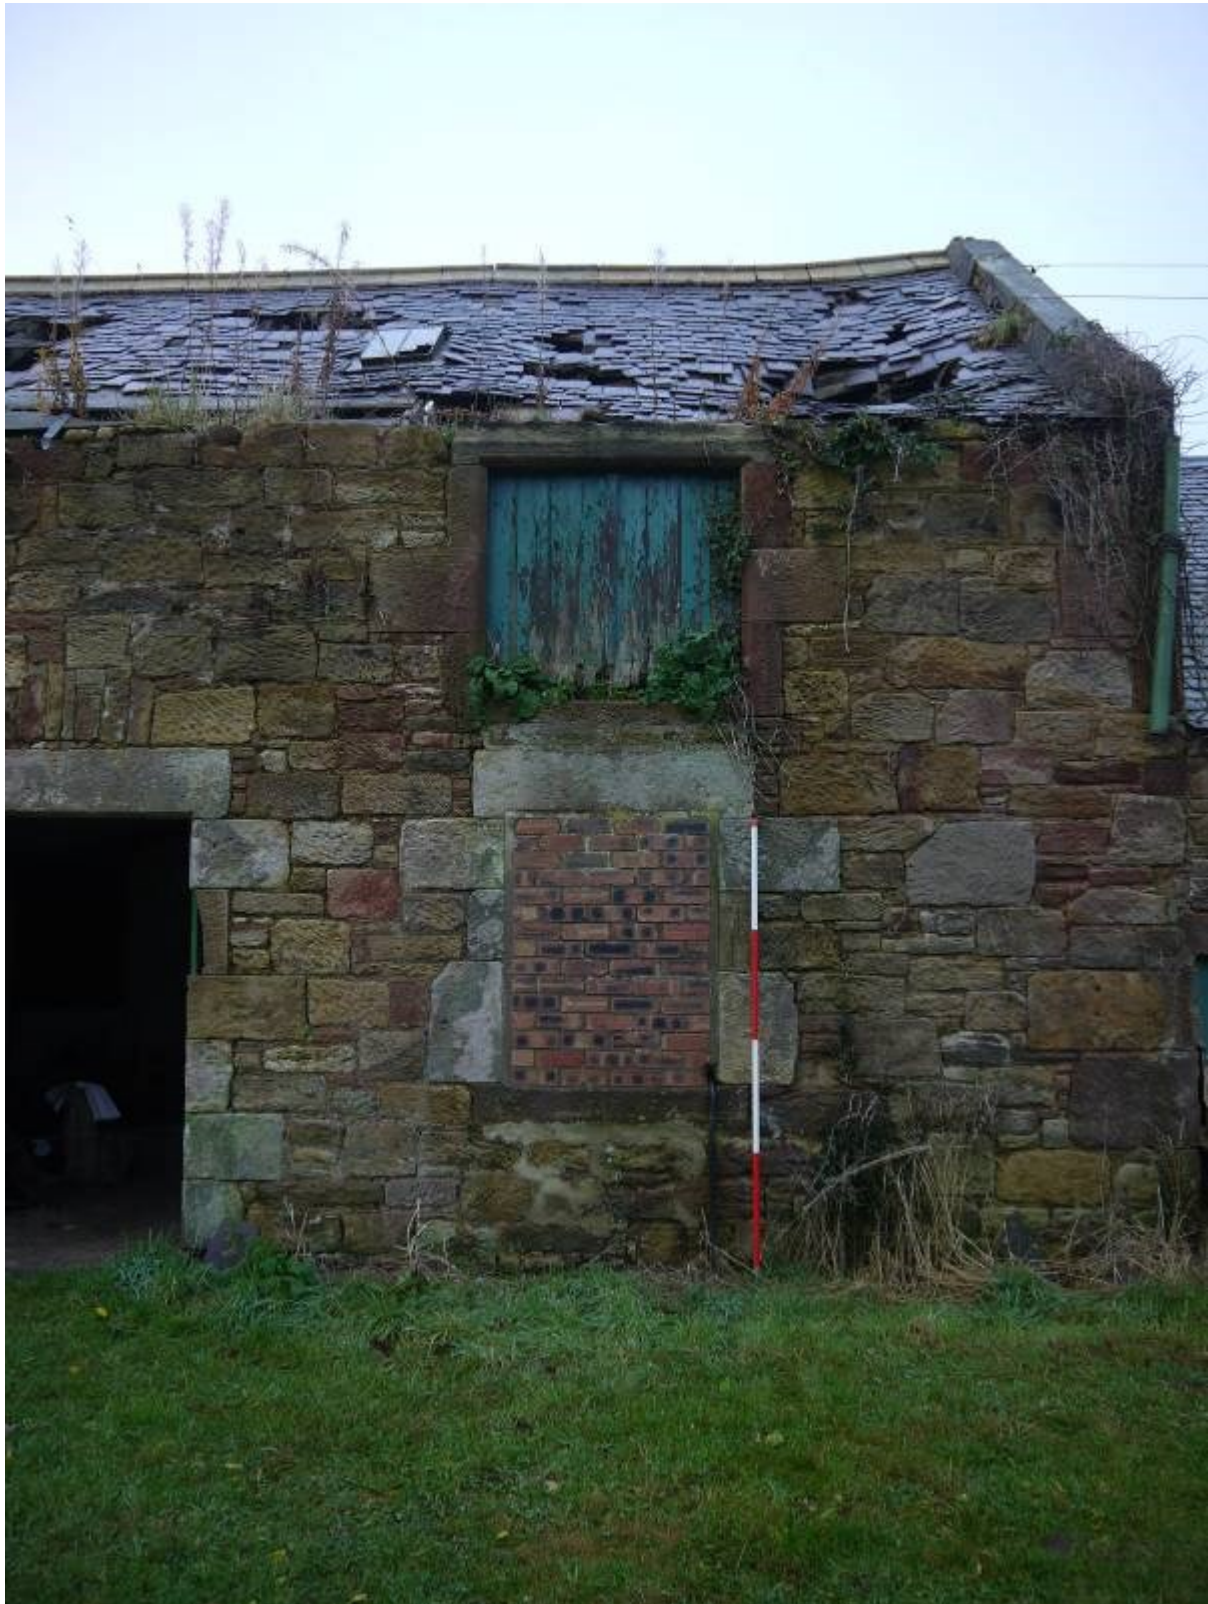
Illustration 15 Northern end of North Eastern elevation of Building B (Phase 1) showing blocked ground floor window and shuttered upstairs window looking South West

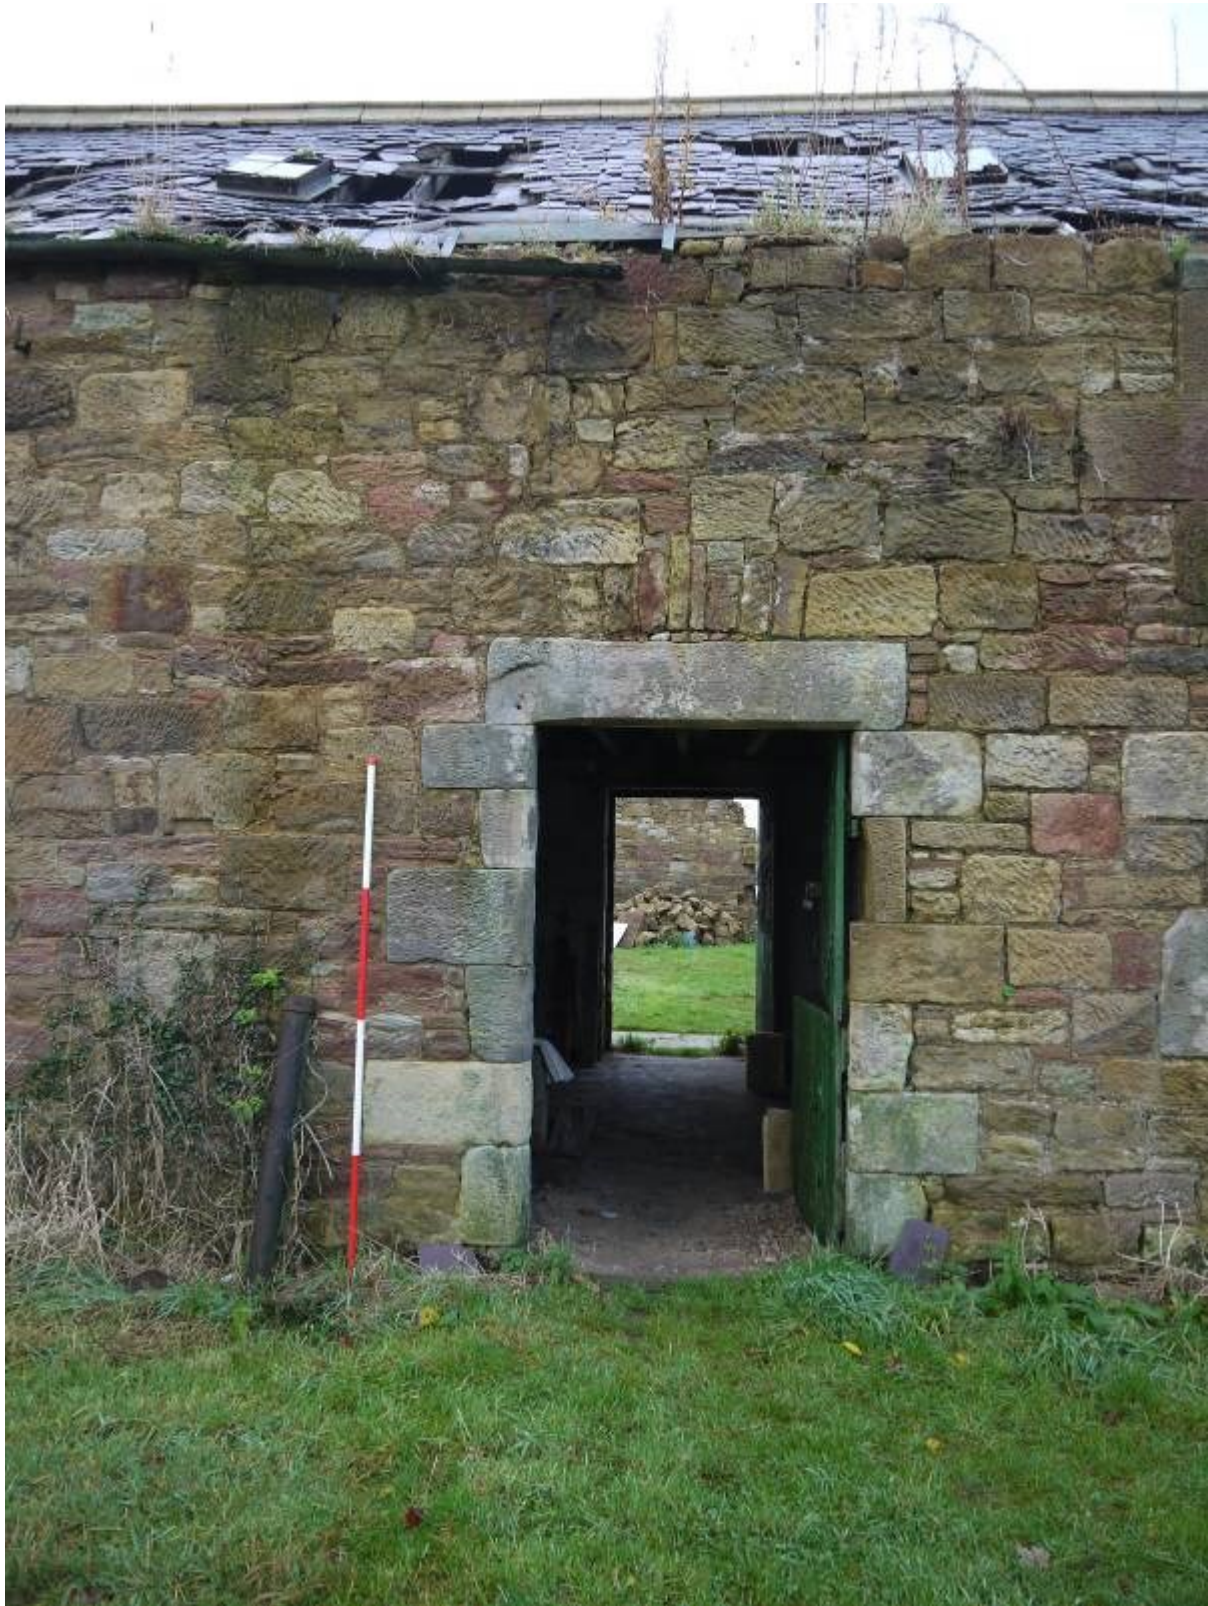
Illustration 16 Doorway into Building B (Phase 1) looking South West into Courtyard

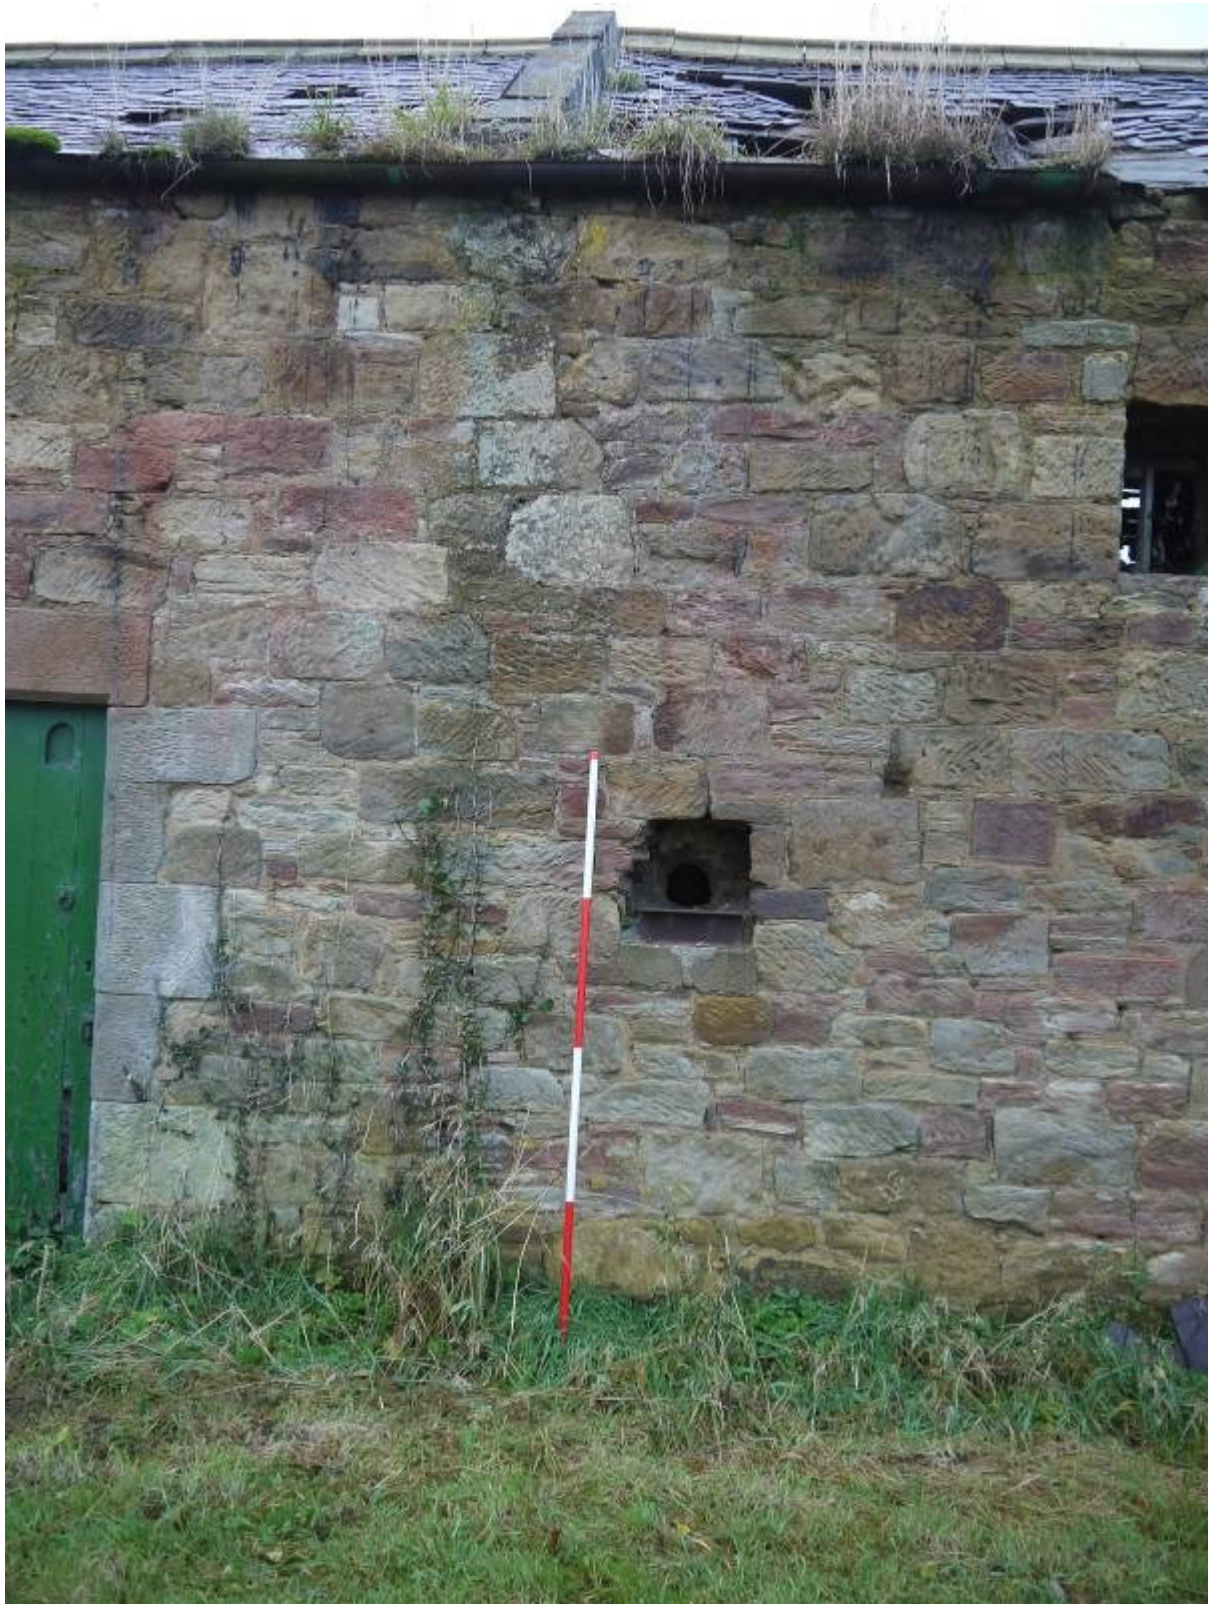
Illustration 17 Small square hole in North Eastern elevation of Building B (Phase 1) providing access to Bamfords Rapid Grinding Rolling Mill looking South West

From limited research by the author the piece of farm machinery inside Building B is a Bamford Rapid Grinding Rolling Mill which was manufactured by the company from 1887 until the 1970's (pers comm. Phillip Wood <http://henrybamfordandsonsutttoxeterengland.co.uk/>). The small square hole in the North Eastern wall of Building B is directly adjacent to one end of this piece of machinery and may suggest that it was driven from the outside? The former functions of rooms A1 and A2 at the North East end of Building A are harder to understand.

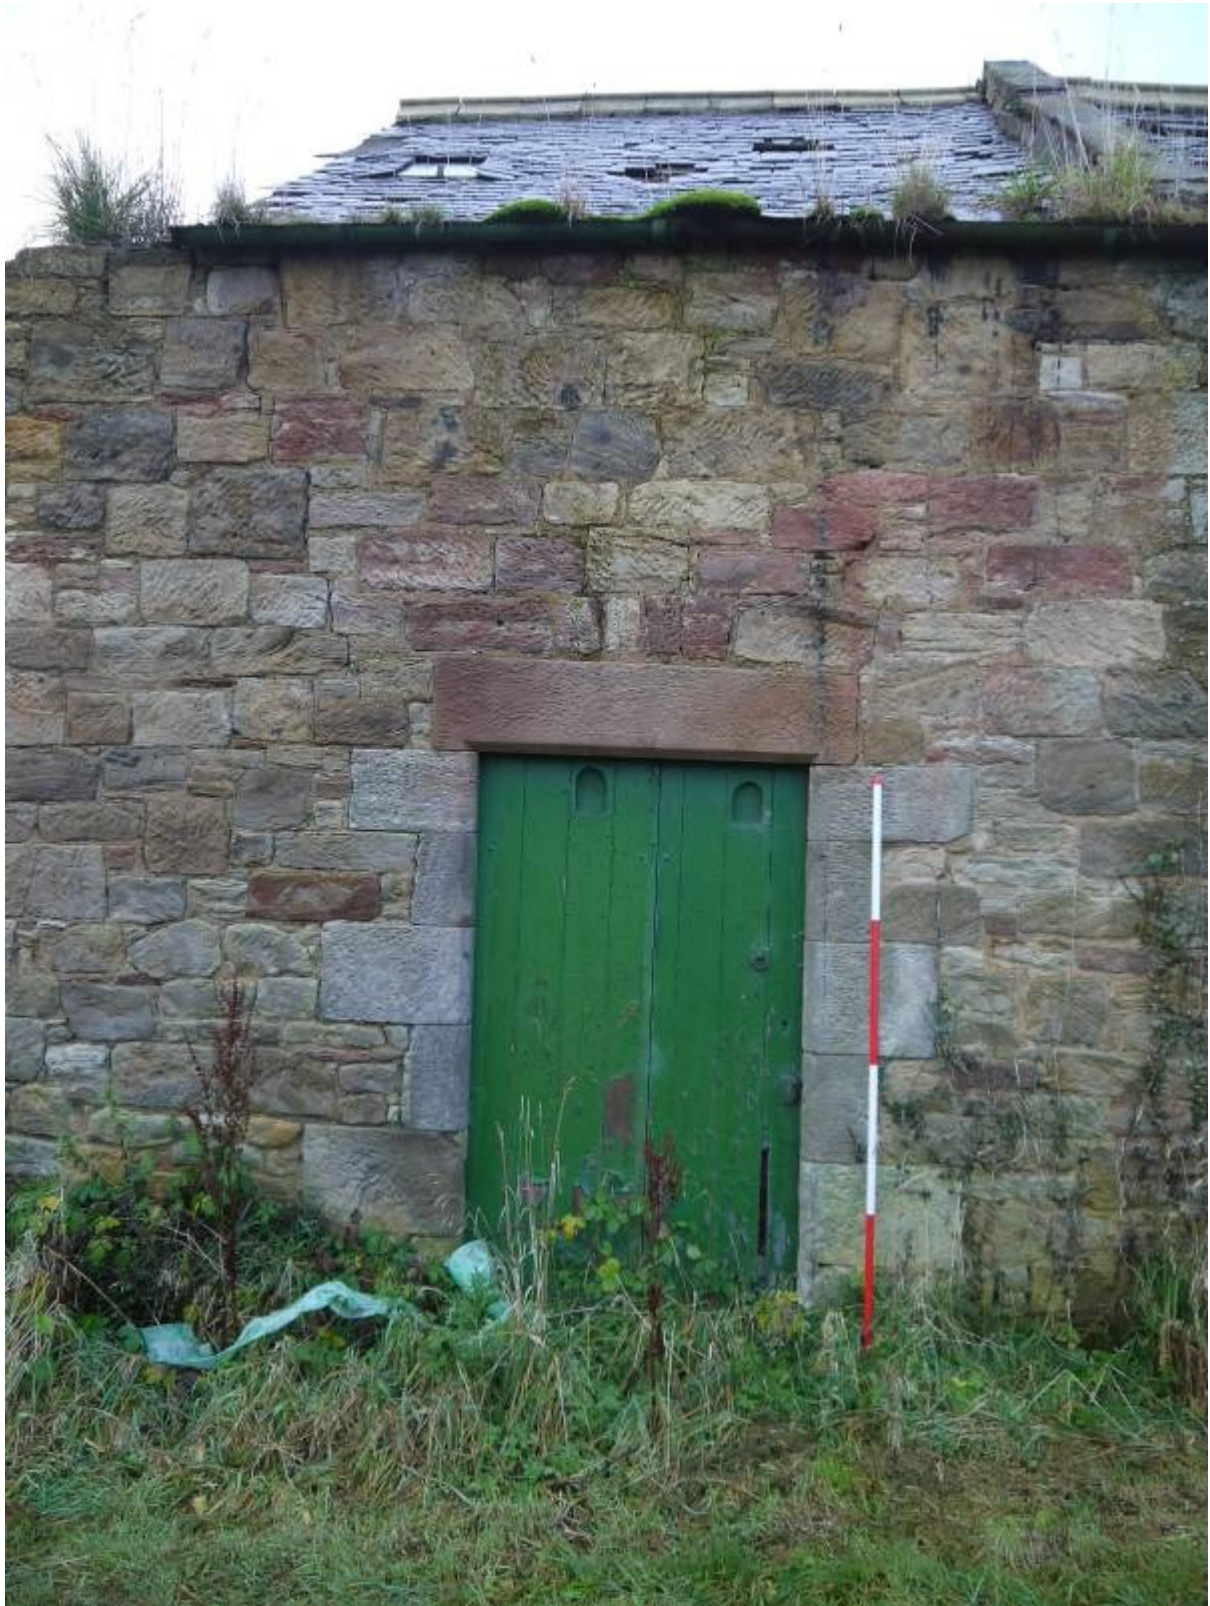
Illustration 18 Doorway in North Eastern elevation of Building B (Phase 1) looking South West

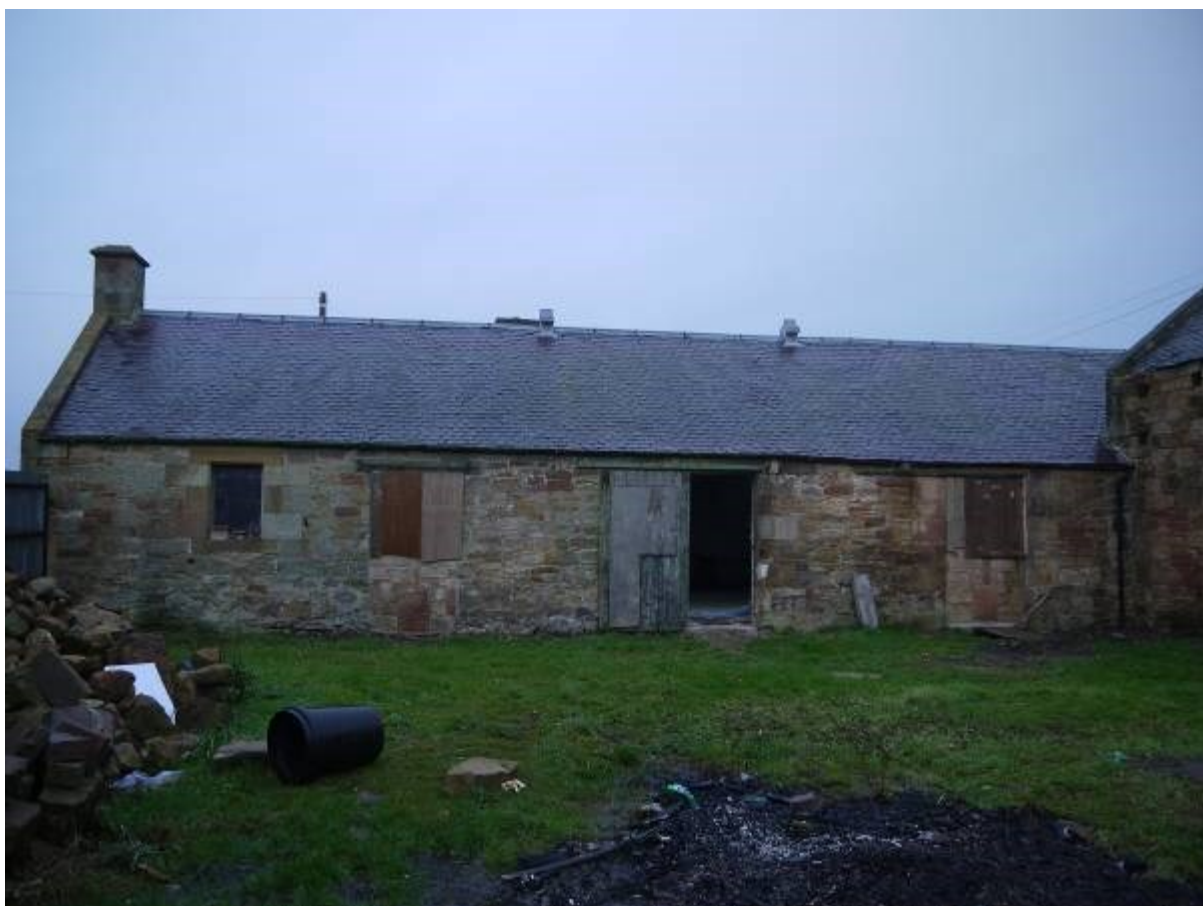
This elevation faces into the internal courtyard (D) and contains one window at its Western end and three doorways. The lower halves of two of these doorways are blocked with mortared sandstone blocks, the upper halves with wooden boards, both have the remains of sliding mechanisms above their lintels. The third doorway has a still operational sliding door.

Illustration 19 South Eastern elevation of Building A (Phase 2) looking North West
