Standing Building Survey
Whitehill Steading by Dalkeith,
Midlothian

28th November 2012

Introduction

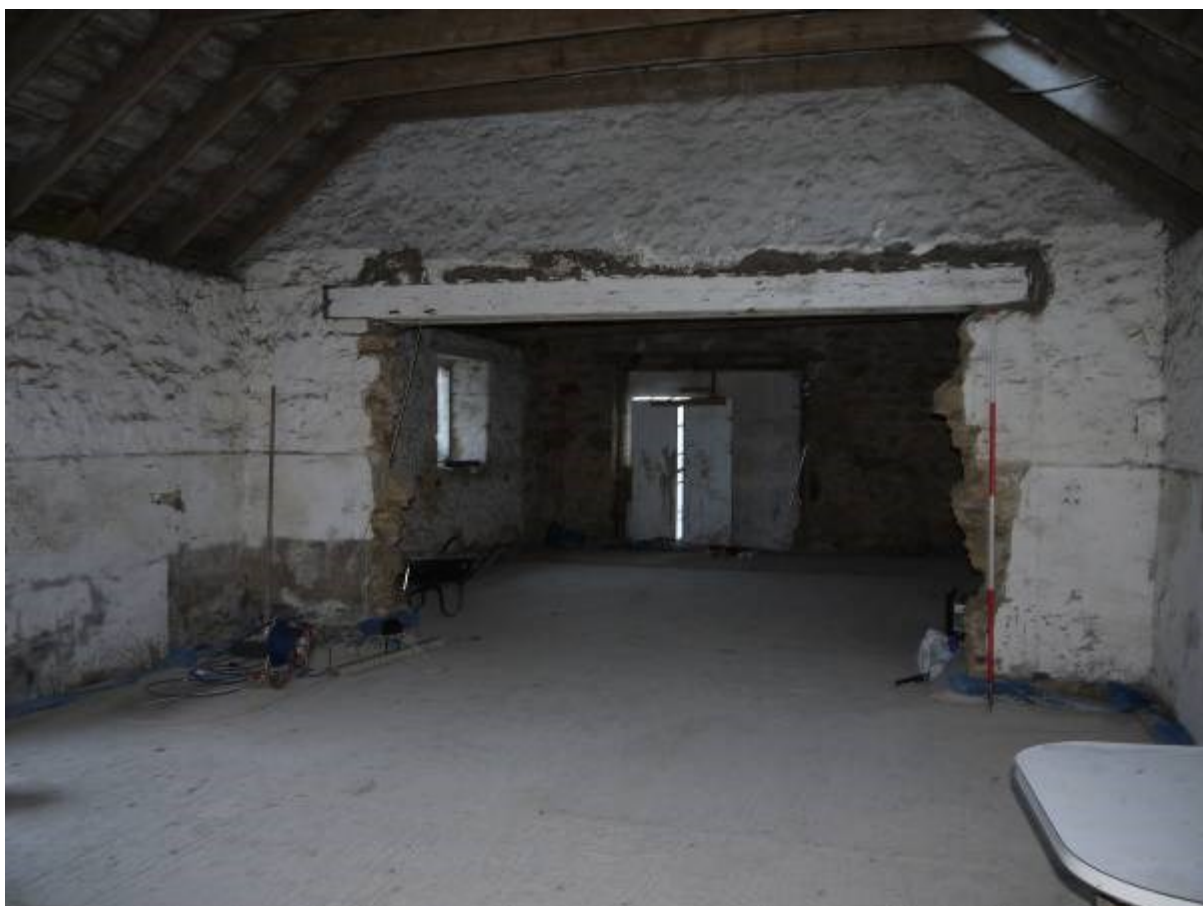
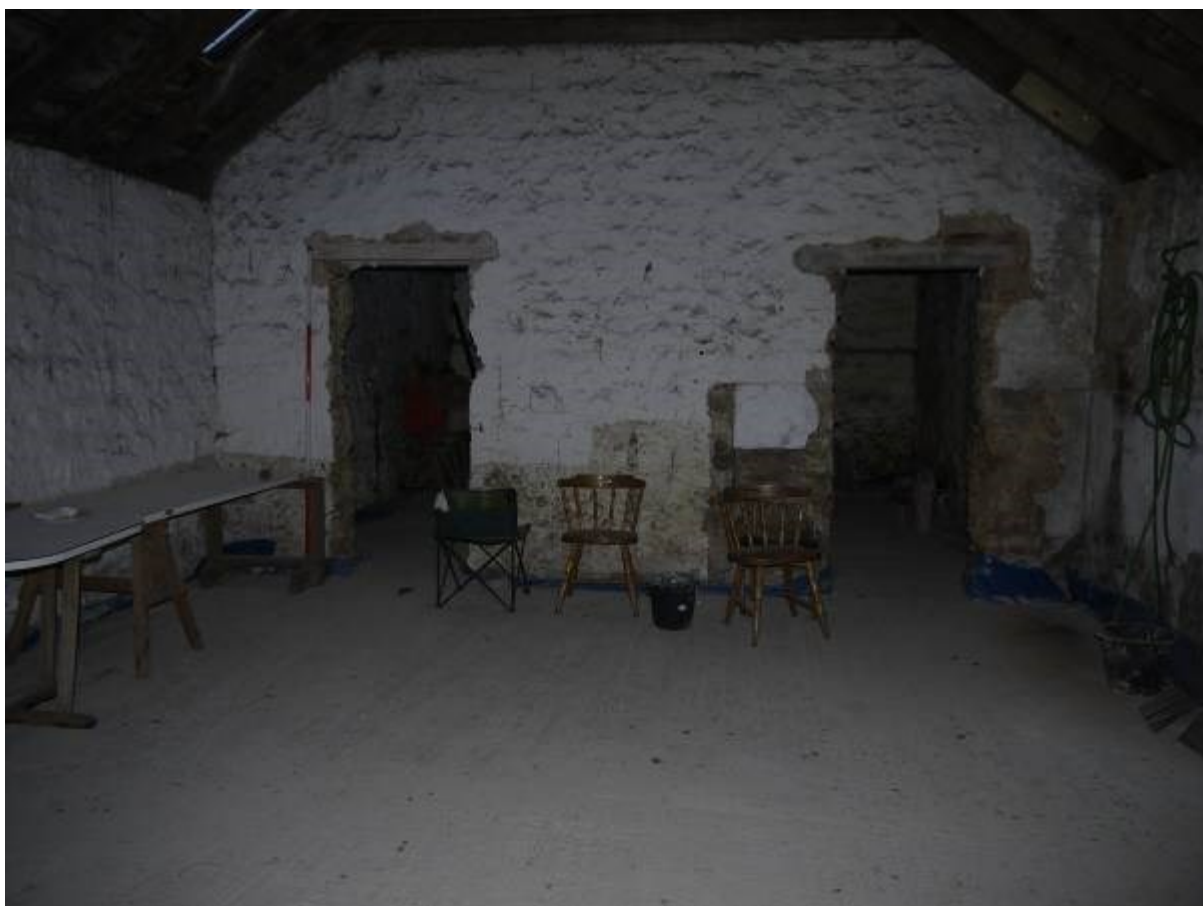
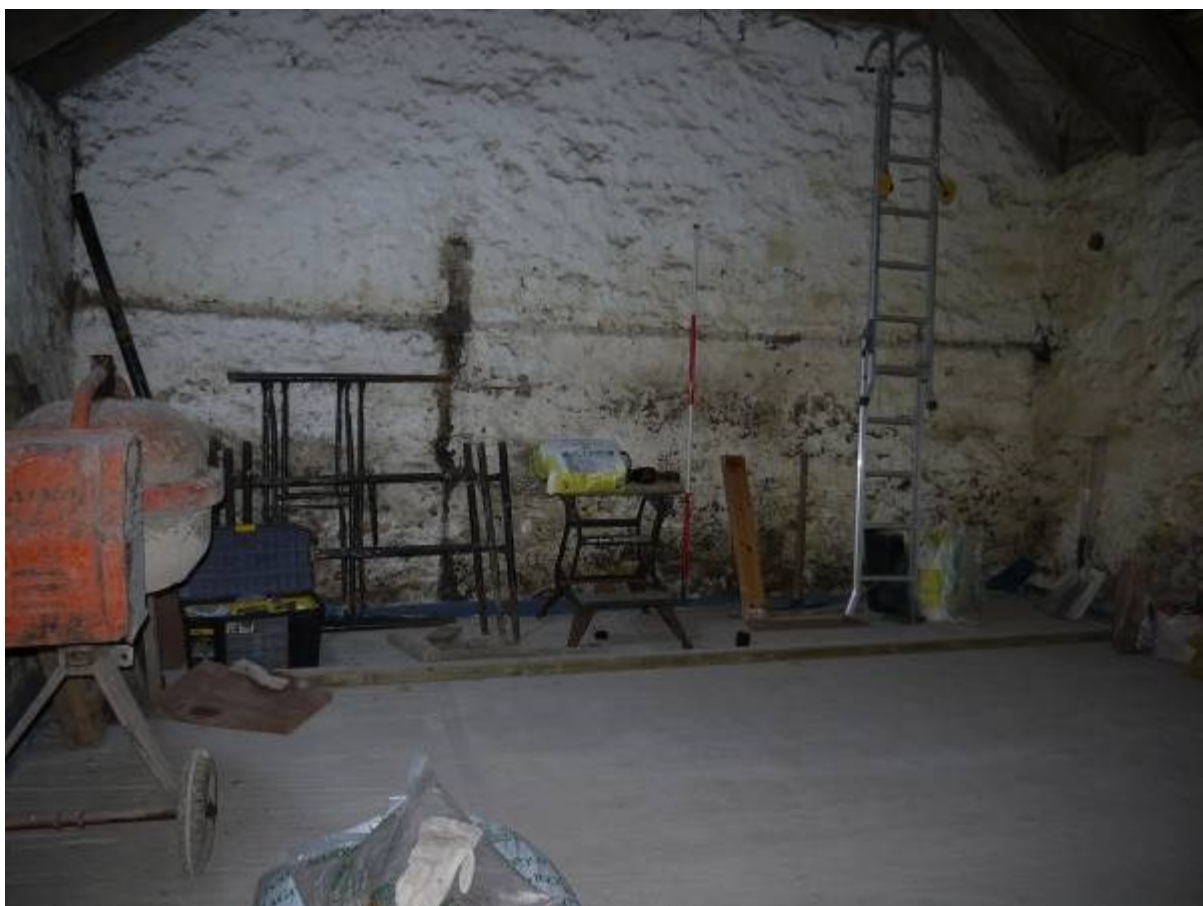
The main part of this building which is accessible from the courtyard is subdivided into three rooms, one to the South West is accessible through a large doorway with a wooden lintel the room to the North East is accessible through two doorways. All three of these rooms have whitewashed walls and now have laid concrete floors. The North Eastern end of Building A is subdivided into two smaller rooms (A1 and A2) which are only accessible from outside the steading complex.

Illustration 20 Interior of Building A (Phase 2) looking South West

Illustration 21 Interior of Building A (Phase 2) looking North West

Illustration 22 Interior of Building A (Phase 2) at North Western end

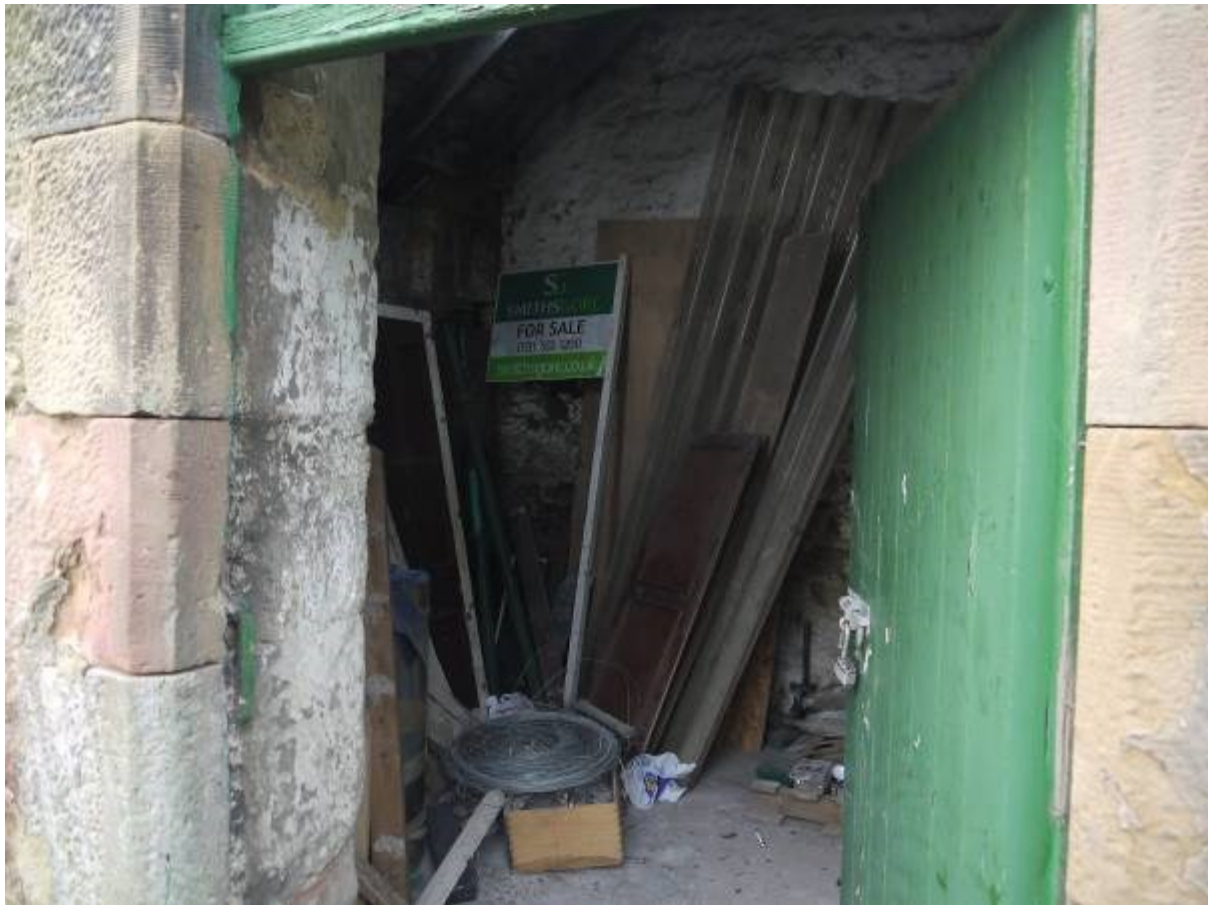
This room measures 3.3m by 3.2m and is accessed through a single doorway on its Northern side. The Southern wall of this room looks like a later insertion as it partially covers the remains of a chimney breast which is visible in its North Eastern wall (coloured purple on Illus 3). This room has a concrete floor.

Illustration 23 Internal view of Room A1 (Phase 3)

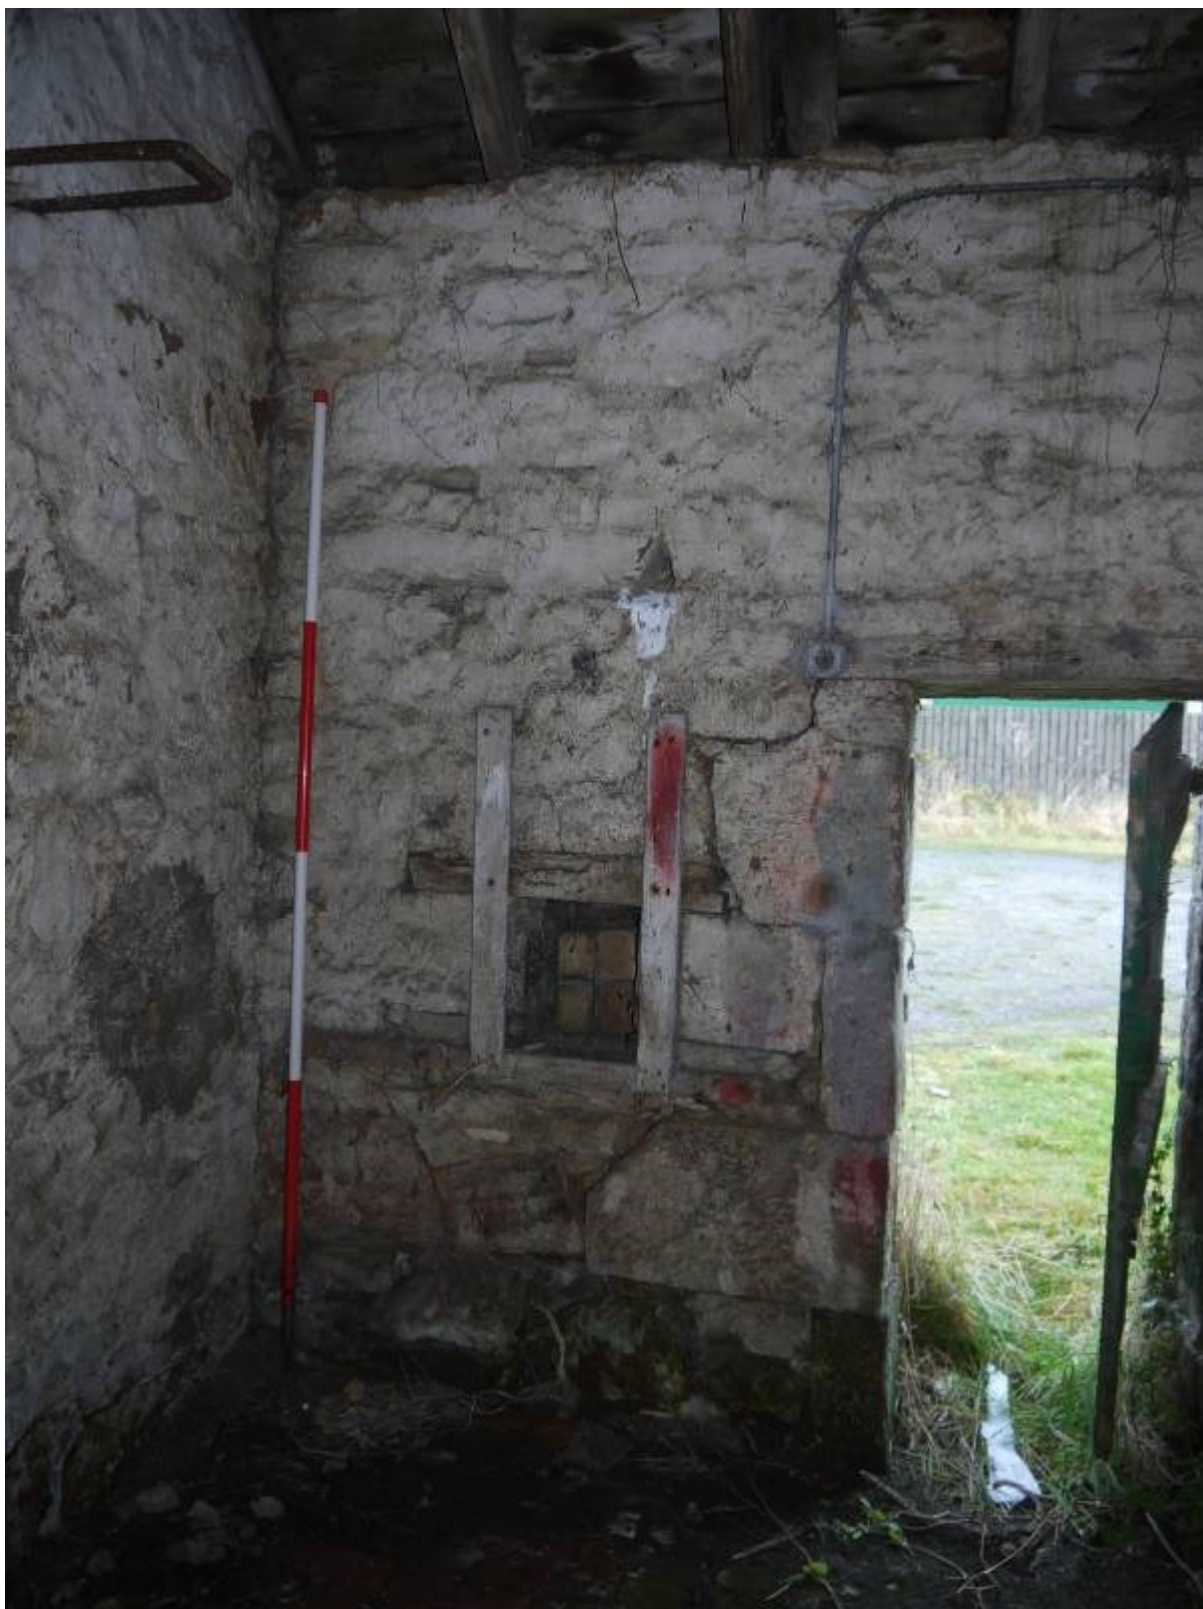
This room measures 2.05m by 3.2m and is accessed through a single narrow doorway on its Eastern side. Its Northern wall is a later insertion (It is the Southern wall of A1). There is a blocked doorway in its South Eastern wall which would have originally provided access to Building B. There is a small blocked square hole in its North Eastern wall of uncertain function. The floor of this room is made up of red bricks.

Illustration 24 Blocked hole in North Eastern wall of Room A2 (Phase 3)

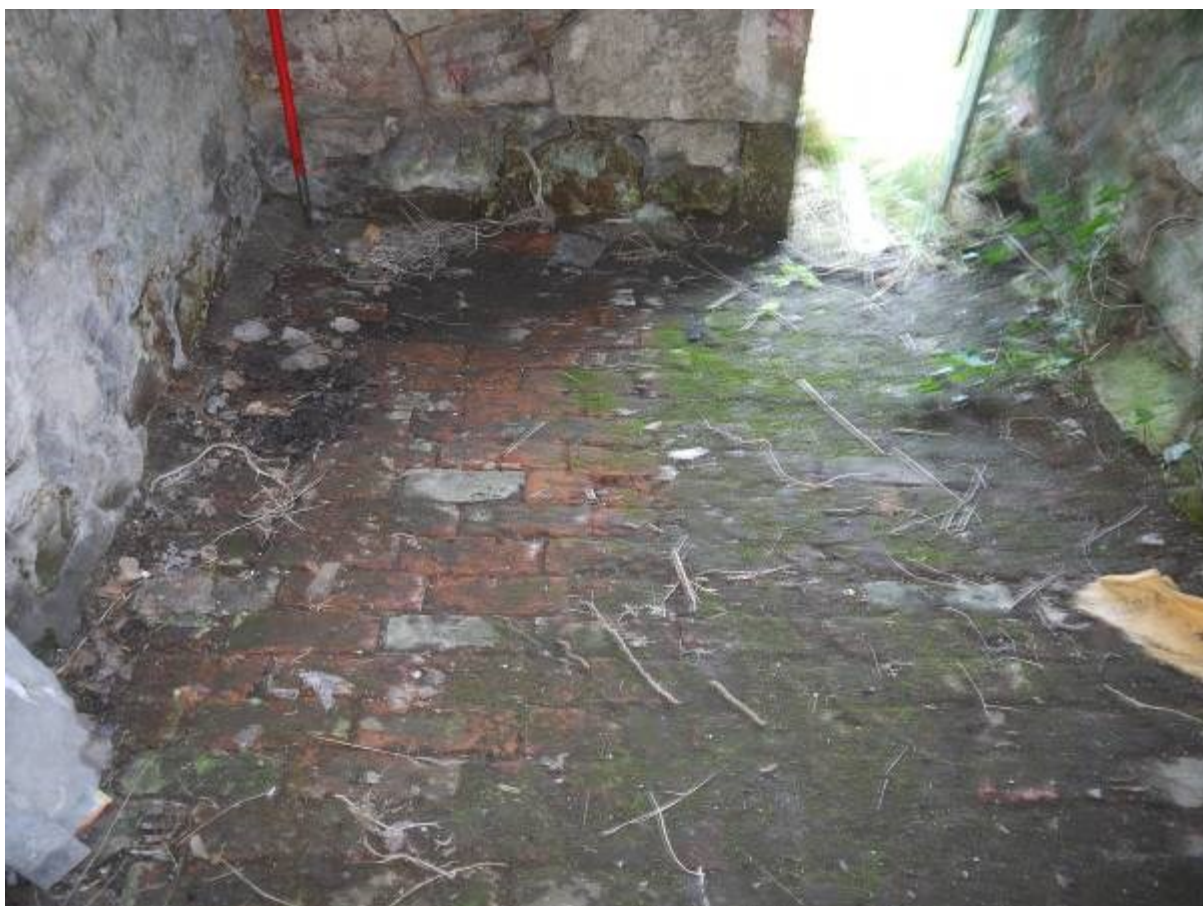
Illustration 25 Brick floor in Room A2 (Phase 3) in Building A

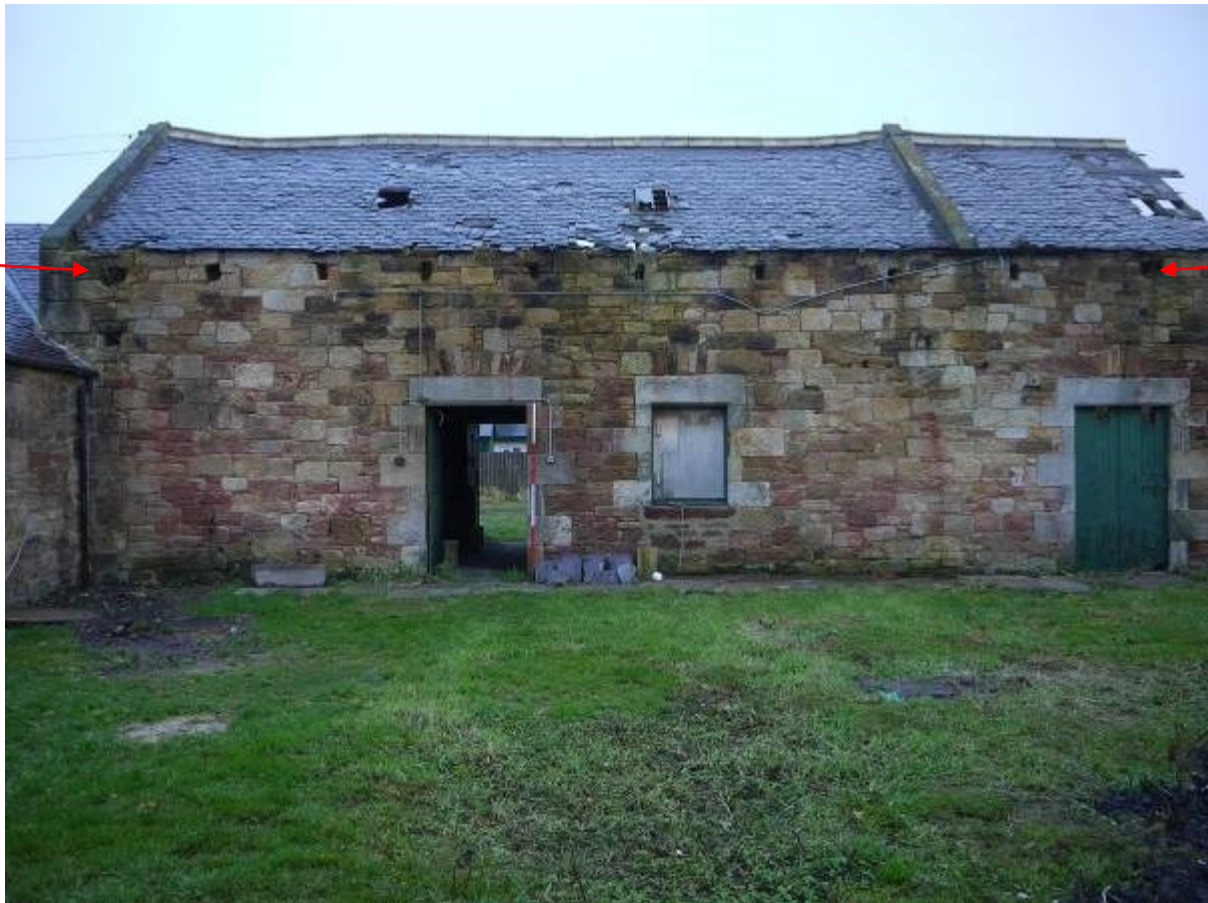
This elevation faces into the internal courtyard (D) and contains two doorways and one window. A line of rectangular holes are visible just below the roof line which may have been to support a structure tacked on to this wall face? The line of stone paving that runs along the face of this elevation seems to match the position of the holes suggesting that there may have been a covered walkway? The wall is built of red, yellow and occasionally grey shaped sandstone blocks. There are quoin stones around the doorways and window.

Illustration 26 South West facing elevation of Building B (Phase 1) looking North East, red arrows indicate line of holes just below roof line

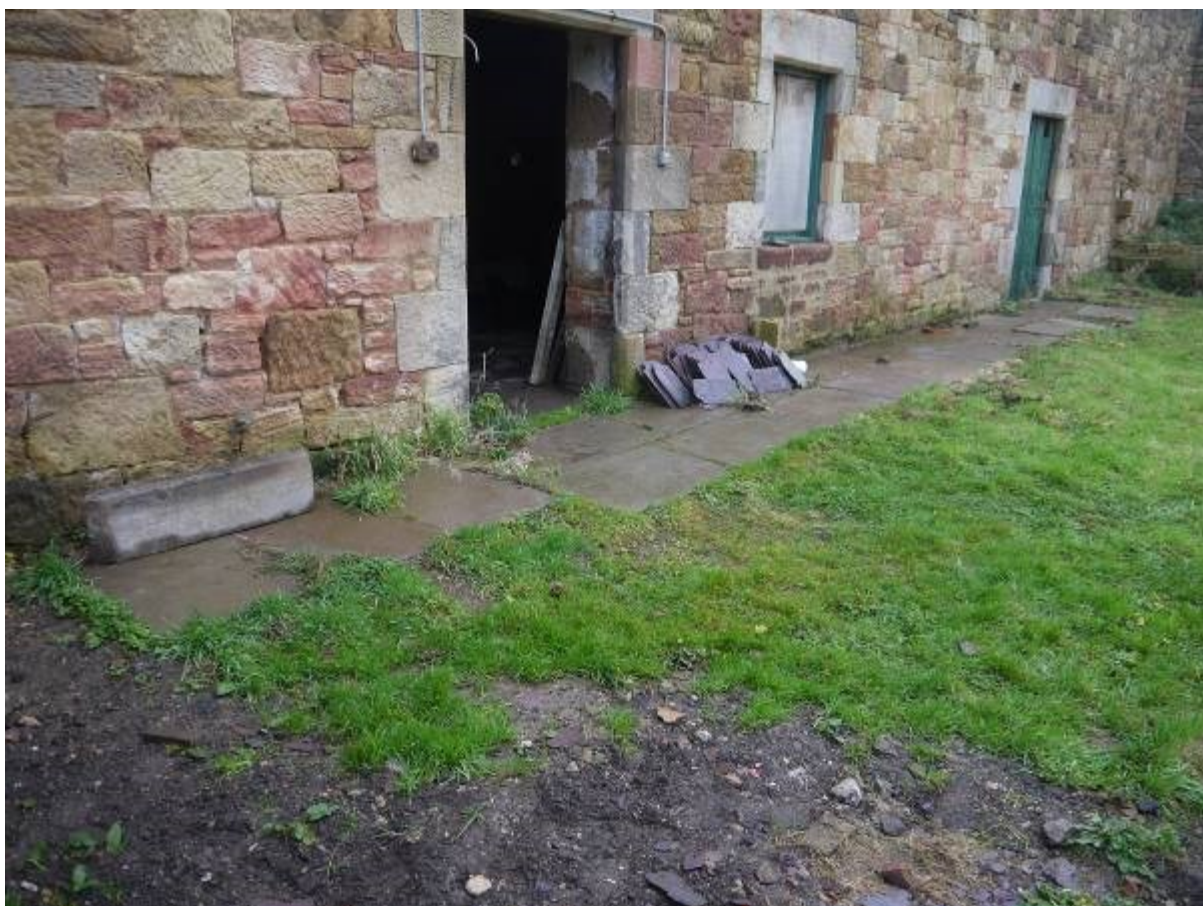
Illustration 27 Paved footpath along front of South Western elevation of Building B (Phase 1)

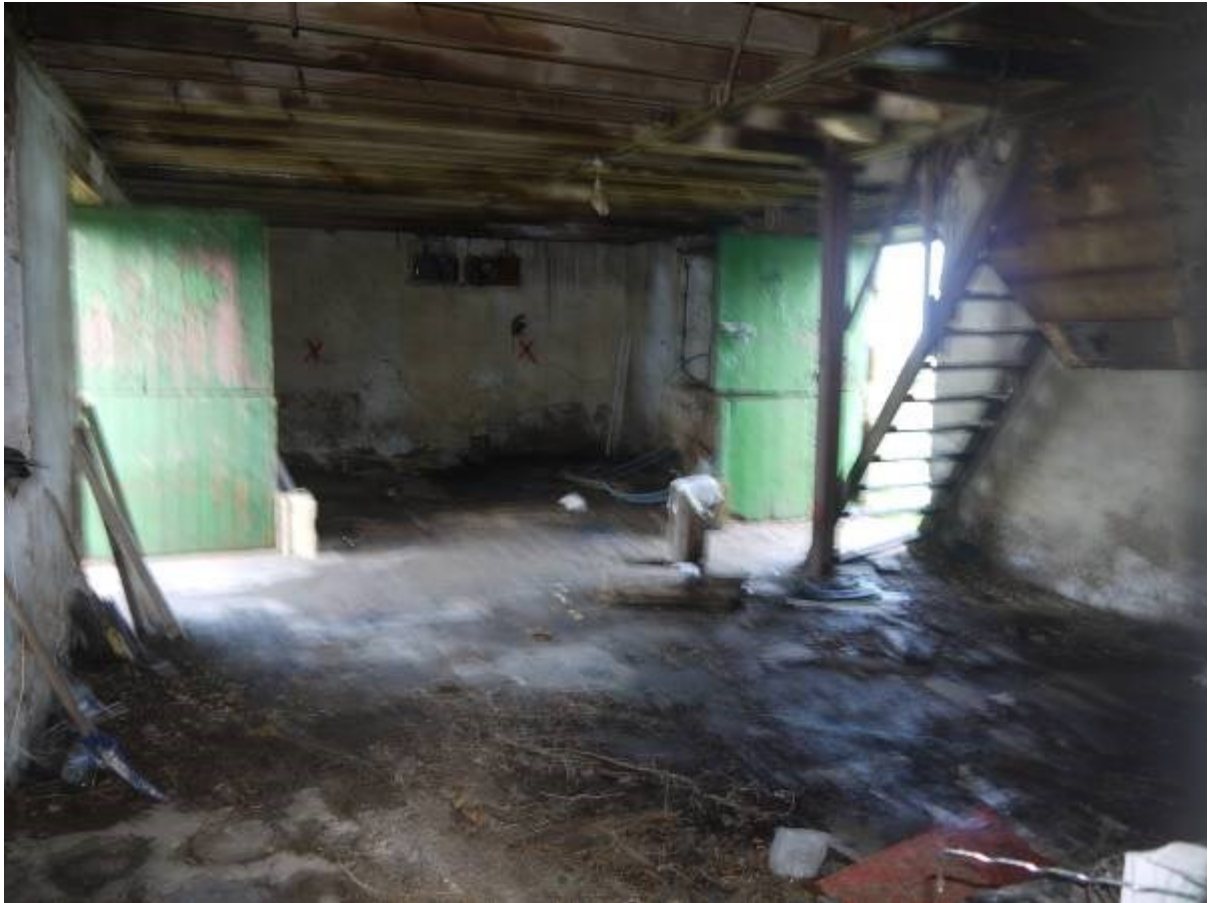
This building which is accessible from both the outside of the steading complex and the internal courtyard is subdivided into two rooms on its ground floor. The first of these rooms has a concrete floor and a wooden staircase that leads up to first floor level. The Northern wall of this room contains a blocked doorway that originally lead into Room A2 (see above). The Southern wall contains a doorway that leads into the second ground floor room (E on plan). In the South East corner of the first room there is a piece of farm machinery mounted on a brick plinth. This piece of machinery has 'BAMFORDS, UTTOXETER, ENGLAND 2583' marked on it in raised lettering.

Illustration 28 Ground floor of Building B (Phase 1) looking North West, blocked doorway between red crosses on wall

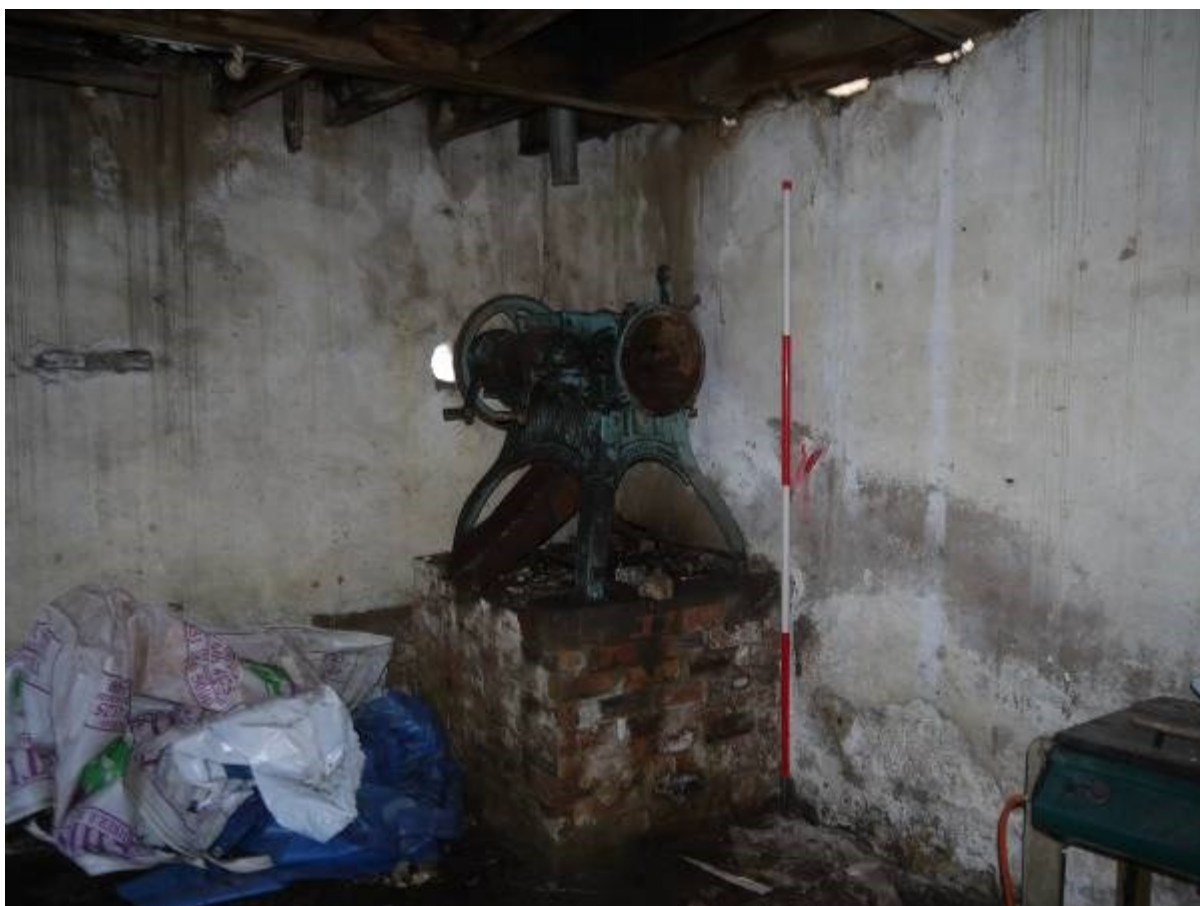
Illustration 29 Bamford Rapid Grinding Rolling Mill in ground floor room of Building B (Phase 1) looking North East (note hole in wall)

From limited research by the author the piece of farm machinery inside Building B is a Bamford Rapid Grinding Rolling Mill which was manufactured by the company from 1887 until the 1970's (pers comm. Phillip Wood <http://henrybamfordandsonsutttoxeterengland.co.uk/>). The small square hole in the North Eastern wall of Building B is directly adjacent to one end of this piece of machinery and may suggest that it was driven from the outside? The former functions of rooms A1 and A2 at the North East end of Building A are harder to understand.

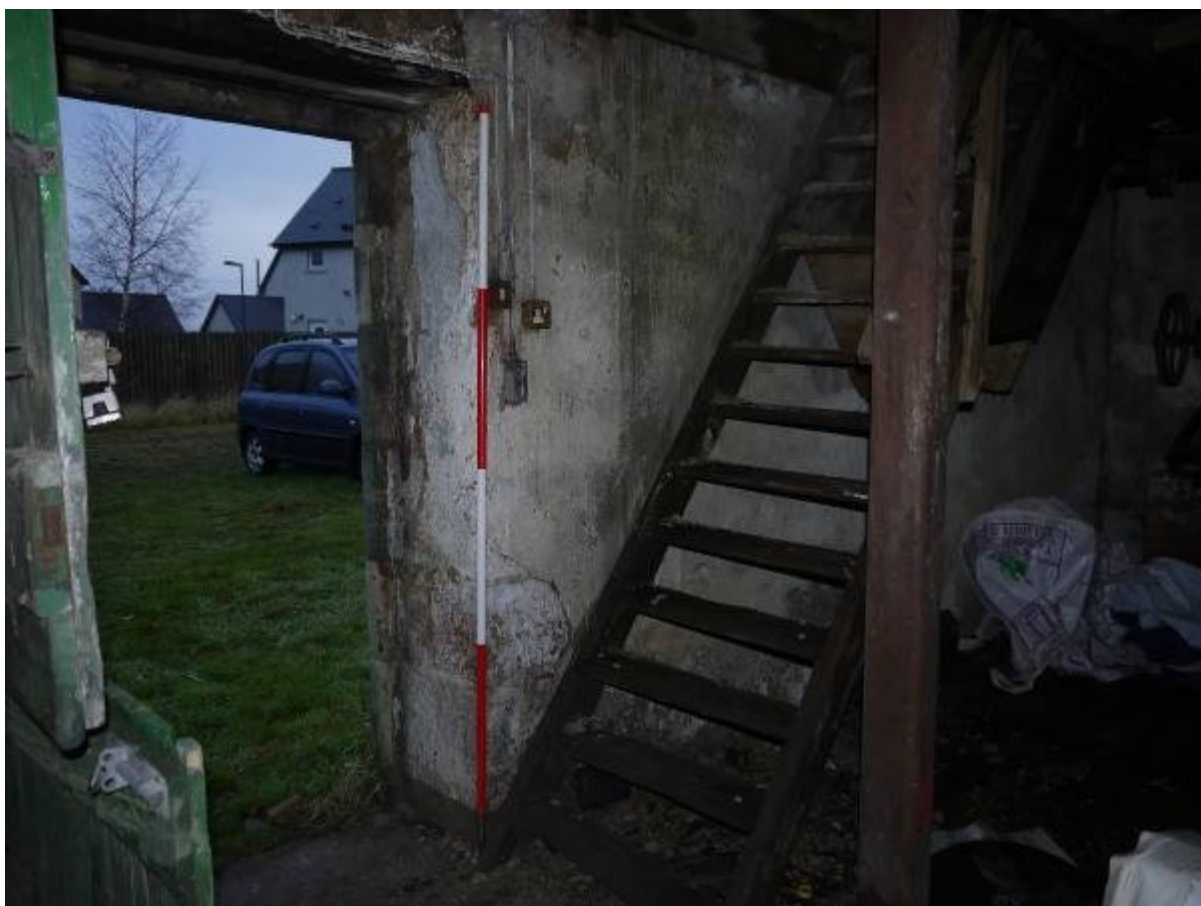
Illustration 30 Wooden staircase leading from ground floor of Building B (Phase 1) to upper floor

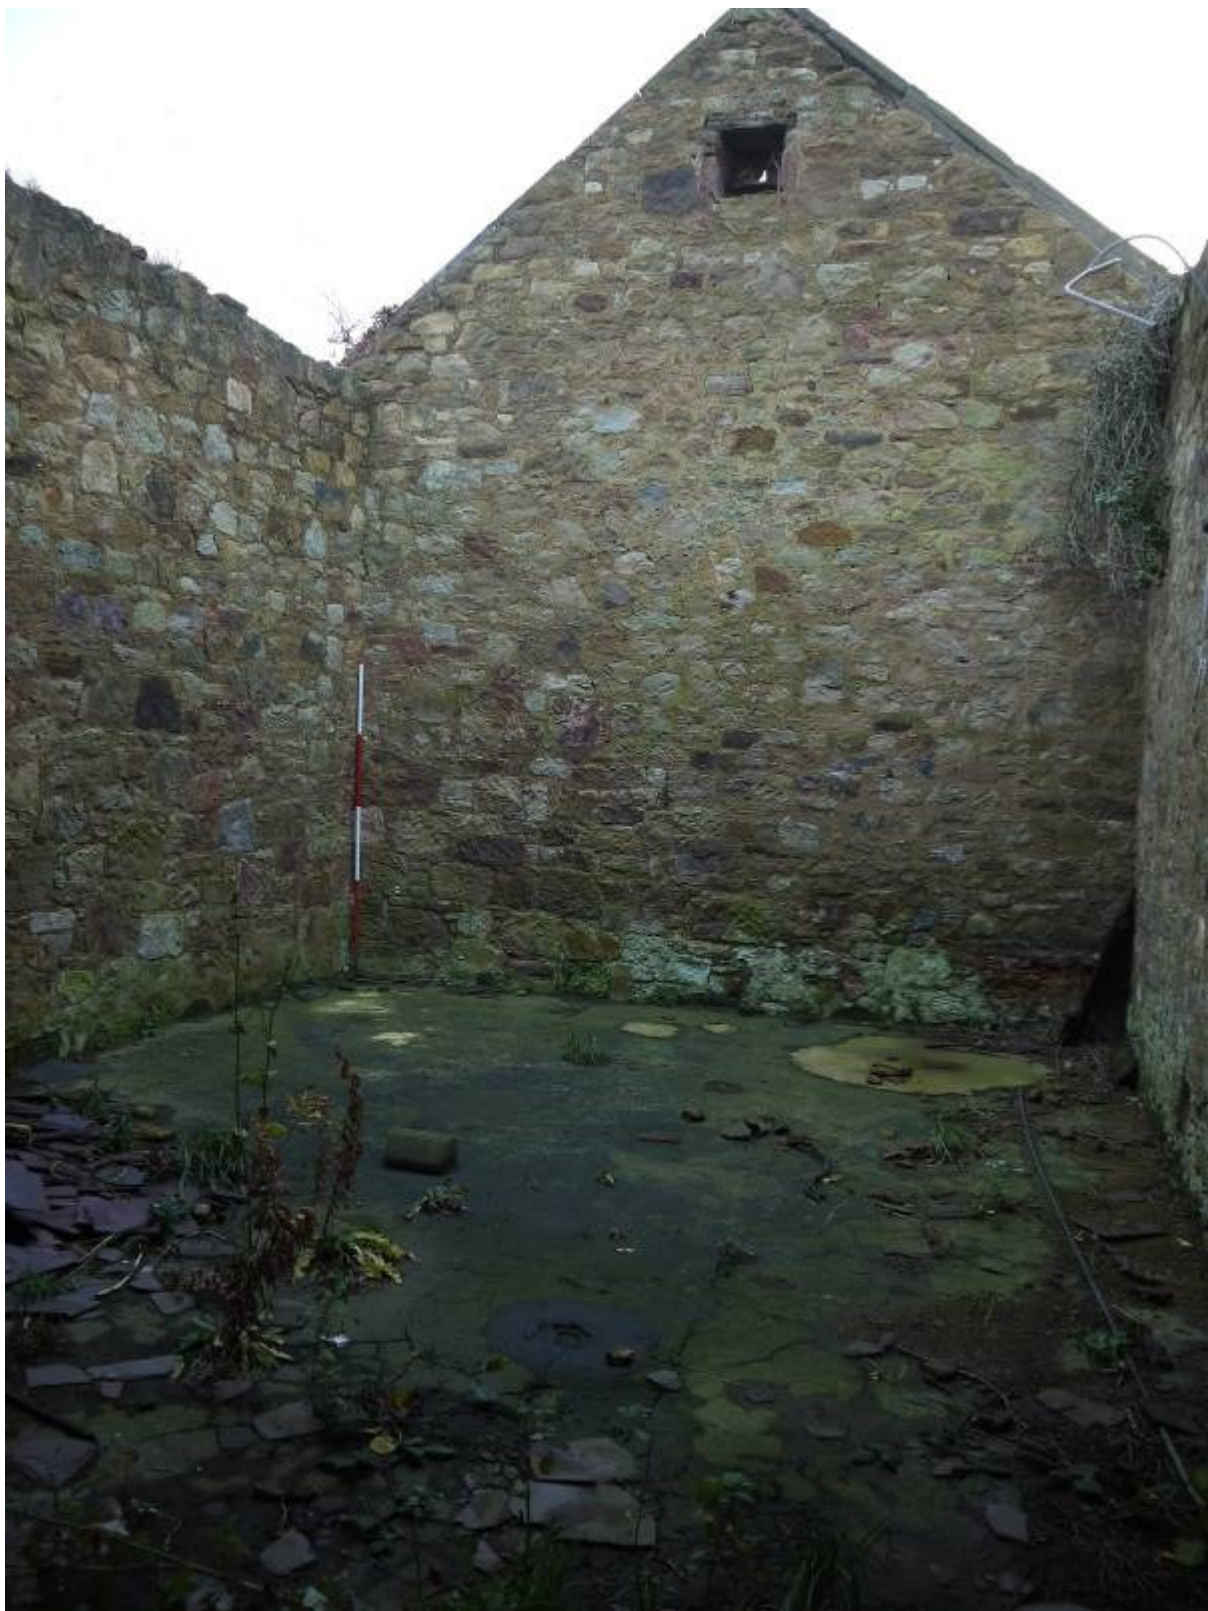
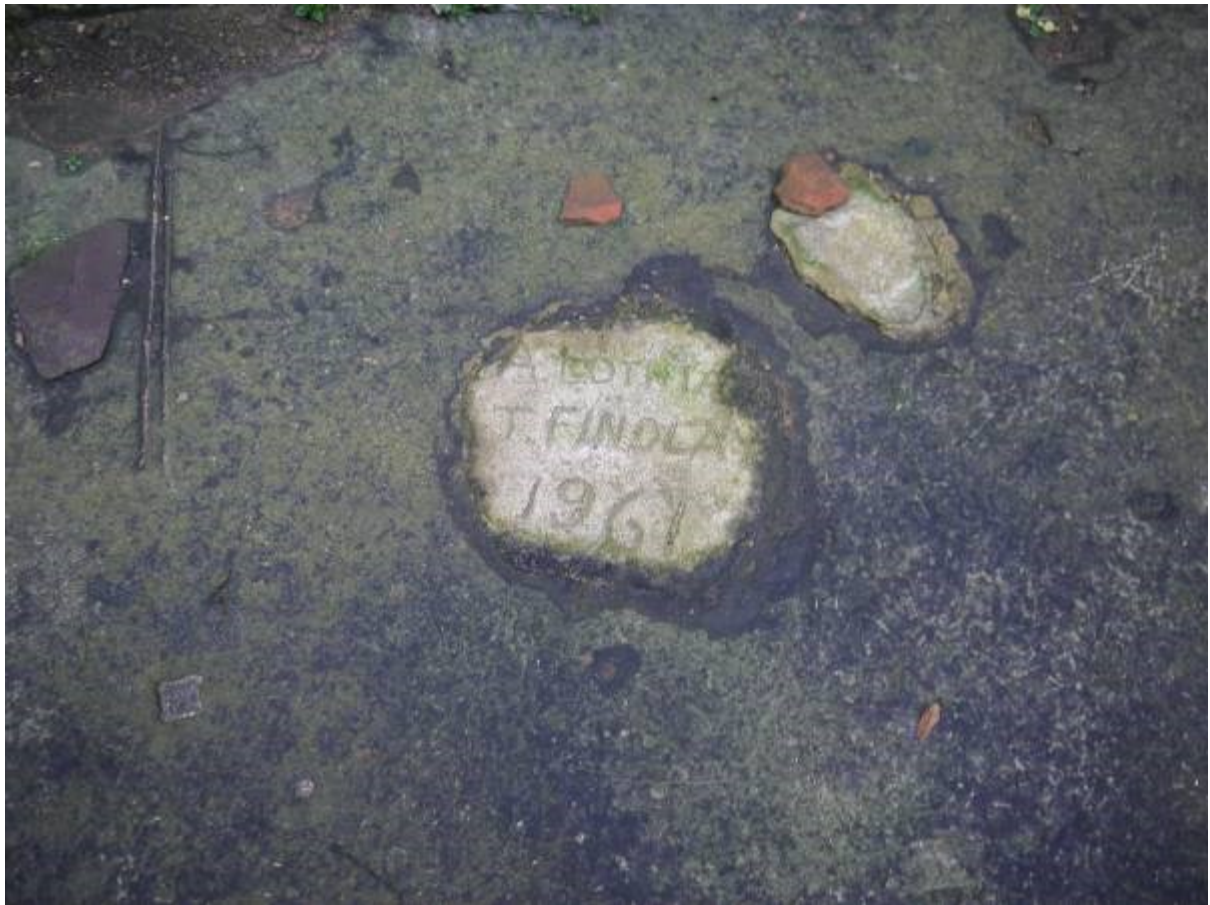
This room is now roofless and has a concrete floor which has a patch marked 'A Lothian T Findlay 1961'. The room has a doorway that leads outside the steading complex and another one that provides access to the internal courtyard. There is a door/window in its Northern wall that provides access into the first floor of Building B.

Illustration 31 Southern room of Building B (Phase 1) looking South East

Illustration 32 Signed patch of concrete floor in Southern room of Building B

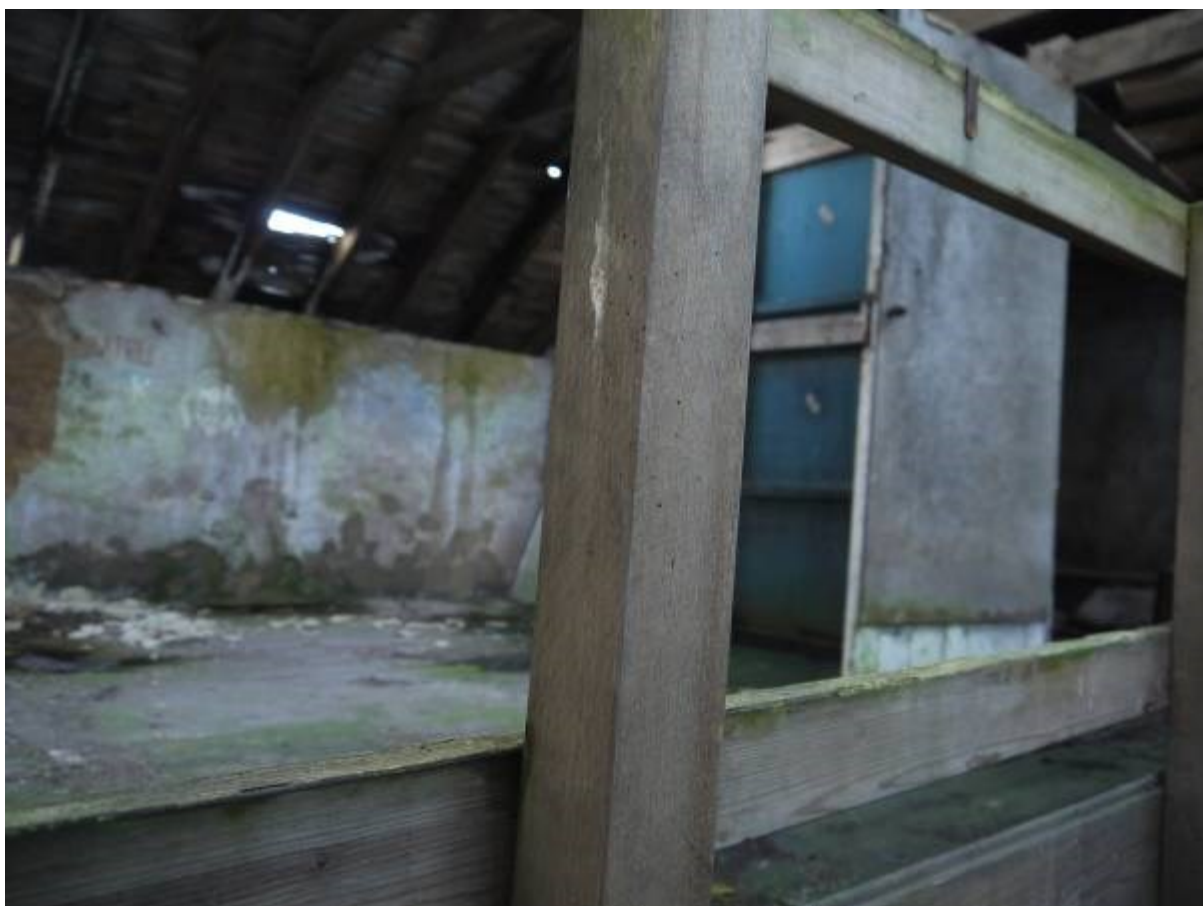
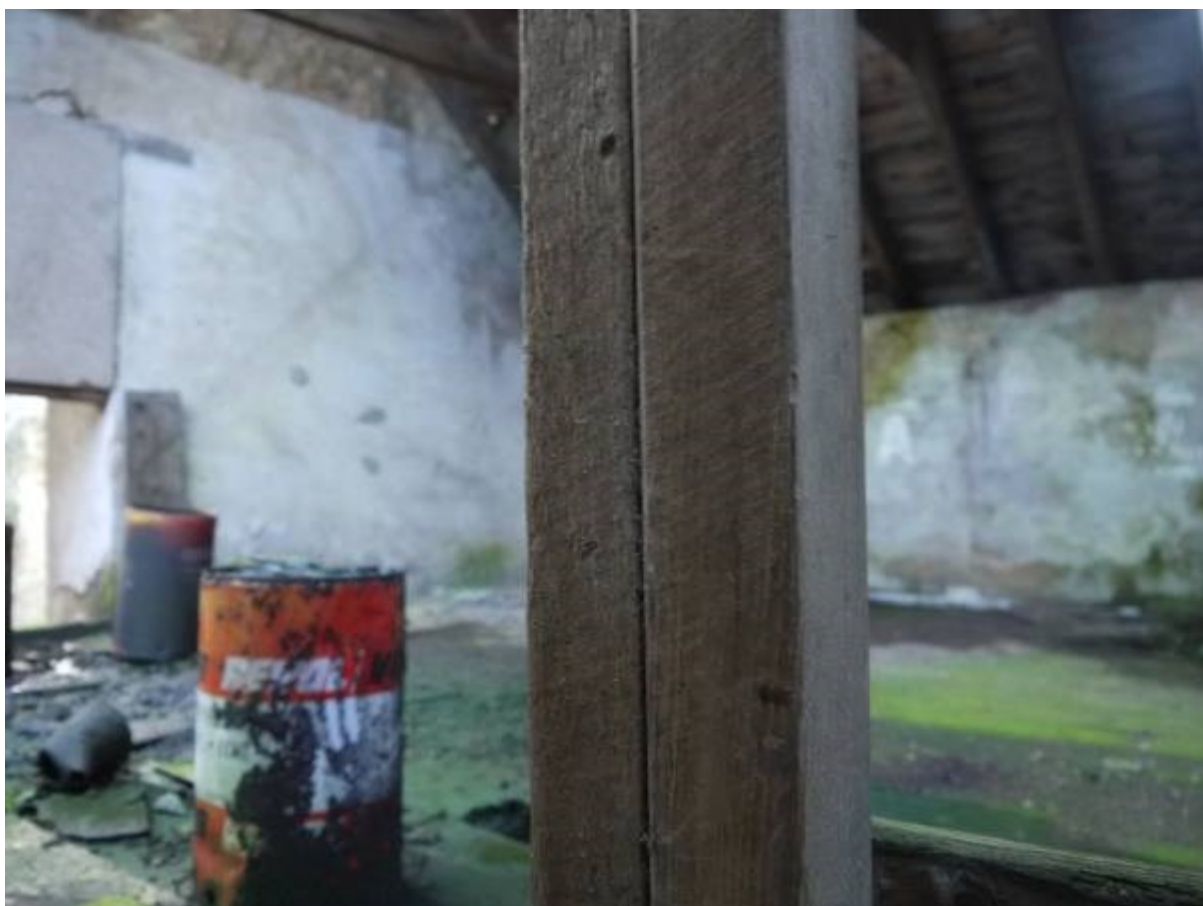
There are two rooms at first floor level both of which have very unsteady wooden floors. The South Western internal wall face of the room accessible from the staircase has several pieces of graffiti carved in it. The wooden roof rafters of the pitched slate roof provide the ceilings for both the upstairs rooms.

Illustration 33 Northern end of upper floor in Building B (Phase 1)

Illustration 34 Southern end of upper floor in Building B (Phase 1)

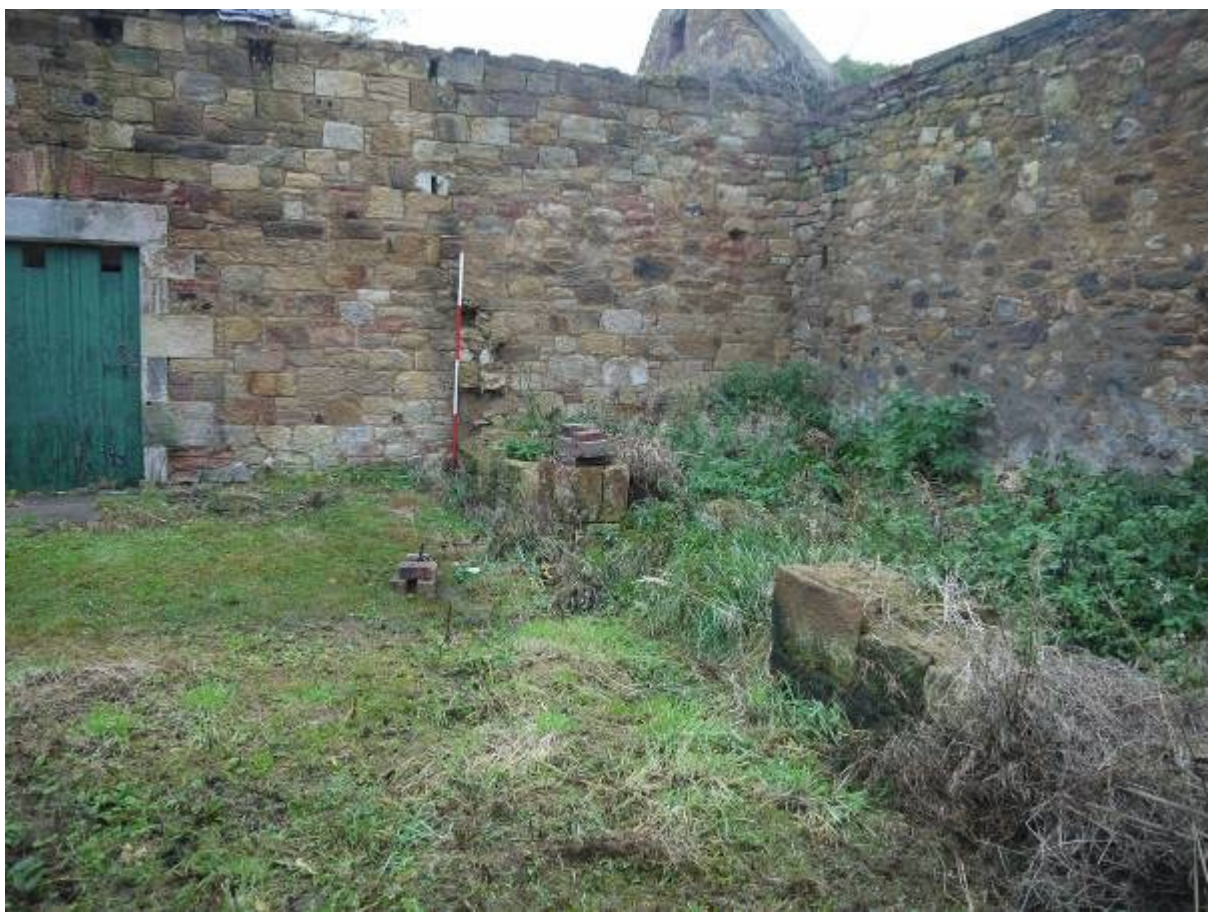
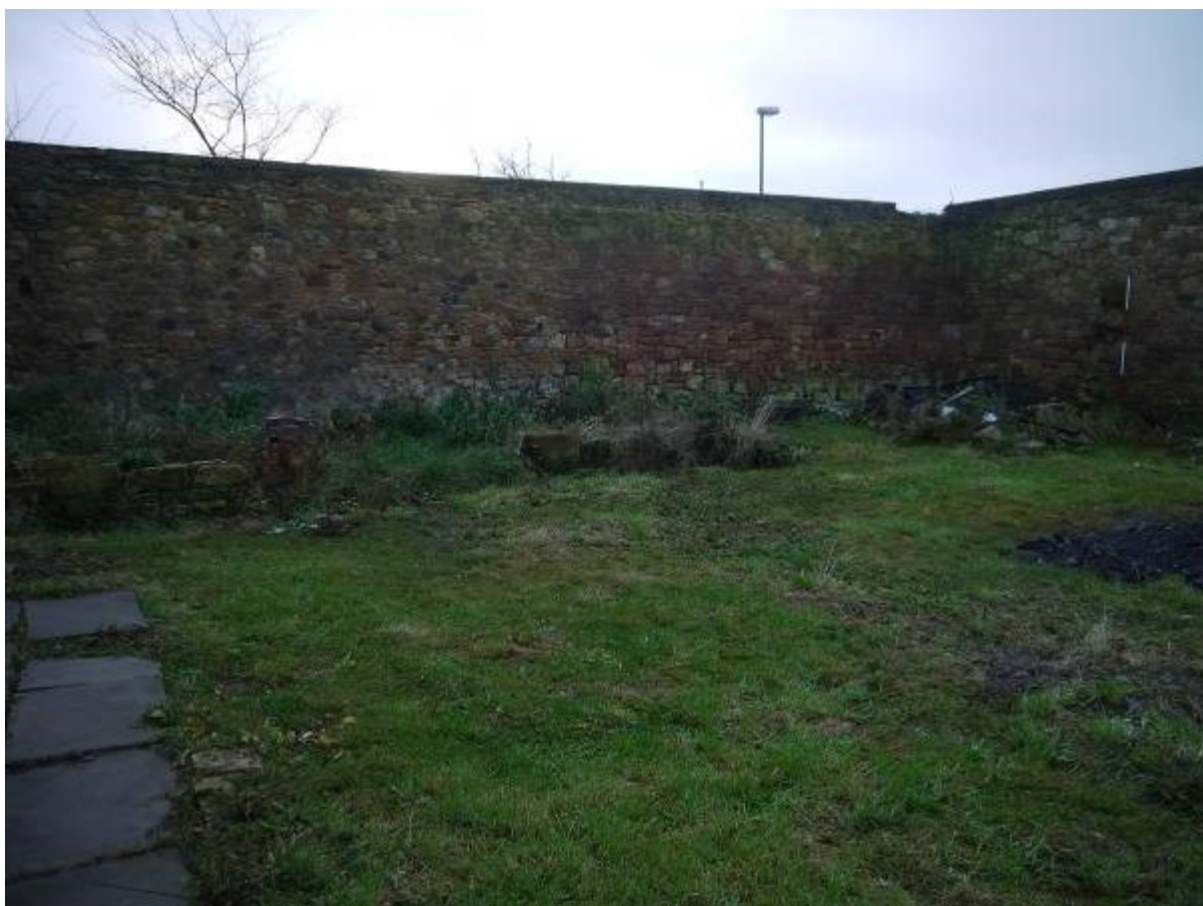
This building has been largely demolished but once formed the South Eastern side to the internal courtyard. Its North Western wall still stands two courses high to a height of 0.56m. At its North

Eastern end this wall was keyed into the wall of Building B and at its South Western end the Steading boundary wall. Roof raggles are visible in the stonework at both ends of the North Western wall indicating that the building once stood 2.10m high. The remains of two doorways/entrances into this building are still visible the Northern one being 2.30m wide the Southern one 2.6m wide.

Illustration 35 Partially demolished remains of Building C (Phase 1) looking North East at its junction with Building B (Phase 1) entrance visible in foreground

Illustration 36 Demolished remains of Building C (Phase 1) looking South East with roof raggles visible in South Eastern wall beside scale, both former entrances visible

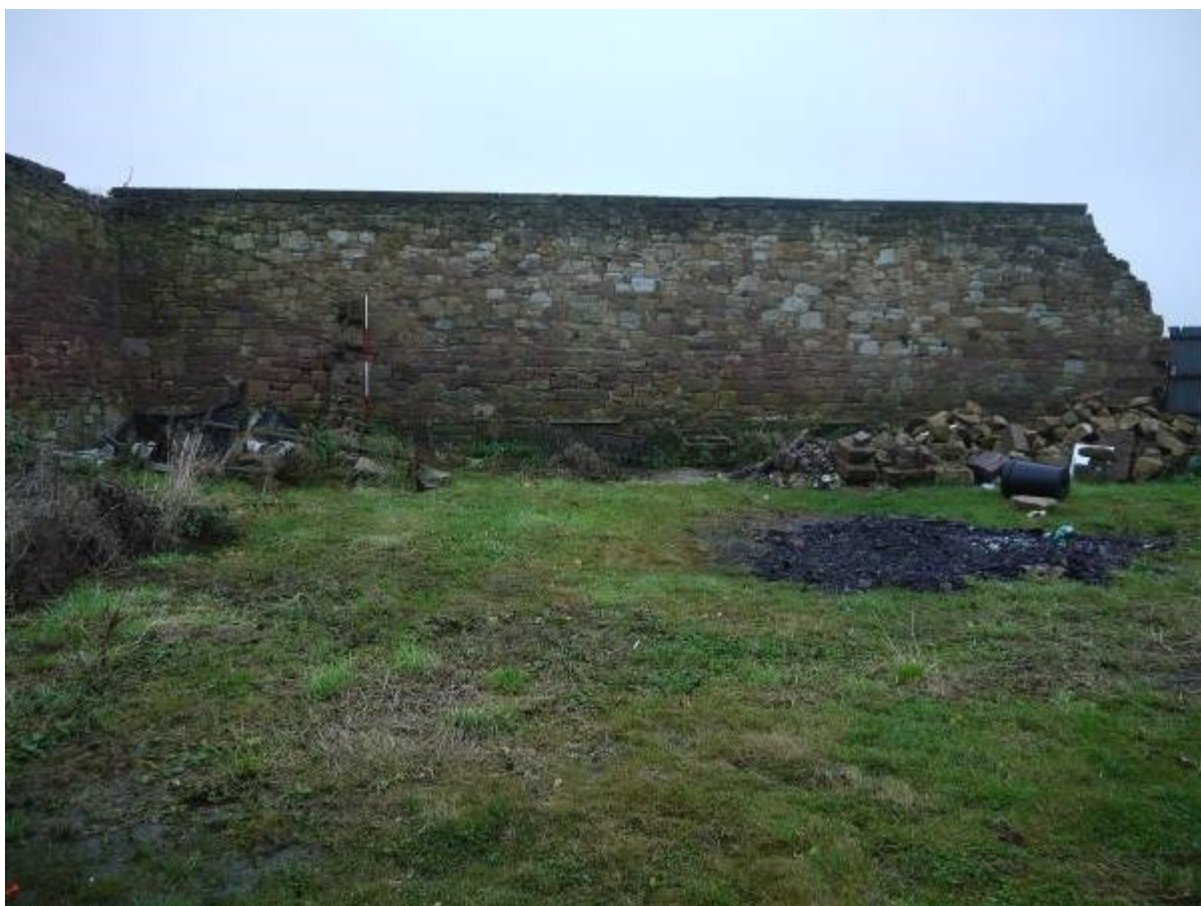
Buildings A, B and C surround an enclosed internal grassed courtyard which has an entrance gate that leads out onto the passing road.

Illustration 37 South Western boundary wall to steading complex with roof raggle of South end of demolished building C (Phase 1) visible beside scale
