Archaeological Watching Brief
on further engineers test pits
Aberdeen Art Gallery and Robert Gordon's
College, Schoolhill, Aberdeen

9th May 2013

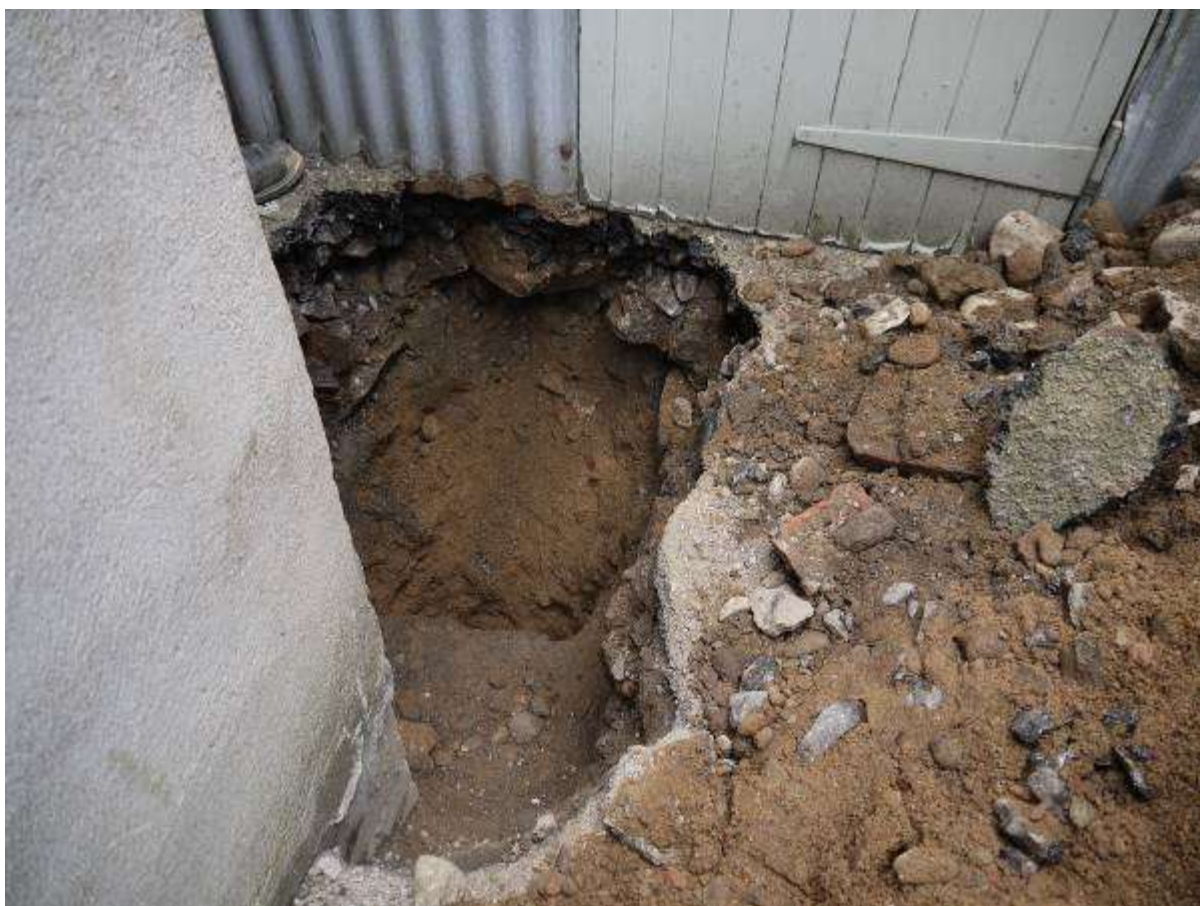
Illustration 4 General view of extended STP1 looking north

This was dug against the northern wall of the Art Gallery in the service yard and measured 1m by 0.50m. A layer of tarmac 0.08m thick (1) was removed to expose a grey brown sandy clay, brick and stones 0.55m thick (2) a concrete wall foundation was hit at a depth of 0.63m below the yard level. This pit was expanded to the north and hit a layer of large laid stone cobbles (3) at depth of 0.40m below modern yard level below this layer was a yellow brown sandy clay and stone (natural) (4) at a depth of 0.50m. This pit was dug to a depth of 1.2m to check the natural deposits. There were no finds.

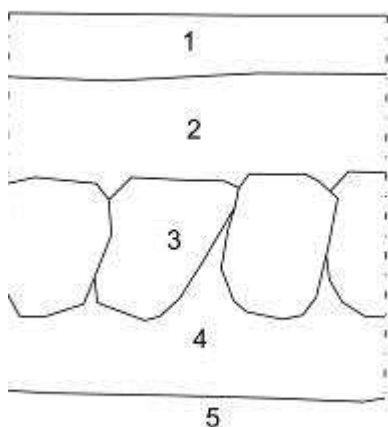
Illustration 5 South facing section of STP1 (context 5 is natural ground surface) Scale 1:10

- 1 Tarmac
- 2 Grey brown sandy clay and stones
- 3 Cobbled surface
- 4 Yellow brown sandy clay (Natural)

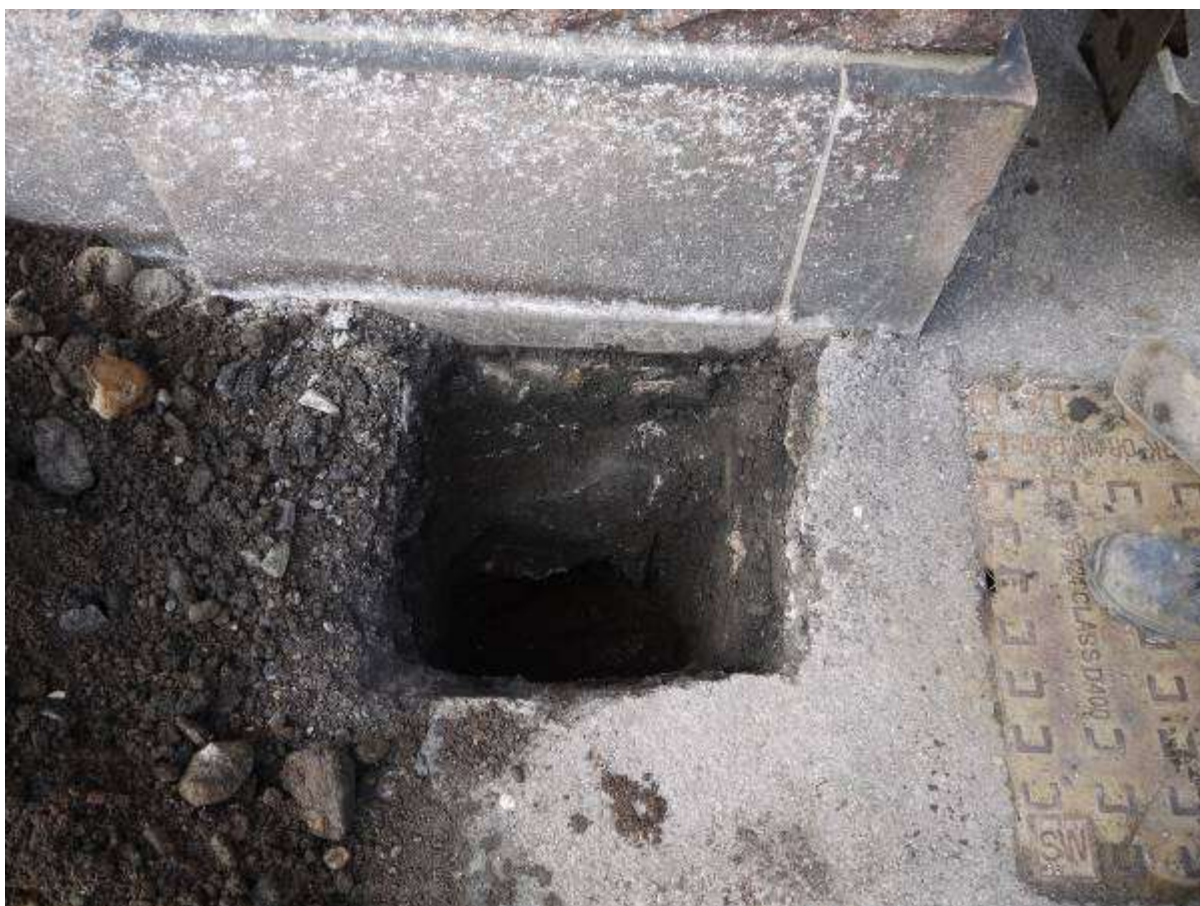
Illustration 6 STP3 looking west

This was dug against the north eastern corner of the Art Gallery building and measured 0.50m by 0.50m. A layer of tarmac 0.10m thick (1) was removed to expose a grey brown sandy clay 0.48m thick (2) this layer directly over lay a brown sandy clay and stones (natural) (3) at depth of 0.58m. The Art Gallery wall has a stepped wall foundation at a depth of 0.50m below current ground level. There were no finds.

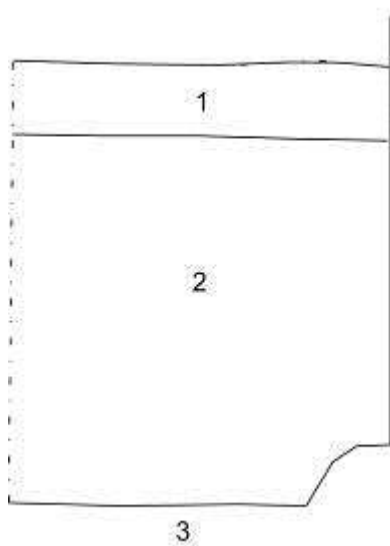
Illustration 7 north facing section of STP3, Aberdeen Art Gallery wall to right (context 3 is natural ground surface) Scale 1:10

- 1 Tarmac
- 2 Grey brown sandy clay
- 3 Brown sandy clay and stones (Natural)

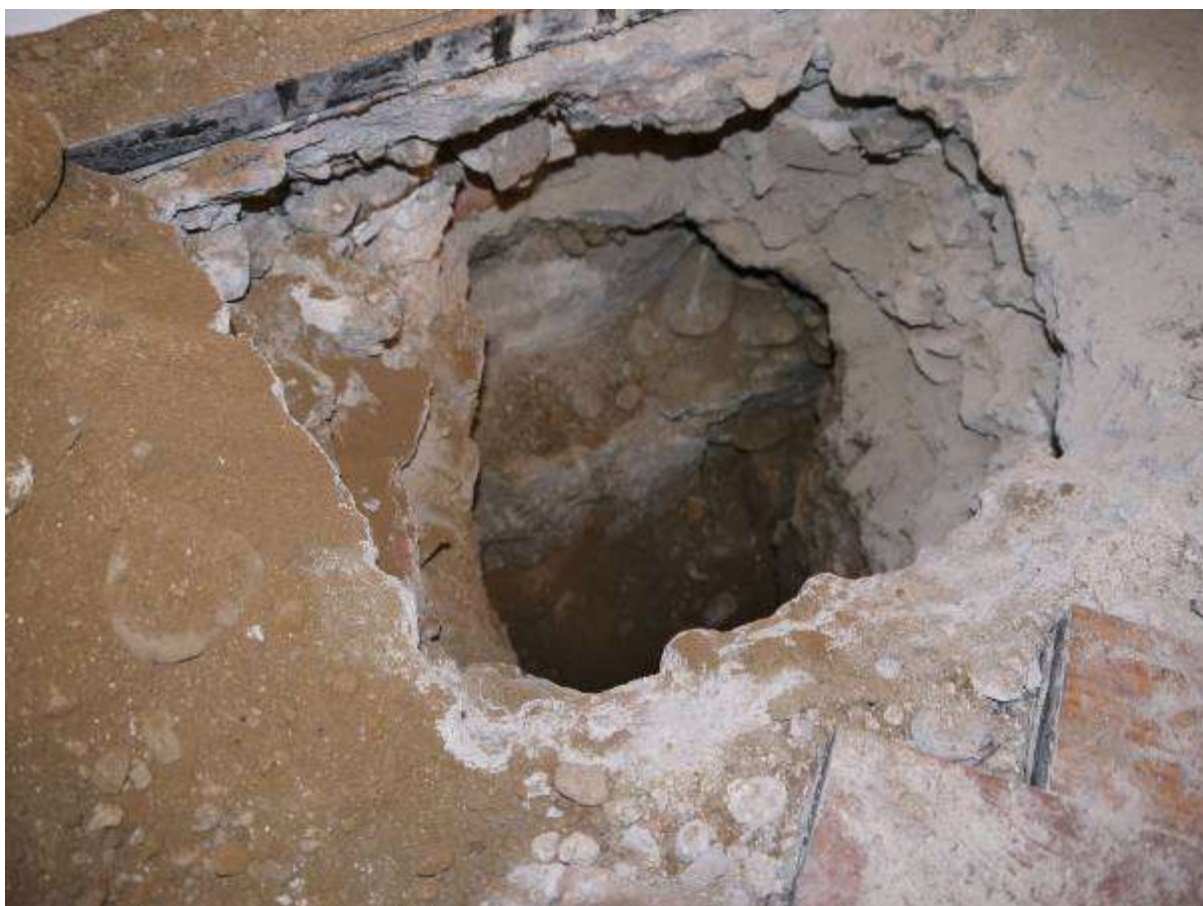
Illustration 9 Wall face in STP4 looking south

This was dug inside the Art Gallery building against one of its internal walls and measured 1m by 0.55m. A layer of concrete 0.13m thick (1) overlay a loose concrete and stone 0.27m thick (2) which overlay a grey brown sandy clay and stone 0.50m thick (3). A deposit of light brown gravel and stones (natural) (4) was reached at a depth of 0.90m below the gallery floor. The gallery wall has a stepped foundation at a depth of 0.60m that is 0.12m thick), the base of the wall foundation is at at 0.90m. There were no finds.

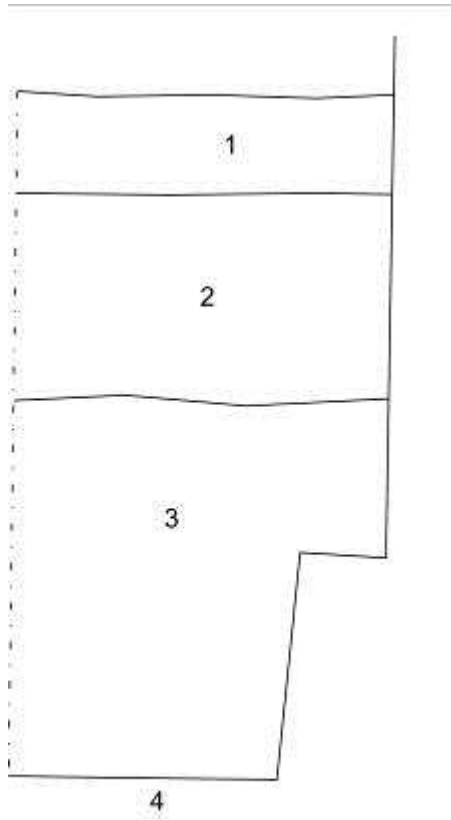
Illustration 10 south facing section of STP4, Aberdeen Art Gallery internal wall to right (context 4 is natural ground surface) Scale 1:10

- 1 Concrete
- 2 Loose concrete and stone
- 3 Grey brown silty clay and stones
- 4 Light brown gravel and stones (Natural)

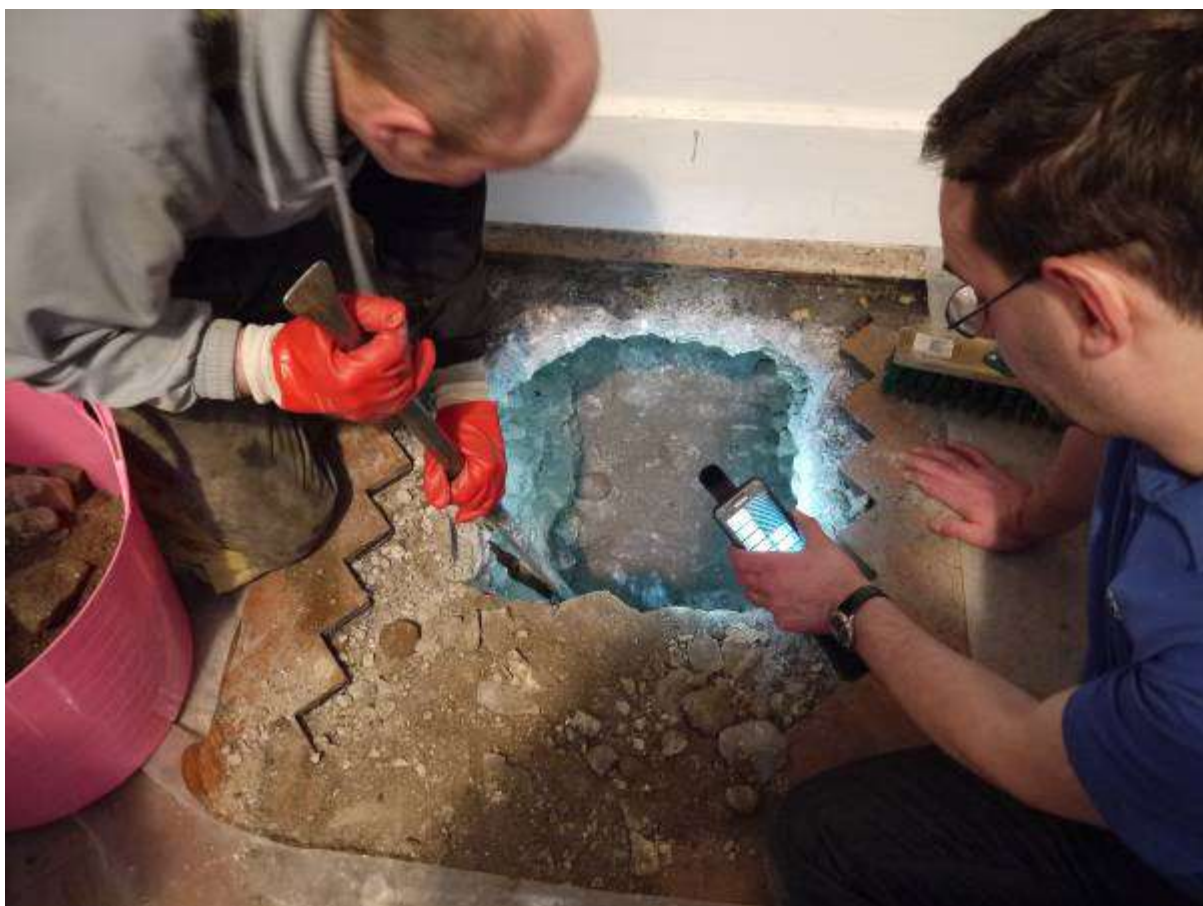
Illustration 12 wall face in STP5 looking west

This was dug inside the Art Gallery building against one of its internal walls and measured 0.50m by 0.50m. A parquet floor 0.05m thick (1) was removed to expose a layer of concrete 0.10m thick (2) which over lay a loose stone 0.37m thick (3) which overlay a moderate brown black silty clay with abundant charcoal, occ stone and mortar flecks 0.58m thick (4), a brown silty clay (natural) (5) was reached at a depth of 1.10m below the gallery floor. The gallery wall has a stepped foundation at a depth of 0.75m which is 0.25m wide and a second step at 0.95m which is 0.10m wide. There were no finds.

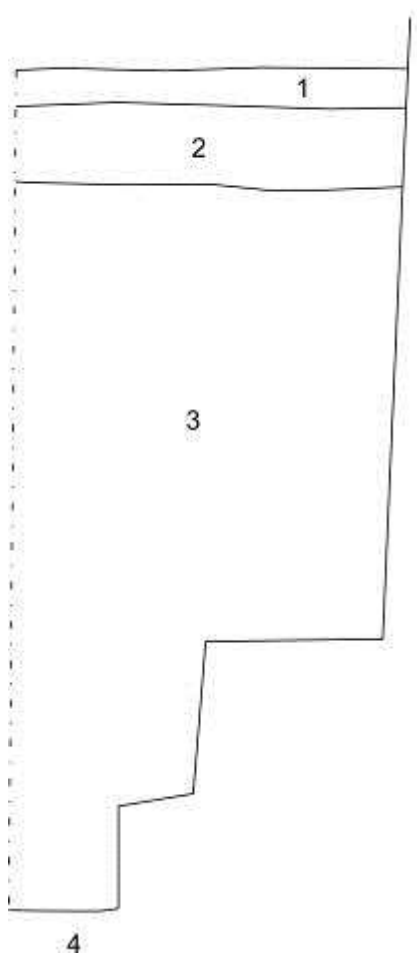
Illustration 13 North facing section of STP5 Aberdeen Art Gallery internal wall to right (Context 4 is natural ground surface) Scale 1:10

- 1 Parquet floor
- 2 Concrete
- 3 Loose stone
- 4 Brown black silty clay with abundant charcoal, occasional stone and mortar flecks
- 5 Brown silty clay (Natural)

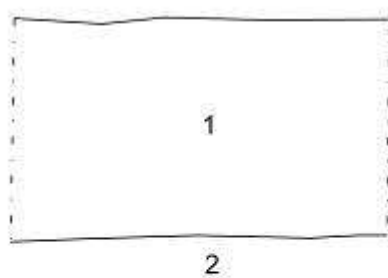
Illustration 15 west facing section of STP6 (Context 2 is granite slab) Scale 1:10

This was inside the Art Gallery staff room and measured 0.55m by 0.30m. This pit was dug to 0.28m below the gallery floor and went straight into a granite slab (2) below the concrete floor (1). It was abandoned.

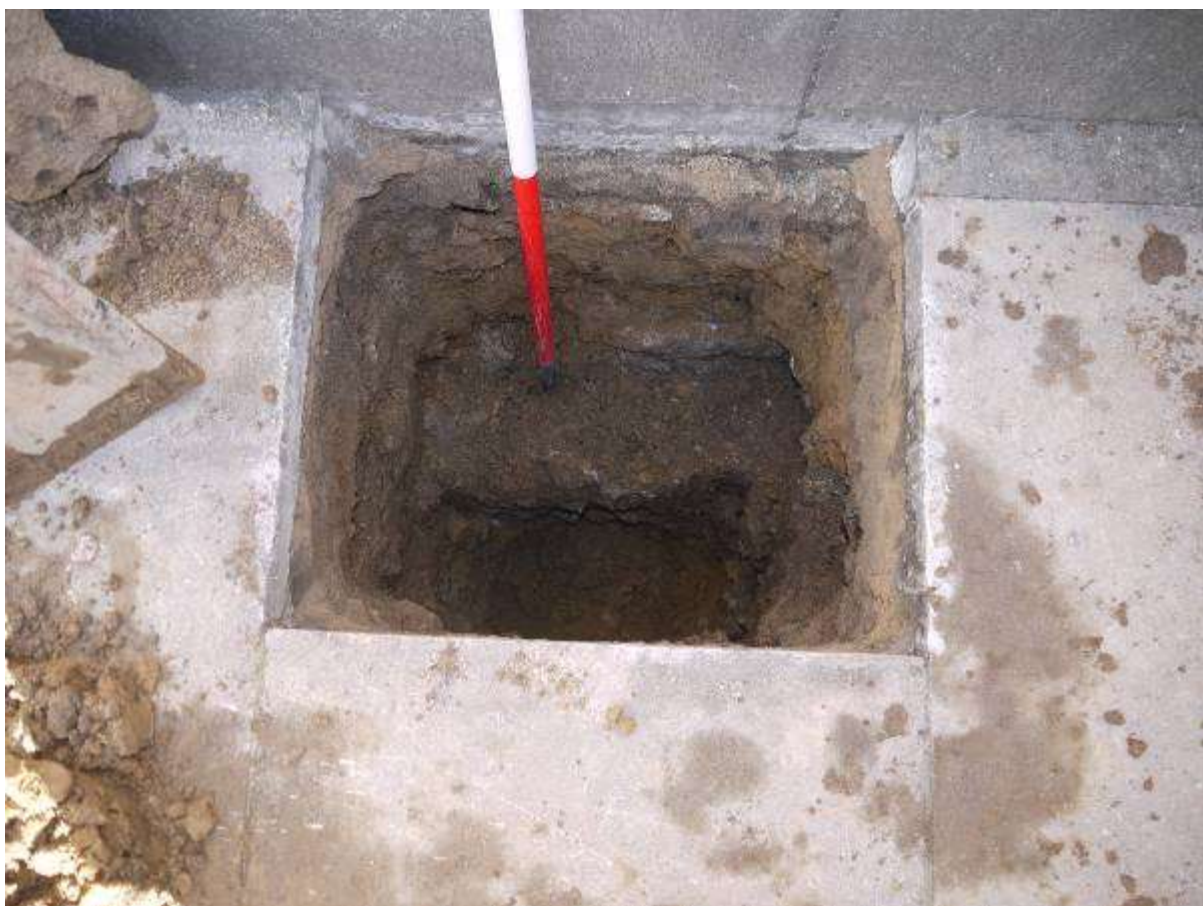
Illustration 17 STP8 excavated to natural and base of wall foundation looking north

This was dug outside the front of the Art Gallery at its western end and measured 0.60m by 0.54m. A stone slab 0.07m thick (1) was lifted to expose 0.22m of yellow sand and clay (2) which overlay 0.65m of grey brown silty clay and stones (3). Yellow brown sandy clay (natural) (4) was reached at a depth of 0.94m below modern ground level, the pit was dug to a depth of 1.30m. The Art Gallery wall has a stepped foundation at a depth of 0.65m (0.20m wide, 0.31m thick). There were no finds.

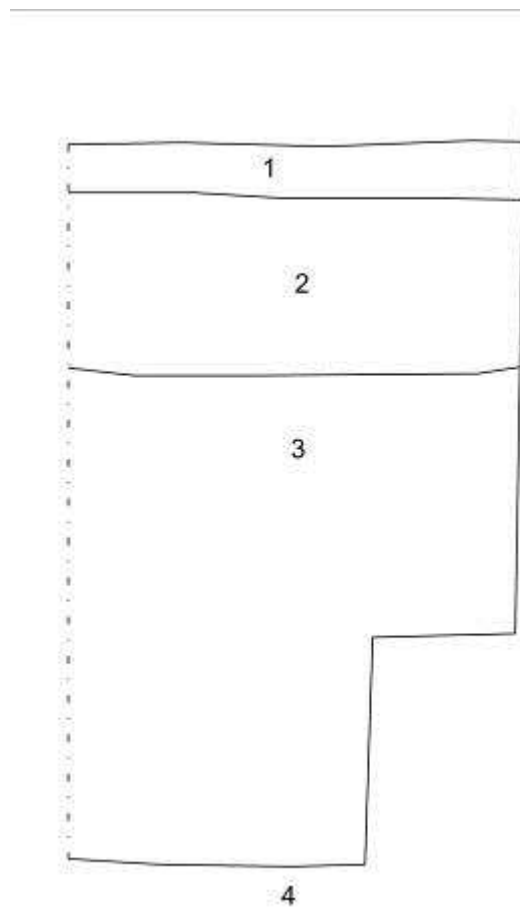
Illustration 18 east facing section of STP8 Aberdeen Art Gallery wall to right (Context 4 is natural ground surface) Scale 1:10

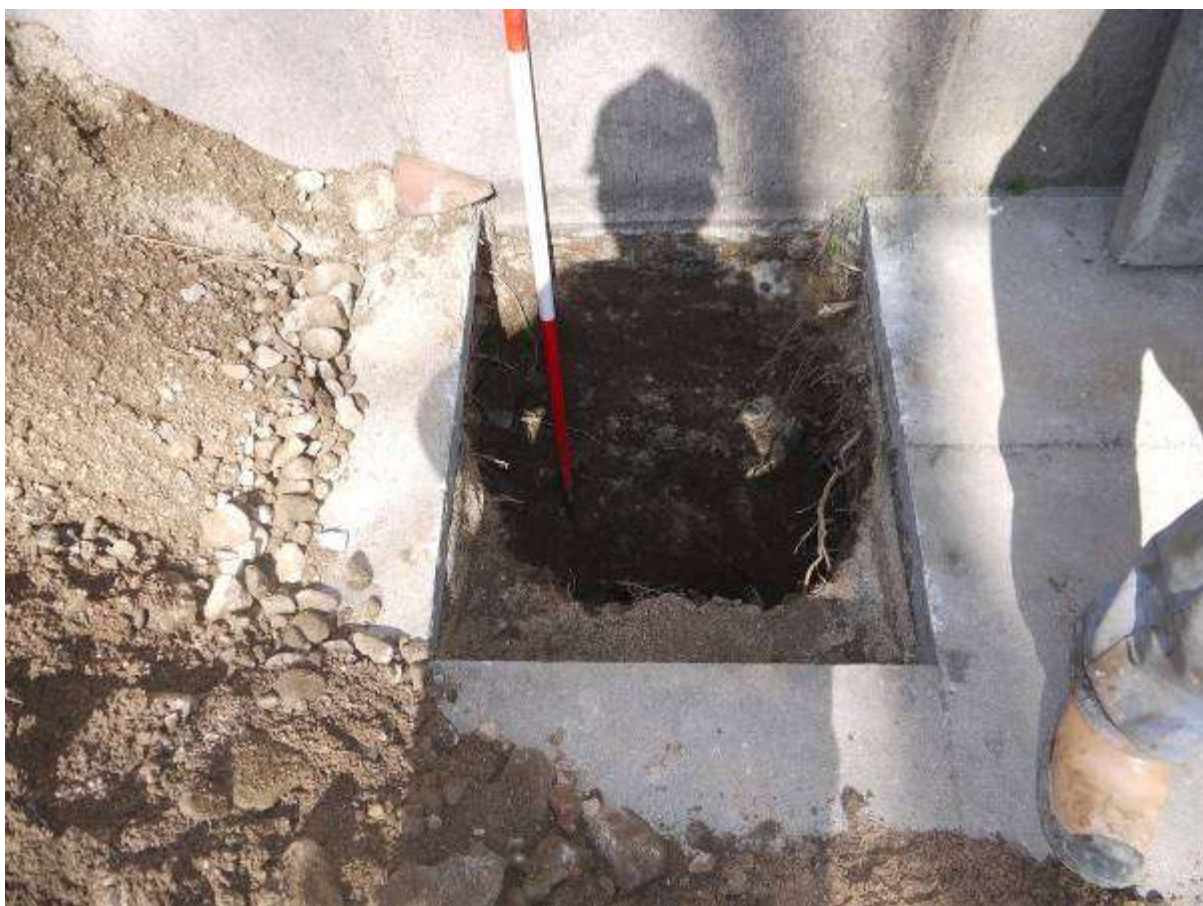
Illustration 20 STP9 excavated to natural and base of wall foundation looking north

This was dug outside the front of the Art Gallery at its eastern end toward the archway into Robert Gordon's College and measured 0.60m by 0.60m. A stone slab 0.07m thick (1) over lay 0.23m of yellow sand (2) which overlay 0.84m of brown sandy clay with frequent stones, occasional broken ceramic pipe and ceramic roof tile (3) which overlay a light brown silty clay (natural) (4) at 1.14m. The Art Gallery wall has a stepped foundation at a depth of 0.90m (0.30m wide and 0.20m thick). Aside from pieces of early modern ceramic drain pipe there were no other finds.

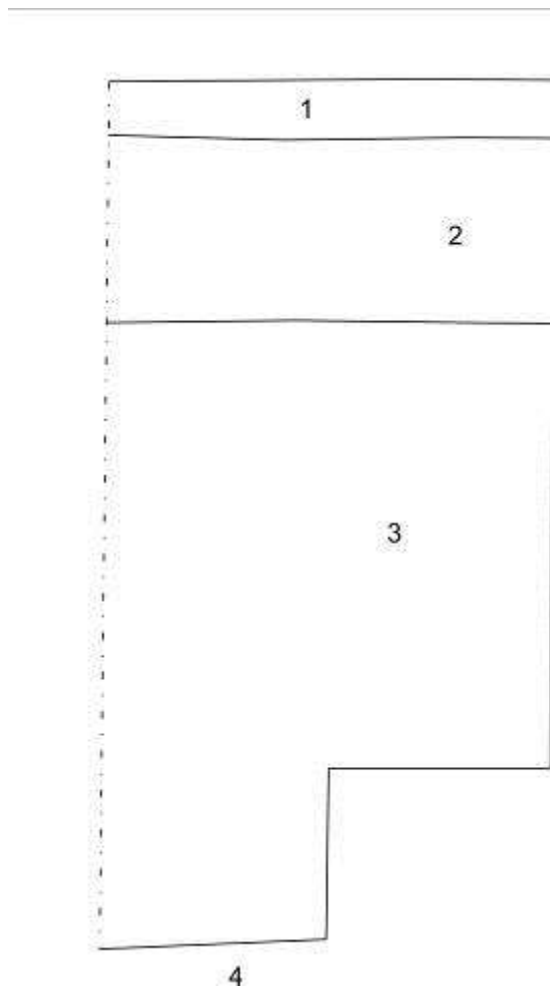
Illustration 21 east facing section of STP9, Aberdeen Art Gallery wall to right (Context 4 is natural)
Scale 1:10

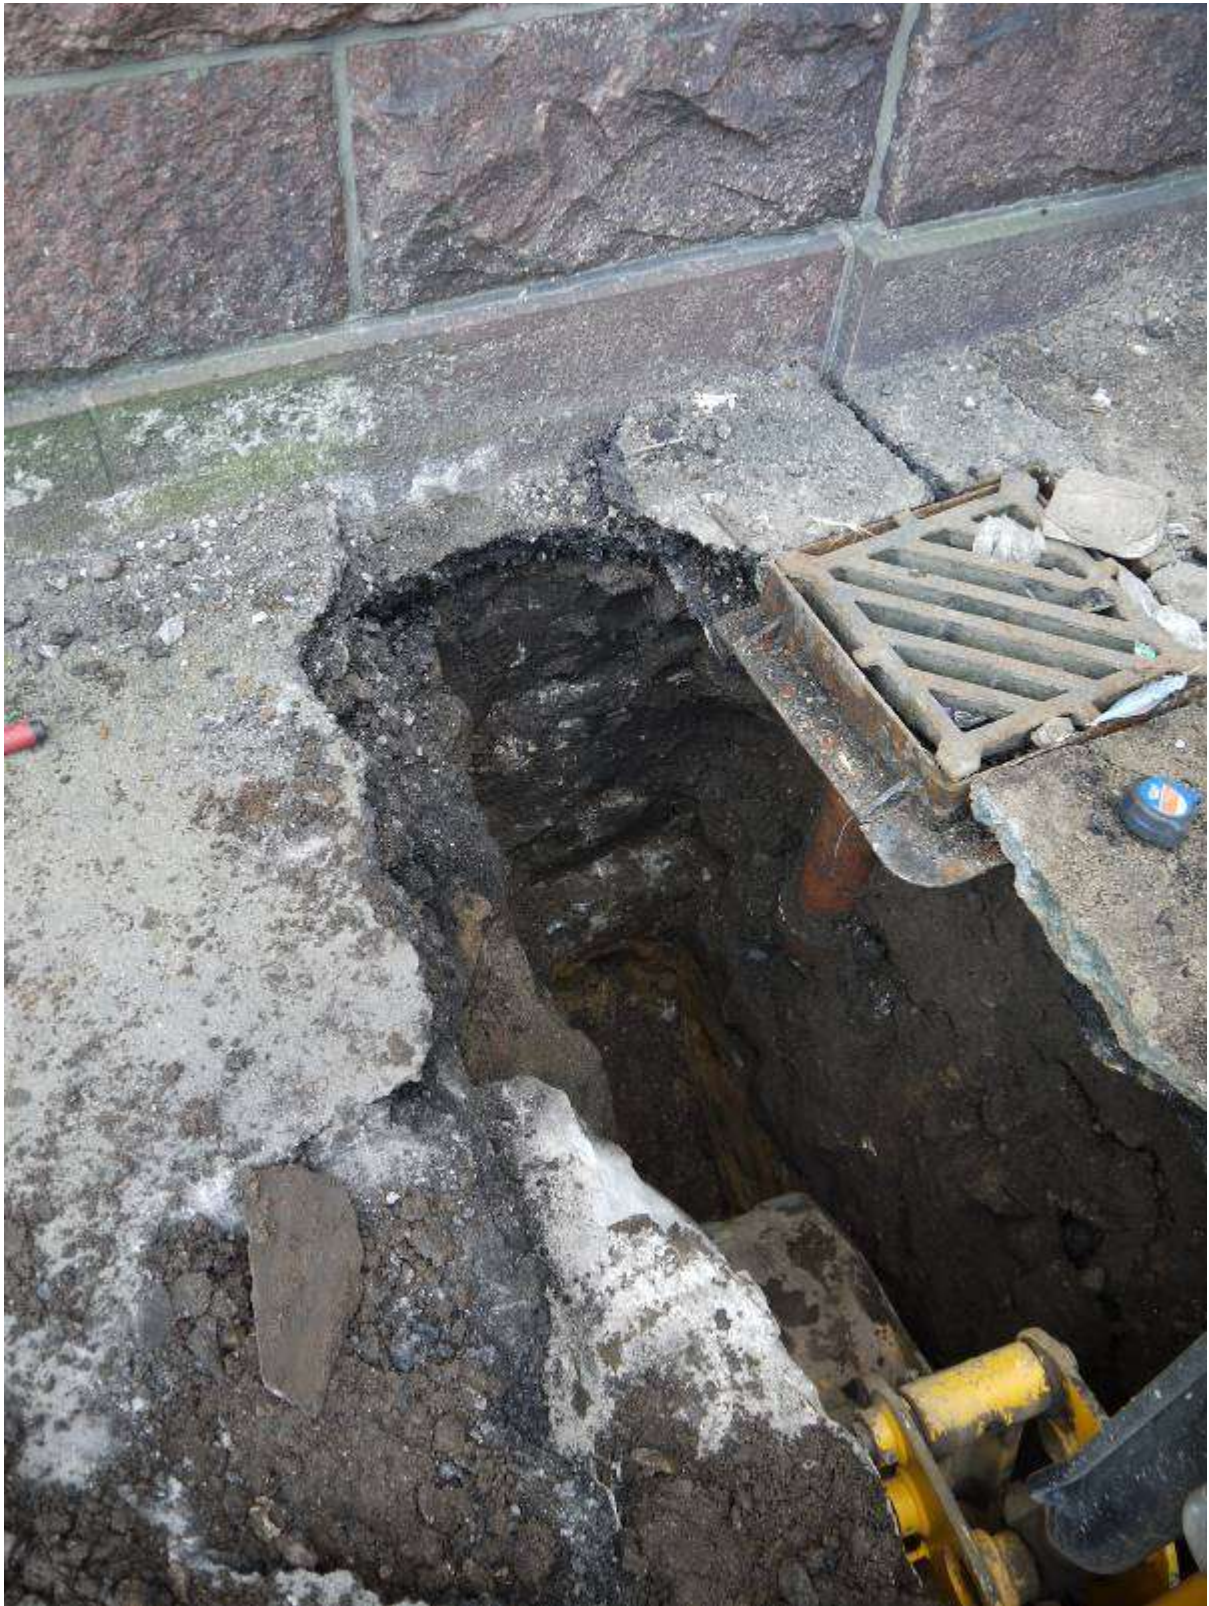
Illustration 23 TP2 excavated to natural and base of wall foundation looking south west

This measured 2m by 0.70m and was dug by mechanical excavator in the Robert Gordon's College car park against the northern wall of the Art Gallery (same location as Test Pit 1 monitored in October 2012). A layer of concrete 0.10m thick (1) was removed to expose a layer of tarmac 0.30m thick (2) which overlay a grey brown sandy clay with stone 1m thick (3) a brown compact sandy clay and stones (natural) (4) was reached at a depth of 1.48m below the car park. This trench was dug to depth of 1.9m to test the natural deposits. The Art Gallery wall has no step at this point but there is a change of build from granite to mortar bonded rough rubble at a depth of 0.55m below the car park.

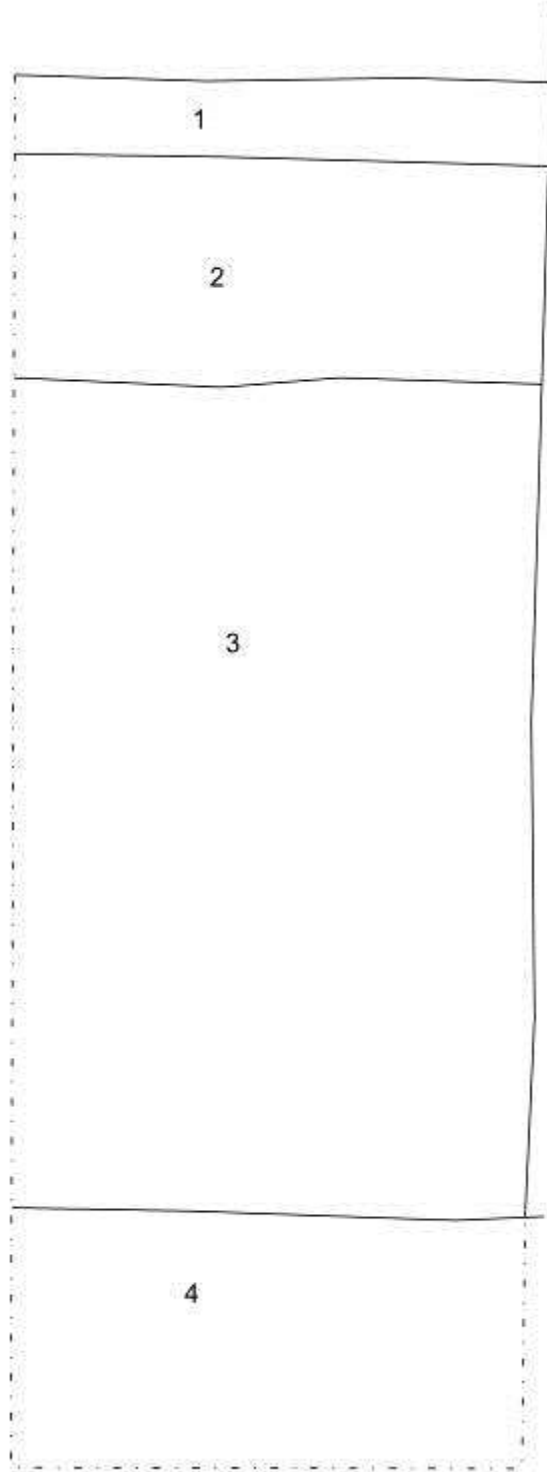
Illustration 24 west facing section of TP2 Aberdeen Art Gallery wall to right (Context 4 is natural ground surface) Scale 1:10

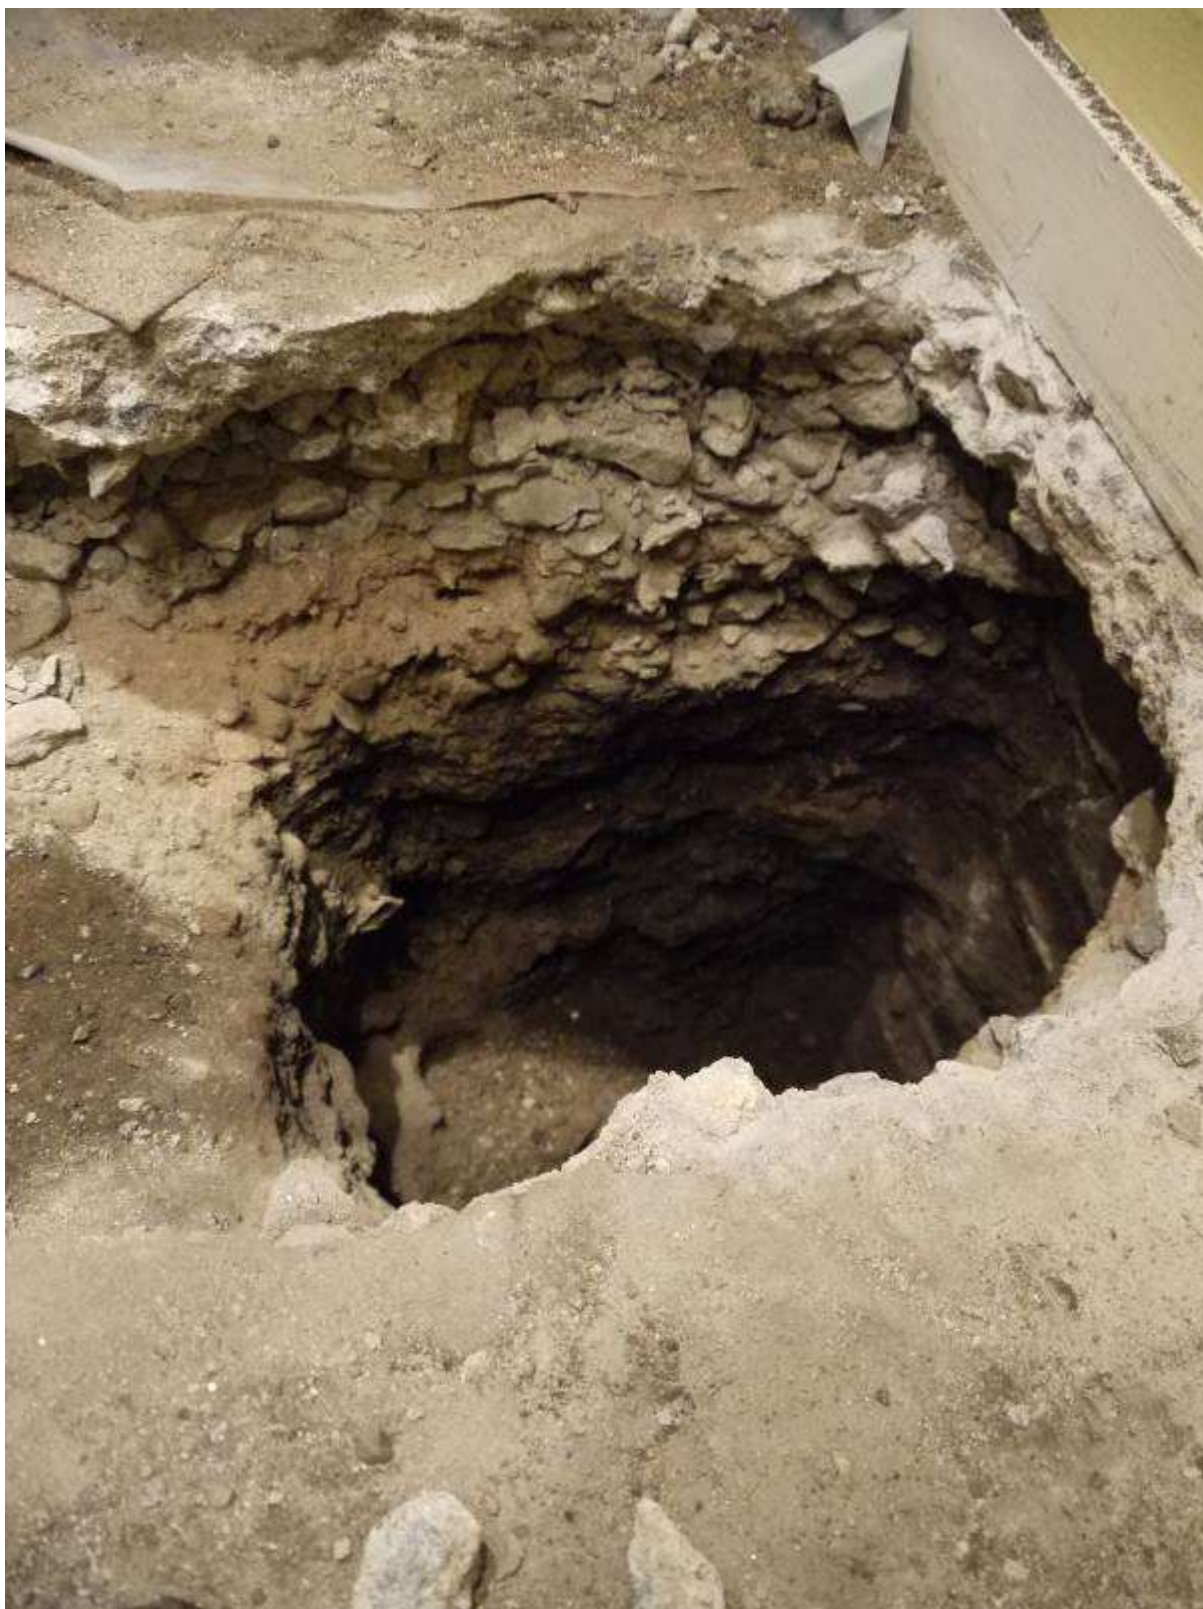
Illustration 26 TP4 excavated to base of wall foundation and natural ground surface looking west

This was dug inside the Art Gallery staff room against one of the internal walls and measured 0.50m by 0.55m. A layer of concrete 0.13m thick (1) overlay loose broken stone 0.17m thick (2) which overlay a homogenous grey black sandy clay with occasional stone and brick (3) to a depth of 1.06m.

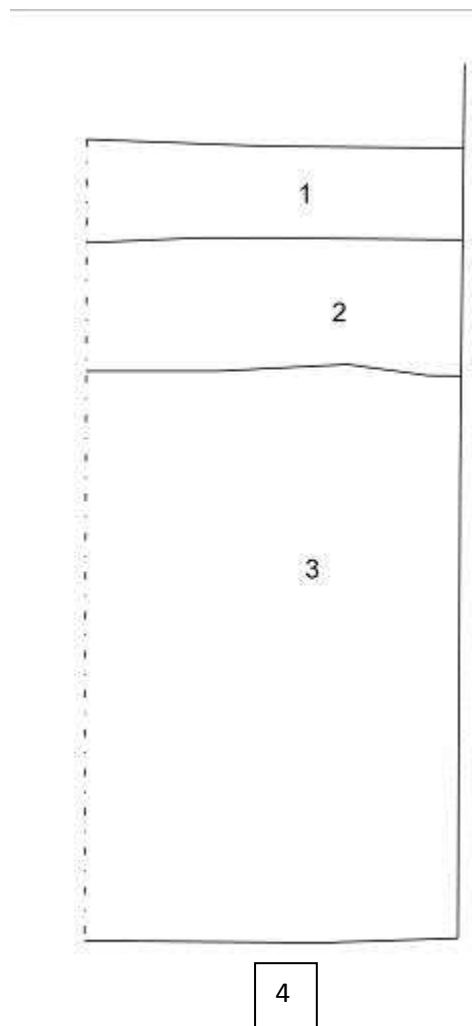
Illustration 27 east facing section of TP4, Aberdeen Art Gallery internal wall to right (Context 4 is natural ground surface)

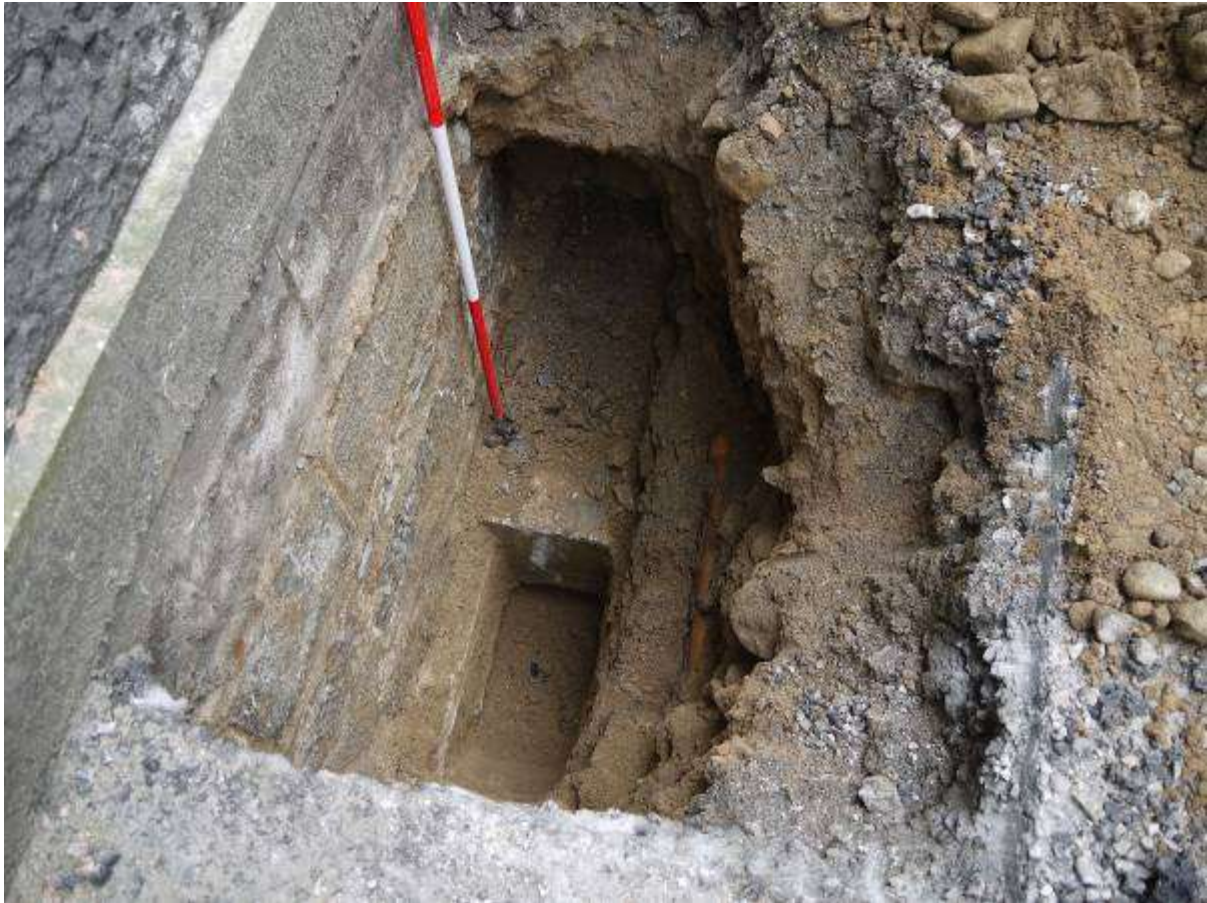
Illustration 29 Machine dug trench against Robert Gordons College in service yard showing deep foundations looking north east

This trench was dug by mechanical excavator against the south facing wall of Robert Gordon's College in the Art Gallery service yard. It measured 1.40m by 1m. A layer of tarmac 0.10m thick (1) overlay 0.25m of grey brown hardcore and gravel (2) which overlay 1.58m of brown sandy clay and stones (3) the base of the wall foundation was reached at 1.93m where it sat on a yellow brown clay (4) (natural). The wall had a stepped foundation at 1.60m. This trench was dug to depth of 2.20m to test the natural deposits. There were no finds.

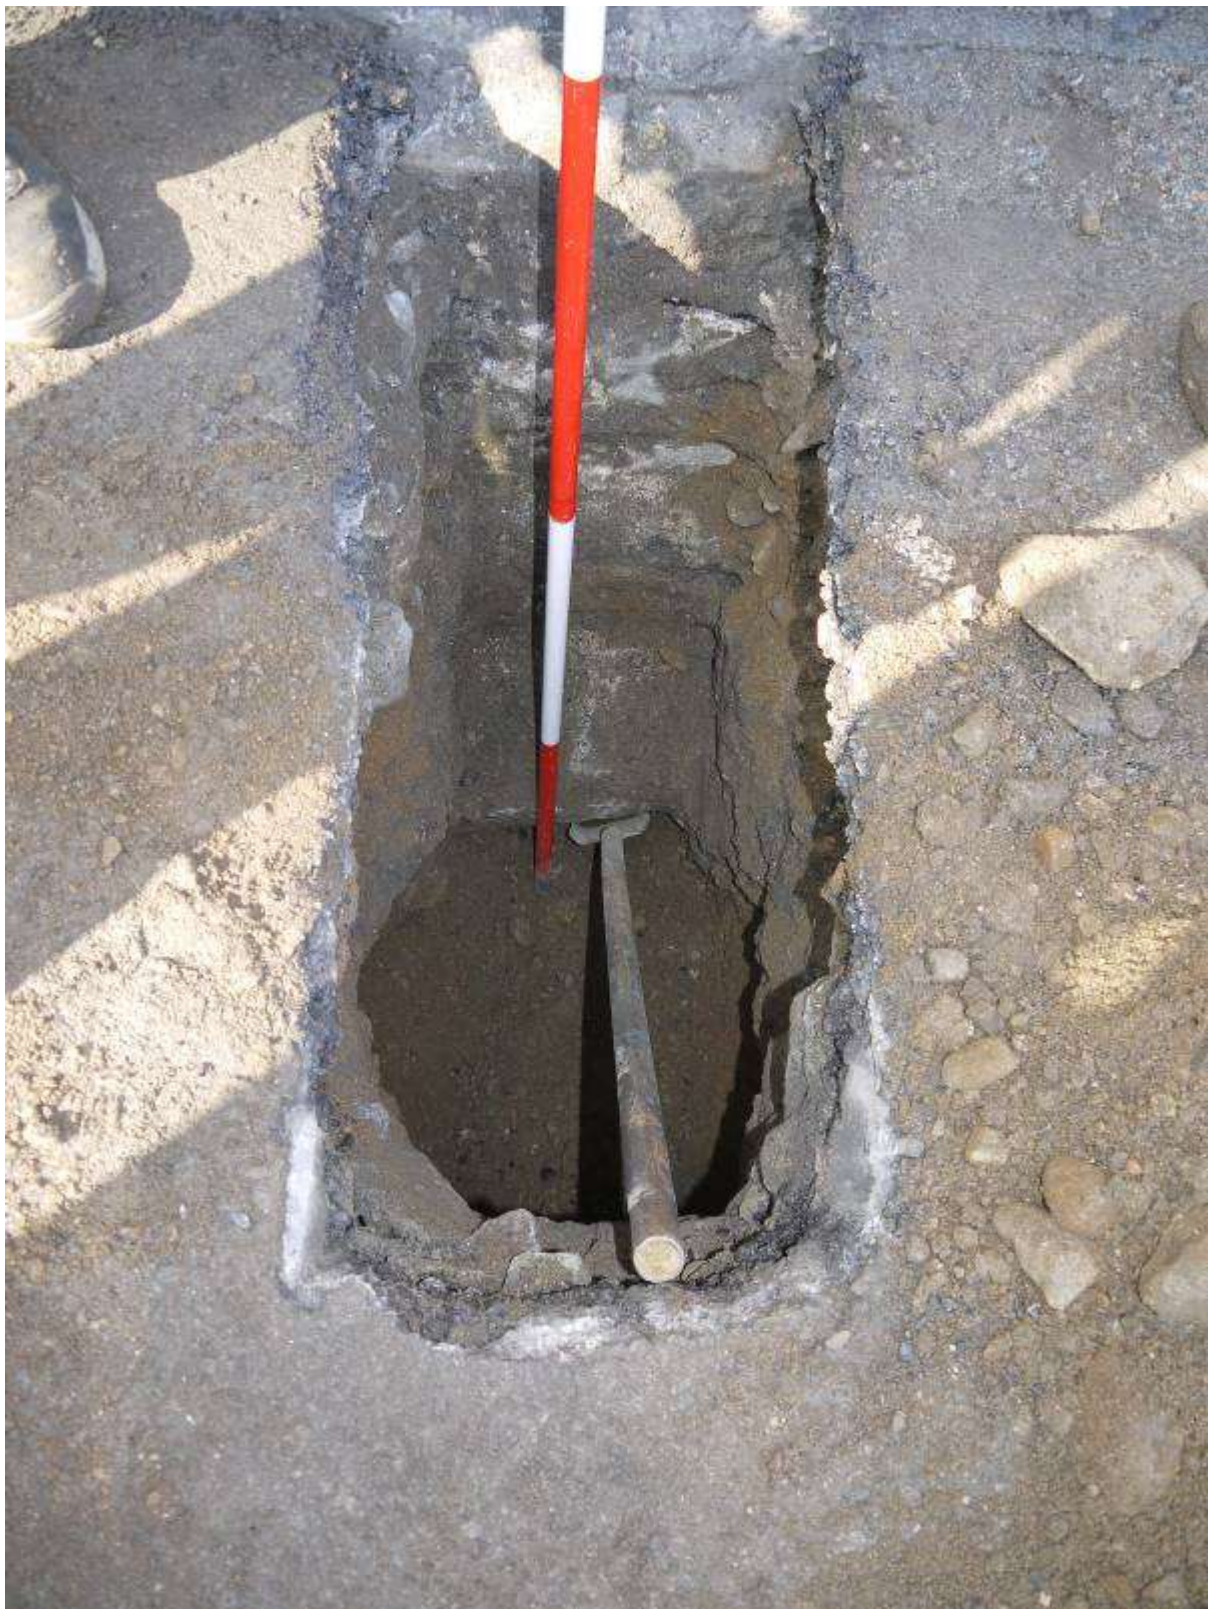
Illustration 31 machine dug trench against east wall of AAG (TPSof3) showing base of foundation

This trench was dug by mechanical excavator to the south of STP 3 against the eastern wall of the Art Gallery. It measured 1m E-W by 0.37m N-S. A layer of tarmac 0.10m thick (1) was removed to reveal 0.18m of grey brown silty clay and stone (2) which overlay 0.20m of orange brown gravel and stone (3) which overlay 0.80m of grey brown sandy clay and occasional stone (4). A layer of gravel and stone (natural) (5) was reached at a depth of 1.5m. The Art Gallery wall has a stepped wall foundation at 0.70m (0.30m wide). A fragment of human leg bone (fibula) was recovered from context 4. An initial trial pit in this area by Raeburn was dug with no archaeological supervision and recovered another two fragments of bone, both of these are pieces of animal bone from a sheep and a cow respectively.

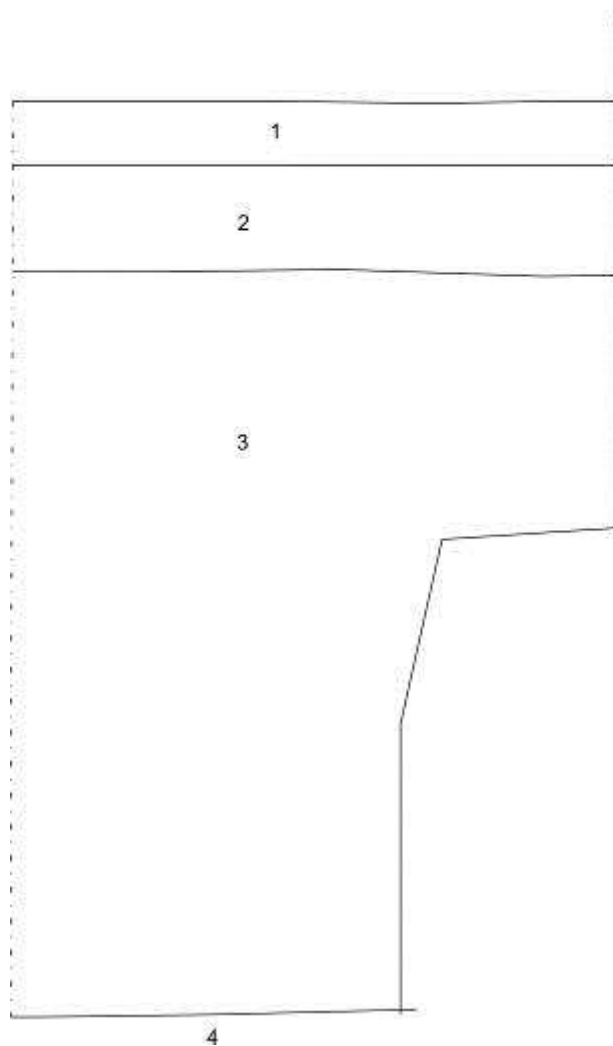
Illustration 32 north facing section of machine dug test pit against eastern wall of Art Gallery (human bone from context 3), context 4 is natural ground surface Scale 1:10

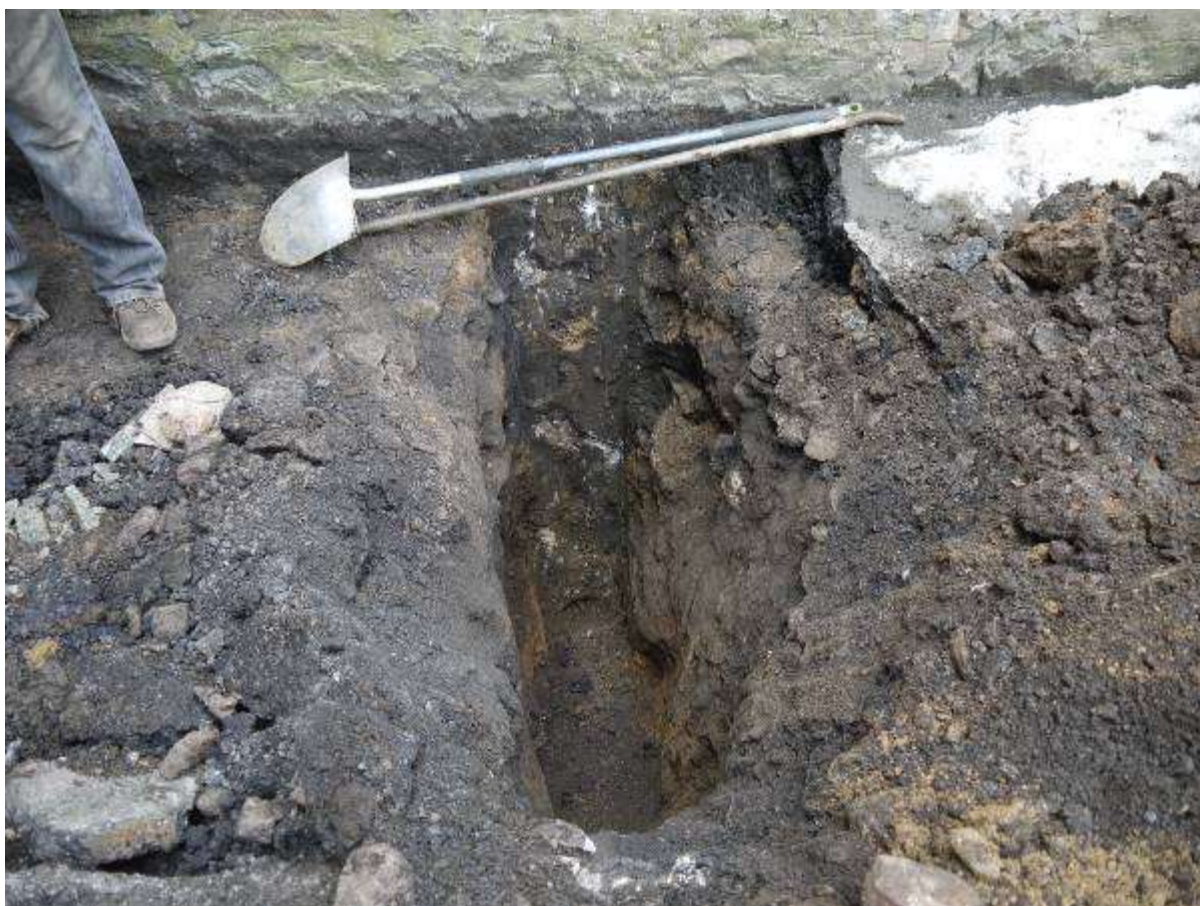
Illustration 33 Machine dug test pit against Robert Gordon's College retaining wall in car park dug to base of wall foundation and natural ground surface looking west

This was dug by mechanical excavator against the eastern face of the retaining wall in the Robert Gordons College car park and measured 2m by 0.70m. A layer of tarmac 0.30m thick (1) was removed to reveal a grey brown sandy clay with stone 1.20m thick (2). A deposit of brown sandy clay and stones (natural) (3) was reached at a depth of 1.5m.

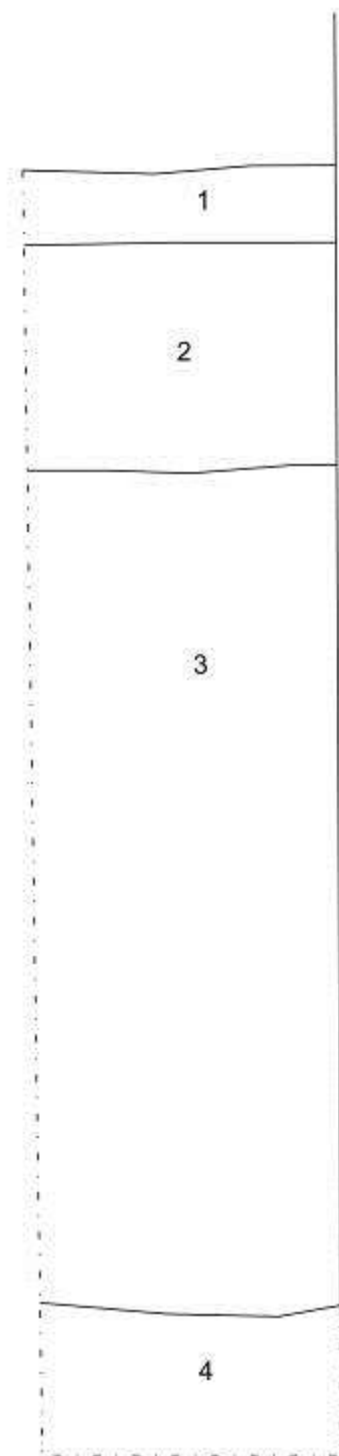
Illustration 34 north facing section of machine dug trench against Robert Gordon's College retaining wall in car park (B on Illus 3)

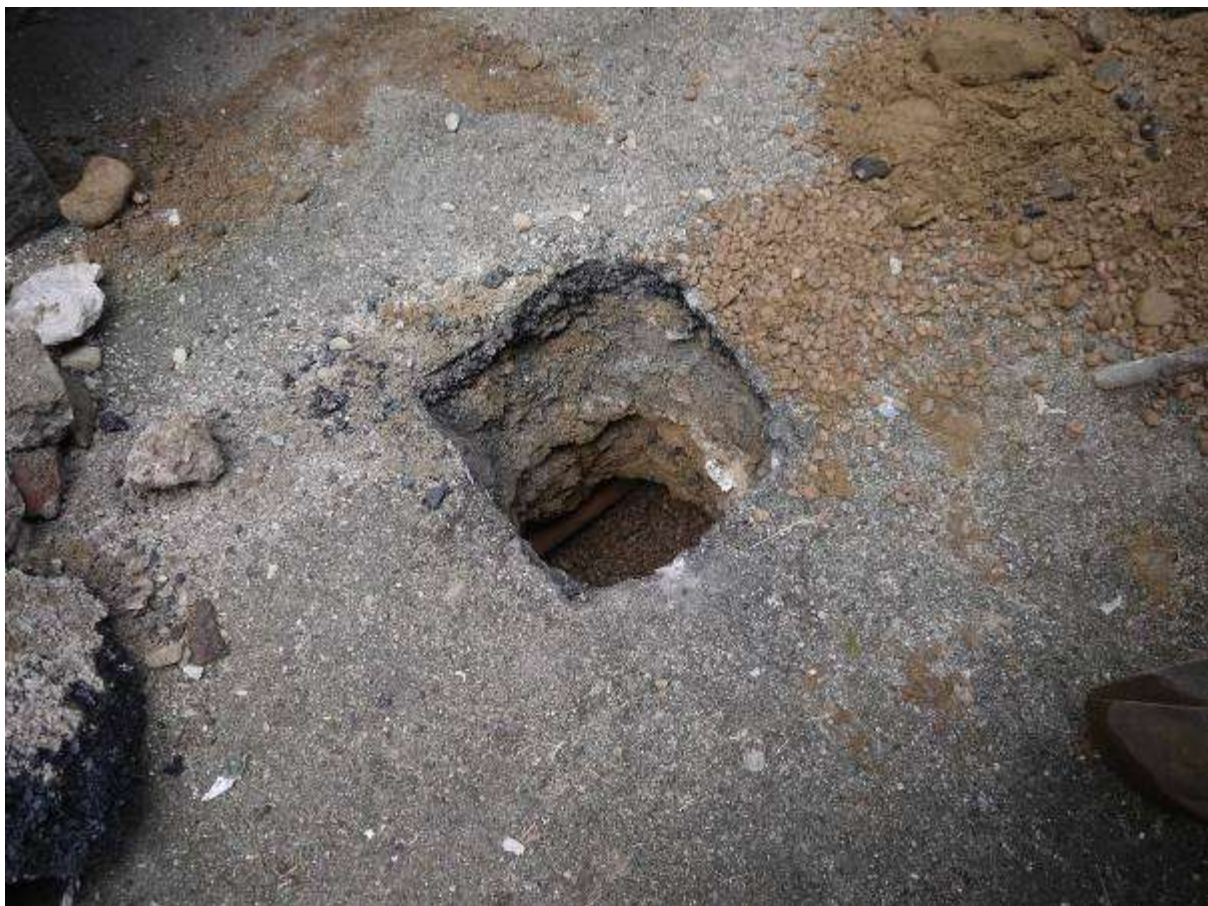
Illustration 36 WS1 totally excavated looking north west

This was hand dug in the Art Gallery service yard in advance of a borehole and measured 0.40m by 0.40m. A layer of tarmac 0.10m thick (1) was removed to expose 0.48m of grey brown hardcore (2) which overlay loose gravel to depth of 1.2m (3). A ceramic pipe was located at a depth of 0.60m. There were no finds.
