Archaeological Watching Brief
on further engineers test pits
Aberdeen Art Gallery and Robert Gordon's
College, Schoolhill, Aberdeen

9th May 2013

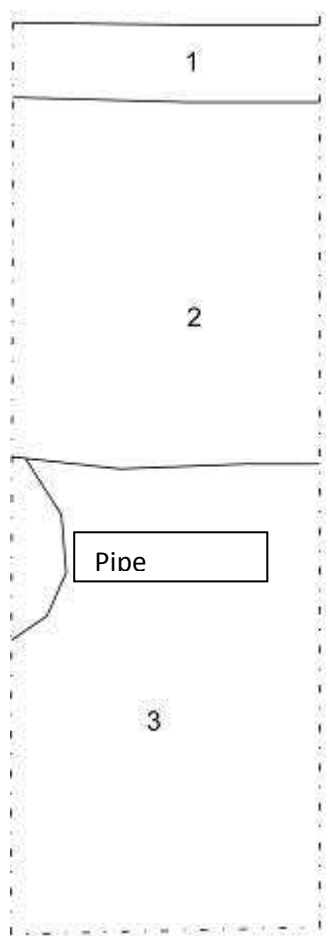
Illustration 37 south facing section of WS1 test pit Scale 1:10

This was hand dug in the Art Gallery service yard in advance of a borehole and measured 0.40m by 0.40m. A layer of tarmac 0.10m thick (1) was removed to expose 0.48m of grey brown hardcore (2) which overlay loose gravel to depth of 1.2m (3). A ceramic pipe was located at a depth of 0.60m. There were no finds.

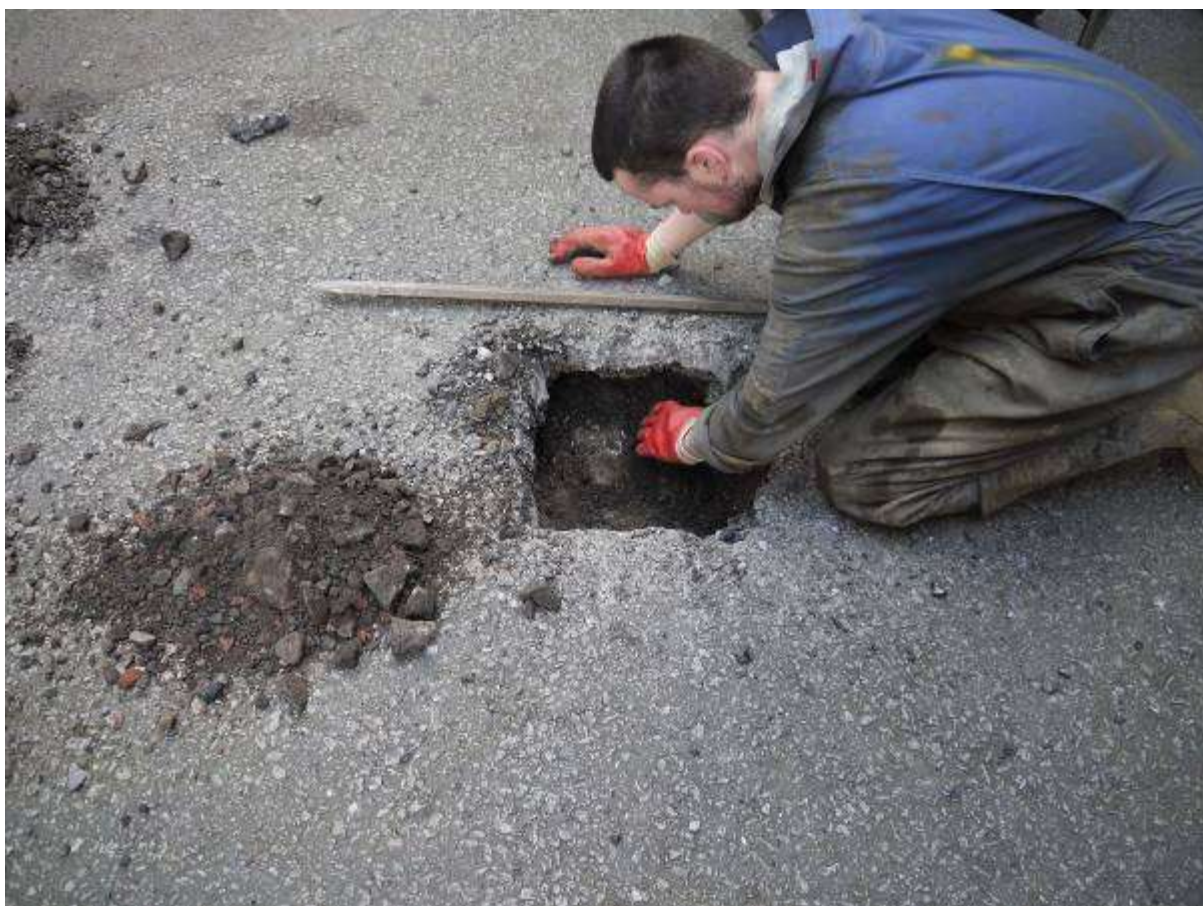
Illustration 39 BH1 test pit cobble layer (3) becoming visible looking east

A layer of tarmac 0.08m thick (1) overlay a deposit of hardcore 0.11m thick (2) which overlay a surface of laid stone cobbles 0.29m thick (3) which overlay 0.30m of dark brown silty clay and frequent stone (4) which sealed a ceramic drain pipe at depth of 0.93m. This pit was abandoned and backfilled.

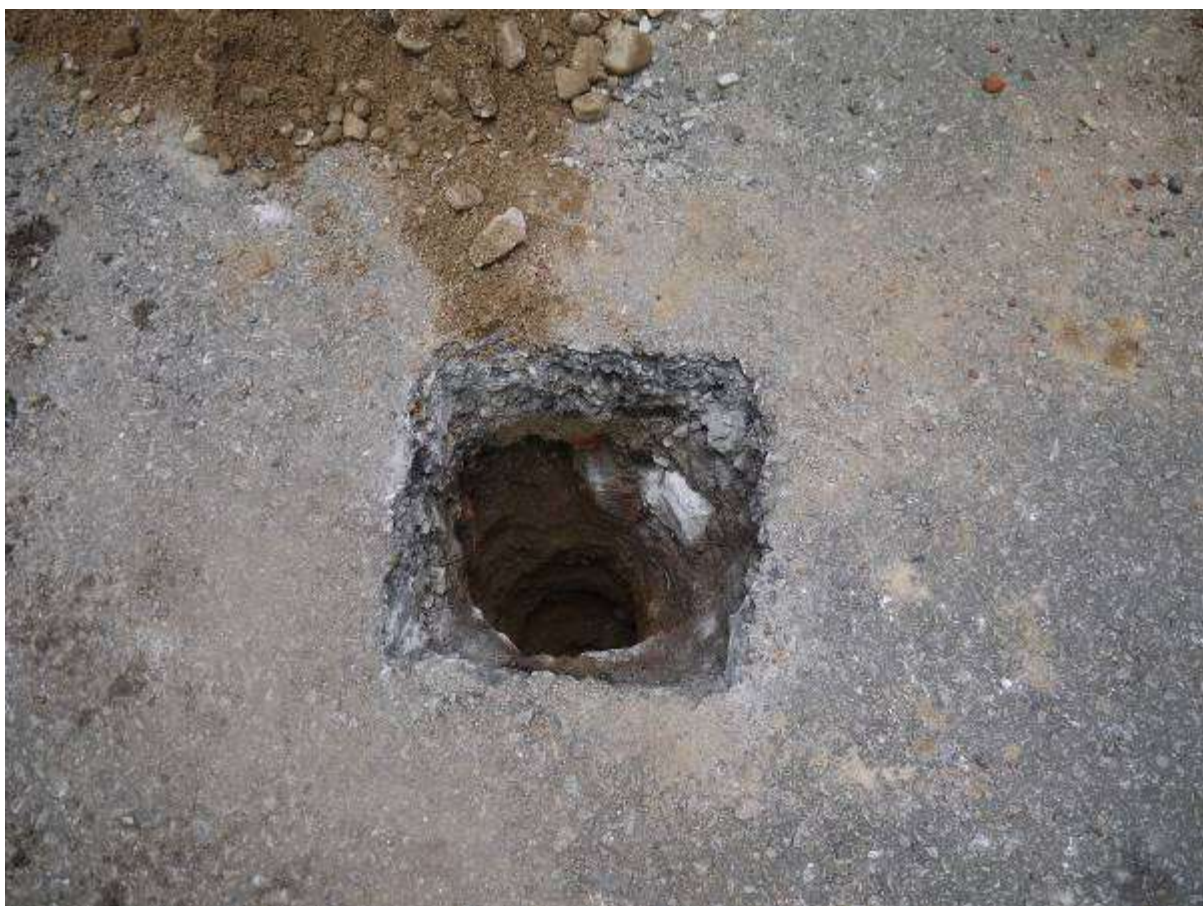
Illustration 40 BH1 test pit 2 totally excavated cobble layer 3 visible in section looking east

A layer of tarmac 0.12m thick (1) overlay a deposit of hardcore 0.10m thick (2) which overlay a surface of laid stone cobbles 0.28m thick (3) which overlay a light brown sandy gravel and stone 0.10m thick (4) a yellow brown sandy clay and stone (natural) (5) was reached at a depth of 0.60m. The pit was dug to 1.2m to check the natural deposits. There were no finds.

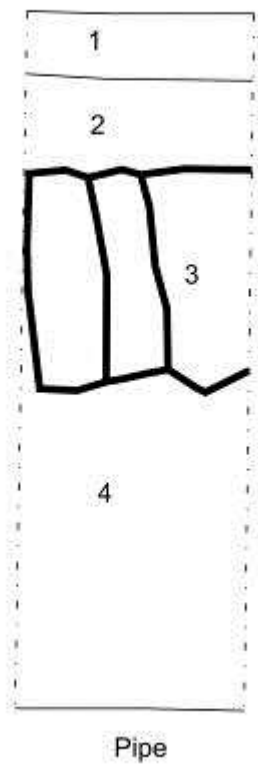
Illustration 41 west facing section of BH1 test pit 1 Scale 1:10

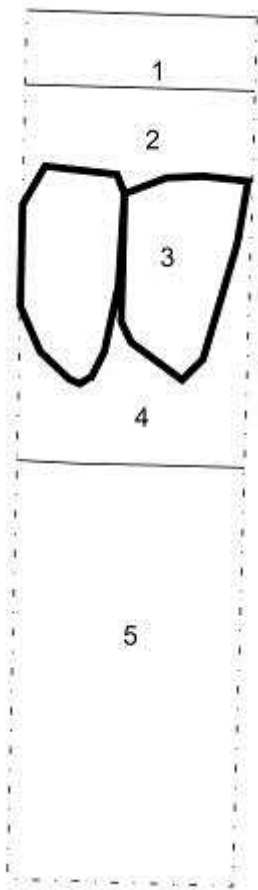
Illustration 42 west facing section of BH1 test pit 2 (Context 5 is natural ground surface) Scale 1:10

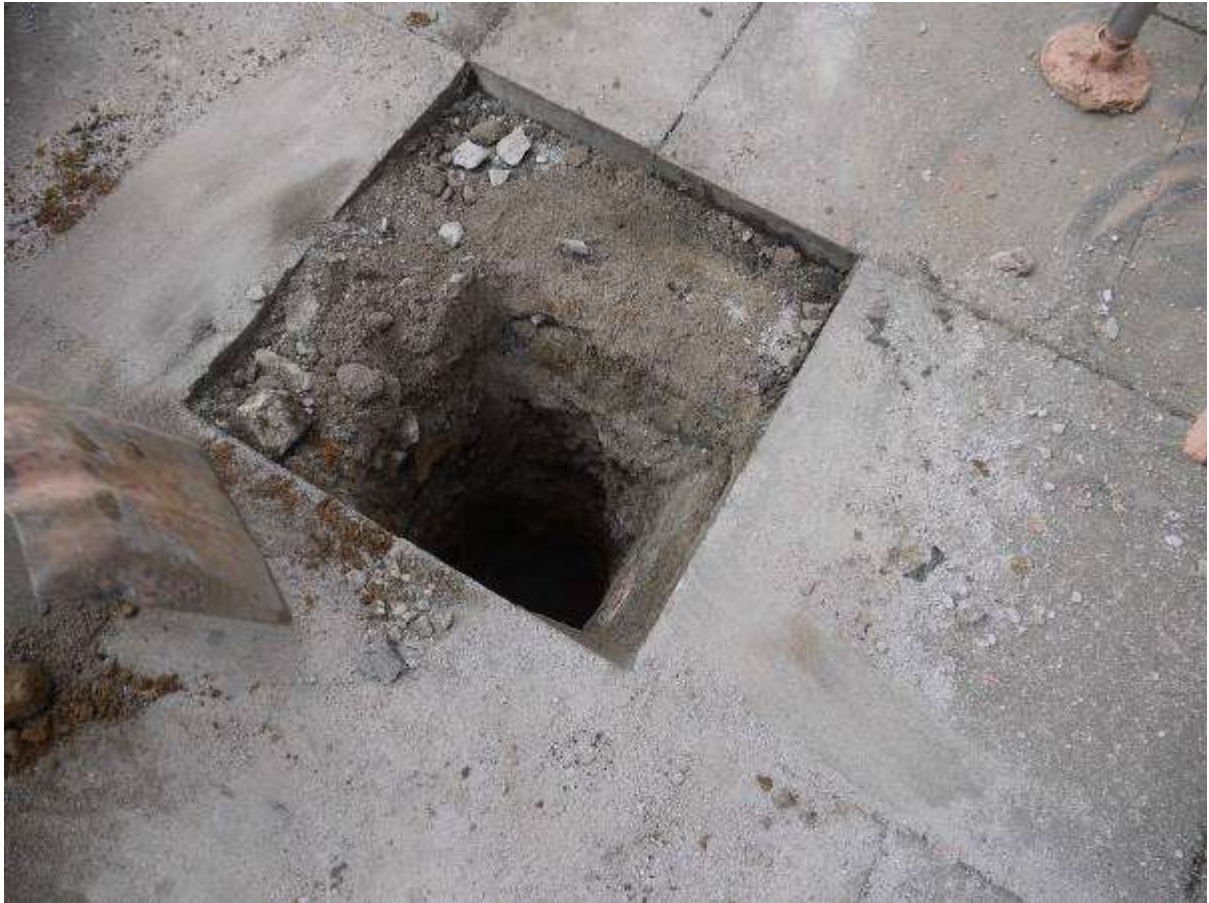
Illustration 44 BH4 test pit totally excavated looking west

This pit was dug outside the front of the Art Gallery and measured 0.60m by 0.40m. A stone slab 0.07m thick (1) overlay 0.45m of concrete stone and gravel (2) which overlay a light brown silty clay and stone (natural) (3) at 0.52m. This pit was dug to 1.10m to check the natural deposits, there were no finds.

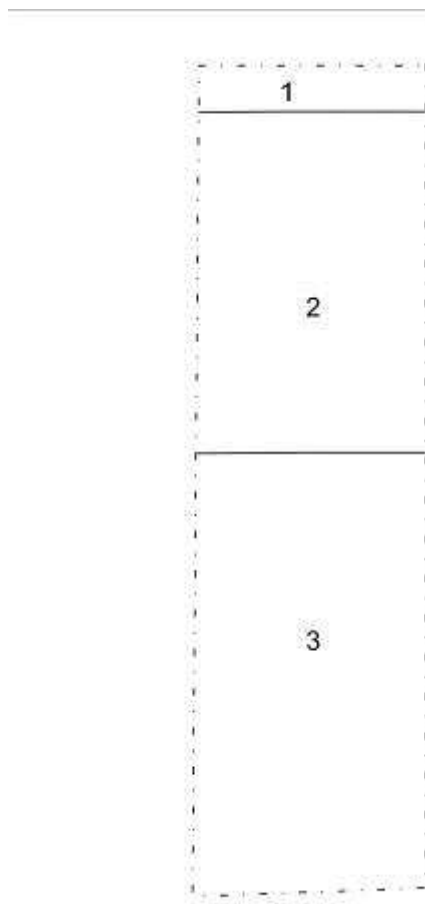
Illustration 45 south facing section of BH4 test pit (context 3 is natural ground surface) Scale 1:10

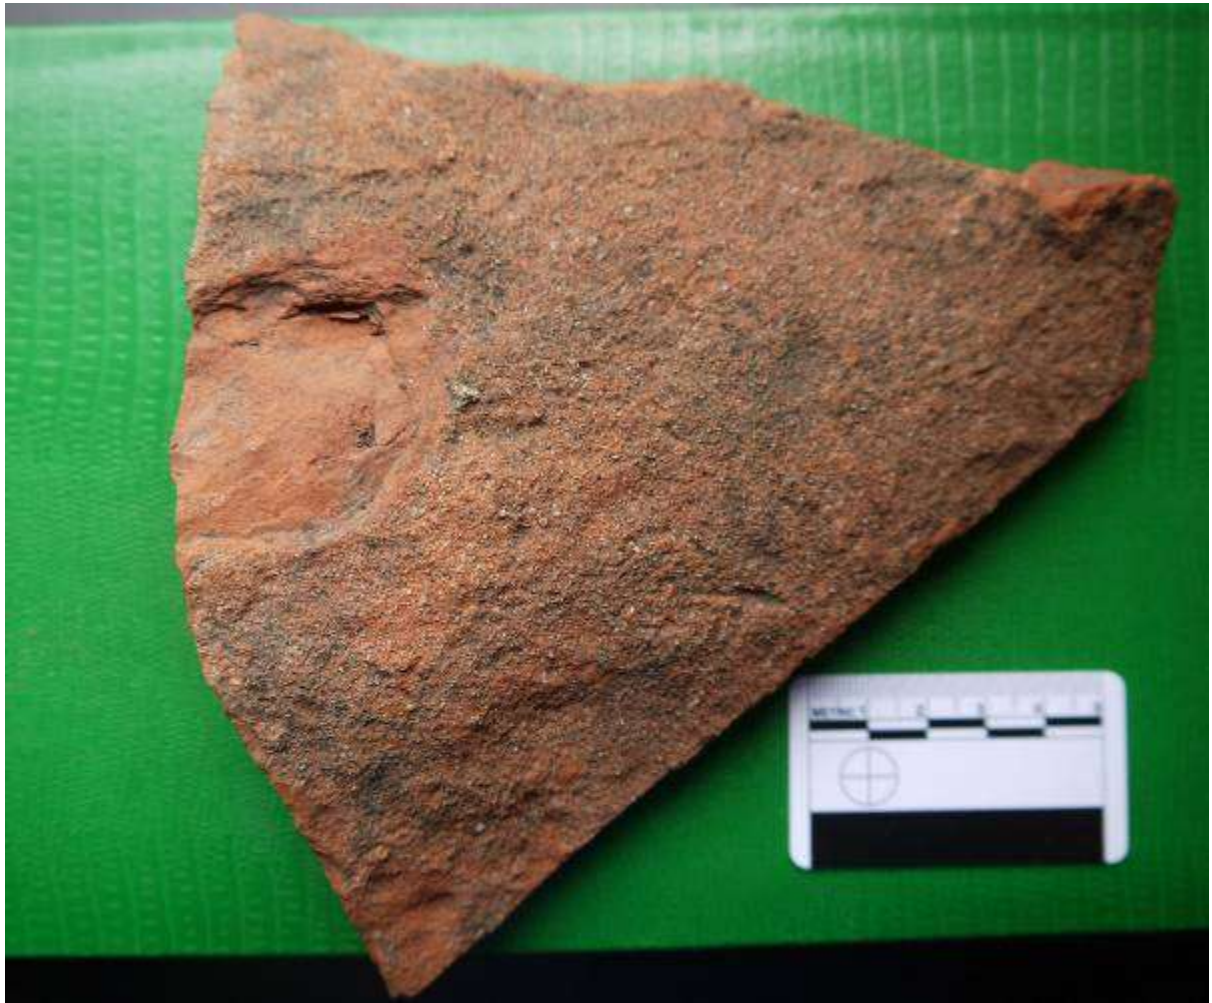
Illustration 47 Piece of mortared building stone from machine dug test pit against east wall of Art Gallery (TPSof3)

This trench was dug by mechanical excavator to the south of STP 3 against the eastern wall of the Art Gallery. It measured 1m E-W by 0.37m N-S. A layer of tarmac 0.10m thick (1) was removed to reveal 0.18m of grey brown silty clay and stone (2) which overlay 0.20m of orange brown gravel and stone (3) which overlay 0.80m of grey brown sandy clay and occasional stone (4). A layer of gravel and stone (natural) (5) was reached at a depth of 1.5m. The Art Gallery wall has a stepped wall foundation at 0.70m (0.30m wide). A fragment of human leg bone (fibula) was recovered from context 4. An initial trial pit in this area by Raeburn was dug with no archaeological supervision and recovered another two fragments of bone, both of these are pieces of animal bone from a sheep and a cow respectively.
